ELECTRICAL SAFETY INSPECTION REPORT

LOGOS APPARELS LTD (BUILDING 4)

Telirchala, Mouchak, Kaliakoir, Gazipur

Inspected on: **November 25, 2020**

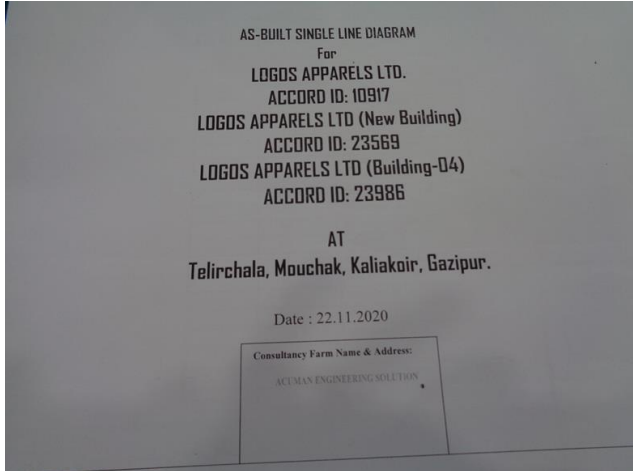
FINDING NO:	E - 1

CATEGORY:	DOCUMENTATION	
FINDING:	Field information has no/less reflection in existing SLD.	
RECOMMENDATION:	Electrical SLD must be updated properly; all the required information must be mentioned there; and it shall be updated when you do substantial amount of changes of your electrical system.	
PRIORITY:	P2	
REMEDIAION TIME FRAME:	2 MONTHS

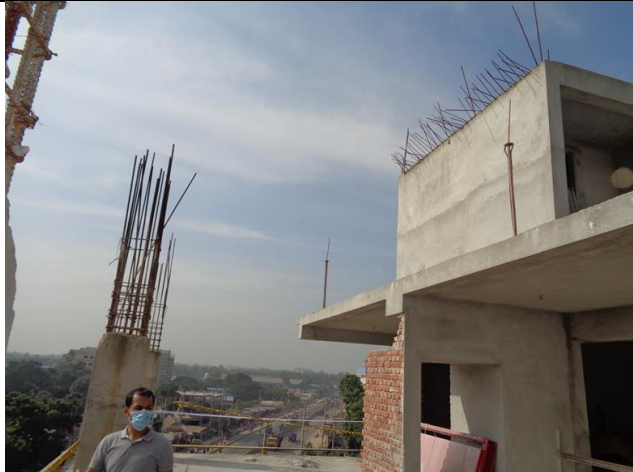
FINDING NO:	E - 2

CATEGORY:	LIGHTNING PROTECTION SYSTEM	
FINDING:	Lightning Protection System (LPS) installation is not completed. LPS design is not as built.	
RECOMMENDATION:	Factory must design Lightning Protection System (LPS) for the whole factory (where the Risk index is more than 40). Once a LPS is designed properly, installation must be done accordingly asap.	
PRIORITY:	P1	
REMEDIAION TIME FRAME:	2 MONTHS
