# **FIRE SAFETY INSPECTION REPORT**

**SHOVON KNITWEAR LIMITED**  
**WEST MASDAIR, FATULLAH, NARAYANGANJ,**  
**BANGLADESH**

**ACCORD**  
on Fire and Building Safety in Bangladesh

May 14, 2014

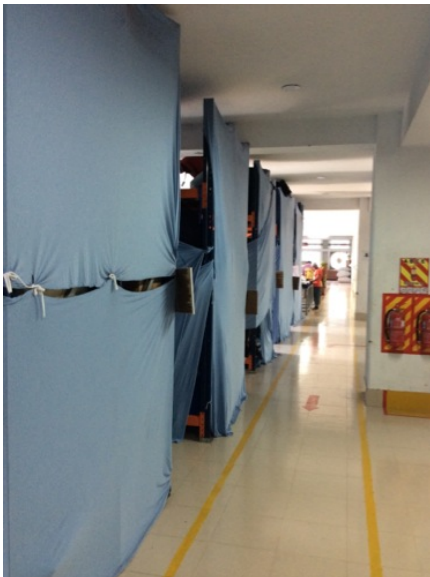
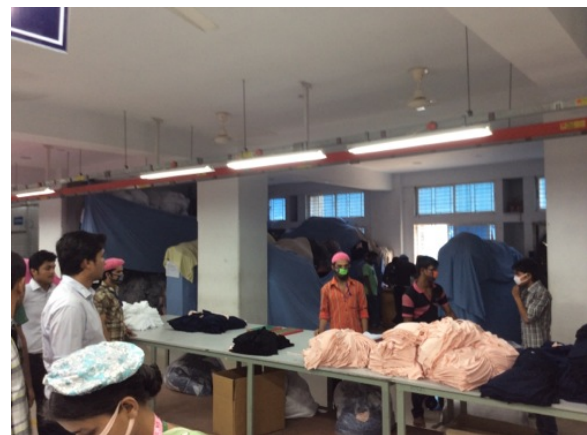
| No. | Category | Finding | Recommendation | Remediation Timeframe |
|---|---|---|---|---|
| F-1 | Fire Rated Construction | Areas used for combustible storage on the 1st floor are not separated by fire-rated construction. | <p>Provide dedicated storage rooms separated by minimum 1-hr fire-rated construction.</p> <p>Where separate storage rooms are not feasible, provide defined storage areas and limit the storage arrangement as follows:</p> <ul style="list-style-type: none"> <li>- Maximum height of 2.4m and maximum area of 23m<sup>2</sup></li> <li>- If sprinkler protected: maximum height of 3.66m and maximum area of 93m<sup>2</sup></li> </ul> <p>Separate areas of unenclosed combustible storage by a minimum clear distance of 3m.</p> | Within 3 months |

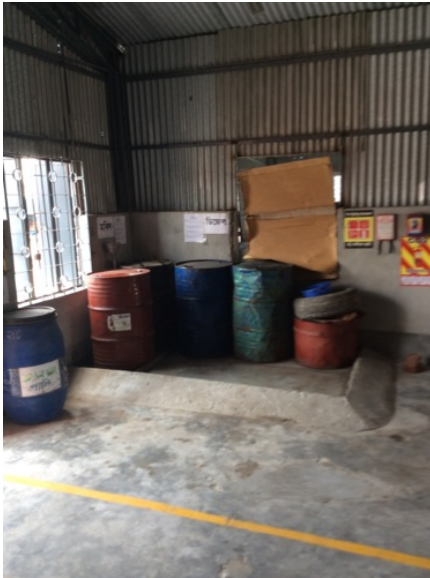
| F-2 | Fire Rated Construction | Diesel drum storage area in the generator room is not separated by fire-rated construction (openings, non-rated doors, penetrations). | Separate the diesel drum storage area by a minimum 2-hr fire-rated construction. | Within 3 months |

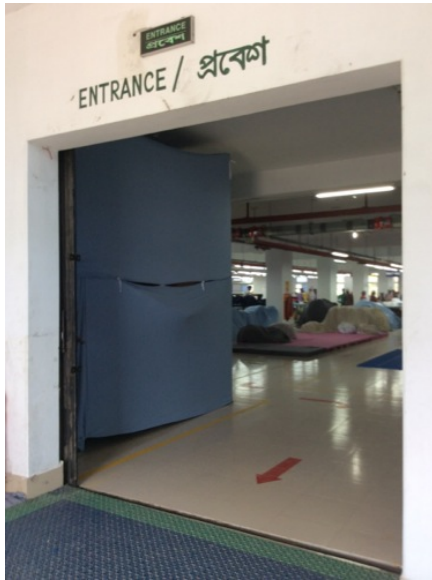
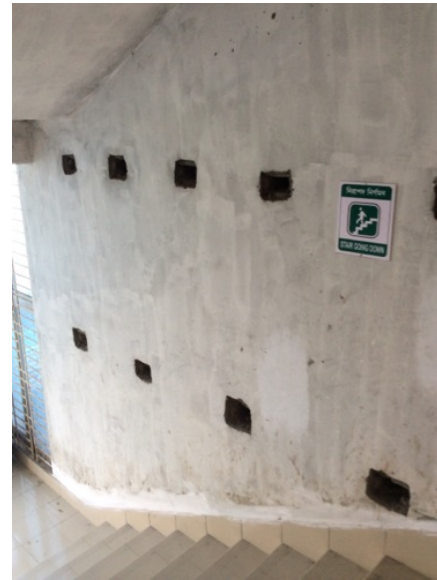
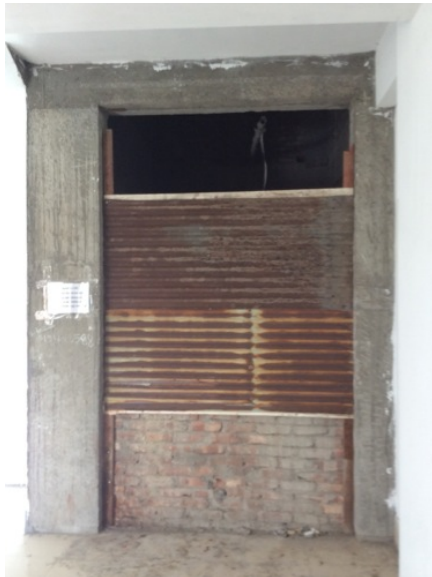
| F-3 | Fire Rated Construction | The exit stairs are not separated from work areas and elevator shaft on each floor by fire-rated construction. | <p>Provide minimum 1.5-hr fire rated doors and seal all unprotected openings to separate the exit stairs from work areas and elevator shaft on all floor levels. Ensure that the fire doors are self-closing and positive latching and that they are provided with fire exit (panic) hardware where serving production floors.</p> <p>If fire doors are required to be held open for functional reasons, provide automatic-closing devices tied to the fire alarm system.</p> | Within 3 months |

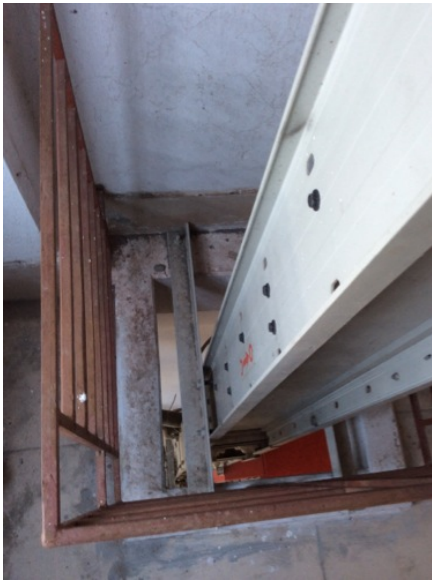
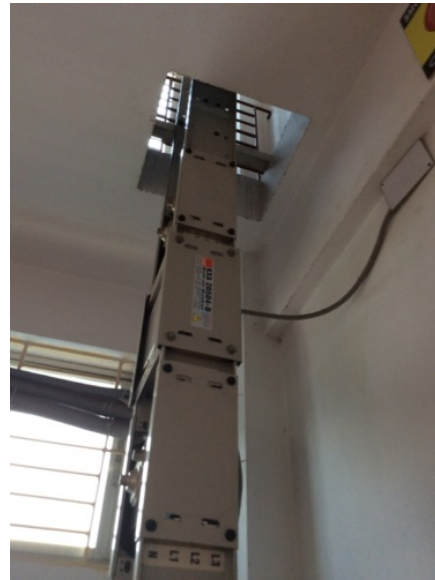
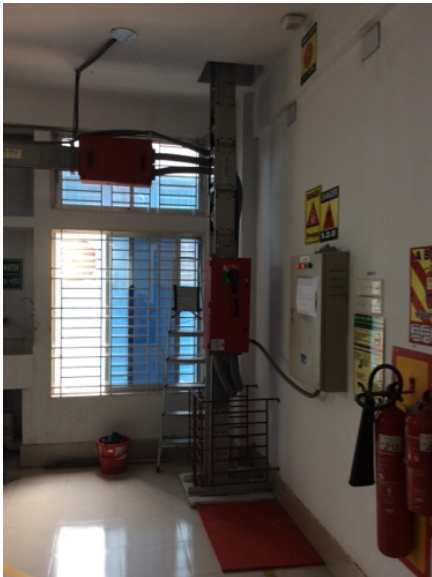
| F-4 | Fire Rated Construction | Unsealed penetrations and openings are located in the fire-rated floor/ceiling assemblies on each floor. | Provide a minimum 2-hr fire-rated shaft to separate the electric shafts from each floor level. | Within 3 months |

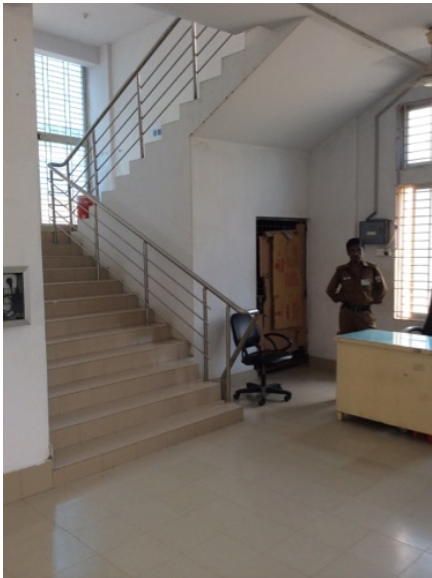
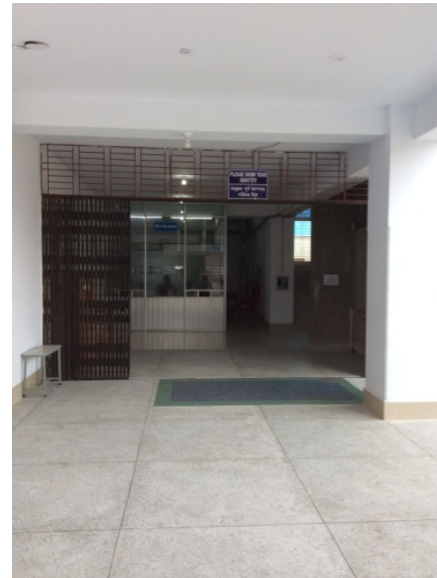
| F-5 | Fire Rated Construction | The northwest exit stairwell to ground floor is not enclosed in fire rated construction. | Provide 2-hr continuous exit stairwell enclosure to exterior ground floor. | Within 3 months |

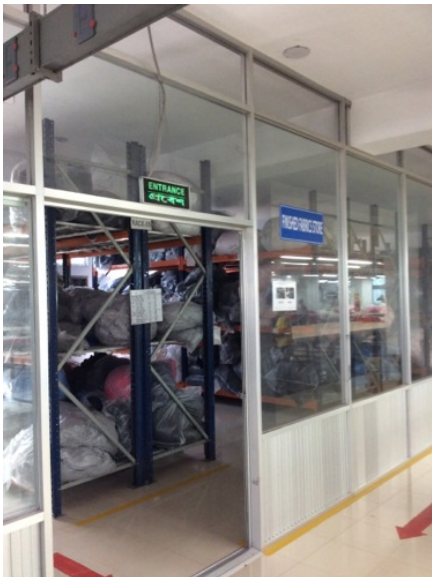
| F-6 | Fire Rated Construction | Rooms used for combustible storage on the 1st floor are not separated by fire-rated construction. | Provide dedicated storage rooms separated by minimum 1-hr fire-rated construction. | Within 3 months |

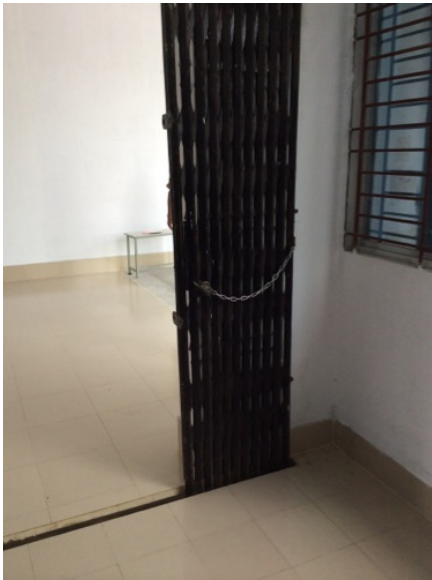
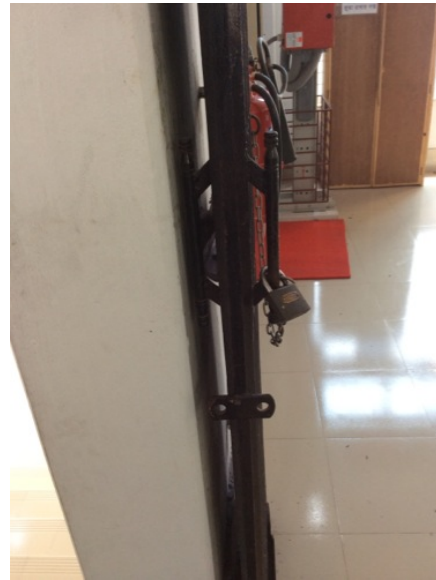
| F-7 | Egress | Egress doors and gates with locking features are provided at exit stairs and exit discharge. | <p>Remove locking features from all egress doors and gates.</p> <p>If locks are required for security reasons, utilize special door locking features complying with NFPA 101.</p> | Immediate |

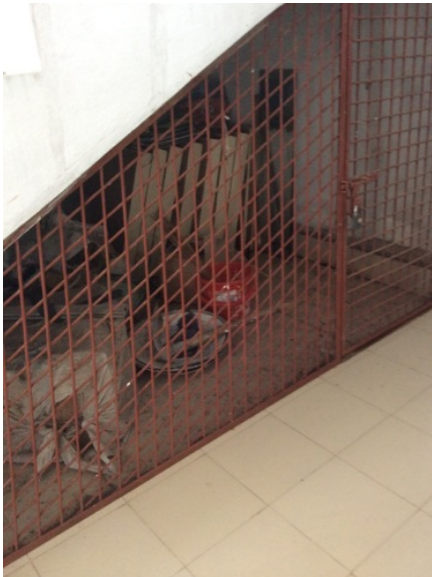
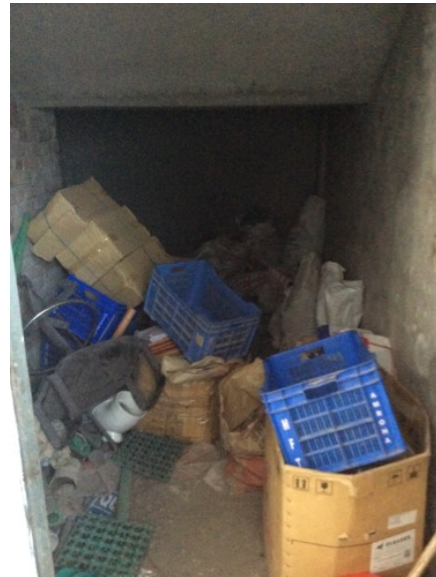
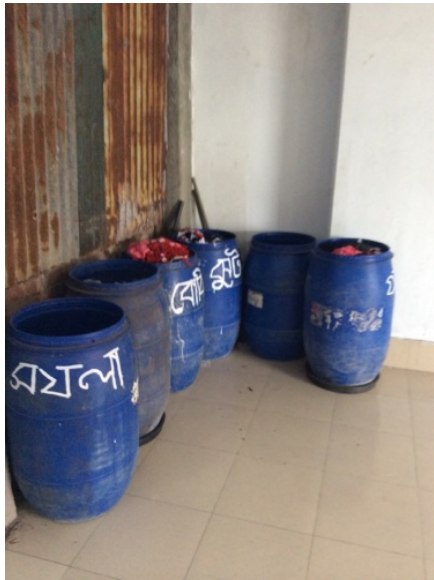
| F-8 | Egress | Storage was located in the northwest and northeast exit stairs. | Remove all storage from exit stairs and egress paths. | Immediate |

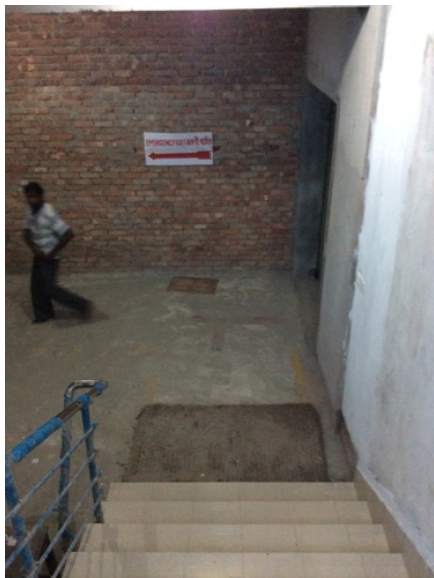
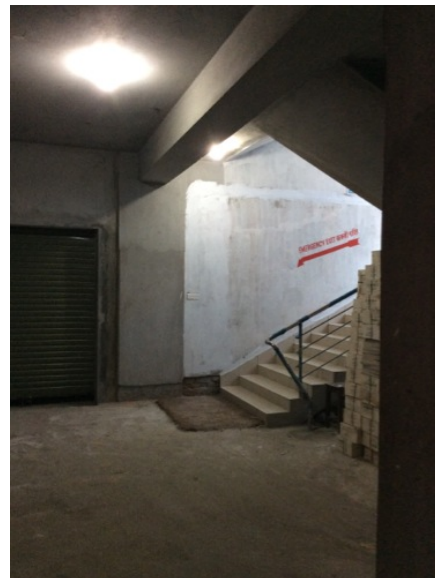
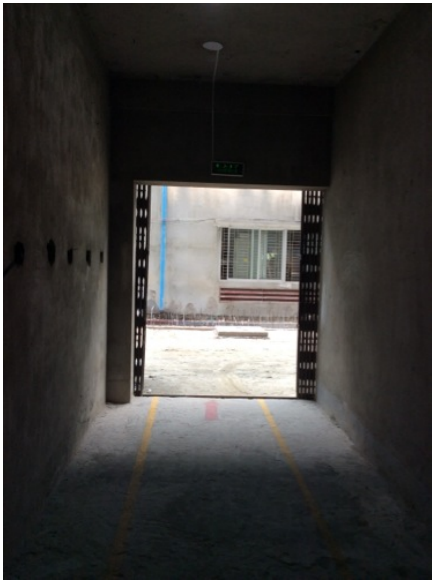
| F-9 | Egress | Southwest exit stair discharge inside the building on the ground floor. | Provide 2-hr fire-rated exit passageway leading directly outside (vestibules to separate any storage areas) or Provide sprinkler protection for discharge floor in accordance with NFPA 13. | Within 6 months |

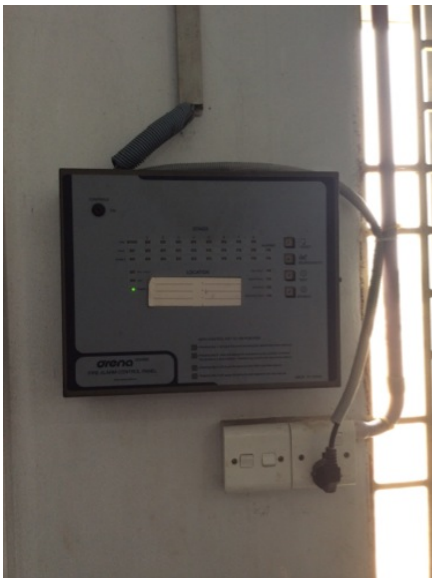
| F-10 | Fire Protection | The fire alarm system is antiquated, not a listed system, and does not provide alarm and notification features consistent with acceptable standards. | Replace the fire alarm system with a new, listed addressable fire alarm system in accordance with NFPA 72. | Design within 4 months, install within 9 months |

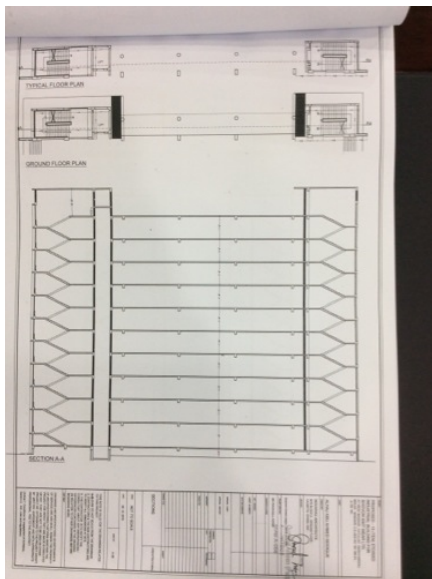
| F-11 | Fire Protection | The high-rise building has an occupied floor greater than 23m (75 ft) and is not provided with automatic sprinkler protection. The large occupant loads, heavy fuel loading, and anticipated extended egress times warrant sprinkler protection. | Provide automatic sprinkler protection throughout the building in accordance with NFPA 13. | Design within 6 months, install within 12 months |
