Sterling Apparels Ltd. Optimum Garments Ltd. Unicorn Sweaters

Baron, Earpur Union, Ashulia, Dhaka
Baron, Earpur Union, Ashulia, Dhaka
(23.936253N, 90.296288E)

12 MARCH 2014

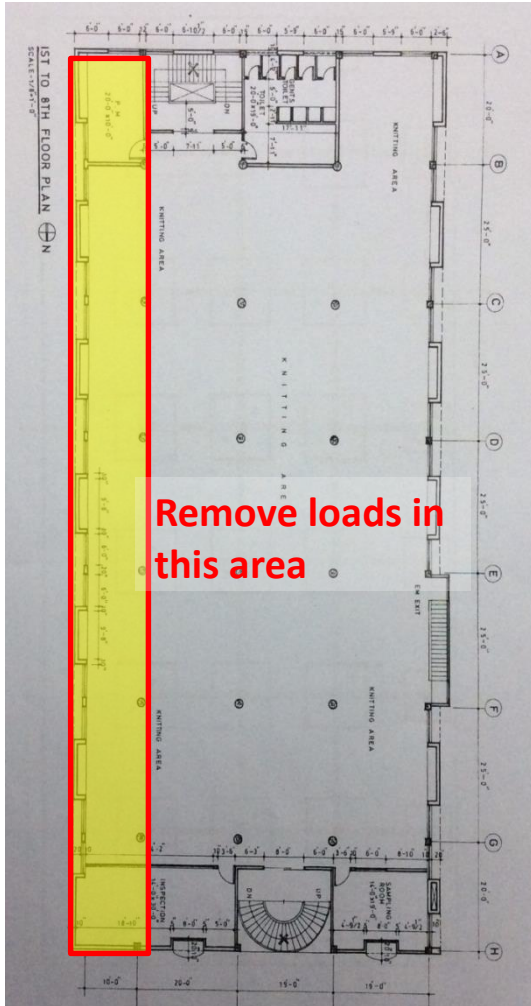
We do have some important concerns with the Main Production Building that need to be addressed immediately. These concerns are due to the following:

- A significant building cantilever imposes high loading on the building perimeter columns.
- Crushed brick aggregate was encountered in columns which does not appear to be consistent with design strength required as noted on the structural drawings

1. All loads, including equipment, garments and personnel, in the area highlighted on levels 1 to 7 are to be removed pending verification of column capacity by the Building Engineer. Maintain Loads in all other areas at current levels.
3. A Detail Engineering Assessment of the as constructed Main Production Building is requested and this should be commenced immediately to the requirements of the scope attached and addressing the concerns as noted. We would recommend that the Detail Engineering Assessment for this building be completed **within 6 weeks** of receiving the report.

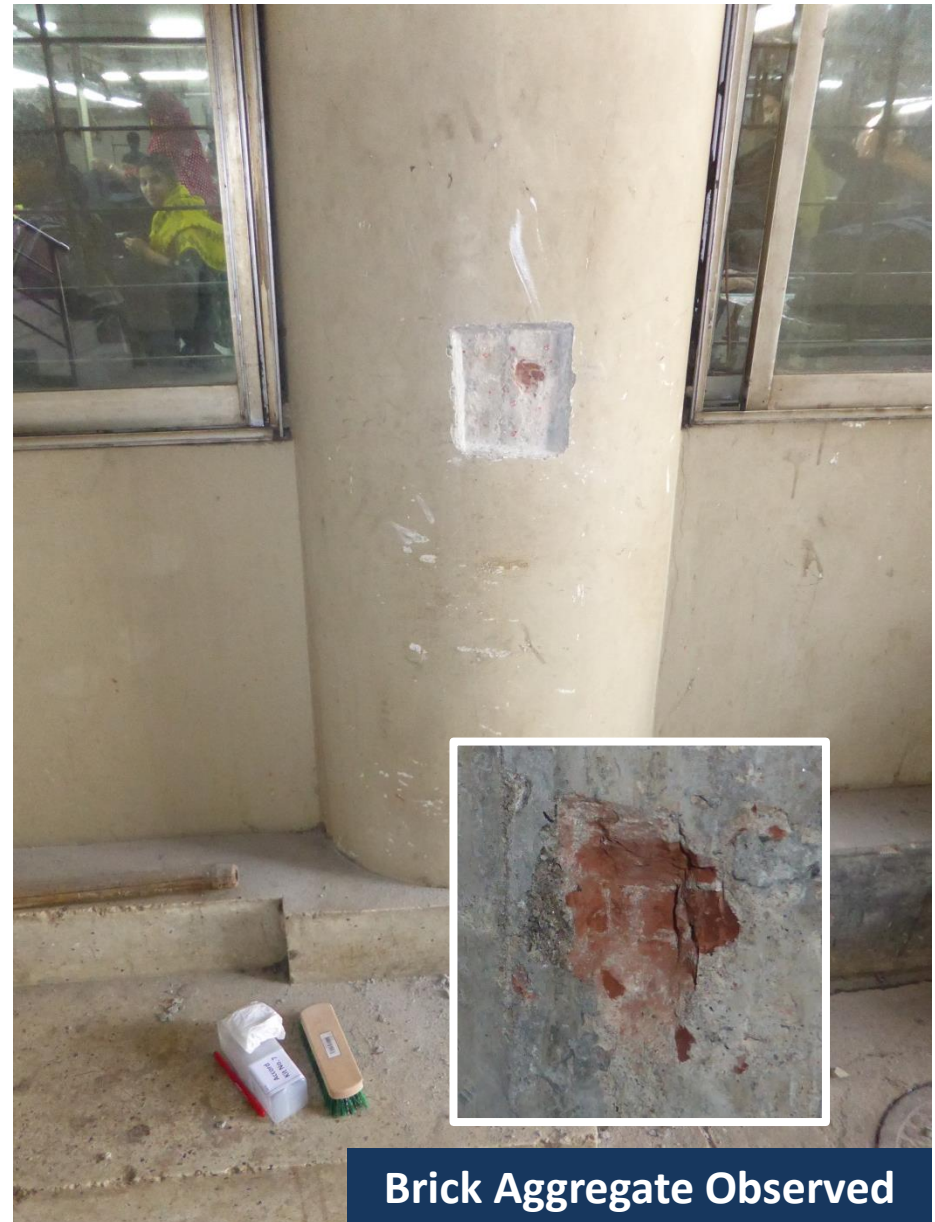
Highly Stressed Column

Cursory calculations indicate column working stress is at high risk level.

Engineer is to perform detailed calculations and concrete tests to prove column size and (if required):

- Reduce loads by vacating floors and removing addition structures
- Reinforce columns

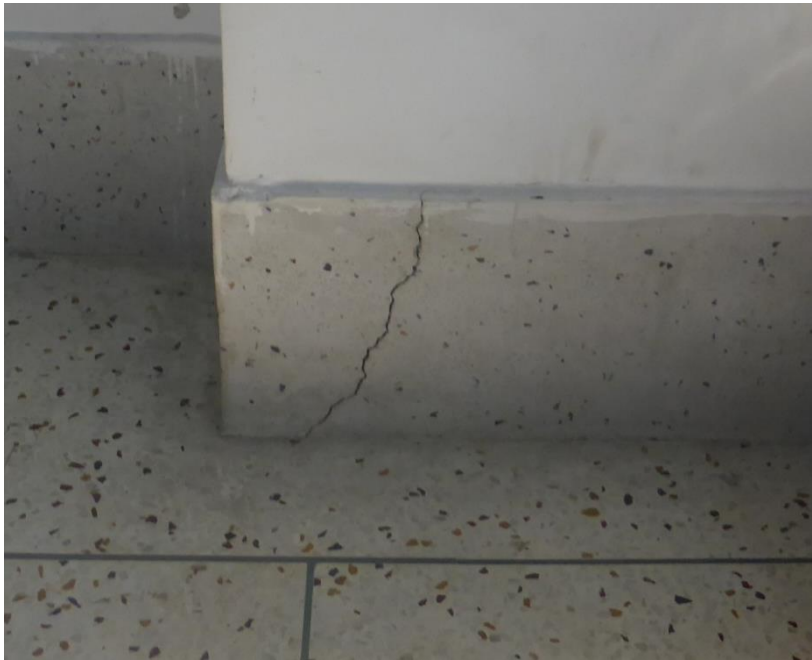
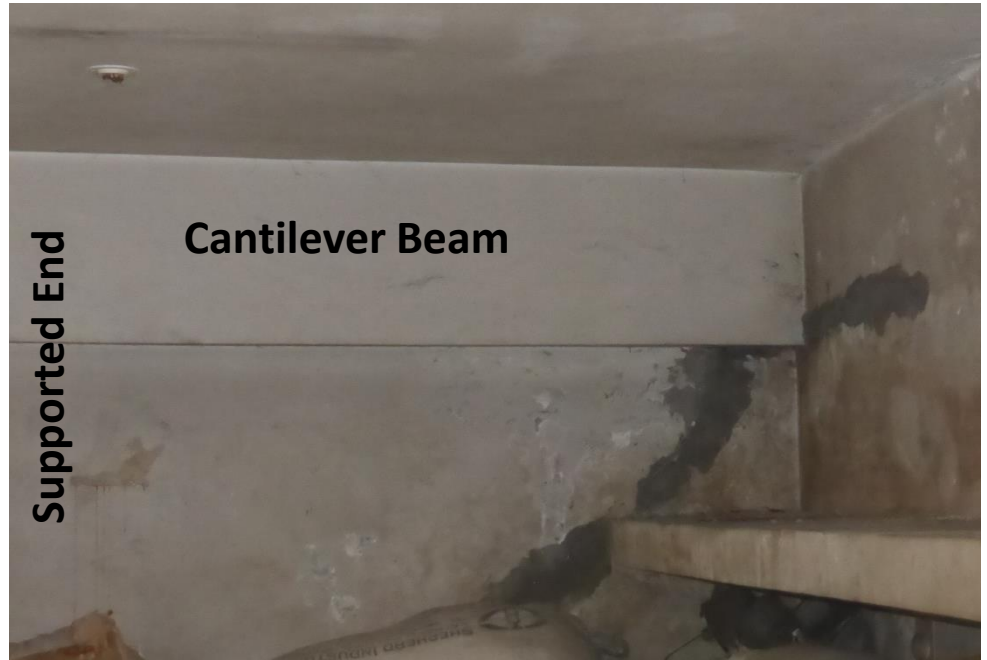
Long Span Cantilever

Cantilever on east façade along full length of building

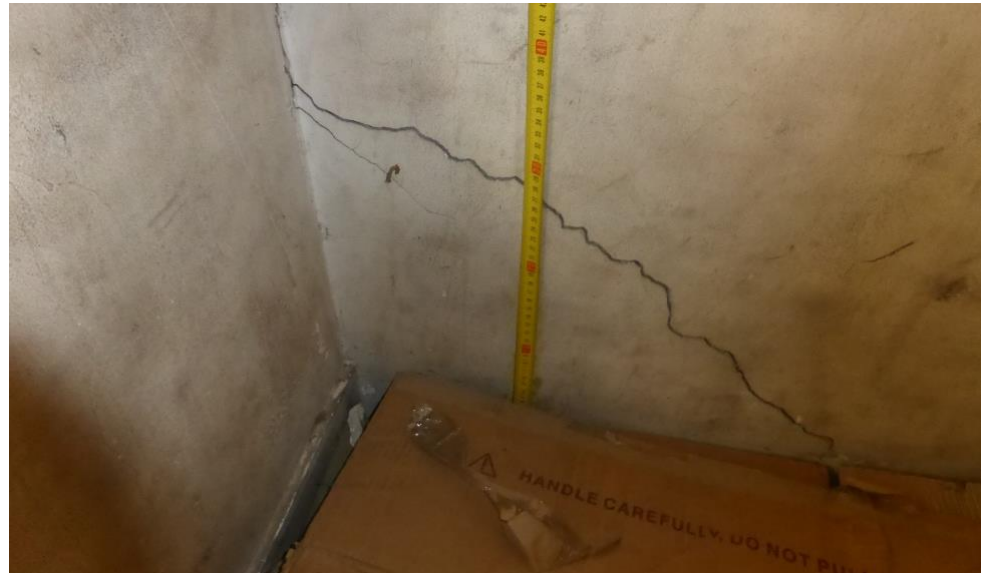
Long spanning cantilever on east façade. Showing evidence of excessive deflection and distress of facades

Structural drawings show a length of 3.535m.

Numerous signs of distress are visible on walls supported on façade.

Item No.	Observation	Recommended Action Plan	Priority
9	Long spanning cantilever with signs of distress.	Reduce Cantilever loading & commence DEA as per item 1 above.	Immediate - Now
10	Long spanning cantilever with signs of distress.	Detail Engineering Assessment to be completed as per item 1.	6-weeks
11	Long spanning cantilever with signs of distress.	Building Engineer to carry out design check on support structure to façade to confirm adequate strength and stiffness.	6-weeks
12	Long spanning cantilever with signs of distress.	Building Engineer to prepare Allowable Floor Loading Plans.	6-months
13	Long spanning cantilever with signs of distress.	Carry out strengthening as required.	6-months
14	Engineering Assessment of vertical extension for canteen on roof and horizontal extension on east face	Reduce loading as per item 1 requirements.	Immediate - Now
15	Engineering Assessment of vertical extension for canteen on roof and horizontal extension on east face	Detail Engineering Assessment to be completed as per item 1 to take account of additional areas.	6-weeks

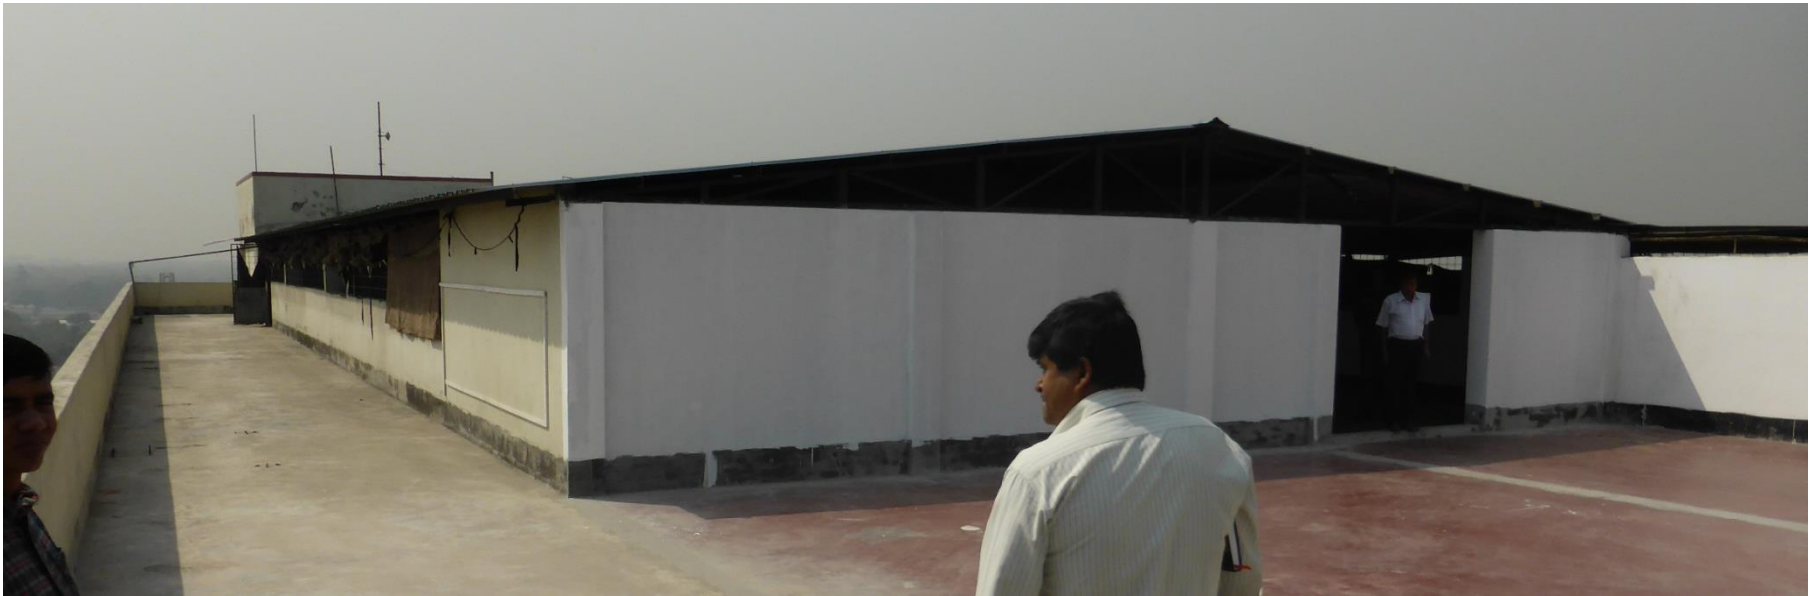
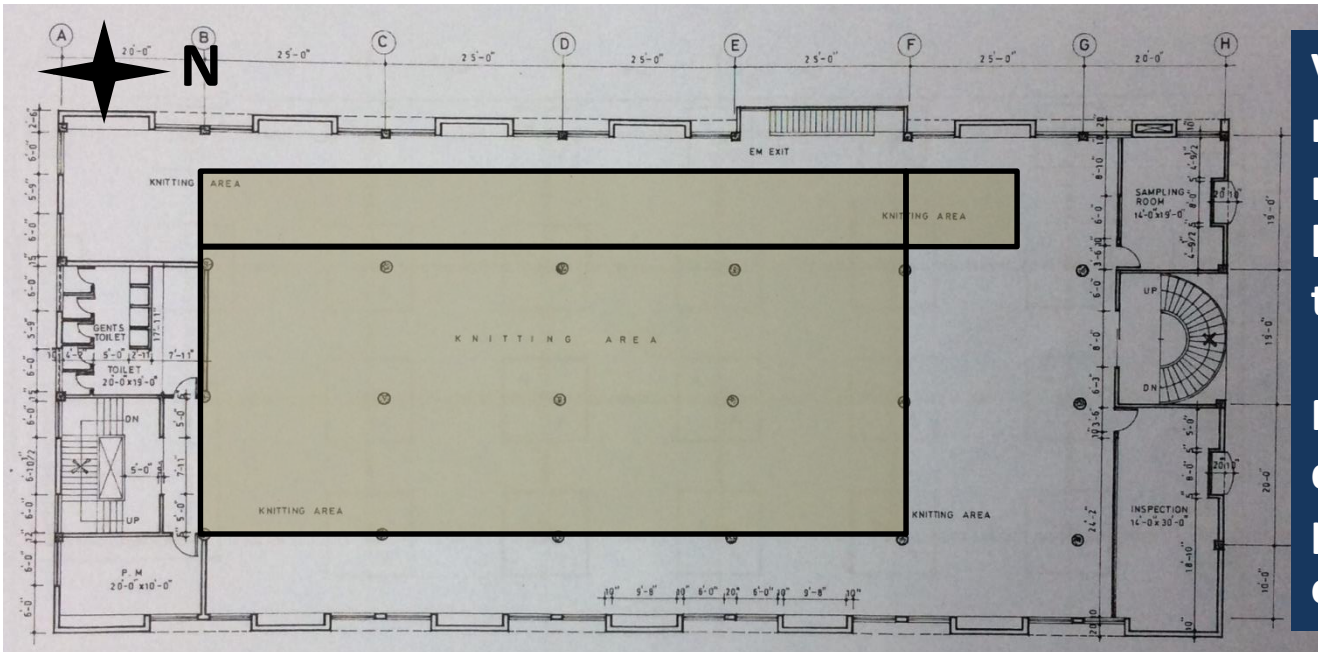
Vertical Extension

Vertical extension on roof comprising of brick masonry walls with a lightweight steel trussed roof.

No structural or design documentation provided for canteen extension.

Check on roof additions required

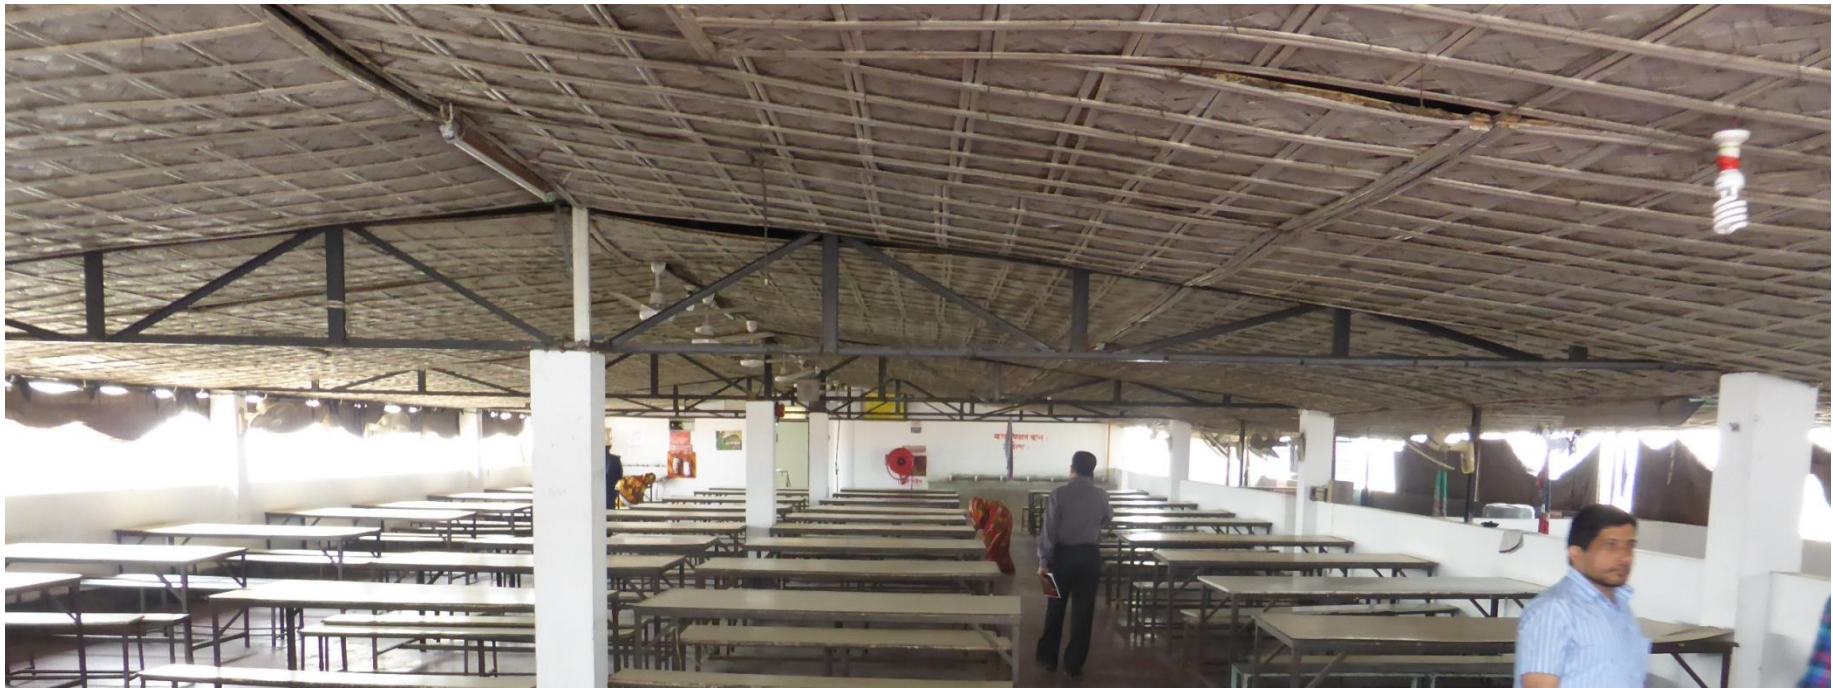
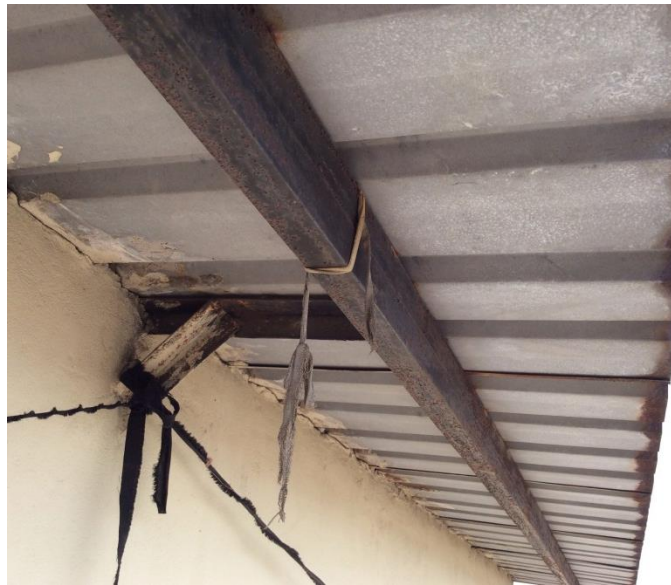
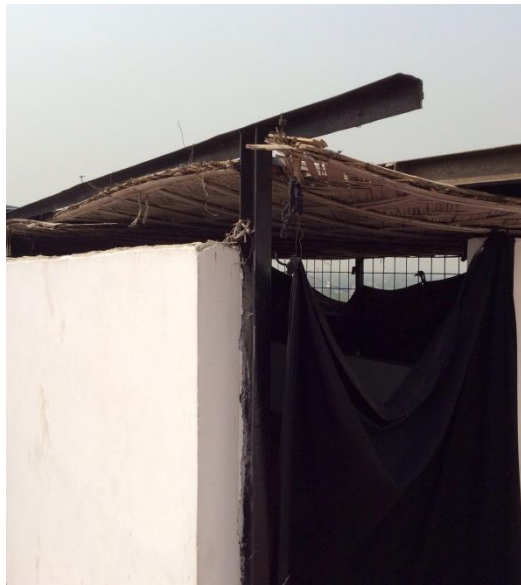
Lightweight steel structure, not on permit plans, open to wind uplift.

Adequacy of tie downs and lateral stability need to be assessed by Building Engineer.

Check on roof additions required

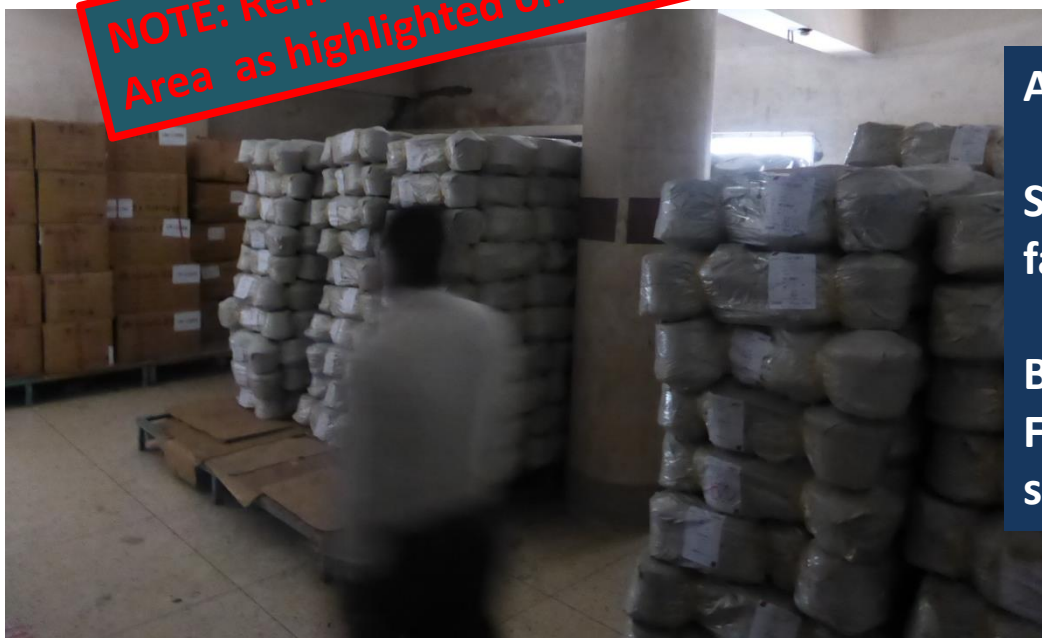
Areas of high loading on structure.

Storage Area for rolled unworked fabric at northern end of 4th Floor

Bonded warehouse located on 1st Floor of structure (including long span cantilever).

Item No.	Observation	Recommended Action Plan	Priority
19	Localised areas of high loading.	Reduce loading on areas highlighted for immediate action as per item 1.	Immediate - Now
20	Localised areas of high loading.	Create controlled loading plans for all floors, designating where storage can be placed and can not be placed taking findings of DEA and Item 1 findings into account.	6-weeks
21	Localised areas of high loading.	Continue to implement load plan.	6-months
22	Protection of critical element adjacent to vehicular access	Place temporary warning /protection (e.g. traffic cone, sand filled barrels as deemed appropriate by Building Engineer) at 1m from column faces.	Immediate - Now
23	Protection of critical element adjacent to vehicular access	Building engineer to design appropriate impact protection for critical column adjacent to truck access zone.	6-weeks
24	Protection of critical element adjacent to vehicular access	Continue to assess and maintain protection	6-months

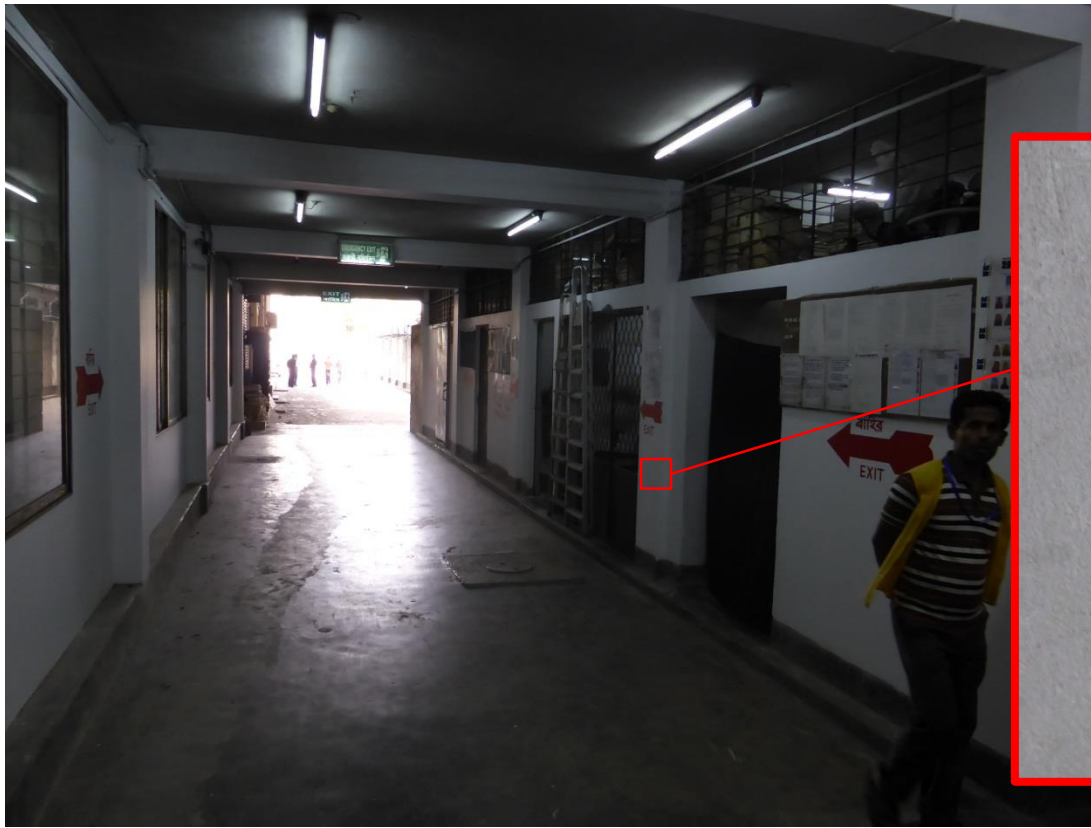
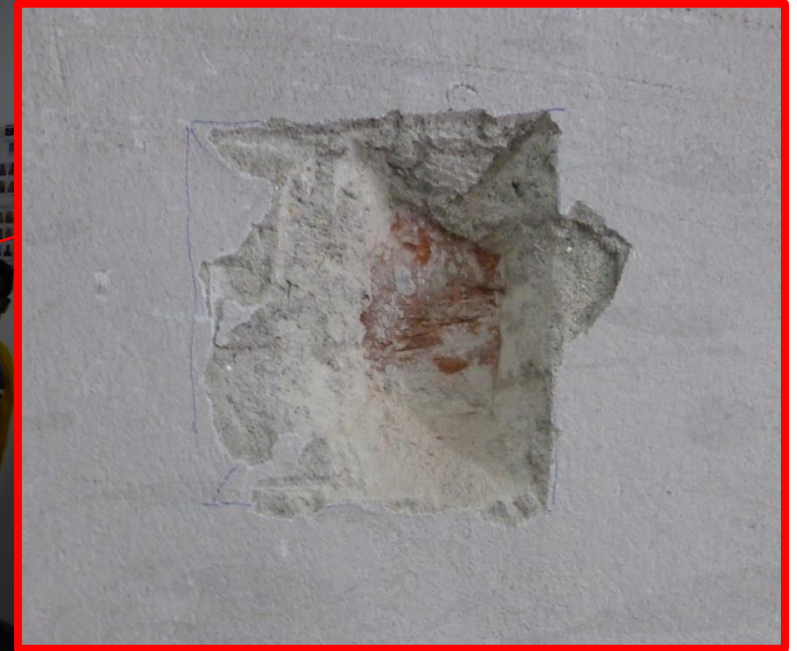
Horizontal Extension

Horizontal extension support column was opened to note the aggregate type.

Found that support consist of a brickwork column with render.

Assessment of adequacy and working stress on column must be carried out by Building Engineer.

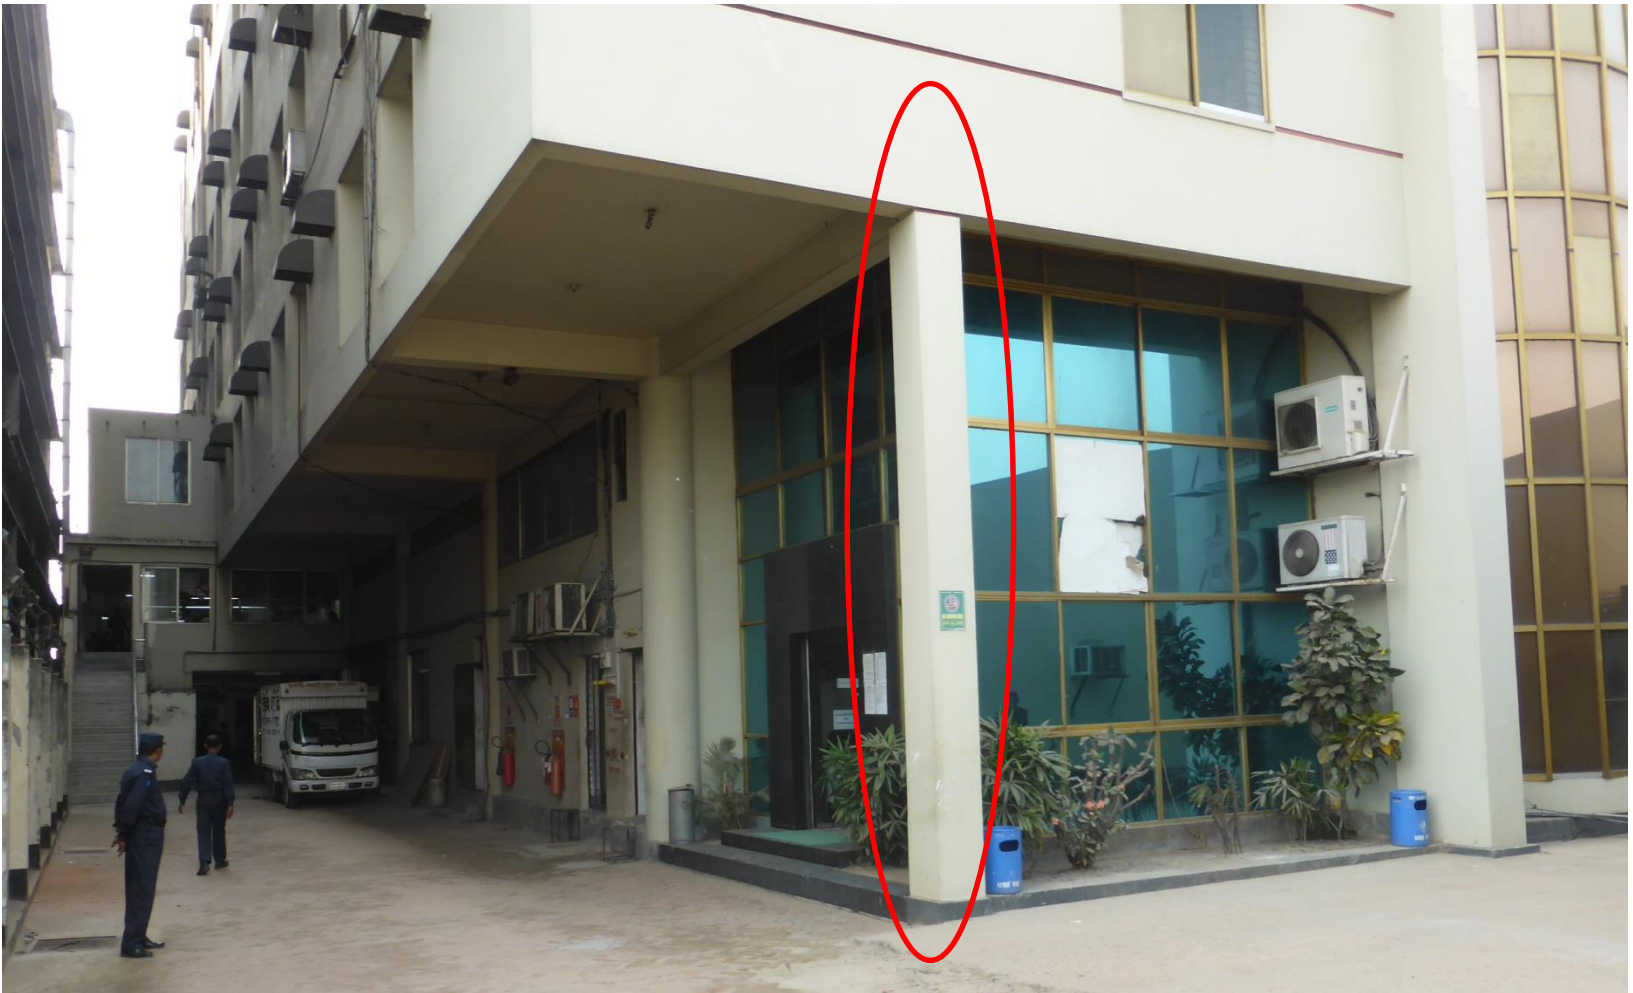
Protection for Critical Element Adjacent to Vehicular Access

Critical element located at front of structure adjacent to truck access. Assessment of impact to column required by Building Engineer. Consider impact protection as appropriate

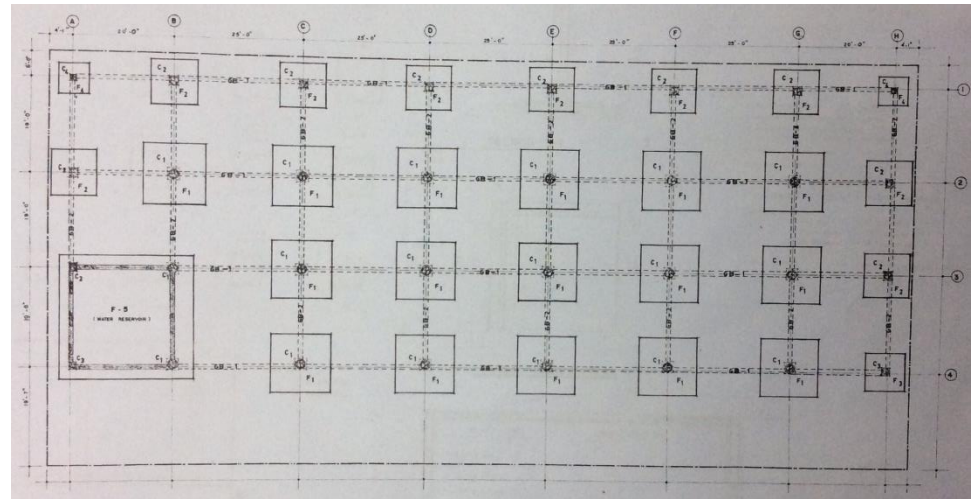
Soils Report – Recommendation vs Design Drawings

Structural drawings show that pad foundations have been used as the foundation.

According to structural information provided, pad foundation were constructed to 1.8m below existing ground level.

Soils Report – Point d. suggests that shallow foundations are not suitable for all foundation locations.

Assessment of adequacy of foundation needs to be assessed by Building Engineer.

25	Assessment of design of foundations in comparison to recommendations of soils report	Detail Engineering Assessment to be completed as per item 1.	6-weeks
26	Assessment of design of foundations in comparison to recommendations of soils report	Building Engineer to review the Geotechnical (Soils) Report by comparison with the construction drawings and the use of pad foundations rather than piled /raft foundations as recommended within the Soils Report.	6-weeks
27	Assessment of design of foundations in comparison to recommendations of soils report	Building Engineer to confirm by calculations and records of site construction that foundation bearing is adequate.	6-weeks
28	Assessment of design of foundations in comparison to recommendations of soils report	Implement actions arising from DEA.	6-months

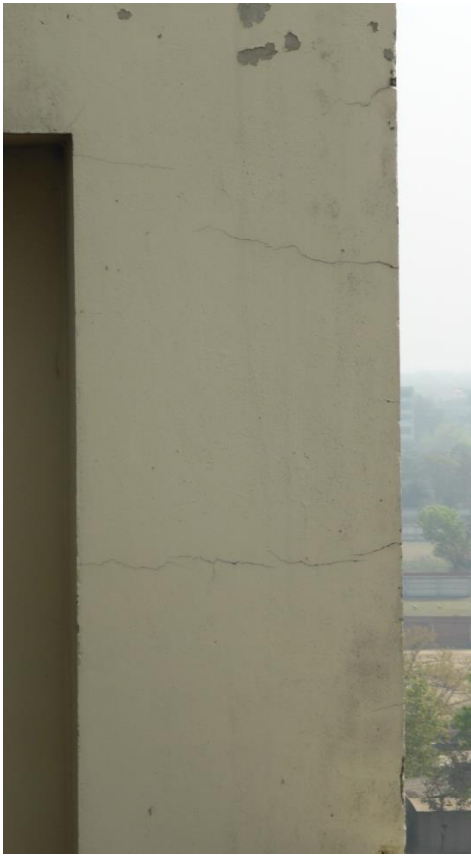
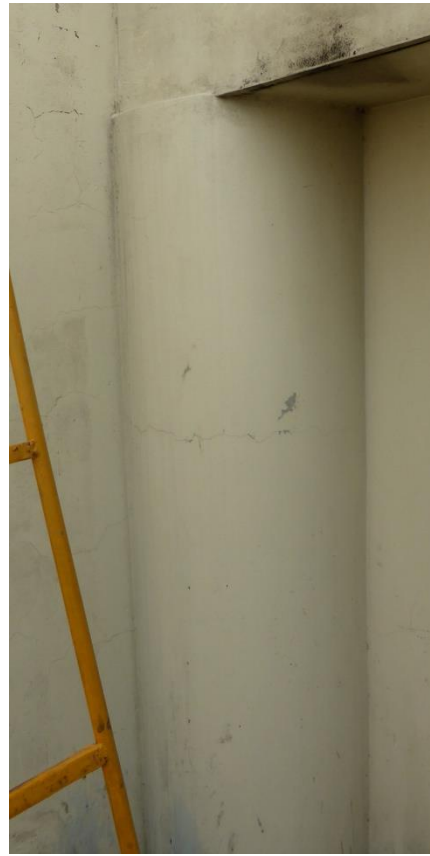
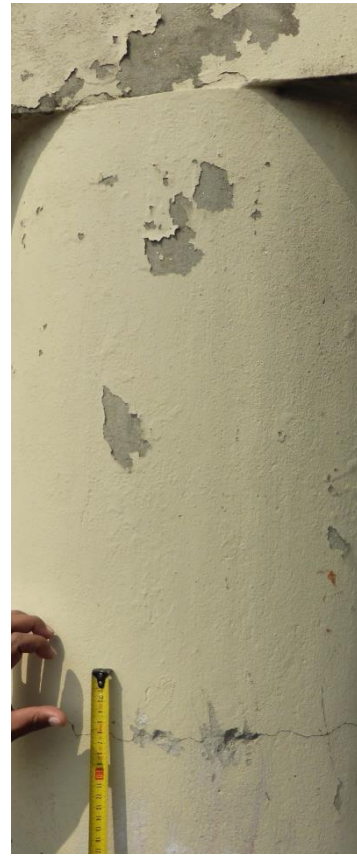
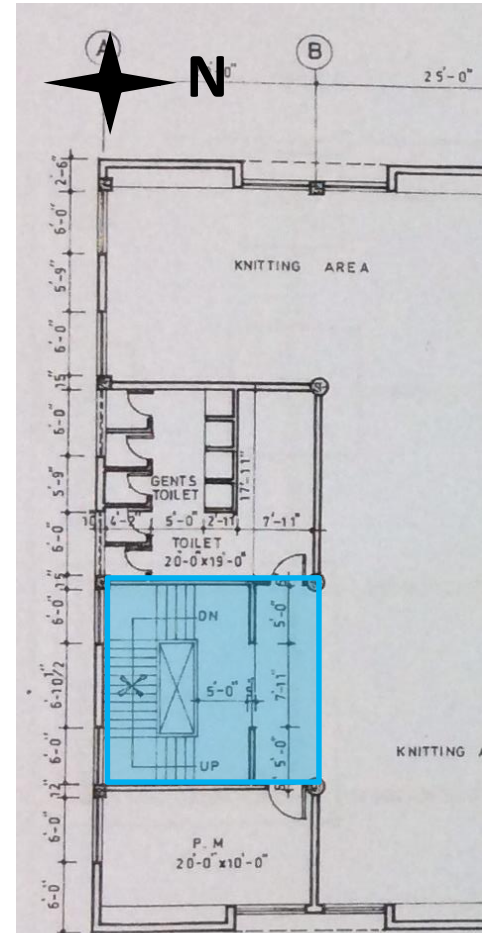
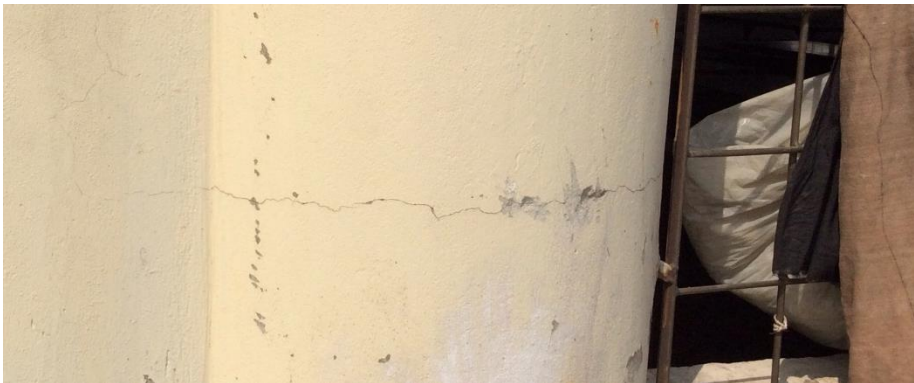
Cracks to Water Tank Support Columns

Water tank located on south area of structure over the stair core.

Visible cracking to columns supporting water tank to be investigated.

Item No.	Observation	Recommended Action Plan	Priority
29	Cracking observed to water tank support structure	Detail Engineering Assessment to be completed as per item 1.	6-weeks
30	Cracking observed to water tank support structure	Sections of plaster finish to walls to be removed to investigate if cracks penetrate the building structure.	6-weeks
31	Cracking observed to water tank support structure	Verify that beam/slab has sufficient capacity to support fully filled water tank.	6-weeks
32	Cracking observed to water tank support structure	Limit water to appropriate level if required.	6-weeks
33	Cracking observed to water tank support structure	Carry out repair or strengthening as required.	6-months
34	Lateral Stability of Single Storey Warehouse Building	Building Engineer to verify that building has an appropriate lateral stability system and submit relevant design documents	6-weeks
35	Lateral Stability of Single Storey Warehouse Building	Carry out strengthening work if required.	6-months

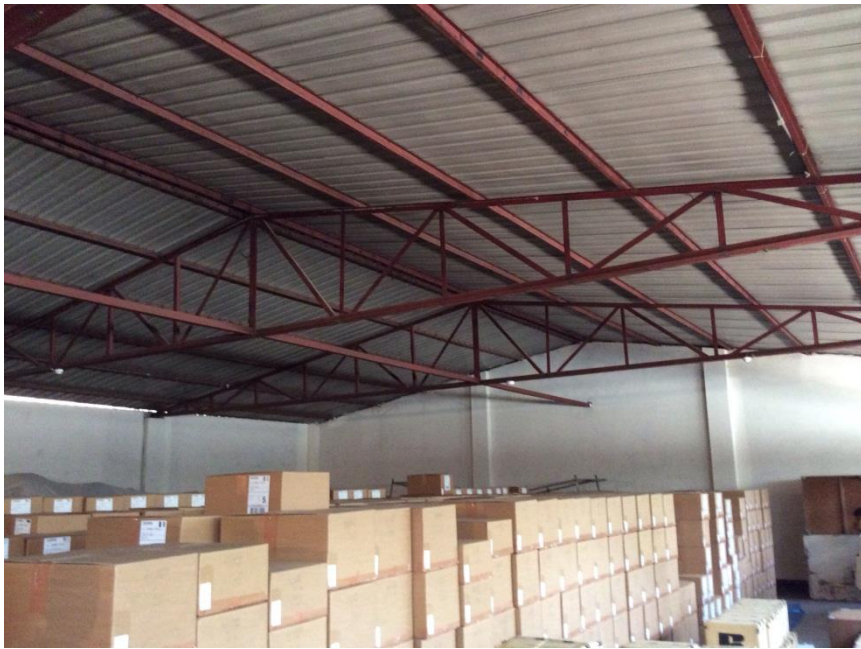
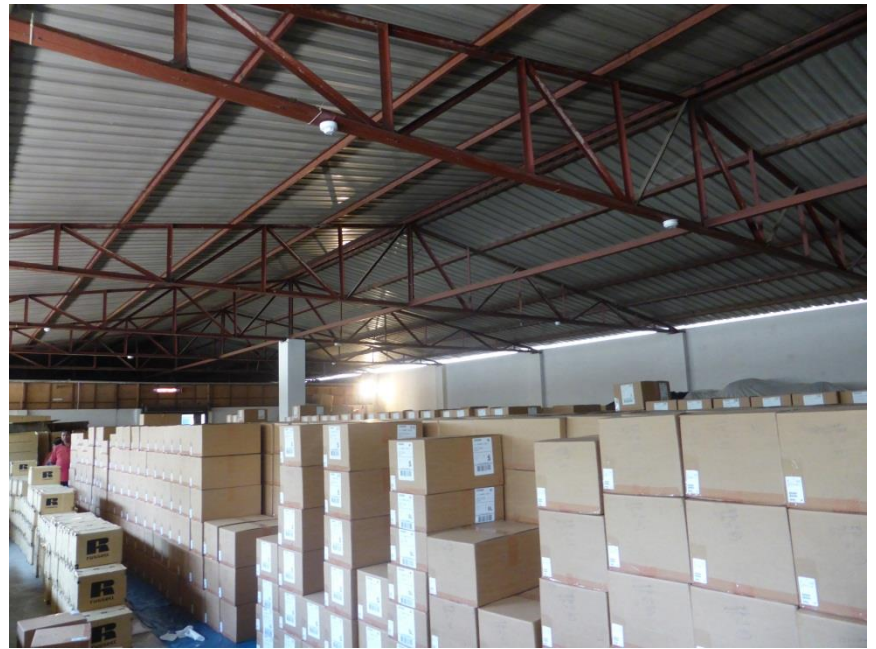
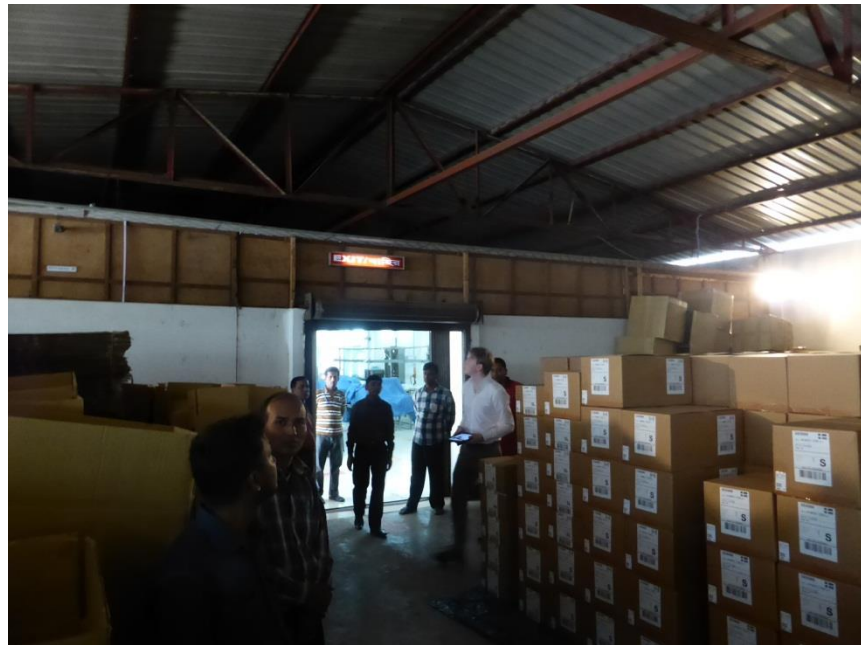
Stability of Single Storey Warehouse

Lateral Stability System for Single Storey industrial unit unclear.

No roof bracing, perimeter walls only evident stability structure.
