# **Pan Pacific Sweaters Ltd (9310)**

# **D&S Pretty Fashions Ltd (9287)**

South Salna, Joybedpur, Gazipur, Dhaka -1230, Bangladesh

19.MARCH.2014

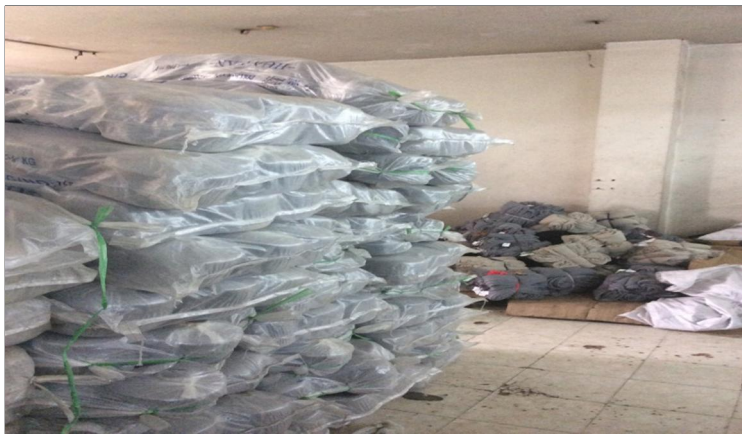
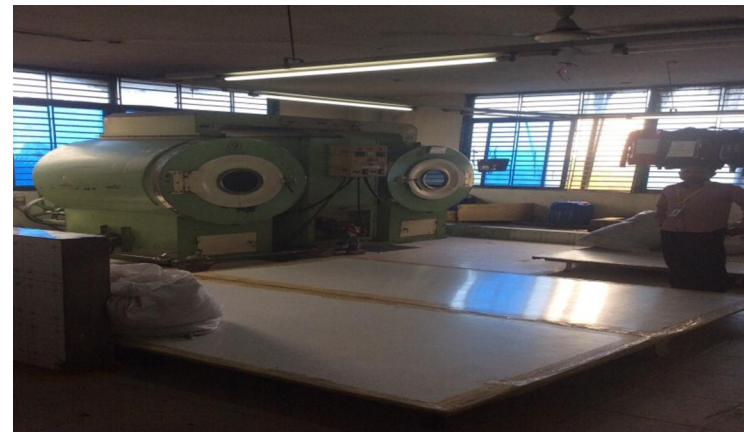
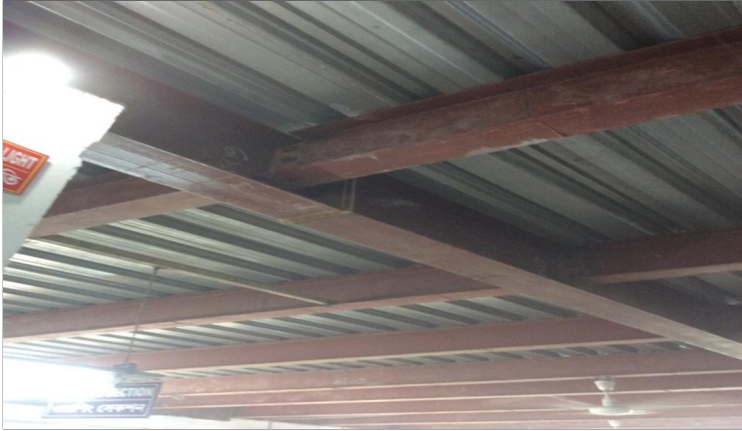
## 1st Priority 1 concern

Based on the load run-down analysis following the agreed minimum design live load assignment, the columns' factor of safety falls between 1.25 and 1.5, giving a AMBER warning. Factory Engineer to review design, loads and columns stresses. Equipment are located at the same place, level to level. This means that the same columns are over used compared to others.

Preliminary load take-down calculations indicates that the columns factor of safety is between 1.25 and 1.5. Heavy storage and equipment located in the same line.

- Factory Engineer to review design, loads and columns stresses.
- Verify insitu concrete stresses by cores from 4 columns.

- Produce and actively manage a loading plan for all floor plates within the factory giving consideration to floor capacity and column capacity.
- Detail Engineering Assessment to be completed

- Continue to implement load plan.

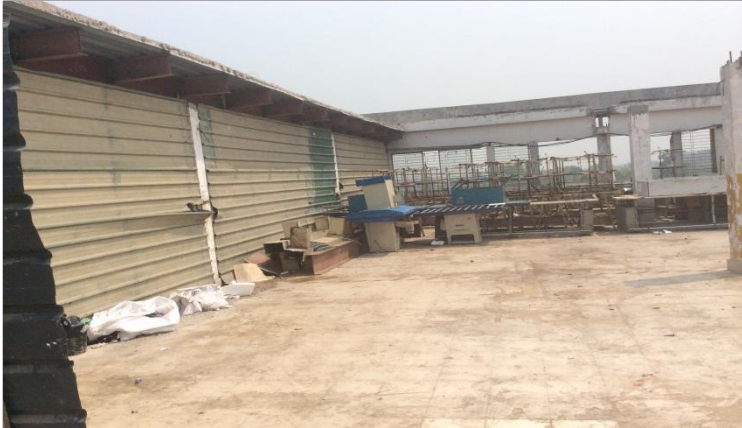
2nd Priority 1 concern

The building plans received, don't show the roof made of structural steel (columns, beams and steel deck filled with 150mm of concrete). The building was constructed from year 2001 to 2004, with brick aggregate, with total of 6 R.C storeys and a steel shed.

Roof made of structural steel

- Factory engineer to check, collect information and produce accurate and complete as-built documentation

- Factory engineer to review design, loads and columns stresses.

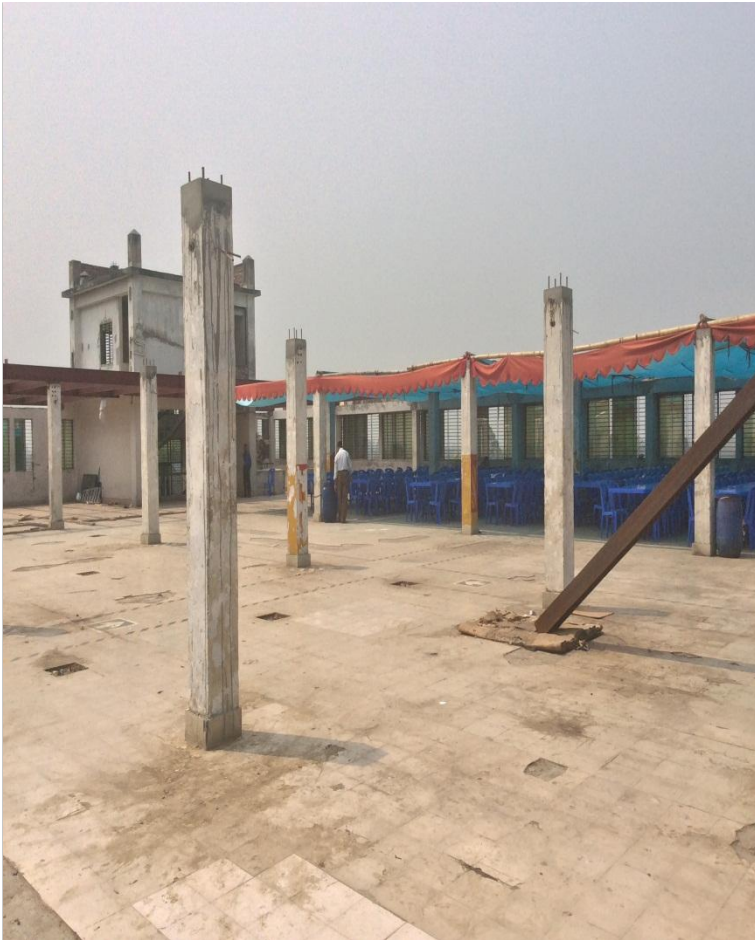
### 1<sup>st</sup> Priority 3 Concern

No waterproofing membrane was visible on the roof of the building. This means that any cracks in the surface finishes on the roof will allow water to seep into the concrete slab beneath the finishes, and cause long-term soaking of the slab.

**Roof Floor does not appear to have any waterproof membrane to protect lower floor from water damage**

Roof appears not to have any waterproofing system applied.

- Consider applying a new waterproofing membrane.
- Manage drainage from above levels and water tanks to downpipes to avoid structural corrosion due to continuous moisture.
