Montex Fabrics Ltd

03 & 26 February & 16 March 2020

Structural Inspection Report

Observations & Actions

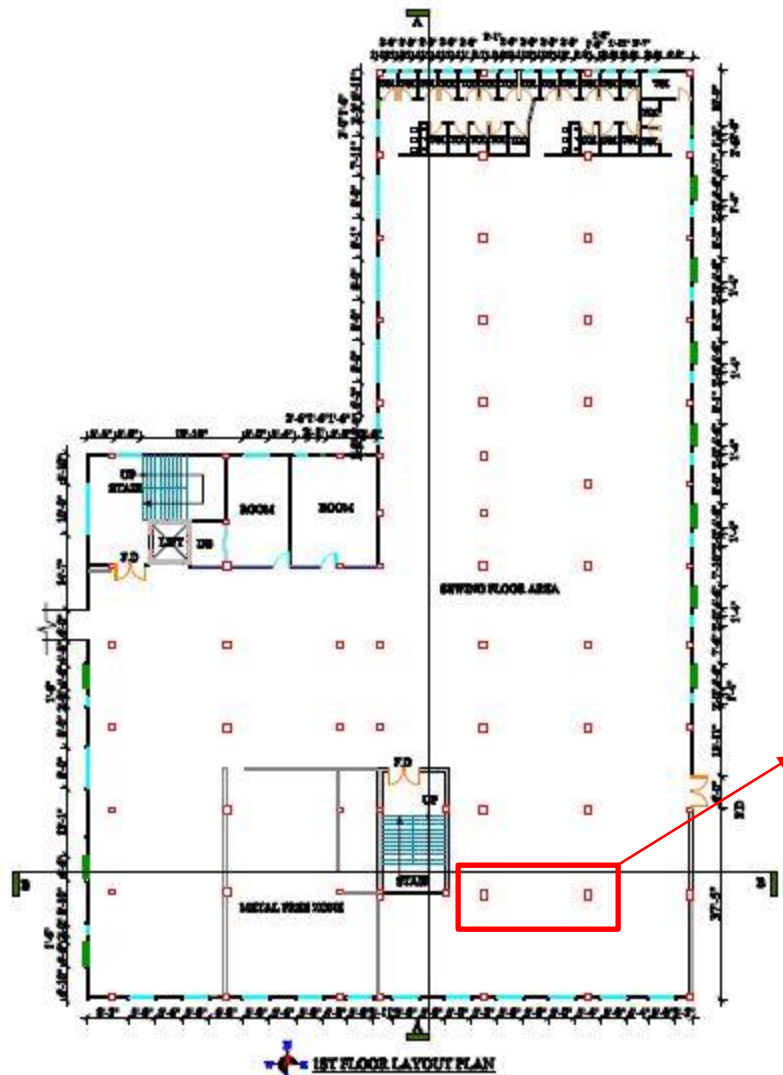
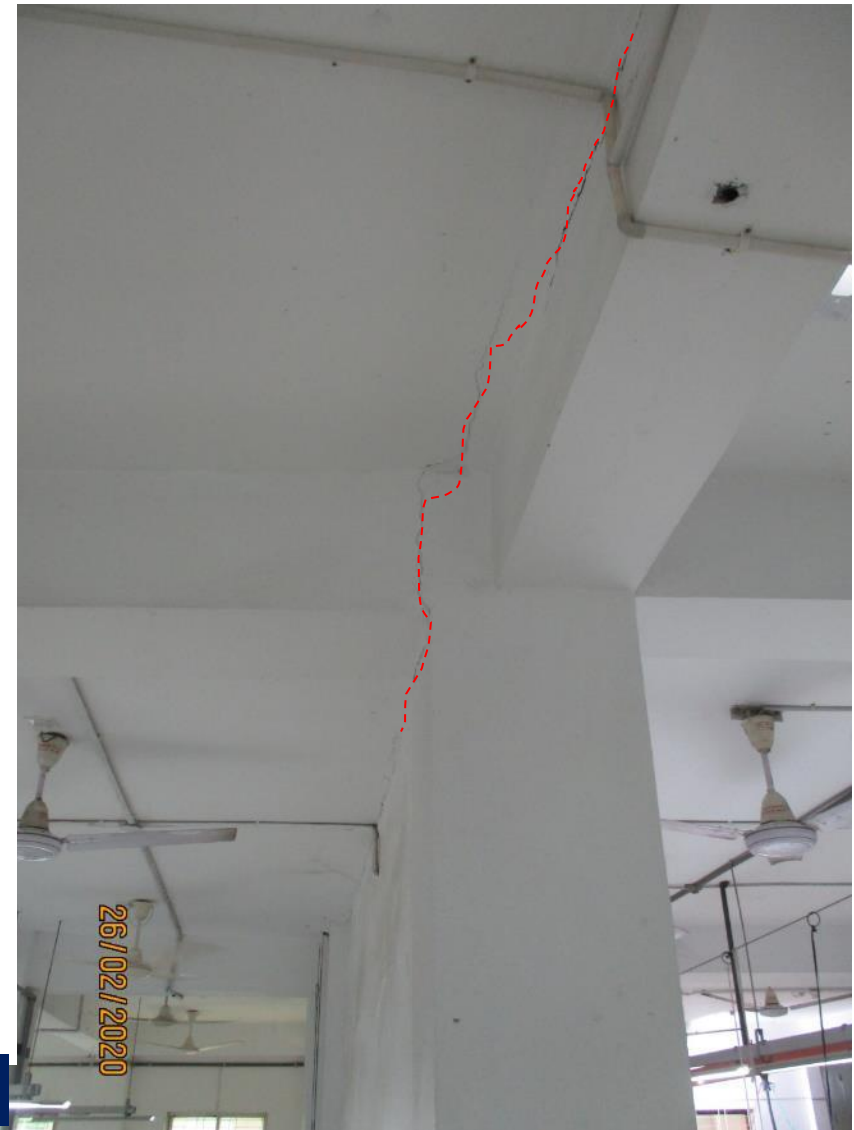
Crack on beam column Joint

Cracks were observed on beam-column joint. Building engineer is required to investigate the cracks and carry out suitable repair work as per recommendation of investigation report.

- Carry out suitable repair works as per investigation report.

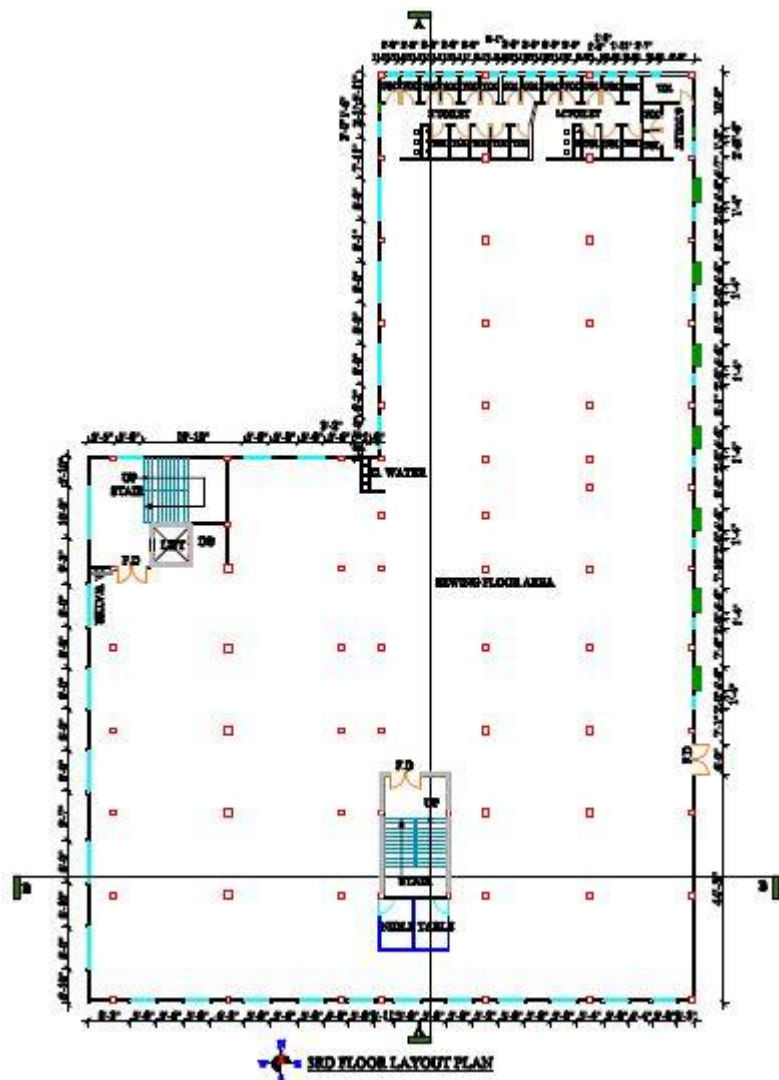
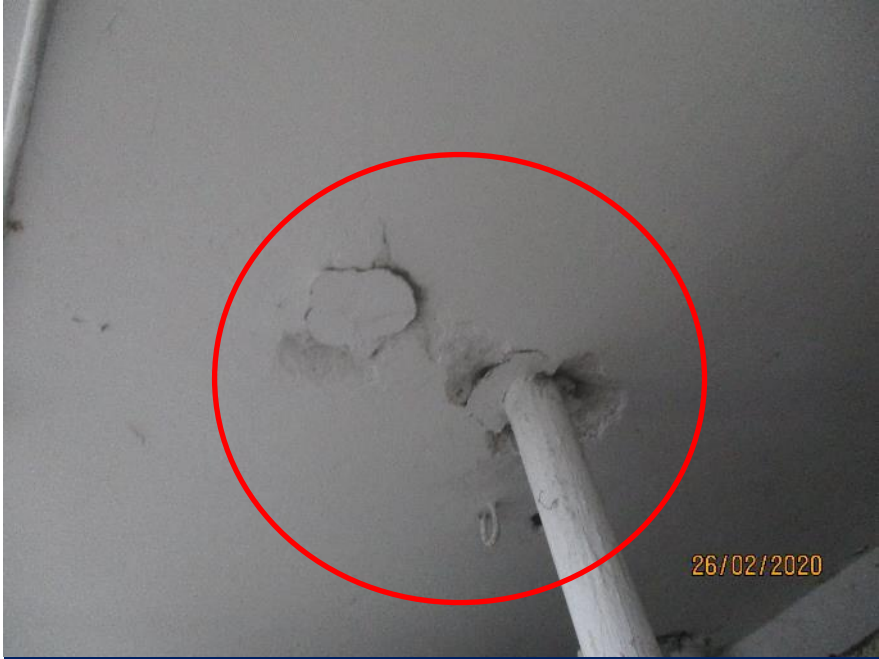
Spalling of concrete at 3rd floor toilet area

Spalling of concrete was observed on 3rd floor toilet zone. Building engineer is required to carryout civil works in a safe manner to the lose concrete.

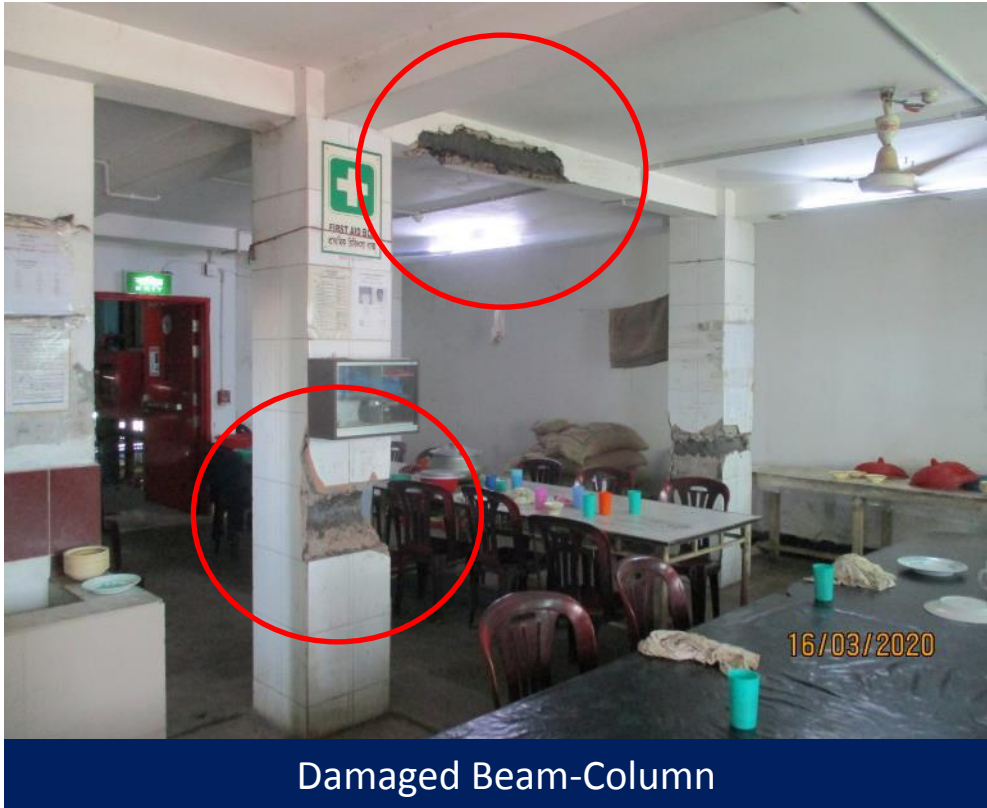
Damaged Beam-Column

Damaged beam-column observed on 3rd floor. Building engineer is required to carry out suitable repair works also check the capacity of the damaged structural members.

- Building engineer is required to carry out suitable repair works.

- Building engineer is required to check the capacity of the damaged structural members.

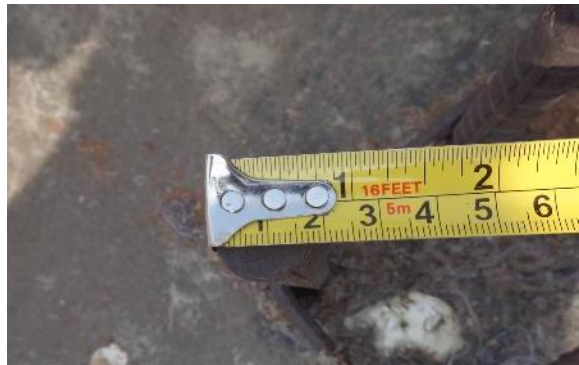
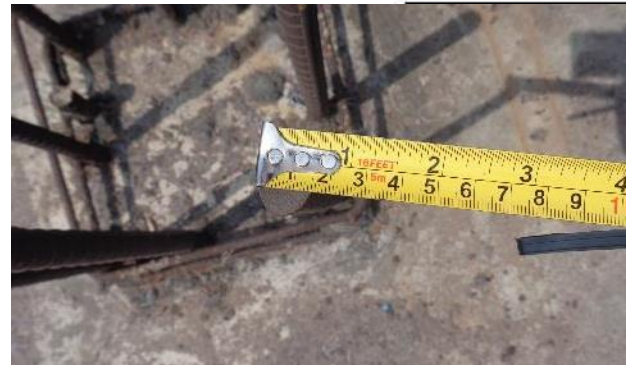
As per column schedule all rebars are 22 mm diameter but onsite some of the rebars were found 20 mm & 16 mm diameter.

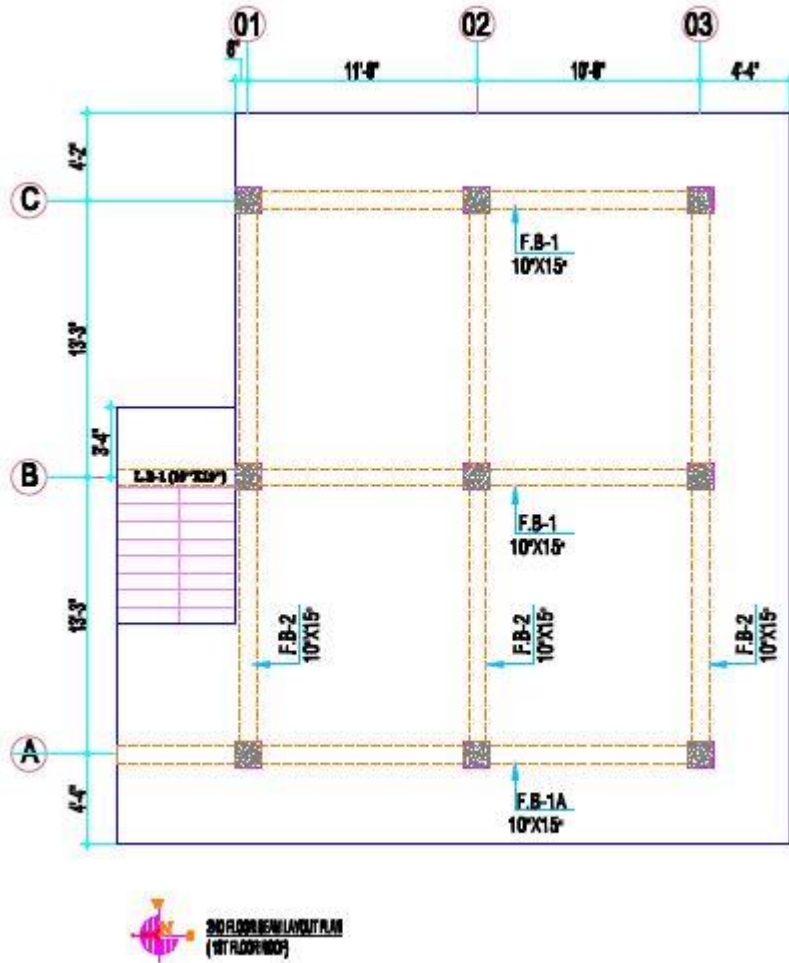
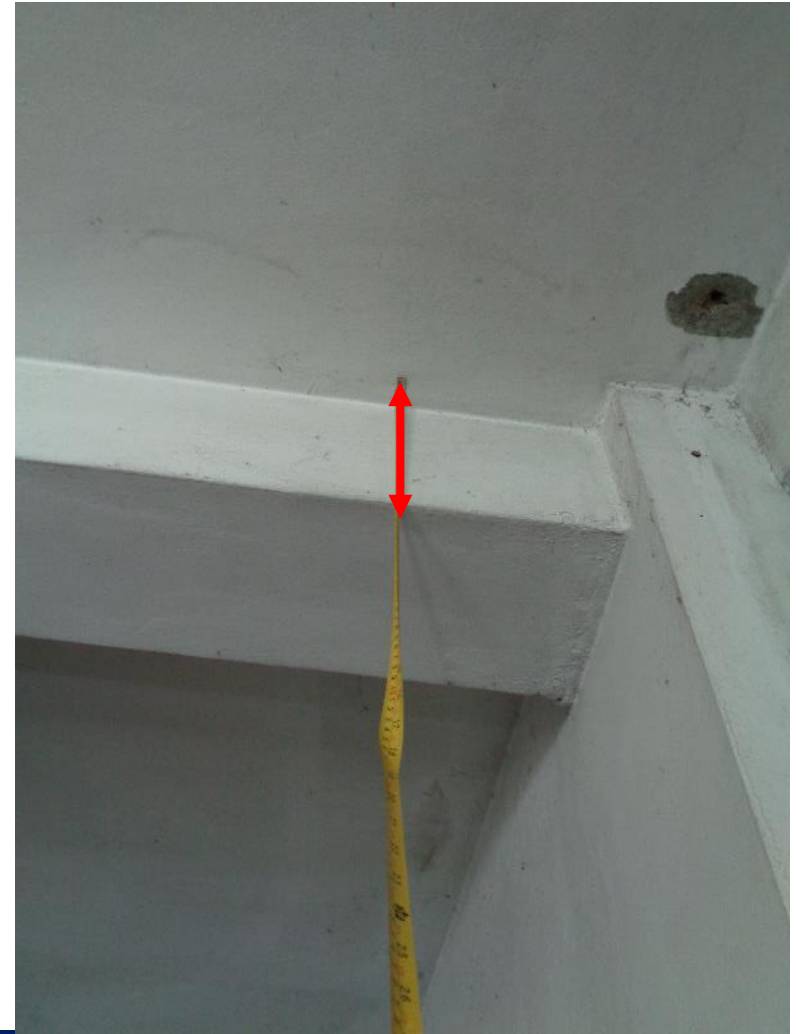
Down stand of the beam was measured 150 mm, but drawings shows 235 mm.

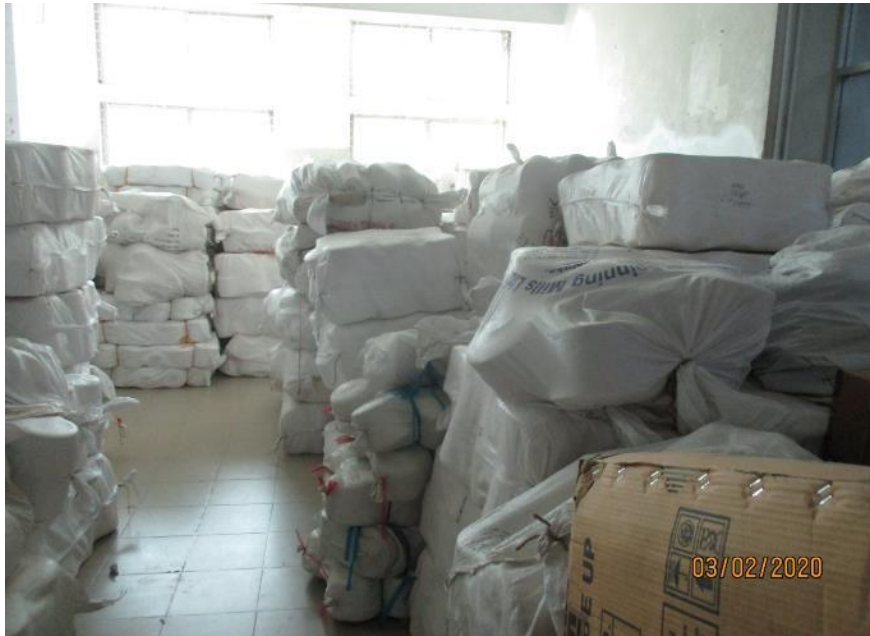
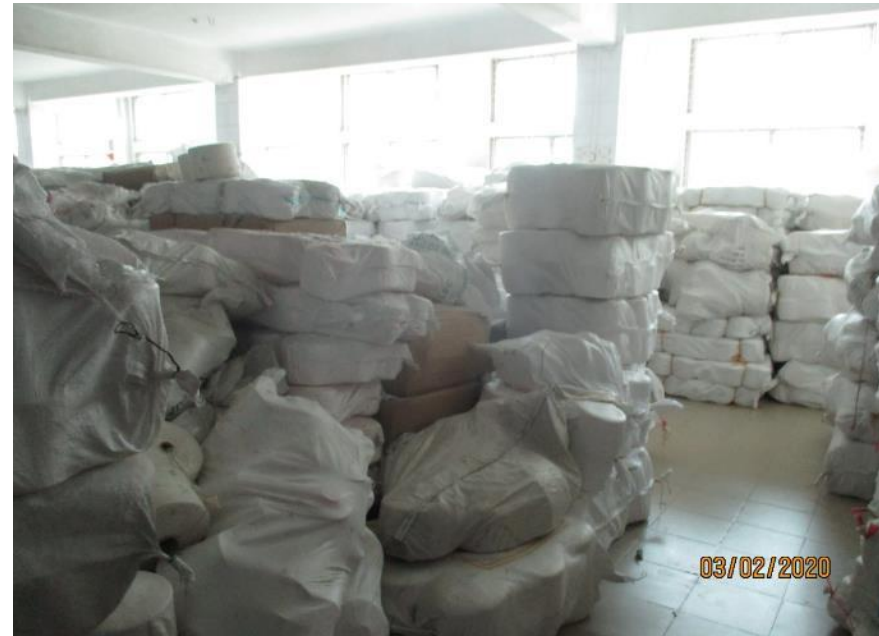
Overloading on floor

Loading was observed above 2 kPa on floors. Building engineer is required to maintain loading below 2 kPa on floors until completion of all required remedial works from engineering assessment.

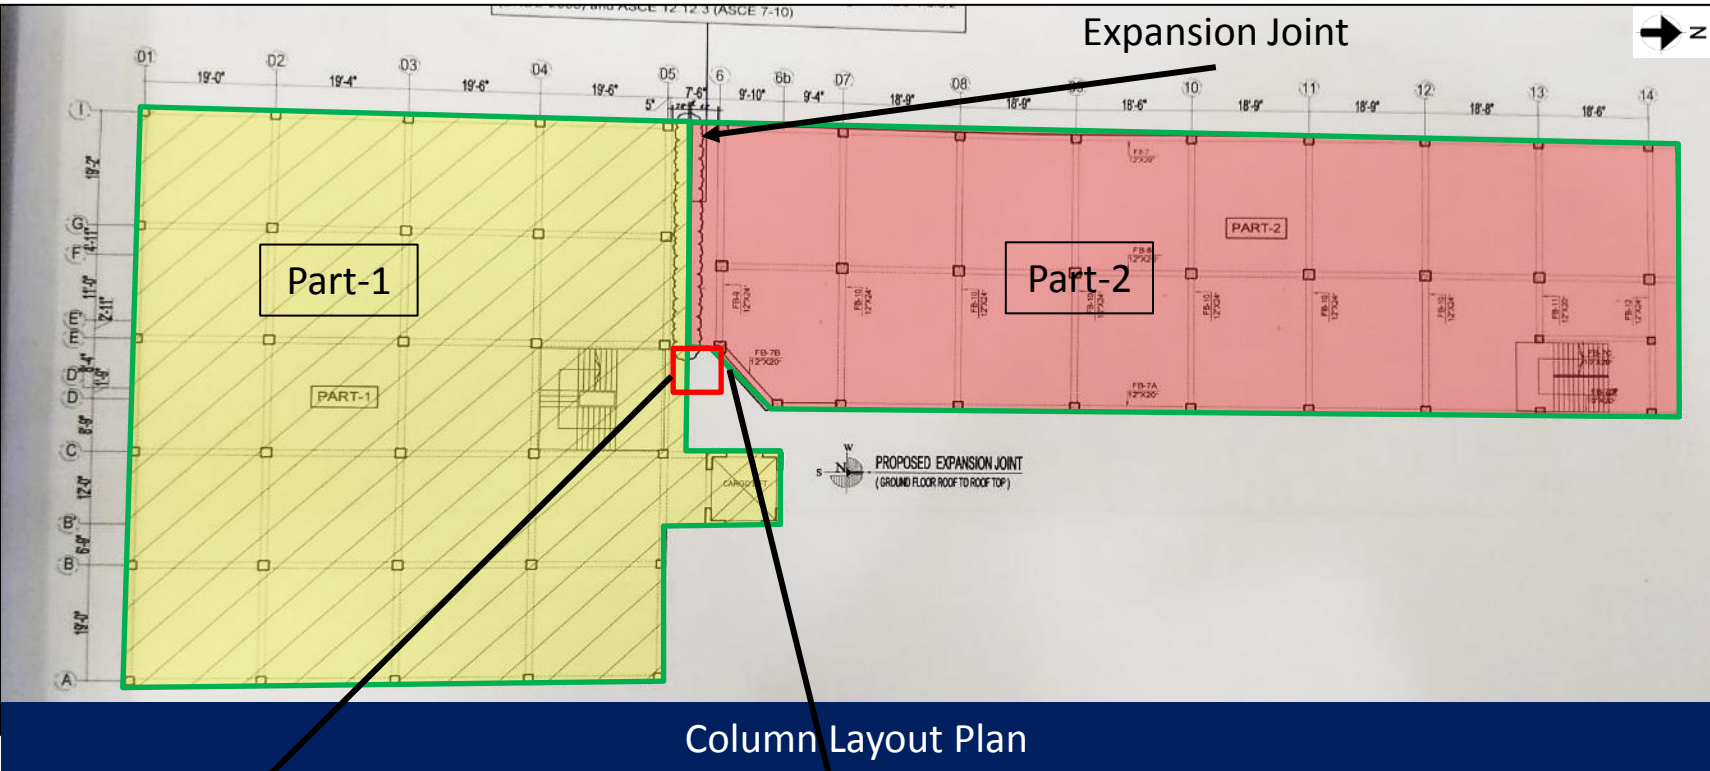
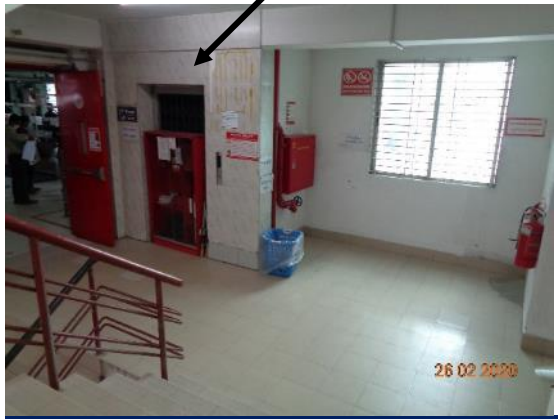
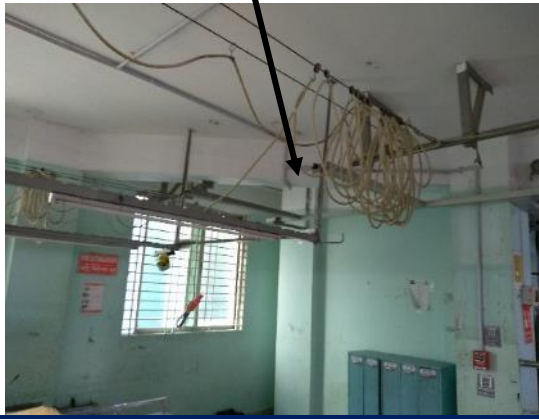
Mismatches in the drawing and missing core cutting location

A lift was found in between Expansion Joint of part-1 & 2. Which is not shown in as-built drawing. Separation of part-1 & part-2 is not clear on that location.

- The building engineer to update the Detailed Engineering Assessment (structural design) report including the software analysis file for further review.
- All core cutting location need to be exposed and revised the core layout plan as per site condition.
- Update and actively manage the floor loading plans based on the column and floor capacity of the building.

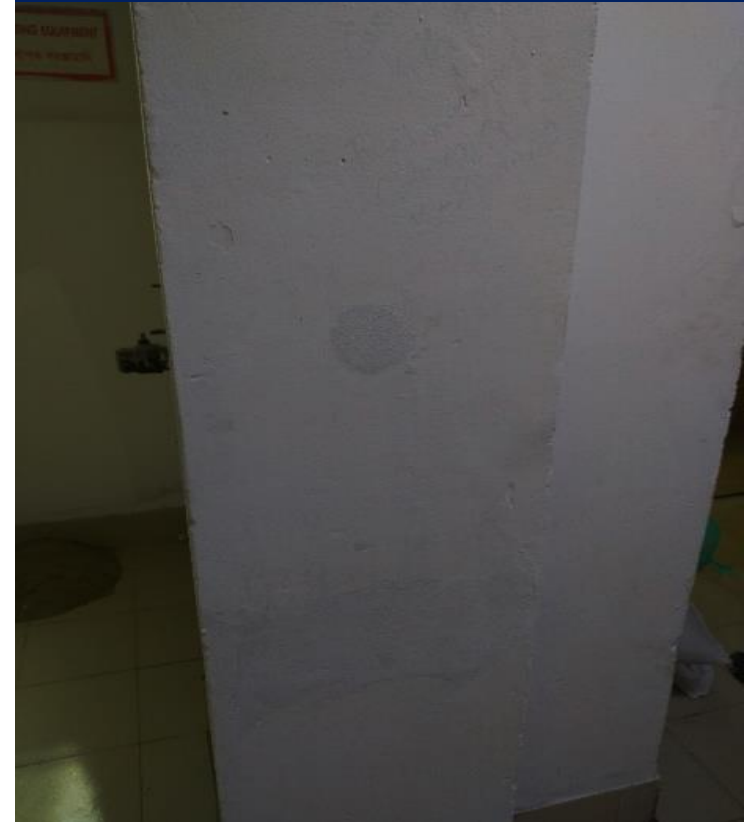
Core

All core location could not be verified as per core cutting layout. All core cutting location need to be exposed and revised the core layout plan as per site condition.

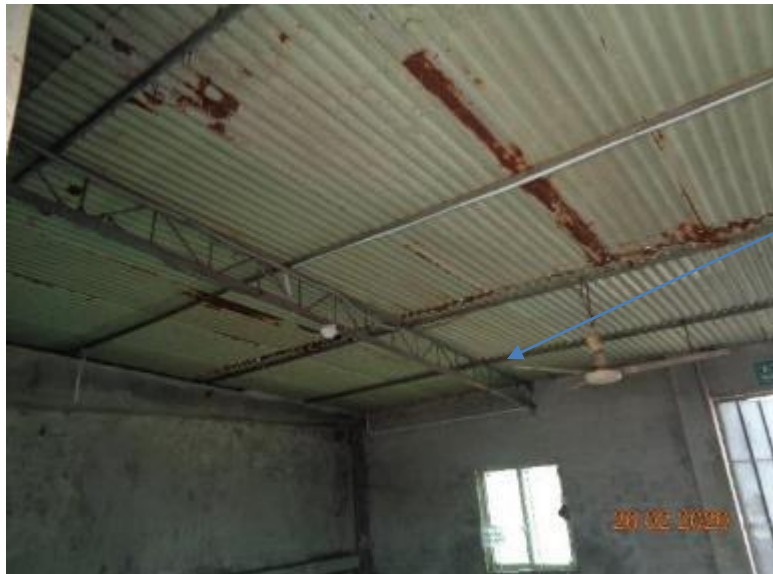
Truss supported on brick wall

Non-engineered shed was found at roof level.
The connections of the truss/rafter with wall are non-engineered.

- Building engineer to check the connection & capacity of the lightweight roof structure against lateral loading.
- Or replace the existing shed with an engineered structure.

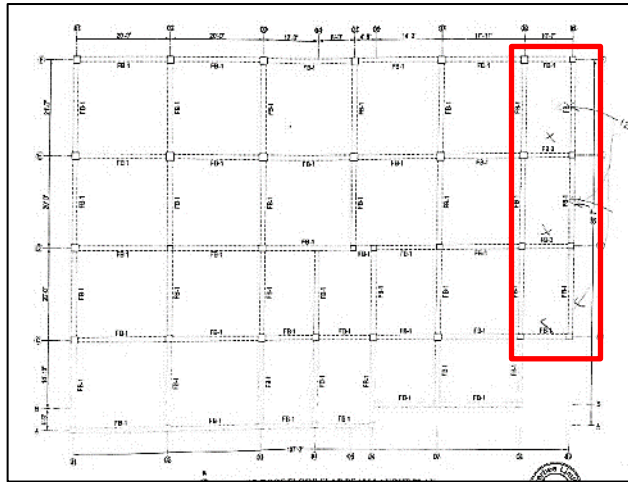
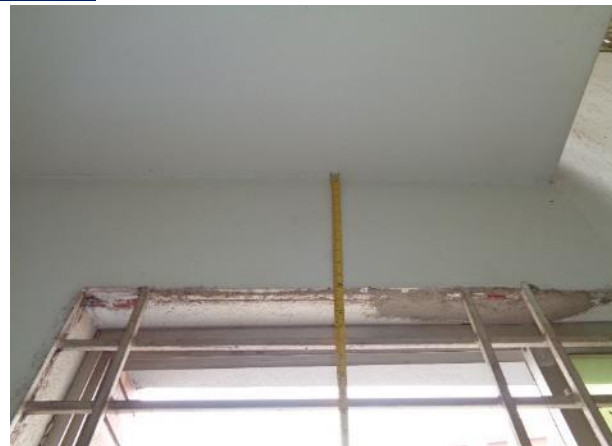
2nd floor beam layout

In the marked area of 2nd floor and roof, the down-stand of beam was measured 300 mm whereas as per drawings it should have been 450 mm (18 inches). Also, beam (FB-3) in the 2nd floor marked area were missing.

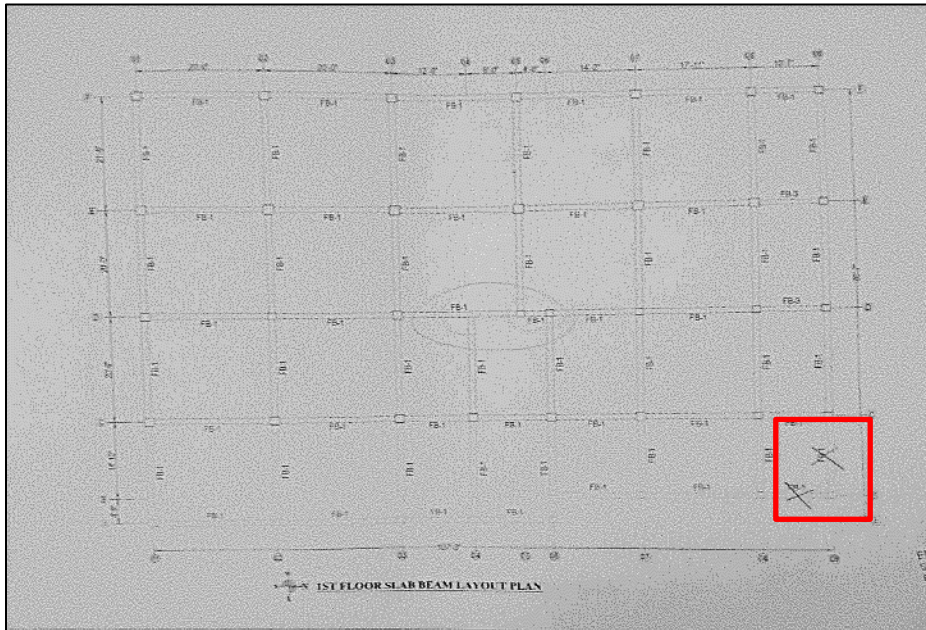
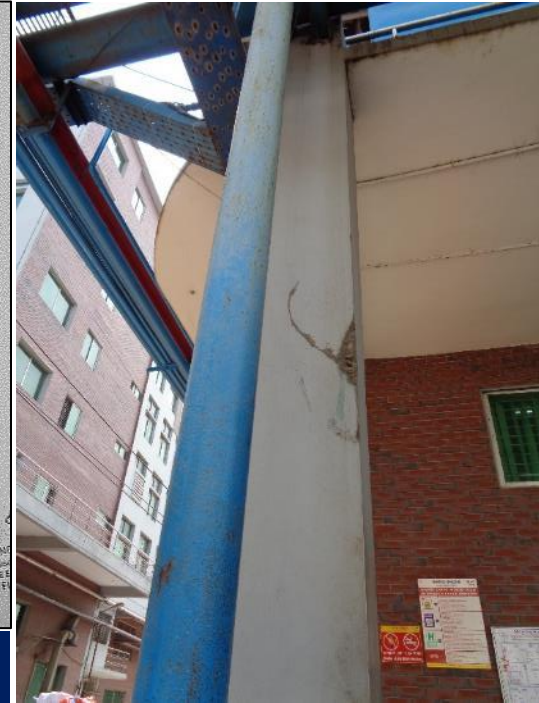
Marked beams in the 1st floor beam layout were missing

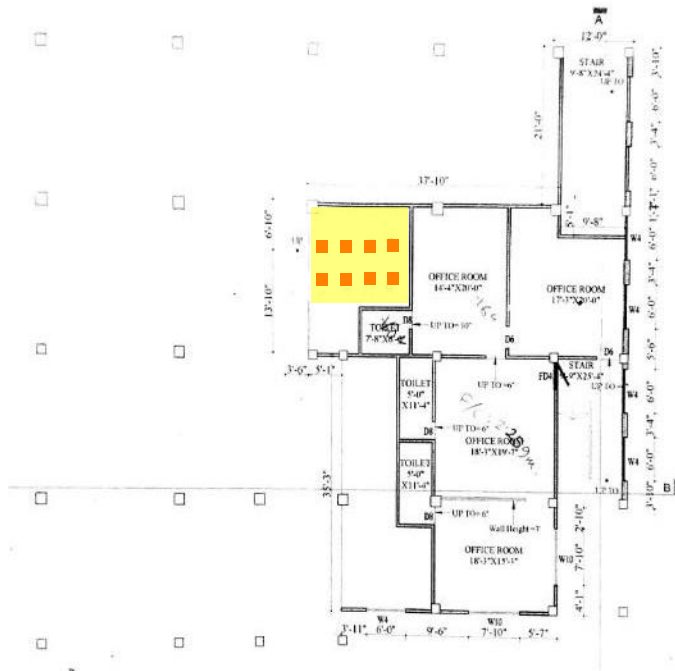
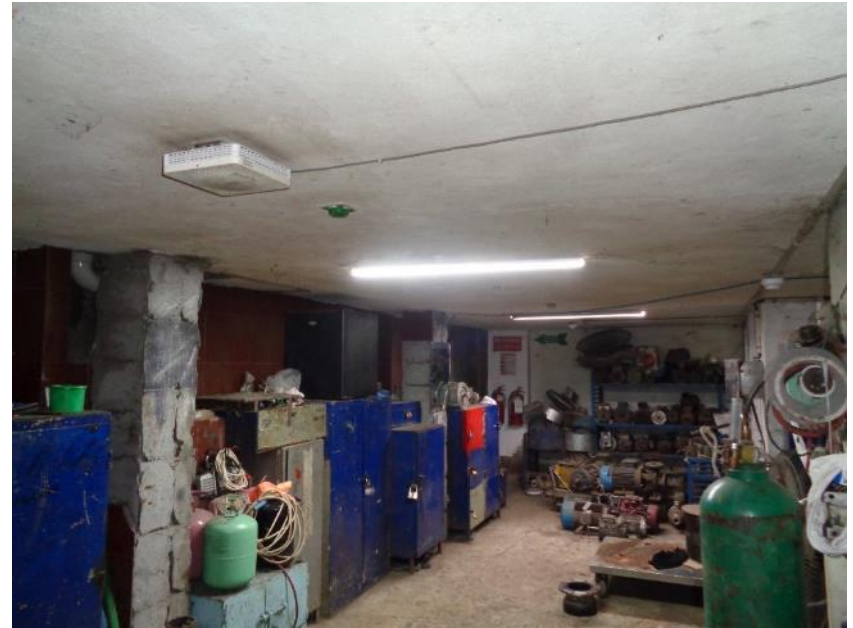
Undocumented mezzanine floor

An undocumented RC mezzanine floor portion was observed in between ground floor and 1st floor. Foundation details of additional columns are unknown.

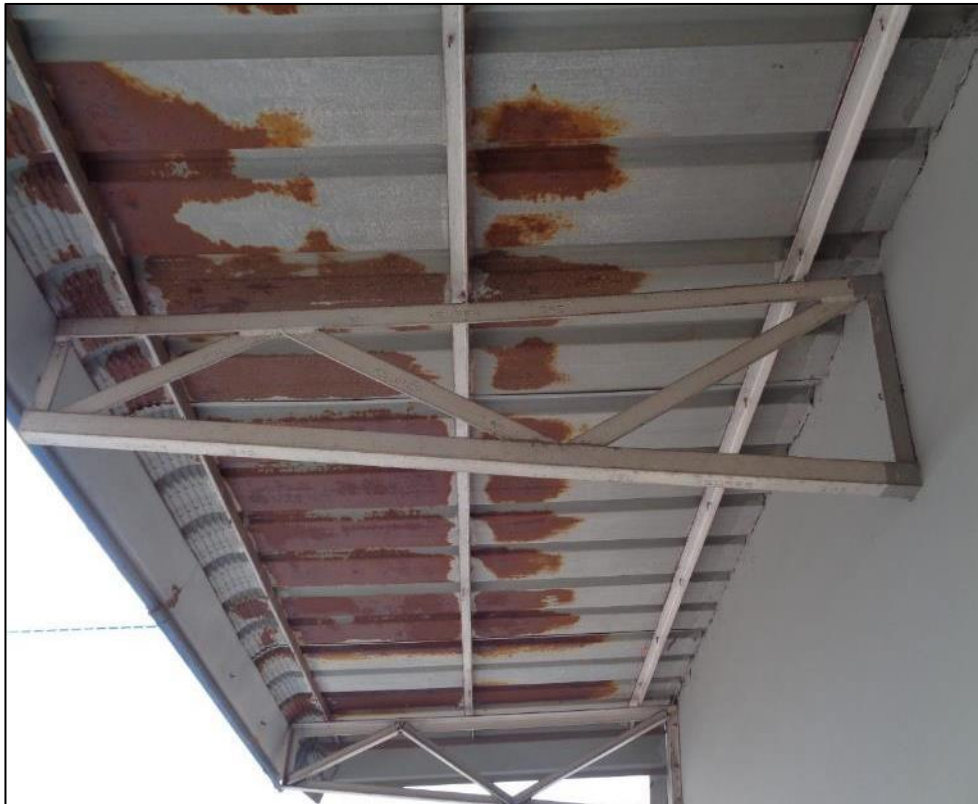
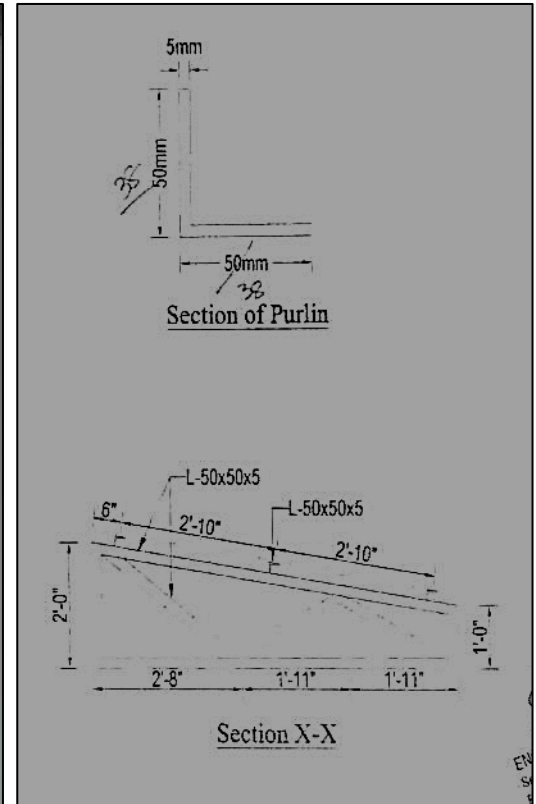
As per the drawing, the angles in canopy are supposed to be 50 mm but during inspection, angles were measured 38 mm.

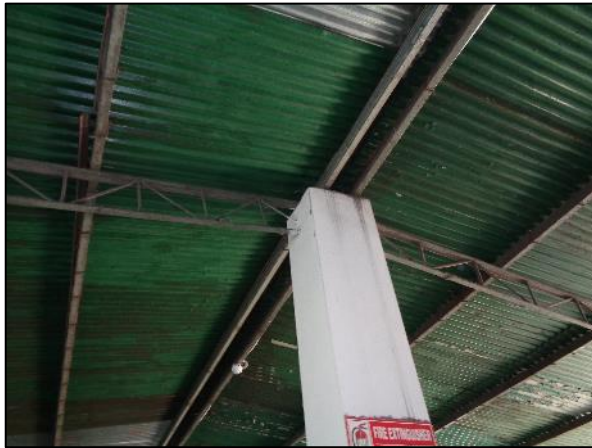
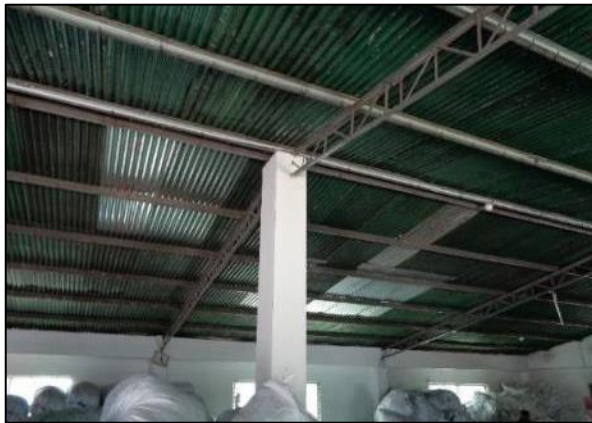
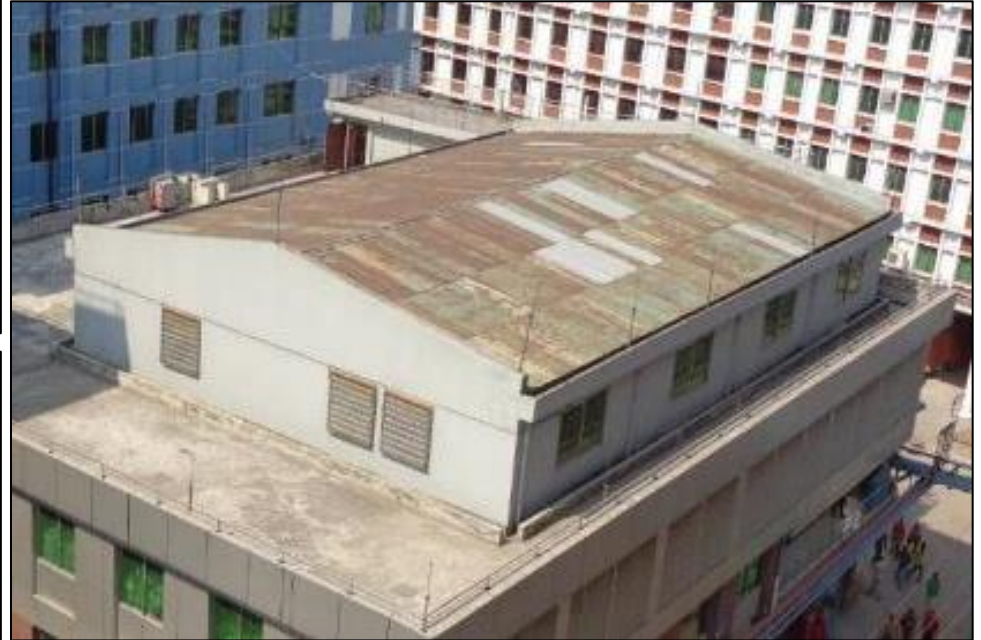
Non-engineered rooftop Shed

There is a rooftop shed on top of the building which is undocumented. The roof trusses are constructed with rebars and angles. Also As per as built drawings, the rooftop shed is required to be demolished but on site rooftop shed was found intact.

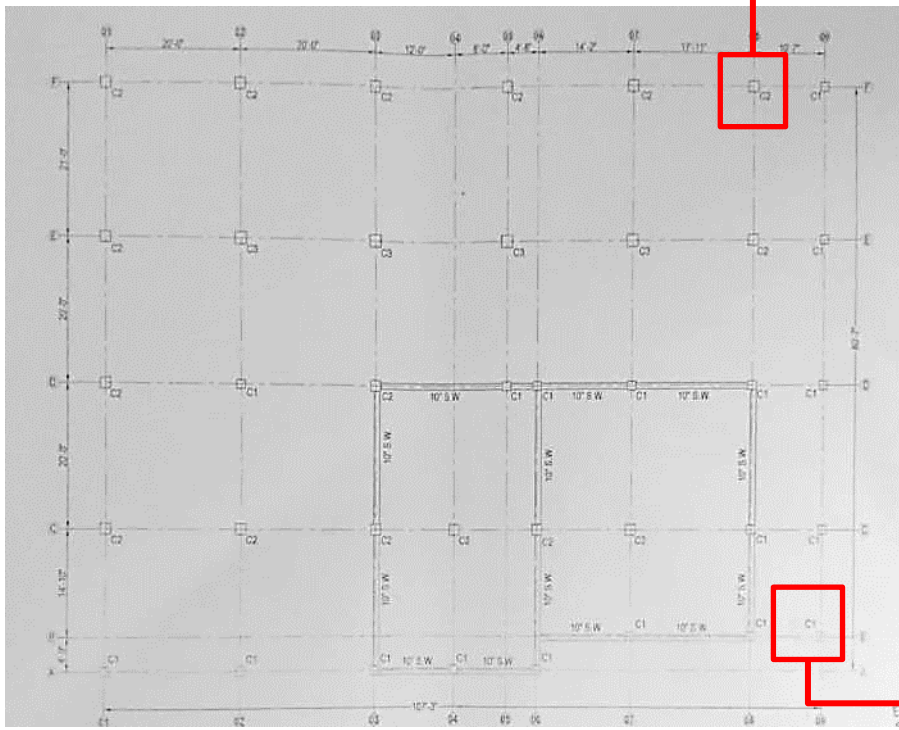
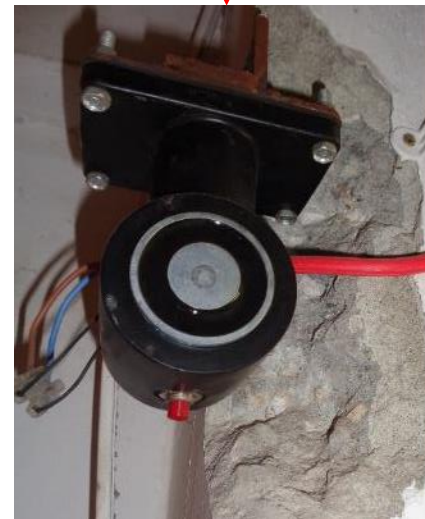
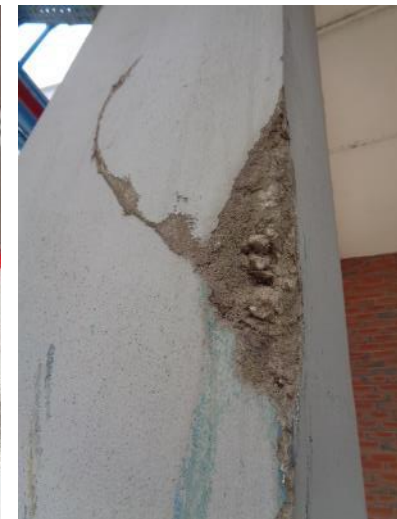
Column damage

Column on Grid F-8 in the 2nd floor was found damaged due to fire door installation. Also, Column on grid B-09 in the ground floor was found damaged.

- Factory Engineer to properly repair the damaged elements.

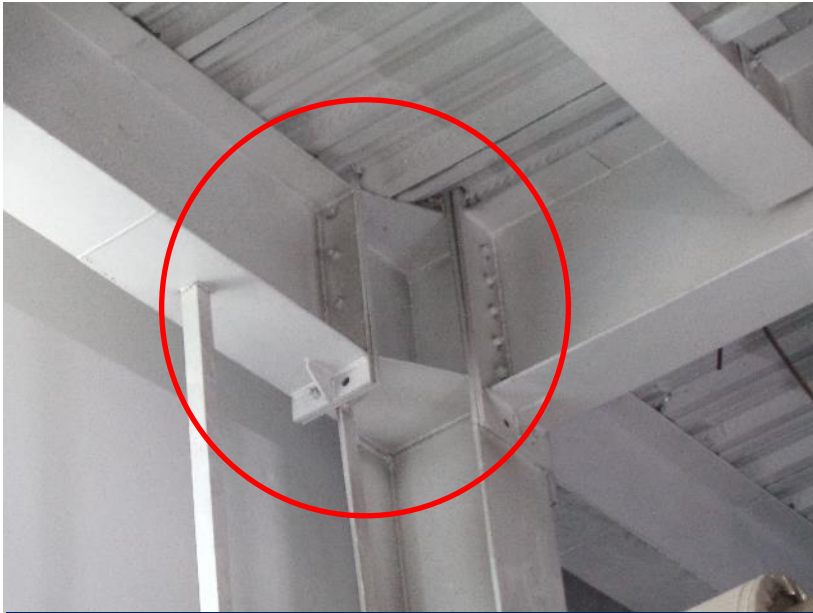
Bolt missing in connection

Bolts were missing in several location of the building. Building engineer is required to identified the location and reinstall the missing bolts as per specification.

- Install the missing bolts as per specification.

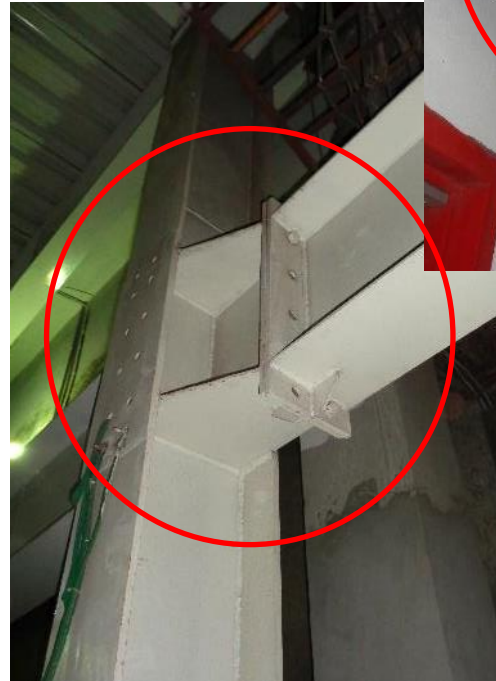
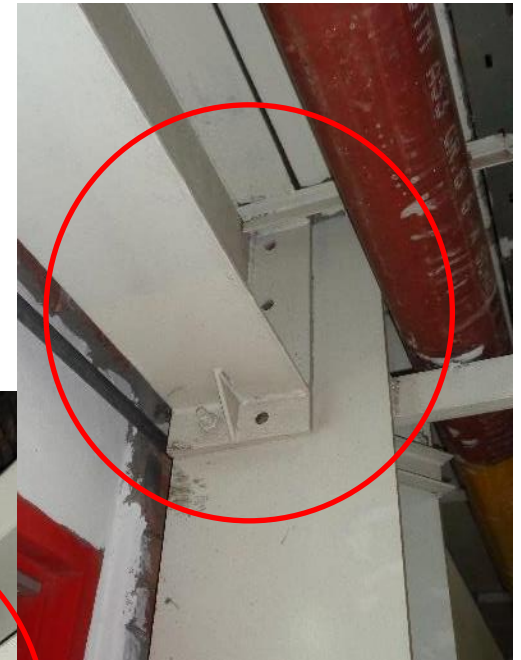
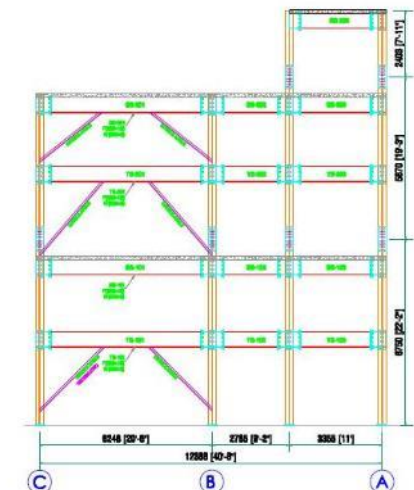
Irregular bracing system observed in the building. Building engineer is required check the existing bracing system for lateral stability.
