# AKH Knitting & Dyeing Ltd.

92, Phulbaria, Tetuljhora, Savar-1347, Dhaka.  
(23.80997 N, 90.248941 E)

18<sup>th</sup> March 2015

# **AKH Knitting & Dyeing - Building 9**

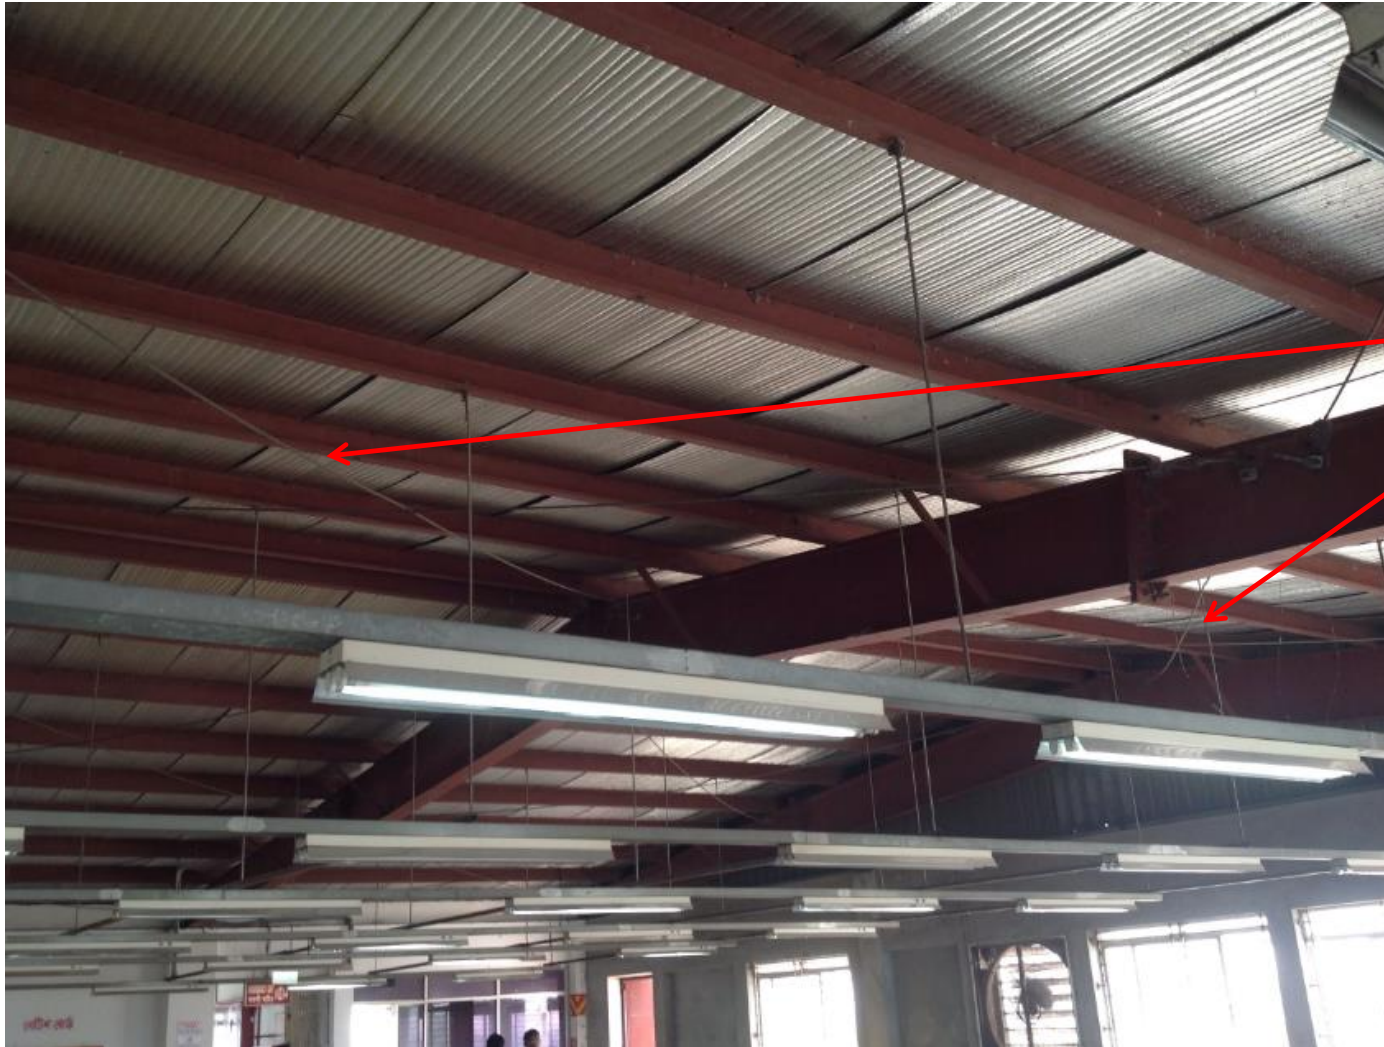
## Roof Bracing in Dining Area of Building 7

Bracing elements are slack and should be tightened to ensure they are functioning correctly.

| Item No. | Observation | Recommended Action Plan | Recommended Timeline |
|---|---|---|---|
| 1 | Roof Bracing in Dining Area of Offices (Building 7) | Re-tighten all horizontal bracing elements in the Roof Structure for the Dining Area of Building 7. | 6-weeks |
| 3 | Roof Bracing in Dining Area of Offices (Building 7) | If bracing elements slacken again, re-tighten accordingly. | 6-months |

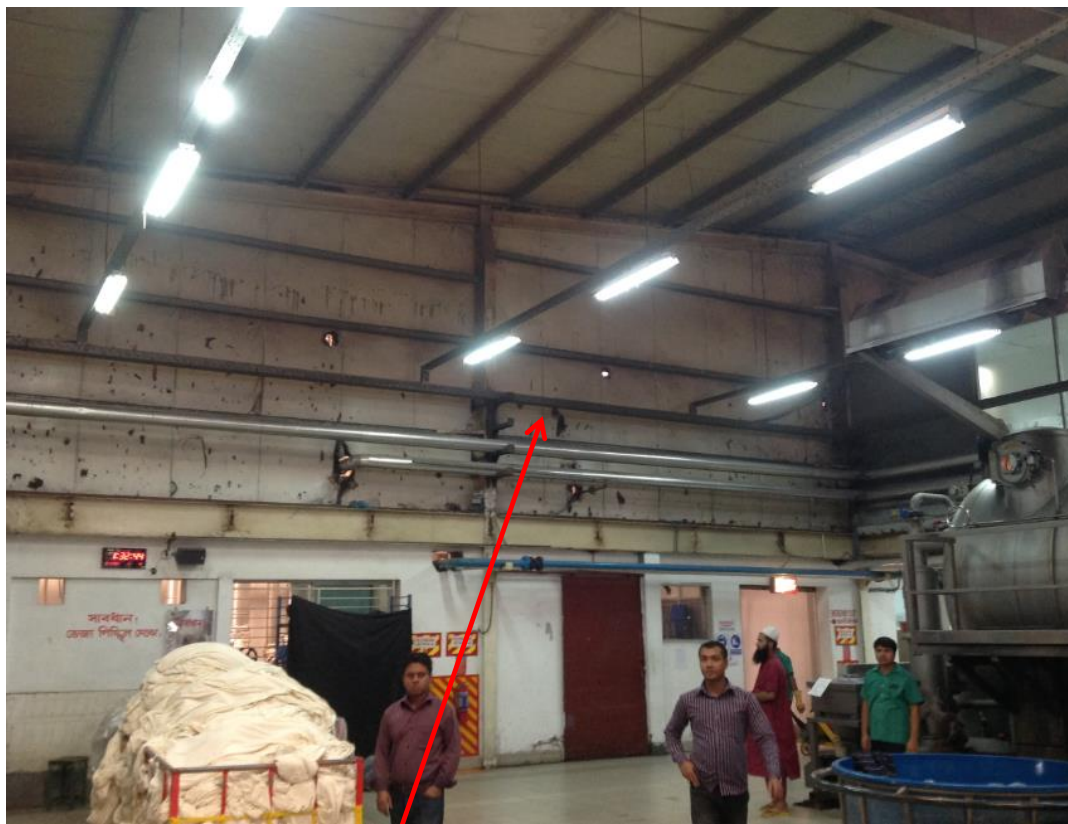
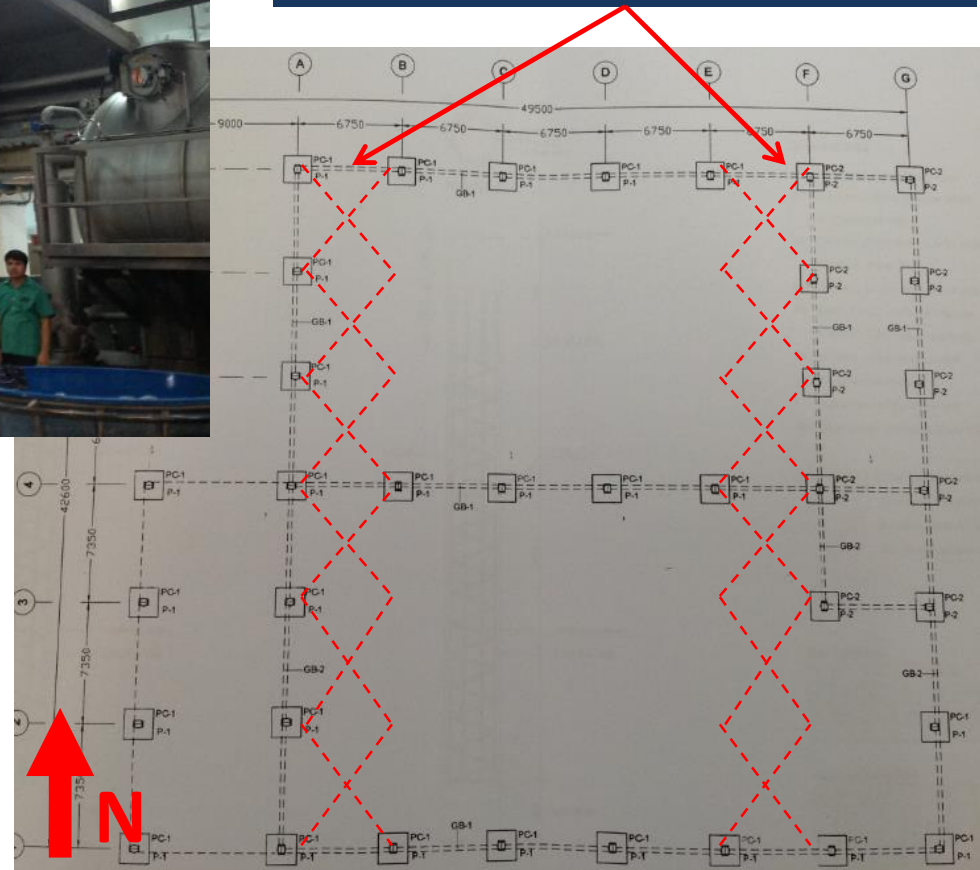
## Dyeing Shed stability system

Cable bracing elements are provided to resist forces in the North-South direction, vertical bracing not continuous to ground in places.

No apparent bracing to resist forces in the East-West direction. Structure stability should be checked for lateral loads.

| Item No. | Observation | Recommended Action Plan | Recommended Timeline |
|---|---|---|---|
| 4 | Dyeing Shed (Building 3) stability system | Review the stability calculations for the Dyeing Shed to ensure it is a robust structure in both directions. | 6-weeks |

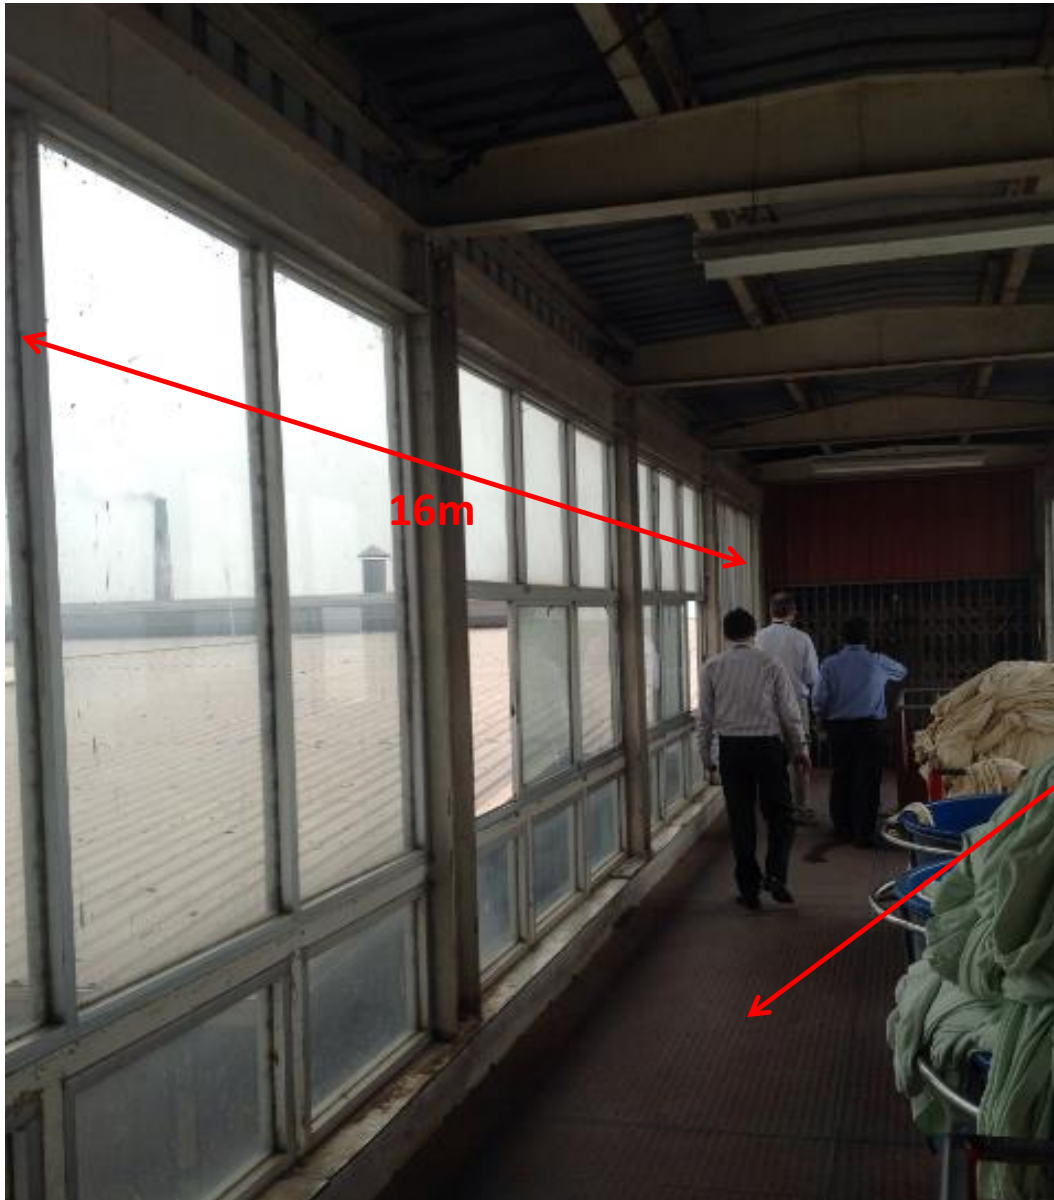
**Walkway from Building 8 into Dyeing Shed**

No drawings or design was provided for the 16m walkway from the Production Building 8 to the Dyeing Shed.

| Item No. | Observation | Recommended Action Plan | Recommended Timeline |
|---|---|---|---|
| 6 | Walkway from Production Building (Building 8) into Dyeing Shed (Building 3) | Review the drawings and calculations for the walkway from Building 8 to Building 3. | 6-weeks |
| 7 | Walkway from Production Building (Building 8) into Dyeing Shed (Building 3) | Check the impact this walkway has on the Building 8 RC structure and provide calculations. | 6-weeks |
| 8 | Walkway from Production Building (Building 8) into Dyeing Shed (Building 3) | Create a loading plan for the maximum load this walkway can carry. | 6-weeks |

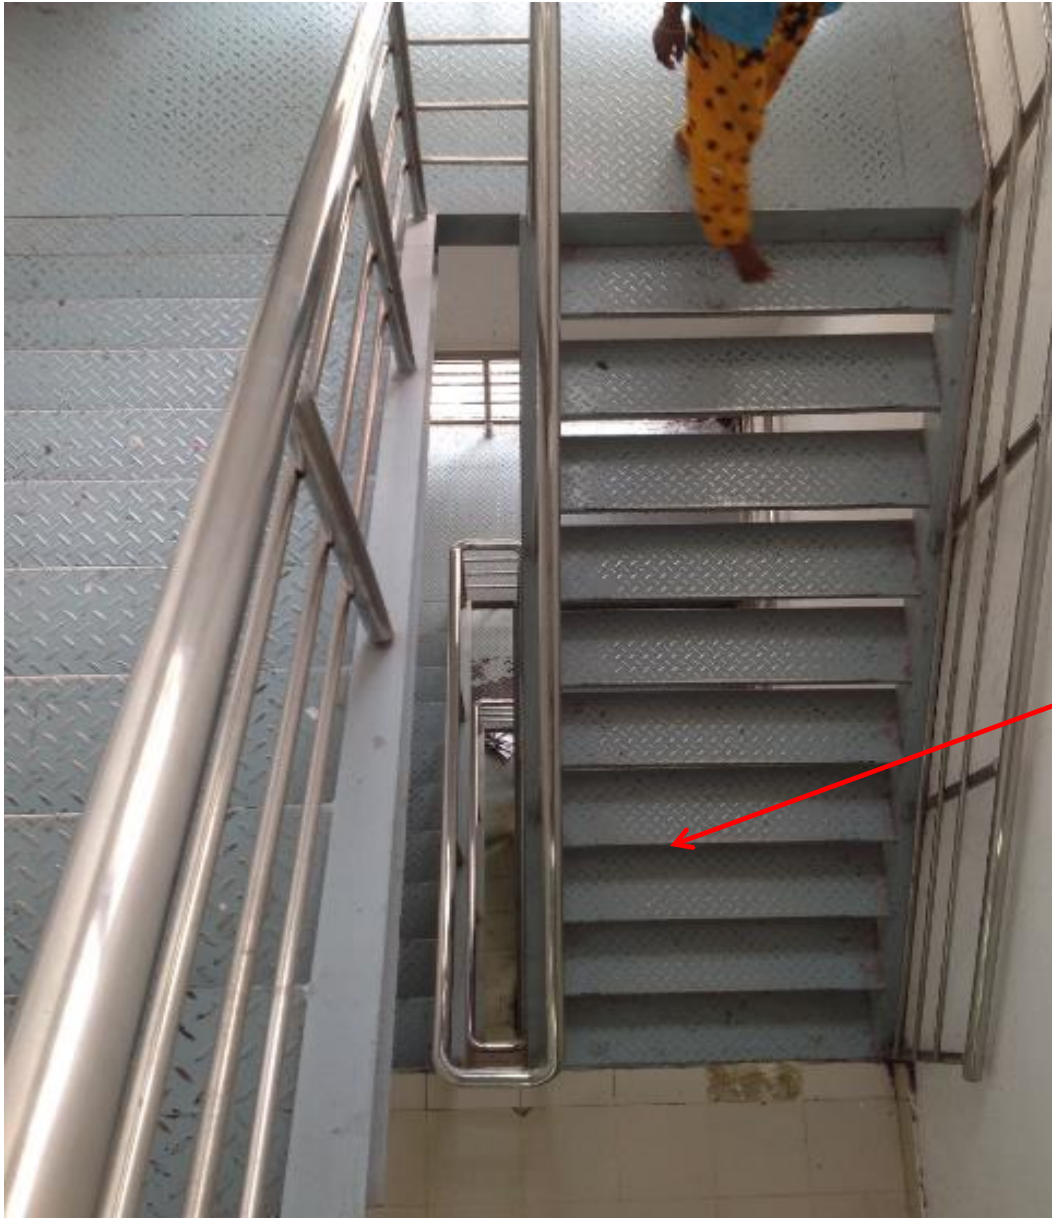
**Steel Stairs in Building 8**

**An internal steel stairs in Building 8 cannot be used as a fire escape as it does not lead people safely outside the building. The stairs goes from 5<sup>th</sup> Floor to 1<sup>st</sup> Floor.**

| Item No. | Observation | Recommended Action Plan | Recommended Timeline |
|---|---|---|---|
| 10 | Steel Stairs in Building 8 does not safely lead people outside and should not be marked as a Fire Escape route. | Clearly label this stairs as an internal stairs only, and not a fire escape. | 6-months |

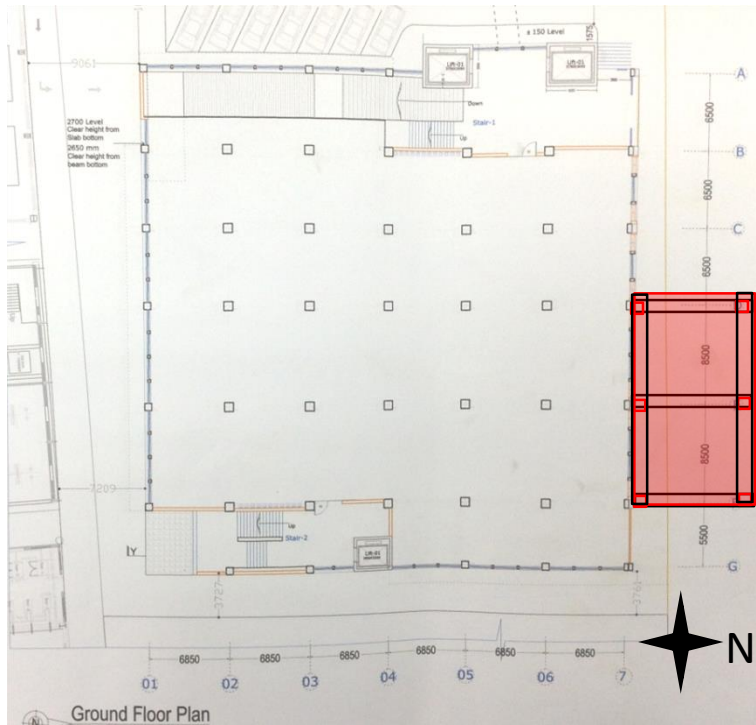
Location of extension

- Horizontal single storey extension to building on the ground floor
- No additional loads added to primary structure, as expansion joint was observed between the columns
- Building documentation to be updated to reflect this additional structure

| Item No. | Observation | Recommended Action Plan | Recommended Timeline |
|---|---|---|---|
| 1 | Undocumented ground floor extension | Building drawings to be updated to match as-built structure. | 6-months |

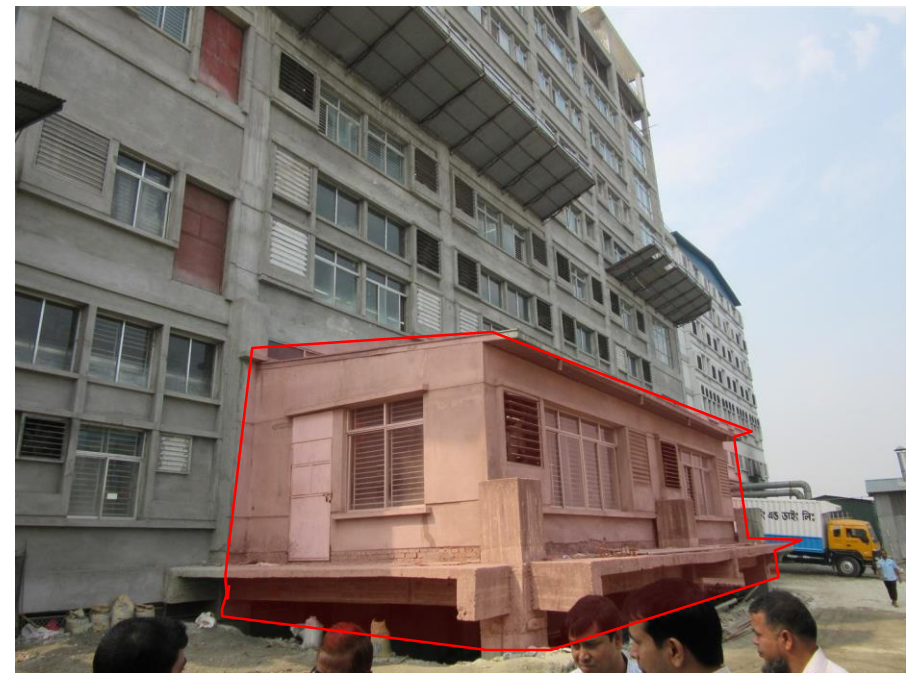
Single Storey Extension on north side of building

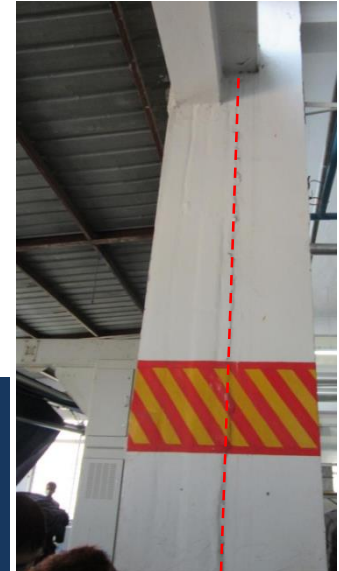
Double column and separation joint between the 2 structures

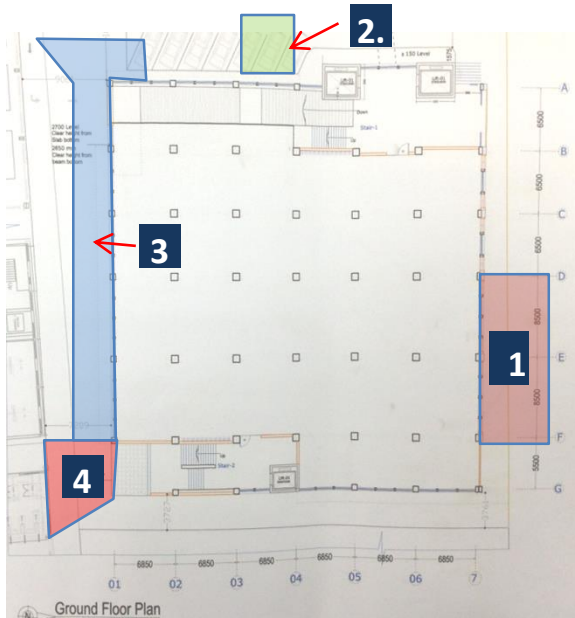
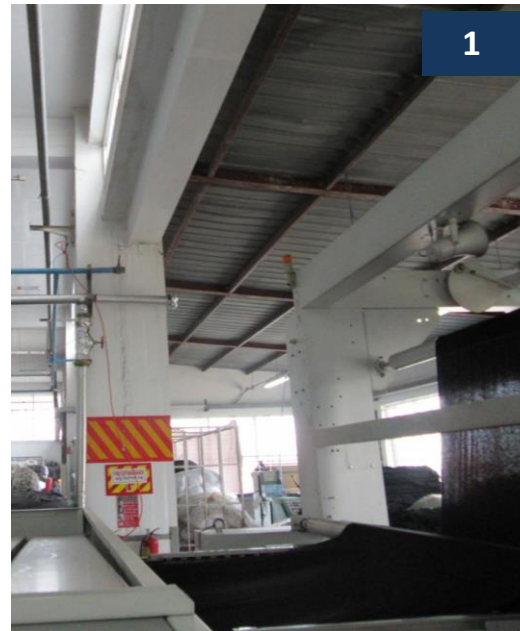
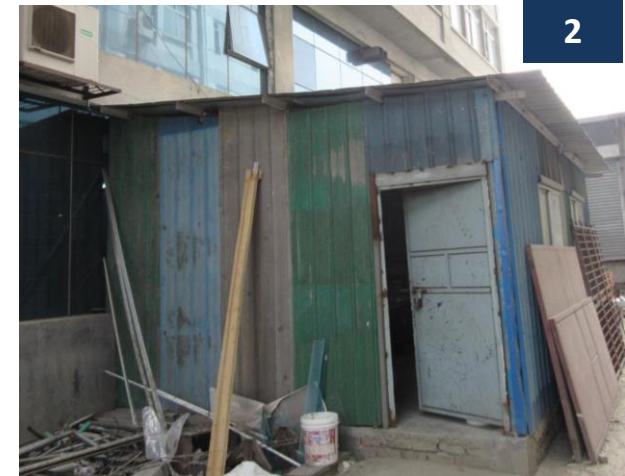
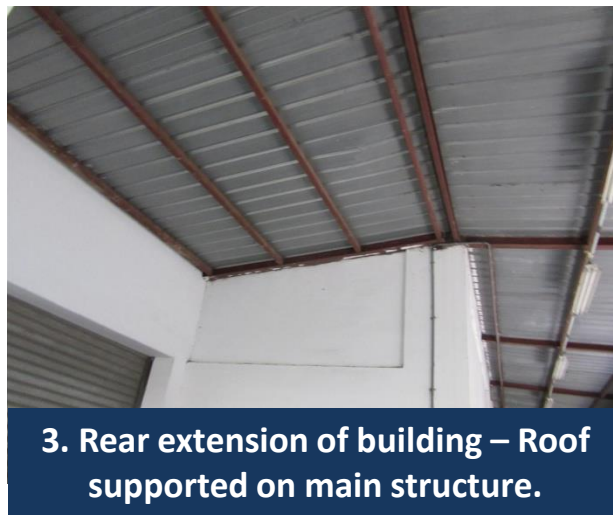
# Apparently non-engineered steel roof structures

- Non-engineered roof structure without bracing system.
- Roof structures subject to uplift in high winds.
- Factory Engineer to assess roof structure for vertical (including uplift) and lateral loads.

| Item No. | Observation | Recommended Action Plan | Recommended Timeline |
|---|---|---|---|
| 2 | Apparently non-engineered steel roof structures | Building Engineer to perform design check for lightweight steel roofs, including lateral stability and uplift in high winds. | 6-months |
| 3 | Apparently non-engineered steel roof structures | Main Building structure to be assessed for additional loading from roof extensions where applicable (e.g. South Extension) | 6-months |

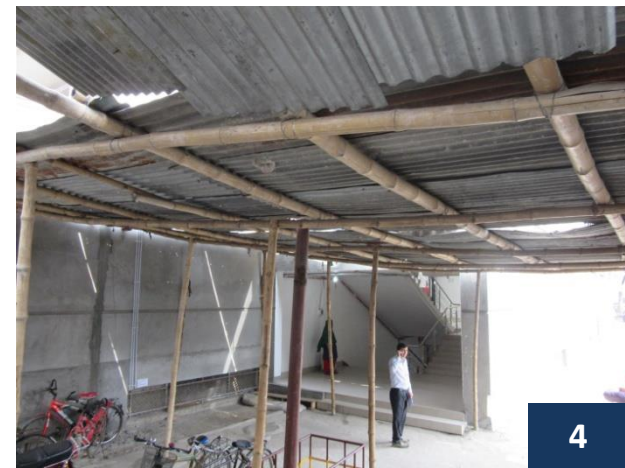
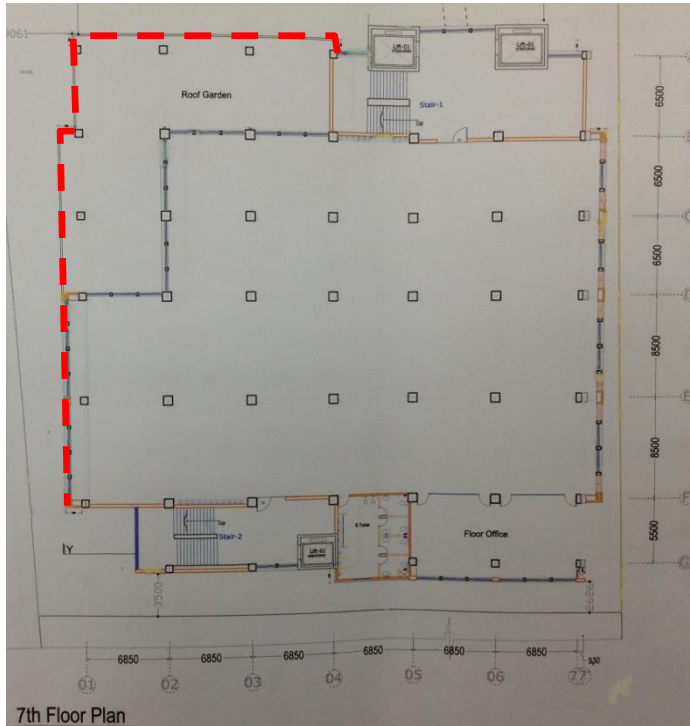
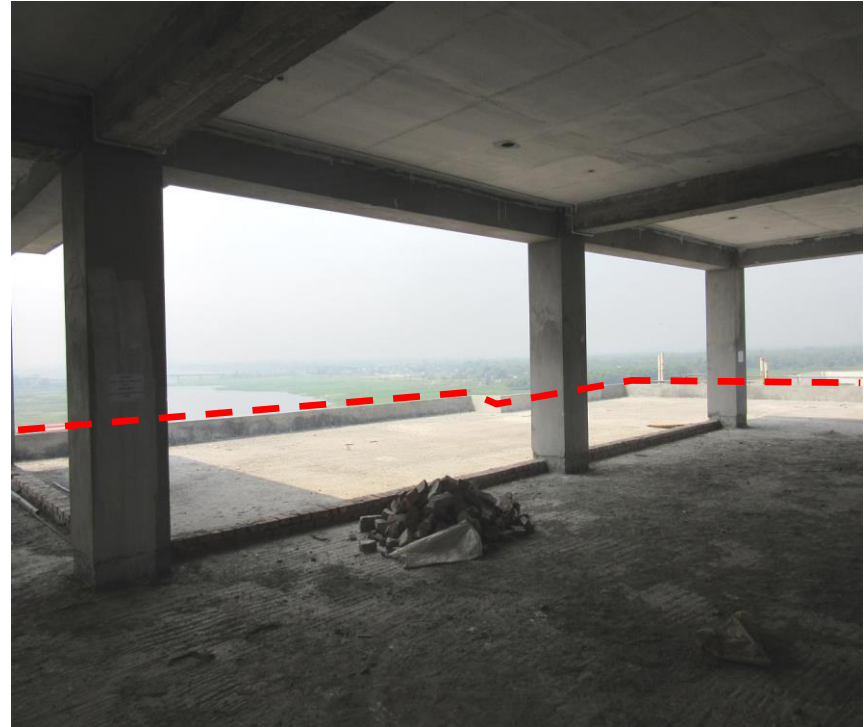
**Limited edge protection on the 7<sup>th</sup> floor**

- Low parapet around future roof garden providing insufficient fall protection.
