FIRE SAFETY INSPECTION REPORT

Glamour Dresses Limited

Factory ID: 24135

Date: 17 February 2021

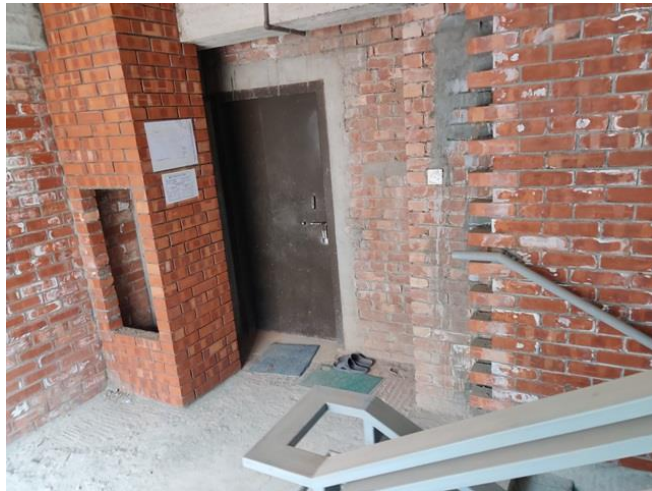
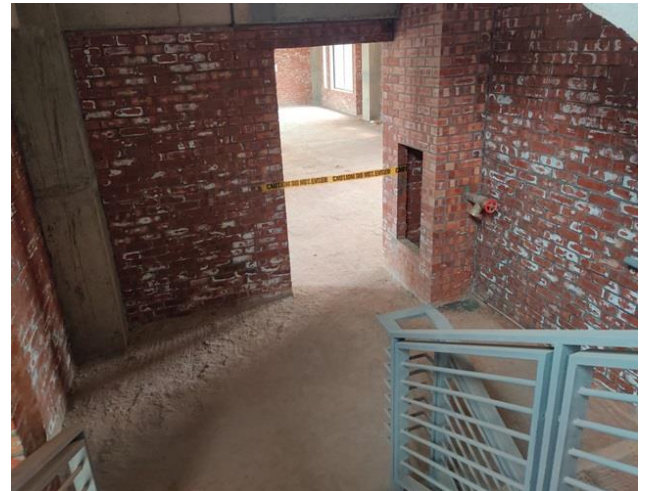
No.	Category	Finding	Recommendation	Remediation Timeframe
F-1	Fire Rated Construction	Exit stairs are not separated from work areas & other spaces on each floor by fire-rated construction due to unprotected openings and penetrations. (Utility Building)	<p>Separate the exit stairs from work areas and other building spaces on all floor levels by minimum 2- hr fire-rated construction. Provide minimum 1.5- hr fire rated doors and seal all unprotected openings and penetrations to maintain the fire separation.</p> <p>Ensure that all fire doors are self-closing and positive latching, and are provided with fire exit (panic) hardware where serving production floors or assembly occupancies.</p> <p>If fire doors are required to be held open for functional reasons, provide automatic-closing devices tied to the fire alarm system.</p> <p>Once fire doors are installed, every door in a stair enclosure serving more than 5 stories shall be provided with re-entry unless it meets ACCORD standard 6.8.3.1.</p>	Within 3 months

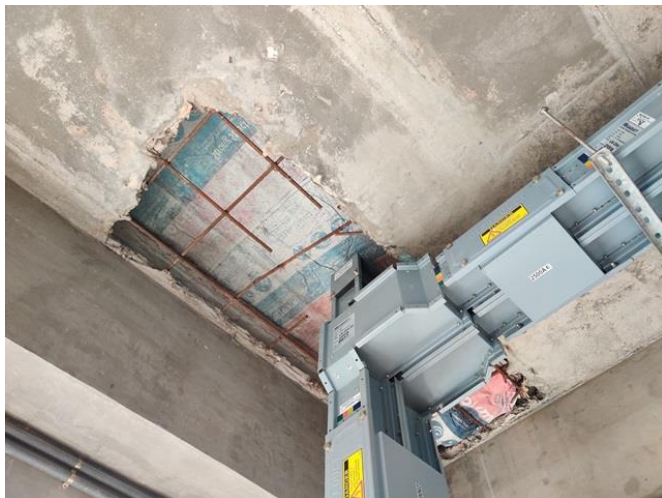
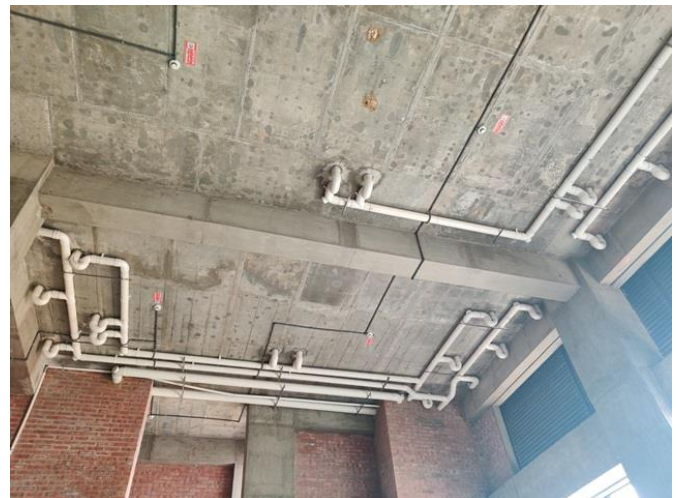
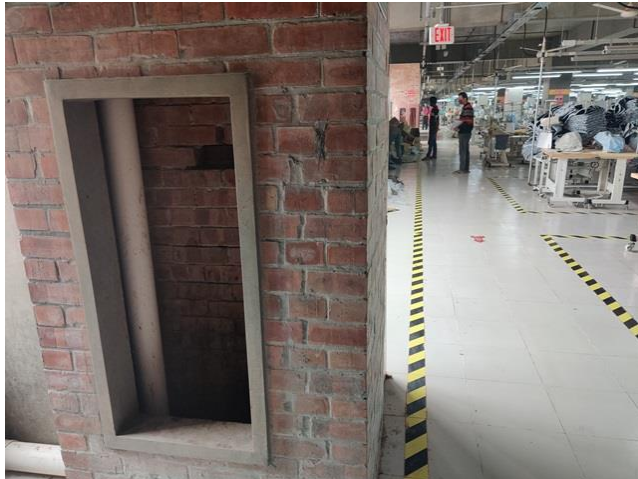
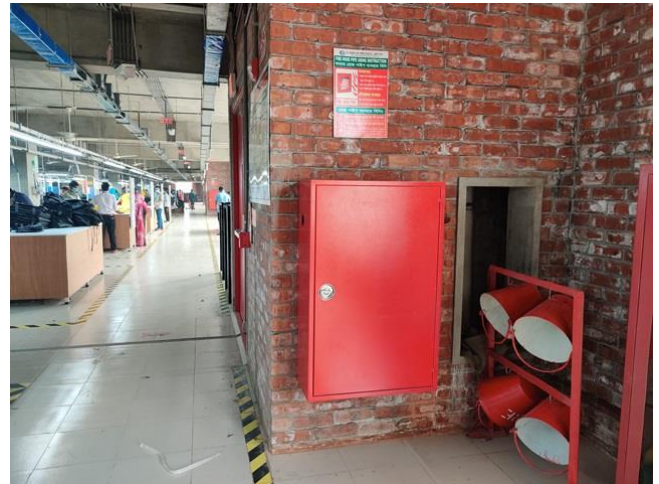
F-2 Fire Rated Construction

Unsealed floor penetrations are located in the fire-rated floor/ceiling assemblies. (electrical riser, toilet waste pipe, rain water pipe, standpipe risers etc.)

Provide a minimum 2-hr fire-rated shaft with opening protection to separate the utility risers from each floor level.
Provide listed through penetration fire stop system or seal all penetrations in floor/ceiling assemblies to maintain the fire separation.

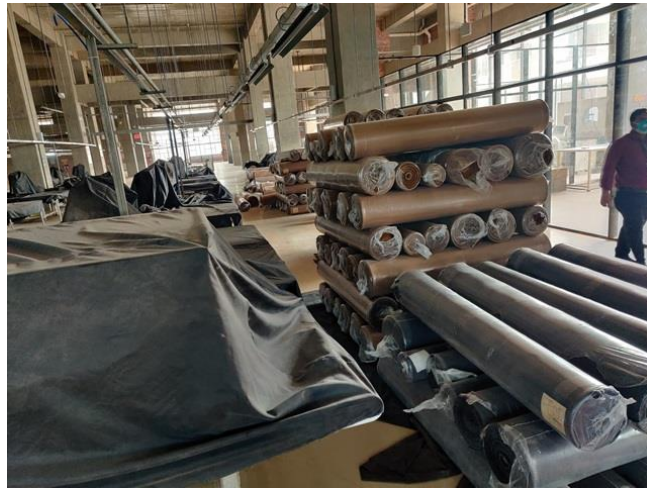
F-3	Fire Rated Construction	Open storage areas on ground floor are not properly defined and/or not within limits.	Provide defined storage areas and limit the storage arrangement as follows: Maximum height of 2.45m (8 ft) and maximum area of 23 m ² (250 ft ²). If sprinkler protected: maximum height of 3.66m (12 ft) and maximum area of 93m ² (1000 ft ²). Separate the areas of unenclosed combustible storage by a minimum clear distance of 3 m (10 ft).	Within 3 months
-----	-------------------------	---	--	-----------------

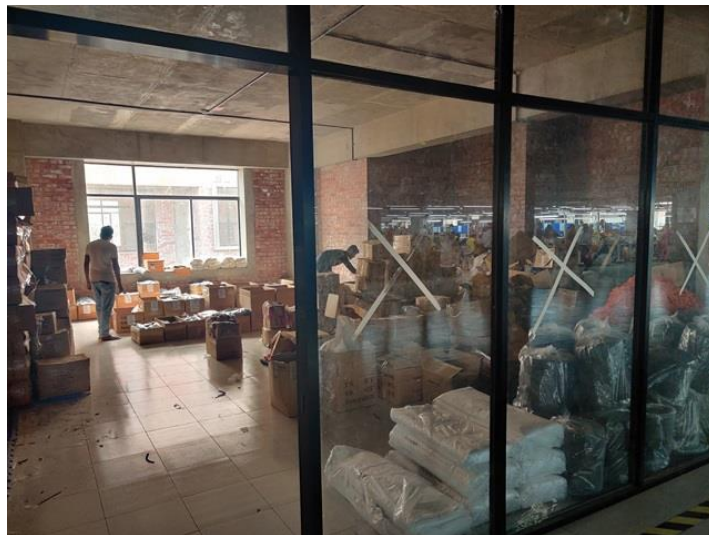
F-4	Fire Rated Construction	Room on 1st floor is used for combustible storage is not separated by a minimum 1-hr fire-rated construction.	Provide dedicated storage rooms separated by minimum 1-hr fire-rated construction.	Within 3 months
-----	-------------------------	---	--	-----------------

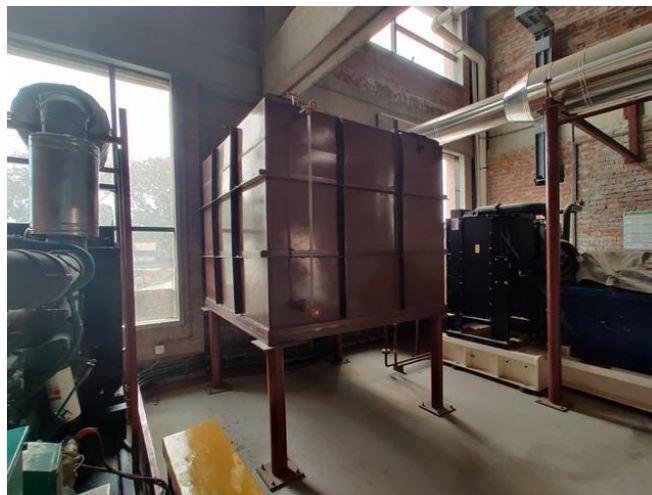
F-5	Fire Rated Construction	Diesel fuel storage was located inside the generator rooms.	Remove all diesel fuel storage from the generator room and relocate to the exterior such that the diesel fuel storage is at least 10 ft from required egress paths. located along egress paths in a utility building, separate the diesel fuel storage with 2-hr fire rated construction. There shall be no diesel fuel storage in a factory production building.	Within 3 month
-----	-------------------------	---	---	----------------

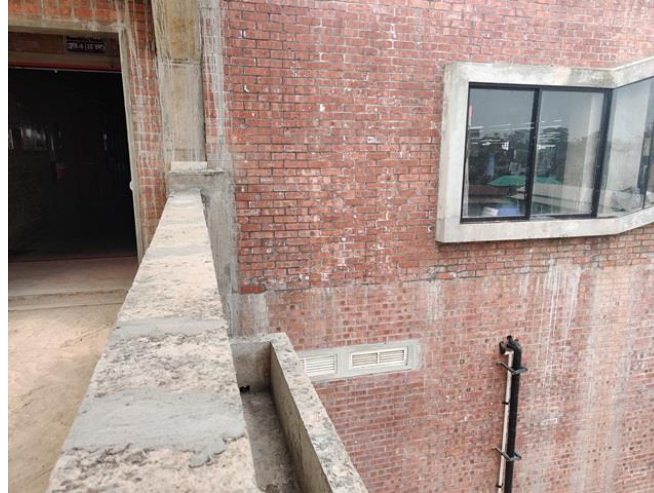
F-6	Fire Rated Construction	Exterior exit stair is not properly separated from the building.	Exterior exit stairs shall be separated from the building with a rating requirement of 1-hr fire rating for 3 or fewer stories and 2-hr fire rating for 4 or more stories. The rating of the exterior wall shall extend 3.05 m (10 ft) beyond the ends of the stair structure.	Within 4 months
-----	-------------------------	--	--	-----------------

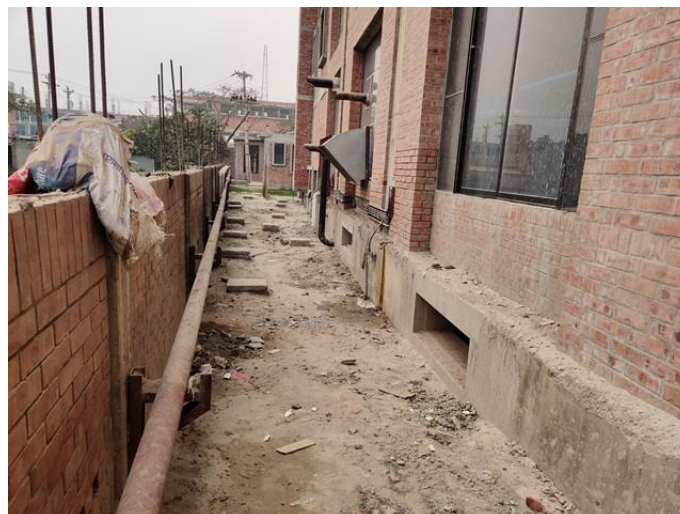
F-7 Fire Rated Construction

The exit discharge path serving the west exit is less than 10 ft wide and is not separated from the building interior.

Seal all penetrations and openings to the interior of the building along the discharge path, up to a height of 10 ft, to provide a minimum 1-hr fire separation.

Additionally egress path shall be even and smooth to ensure uninterrupted and unobstructed safe exit.

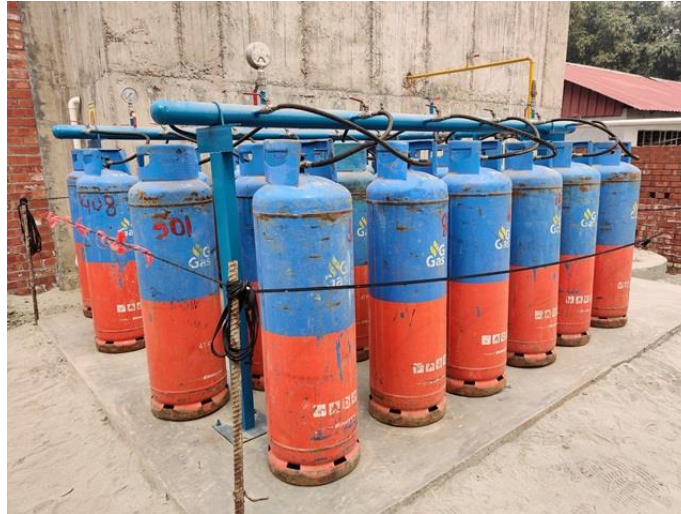
F-8	Fire Rated Construction	Liquefied or compressed gas cylinders are located within the factory on ground floor.	The storage or use of liquefied or compressed flammable gas cylinders shall be prohibited within the factory building.	Immediately
-----	-------------------------	---	--	-------------

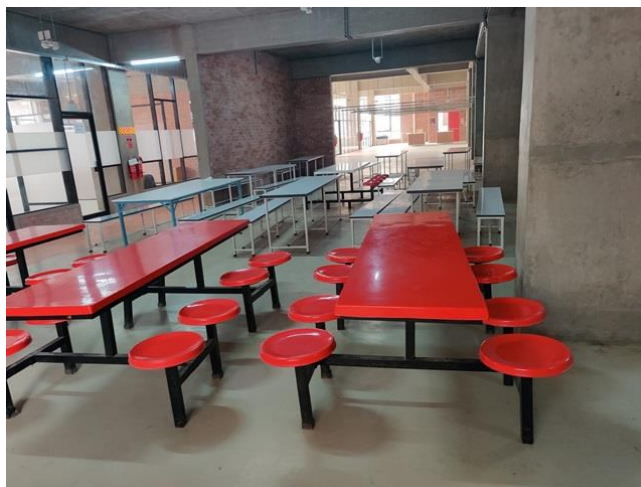
F-9	Fire Rated Construction	Dining at ground floor is not separated from other occupancy.	Separate the dining facility by 3-hr rated construction and opening protection. Provide at least two exit leading directly outside of the building or exit stair.	Within 3 months
-----	-------------------------	---	---	-----------------

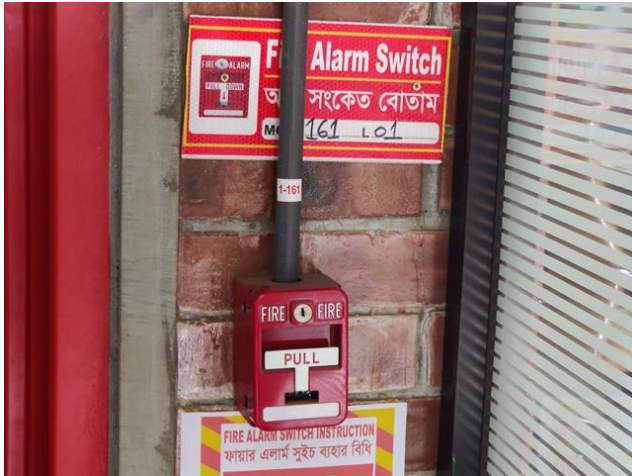
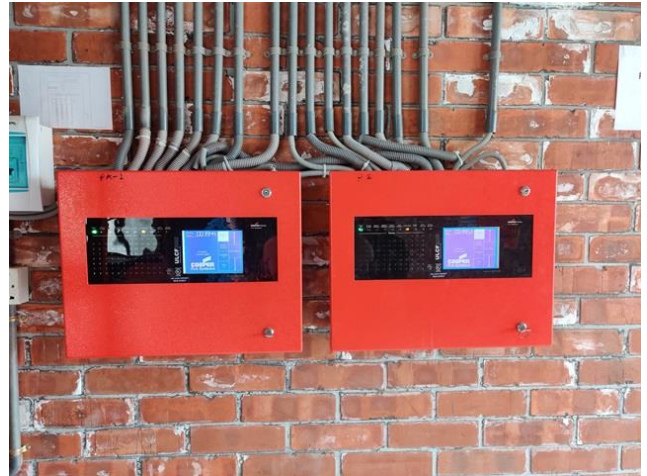
F-10	Fire Protection	The fire alarm system installation requires detailed review to confirm compliance with NFPA 72 and ACCORD standard.	Submit as-built drawings, testing records, equipment certification and other relevant documentation to the RSC for review and approval/acceptance test.	Within 3 months
------	-----------------	---	---	-----------------

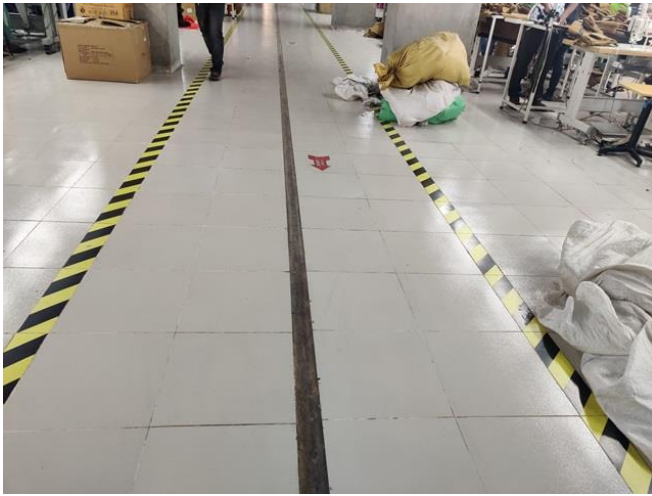
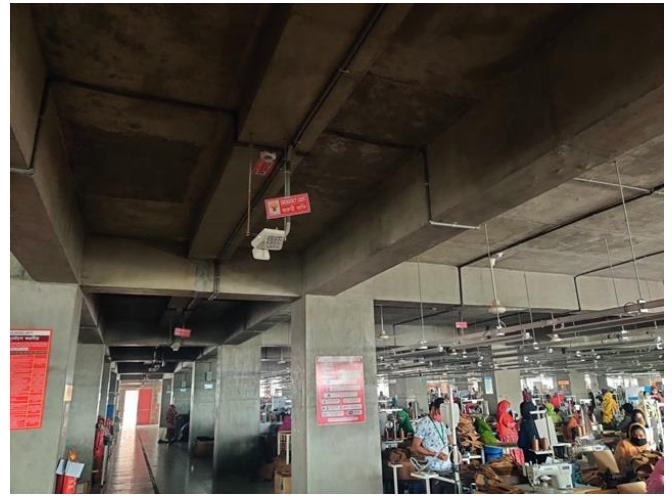
F-11	Fire Rated Construction	Reportedly Building expansion joint has been sealed by adequate fire rated sealant material however supporting documents and/or product certificate was not provided.	Seal the expansion joints by 2-hr fire rated materials to ensure the required fire separation as well as to maintain structural characteristic for the expansion joint. If sealed by listed rated material, provide all the relevant documents and certificate during followup.	Within 3 months
------	-------------------------	---	--	-----------------

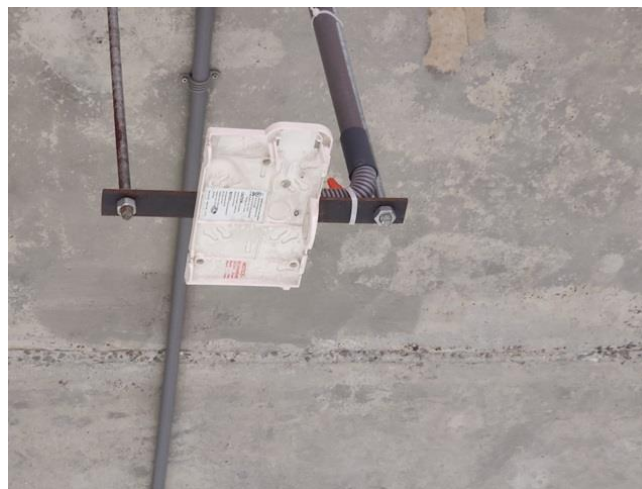
F-12 Egress Lighting

Emergency lighting did not function in test mode (burned out, broken, etc.).

Regularly test the emergency lighting system on each floor and replace/repair lights as needed.
