Aliza Fashions Ltd. Aliza Fashion Trousers Ltd.

Chaydana, National University, Gazipur
(23.957721N, 90.378621E)
29th March 2015

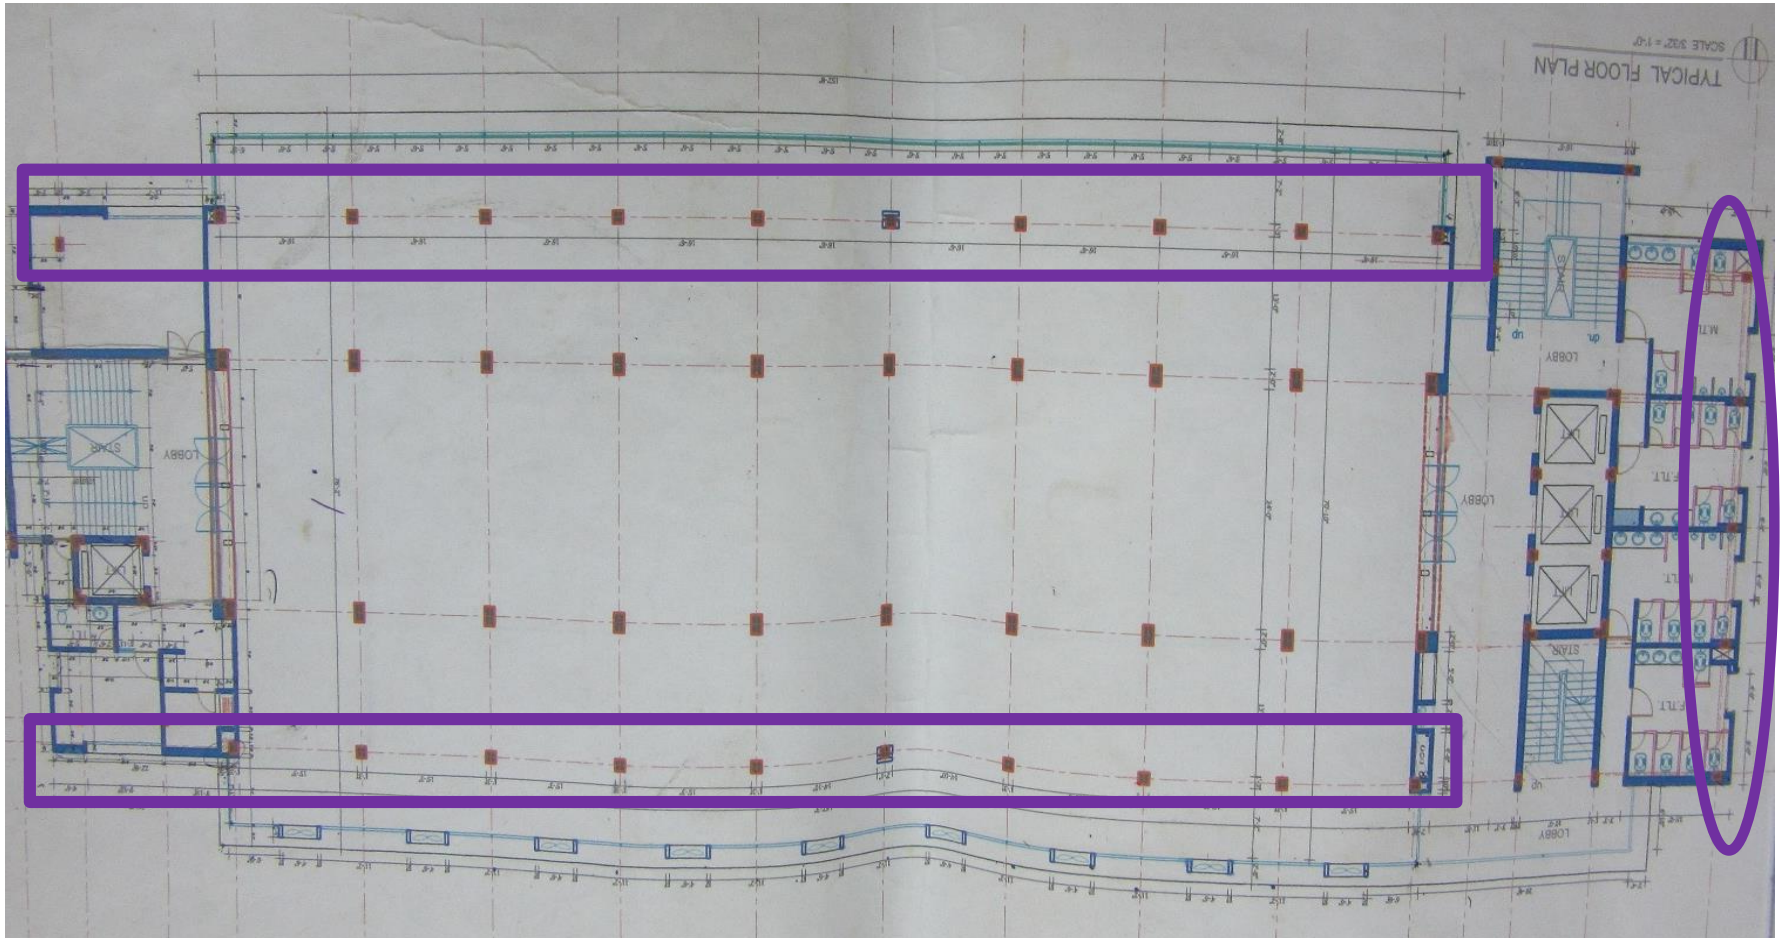
High stress levels in columns

Cursory calculations indicate that certain columns at Ground Floor are highly stressed under the current loading condition

Item No.	Observation	Recommended Action Plan	Recommended Timeline
1	High stress levels in columns	Building Engineer to review design, loads and column stresses in all the columns in the toilet area	Immediate - Now
2	High stress levels in columns	A Detail Engineering Assessment (DEA) of Building 5 is to be commenced, see attached Scope.	Immediate - Now
3	High stress levels in columns	Verify in-situ concrete stresses by taking 100mm dia. cores from a min. of 4 columns at Ground Floor and verify grade/number of and diameter of reinforcement used.	Immediate - Now
4	High stress levels in columns	Detail Engineering Assessment to be completed	6-weeks
5	High stress levels in columns	Produce and actively manage a loading plan for all floor plates within the Building, giving consideration to floor capacity and column capacity.	6-weeks
6	High stress levels in columns	Actions identified in the Detail Engineering Assessment to be implemented.	6-months

7	High stress levels in columns	Continue to implement the load management plan.	6-months

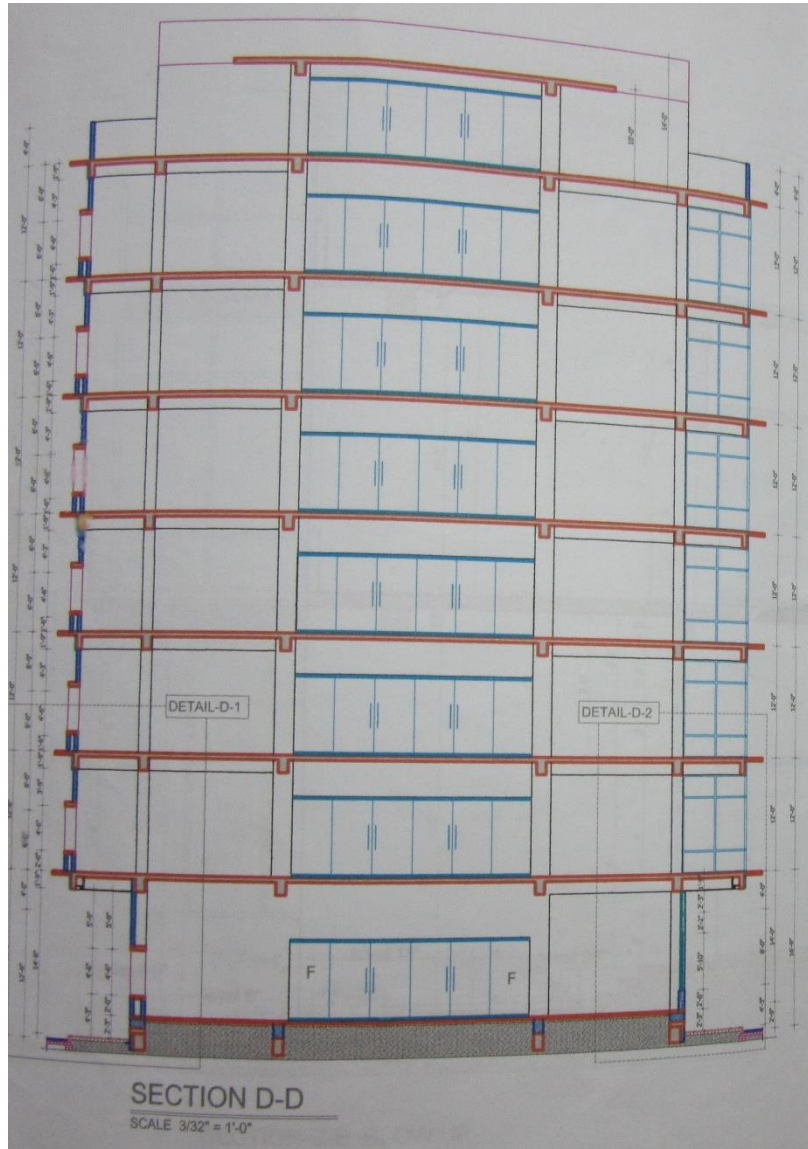
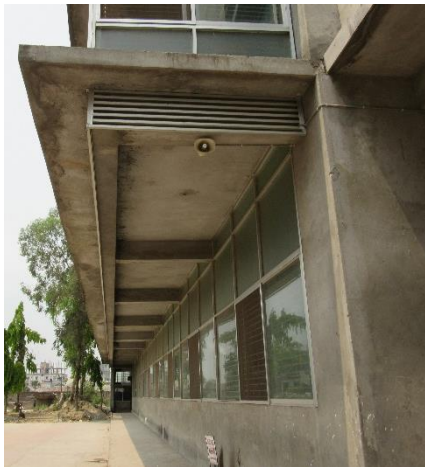
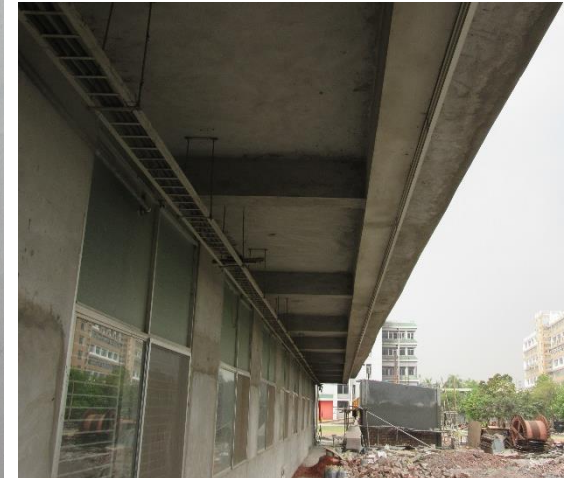
Cantilever slabs to all levels at north and south elevations

Long cantilevers at all floors.

Item No.	Observation	Recommended Action Plan	Recommended Timeline
8	Cantilever slabs to all levels at north and south elevations	As part of the DEA, Building Engineer to carry out a design check of the cantilevers to ensure structural integrity of the slabs and beams.	6-weeks
9	Cantilever slabs to all levels at north and south elevations	Implement any actions arising from design check.	6-months
10	Heavily loaded areas	As part of the DEA, Building Engineer to confirm design loading of slabs and incorporate it into the loading plan for all floor plates.	6-weeks
11	Heavily loaded areas	Produce a loading plan and actively manage the floor loading for all floor plates giving consideration to floor capacity and column capacity.	6-weeks
12	Heavily loaded areas	Continue to implement the loading plan.	6-months

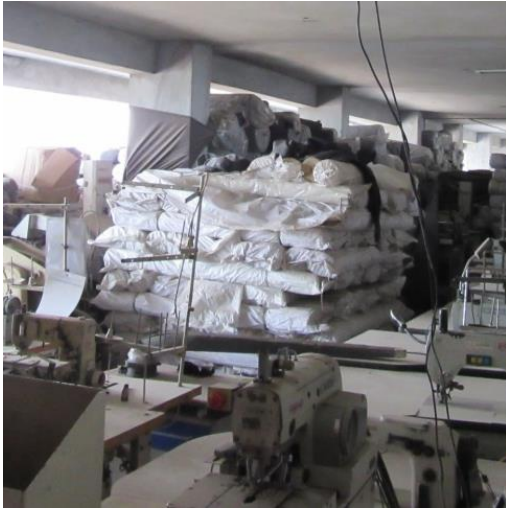
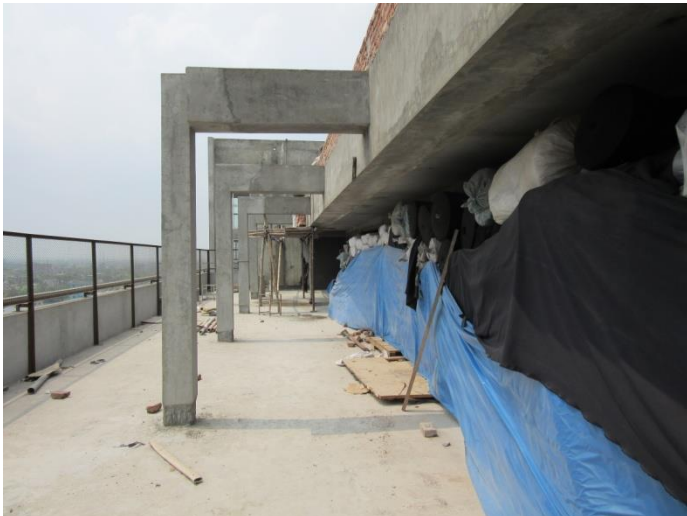
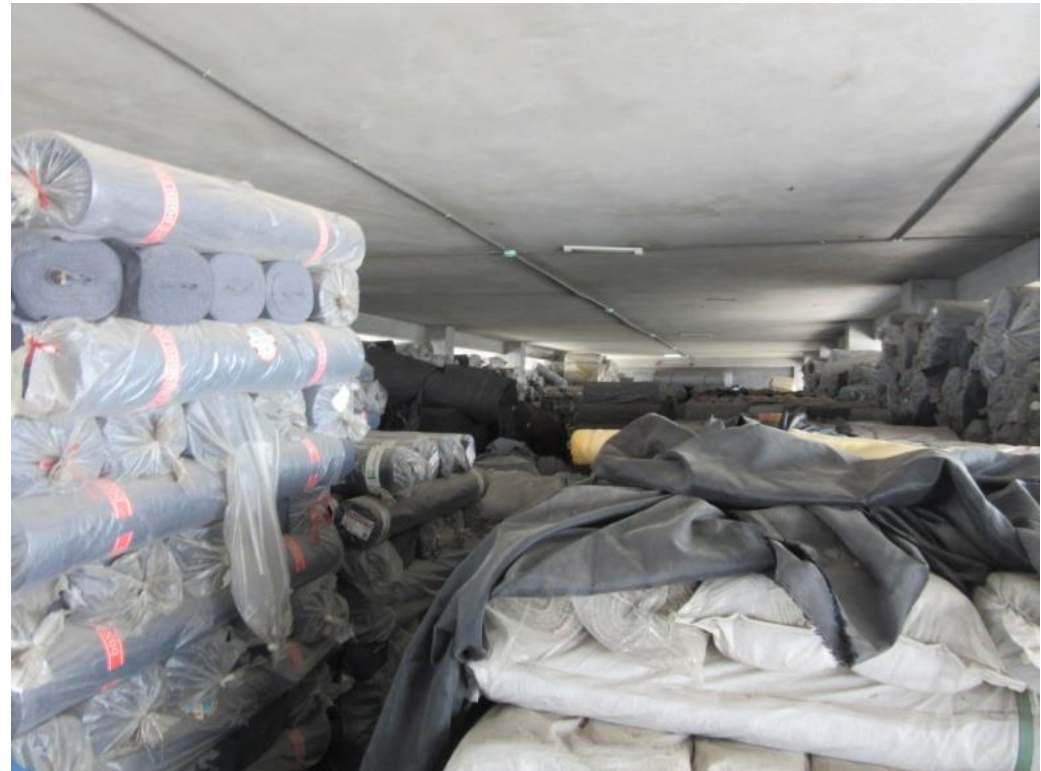
Heavily loaded areas

Heavy uncontrolled loading is observed on 7th floor, 6th floor and 5th floor.

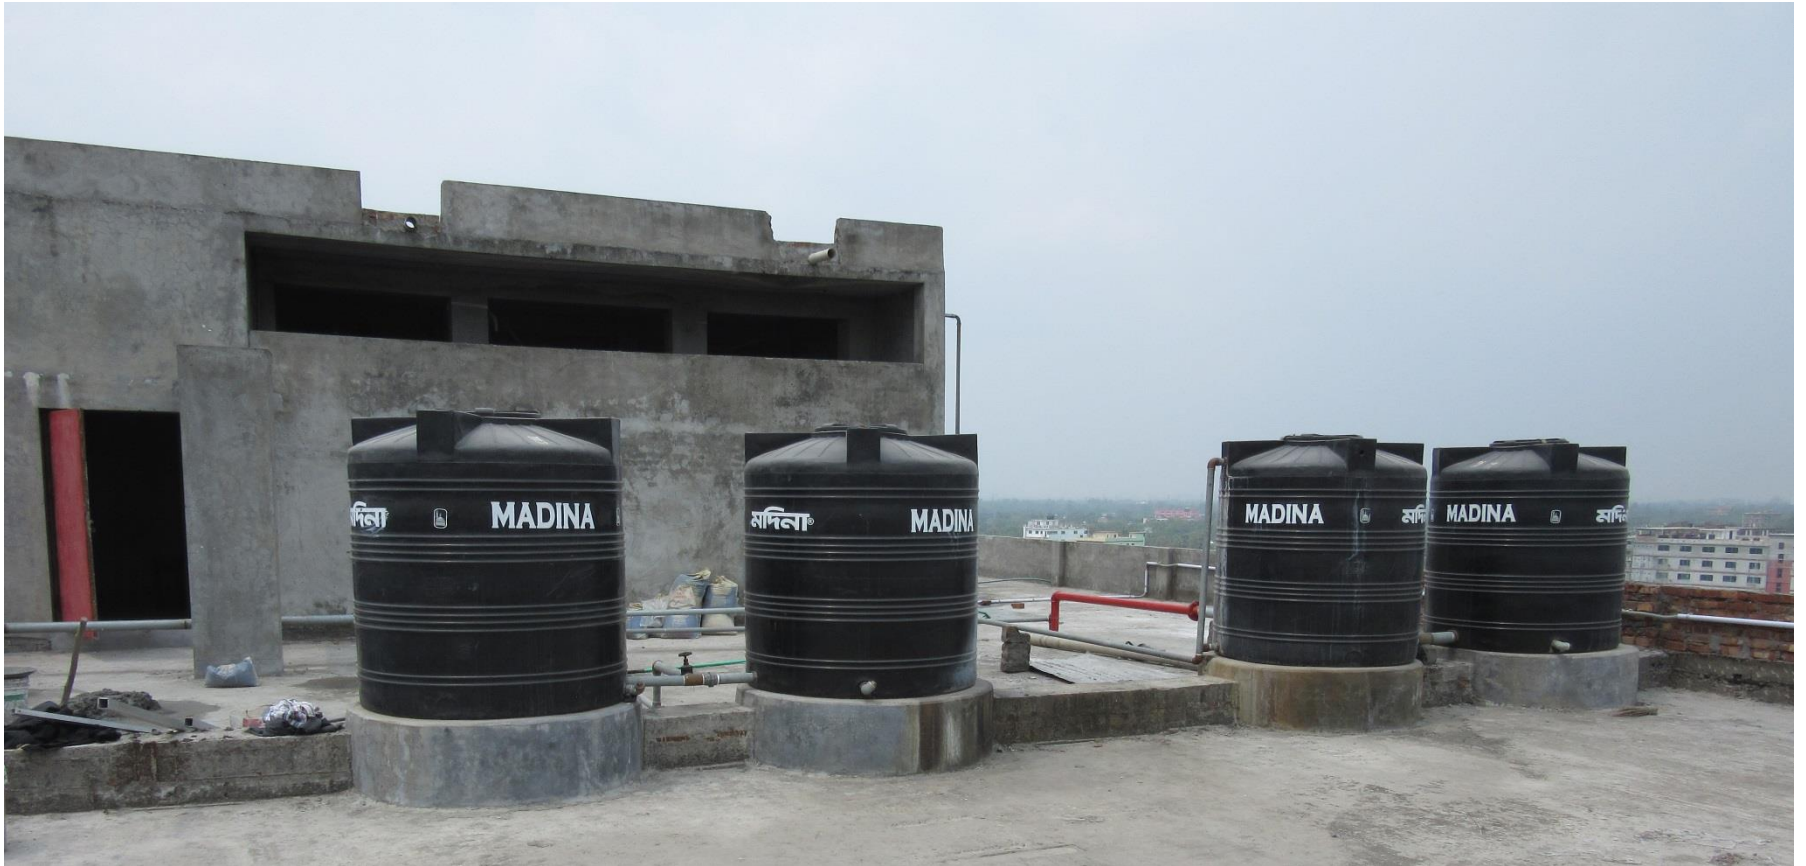
Water tanks are positioned in one line
