# INITIAL FIRE SAFETY INSPECTION REPORT

**Factory Name: Four H Fashions Ltd.**

**ADDRESS: 2852/A Chandgaon I/A, Mohora, Kalurghat, Chandgaon, Chittagong.**

**Date: 16-Feb-2021**

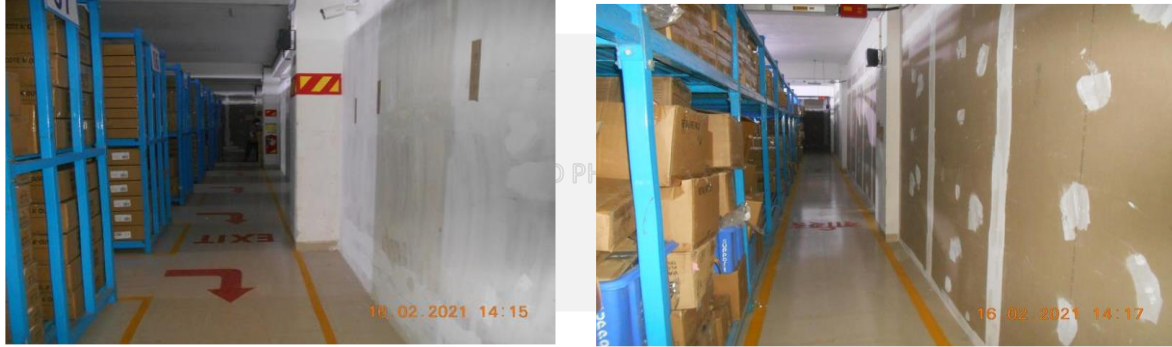
| Sl No. | Category | Findings | Required Action | Remediation Time Frame |
|---|---|---|---|---|
| 1 | Fire Rated Construction | Rooms used for combustible storage are not separated by fire rated construction on 1st floor (finished goods store). | Separate the dedicated storage rooms by minimum 1-hr fire-rated construction. Provide 0.75 hr. fire rated door and seal all penetrations and openings by 1 hr. fire rated fire rated barrier construction. | Within 3 months |

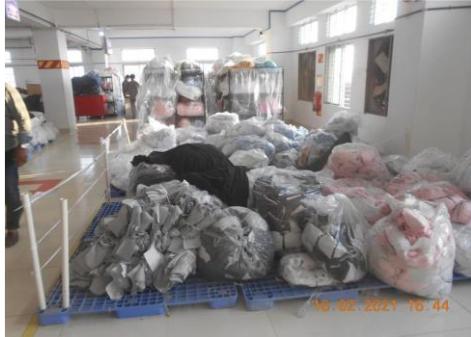
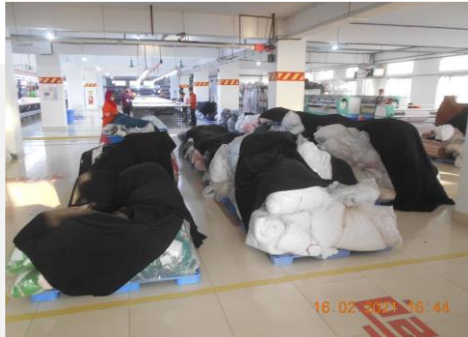
| 2 | Fire Rated Construction | <p>Areas used for combustible storage are not separated by fire-rated construction.</p> <p>Location: Fabric and accessories store on ground floor, finished goods store on 1st floor and open storage area on 4th floor.</p> | <p>Provide dedicated storage rooms separated by minimum 1-hr fire-rated construction.</p> <p>Or,</p> <p>Where separate storage rooms are not feasible, Provide defined storage areas and limit the storage arrangement as follows:-</p> <p>1. General Condition: Maximum height of 2.4m and maximum area of 23m<sup>2</sup>. Separate areas of unenclosed combustible storage by a minimum clear distance of 3m.</p> <p>2. If sprinkler protected: maximum height of 3.66m and maximum area of 93m<sup>2</sup>. Separate areas of unenclosed combustible storage by a minimum clear distance of 3m.</p> | Within 3 months |

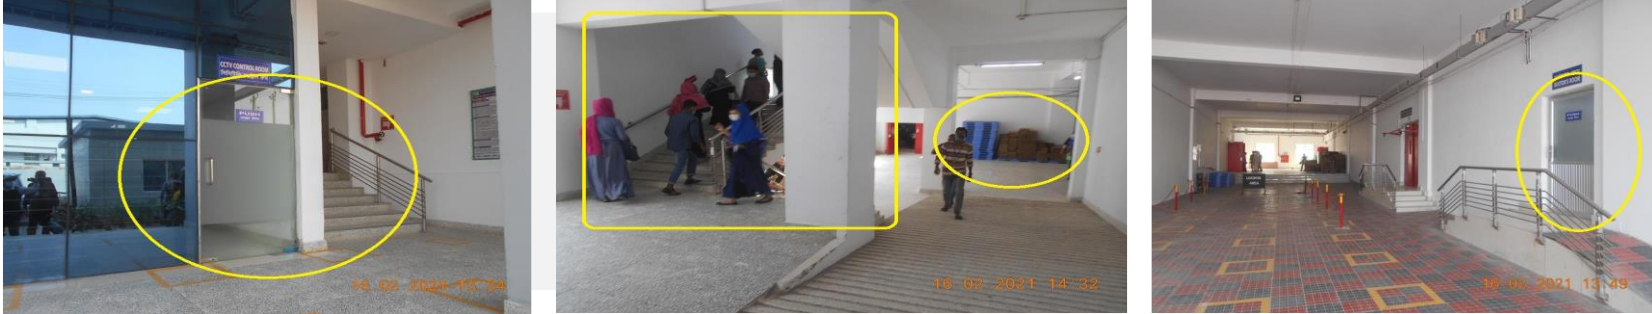
| 3 | Fire Rated Construction | The north-west and south-east exit stair discharges are not separated by fire-rated construction from the office areas, doctor's room, loading/unloading area and other spaces due to unprotected opening on ground floor of production building. | Separate the exit discharge from the office areas, doctor's room, loading/unloading area and other building spaces by a minimum of 2-hr fire-rated construction. Provide 1.5 -hr fire-rated doors and seal all unprotected openings and penetrations to maintain fire separation. Ensure that the fire doors are self-closing and positive latching and that they are provided with a fire exit (panic) hardware where serving production floors. If fire doors are required to be held open for functional reasons, provide automatic closing devices tied to the fire alarm system. | Within 6 months |

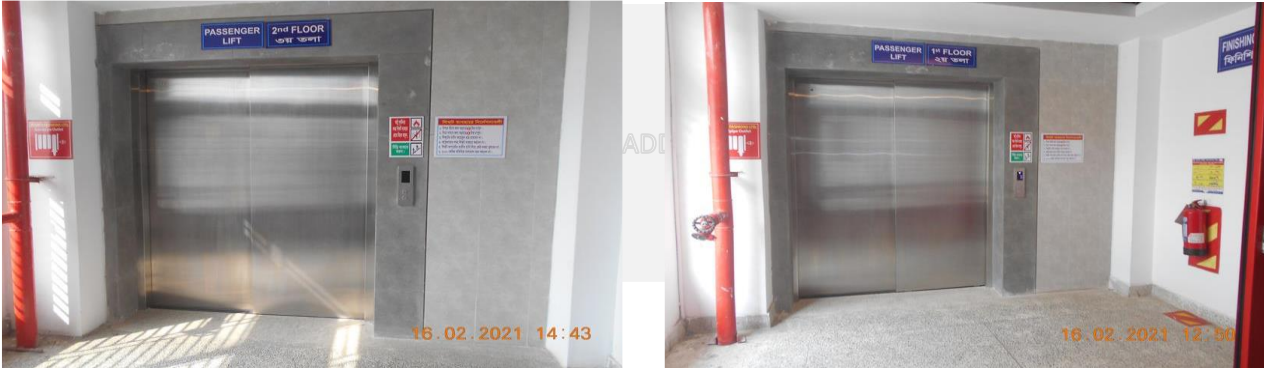
| 4 | Fire Rated Construction | Elevators are installed in the exit stair enclosure and not fire rated. | Modify the elevator and stair enclosure arrangement in a way to satisfy Accord standard 6.14.3. Elevator shall not open into an exit enclosure. Elevator landing door shall be of 1.5-hr fire rated. | Within 4 months |

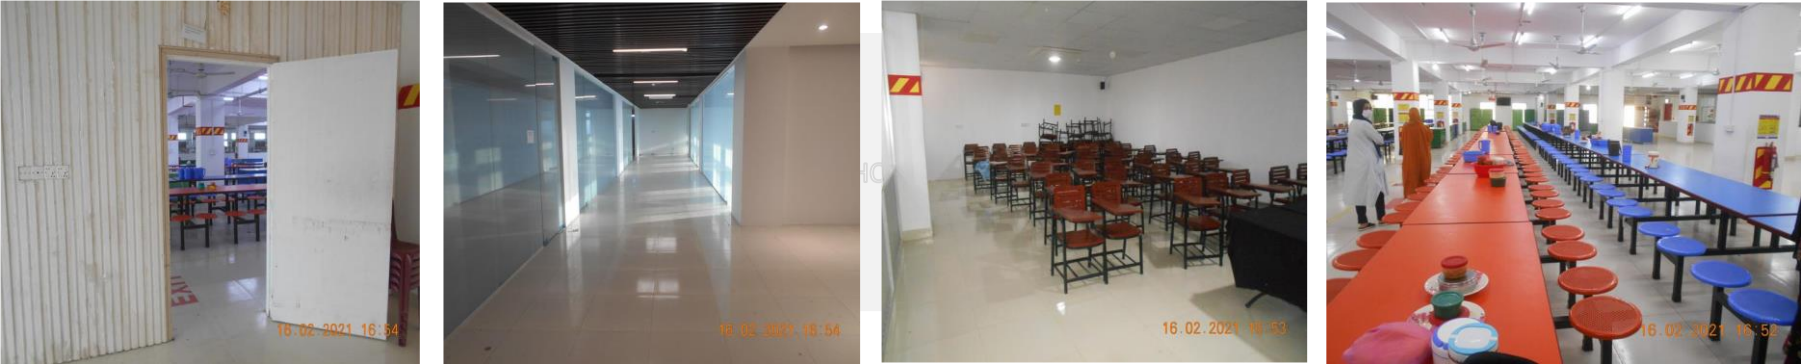
| 5 | Fire Rated Construction | <p>Dining area and other areas (i.e idle machine zone, training room, conference room, sample display room and LAB room) is not separated by fire-rated construction (openings, non-rated doors, penetrations).</p> <p><b>Location:</b> On 6th floor.</p> | <p>Separate the dining area from others occupancy by a minimum 2- hr fire-rated construction. Seal and/or protect all openings to maintain the required fire separations.</p> | <p>Within 3 months</p> |

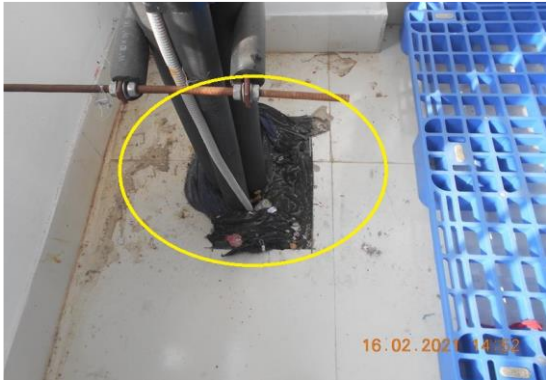
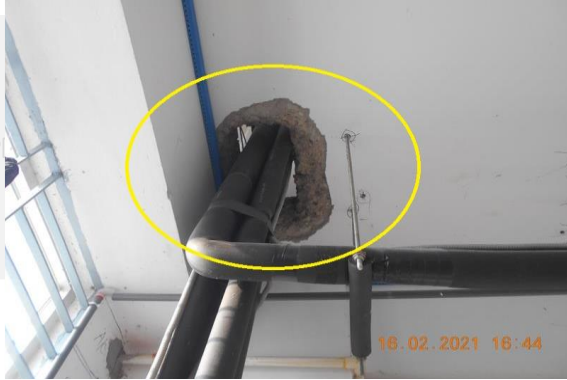
| 6 | Fire rated construction | <p>Unsealed penetrations and openings (VRF AC pipe riser) are located in the fire rated floor/ceiling assemblies.</p> <p><b>Location:</b> On ground to 5th floor.</p> | <p>Provide a minimum 2-hr fire rated shaft to separate the utility risers from each floor level.</p> <p>or</p> <p>Seal all penetrations and openings in floors/ceiling assemblies by listed fire rated materials to maintain the fire separation.</p> | Within 3 months |

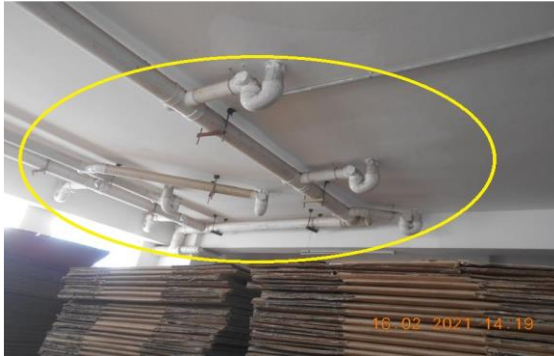
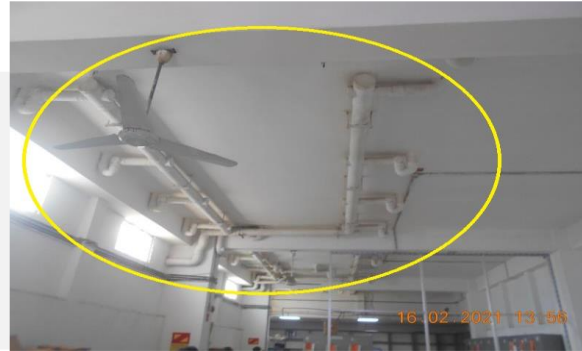
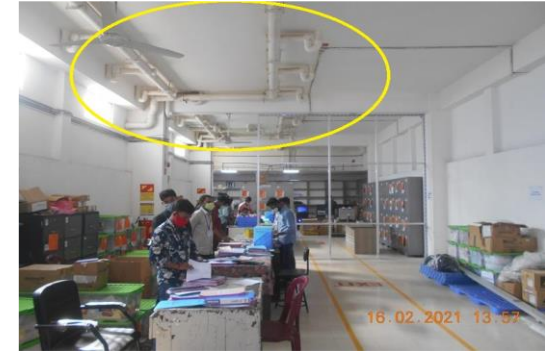
| 7 | Fire rated construction | Unsealed penetrations and openings (i.e. bathroom plumbing pipes) are located on several locations (i.e. Fabric store and accessories store on ground floor) in the fire rated floor/ceiling assemblies. | Seal all penetrations and openings in floor/ceiling (full thickness of the floor/ceiling: minimum 2 hr.) assemblies by third-party certified fire rated materials to maintain the fire resistance rating.<br>or<br>Provide a minimum 2-hr fire rated shaft to separate the utility risers from each floor if required. | Within 3 months |

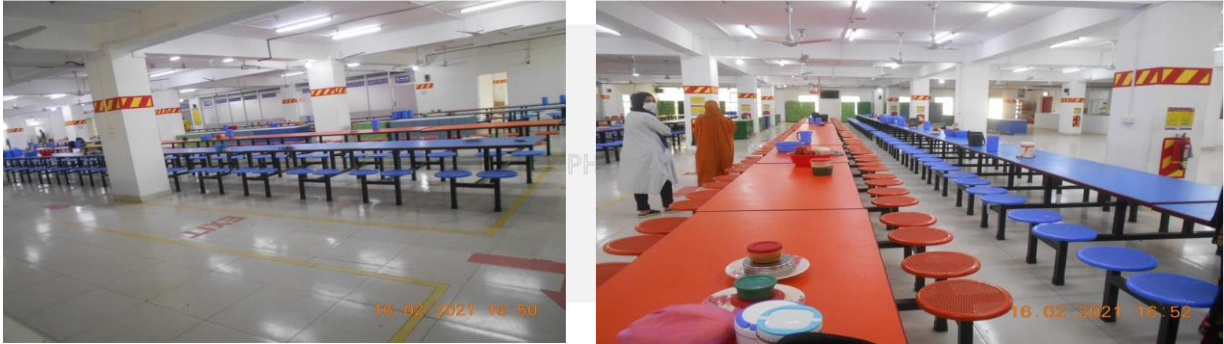
| 8 | Means of Egress | Exit capacity is not adequate for the occupant load.<br>Exit capacity is not adequate for the occupant load of dining hall on 5th floor of the production building. Available capacity of the dining hall was 403 and occupant load was found more than 490. | Reduce occupant load to not more than available exit capacity.<br>or<br>Provide additional exits to increase the exit capacity. | Immediately |

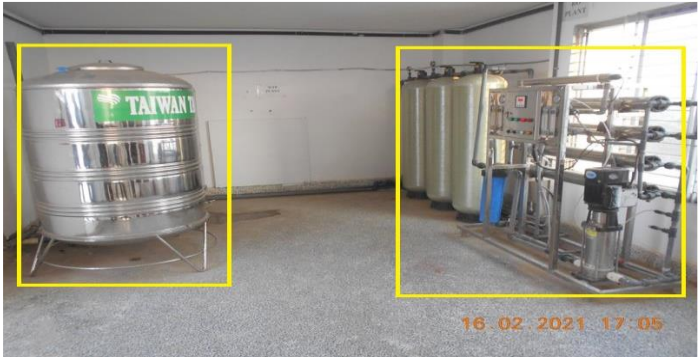
| 9 | Means of Egress | Obstruction (RO plant) was located at top of south-east exit stair. | Keep egress path and exit stair free from obstructions/storage. | Within 1 months |

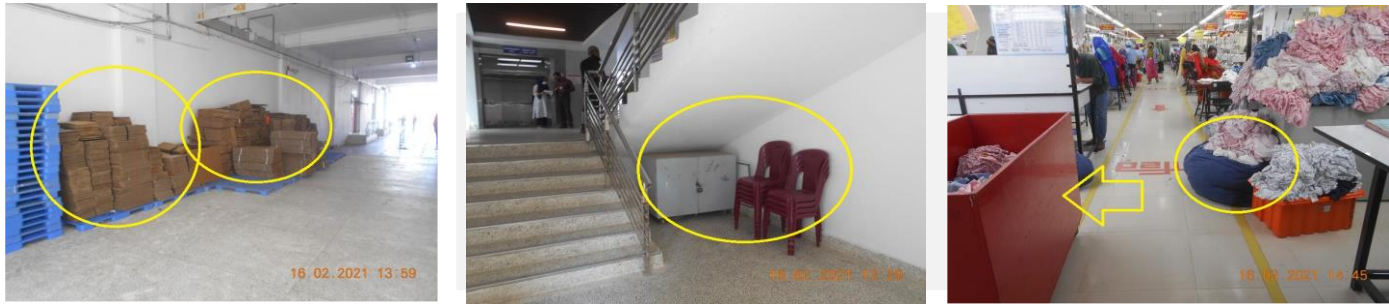
| 10 | Means of Egress | <p>Storage materials were located inside of exit stairs and egress paths on several floors.</p> <p><b>Location:</b> On ground and 2nd floor.</p> | <p>Keep egress path and exit stair free from obstructions/storage.</p> | Immediately |

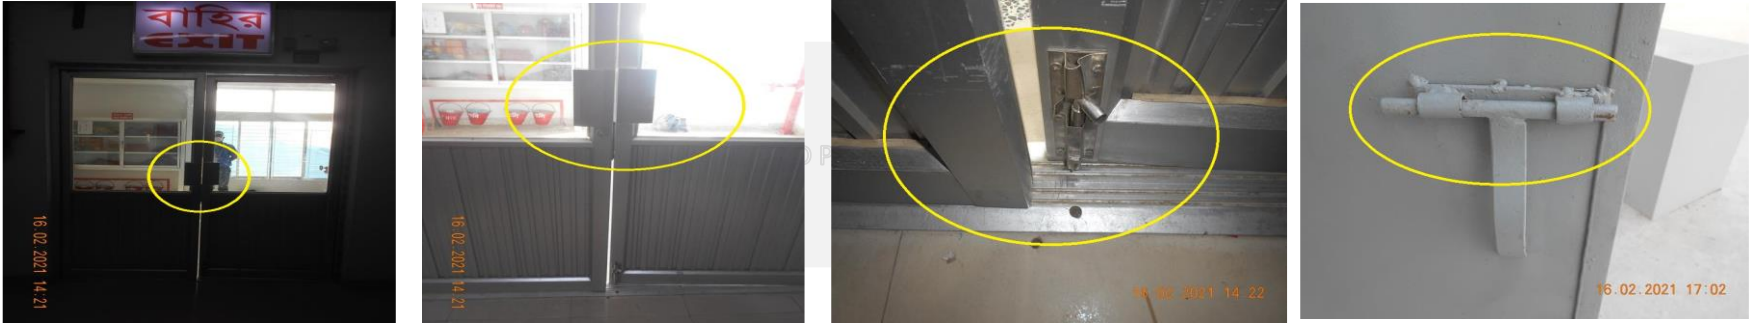
| 11 | Means of Egress | Egress doors/gates with locking features not complying with NFPA101 are provided at building exits, exit stairs, along egress routes, exit discharge on several locations. | Remove locking features from all egress doors/gates. If locks are required for security reasons, utilize specialized door locking features complying with NFPA101. | Immediately |

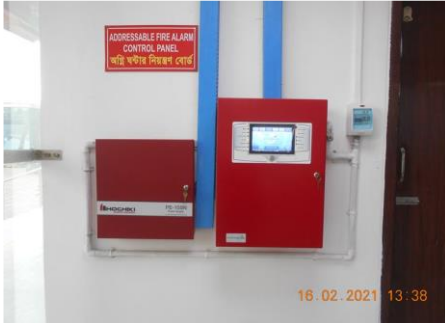
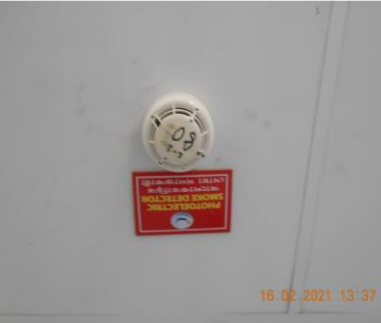
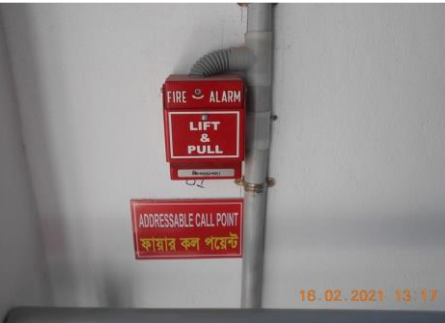
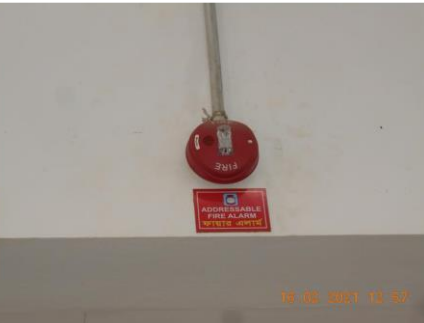
| 12 | Fire Detection and Alarm System | Automatic fire alarm & detection system installation requires detailed review to confirm compliance with NFPA 72 and ACCORD standards. | Submit as-built drawings, testing records, equipment certification and other relevant documentation to the RSC for review and approval. Installation shall be as per the reviewed design with listed equipment. | Design within 2 months, Modification within 4 months |

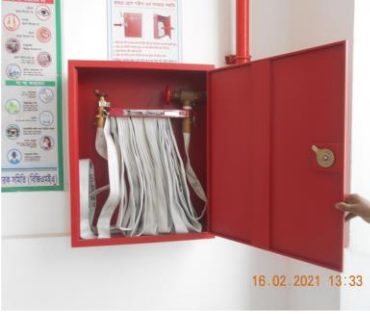
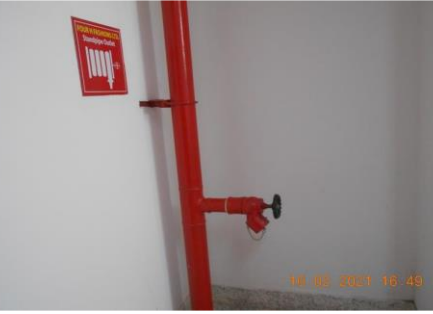
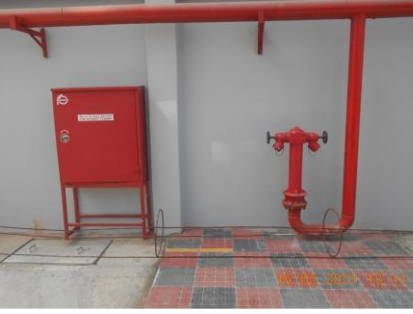
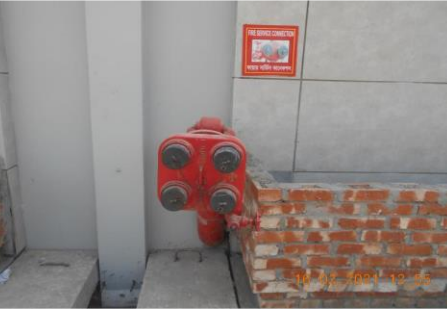
| 13 | Fire Protection System | The existing building has an occupied floor greater than 10 meter (33 feet) and requires standpipe system detailed review to confirm compliance with NFPA 14 and ACCORD standards. | Submit the as-built design of standpipe system to RSC in accordance with NFPA 14. Installation shall be as per the reviewed design with listed equipment. | Design within 2 months, Modification within 4 months |

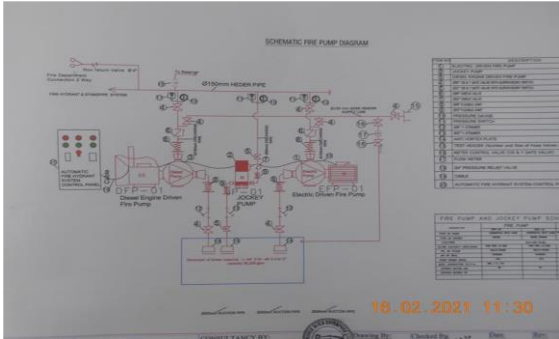
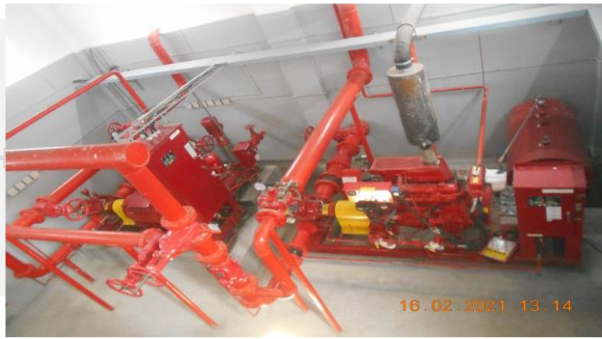
| 14 | Fire Protection System | Fire pump installation requires detailed review to confirm compliance with NFPA 20 and ACCORD standards. | Submit the as-built design of fire pump system to RSC in accordance with NFPA 20. Installation shall be as per the reviewed design with listed equipment. | Design within 2 months, Modification within 4 months |

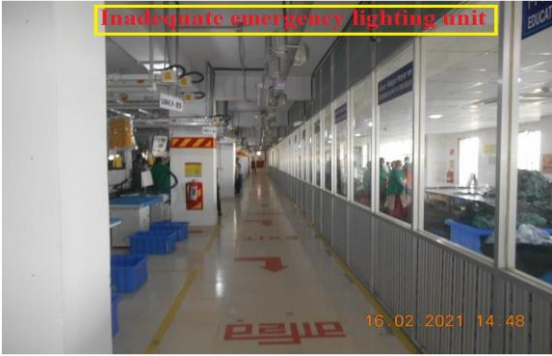
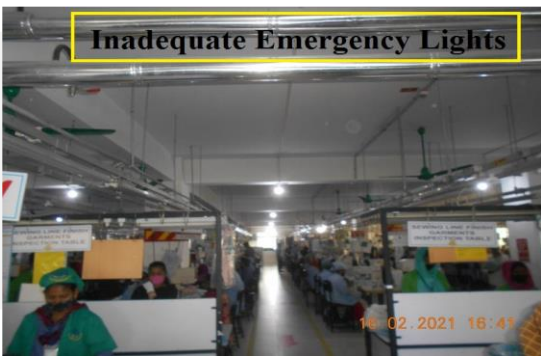
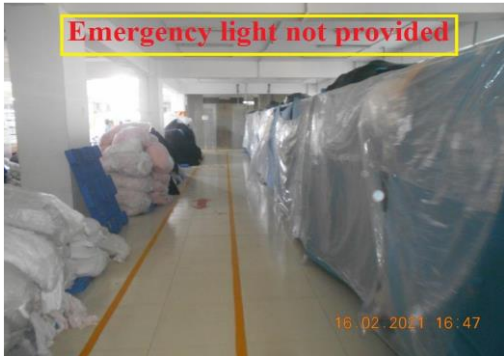
| 18 | Egress Lighting | Based on the number and location of emergency lights observed, adequate illumination levels are not anticipated along egress routes. | Test the emergency lighting system on each floor and provide additional emergency fixtures to provide adequate illumination along the means of egress. Provide a minimum illumination of 10 lux at the floor level within exit stairs and exit discharge paths and minimum 2.5 lux along exit access aisles. | Within 3 months |

| | | <p>Inadequate emergency lighting unit</p> <p>16.02.2021 14:48</p> | <p>Inadequate Emergency Lights</p> <p>16.02.2021 16:41</p> | <p>Emergency light not provided</p> <p>16.02.2021 16:47</p> |

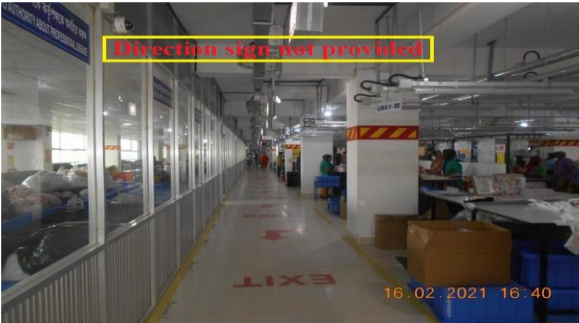
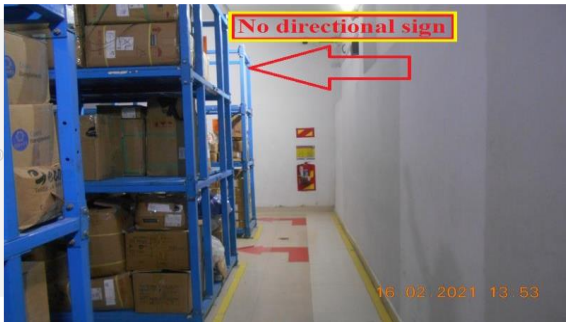
| 19 | Egress Lighting | <p>The directional signs are not provided where there is a change in direction and where the continuation of the egress path is not obvious.</p> <p>Location: On all floors.</p> | <p>Install illuminated directional signs shall be provided where there is a change in the direction for the path of travel and the direction to an exit is not obvious.</p> | Within 1 month |
| | | <p>Direction sign not provided</p> <p>16.02.2021 16:40</p> | <p>No directional sign</p> <p>16.02.2021 13:53</p> | |

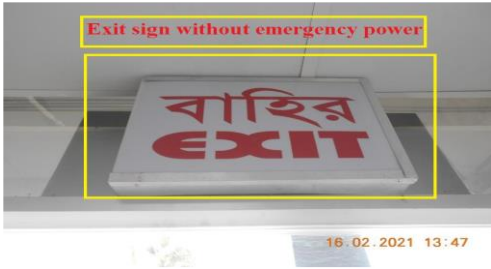
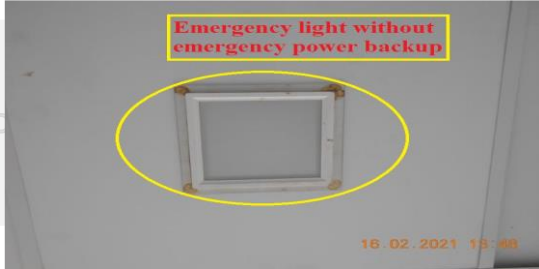
| 20 | Egress Lighting | Emergency power is not provided/connected with some directional sign/exit sign and emergency light units on several floors. | Provide emergency power connection with the directional sign/exit sign and emergency lighting units. | Within 1 month |
| <div style="display: flex; justify-content: space-around; align-items: center;"> <div style="text-align: center;"> <p>Exit sign without emergency power</p> </div> <div style="text-align: center;"> <p>Emergency light without emergency power backup</p> </div> </div> | | | | |
