# INITIAL FIRE SAFETY INSPECTION REPORT

**Factory Name: Universal Jeans-3**

**ADDRESS: Plot # 69, Sector # 7, Export Processing Zone, Chattogram -4223**

**Date: 17-Feb-2021**

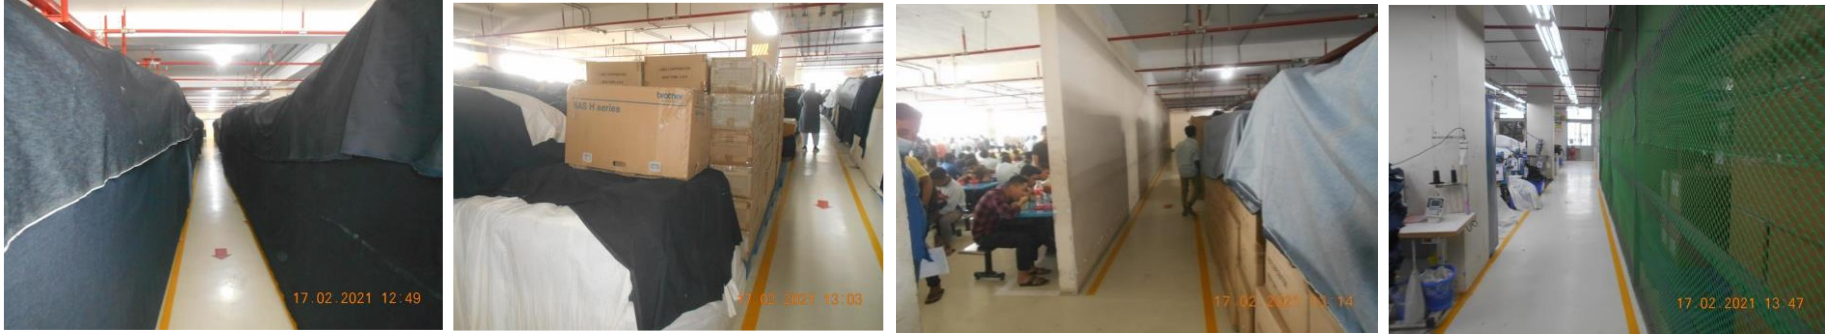
| SI No. | Category | Findings | Required Action | Remediation Time Frame |
|---|---|---|---|---|
| 1 | Fire Rated Construction | <p>Rooms used for combustible storage are not separated by fire rated construction on several floors.</p> <p><b>Location:</b> Finished goods store on 3rd floor and garments stock storage on the 6th and 7th floor of the main building.</p> | <p>Separate the dedicated storage rooms by minimum 1-hr fire-rated construction. Provide 0.75 hr. fire rated door and seal all penetrations and openings by 1 hr. fire rated fire rated barrier construction.</p> | Within 3 months |

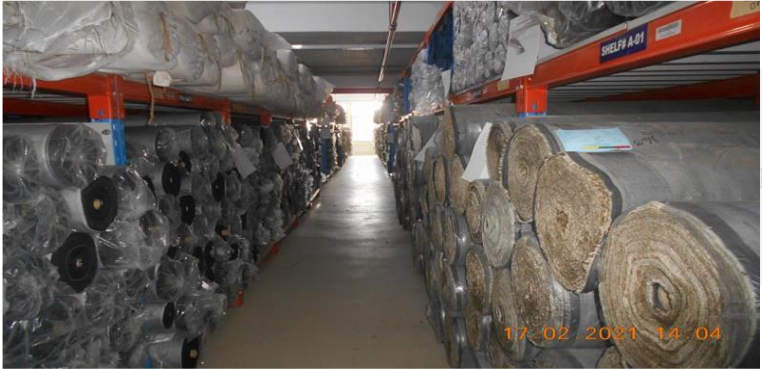
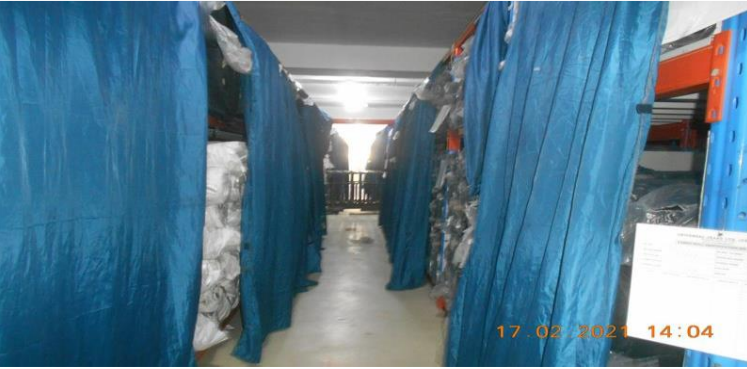
| 2 | Fire Rated Construction | Areas used for combustible storage are not separated by fire-rated construction.<br>Location: Cutting section on 4th floor. | <p>Provide dedicated storage rooms separated by minimum 1-hr fire-rated construction.</p> <p>Or,</p> <p>Where separate storage rooms are not feasible, Provide defined storage areas and limit the storage arrangement as follows:-</p> <p>1. General Condition: Maximum height of 2.4m and maximum area of 23m<sup>2</sup>. Separate areas of unenclosed combustible storage by a minimum clear distance of 3m.</p> <p>2. If sprinkler protected: maximum height of 3.66m and maximum area of 93m<sup>2</sup>. Separate areas of unenclosed combustible storage by a minimum clear distance of 3m.</p> | Within 3 months |

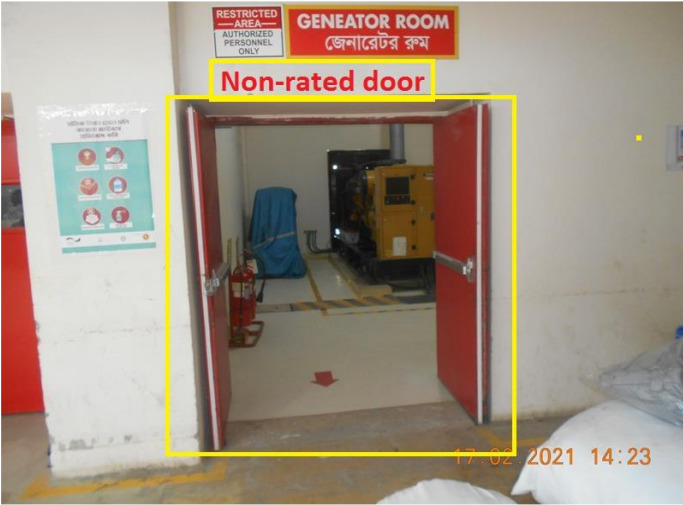
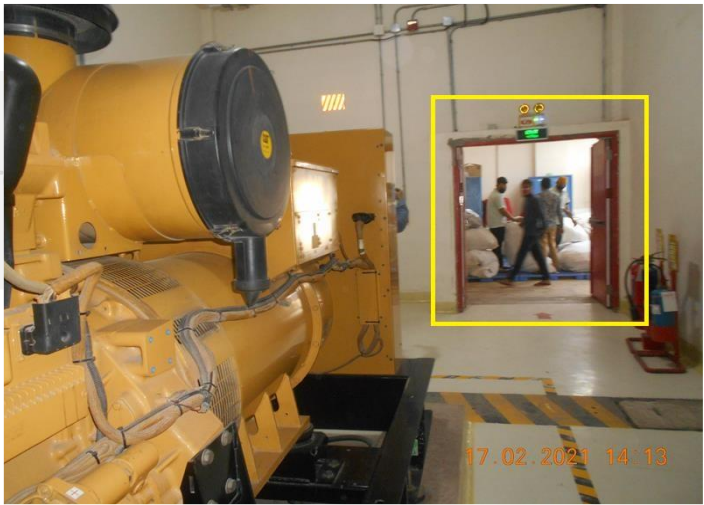
| 3 | Fire Rated Construction | The generator room is not separated by fire rated constructions (openings, non-rated doors, penetrations) on ground floor of the main building. | Separate the generator room by a minimum 2-hr fire rated construction. Seal and/or protected all openings to maintain fire separations. | Within 3 months |

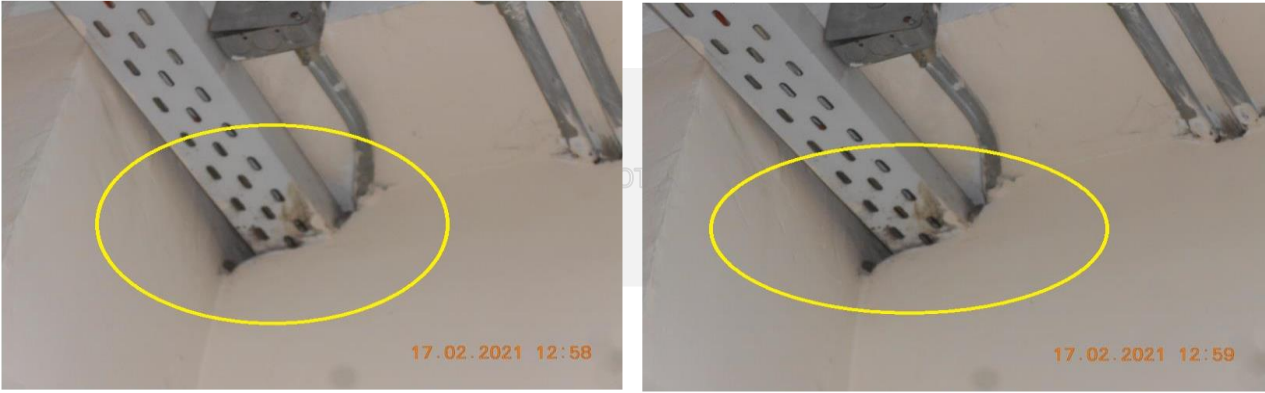
| 4 | Fire Rated Construction | <p>Unsealed penetrations and openings are located in the exit stair enclosures.</p> <p><b>Location:</b> Most of the floors of south-west stair.</p> | <p>Seal all penetrations and openings in exit stair enclosure walls to maintain the fire separations.</p> | Within 3 months |

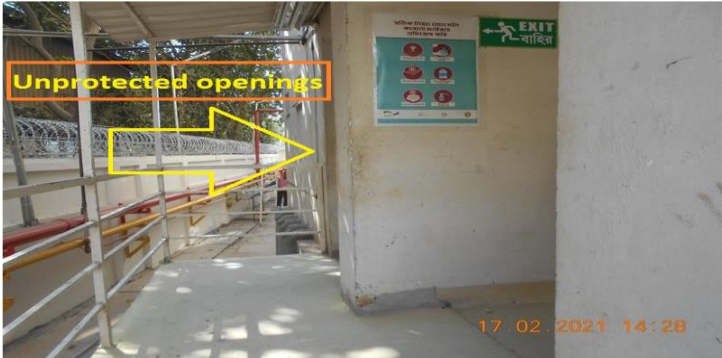
| 5 | Fire Rated Construction | The south-east exit discharge path is less than 10 ft. wide and is not separated from the building interior. | <p>Seal all penetrations and openings to the interior of the building along the discharge path, up to a height of 10 ft., to provide a minimum 1-hr fire separation.</p> <p>Alternatively, provide a second remote discharge path to the public way.</p> | Within 6 months |

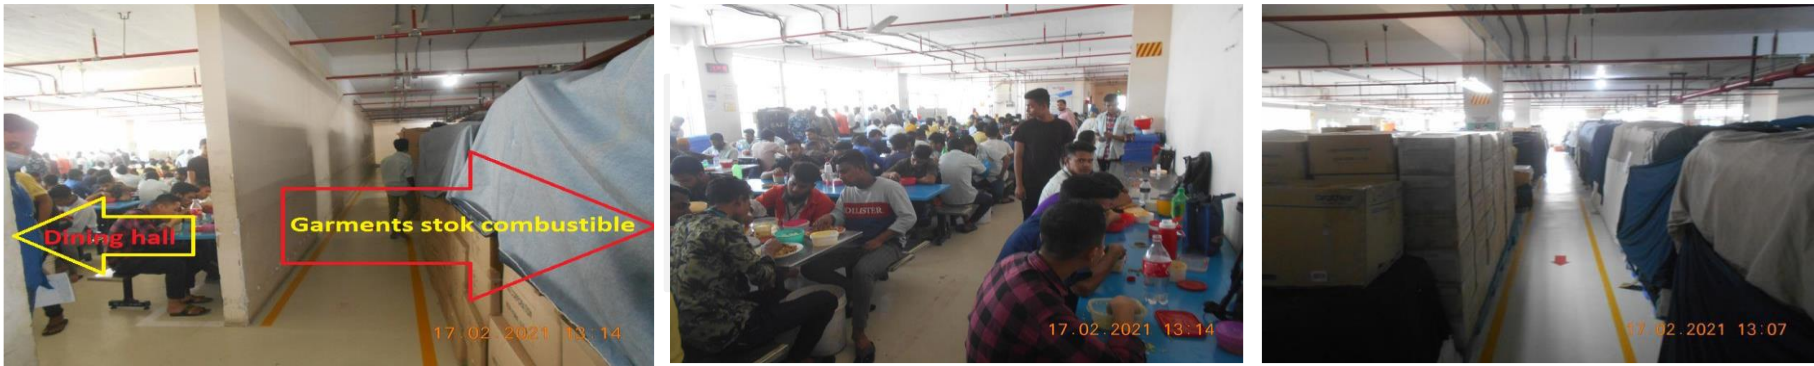
| 6 | Fire Rated Construction | <p>Dining hall and garments stock storage areas are not separated by fire-rated construction (openings, non-rated doors, penetrations).<br/> <b>Location:</b> On 6th floor.</p> | <p>Separate the dining area from garments stock storage area by a minimum 3- hr. fire-rated construction. Seal and/or protect all openings to maintain the required fire separations.</p> | Within 3 months |

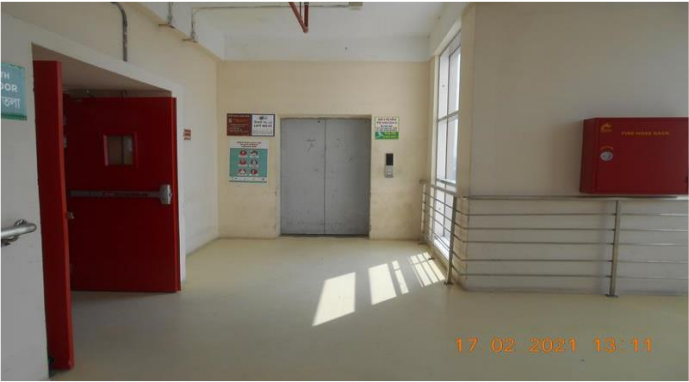
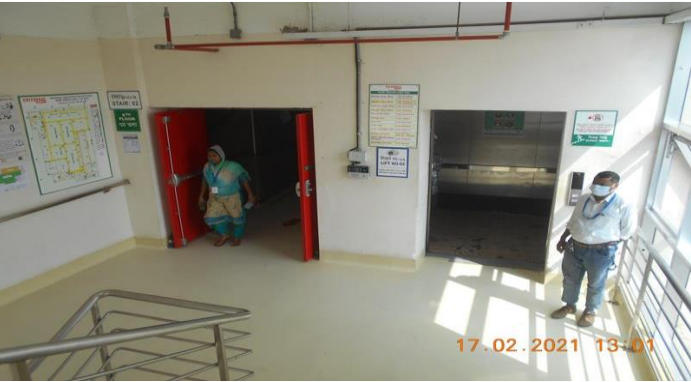
| 7 | Fire Rated Construction | <p>Elevators are installed in the exit stair enclosure and not fire rated.</p> | <p>Modify the elevator and stair enclosure arrangement in a way to satisfy Accord standard 6.14.3. Elevator shall not open into an exit enclosure. Elevator landing door shall be of 1.5-hr fire rated.</p> | Within 4 months |

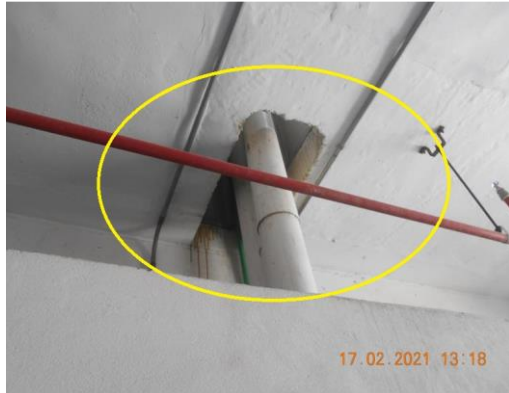
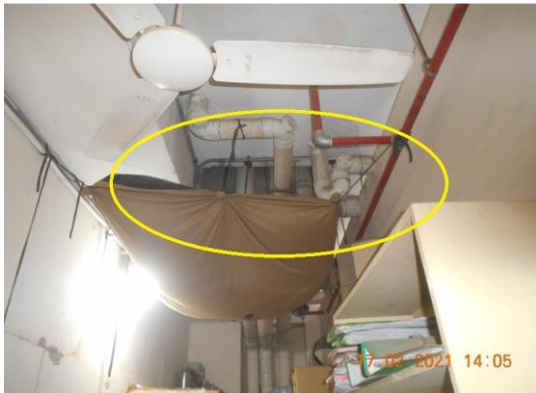
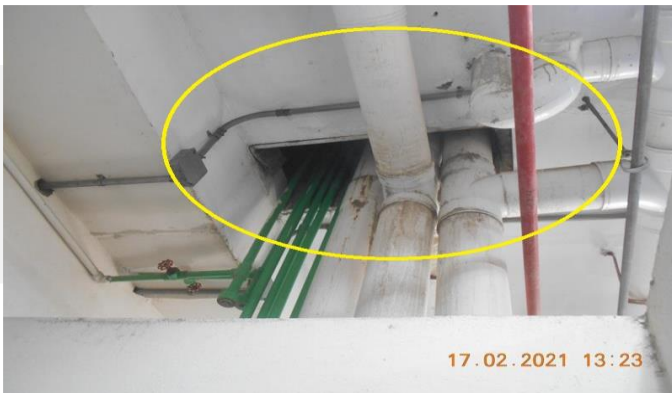
| 8 | Fire Rated Construction | <p>Unsealed penetrations and openings (i.e. Bathroom plumbing pipes) are located on all floors locations in the fire rated floor/ceiling assemblies.</p> | <p>Seal all penetrations and openings in floor/ceiling (full thickness of the floor/ceiling: minimum 2 hr.) assemblies by third-party certified fire rated materials to maintain the fire resistance rating.</p> <p>or</p> <p>Provide a minimum 2-hr fire rated shaft to separate the utility risers from each floor if required.</p> | Within 3 months |

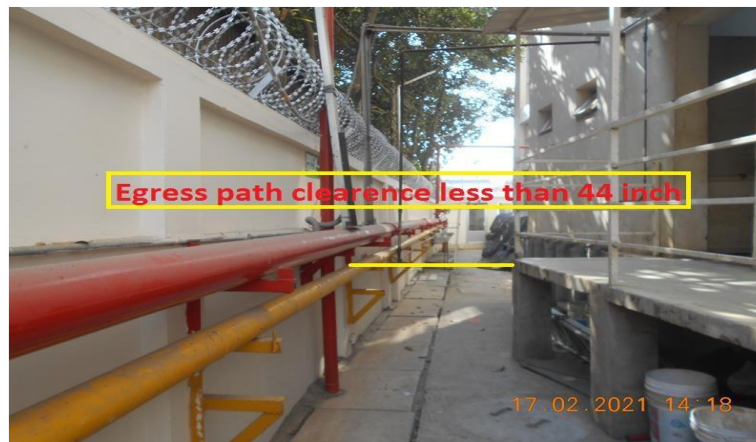
| 9 | Means of Egress | <p>The narrow egress path is not adequate for serving an occupant load 50 or more.</p> <p><b>Location:</b> Egress discharge path of south-east exit stair on ground floor.</p> | <p>Modify the egress path or provide minimum clear width of passageway serving an occupant of 50 or more shall not be less than 44 inch.</p> | Within 3 months |

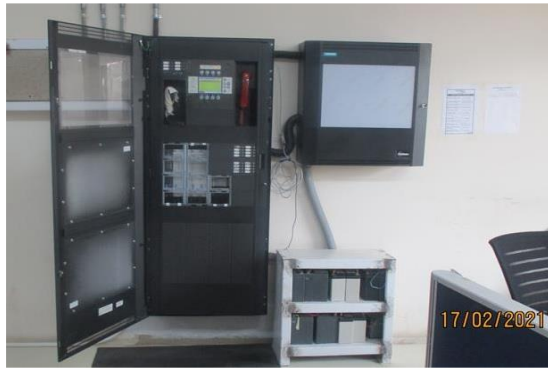
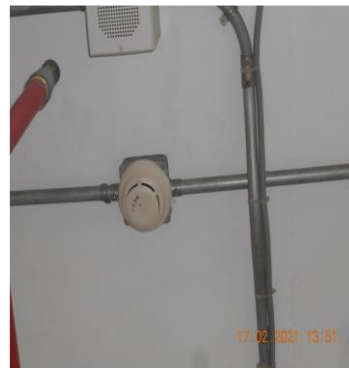
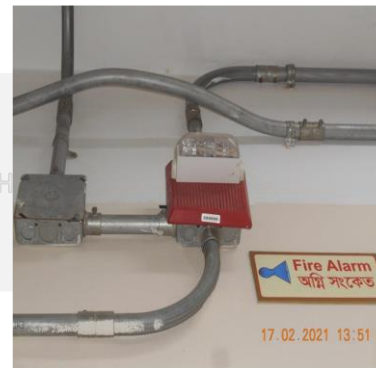
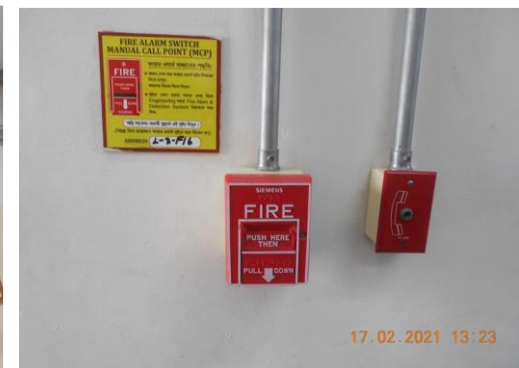
| 10 | Fire Detection and Alarm System | Automatic fire alarm & detection system installation requires detailed review to confirm compliance with NFPA 72 and ACCORD standards. | Submit as-built drawings, equipment certification and other relevant documentation of fire alarm and detection system to the RSC for review and approval. Installation shall be as per the reviewed design with listed equipment and NFPA-72. | Design submission within 2 months, Modification within 4 months |

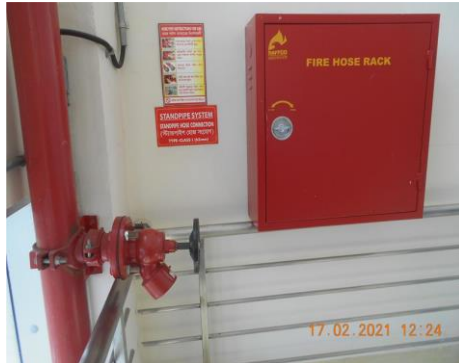
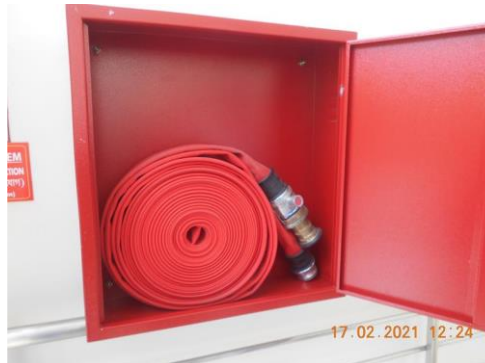
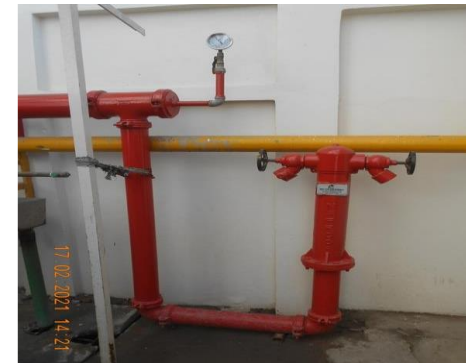
| 11 | Fire Protection System | The existing building has an occupied floor greater than 10 meter (33 feet) and requires standpipe system detailed review to confirm compliance with NFPA 14 and ACCORD standards. | Submit as-built drawings, equipment certification and other relevant documentation of standpipe system to the RSC for review and approval. Installation shall be as per the reviewed design with listed equipment and NFPA-14. | Design submission within 2 months, Modification within 4 months |

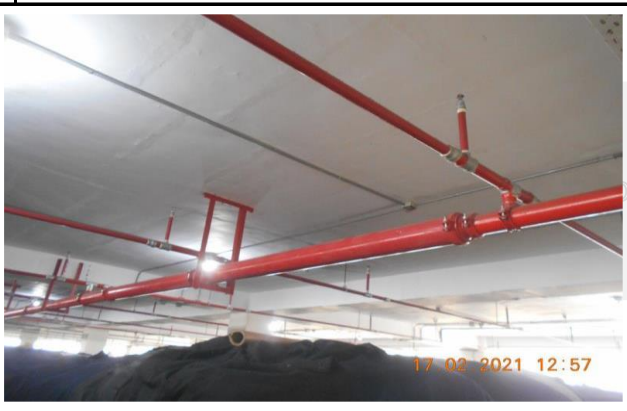
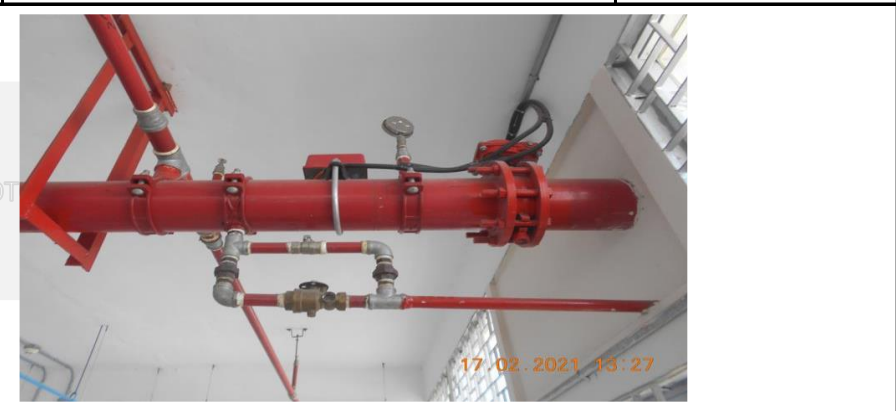
| 12 | Fire Protection System | The existing building has an occupied floor greater than 23 meter (75 feet) and requires automatic sprinkler system detailed review to confirm compliance with NFPA 13 and ACCORD standards. | Submit as-built drawings, equipment certification and other relevant documentation of sprinkler system to the RSC for review and approval. Installation shall be as per the reviewed design and NFPA 13. | Design submission within 2 months, Modification within 4 months |

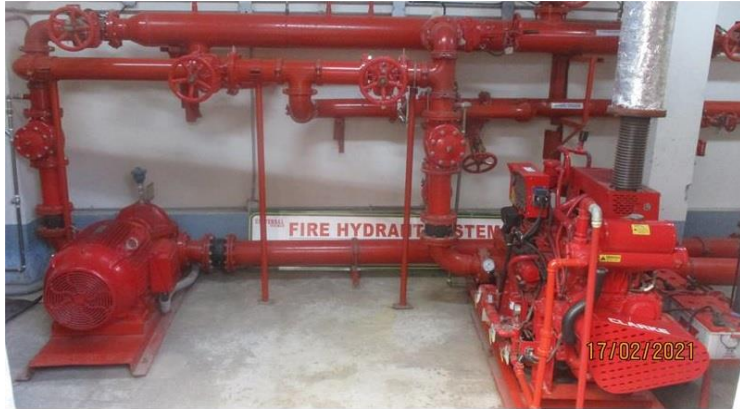
| 13 | Fire Protection System | Fire pump installation requires detailed review to confirm compliance with NFPA 20 and ACCORD standards. | Submit as-built drawings, equipment certification and other relevant documentation of fire pump to the RSC for review and approval. Installation shall be as per the reviewed design and NFPA 20. | Design submission within 2 months,<br>Modification within 4 months |

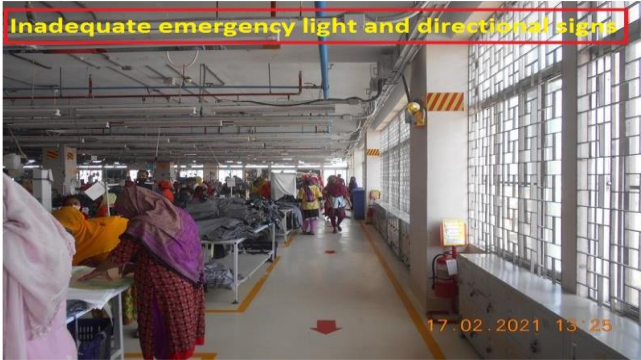
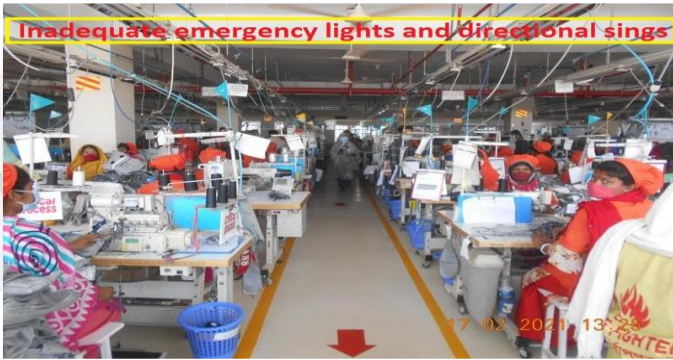
| 17 | Egress Lighting | Based on the number and location of emergency lights observed, adequate illumination levels are not anticipated along egress routes.<br><b>Location:</b> On all floors. | Test the emergency lighting system on each floor and provide additional emergency fixtures to provide adequate illumination along the means of egress. Provide a minimum illumination of 10 lux at the floor level within exit stairs and exit discharge paths and minimum 2.5 lux along exit access aisles. | Within 3 months |

| | | <p>Inadequate emergency light and directional sign</p> | <p>Inadequate emergency lights and directional signs</p> | |

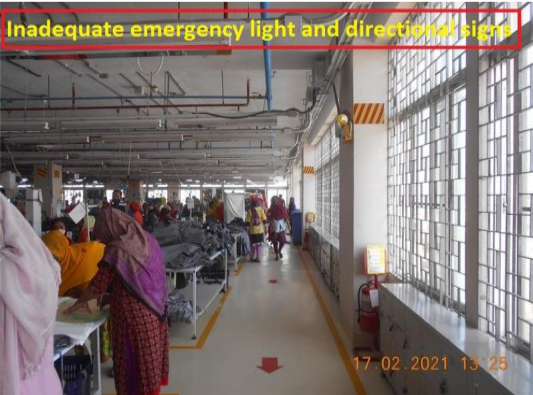
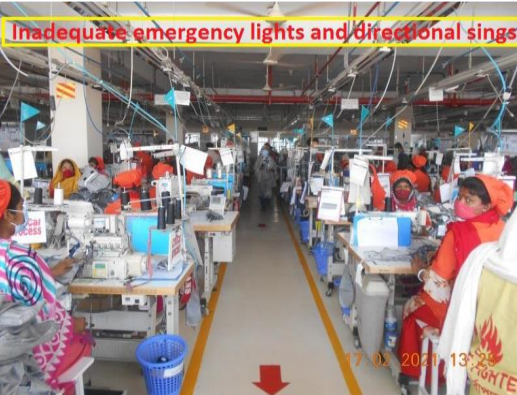
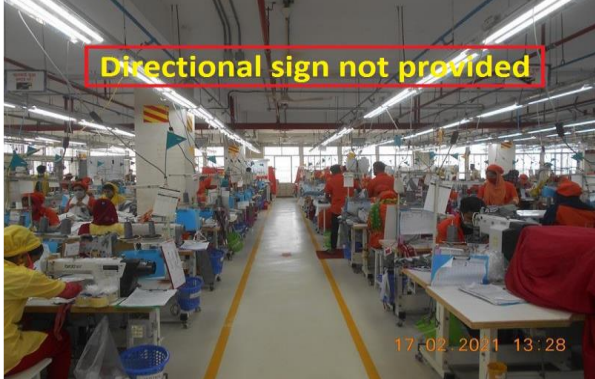
| 18 | Egress Lighting | <p>The directional signs are not provided where there is a change in direction and where the continuation of the egress path is not obvious.<br/>Location: On all floors.</p> | <p>Install illuminated directional signs shall be provided where there is a change in the direction for the path of travel and the direction to an exit is not obvious.</p> | Within 1 month |
| | | <p>Inadequate emergency light and directional sign</p> | <p>Inadequate emergency lights and directional signs</p> | <p>Directional sign not provided</p> |
