# INITIAL FIRE SAFETY INSPECTION REPORT

**Bravo Apparel Manufacturer Ltd.**

**ADDRESS: Alam Tower, Hemerdigi, Tongi I/A, Tongi-Gazipur**

**Date: 17-02-2021**

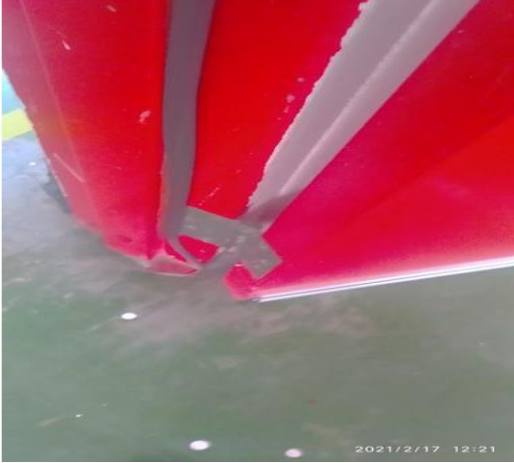
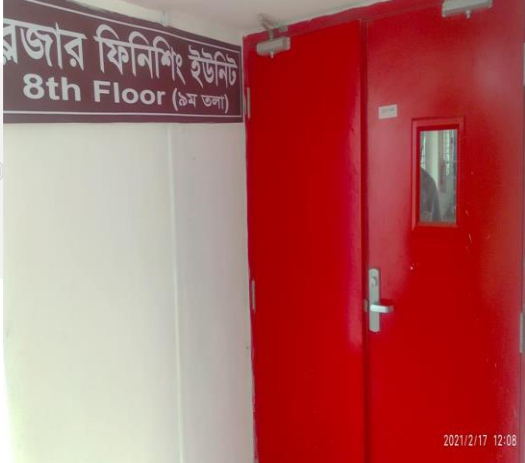
| SI No. | Category | Findings | Required Action | Remediation Time Frame |
|---|---|---|---|---|
| 1 | Fire Rated Construction | Door coordinators and smoke seals were not properly functional on most of the doors. | <p>Provide minimum 1.5-hr fire rated doors to separate the exit stairs from work areas and other building spaces on all floor levels. Ensure that the fire doors are self-closing and positive latching and that they are provided with fire exit (panic) hardware where serving production floors.</p> <p>If fire doors are required to be held open for functional reasons, provide automatic-closing devices tied to the fire alarm system</p> | Within 3 months |

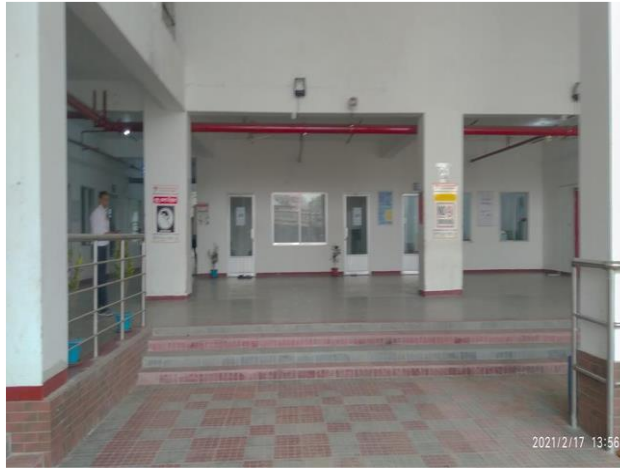
| 2 | Fire Rated Construction | Exit stair-1 (South-East) is discharged the occupants inside the building at ground floor | <p>1. Modify stair to discharge directly outside.<br/>Or</p> <p>2. Provide 2-hr fire-rated exit passageway leading directly outside (vestibules to separate any storage areas).</p> <p>Note: A maximum of 50 percent of the number and capacity of the exit enclosures can discharge through areas on the level of exit discharge where all the conditions described in Accord building standard 6.17.3 are met</p> | Within 3 months |

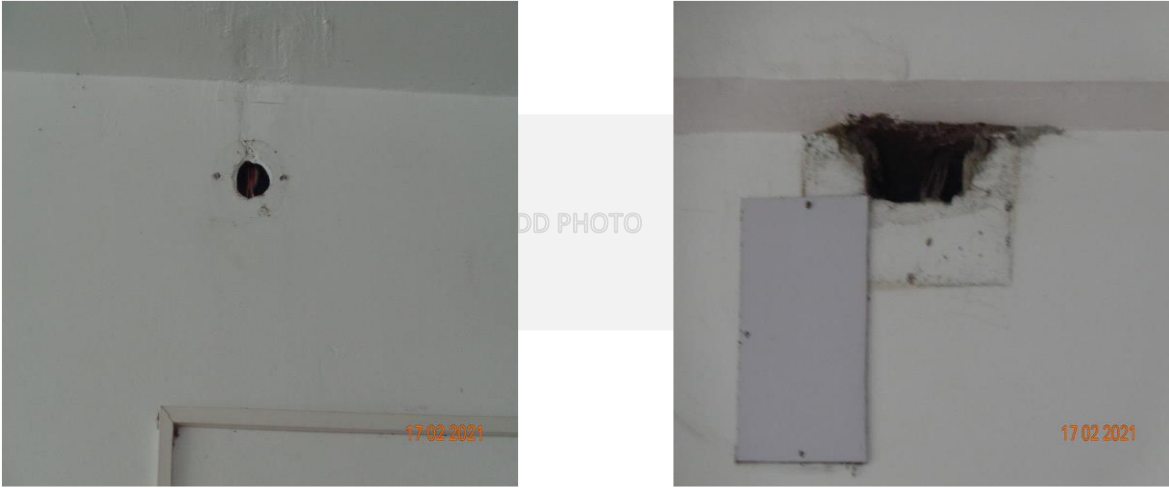
| 3 | Opening/Penetration to Exit enclosure | Unsealed penetrations and openings are located in exit stair (Stair-1) enclosures. | Seal all penetrations and openings in the wall of exit enclosure walls (full thickness of the wall) by fire rated materials to maintain the fire resistance rating. | Within 3 months |

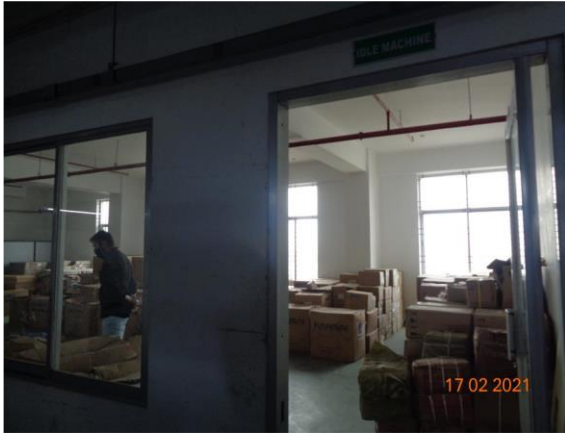
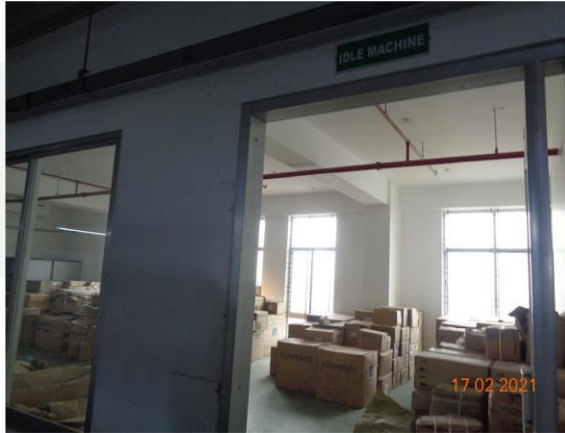
| 4 | Fire Rated Construction | Room used for combustible storage are not separated by fire rated construction located at several floors | <p>Separate the storage room by a minimum 1- hr fire-rated construction. Seal and/or protect all openings to maintain the required fire separations.</p> <p>Openings from exit enclosure to storage spaces shall be provided with a vestibule with fire rated construction and openings.</p> <p>Provide a 1.5-hr. fire rated door on the exit stair side and a 1-hr. fire rated door on the storage room side. Ensure that the fire rating of the vestibule construction matches that of the exit stair enclosure.</p> | Within 3 months |

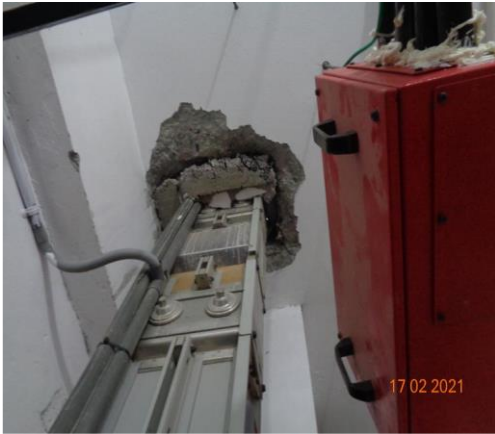
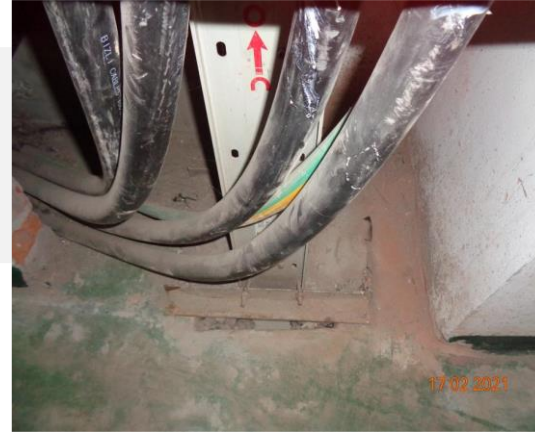
| 5 | Fire Rated Construction | Unsealed electrical riser is located in the fire-rated floor/ceiling assemblies | Provide a minimum 2-hr fire-rated shaft to separate the utility risers from each floor level and seal all penetrations in floor/ceiling assemblies to maintain the fire separation | Within 3 months |

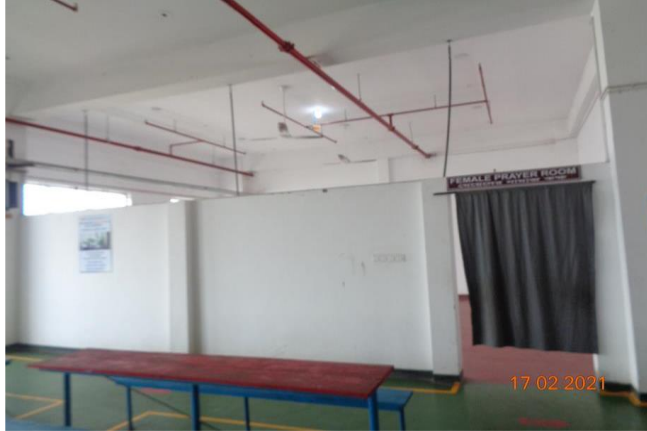
| 6 | Fire Rated Construction | Dining is not separated from female prayer room on 8th floor | Re-locate the dining area or separate the dining area from other occupancies with 2-hr fire rated construction.<br>&<br>Provide required exits that lead directly to the street or exit stairwell or leading to a corridor or open space. | Within 3 months |

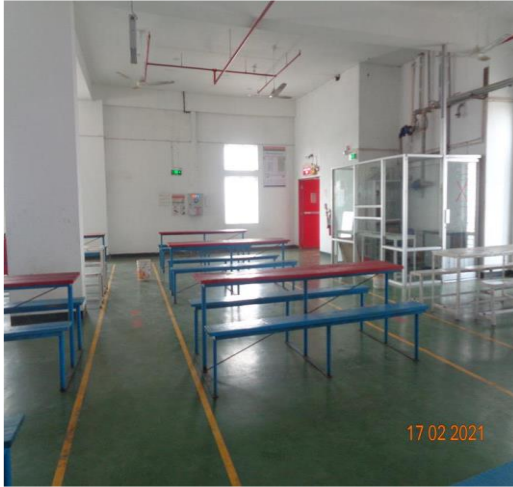
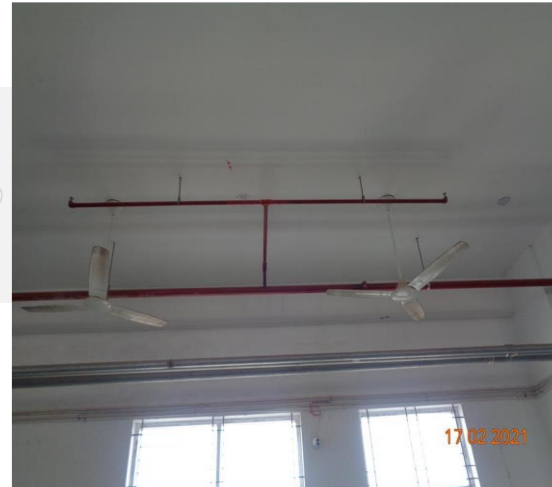
| 9 | Egress Lighting | Directional signs are not provided where direction of the path of travel to an exit has changed | Illuminated directional signs shall be provided where there is a change in the direction for the path of travel and the direction to an exit is not obvious | Within 2 months |

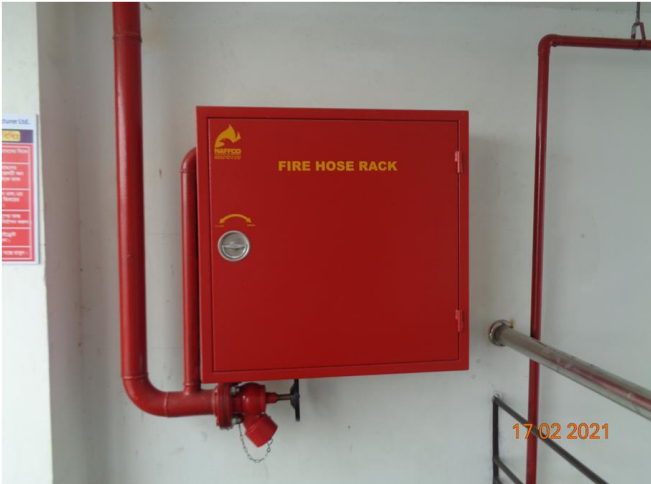
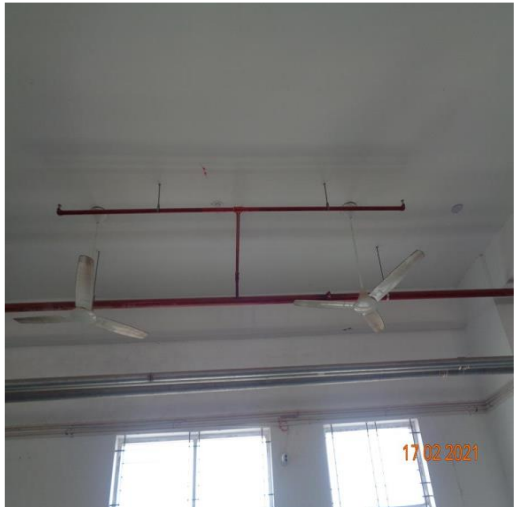
| 10 | Fire Protection system | The highest occupied floor of existing building is more than 75 ft. above grade where automatic combined sprinkler system is mandatory and factory has installed automatic sprinkler system along with Class-III standpipe system. Combined sprinkler system installation requires detailed review to confirm compliance with NFPA 13, 14, 22,24 & 25 and ACCORD standards. | Submit as-built drawings, testing records, equipment certification and other relevant documentation to the RSC for review and approval. | Within 3 months |

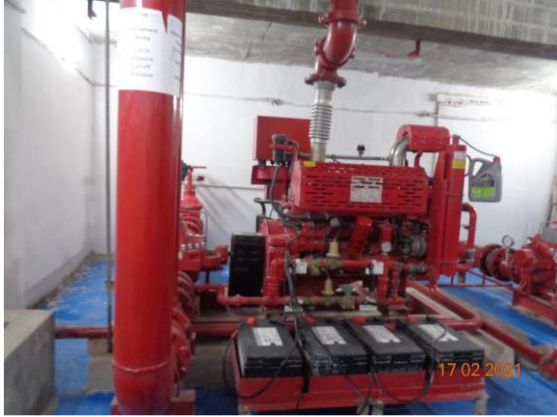
| | Fire Protection System (Fire Pump) | Fire pump installation requires detailed review to confirm compliance with NFPA 20 and ACCORD standards | Submit as-built drawings, testing records, equipment certification and other relevant documentation to the RSC for review and approval | Within 3 months |

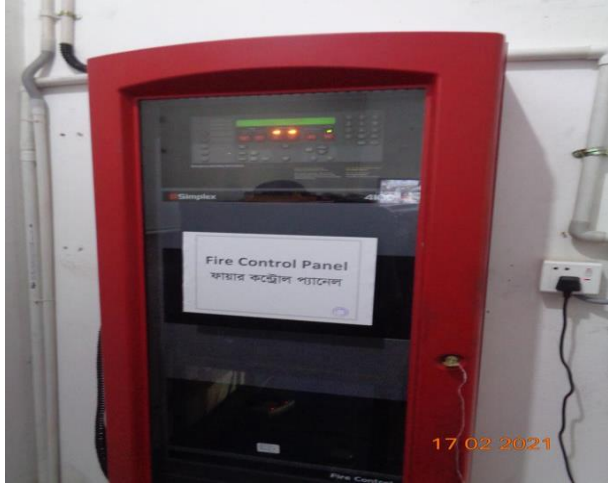
| 12 | Fire Alarm & Detection System | Fire detection system installation requires detailed review to confirm compliance with NFPA 72 and ACCORD standards. | Submit as-built drawings, testing records, equipment certification and other relevant documentation to the RSC for review and approval. | Within 3 months |

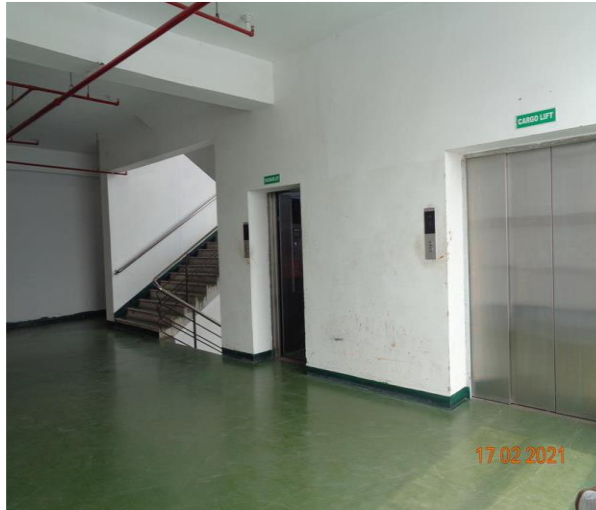
| 13 | Means of Egress | Elevator installed in exit stair enclosure and not fire rated. | Modify the elevator and stair enclosure arrangement in a way to satisfy Accord standard 6.14.3. Elevator shall not open into an exit enclosure.<br>Elevator landing door shall be of 1.5-hr fire rated. | Within 4 months |

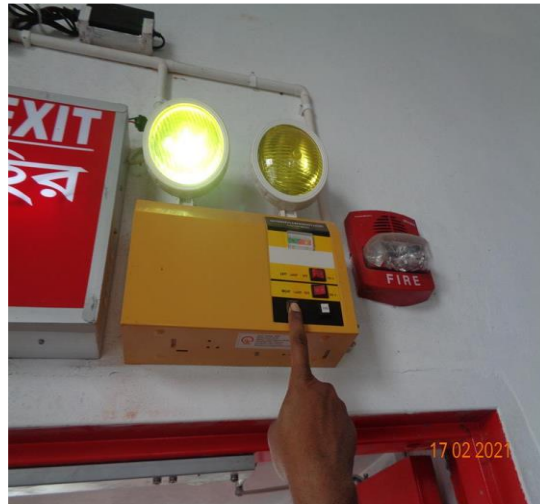
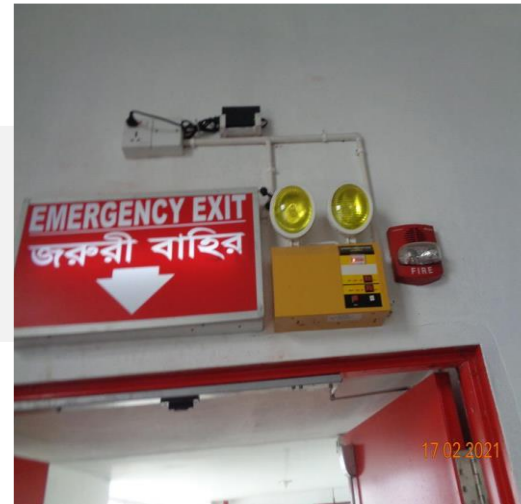
| 14 | Emergency Light | Manual on-off switch is provided for [emergency lighting / exit signage] units in most of the floors | Remove manual on/off switches from [emergency lighting /exit signage] units to prevent them from being switched off | Within 1 month |

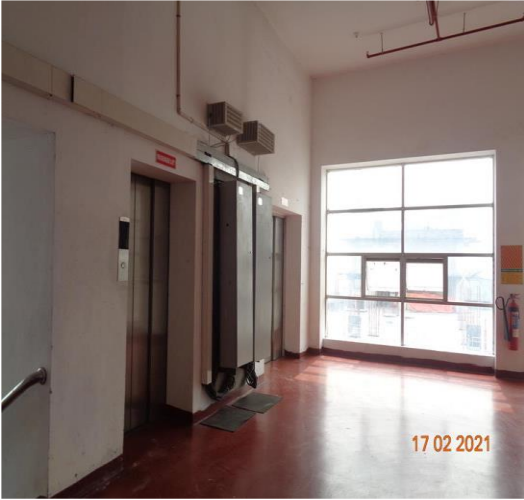
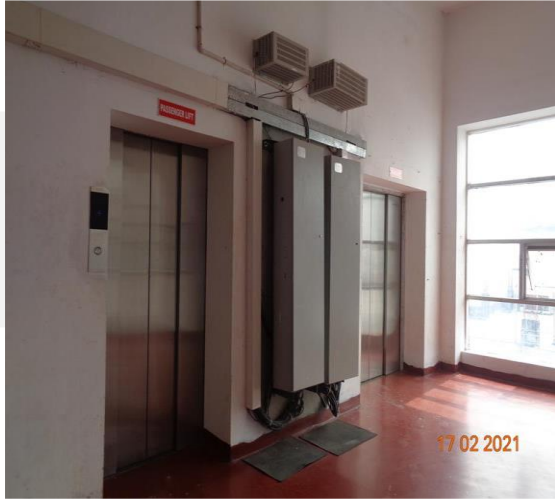
| 16 | Electrical panel board located on staircase | Electrical panel board for elevator were located in 8th floor exit stair enclosures | Remove and re-locate all electrical panels from exit stair enclosures | Within 3 months |

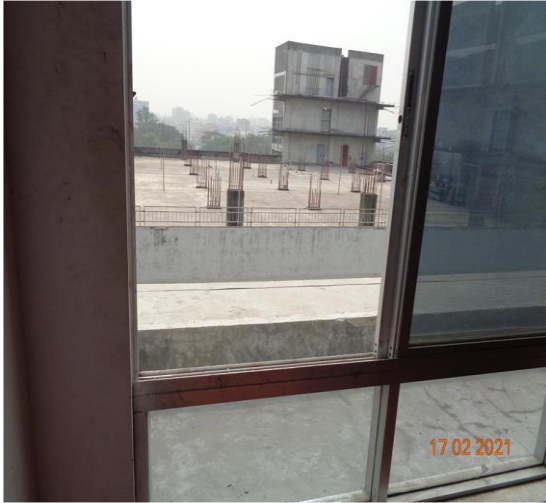
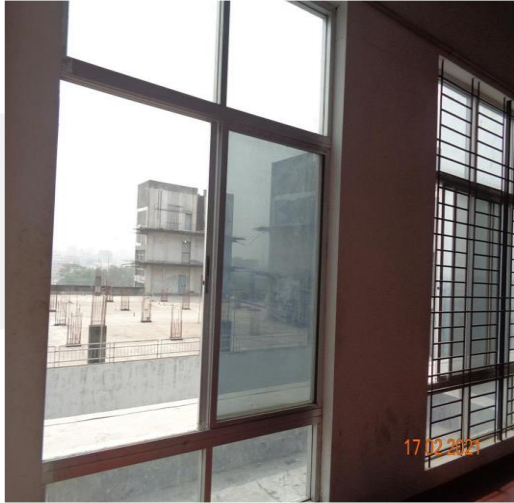
| 17 | Guard rail | No guard rail provided for south side of the main production building on several floors | Provide guard rail on open side with minimum height 42 inches. | Within 3 months |

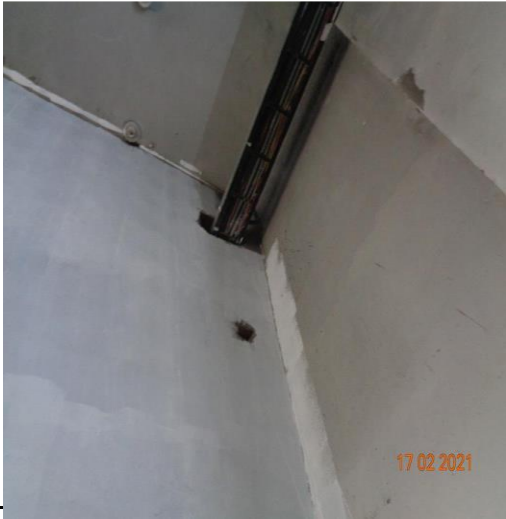
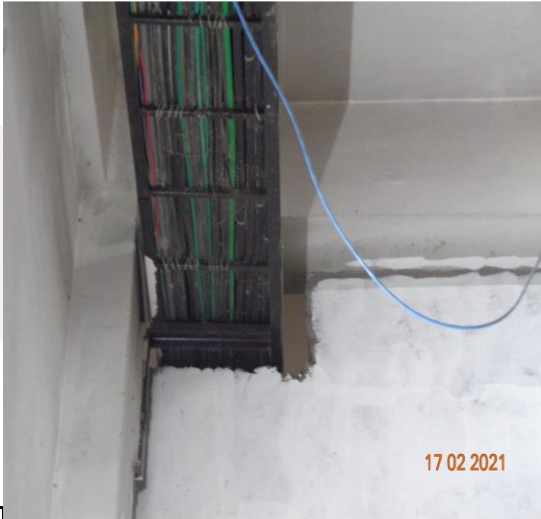
| 18 | Fire rated construction | <p>The [boiler/generator/air compressor] rooms are not separated by fire rated construction due to penetrations</p> <p>Location: Utility Building-1</p> | <p>Separate the [Boiler/generator/air compressor] rooms by a minimum 2-hr fire rated construction. Seal and/or protected all openings to maintain fire separations</p> | Within 3 months |

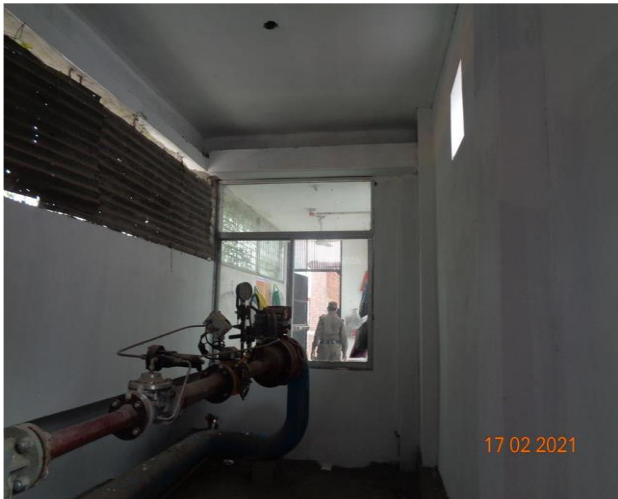
| 19 | Fire rated construction | Security room-1 is not separated from RMS room | Separate the security room from RMS room by a minimum 2-hr fire rated construction. Seal and/or protected all openings to maintain fire separations | Within 3 months |
