FIRE SAFETY INSPECTION REPORT

**AMS INTERNATIONAL SWEATERS LTD.
34, CHOYDANA, NATIONAL UNIVERSITY, GAZIPUR**

ACCORD
on Fire and Building Safety in Bangladesh

May 22, 2014

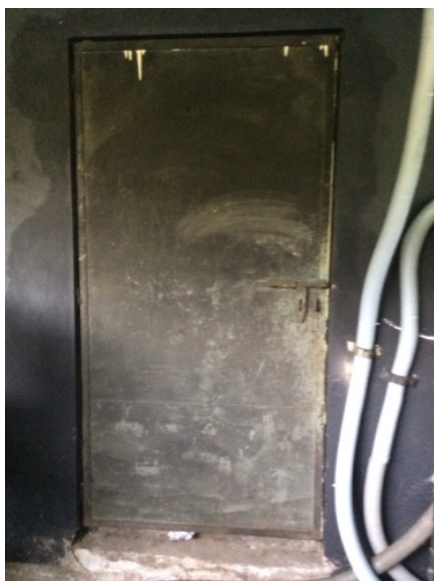
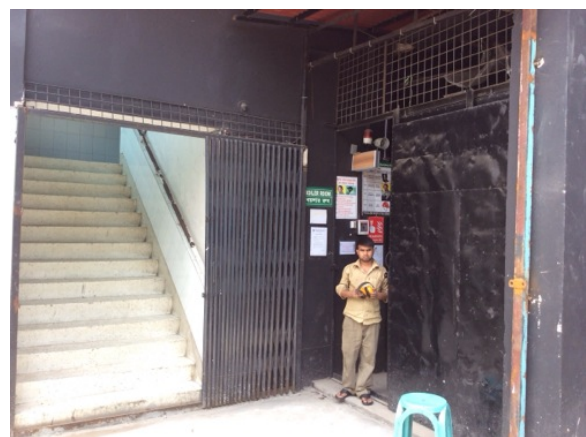
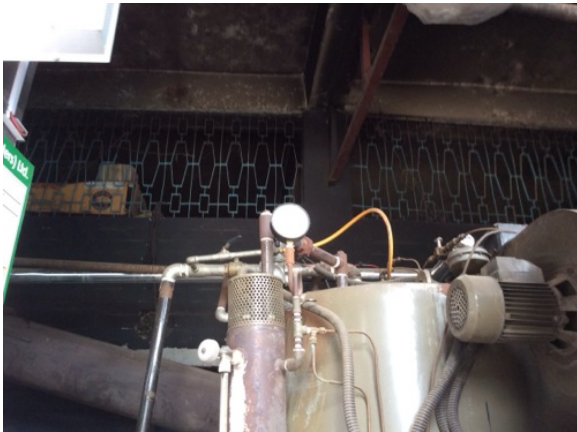
No.	Category	Finding	Recommendation	Remediation Timeframe
F-1	Fire Rated Construction	<p>The generator room is not separated from the working areas of Malim (BD) Co. Ltd. (adjacent building) by means of fire-rated construction (non-rated door).</p> <p>The boiler room is not separated from the discharge of the southern exit stair and the working areas of Malim (BD) Co. Ltd. on the ground floor by means of fire-rated separation (non-rated door and unprotected openings)</p>	<p>Separate the boiler and generator room from the adjacent working areas and discharge pathways by a minimum 2-hr fire-rated construction. Seal and/or protected all openings to maintain the required fire separations.</p>	Within 3 months

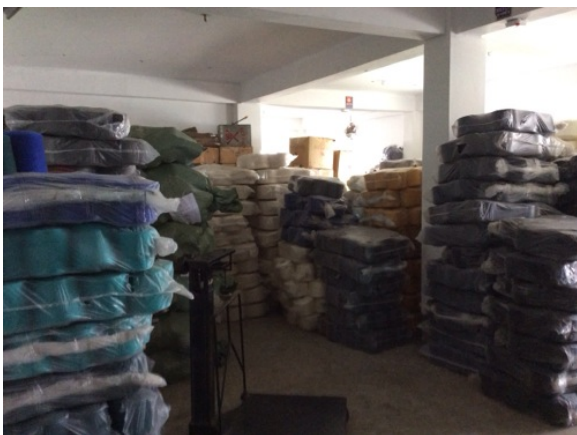
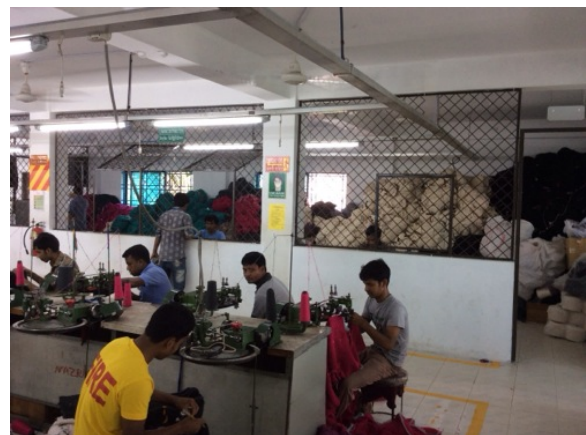
F-2	Fire Rated Construction	Dedicated storage areas on the 4th (Bonded ware house) and 2nd floor (Linking and distribution room) were not separated from the working area by means of fire rated construction (non-rated door and unprotected openings)	Provide dedicated storage rooms separated by minimum 1-hr fire-rated construction.	Within 3 months
-----	-------------------------	---	--	-----------------

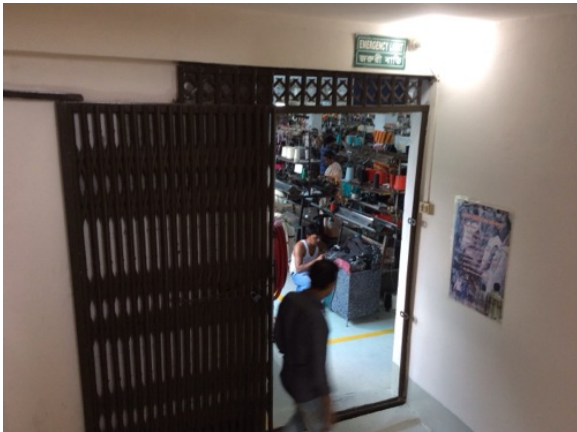
F-3	Fire Rated Construction	The exit stairs are not separated from work areas on each floor by fire-rated construction.	Provide minimum 1.5-hr fire rated doors and seal all unprotected openings to separate the exit stairs from work areas and other building spaces on all floor levels. Ensure that the fire doors are self-closing and positive latching and that they are provided with fire exit (panic) hardware where serving production floors. If fire doors are required to be held open for functional reasons, provide automatic-closing devices tied to the fire alarm system.	Within 3 months
-----	-------------------------	---	---	-----------------

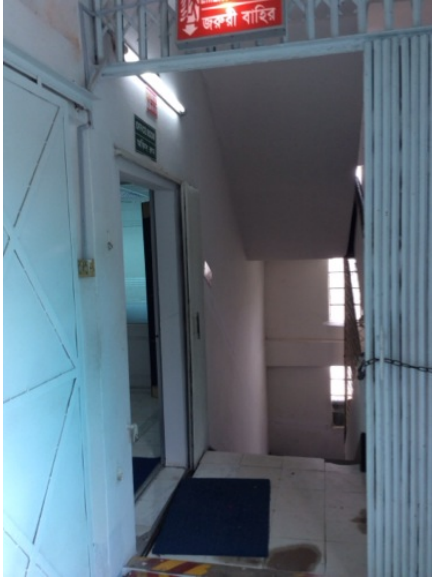
F-4	Fire Rated Construction	Unsealed penetrations and openings were observed in the northern stair enclosure on the 1st floor.	Seal all penetrations and openings in exit stair enclosure walls to maintain the fire separation.	Within 3 months
-----	-------------------------	--	---	-----------------

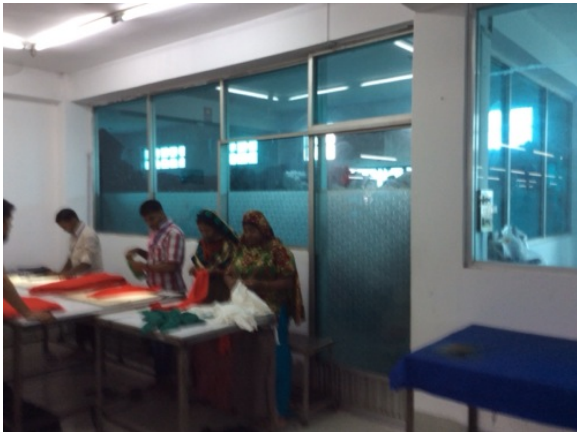
F-5	Fire Rated Construction	The transient storage area on the 3rd floor was not separated from the adjacent working areas by means of fire rated construction.	Provide dedicated storage rooms separated by minimum 1-hr fire-rated construction. Or Provide defined storage areas and limit the storage arrangement as follows: - Maximum height of 2.4m and maximum area of 23m ² - If sprinkler protected: maximum height of 3.66m and maximum area of 93m ² Separate areas of unenclosed combustible storage by a minimum clear distance of 3m.	Within 3 months
-----	-------------------------	--	---	-----------------

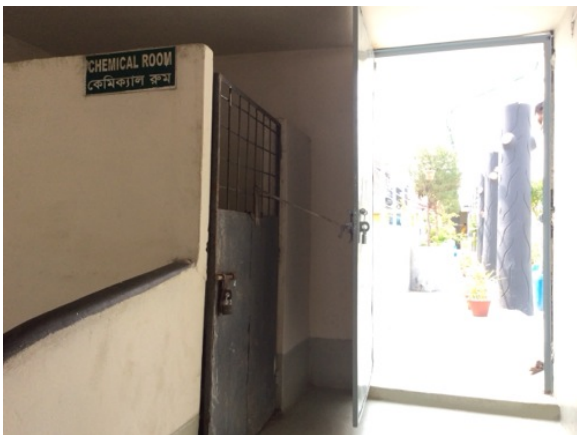
F-6	Fire Rated Construction	Hazardous materials storage area is not separated from the discharge of the northern exit stair by fire-rated construction (openings, non-rated doors, penetrations).	Separate the hazardous materials / flammable liquid storage room by a minimum 2-hr fire-rated construction. Seal and/or protected all openings to maintain the required fire separations.	Within 3 months
-----	-------------------------	---	---	-----------------

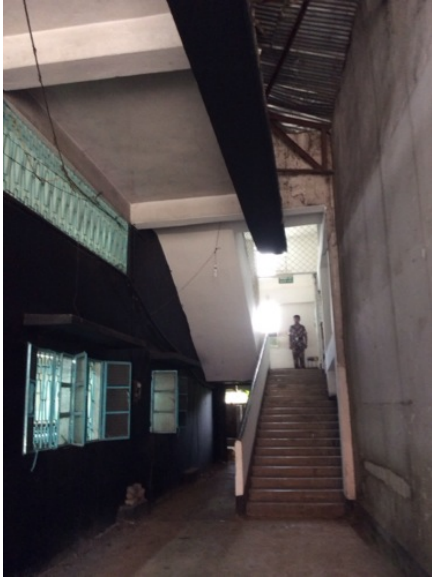
F-7	Fire Rated Construction	The exit discharge path serving the northern exit is less than 10 ft wide and is not separated from the building interior.	Seal all penetrations and openings to the interior of the building along the discharge path, up to a height of 10 ft., to provide a minimum 1-hr fire separation.	Within 6 months
-----	-------------------------	--	---	-----------------

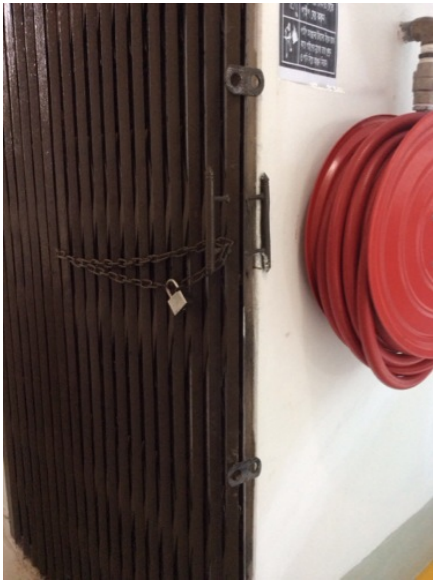
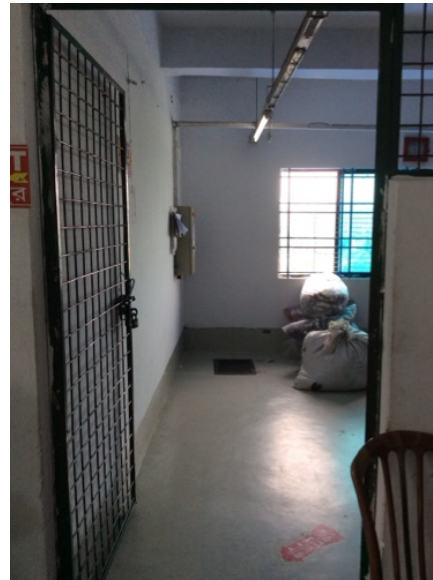
F-8	Egress	Egress doors and gates with locking features are provided at all building exits, exit stairs, along egress routes and at all exit discharges.	Remove locking features from all egress doors / gates. If locks are required for security reasons, utilize special door locking features complying with NFPA 101.	Immediate
-----	--------	---	--	-----------

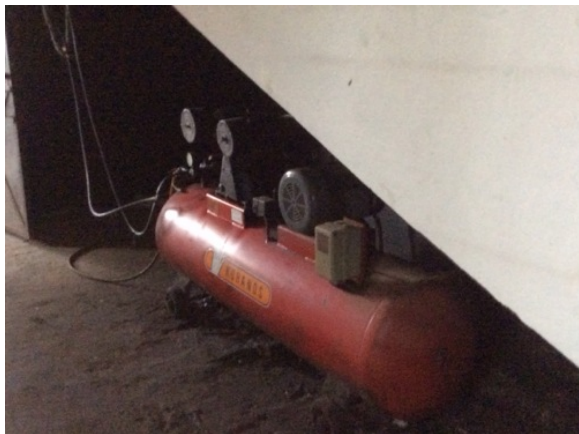
F-9 Egress

An air compressor was located on the ground floor of the northern stair.

Remove all storage from exit stairs and egress paths.

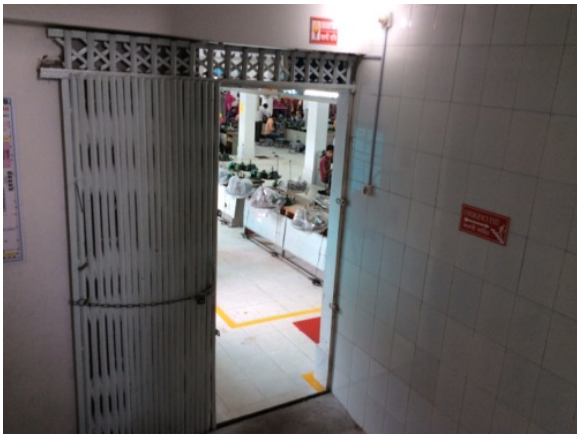
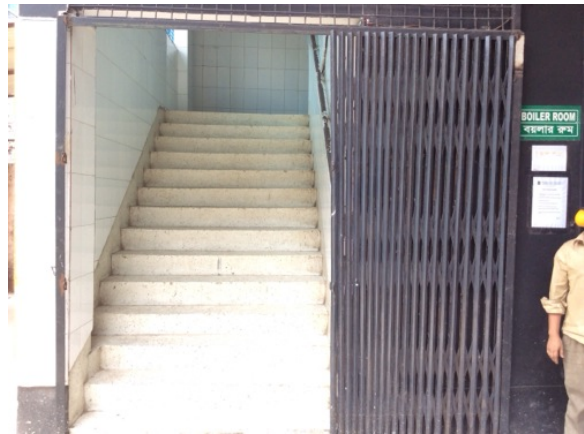
F-10	Egress	Collapsible gates and sliding doors are provided at all building exits, exit stairs, and exit discharges.	Replace all gates / sliding doors along the means of egress with side-hinged, swinging egress doors. If locks are required for security reasons, utilize special door locking features complying with NFPA 101.	Within 1 month
------	--------	---	--	----------------

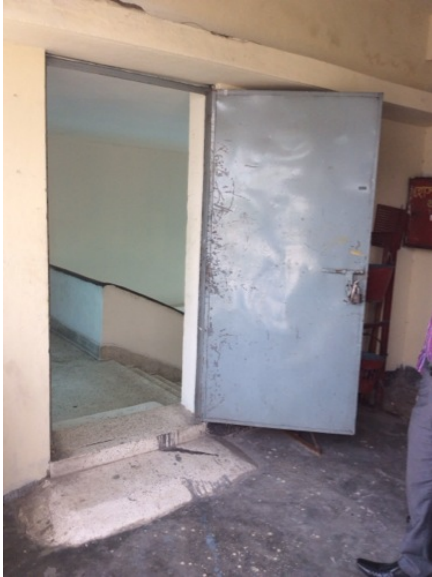
F-11	Egress	Both the exit stair doors on the 5th floor do not swing in the direction of egress travel.	Modify the egress door to swing in the direction of egress travel.	Within 3 months
------	--------	--	--	-----------------

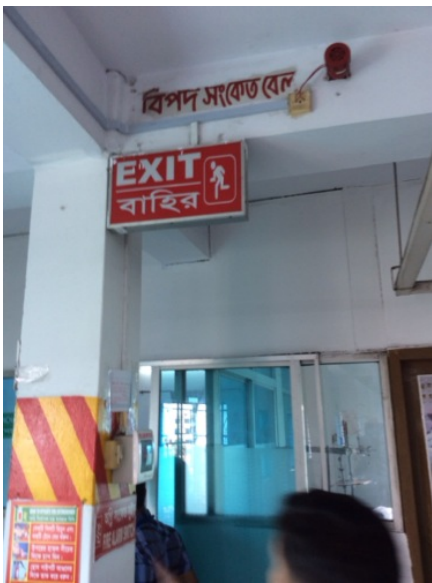
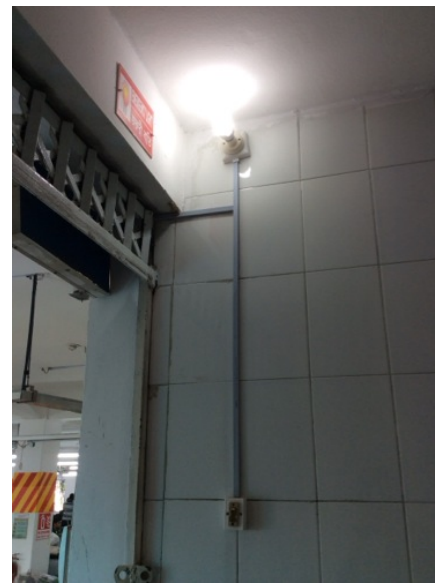
F-15	Fire Protection	Inspection, testing, and maintenance for the fire alarm system were not in accordance with NFPA 72.	Inspect, test and maintain the fire alarm system, and keep written records on-site, in accordance with NFPA 72.	Within 3 months
F-16	Egress Lighting	Manual on-off switch is provided for emergency lighting and exit signage units on many floors.	Remove manual on/off switches from emergency lighting and exit signage units to prevent them from being switched off.	Within 1 month
F-17	Egress Lighting	Inspection, testing, and maintenance records for the emergency lighting system were not available.	Inspect, test and maintain the emergency lighting system in accordance with The ACCORD standard. Keep written records on-site.	Within 3 months
