# INITIAL FIRE SAFETY INSPECTION REPORT

**Chaity Composite Ltd.- Annex building**

**RSC ID: 24170**

**Date: 15-Mar-2021**

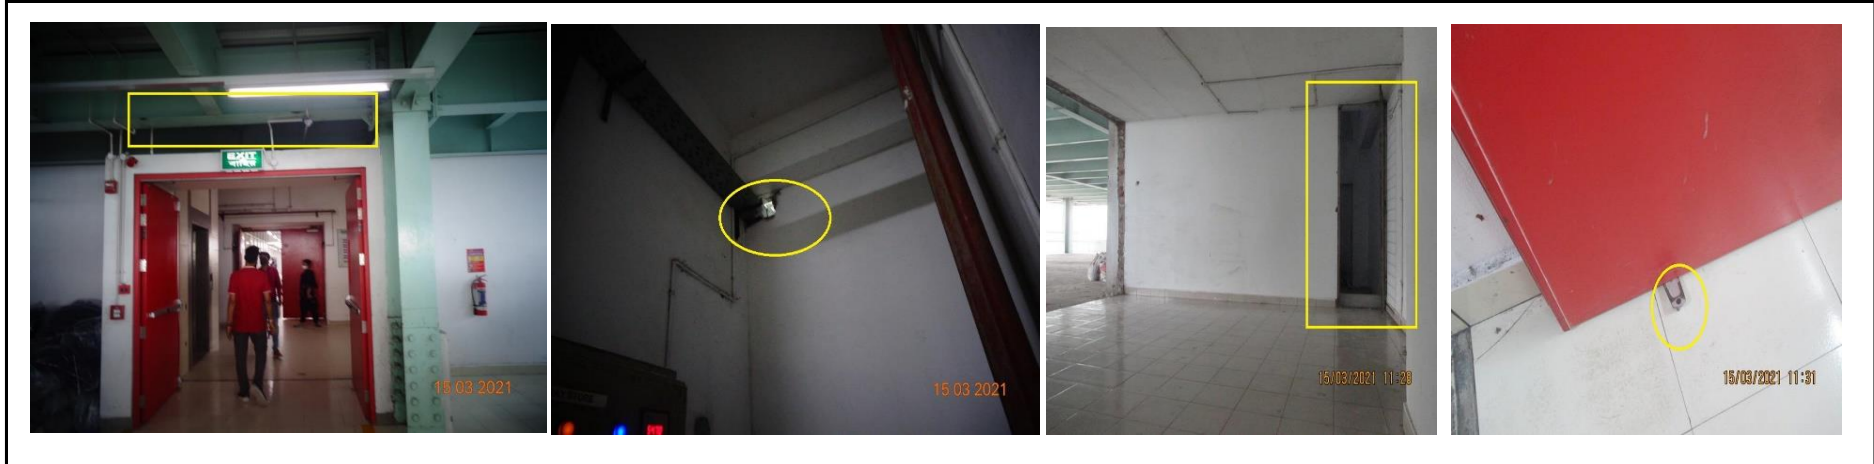
SI No.	Category	Findings	Required Action	Remediation Time Frame
F-1	Fire Rated Construction	Exit Enclosures are not properly fire separated from other occupancy on each floor by fire rated construction due to unprotected opening & penetration.	<p>Provide minimum 2-hr fire rated separation exit enclosure. Provide minimum 1.5-hr fire rated doors and seal all unprotected openings and penetration to separate the exit stairs from work areas and other building spaces on all floor levels.</p> <p>Ensure that the fire doors are self-closing and positive latching and that they are provided with fire exit (panic) hardware where serving production floors. If fire doors are required to be held open for functional reasons, provide automatic closing devices tied to the fire alarm system.</p>	Within 3 months

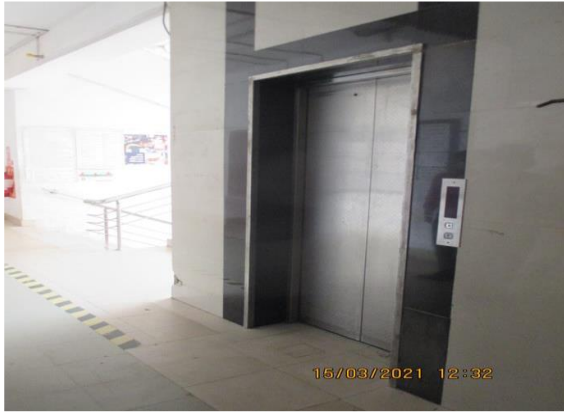
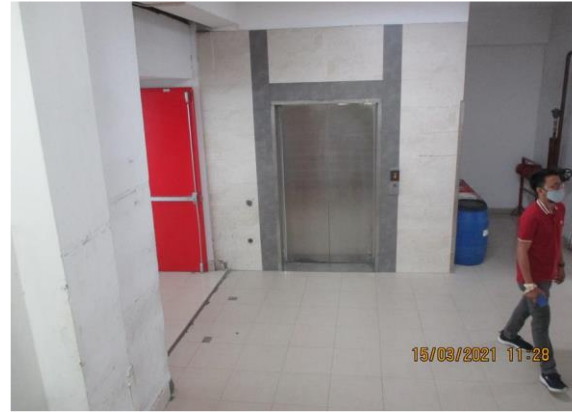
F-2	Fire Rated Construction	Elevator shafts are directly open into the inside of stair-1(Garments building) & Stair-1(share Store building)	For new construction, elevators shall not open into an exit enclosure as per ACCORD Standard-6.14.3. So, separate the stair enclosure from elevator shaft .	Within 3 months
-----	-------------------------	---	---	-----------------

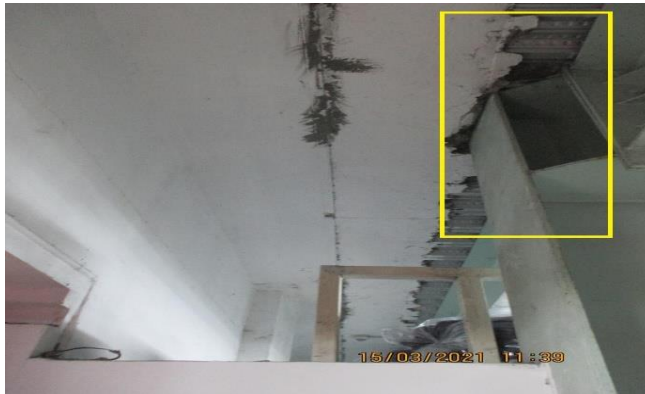
F-3	Fire Rated Construction	Building expansion joint( Store building & Garments Building with Annex Building ) are not sealed by fire rated sealant/material located at each floor/ceiling level.	Seal the building expansion joint opening by full thickness of the floor/ceiling ( min for 3 hr.) by listed fire rated sealant/material to maintain required floor to floor separation.	Within 3 months
-----	-------------------------	---	---	-----------------

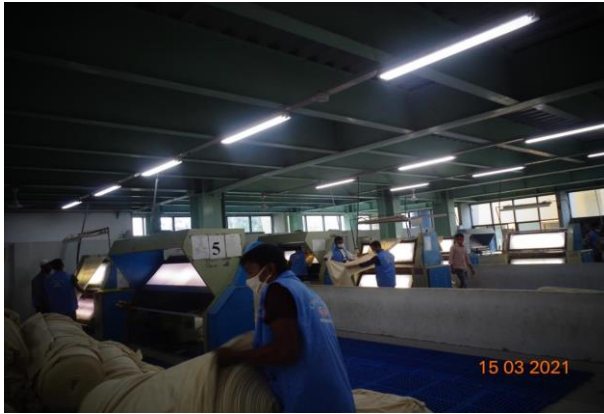
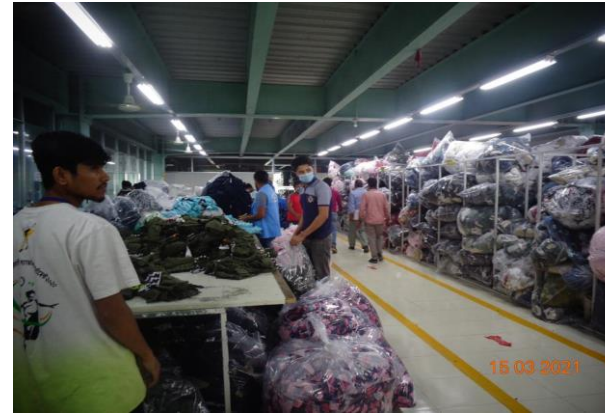
F-4	Fire Rated Construction	<p>The building is a new structure &amp; The main structural element of the building is constructed by steel which is non-rated and were found in exposed condition without any fire protection.</p>	<p>Construction of new high-rise factories containing G and/or H2 occupancies (factories) shall be Type 1 construction as required in BNBC Part 3 Table 3.2.4. Provide/ensure required fire rating on the structural elements by following Section 4.4 and Table 4.4.1 of the Accord Standard or Table 3.3.1 and Table 4.1.1 from BNBC. Consult a qualified fire protection engineer to design the rated construction barriers in between floors and in structural members.</p>	Within 6 months
-----	-------------------------	--	---	-----------------

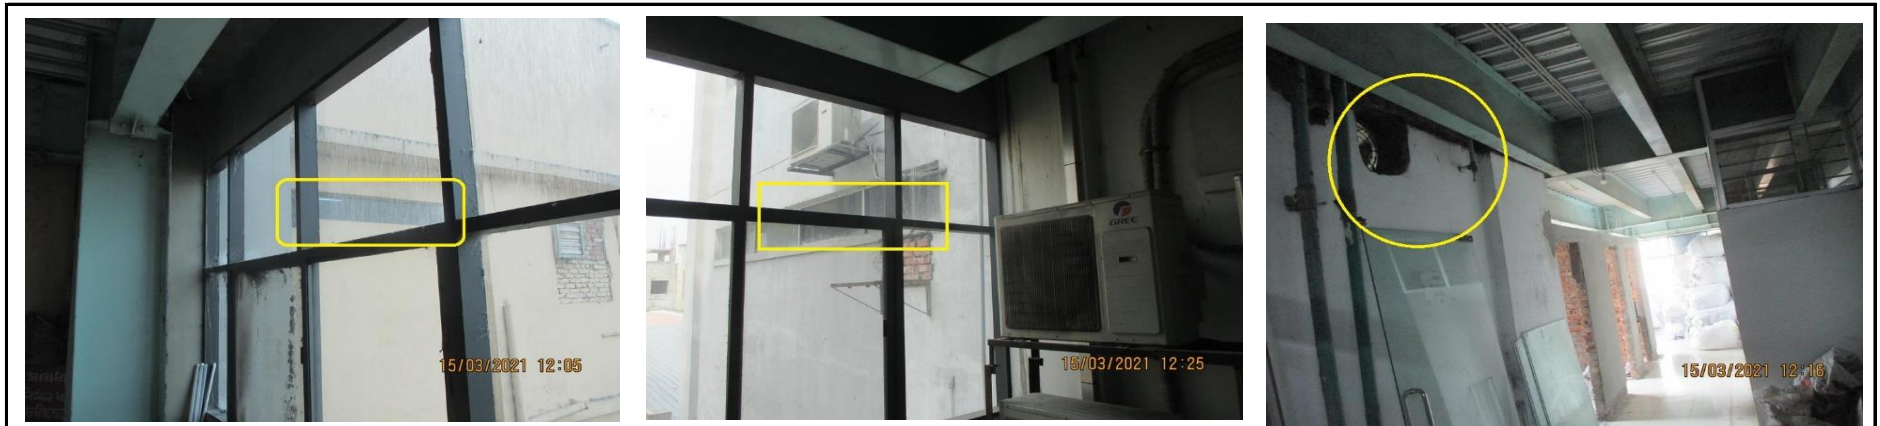
F-5	Fire Rated Construction	Exterior wall are not properly fire separated by fire rated construction due to unprotected opening within 10 feet between Annex building & Garments building each level all floor .Location west side & north side of annex building.	Exterior wall shall be separated by minimum 2-hr fire-rated construction and The rating of the exterior wall shall extend 3.05 m (10 ft.) beyond the ends of the stair structure.	Within 3 months
-----	-------------------------	--	---	-----------------

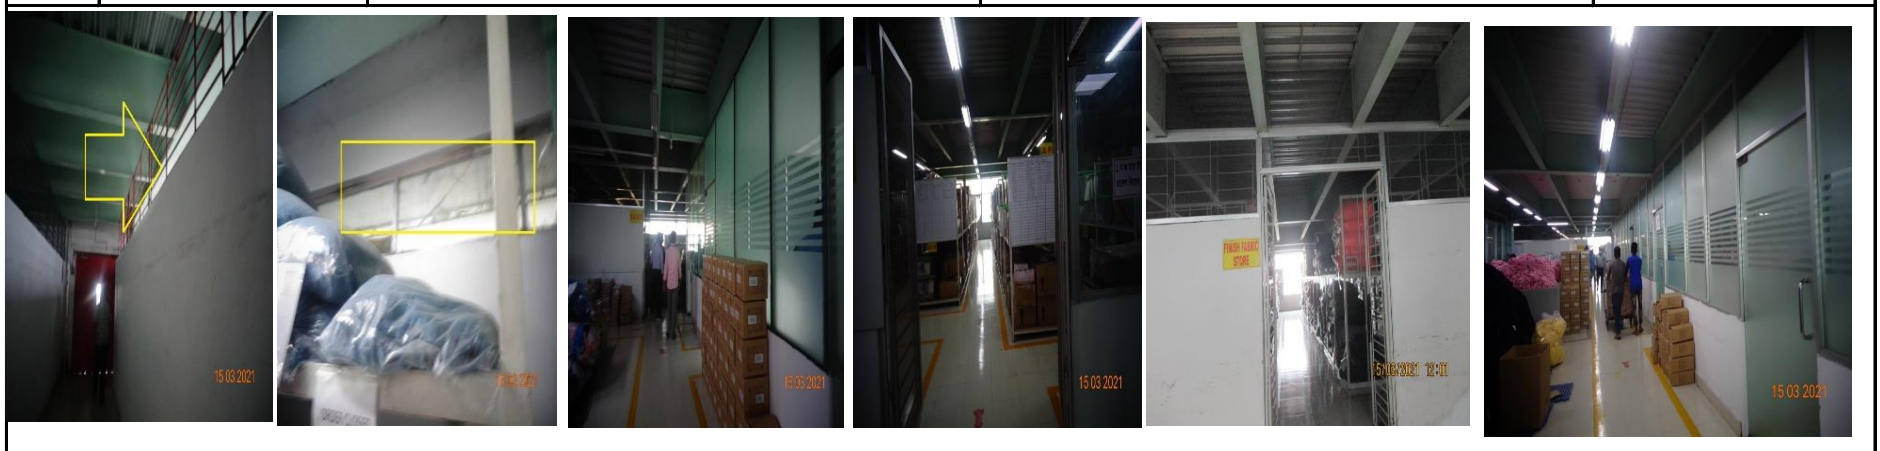
F-6	Fire Rated Construction	Room used for combustible storage on the Ground, first, 2nd, 3rd, 4th & 5th floor are not properly fire separated from the surrounding occupancy/area by fire rated construction. Location: Each level all floor of Annex building.	Provide dedicated storage rooms separated by minimum 1 hr. fire rated construction.	Within 3 months
-----	-------------------------	---	---	-----------------

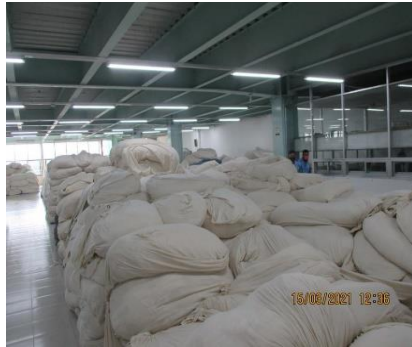
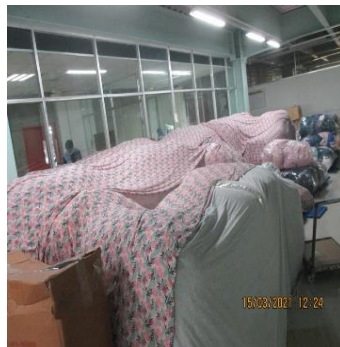
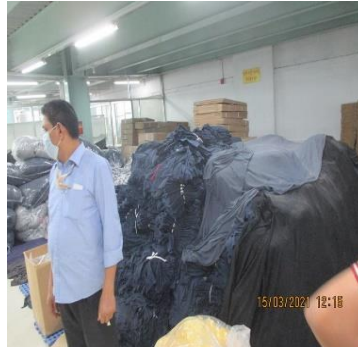
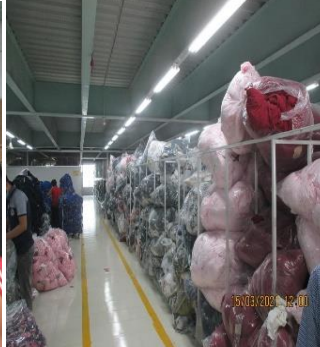
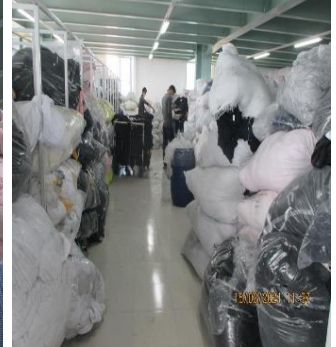
F-7	Fire Rated Construction	Areas used for in-process storage of combustible materials are open to the surrounding occupancy which are not separated by fire rated construction at Ground ,1st,2nd,3rd,4th & 5th floor floor of Annex building.	Provide dedicated storage rooms separated by minimum 1-hr fire-rated construction. Or, Where separate storage rooms are not feasible, Provide defined storage areas and limit the storage arrangement as follows:- 1. General Condition: Maximum height of 2.4m and maximum area of 23m <sup>2</sup> . Separate areas of unenclosed combustible storage by a minimum clear distance of 3m. 2. If sprinkler protected: maximum height of 3.66m and maximum area of 93m <sup>2</sup> . Separate areas of unenclosed combustible storage by a minimum clear distance of 3m.	Within 3 months
-----	-------------------------	---	--	-----------------

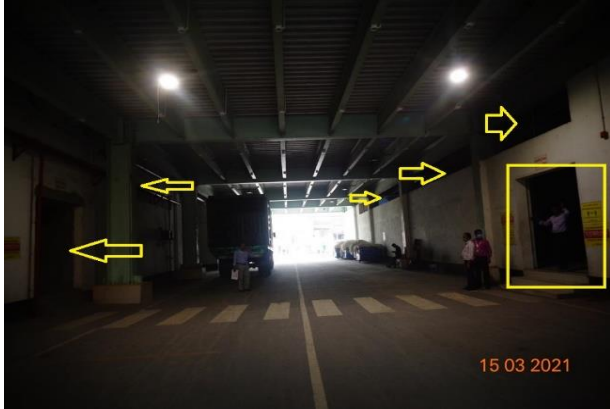
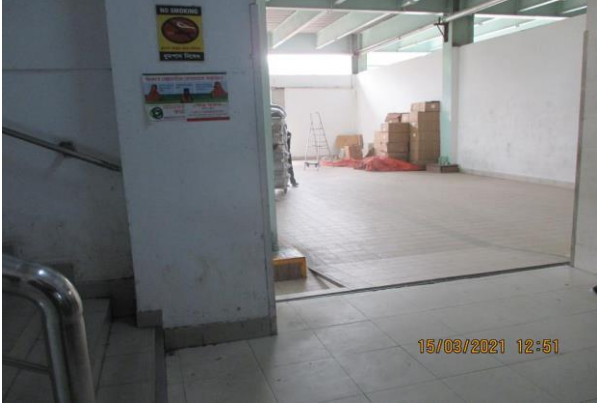
F-8	Fire Rated Construction	Exit discharge path(passageway) of the stairs are not properly fire separated by fire rated construction due to unprotected opening & penetration. Location: Stair 05 of Garments Building ( Between Annex & garments building. ) and Stair 01 of store building.	<ol style="list-style-type: none"> <li>1. Modify stair to discharge directly outside.</li> <li>Or</li> <li>2. Provide 2-hr fire-rated exit passageway leading directly outside (vestibules to separate any storage areas).</li> <li>Or</li> <li>3. Provide sprinkler protection for discharge floor in accordance with NFPA 13.</li> </ol>	Within 3 months
<div style="display: flex; justify-content: space-around;">

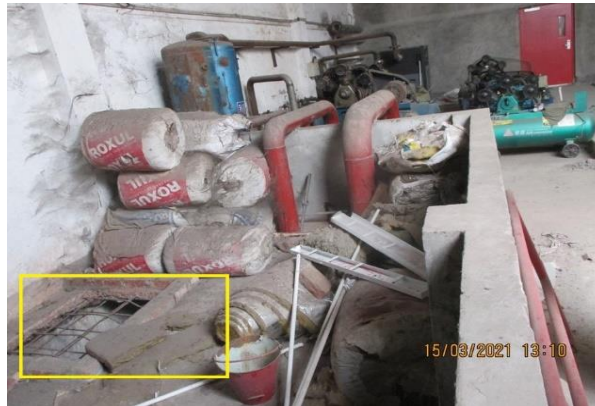
F-9	Fire Rated Construction	The fire pump room was not properly separated from compressor room by fire rated construction due to unprotected opening. Location: Shed-02	Provide fire pump room with 2 hr. rated fire separation by fire rated construction. Seal all unprotected opening & penetrations..	Within 3 months
-----	-------------------------	---	---	-----------------

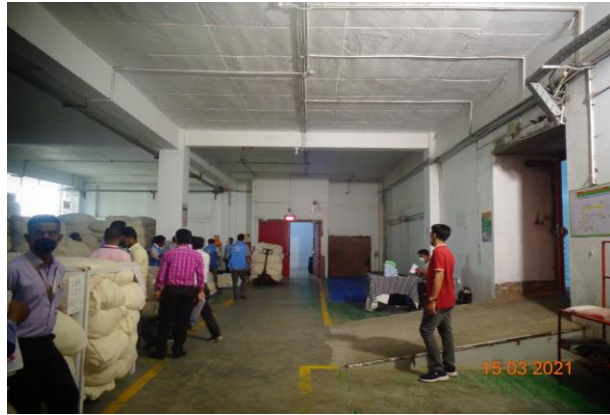
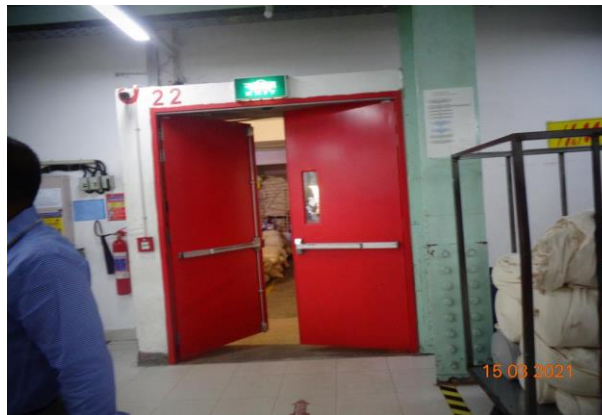
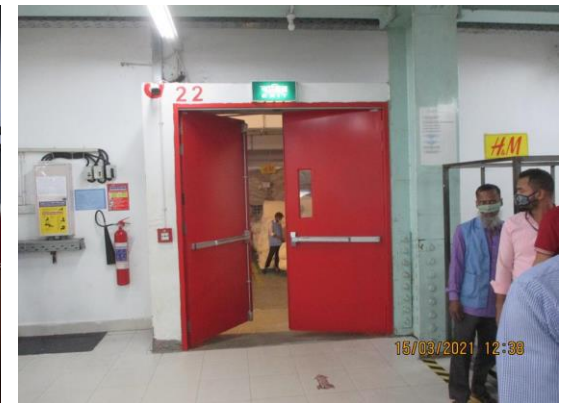
F-10	Fire Rated Construction	Gray fabric inspection area are directly discharge inside of the Gray fabric storage of Store building at first floor without proper fire rated corridor or fire separation.	<p>1. Modify gray fabric inspection area discharge to directly outside.</p> <p>Or</p> <p>2. Provide 2-hr fire-rated exit access corridors leading directly outside (vestibules to separate any storage areas).</p> <p>The clearance under the bottom of a fire door shall be a maximum of 19mm.</p> <p>If fire doors are required to be held open for functional reasons, provide automatic closing devices tied to the fire alarm system.</p>	Within 3 months
------	-------------------------	--	--	-----------------

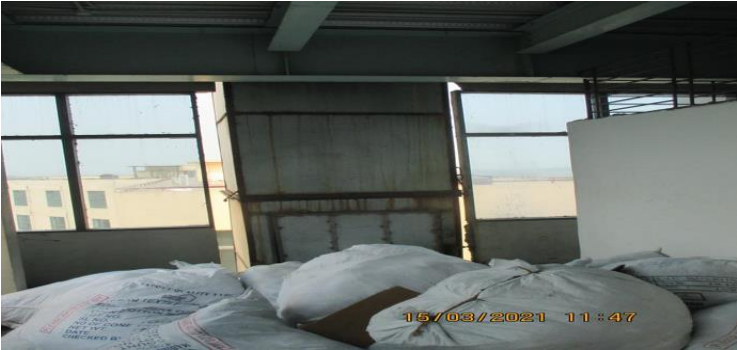
F-11	Fire Rated Construction	Unprotected vertical shaft connecting multiple floor were noted for the Annex Building.	<p>Separate the shaft/duct from the other occupancy by minimum 2-hr fire-rated construction .</p> <p>or</p> <p>Provide a minimum 2-hr fire-rated shaft to separate the duct from each floor if required.</p>	Within 3 months

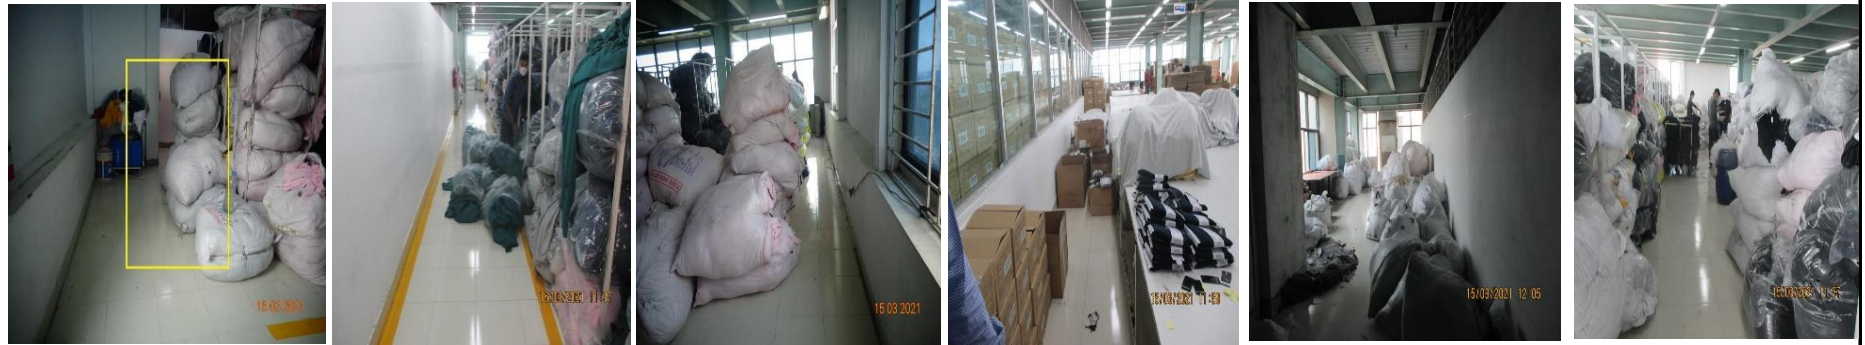
F-13	Means of Egress	The egress path along the means of egress has been interrupted by obstruction/storage each floor all level. Location: All floor of Annex building.	Means of egress shall be maintained continuously free and clear of all obstructions/storage. Or Aisles shall be provided with a minimum unobstructed clear- with of 0.9m (36 in).	Immediately
------	-----------------	--	---	-------------

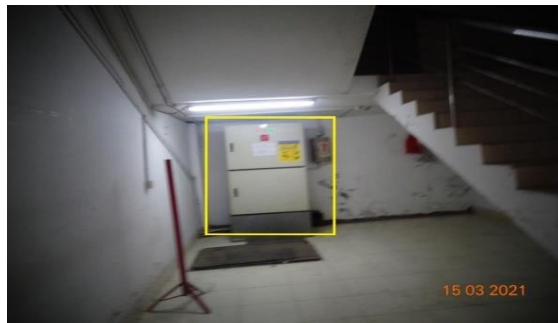
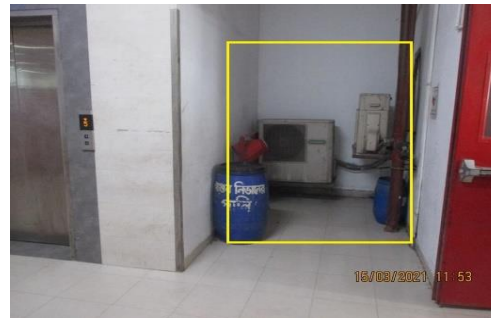
F-14	Means of Egress	Electrical panel boards (DB) & air conditioner are located on the inside of Exit stair-1(share to store building stair) each level all floor.	Remove electrical panel boards & air conditioner from exit stairs.	Within 1 month
------	-----------------	---	--	----------------

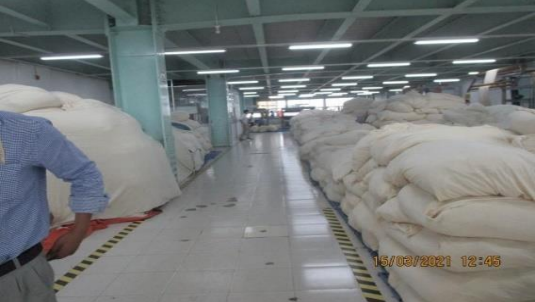
F-15	Means of Egress	The common path of egress travel was founded more than 23m located at first floor of Annex building.	Reconfigure the egress arrangement to reduce the maximum common path of travel to not more than 23m or 30m when complete sprinkler protection is provided	Within 3 months
<div style="display: flex; justify-content: space-around;">

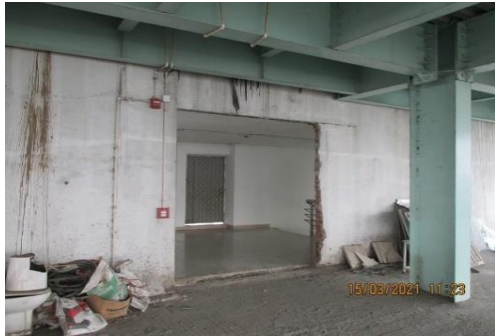
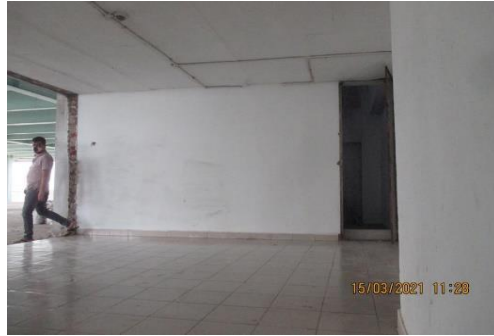
</div>				
F-16	Means of Egress	A single means of exit has been provided at 6th floor .	Provide additional required remotely located exit stair from 6th Floor.	Within 3 months

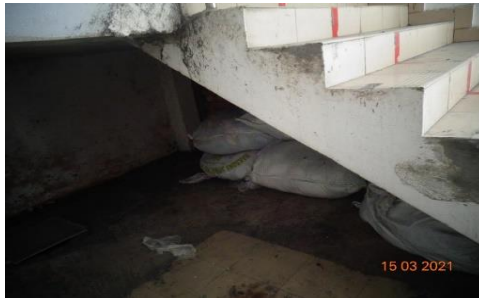
F-17	Means of Egress	Storage was located inside in exit stair-5(share garment building)	Remove storage from the exit stairs and egress path	Immediately
------	-----------------	--	---	-------------

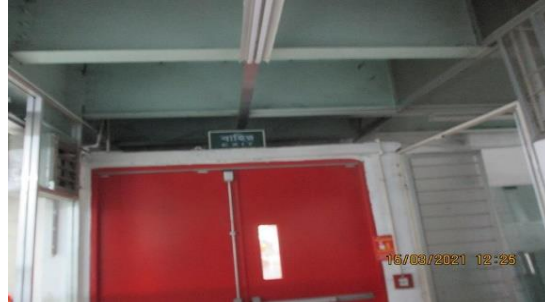
F-18	Means of Egress	Fire evacuation maps is not posted at the entrance of all exit stair.	Fire evacuation maps shall be posted at the entrance to each exit stair.	Within 1 months
F-19	Means of Egress	Occupant load sign is not posted at the exit stair at all level	Occupant load sign shall be posted at the entrance to exit stair at all level.	Within 1 months
F-20	Egress lighting	Exit sign not provided at exit.	Lighted exit signs shall be placed at entrance to an exit. Additional exit signs shall be placed throughout the facility anywhere the continuation of the egress is not obvious. Lighted exit signs shall be provided with either battery backup or uninterruptable power supply systems and shall be continuously illuminated.	Within 1 months
F-21	Egress lighting	Emergency lights not illuminated during testing (burned out, broken, etc.).	Regularly inspect all emergency lighting system as per Accord standard and replace/install lights as needed to illuminate signs.	Within 1 months

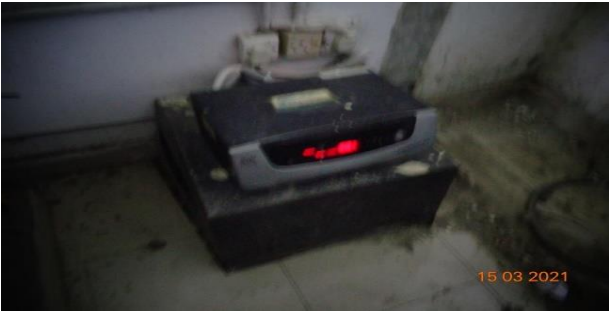
F-24	Egress lighting	Manual on-off switch is provided for emergency lighting backup source IPS	Remove manual on/off switches from emergency lighting / exit signage units to prevent them from being switched off.	Within 1 month

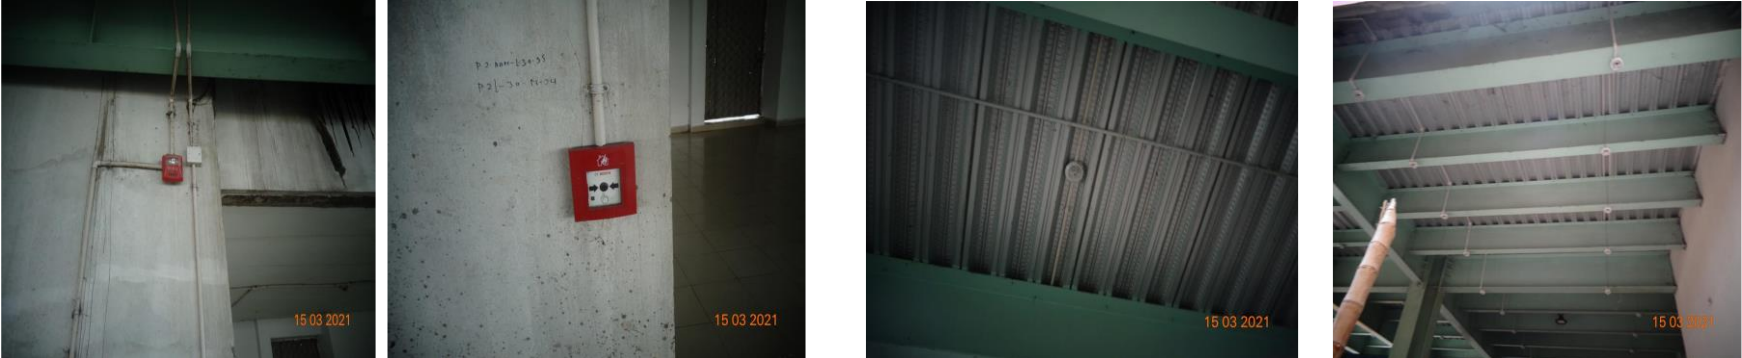
F-26	Fire Protection System	Fire alarm system installation requires detailed review to confirm compliance with NFPA 72 and ACCORD standards.	Submit design to RSC for review and modify installation if required. Installation of Fire Alarm system should be in accordance with ACCORD standard and NFPA 72.	Design within 2 months, Install within 4 months (If modification required)

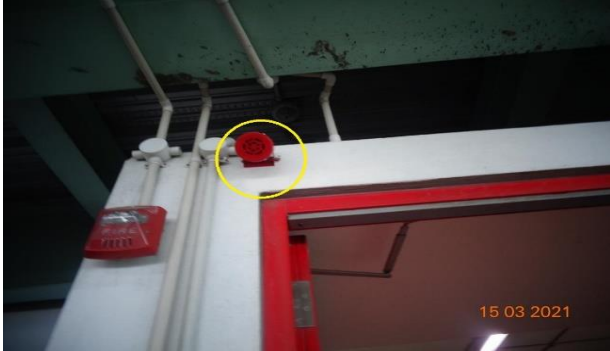
F-28	Fire Protection System	The building is equipped with single-station smoke alarms.	Remove single-station smoke alarms. Provide automatic smoke detection throughout the building, tied into the fire alarm system, in accordance with NFPA 72.	Design within 2 months, Install within 4 months (If modification required)

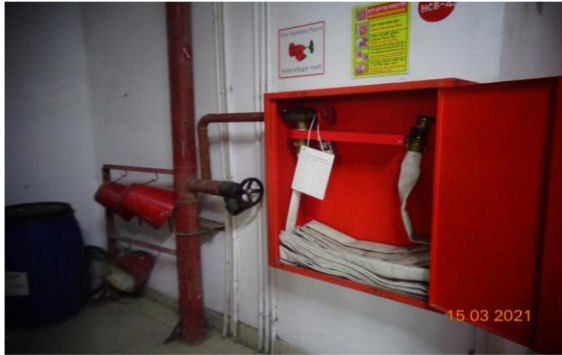
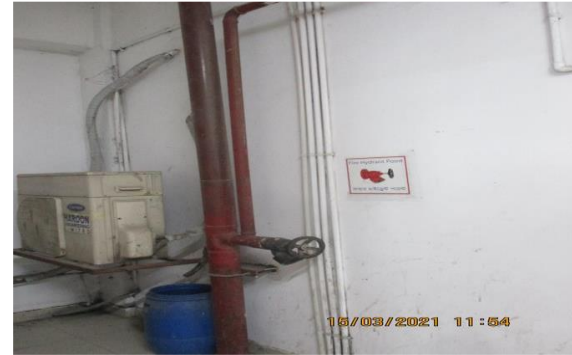
F-29	Fire Protection System	The Standpipe System requires detailed review to confirm compliance with NFPA 14 and ACCORD standards. Fire Pump NFPA-20.	Submit design to RSC for review and modify installation if required. Installation of Standpipe system should be in accordance with ACCORD standard and NFPA 14, 20, 22 and 24.	Design within 2 months, Install within 4 months (If modification required)

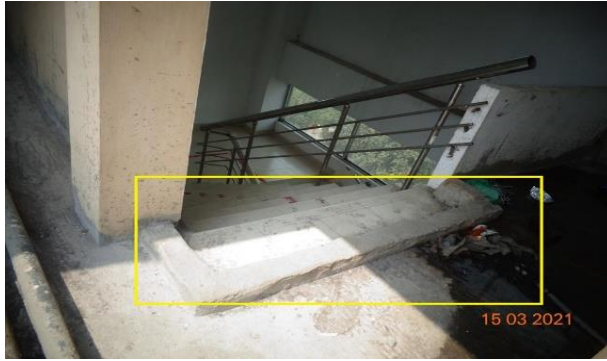
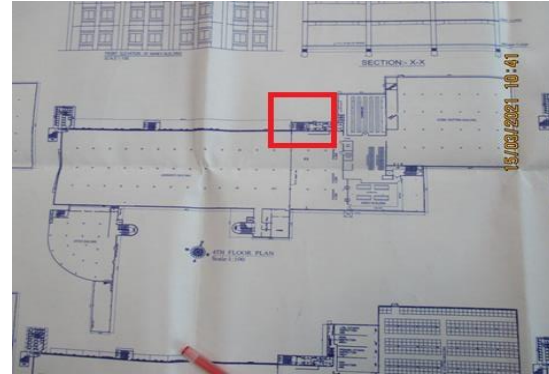
F-32	Fire Protection System	Inspection, testing, and maintenance of the extinguisher system is not in accordance with NFPA 10 or as per Accord standard.	Inspect, test and maintain the extinguisher system, and keep written records on-site, in accordance with NFPA 10 or as per Accord standard.	Within 3months
F-33	Means of Egress	Exit capacity is not adequate for the occupant load on the 2nd & 3rd floor (whole floor). The 2nd & 3rd floor has 1505 & 1547 occupants respectively and the exit capacity is 1407.	Reduce occupant load to not more than available exit capacity for the entire floor. (Immediately) Or, Provide additional exit/s to meet the exit capacity of each building separately.	Immediately
F-34	Means of Egress	Garments building stair-5 are used for annex building emergency evacuation which consider as new construction and Inadequate stair width.	In new construction and for newly constructed stairs, stairs shall have a min. width of 1.50 m (60 in.) for all industrial occupancies according to Accord Standard 6.5.6.2.1	Within 3 months
