# Iris Fabrics Ltd. (9447)

Zirani Bazar, Kashimpur, Gazipur

24.MARCH.2014

ACCORD  
on Fire and Building Safety in Bangladesh

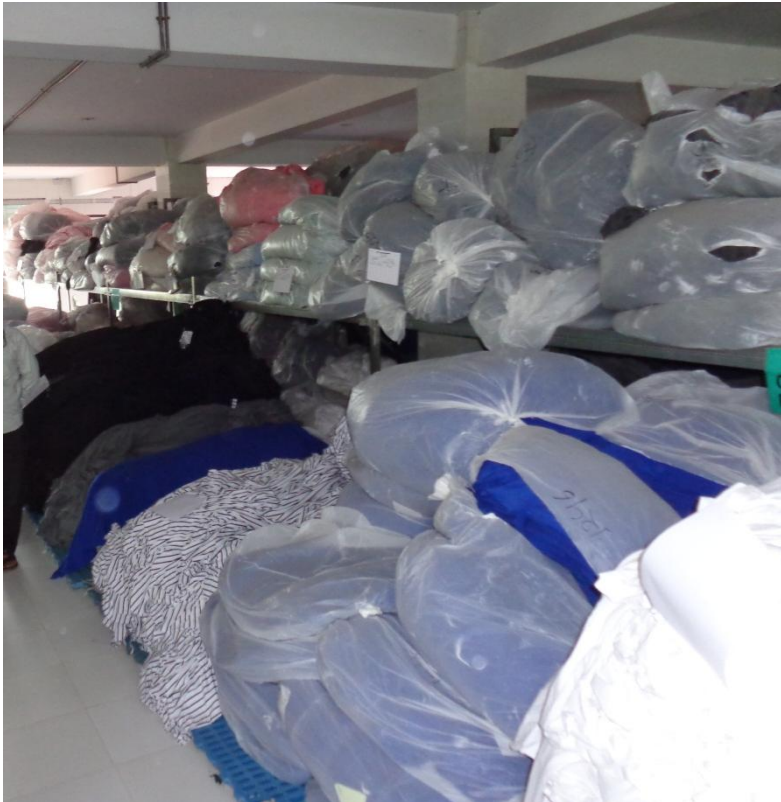
**ITEM 1: (Priority 1) Slab loadings were quite high throughout Building A in localized areas due to high storage loads. The dormitory is being used for excessively high levels of storage during its construction.**

Storage levels were higher than desirable in localized areas distributed throughout Building A.

- Reduce storage loads throughout factory Building A and throughout Dormitory to design load levels

- Factory engineer to develop and actively monitor a loading plan for all floor plates within the factory complex giving consideration to slab, column and foundation capacity.

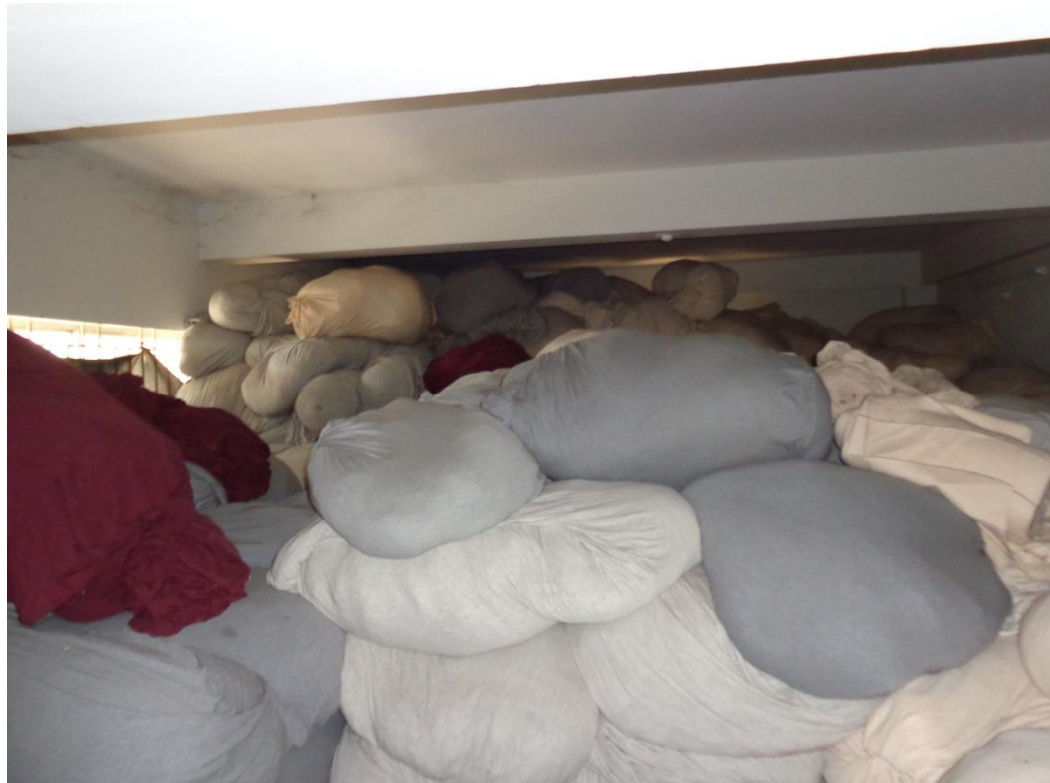
Storage levels were very high and widely distributed throughout the Dormitory.

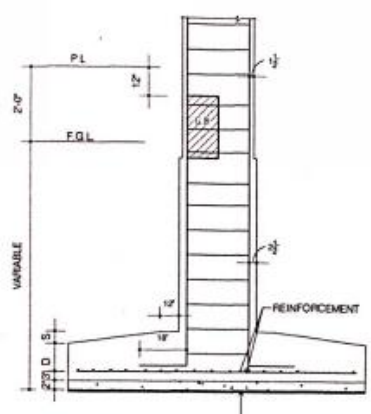
SECTION X-X OF FOOTING (OUTER COL)

**ITEM 2: (Priority 2) Soil bearing capacity does not appear adequate to safely support the loads developed at the footing level of Building A.**

Soil bearing capacity does not appear adequate to support spread footing loads

- Detailed engineering assessment to be performed upon Building A foundations

- Implement all works mandated by the above mentioned detailed engineering assessment

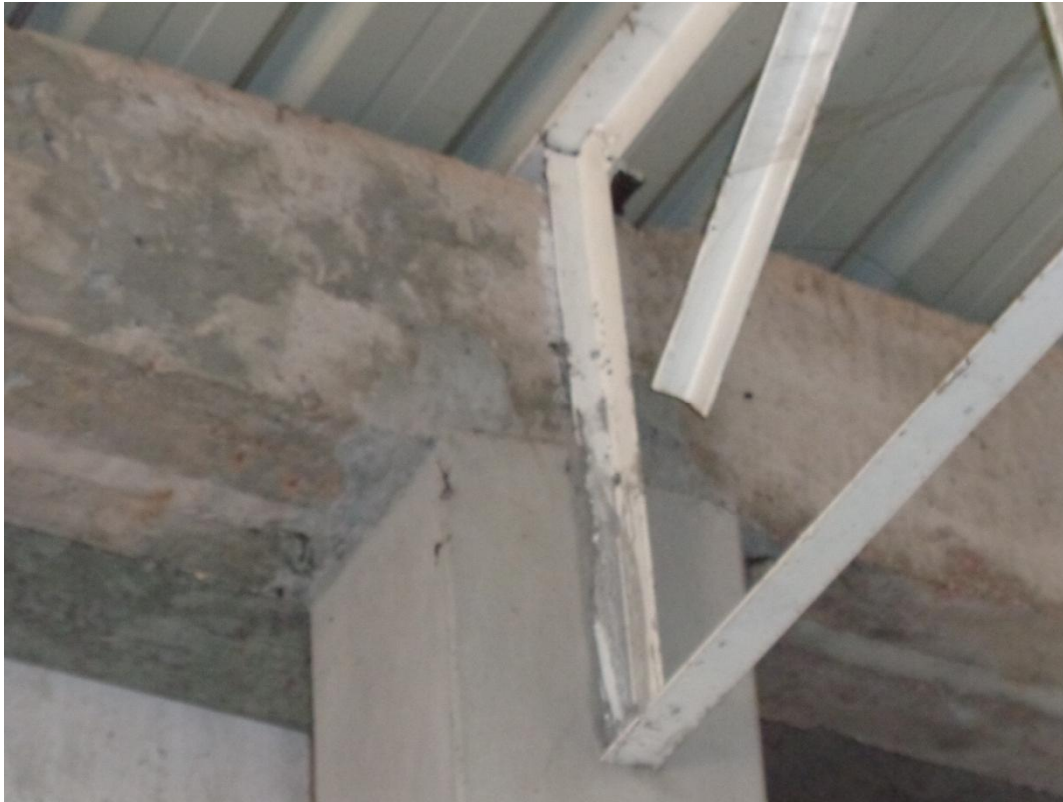
## Poorly Framed Roof Trusses in Storage Shed

**ITEM 3: (Priority 2) Storage shed steel roof truss framing appears poorly constructed within the north most storage shed. Other sheds have steel beam roof framing.**

Roof framing in the storage shed utilizing truss framing was poorly build and employed questionable framing methods

- Factory engineer to conduct a review of the storage shed roof truss framing to determine its adequacy

- Perform any remediation required to the shed roof truss framing or demolish the shed
