# **FIRE SAFETY INSPECTION REPORT**

## **Lida Textile & Dyeing Limited- Extended Buildings- New unit**

**Factory ID: 24024**

**Date: 20-Oct-2020**

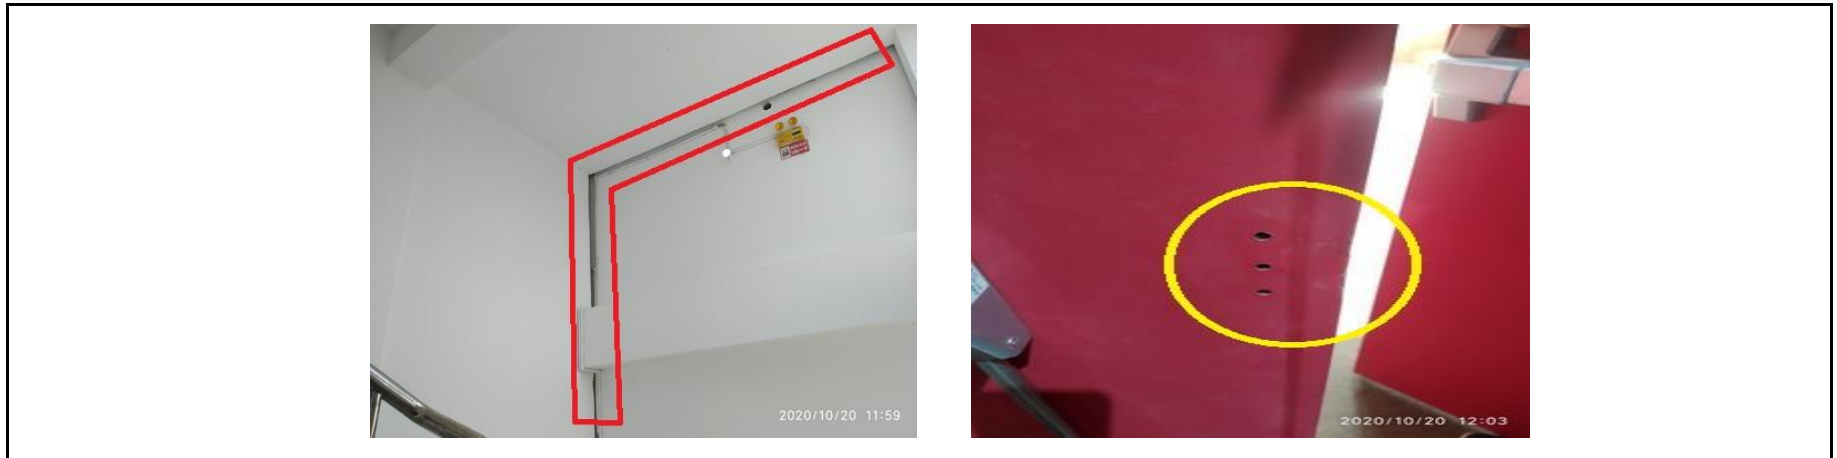
| SI No. | Category | Findings | Required Action | Remediation Time Frame |
|---|---|---|---|---|
| 1 | Fire-rated construction | <p>The exit stairs are not separated from [work areas, other spaces] on each floor by fire-rated construction due to unsealed penetrations and openings.</p> <p>Location: Automated ware house- extended part</p> | <p>Stair shall be enclosed with a minimum 2-hr fire-rated construction. Seal all unprotected openings and provide minimum 2-hr fire rated doors to separate the exit stairs from work areas and other building spaces on all floor levels. The clearance under the bottom of a fire door shall be a maximum of 3/4 in. (19 mm). Ensure that the fire doors are self-closing, positive latching and that they are provided with fire exit (panic) hardware where serving production floors. Provide vestibules to separate the storage areas.</p> <p>If fire doors are required to be held open for functional reasons, provide automatic-closing devices tied to the fire alarm system.</p> <p>Penetrations into and through an exit enclosure shall be prohibited with the exception of required exit doors, sprinkler piping, standpipes, electrical raceway for fire alarm equipment, and electrical conduit serving the exit enclosure.</p> | Within 3 months |

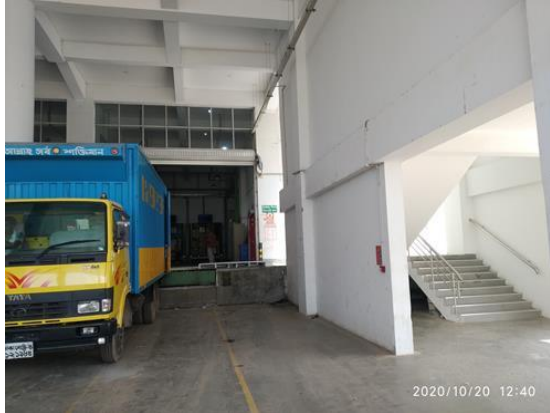
| 2 | Fire-rated Construction | Exit stair-3 is discharge the occupants inside the building at ground floor.<br>Location: Automated ware house- extended part | <p>1. Modify stair to discharge directly outside.<br/>Or<br/>2. Provide 2-hr fire-rated exit passageway leading directly outside (vestibules to separate any storage areas).</p> <p><b>Note: A maximum of 50 percent of the number and capacity of the exit enclosures can discharge through areas on the level of exit discharge where all the conditions described in Accord building standard 6.17.3 are met.</b></p> | Within 3 months |

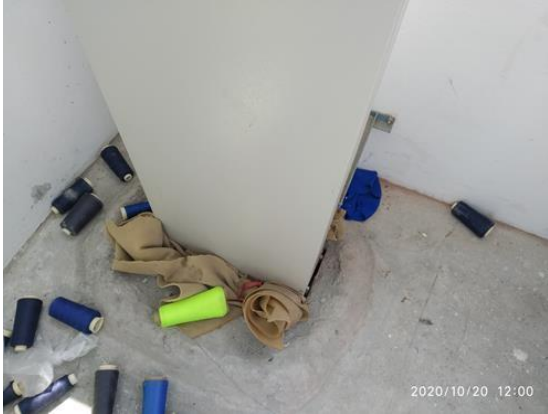
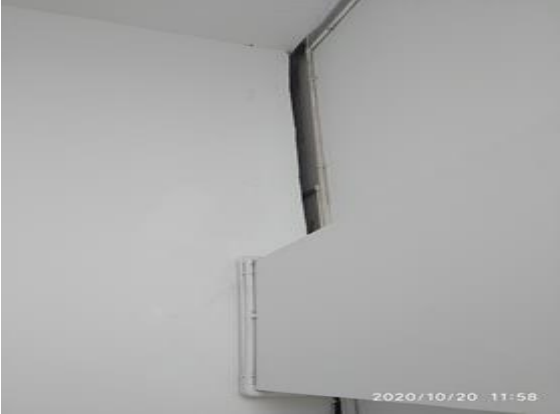
| 3 | Fire-rated Construction | <p>Penetrations through floor/ceiling assemblies are found unsealed.</p> <p>Location: Building expansion joint &amp; electrical riser of Automated ware house- extended part</p> | <p>Seal all penetrations and openings in floor/ceiling (full thickness of the floor/ceiling) assemblies by third-party certified fire rated materials to maintain the fire resistance rating.</p> <p>Provide a minimum 2-hr fire rated shaft to separate the utility risers from each floor if required.</p> | Within 3 months |

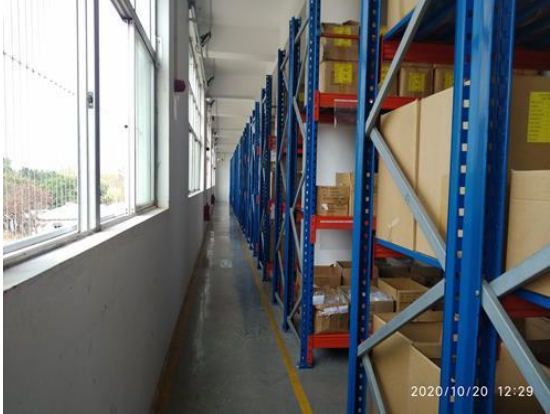
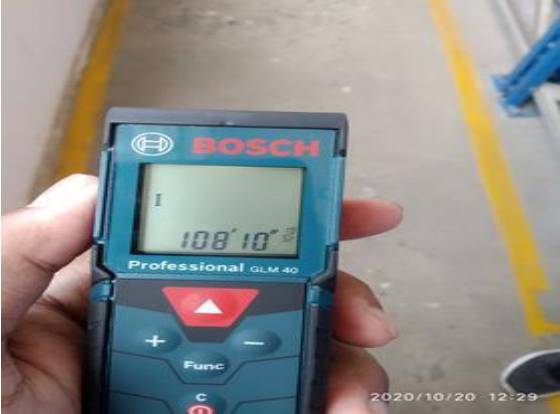
| 4 | Egress | Common path of egress travel exceeds 30 m (100 ft).<br>Location: Automated ware house- extended part, 1st floor | Reconfigure the egress arrangement to reduce the maximum common path of travel to meet Accord Building Standard 6.13.2. | Within 2 months |

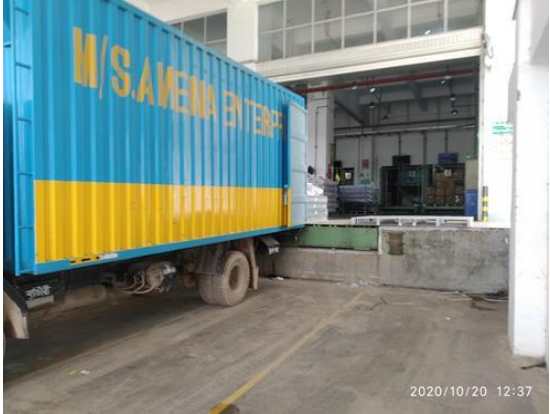
| 5 | Egress | <p>Guards are not provided on the open sides of ground floor where the elevation exceeds 760 mm (30 in.) above the floor below.</p> <p>Location: Automated ware house- extended part, ground floor</p> | <p>Minimum (height) 1067 mm (42 in.) guards shall be provided at all open sides of means of egress that exceed 760 mm (30 in.) above the floor or finished ground below.</p> | With in 2 months |

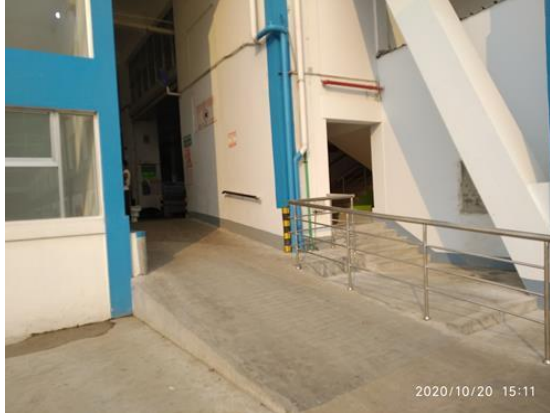
| 6 | Egress | Handrails are not provided on both side of the ramp in the ground floor.<br>Location: Automated ware house- extended part | Provide handrails on at least both side of ramp having a minimum height of 865 mm (34 in.) and a maximum height of 965 mm (38 in.) as measured from the leading edge of the tread. | With in 2 months |

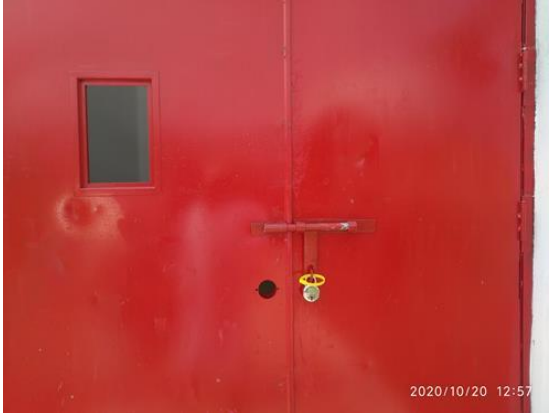
| 7 | Egress | Doors along means of egress are provided with non compliant locking system. Location: Chemical Store | Remove locking features from all egress doors / gates. If locks are required for security reasons, utilize special door locking features complying with Accord building standard 6.8.2 & NFPA 101. | Immediately |

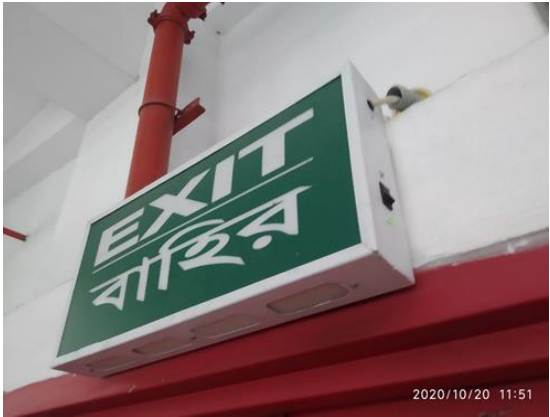
| 9 | Egress Lighting | Manual on-off switch is provided for emergency lighting / exit signage units.<br>Location: Automated ware house- extended part | Remove manual on/off switches from emergency lighting / exit signage units to prevent them from being switched off. | Within 1 month |

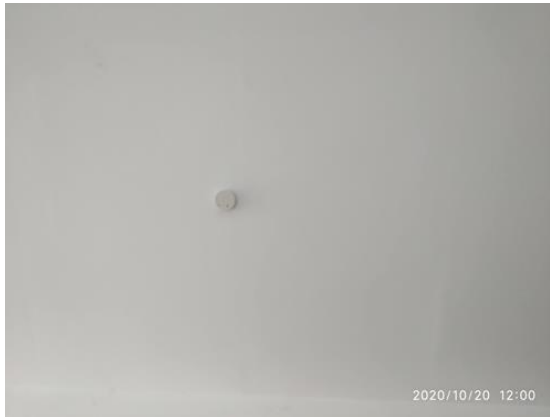
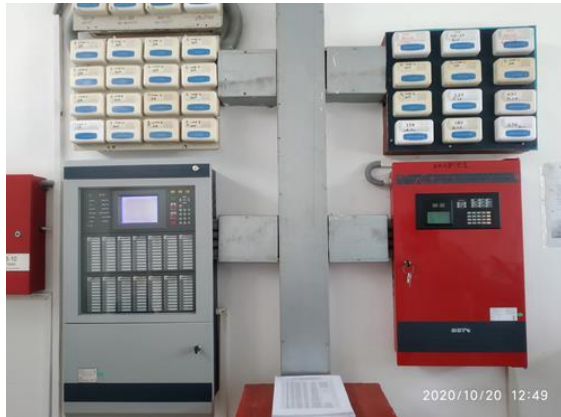
| 10 | Fire Alarm | The building is equipped with single-station smoke alarms. Smoke alarm activation sounds only a local alarm and does not provide automatic fire alarm notification of occupants. (automated warehouse- extended part, Chemical store, Security Building, Boiler Building) | Remove single-station smoke alarms. Provide automatic smoke detection throughout/entire the building, tied into the fire alarm system, in accordance with NFPA 72. | Design within 2 months, installation/modification within 4 months |

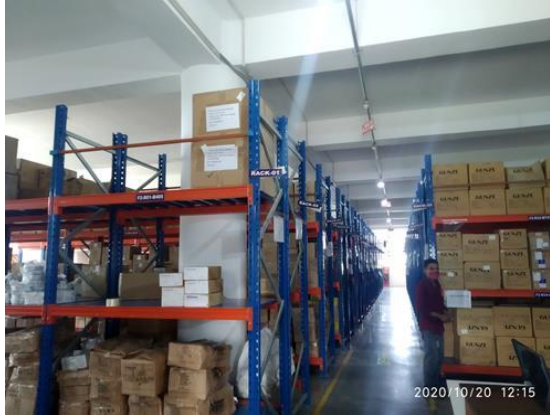
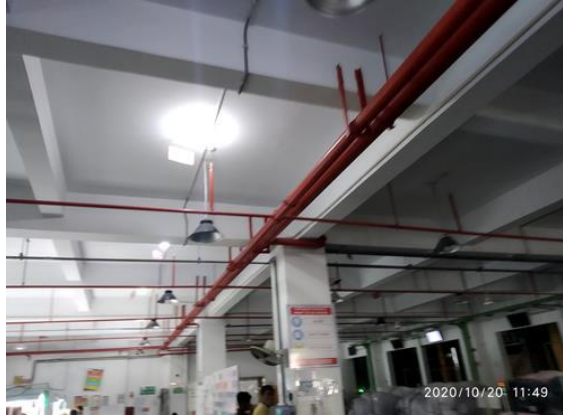
| 11 | Fire Protection | The height of the highest occupied floor of Automated ware house- extended part is greater than 23 m (75 ft) above the finished grade is not protected with an approved automatic sprinkler system. | Provide an automatic sprinkler protection along with required standpipe system throughout the building in accordance with NFPA 13, 14, 20, 22 and 24. | Design within 2 months, installation/modification within 6 months |
