# METRO KNITTING & DYEING MILLS LTD (9509)

Ramarbag, Kutubpur, Fatullah  
(+23.6453135N, 90.4891263E)  
24 March 2014

ACCORD  
on Fire and Building Safety in Bangladesh

# Site Observations

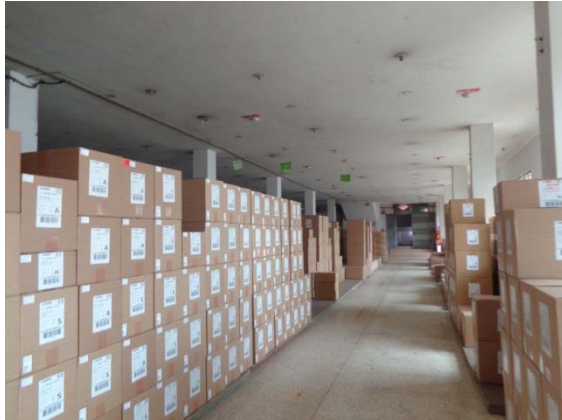
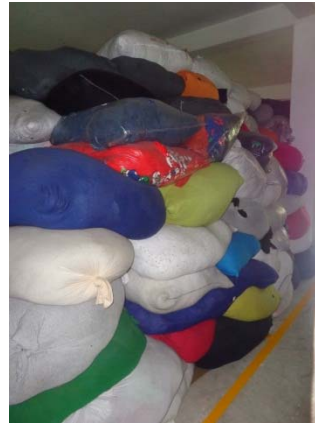
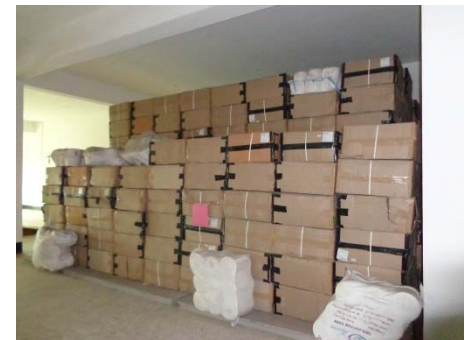
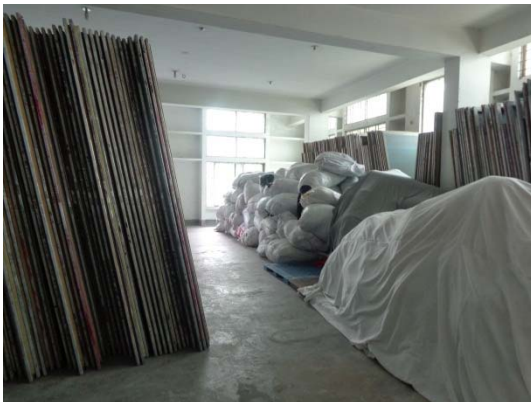
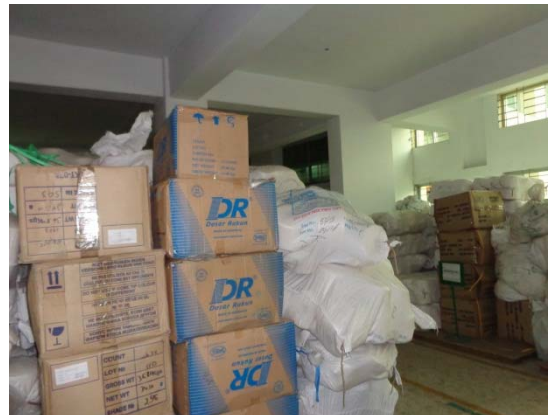
**Excessive Storage**

**High loads on storage areas**

Excessive and uncontrolled storage of boxes and fabric.

**ITEM 3: (3<sup>rd</sup> Priority 1 – Building 4, 7, 8, 11) Uncontrolled and excessive storage.**

High storage loads.

- Immediately reduce stacking height of boxes and fabric to ensure total load does not exceed 3.0kPa.

- Mark the maximum allowable height of fabric and box stacking to ensure full compliance with specified design loads.

- Produce and actively manage a loading plan, ensuring maximum height of storage is adhered to in the long-term.

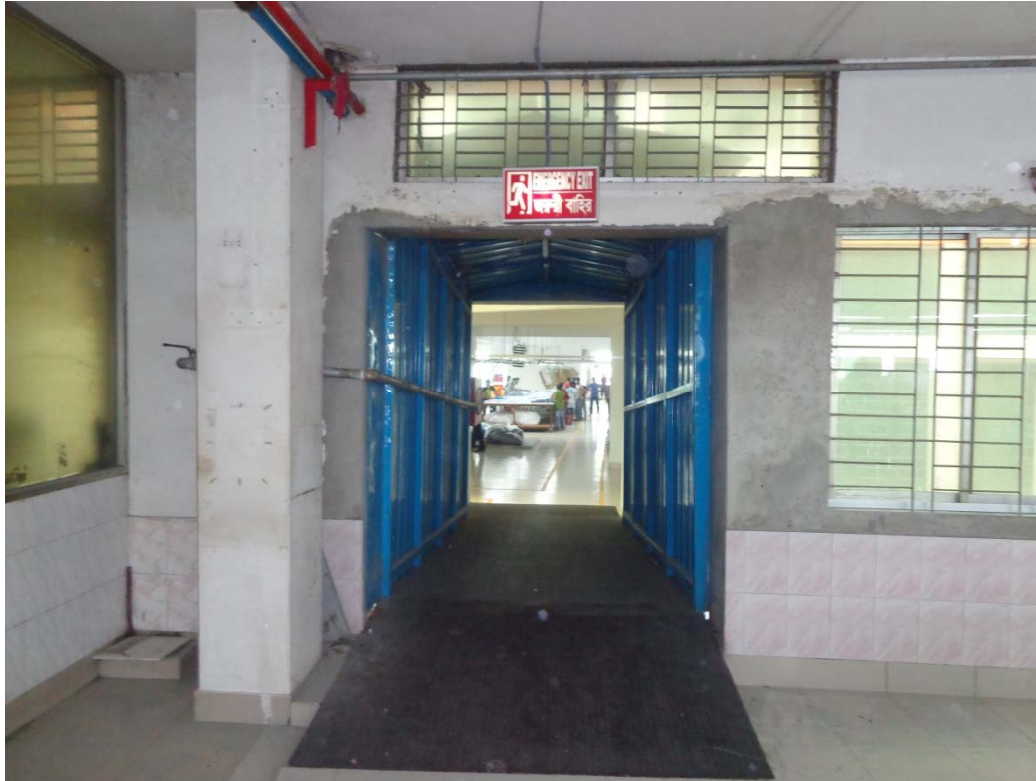
**Connecting bridge**

**Presence of a connecting walkway between  
Buildings 2 and 7 and Buildings 6 and 8**

Building Engineer to check that beams and columns have been designed to accommodate loads.

**ITEM 5: (2<sup>nd</sup> Priority 2 – Building 7) Presence of a walkway between Buildings 2 & 7**

- The factory engineer is to verify the capacity of beams and columns.

- Carry out any remedial measures that the factory engineer considers necessary to ensure the long term stability of both the walkway and the building itself.

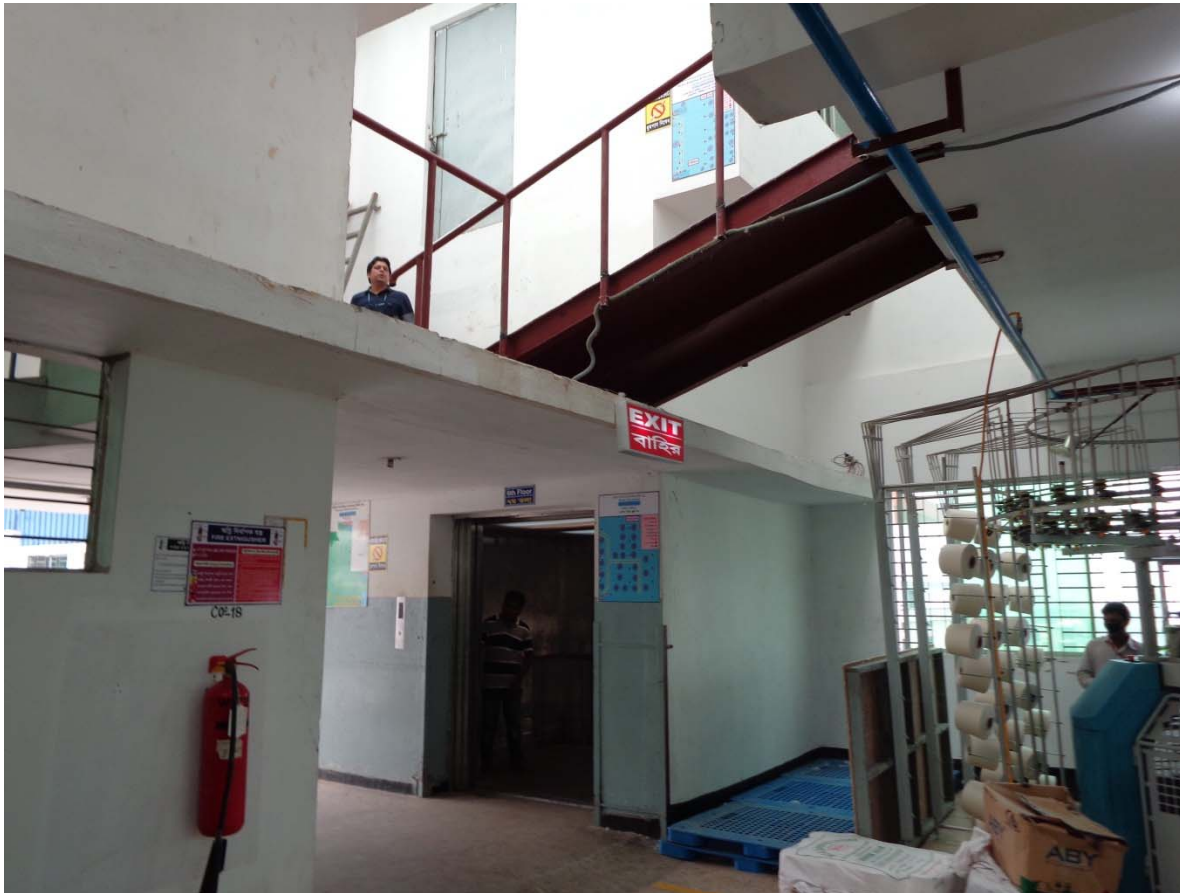
**Connecting bridge**

Steel walkway connecting Building 6 and the overhang of building 8. Engineer to check that slabs, beams and columns have been designed to accommodate loads.

**ITEM 6: (3<sup>rd</sup> Priority 2 – Buildings 6 & 8 ) Presence of a walkway between Buildings 6 & 8.**

- The factory engineer is to verify the capacity of beams and columns.

- Carry out any remedial measures that the factory engineer considers necessary to ensure the long term stability of both the walkway and the building itself.

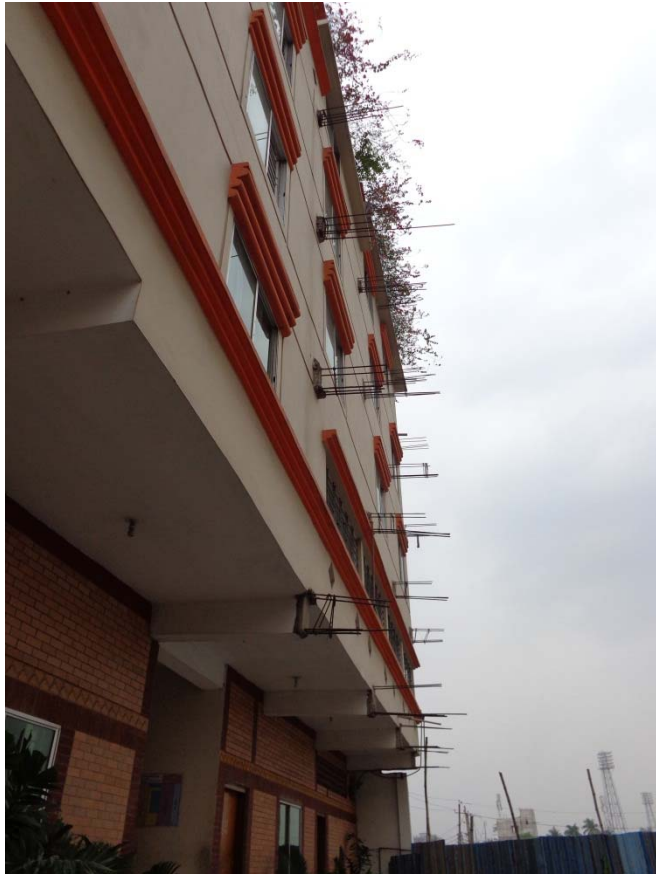
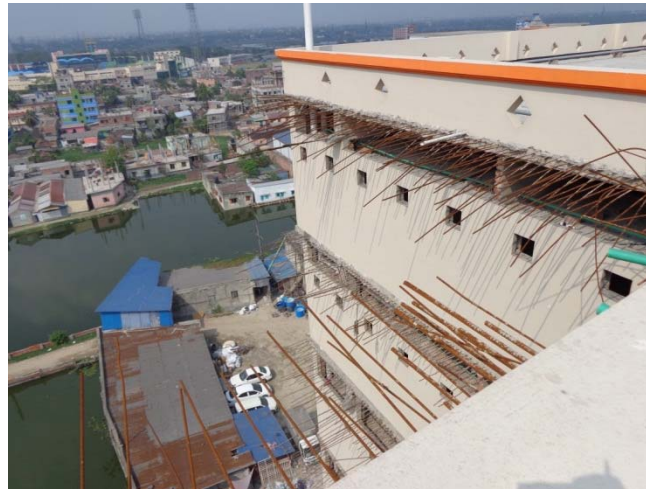
**Future building**

**Rebars left in place for future building**

Rebars were left in place for the construction of a future adjacent building. The 2 building should be separated by a movement joint.

- Rebars to be cut and future building to be constructed with a movement joint.

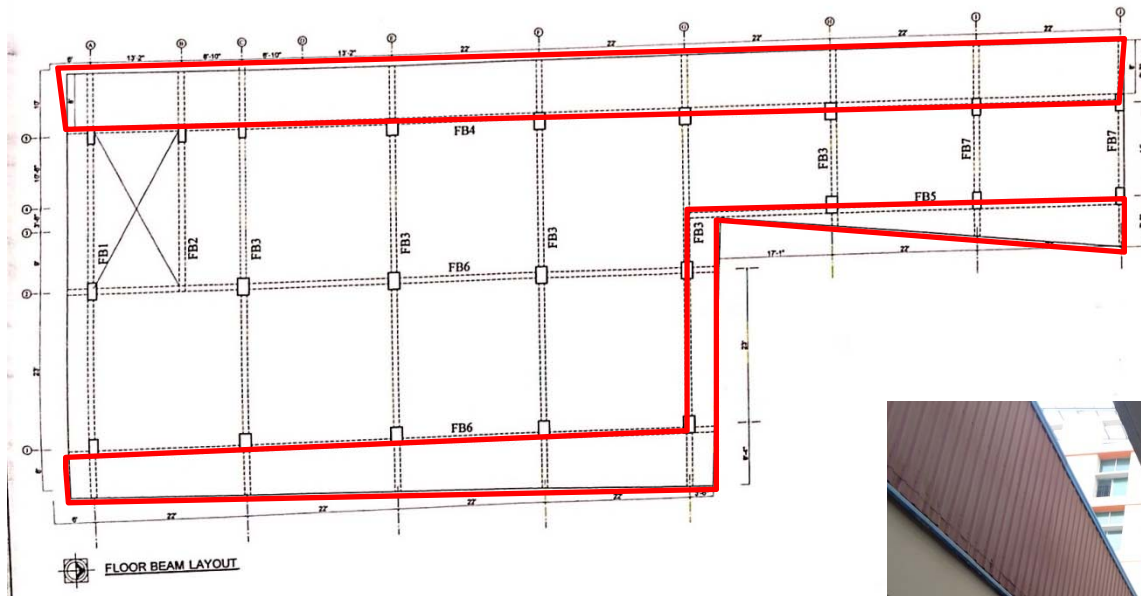
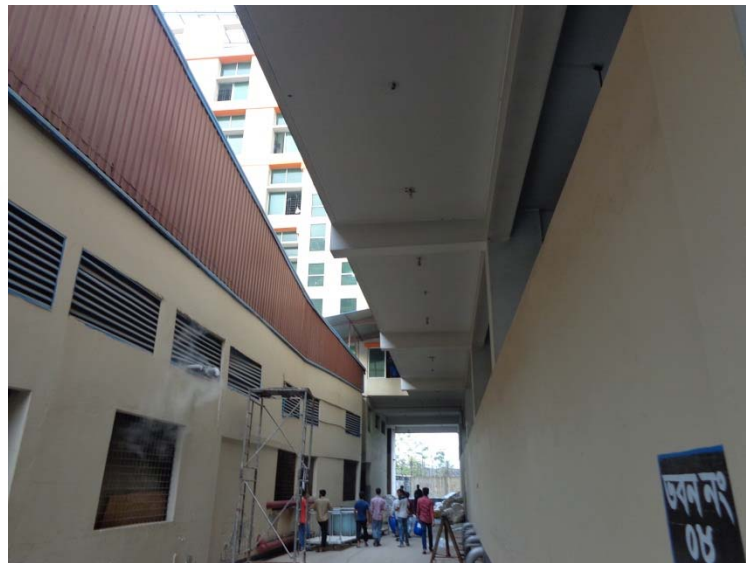
## Overhangs

# **Storage located on slab overhangs of Buildings 8 & 11**

Remove all storage from the overhangs to ensure the longevity of the building.

- Storage should be removed from overhangs.
- Produce and actively manage a loading plan.

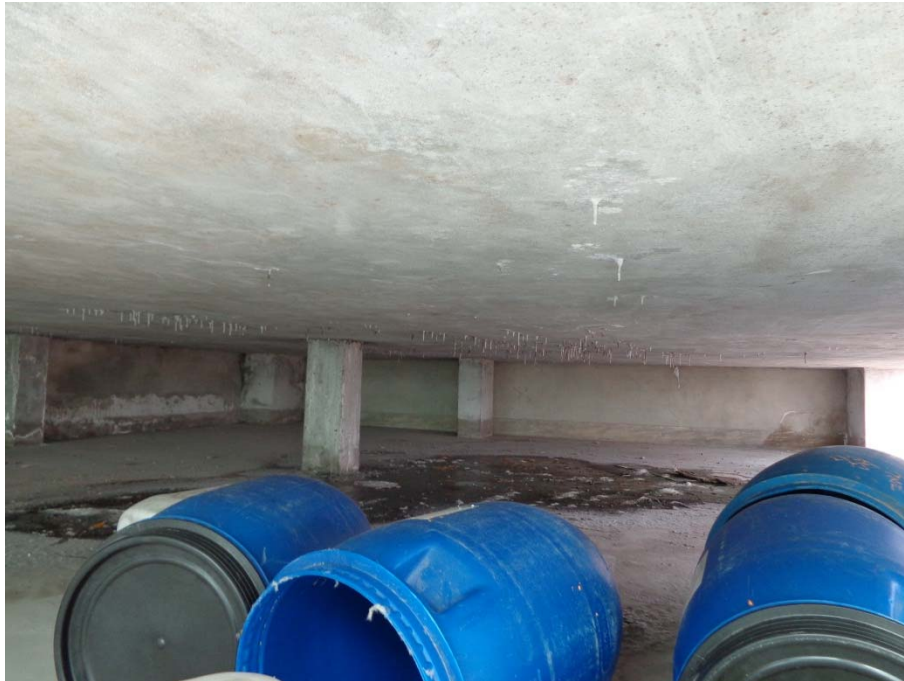
**Water damage**

**R.C Fire water tank on Building 8 is leaking  
on the slab**

The R.C fire water tank on the roof is leaking. Damage should be repaired and water proofing membrane added.

- Waterproof the tank to stop the leak.
- Repair any damage done to the tank and slab.
- Waterproof the slab under the tank to prevent further damage.

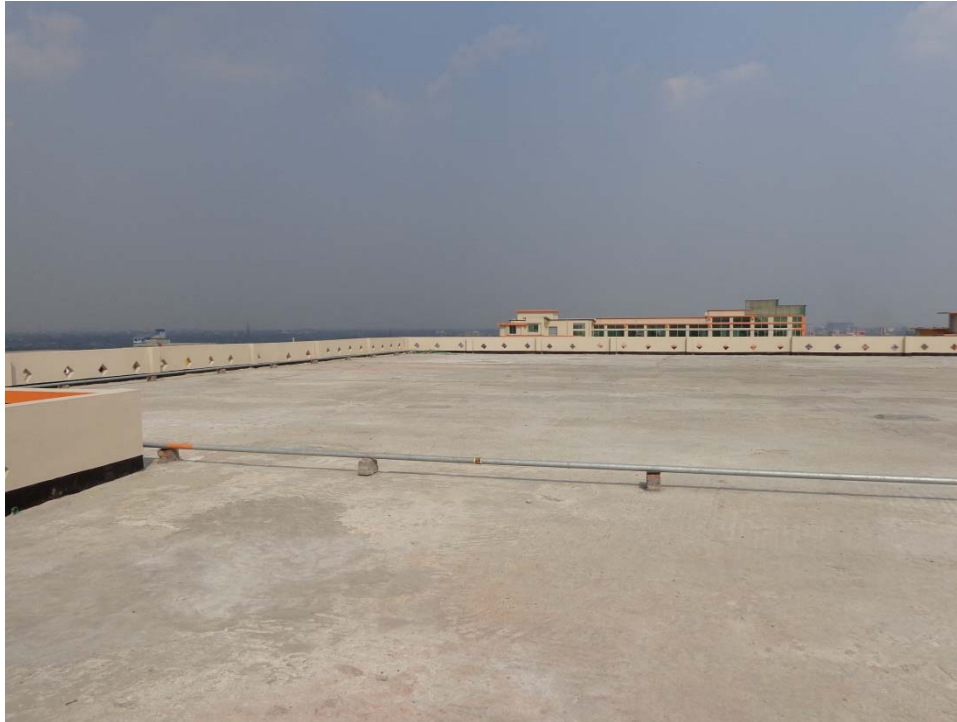
**Roof appears not to have any waterproofing  
system applied**

No waterproofing membrane was visible on the roof of the building. This means that any cracks in the surface finishes on the roof will allow water to seep into the concrete slab beneath the finishes, and cause long-term soaking of the slab.

**Roof Floor does not appear to have any waterproof membrane to protect lower floor from water damage**

- Consider applying a new waterproofing membrane.
