# **INITIAL FIRE SAFETY INSPECTION REPORT**

## **SAIHAM KNIT COMPOSITE LTD. (Extension Area)**

**Factory ID: 24022**

**Date: 25 February and 02 June 2021**

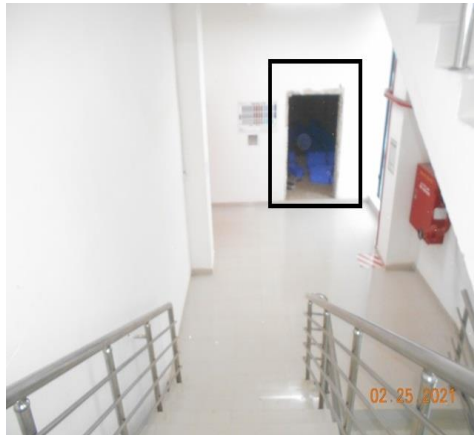
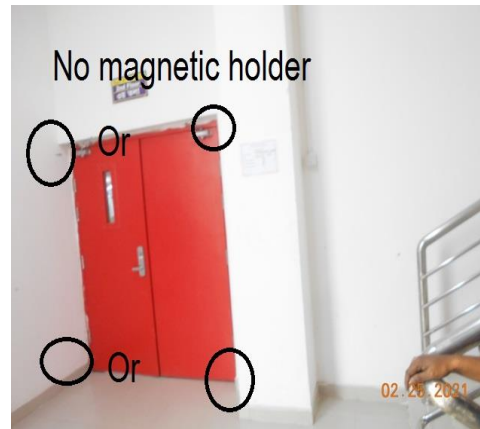
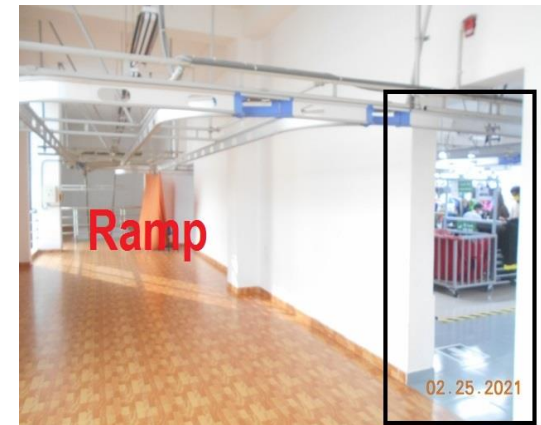
| SI No. | Category | Findings | Required Action | Remediation Time Frame |
|---|---|---|---|---|
| F-1 | Fire-Rated Construction | The exit stairs are separated from work areas & other spaces on each floor by fire rated construction and fire door except ramp, one opening at stair-4,non rated glass from machine room to stair-5 on ground floor ( building-1). Also magnetic door holders were missed installed door ( building-1,3 & 4) | <p>Stair shall be enclosed with a minimum 2-hr fire-rated construction. Seal all unprotected openings and provide minimum 1.5 -hr. fire rated doors to separate the exit stairs from work areas and other building spaces on all floor levels. Ensure that the fire doors are self-closing, positive latching and that they are provided with fire exit (panic) hardware where serving production floors.</p> <p>If fire doors are required to be held open for functional reasons, provide automatic-closing devices tied to the fire alarm system.</p> | Within 3 months |

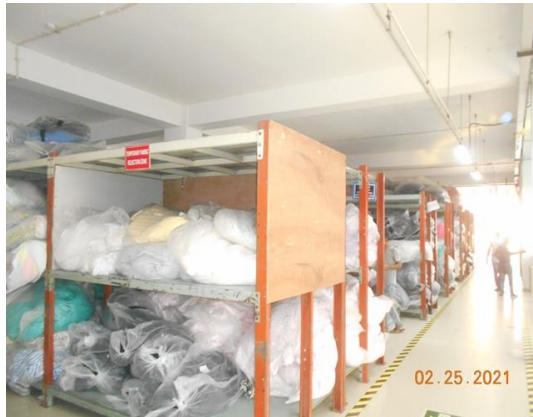
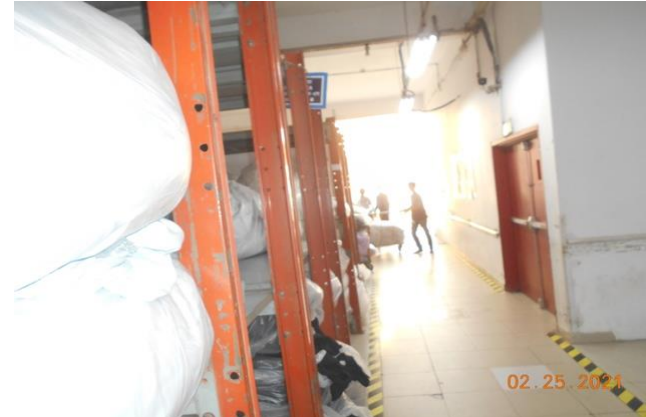
| F-2 | Fire Rated Construction | <p>Room used for combustible storage are not separated by fire rated construction.</p> <p><b>Location:</b> Fabric storage on ground floor of the South side ( building-1)</p> | <p>Provide dedicated storage rooms separated by minimum 1-hr fire-rated construction. Where separate storage rooms are not feasible, provide defined storage areas and limit the storage arrangement as follows: - Maximum height of 2.4m and maximum area of 23 m<sup>2</sup> - If sprinkler protected: maximum height of 3.66m and maximum area of 93 m<sup>2</sup> Separate areas of unenclosed combustible storage by a minimum clear distance of 3m.</p> | Within 3 months |

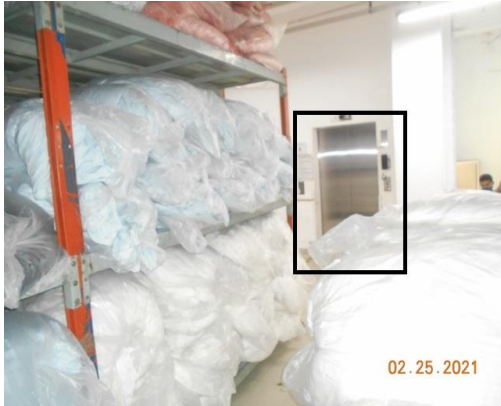
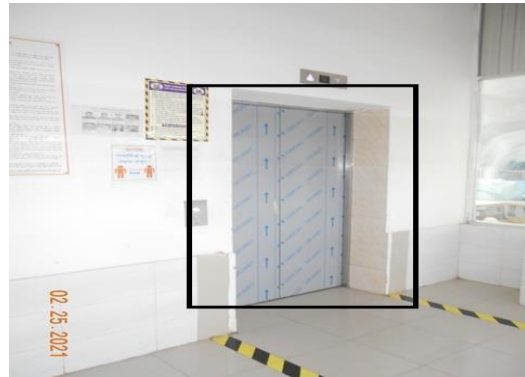
| F-3 | Fire Rated Construction | <p>Elevator is discharge inside the each production floor.</p> <p><b>Location:</b> South side of the building-1.</p> | <p>Provide a minimum 2-hr fire rated elevator shaft to separate it from each floor. Seal and/or protect all openings to maintain fire separations</p> | Within 3 months |

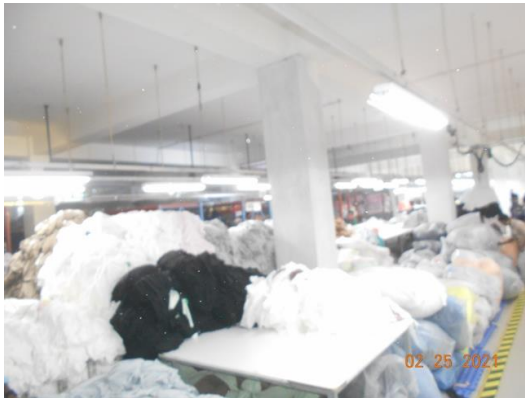
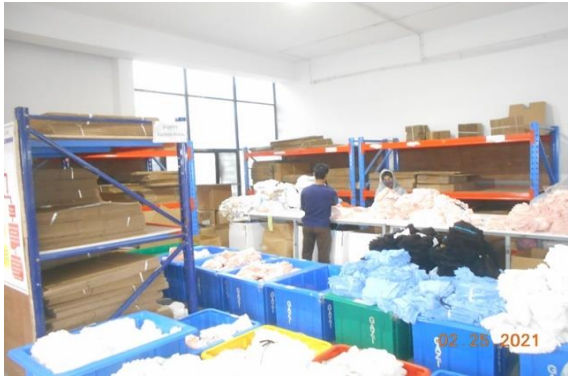
| F-4 | Fire-Rated Construction | <p>Areas used (<b>in-process storage</b>) for combustible materials are open to the surrounding occupancy.</p> <p><b>Location:</b> Ground and 1st floor of building-1 and B-4.</p> | <p>Provide defined storage areas and limit the storage arrangement as follows:-</p> <ol style="list-style-type: none"> <li>1. General Condition: Maximum height of 2.4m and maximum area of 23m<sup>2</sup>. Separate areas of unenclosed combustible storage by a minimum clear distance of 3m.</li> <li>2. If sprinkler protected: maximum height of 3.66m and maximum area of 93m<sup>2</sup>. Separate areas of unenclosed combustible storage by a minimum clear distance of 3m.<br/>or</li> <li>3. Enclose the storage area from the surrounding occupancy with a minimum 1 fire rated hour construction.</li> </ol> | Within 3 months |

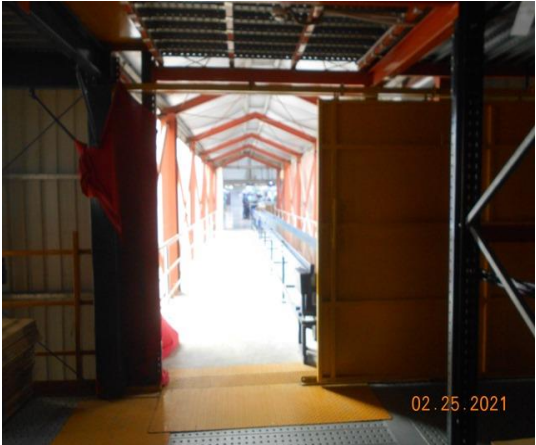
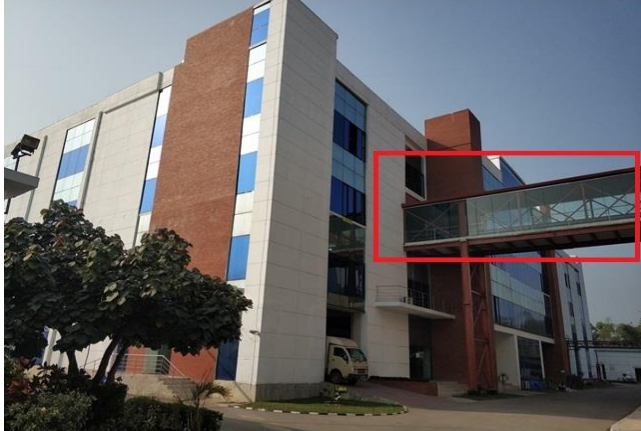
| F-5 | Fire-Rated Construction | Connecting bridge between Building -1(Special) and Building -12(SSL central warehouse) were observed without proper fire separation. | Provide minimum 1.5-hr fire rated doors and seal all unprotected openings to separate the buildings from work areas and other building spaces on all floor levels. Ensure that the fire doors are self-closing and positive latching and that they are provided with fire exit (panic) hardware where serving production floors. If fire doors are required to be held open for functional reasons, provide automatic-closing devices tied to the fire alarm system. | Within 3 months |

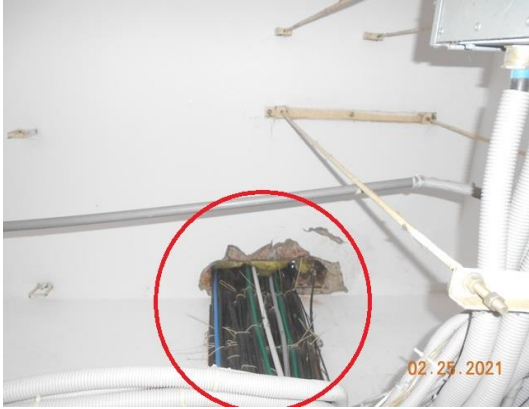
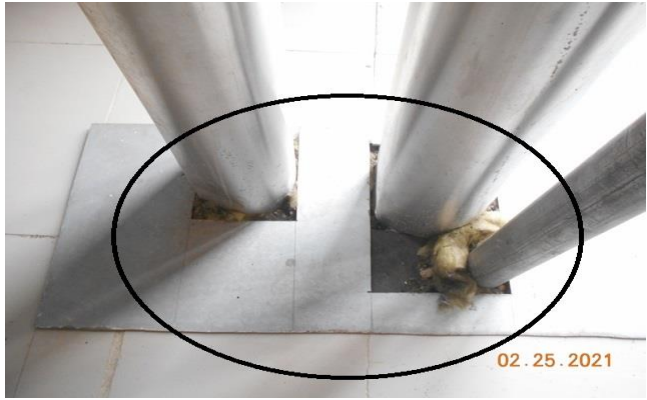
| F-6 | Fire Rated Construction | Unsealed penetrations and openings are located in the fire rated floor/ceiling assemblies.<br>Location: Boiler pipe & electrical riser in the East & North side and Opening on South side from 2nd to 1st floor ( building-1). | Provide a minimum 2-hr fire rated shaft to separate the utility risers from each floor level.<br>Seal all penetrations and openings in floors/ceiling assemblies to maintain the fire separation. | Within 3 months |

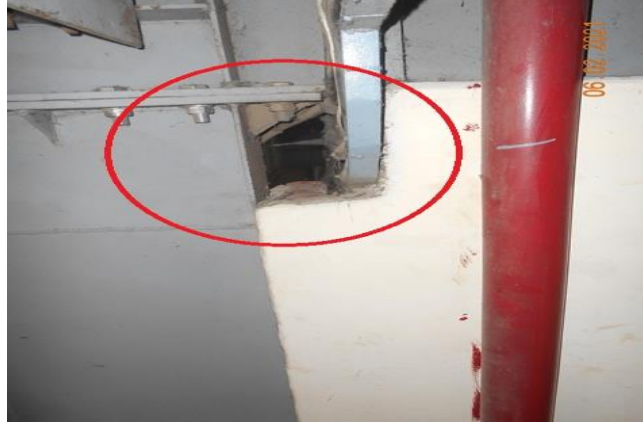
| F-7 | Fire Rated Construction | Unsealed penetrations and openings are located in the exit stair enclosures. Location: stair-4 of building-4. | Seal all penetrations and openings in exit stair enclosure walls to maintain the fire separations. | Within 3 months |

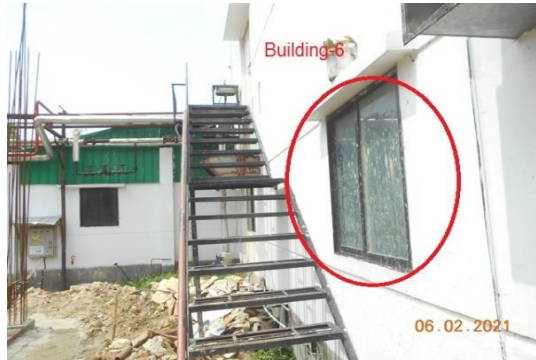
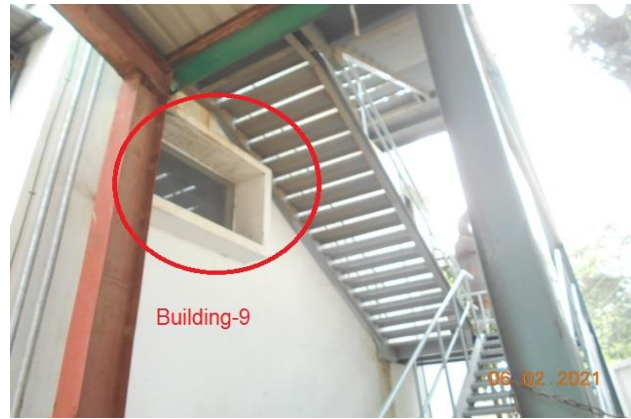
| F-8 | Fire Rated Construction | Exterior exit stairs are not properly separated from the building and stair exit discharge.<br>Location: Stair-1 of building-6 and building-9. | Exterior exit stairs shall be separated from the building with a rating requirement of 2 hr. fire rating for 4 or more stories. The rating of the exterior wall shall extend 3.05 m (10 ft) beyond the ends of the stair structure. | Within 3 months |

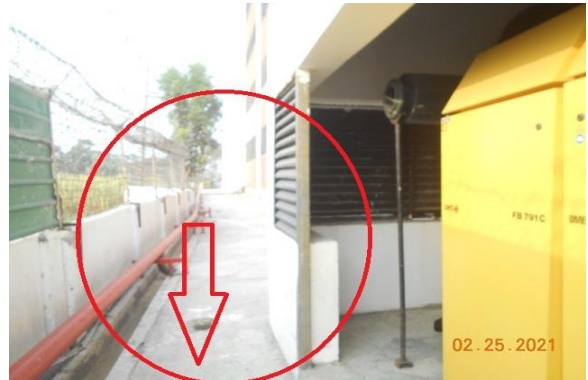
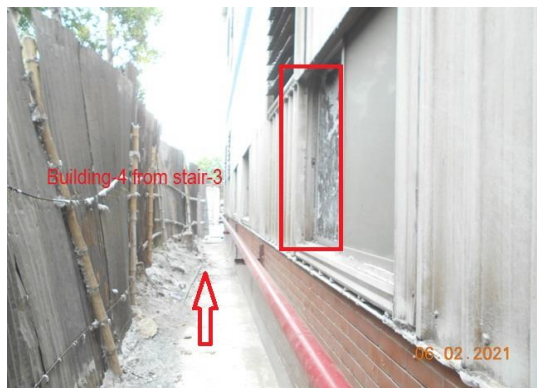
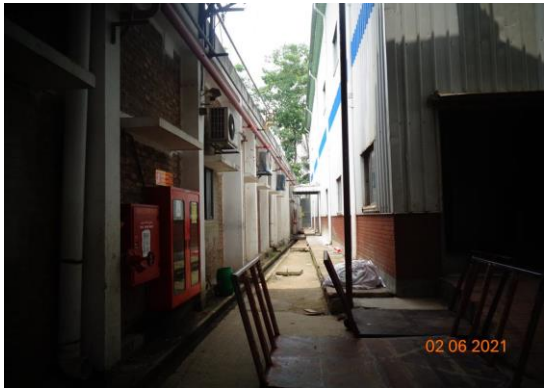
| F-9 | Fire-Rated Construction | <p>The exit discharge path is less than 10ft. wide and is not separated from the suction machine room ( the West exit on building-1) and building interior glass window (the East exit of the building-4 at stair-3) and south side of building 5(printing)</p> | <p>Seal all penetrations and openings to the interior of the building along the discharge path, up to a height of 10 ft, to provide a minimum 1-hr fire separation. Alternatively, provide a second remote discharge path to the public way (only include this if feasible).</p> | Within 6 months |

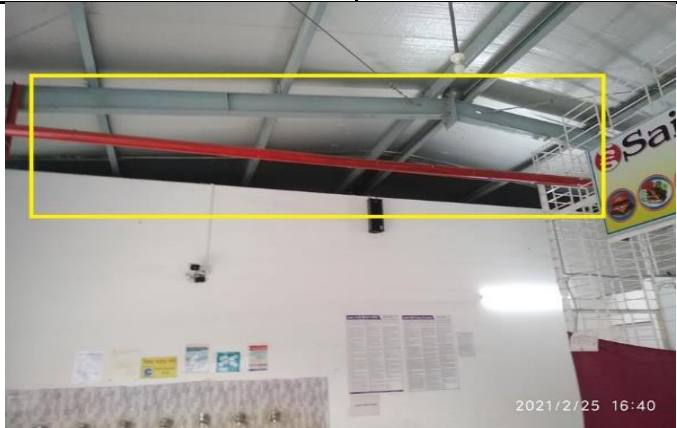
| F-10 | Fire Rated Construction | <p>SSL canteen/Dining room are not proper fire separated from wastage storage by fire rated construction due to unprotected opening &amp; penetration.</p> <p><b>Location:</b> Building-13(SSL canteen/Dining and wastage room)</p> | <p>Seal all penetrations and openings in floor/ceiling (full thickness of the floor/ceiling) assemblies by fire rated materials to maintain the fire resistance rating.</p> <p>Provide a minimum 2-hr fire rated shaft to separate the utility risers from each floor if required.</p> | Within 3 months |

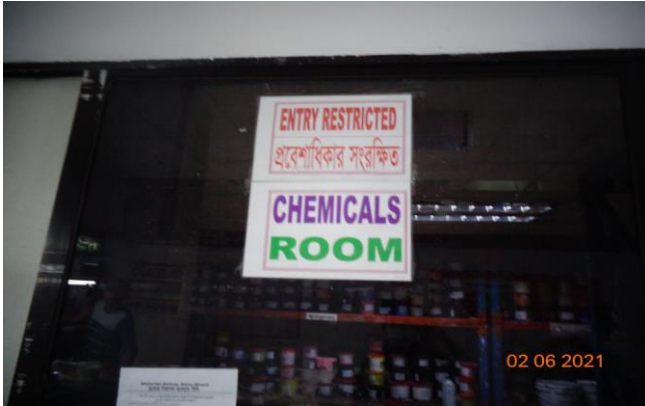
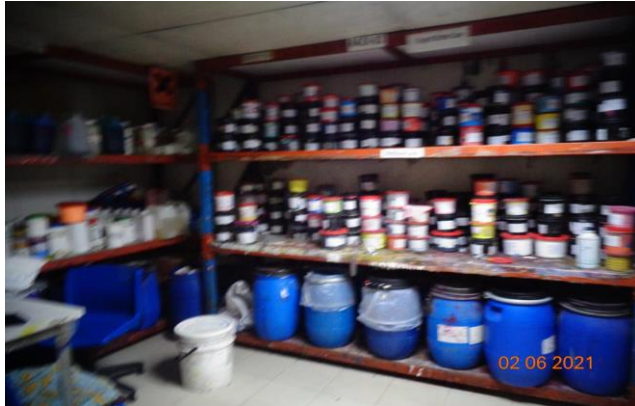
| F-11 | Fire Rated Construction | Chemical storage area is not separated by fire-rated construction having non rated door and unsealed penetrations and openings.<br>Location : Location of building 05(printing & embroidery shed) | Separate the chemical storage room by 4-hr fire rated construction. Seal all penetrations and protect the openings to maintain the required fire separations. Keep 16-points MSDS of all chemicals in the storage area.<br><br>** As per BNBC, chemical storage room will be Type-1 construction. | Within 3 months |

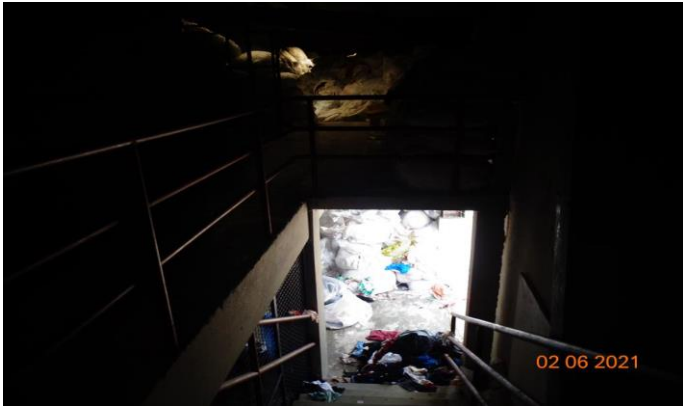
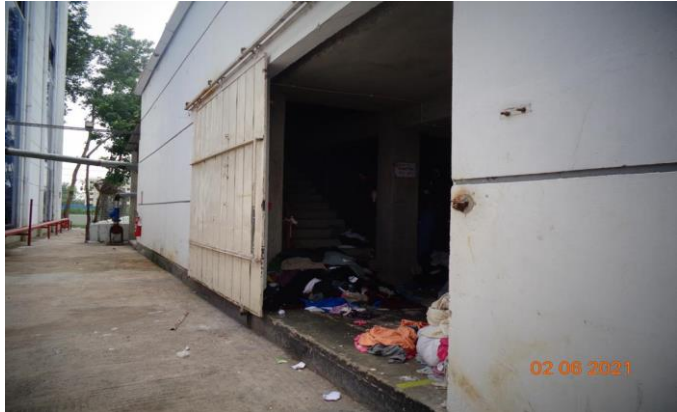
| F-12 | Fire Rated Construction | Exit stair(s) is discharge inside the ground floor storage area in the building 11.<br>Location: Building11(wastage godown) | <ol style="list-style-type: none"> <li>1. Modify stair to discharge directly outside.</li> </ol> Or <ol style="list-style-type: none"> <li>2. Provide 2-hr fire-rated exit passageway leading directly outside (vestibules to separate any storage areas).</li> </ol> Or <ol style="list-style-type: none"> <li>3. Provide sprinkler protection for discharge floor in accordance with NFPA 13.</li> </ol> | Within 3 months |

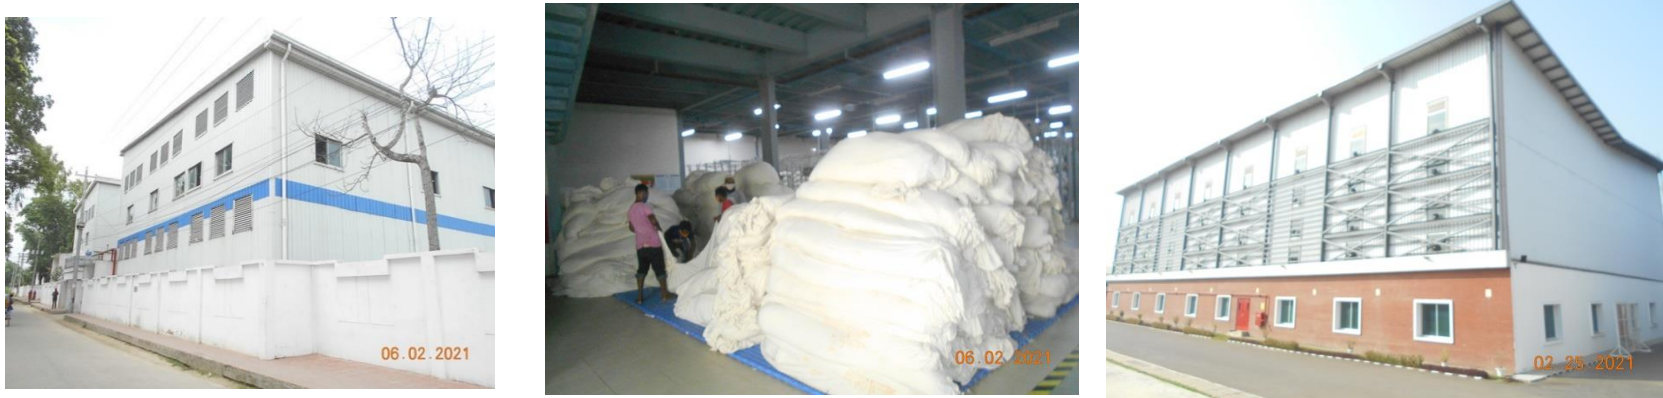
| F-13 | Fire Rated Construction | The building is classified as a new and non-rated structure where all the structure elements were exposed with any fire protection which is a violation of Accord standard 3.5. Location: Buildings 02,04,07 and 12. | Construction of new building containing G and/or H2 occupancies (factories) shall be Type 1 or Type 2 construction as required in BNBC Part 3 Table 3.2.4. Provide/ensure required fire rating on the structural elements by following Section 4.4 and Table 4.4.1 of the Accord Standard or Table 3.3.1 and Table 4.1.1 from BNBC. Consult a qualified fire protection engineer to design the rated construction barriers in between floors and in structural members. | Within 6 months |

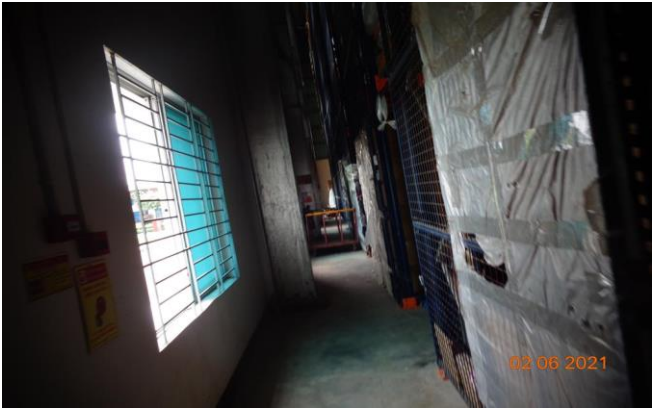
| F-14 | Means of Egress | Aisles are not provide with a minimum unobstructed clear with of 36 in. Location: Building 2 & building 12. | Aisles shall be provided with a minimum unobstructed clear- with of 0.9m (36 in). | within 1 month |

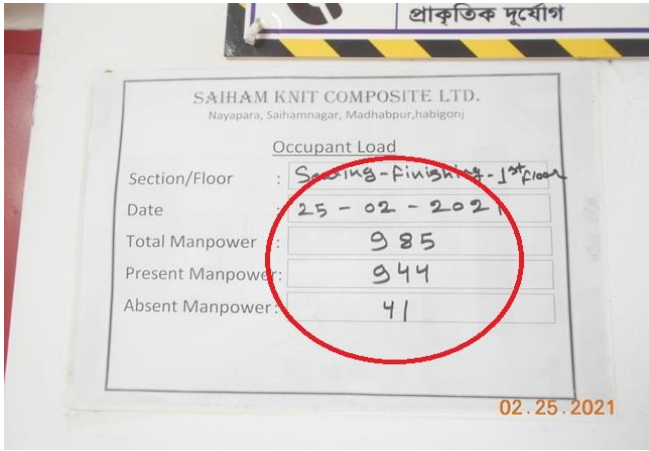
| F-15 | Mean of Egress | <p>Exit capacity is not adequate for the occupant load.</p> <p>Location: 1st floor, occupant load was 985 ( building-1).</p> | <p>Reduce occupant load to not more than available exit capacity ( 880).</p> <p>Or Provide additional exits to increase the exit capacity.</p> | Immediately |

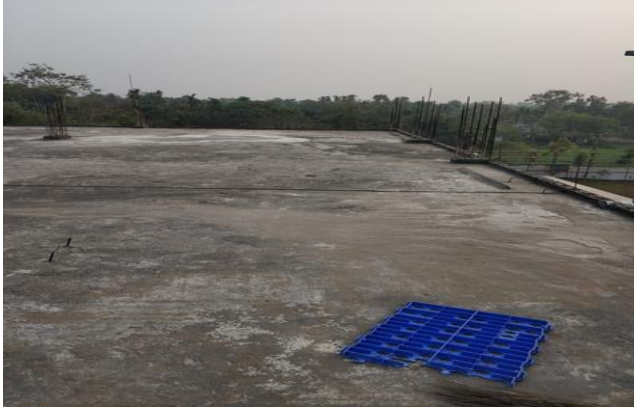
| F-16 | Mean of Egress | Parapets or guards are not provided in occupied roof.<br>OR<br>Parapets or guards are provided in occupied roof which is less than 1067mm (42 inch.). Location: Building-3 | Provide parapets or guards with a minimum height of 1067mm (42 inch.). | Within 3 months |

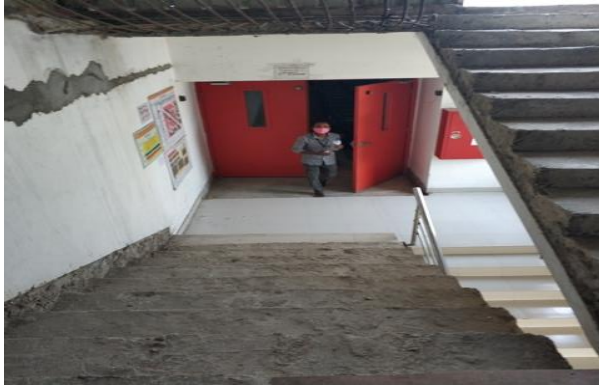
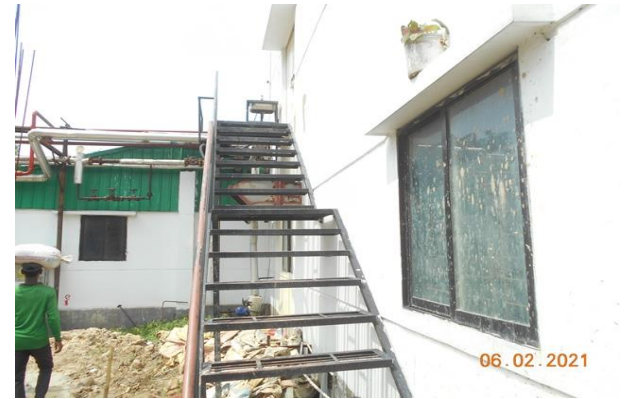
| F-17 | Mean of Egress | Handrails are not provided on both sides of each exit stairs on all floors. Having handrails on one side of said staircase, may pose as a falling hazard during evacuation. Location: Building -3 and building-6. | Provide handrails on both sides of the exit stair. New handrails shall have a minimum height of 865 mm (34 in.) and a maximum height of 965 mm (38 in.) as measured from the leading edge of the tread. Intermediate handrails shall be provided when the stair width exceeds 2.2 m (87 in.) | Within 3 months |

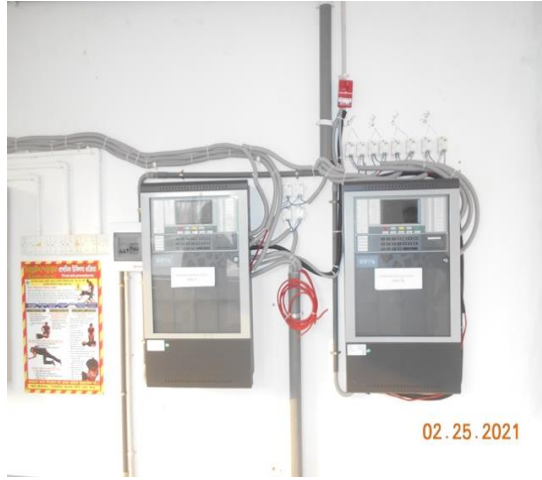
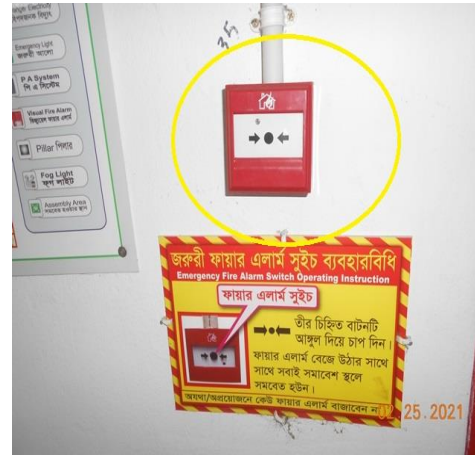
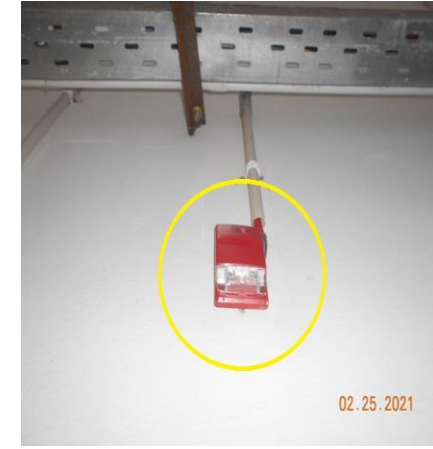
| F-18 | Fire Detection and Alarm System | <p>Automatic fire alarm &amp; detection system installation requires detailed review to confirm compliance with NFPA 72 and ACCORD standards.</p> <p><b>Location:</b> B-1,B-2,B-3,B-4,B-5,B-6,B-7,B-8,B-9,B-10,B-11,B-12 ,B-13 and B-14.</p> | <p>Submit the as-built design of fire alarm system to RSC in accordance with NFPA 72. Installation shall be as per the reviewed design with a <b>listed Addressable</b> Fire Alarm System.</p> | Within 3 months |

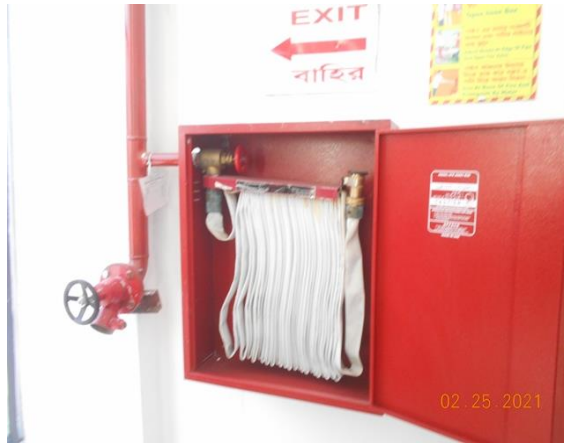
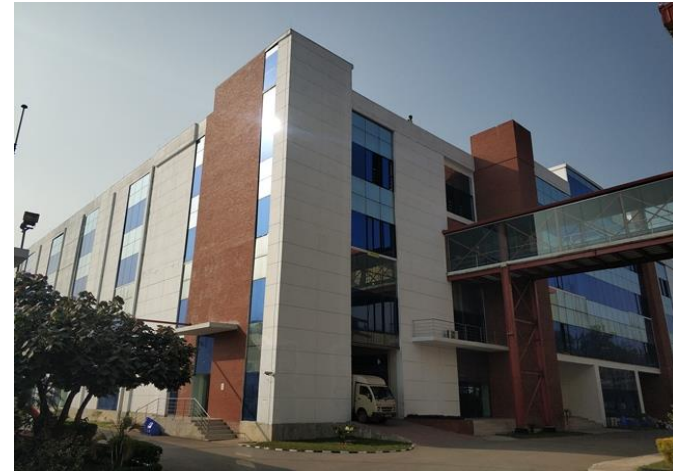
| F-20 | Fire Protection | Standpipe system installation requires detailed review to confirm compliance with NFPA 14 and ACCORD standards(Building-1). | Submit as-built drawings, testing records, equipment certification and other relevant documentation to the RSC for review and approval. | Within 3 months |

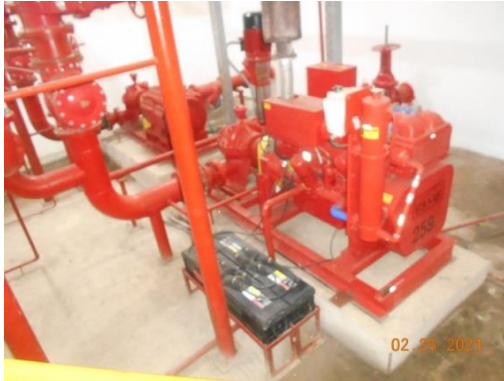
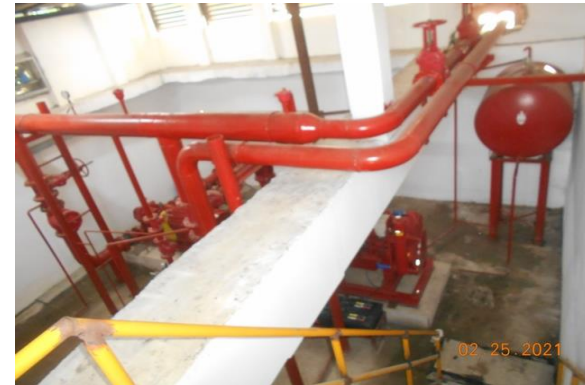
| F-22 | Fire-protection | Fire pump installation requires detailed review to confirm compliance with NFPA 20 and ACCORD standards. | Submit as-built drawings, testing records, equipment certification and other relevant documentation to the RSC for review and approval. | Within 3 months |

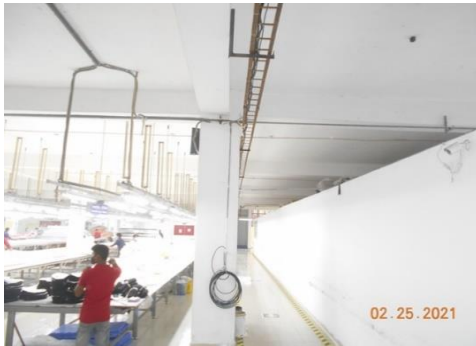
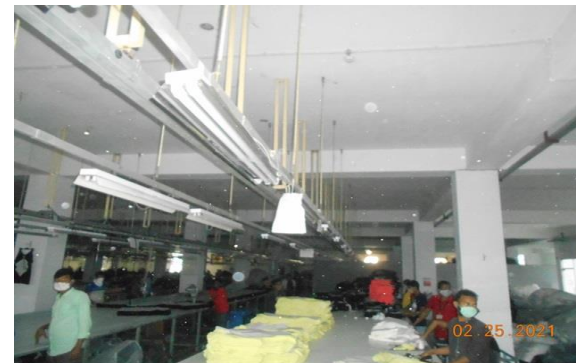
| F-25 | Egress Lighting | Based on the number and location of emergency lights observed, adequate illumination levels are not anticipated along egress routes.<br><b>Location:</b> North side on ground floor building-1, B-2, B-5 and B-12. | Test the emergency lighting system on each floor and provide additional emergency fixtures to supply adequate illumination along the means of egress. Provide a minimum illumination of 10 lux at the floor level within exit stairs and along exit discharge paths and a minimum 2.5 lux along exit access aisles. | Within 3 months |

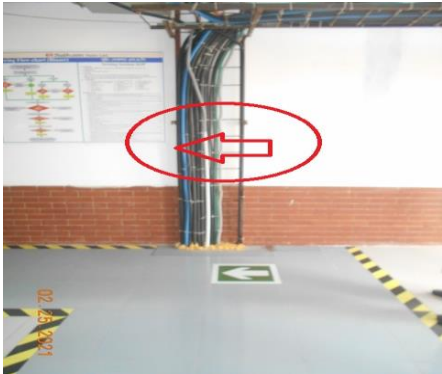
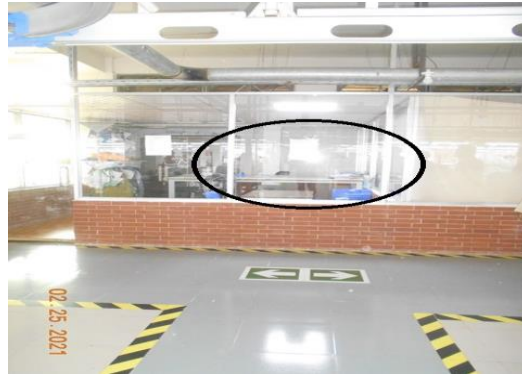
| F-26 | Egress Lighting | <p>Illuminated directional signs are not provided where direction of the path of travel to an exit has changed.</p> <p><b>Location:</b> Several location of each floor of building- 1, B-2,B- 4 ,B-5 and B-12.</p> | <p>Illuminated directional signs shall be provided where there is a change in the direction for the path of travel and the direction to an exit is not obvious.</p> | Within 1 month |
