Rahman Knit Garments Ltd.

Hariharpara, Panchabati, Fatullah, Narayanganj
(23.63014, 90.48090)

30th December 2020 & 24th January 2021.

Observations

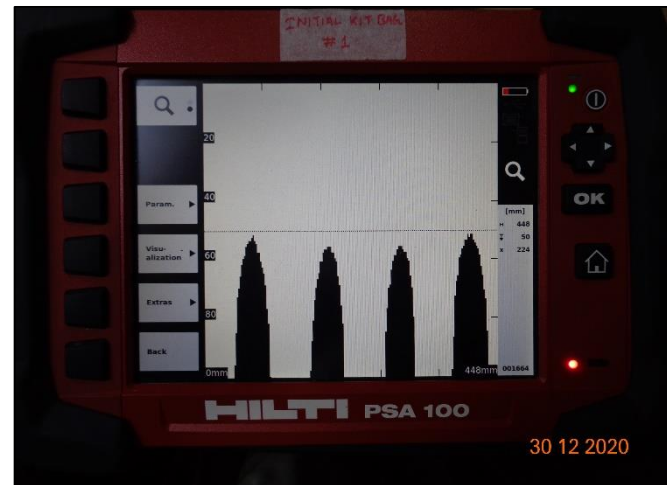
16 numbers of rebar shown in as-built column schedule for column C1.

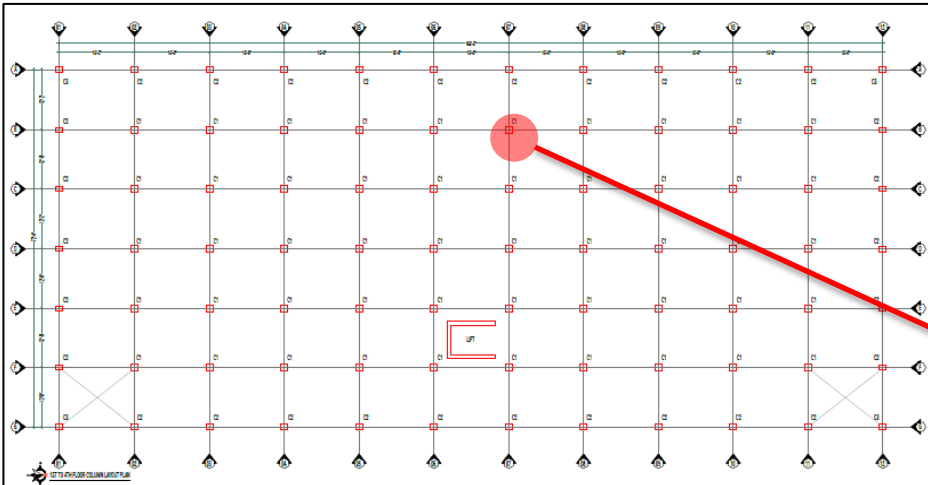
14 number of rebar was found for the column C1 instead of 16 number rebar.

Column Layout plan. Column re-bar was verified by ferro-scanning at marked location (4th floor).

Factory engineer is required to survey the whole structure and update the as-built drawing as per on-site condition. Also, review the column stress according to the floor capacity.

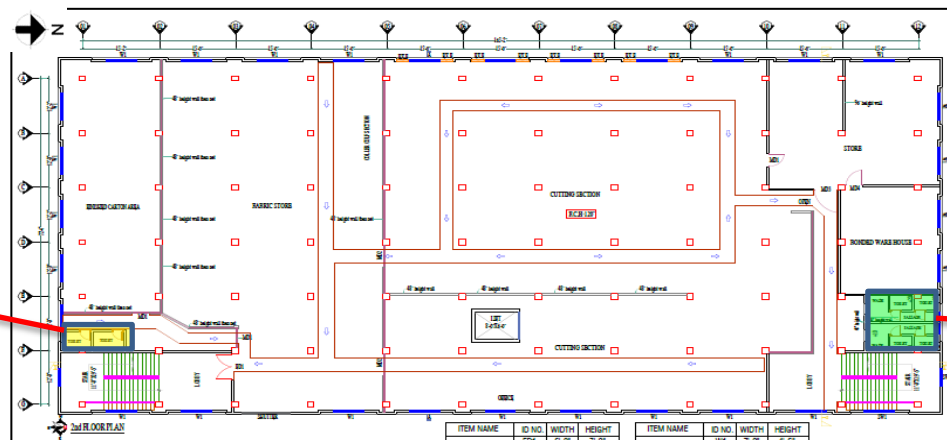
Toilet areas in different floor have built-up approx. 140 mm. This built-up areas are not shown in as-built drawing. The factory engineer is required to survey the whole structure and update the as-built drawing as per on-site condition.

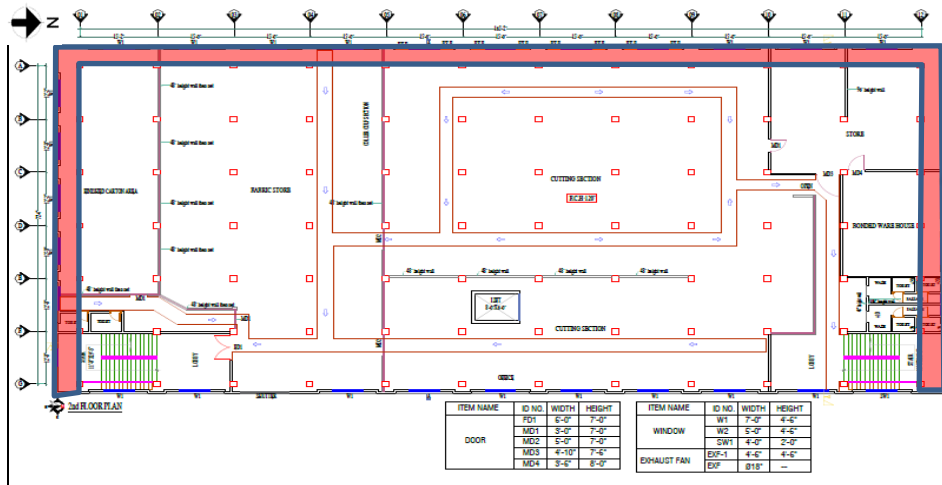
Cantilever slab was found in highlighted periphery areas measured 1.42m on site but dimension was not mentioned in as-built drawing. Factory engineer is required to survey the whole structure and update the as-built drawing as per on-site condition.

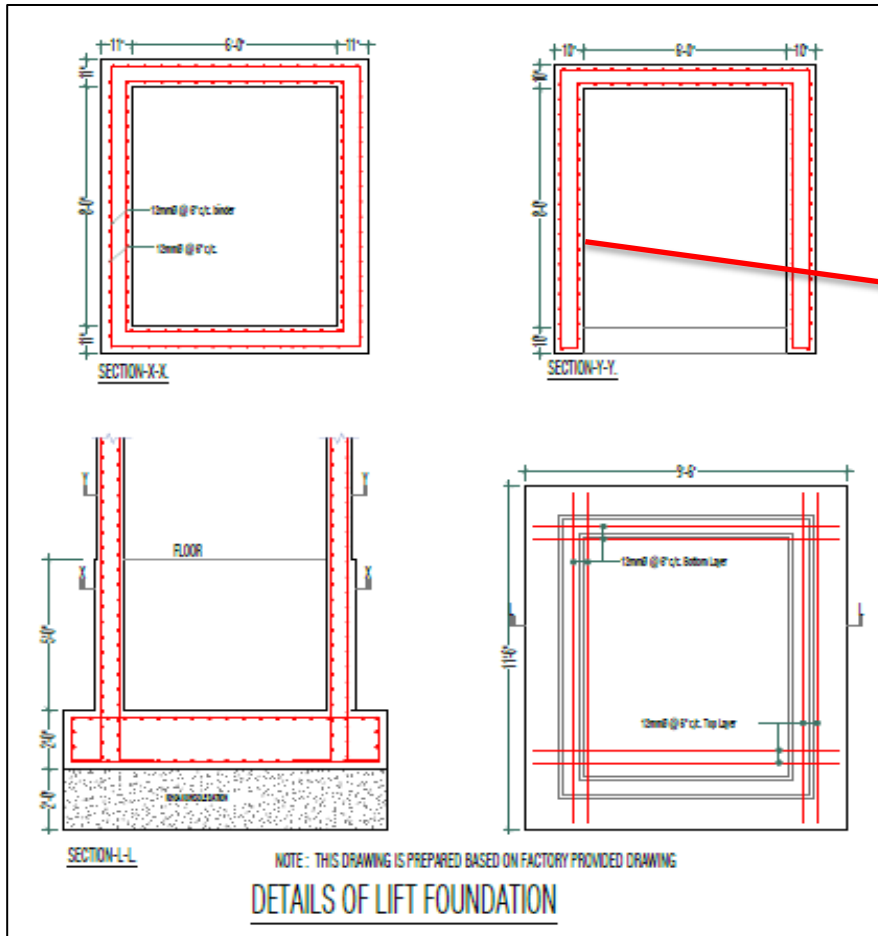
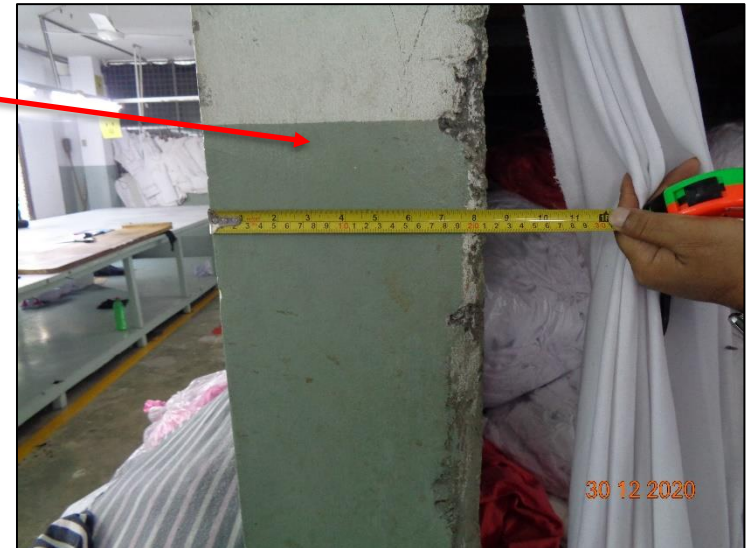
Thickness of highlighted RC shear wall at lift core found 200 mm instead of 250 mm. Factory engineer is required to survey the whole structure and update as-built drawing as per on site condition.

Thickness of shear wall at lift core was mentioned 250 mm in as-built drawing.

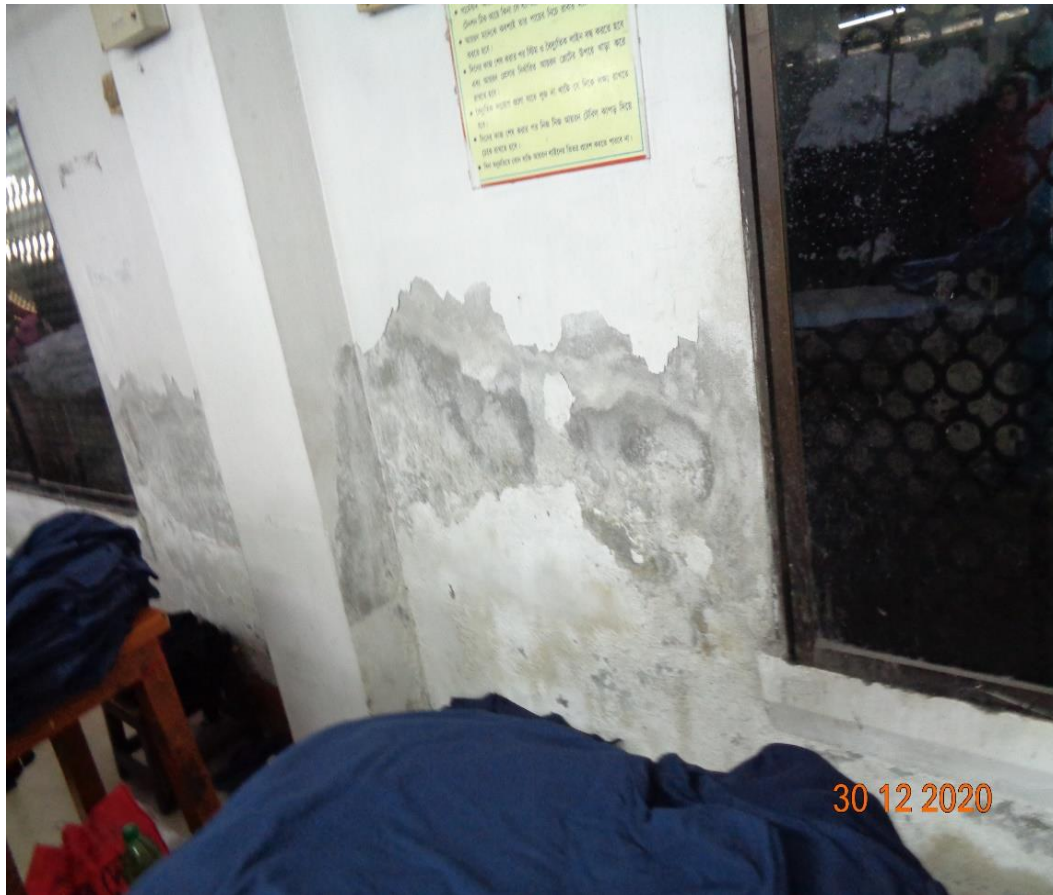
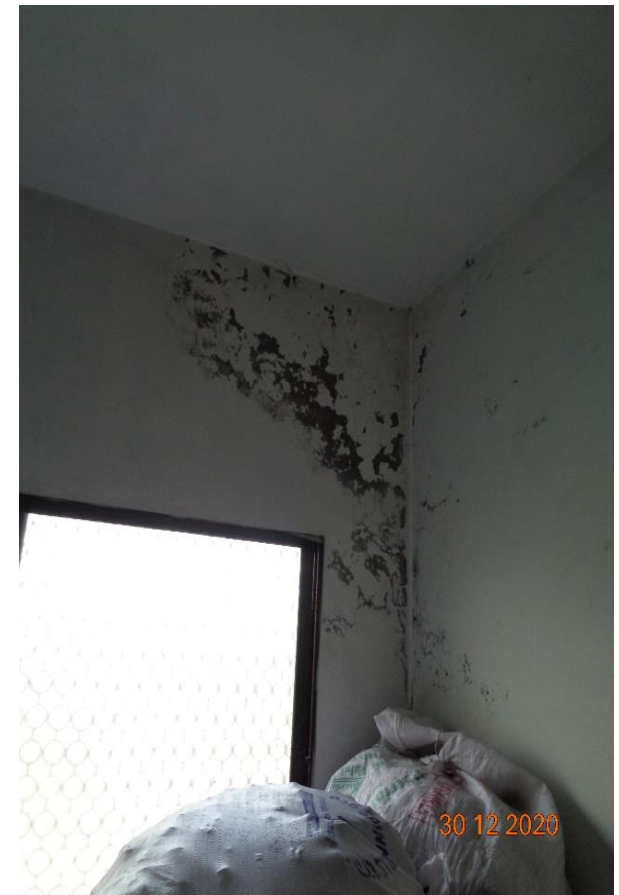
Dampness in masonry wall near washroom

Dampness was found in masonry wall near washroom at several location. Factory engineer is required to investigate the reason of dampness and apply suitable method to repair dampness.

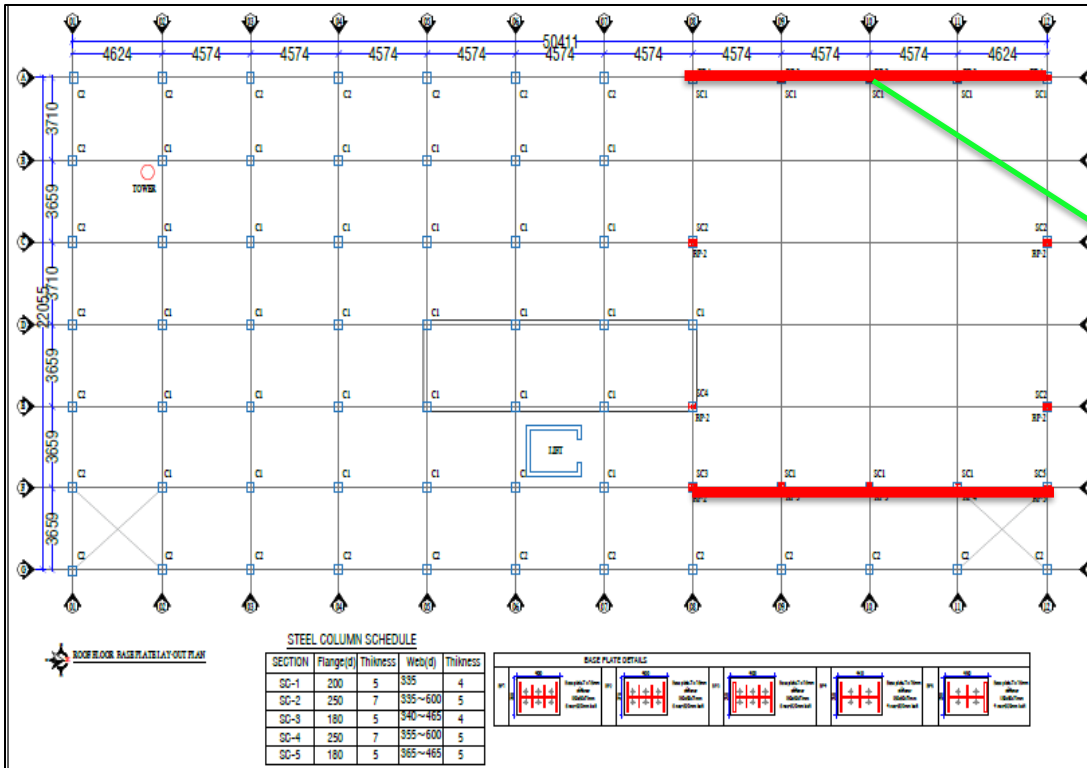
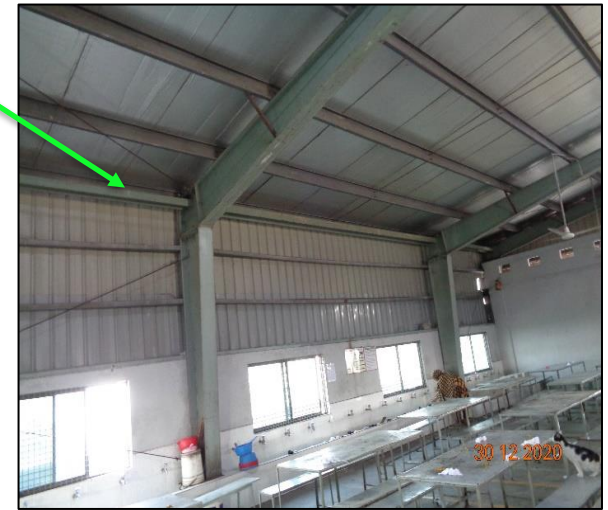
Compression strut has been found in roof shed at edge column to column. But no details has been provided in as-built drawing. Factory engineer is required to survey the whole structure and update the as-built drawing as per on-site condition.

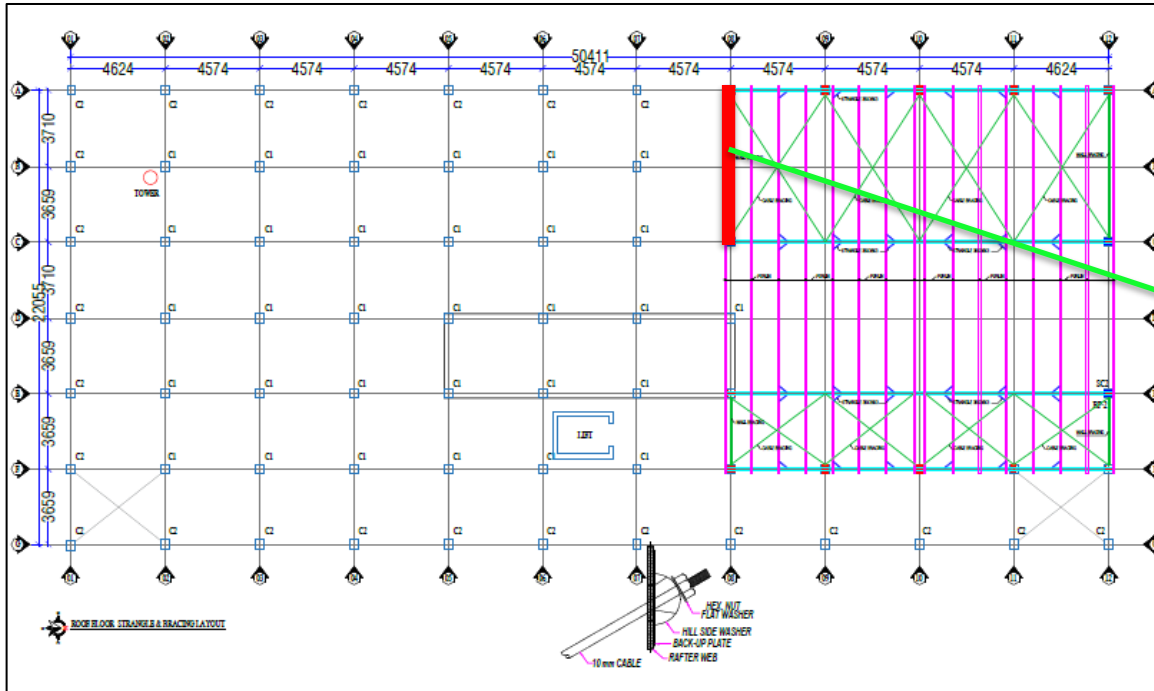
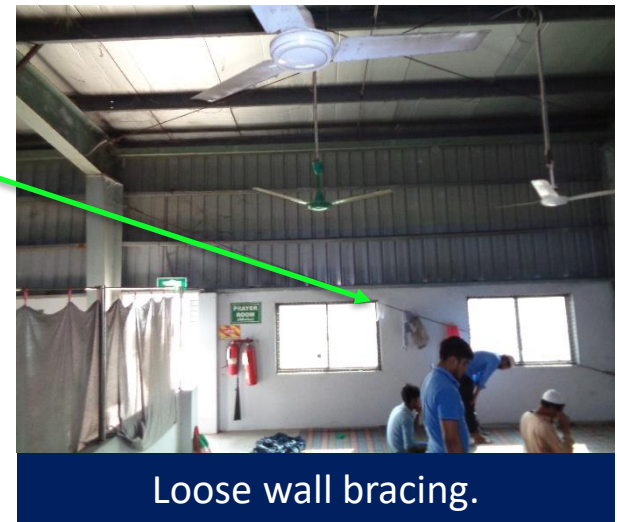
Loose bracing in roof shed.

Wall bracing was found loose at highlighted location in roof shed. Factory engineer is required to survey the whole structure and tighten all loose bracings.

06	Loose bracing in roof shed (Building 01-Garments Building)	Factory engineer is required to survey the whole structure and tighten all loose bracings.	6-weeks
07	Corrosion in steel member (Building 01-Garments Building-roof shed)	Factory engineer is required to identify the corroded locations and investigate the reason of corrosion and implement proper remedial measure accordingly.	6-weeks

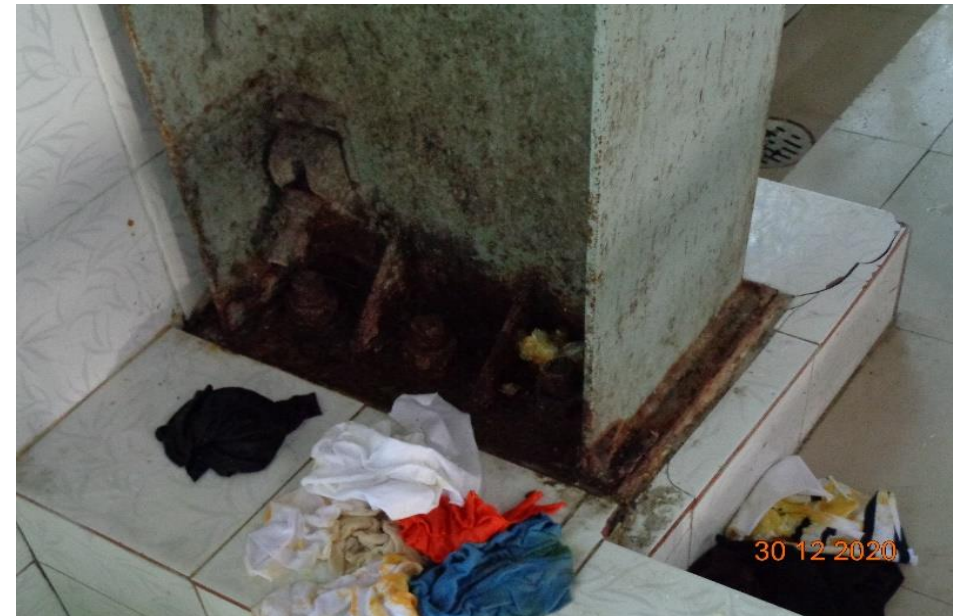
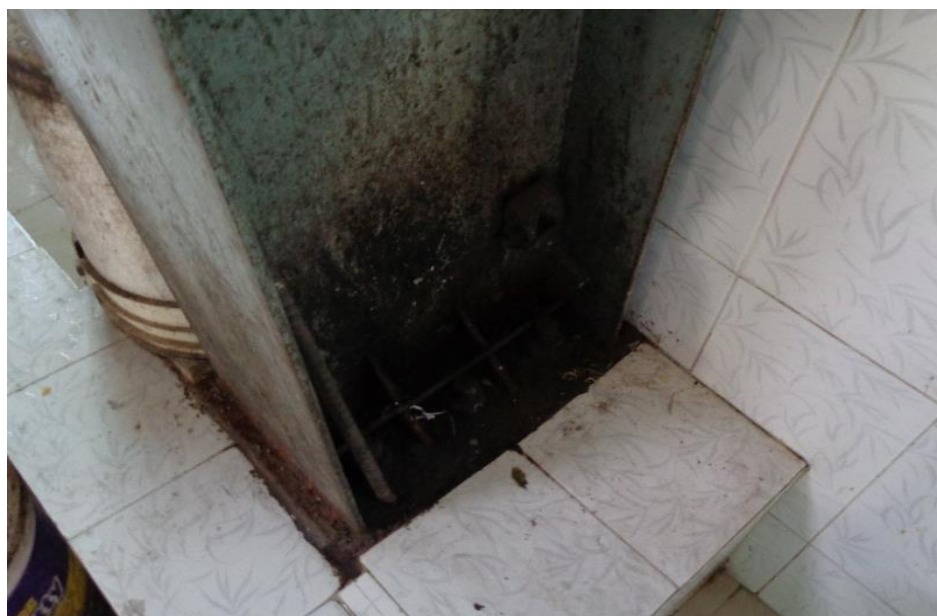
Corrosion in steel member

Corrosion was found in steel member in several locations. Factory engineer is required to identify the corroded locations and investigate the reason of corrosion and implement proper remedial measure accordingly.

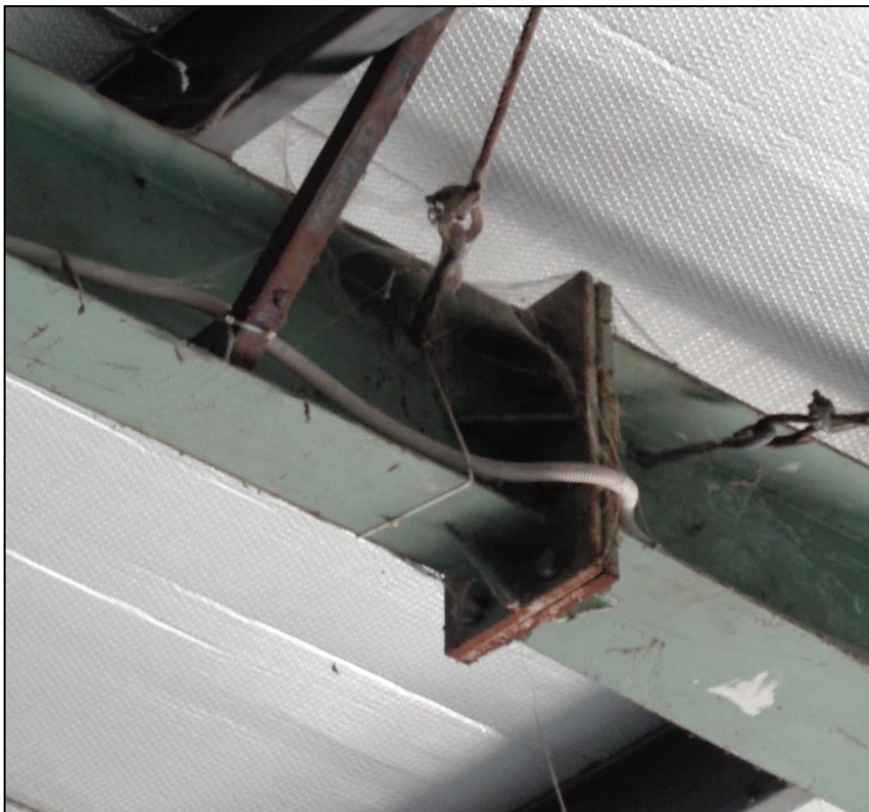
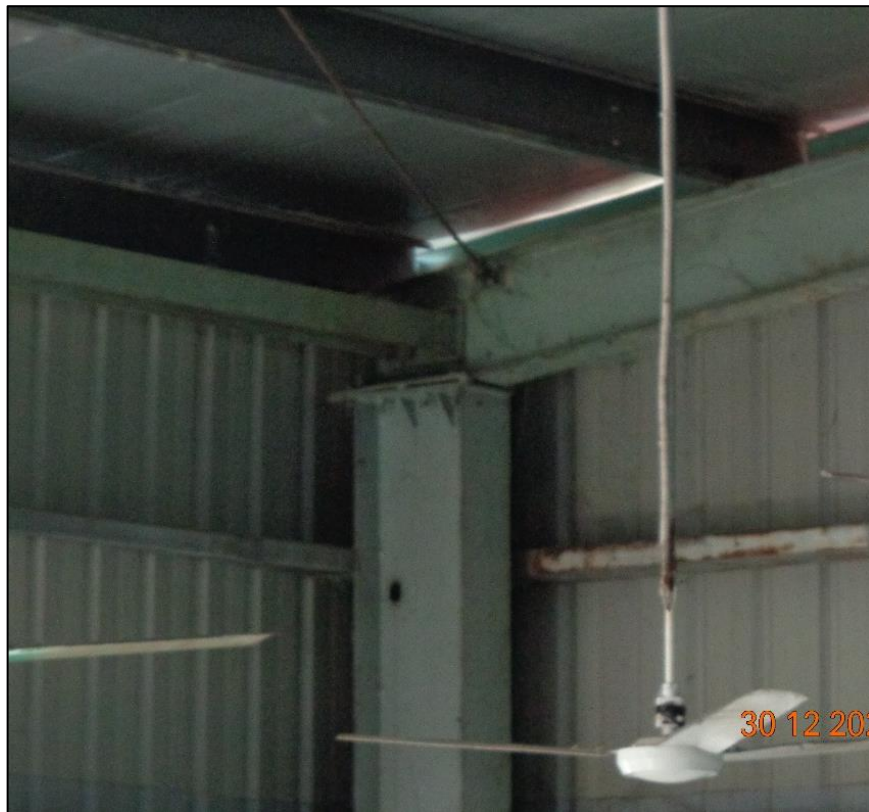
Gap in connection

Gaps were found in steel member connection at several locations. Factory is required to repair the connection gaps as per guidance by the factory engineer.

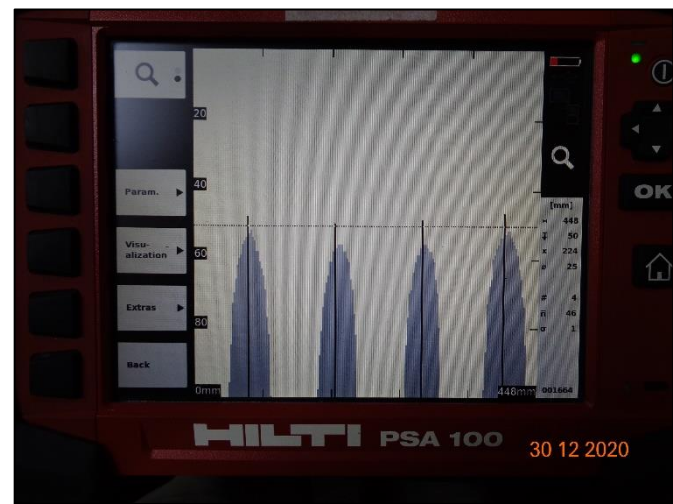
12 & 10 numbers of rebar shown in as-built column schedule for column C2 & C3, respectively.

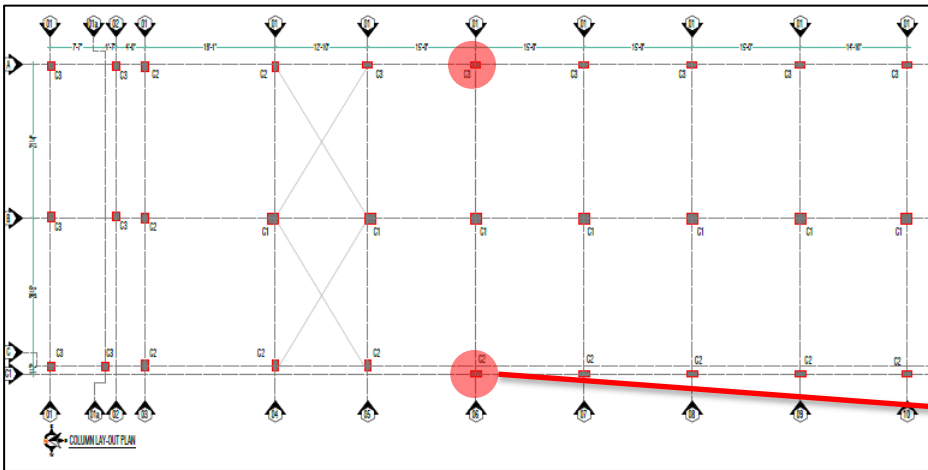
8 & 6 numbers of rebar was found for the column C2 & C3, instead of 12 & 10 number rebar, respectively.

Column Layout plan. Column re-bar was verified by ferro-scanning at marked location.

Factory engineer is required to survey the whole structure and update the as-built drawing as per on-site condition. Also, review the column stress according to the floor capacity.

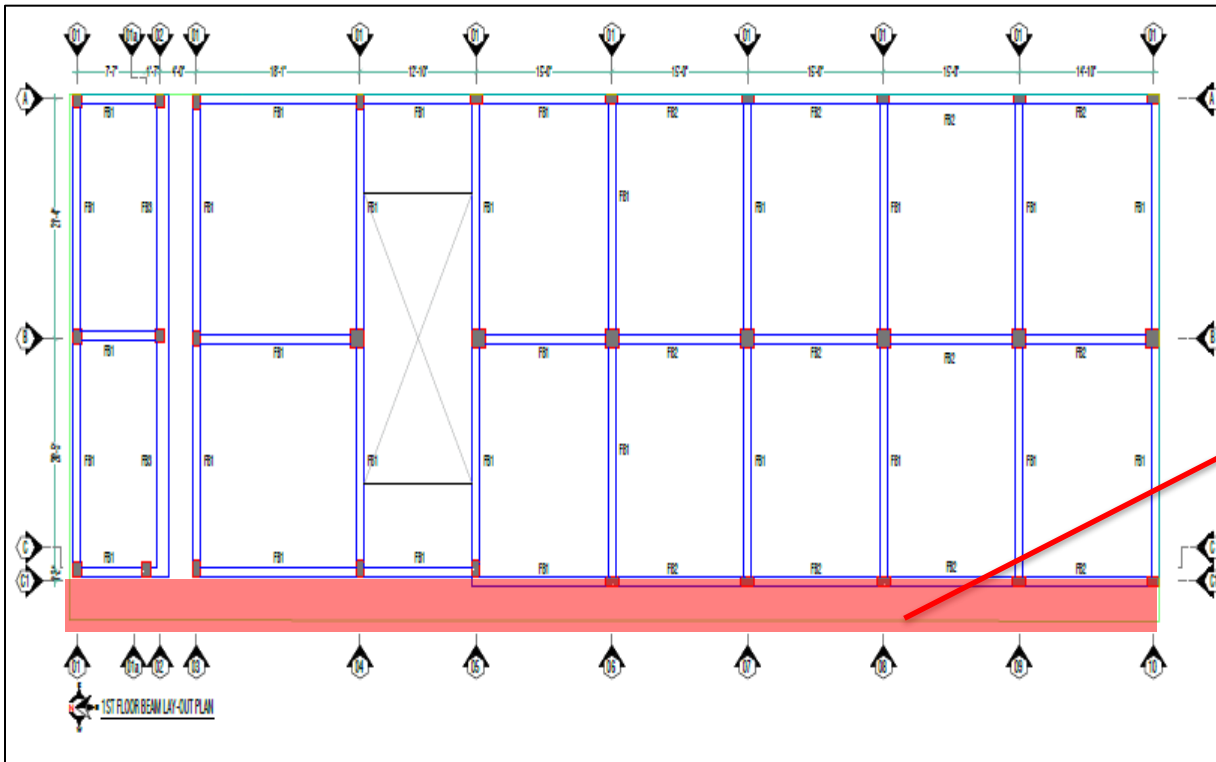
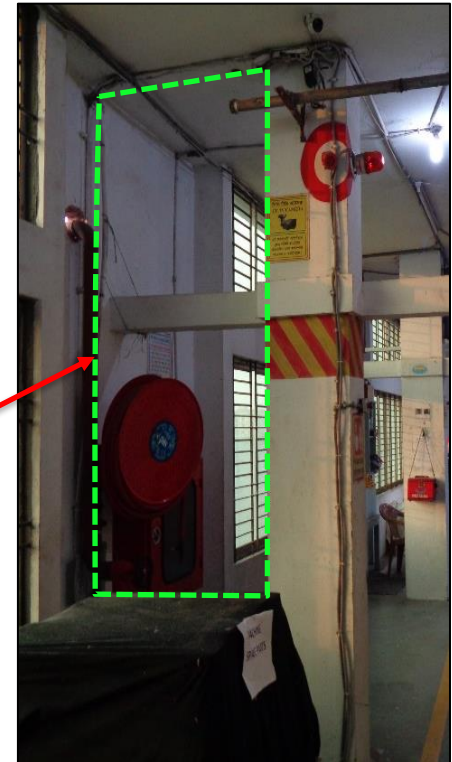
Cantilever slab was found in highlighted periphery areas measured 0.85 m on site but dimension was not mentioned in as-built drawing. Factory engineer is required to survey the whole structure and update the as-built drawing as per on-site condition.

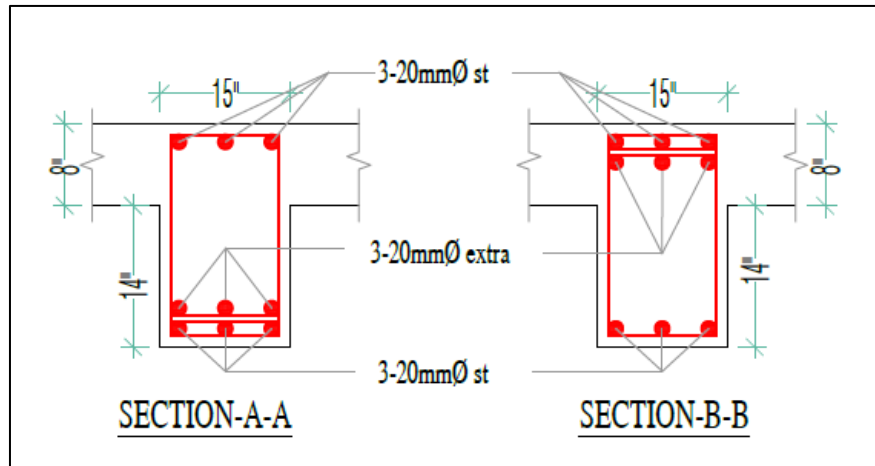
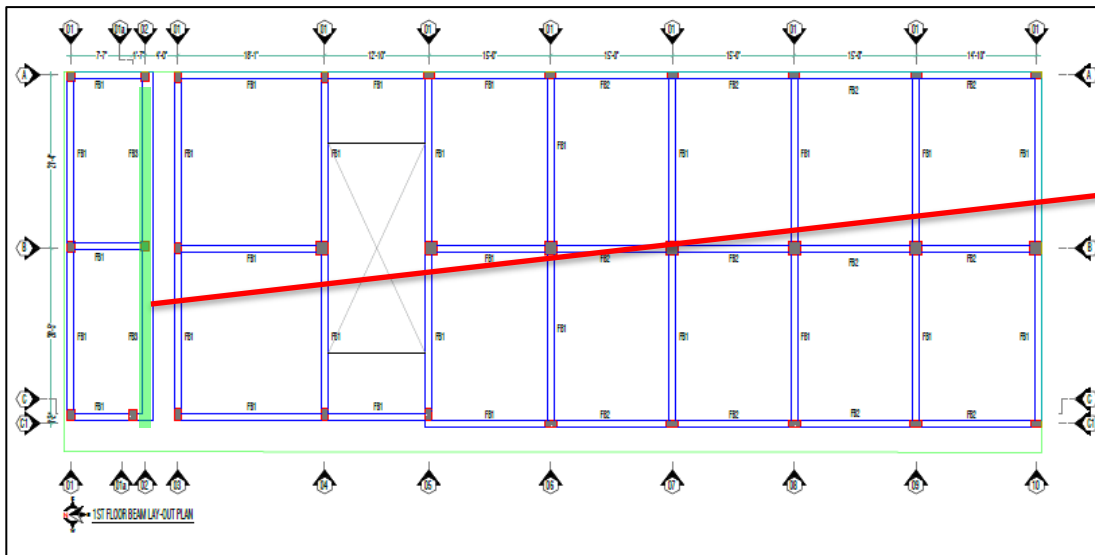
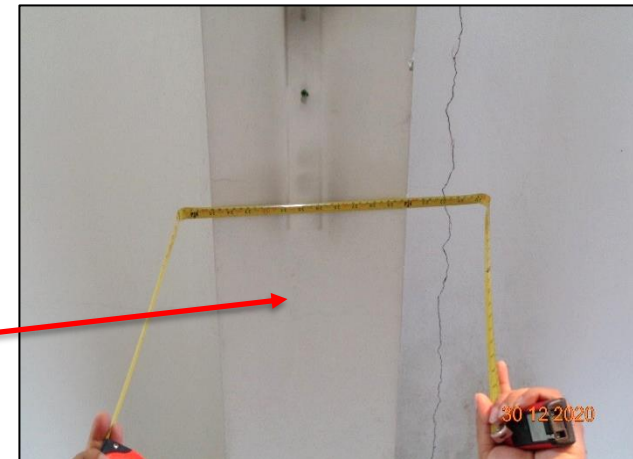
Capacity of second floor beam to be checked

Beam width measured 275 mm

Width of Floor Beam FB3 was found 275mm instead of 375mm. Factory engineer is required to check the adequacy of highlighted beam under existing loading and update the as-built drawing as per on-site condition.

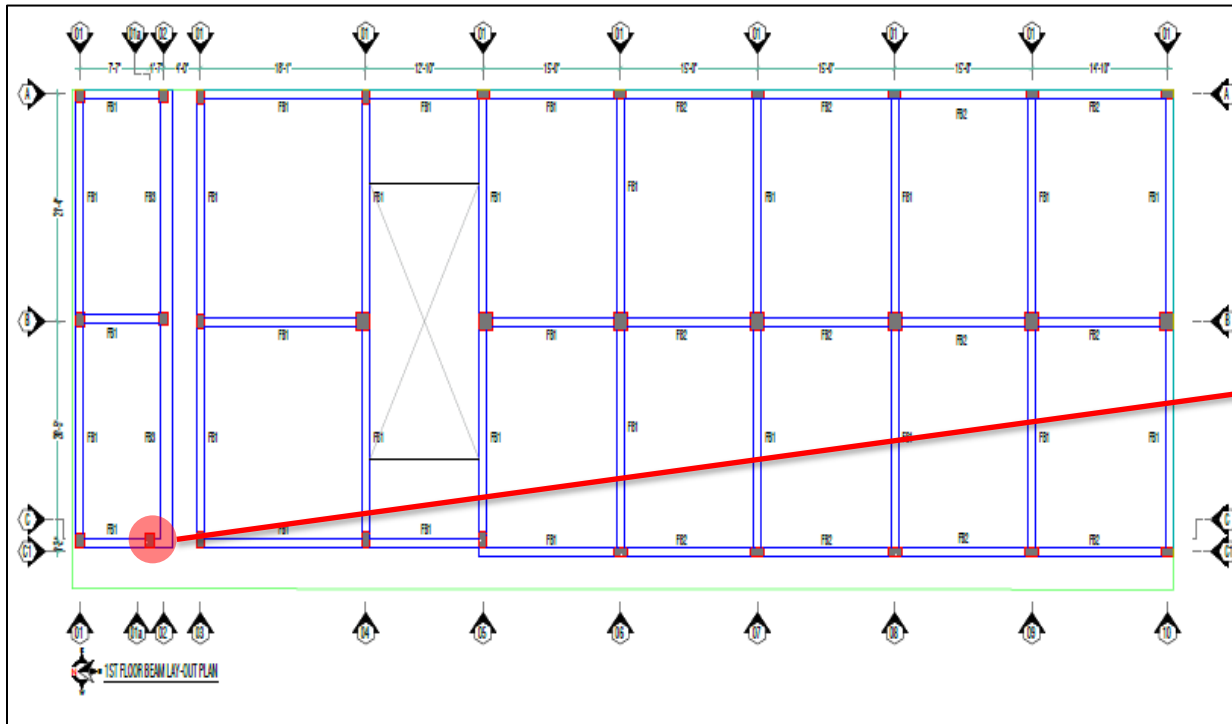
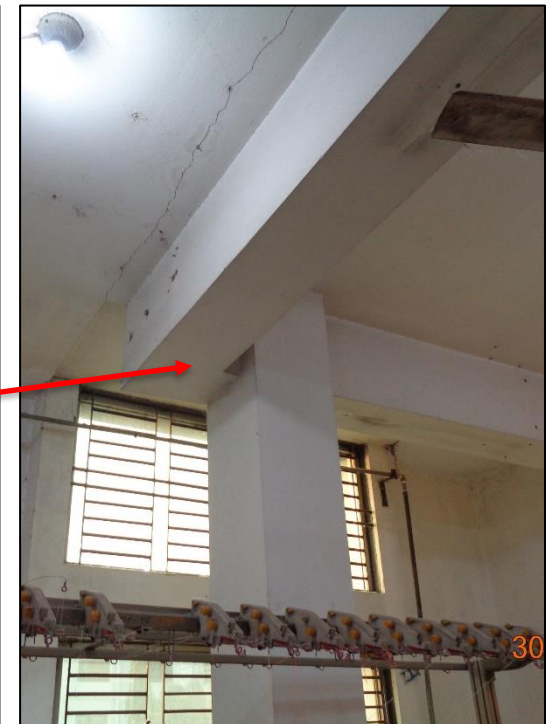
Eccentric connection was found in highlighted location of the building where beam is resting outside of column which indicates the irregularity in load transfer system. Factory engineer is required to check the adequacy of highlighted beam under existing loading and update the as-built drawing as per on-site condition.

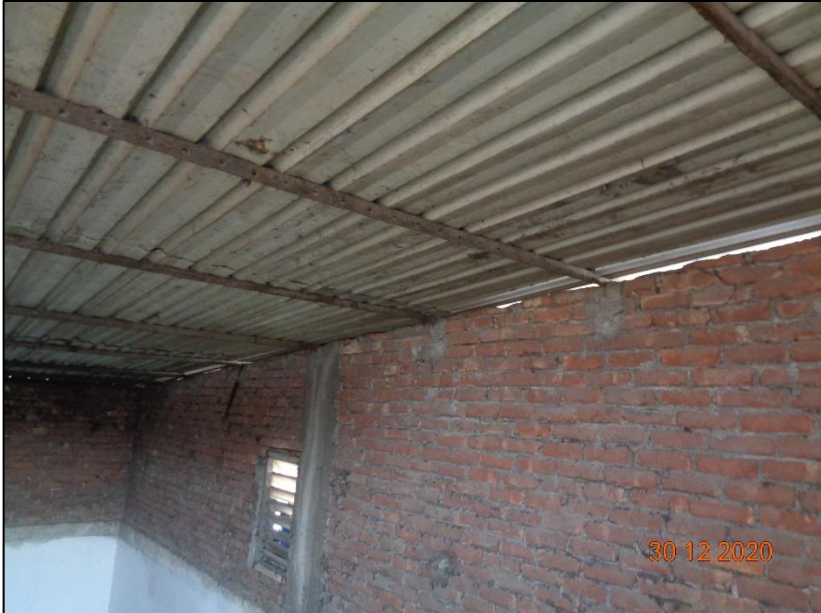
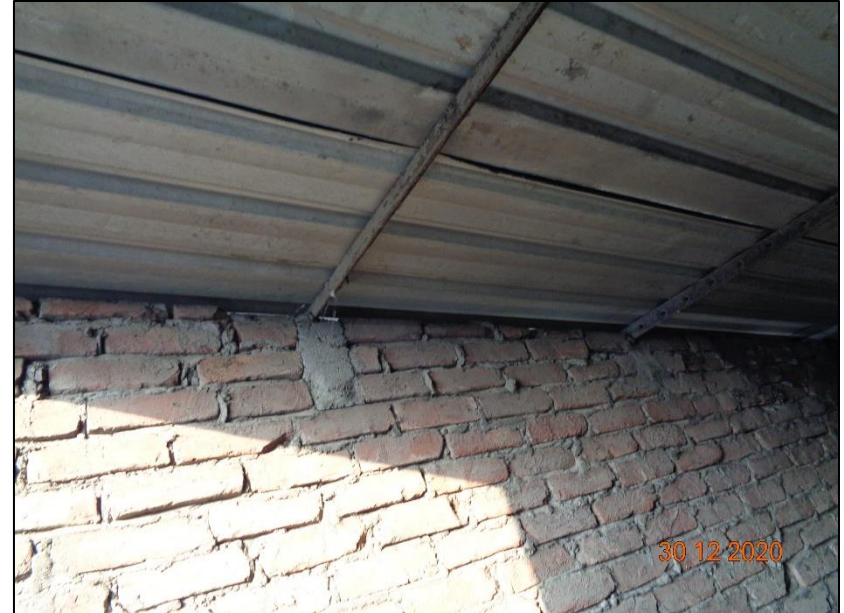
Lightweight roof shed over stair case appears to be non-engineered

Connection of steel member with brick wall

A lightweight roof shed was found over stair-case. Connection of the steel members with brick wall appears to be non-engineered and steel members appears to be undersized. Factory engineer is required to replace the shed with proper connection and adequate member size otherwise demolish the shed.

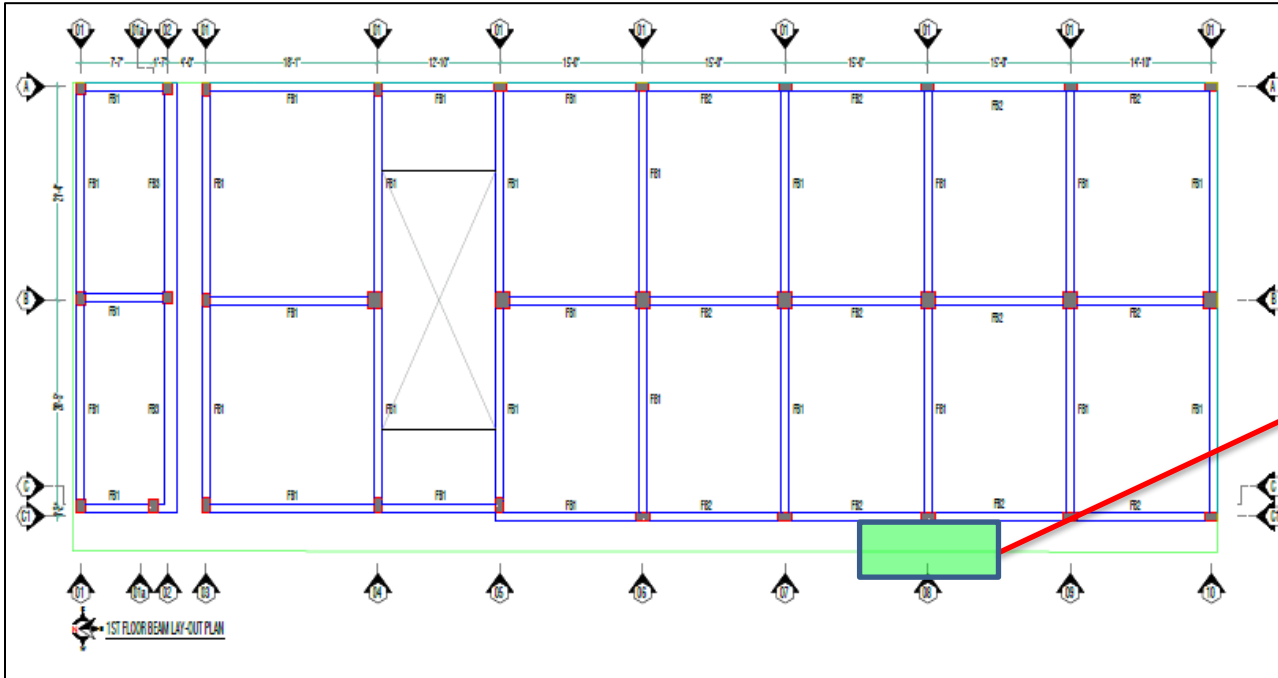
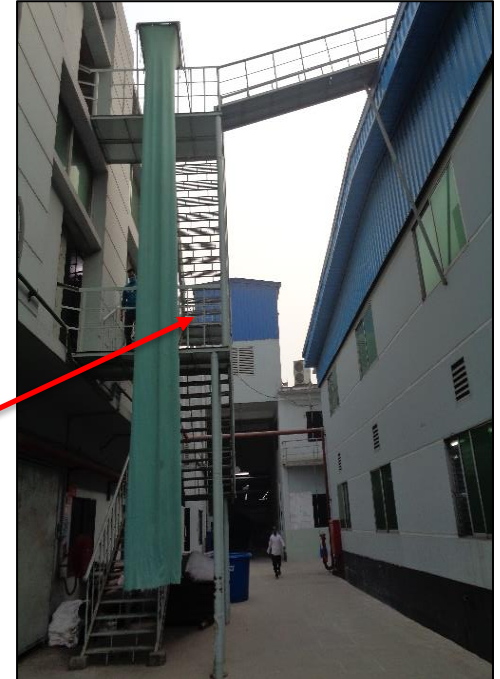
Undocumented external steel stair at west side

An undocumented steel stair was found adjacent to knitting building. No drawing was available for this steel stair. Factory engineer is required to survey the whole structure and update the as-built drawing as per on-site condition.

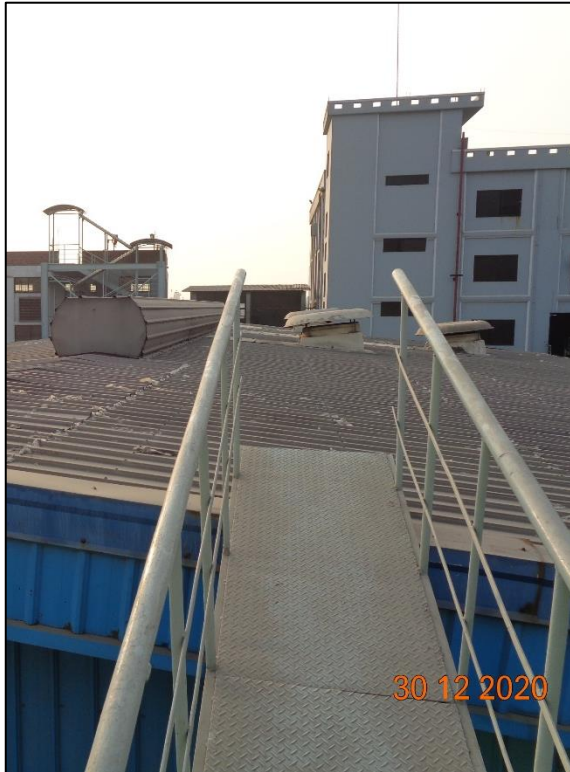
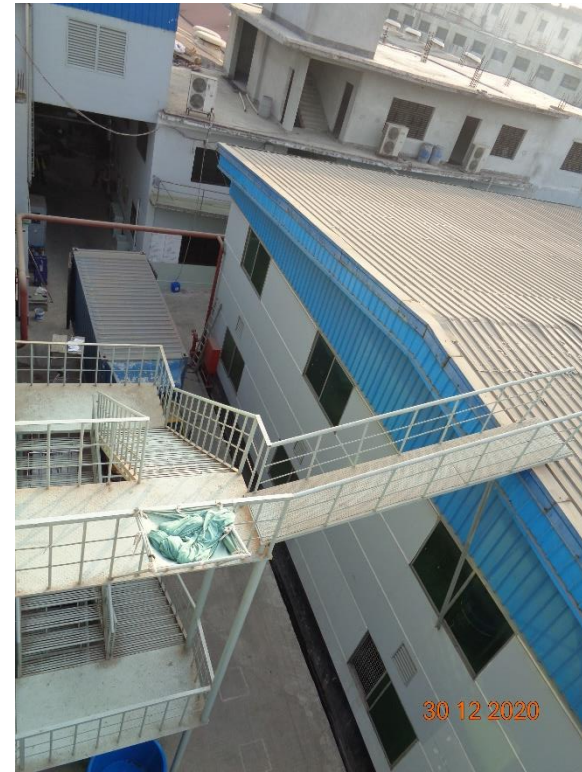
Falling hazard at external stair

Access path to Yarn building

Adjacent steel stair

Adjacent steel stair has access to yarn building which may cause falling hazard. Factory is required to restrict access to Yarn Dyeing Building through this opening.

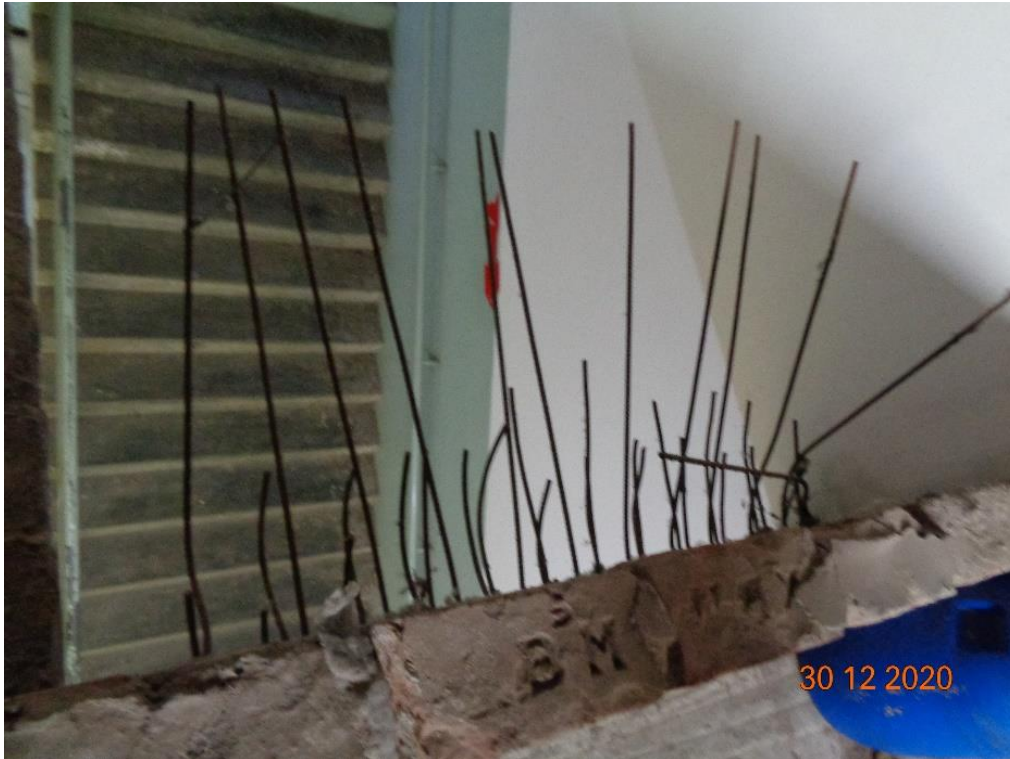
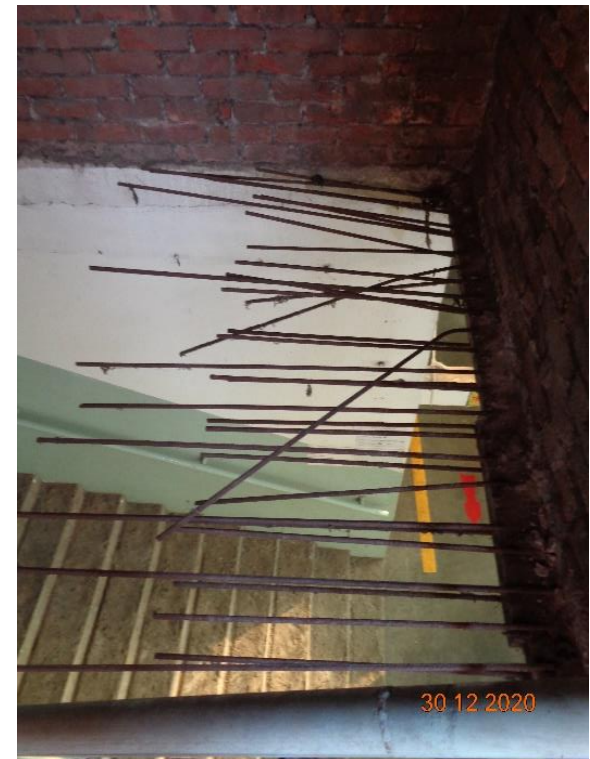
Exposed rebar at stair landing

Exposed rebar at landing

Exposed rebar was found on roof stair landing. The exposed rebar's are prone to be corroded. Factory is required to provide rust proof paint to prevent future corrosion.

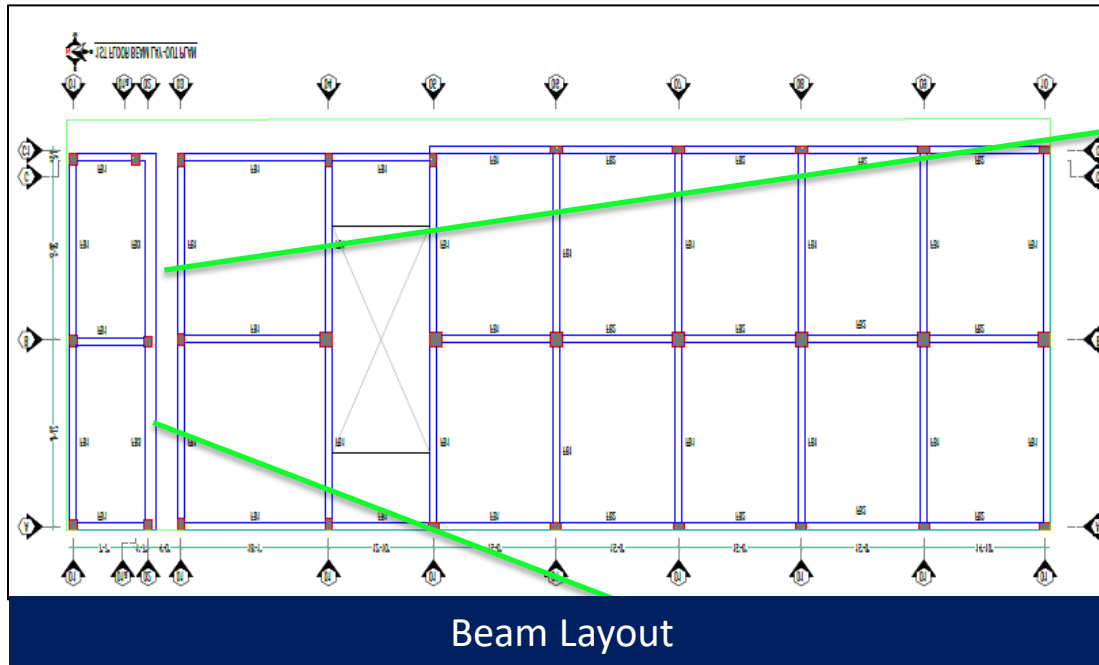
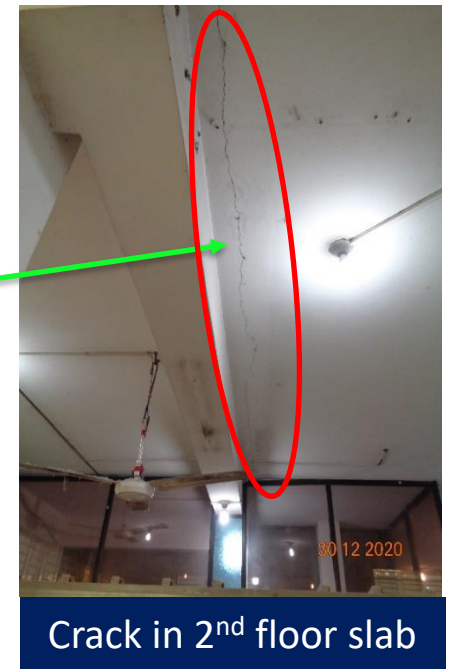
Cracks in beam and slab

Crack was found in second floor slab and first floor beam. Factory engineer is required to investigate the cause of crack and repair the crack with a suitable method.

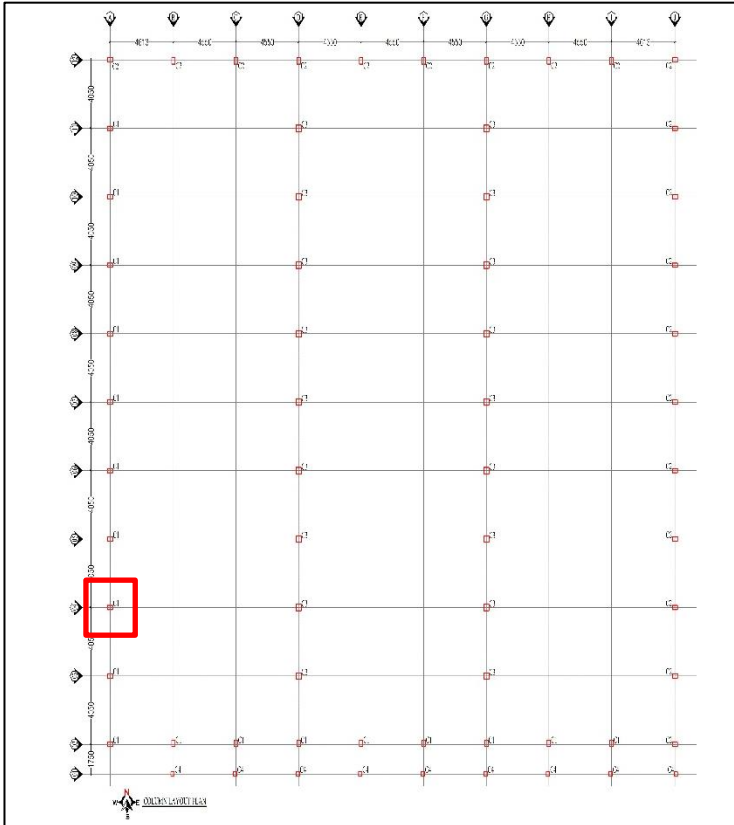
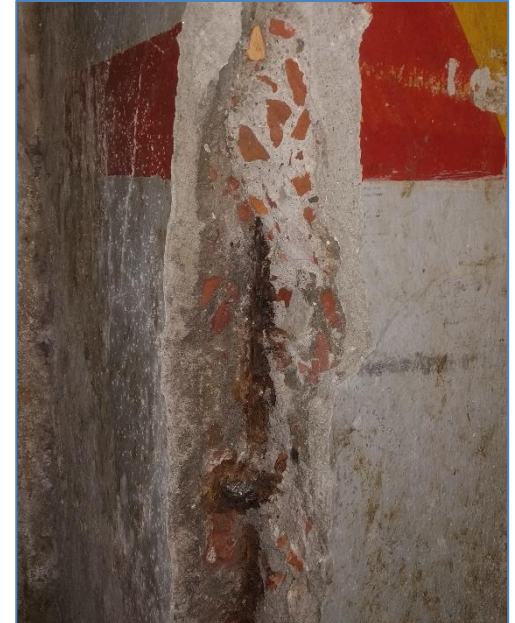
Crack in column

Column layout (cracked column is marked)

Crack extended to rebars

During inspection, marked column was found cracked on the surface. Upon breaking it was revealed that the crack extends up to rebar. Factory engineer is immediately required to investigate the cause of crack and repair the crack with a suitable method.

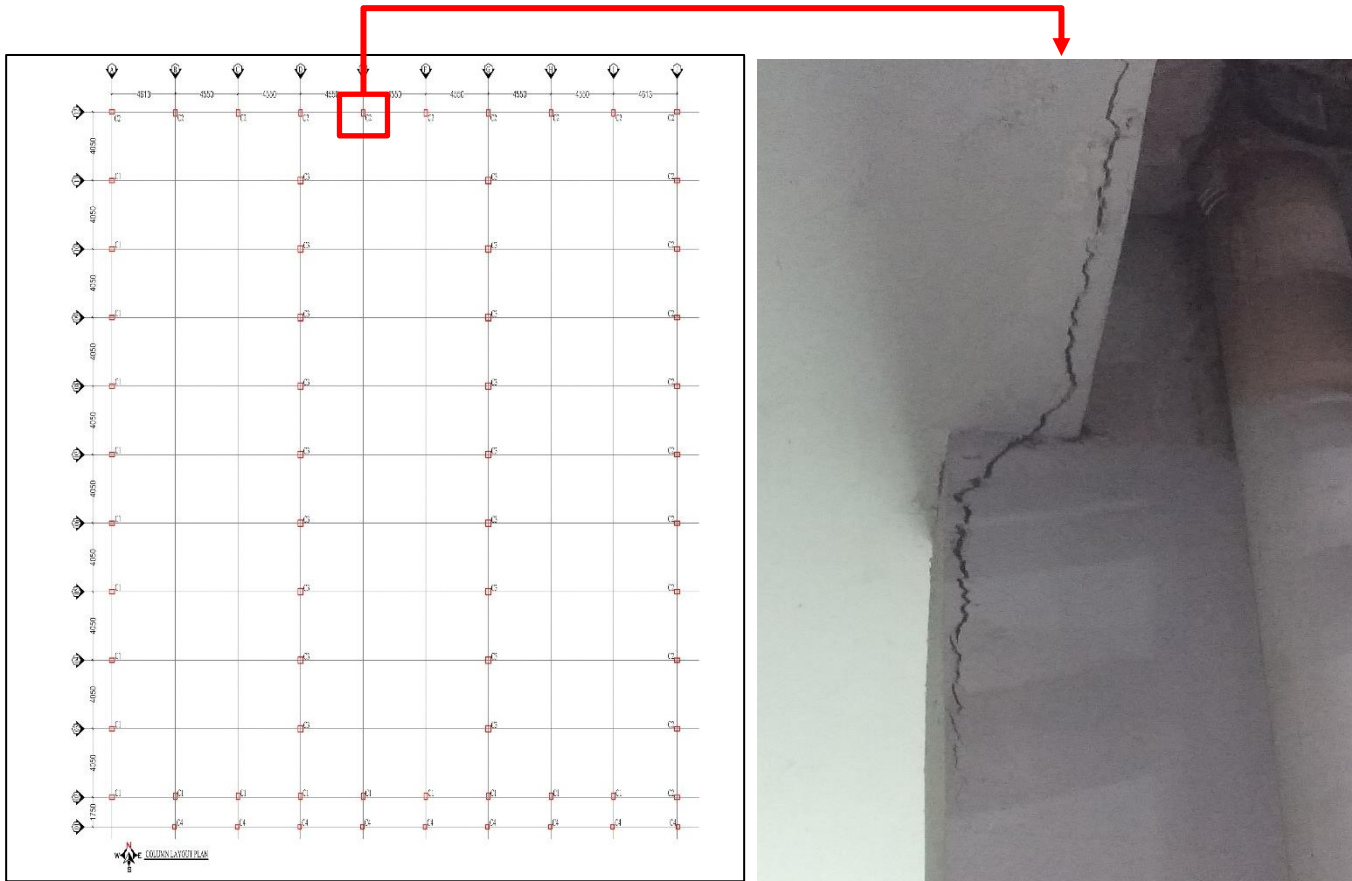
Column layout (cracked column is marked)

During inspection, cracks were observed on highlighted column. Factory engineer is immediately required to investigate the cause of crack and repair the crack with a suitable method.
