Rahman Knit Garments Ltd.

Hariharpara, Panchabati, Fatullah, Narayanganj
(23.63014, 90.48090)

30th December 2020 & 24th January 2021.

Observations

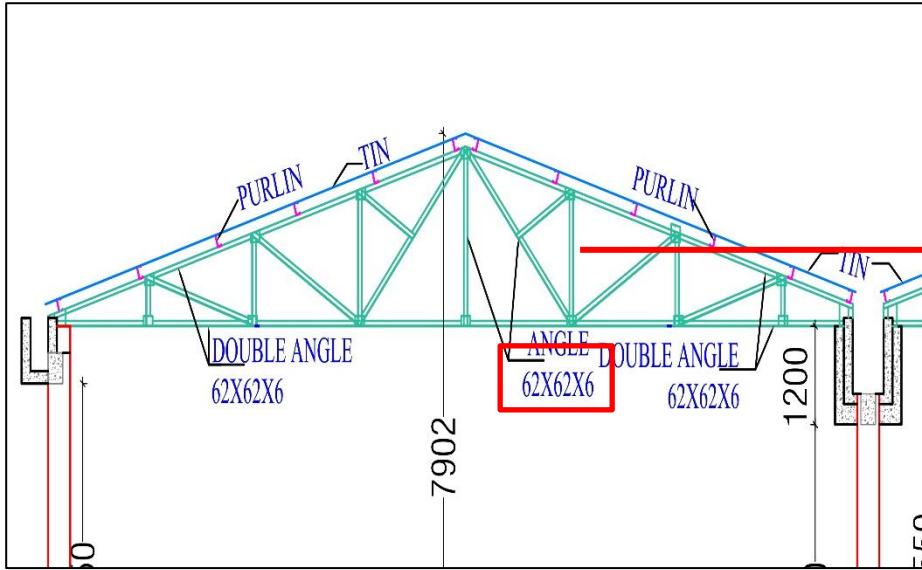
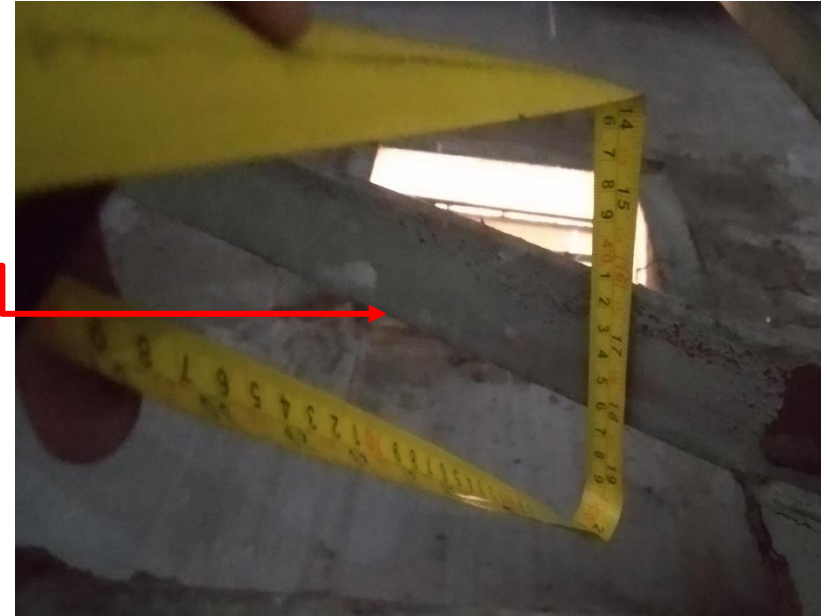
Size of diagonal Section shown in drawing 62X62X6

Size measured on site 50X50X6.

The dimension of diagonals of the truss was found 50X50X6 instead of 62X62X6. Factory engineer is required to check the adequacy of truss members against lateral load and update the as-built drawing as per on-site condition.

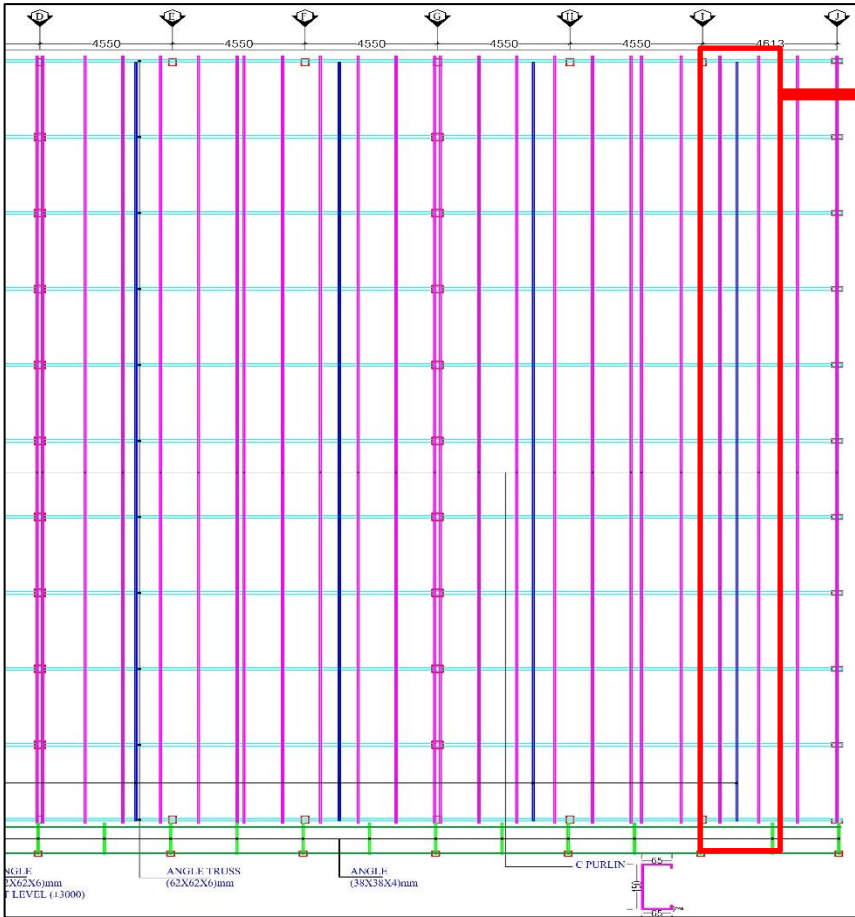
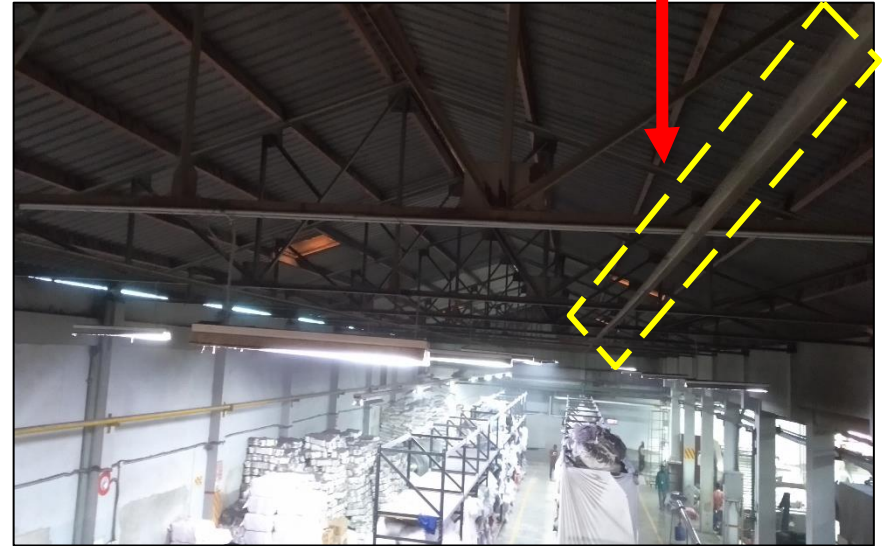
Lack of lateral stability

Compression strut marked in the picture

The trusses are connected with one another by compression struts only along long direction and roof bracing is not provided therefore lateral stability system along long direction appears to be weak. Factory engineer is required to check the lateral stability of the shed against all lateral loading.

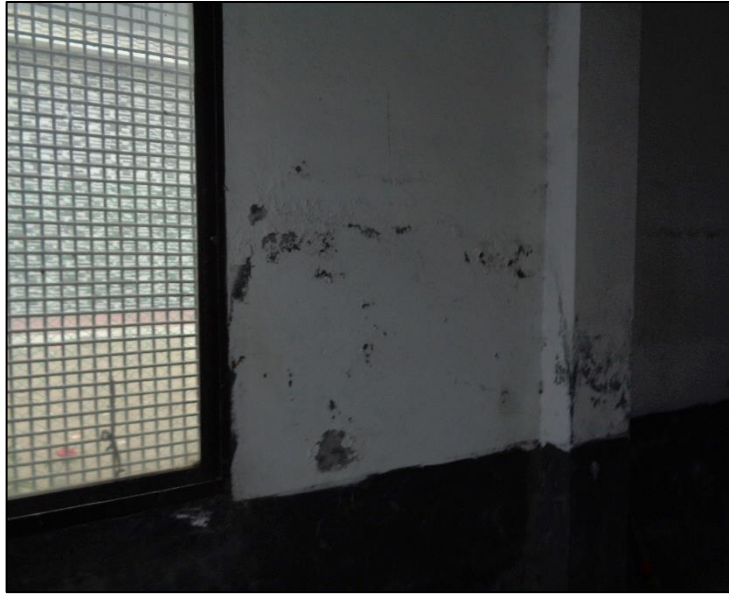
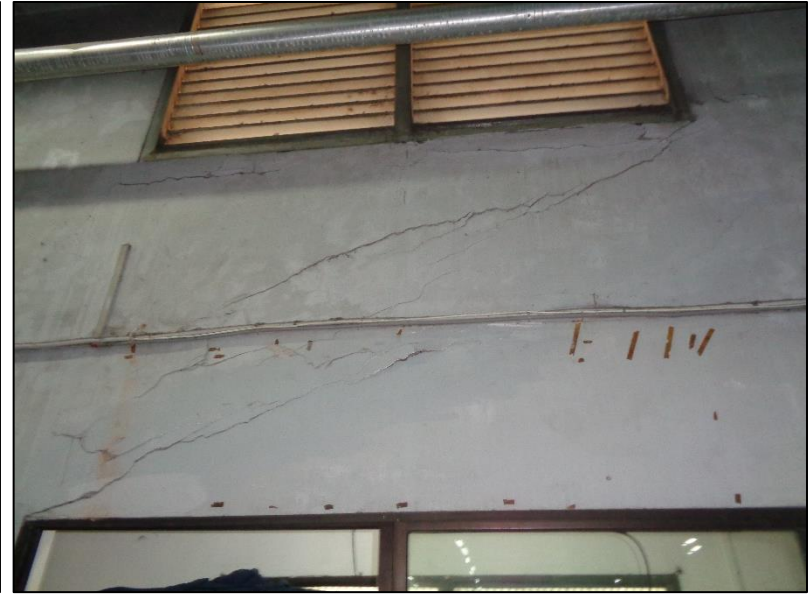
Crack and dampness in wall

Dampness in wall

Crack in wall

Crack and dampness were found at side wall of the shed. Factory engineer is required to investigate the cause of the crack and dampness. Repair all cracks and dampness as per investigation report.

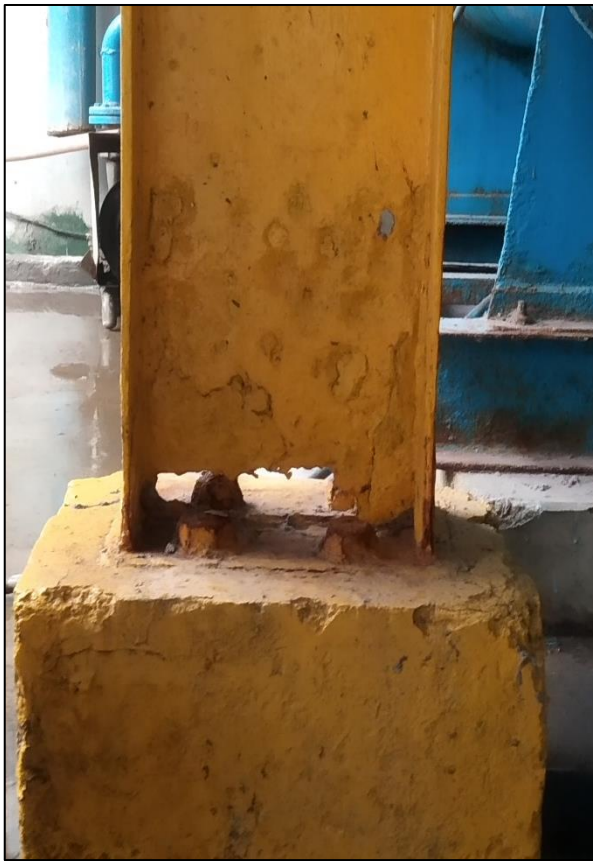
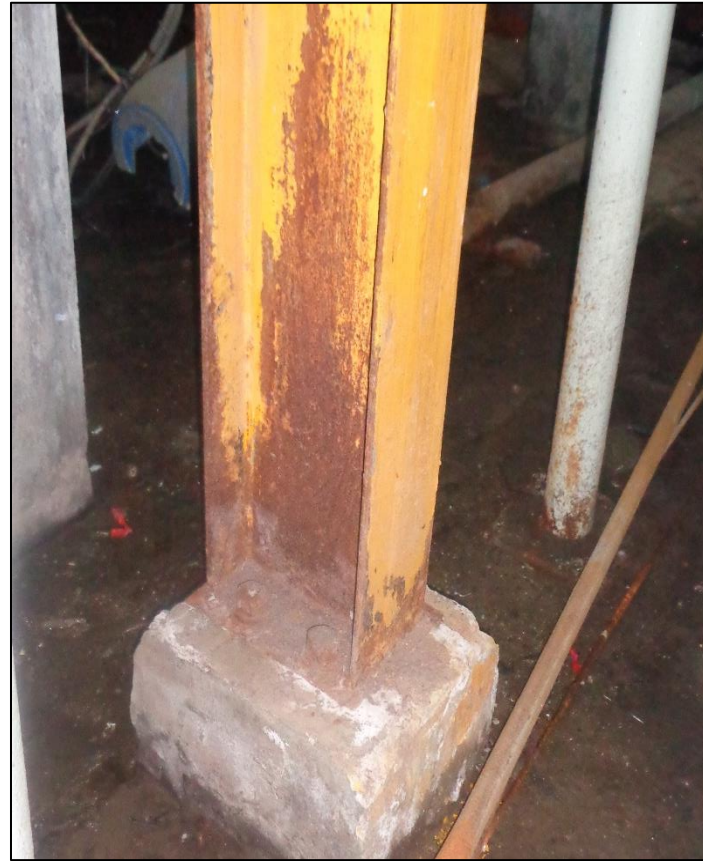
Heavy Corrosion on Structural Members

Corrosion damaged column

Corroded column

Several columns were found heavily corroded at the time of inspection. Factory engineer is immediately required to investigate the cause of corrosion, repair the corroded columns with a suitable method and provide rust proof paint to all steel members to prevent future corrosion.

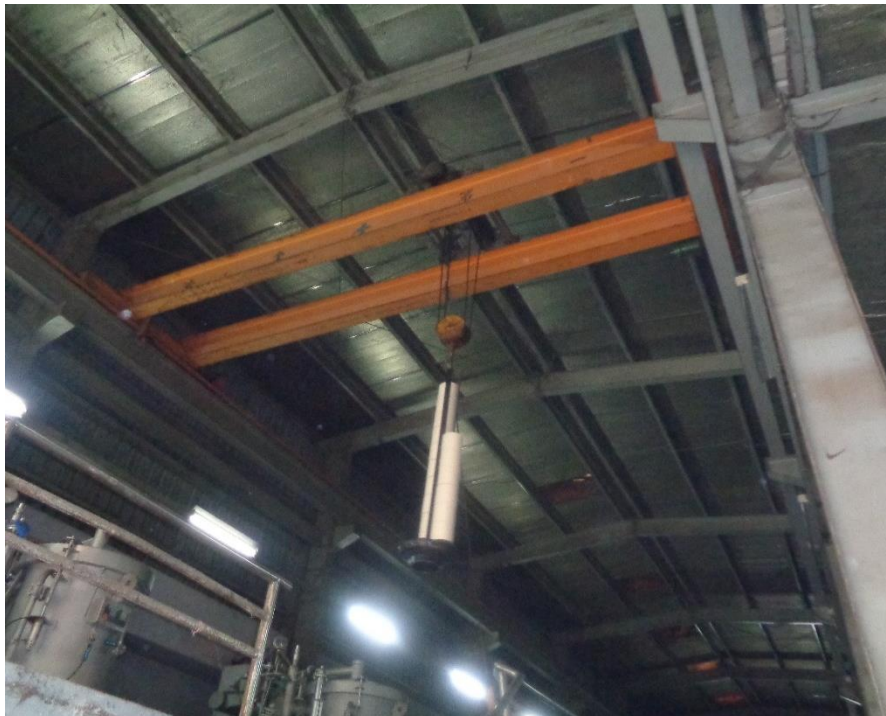
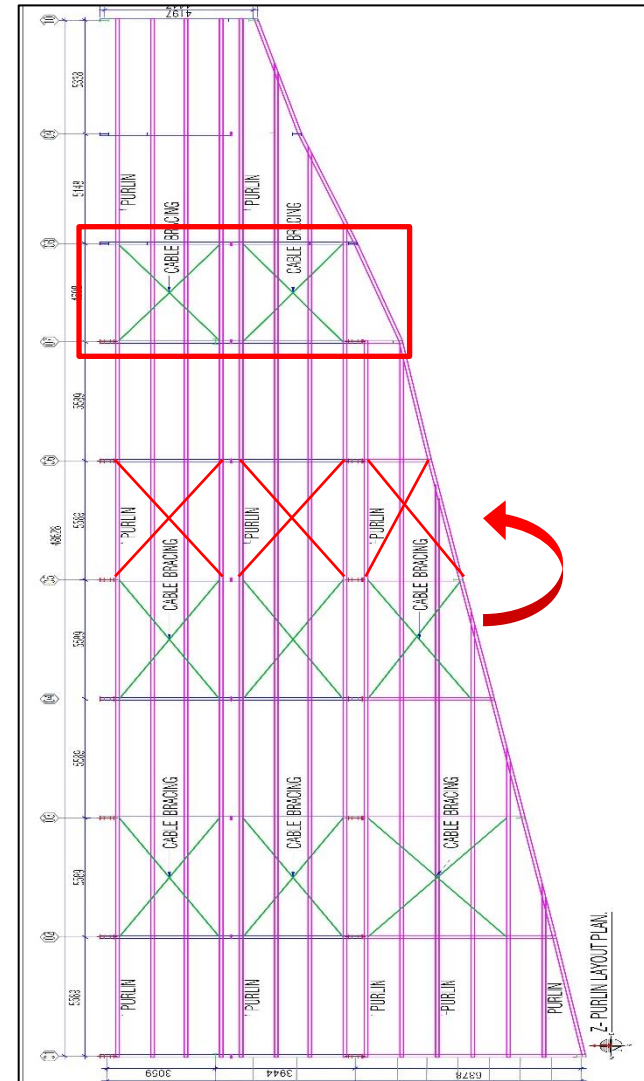
Roof bracings were supposed to be between gridline 4 and 5 as per as built drawings but during inspection cable bracings were found between gridline 5 and gridline 6. Also, bracings between gridline 7 and gridline 8 were missing. Factory engineer is required to check the lateral stability of the shed considering the discrepancies and update the as-built drawing as per on-site condition.

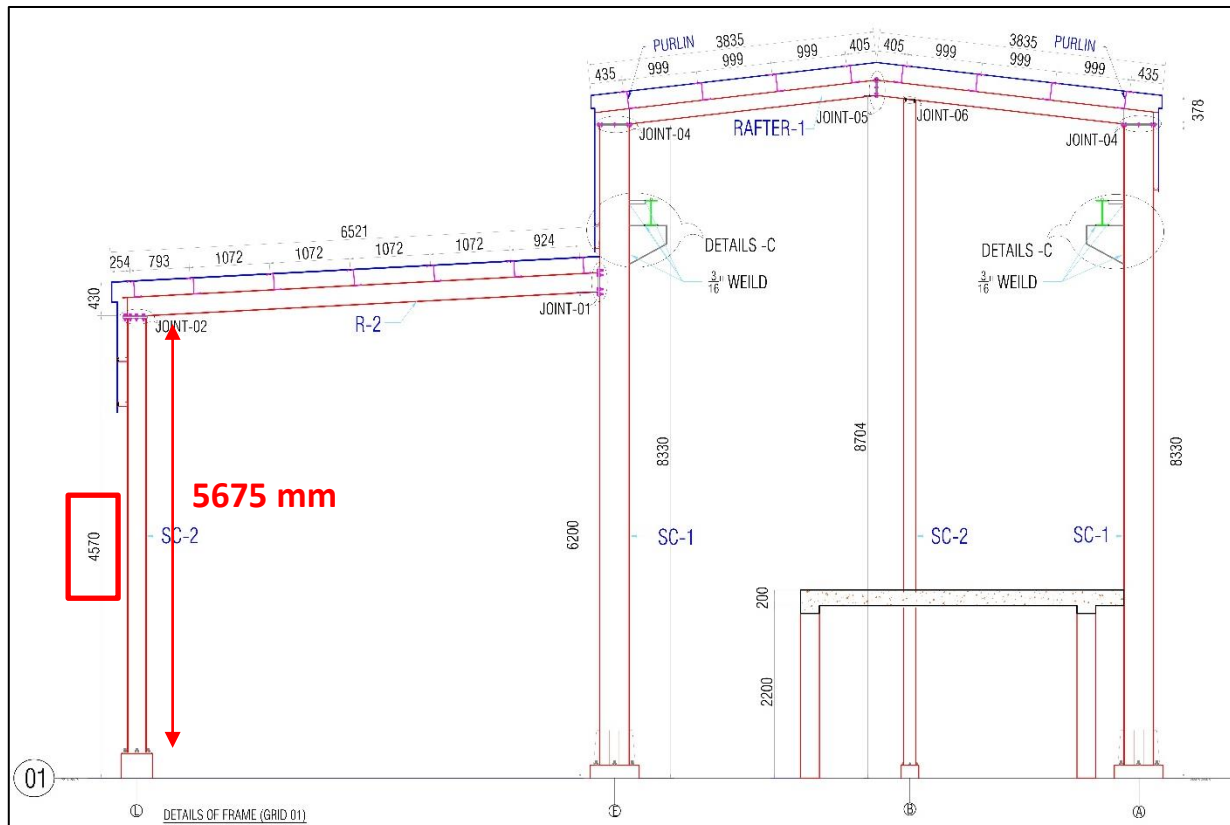
Section drawing on grid 01

As per as built drawings, marked height on grid 01 was supposed to be 4570 mm but on site it was measured to be 5675 mm. Factory engineer is required to check the lateral stability of the shed considering the discrepancies and update the as-built drawing as per on-site condition.

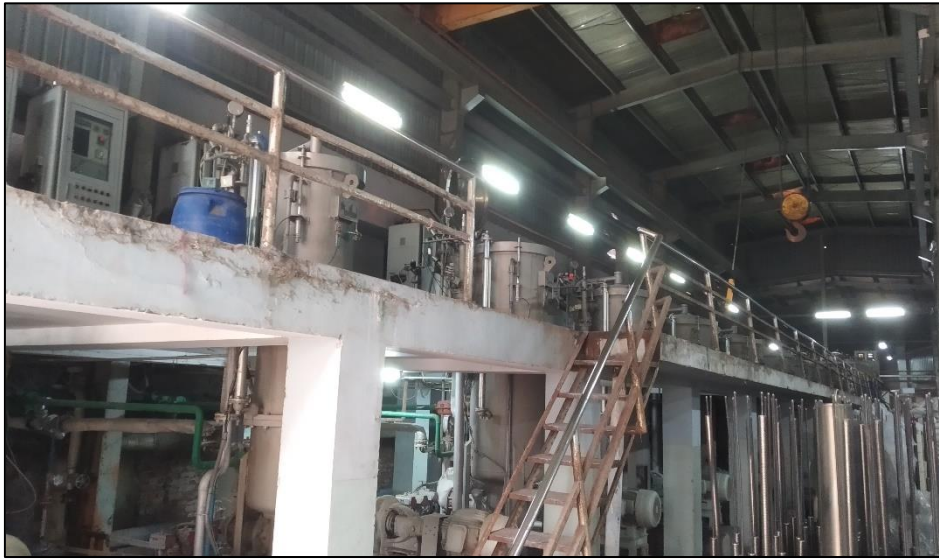
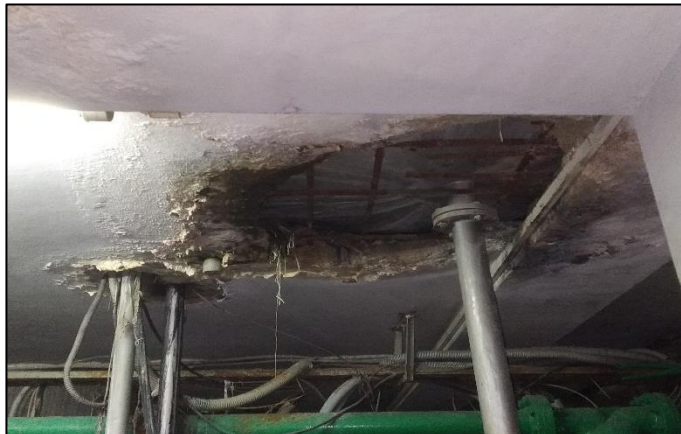
Undocumented Mezzanine Floor

Drawing is not available for mezzanine floor

Dampness in column

Hole in the slab for boiler pipe

An undocumented Mezzanine floor was found inside Building-3 (Dyeing Shed (part-B)) and no drawing was available for this structure. Dampness was visible in column and a hole was found in slab. Factory engineer is required to survey the whole structures and produce as-built drawing for this structure. Check the adequacy of the slab and repair if required. Also, repair all damp areas by the guidance of factory engineer.

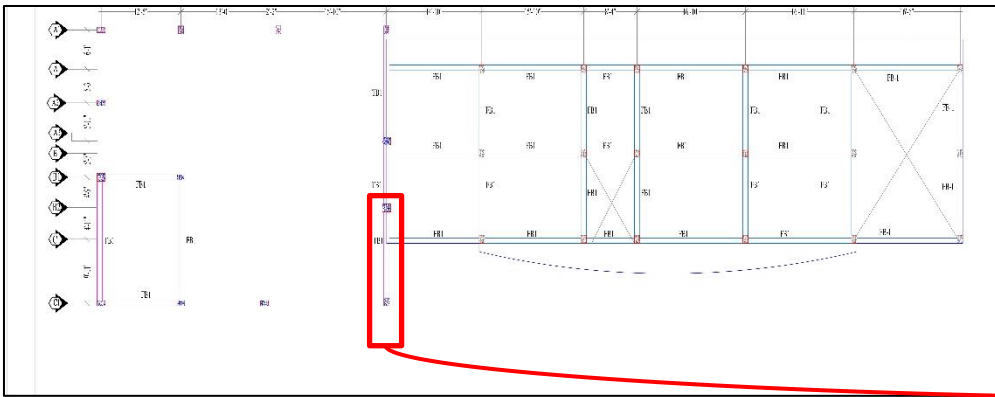
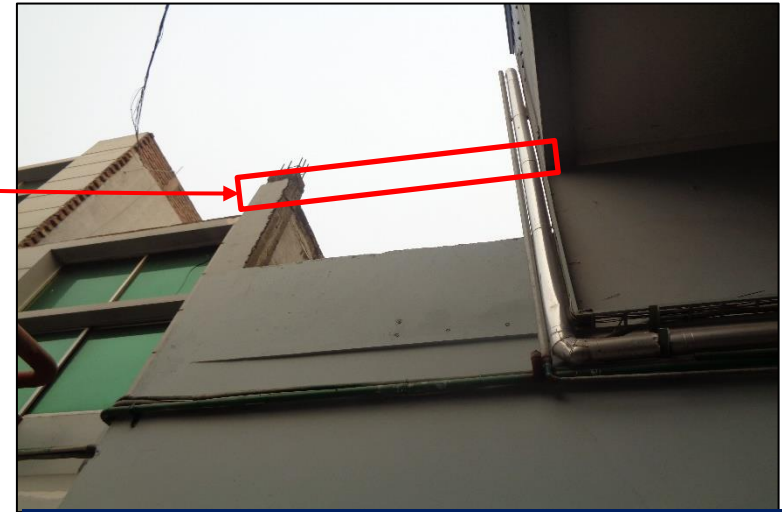
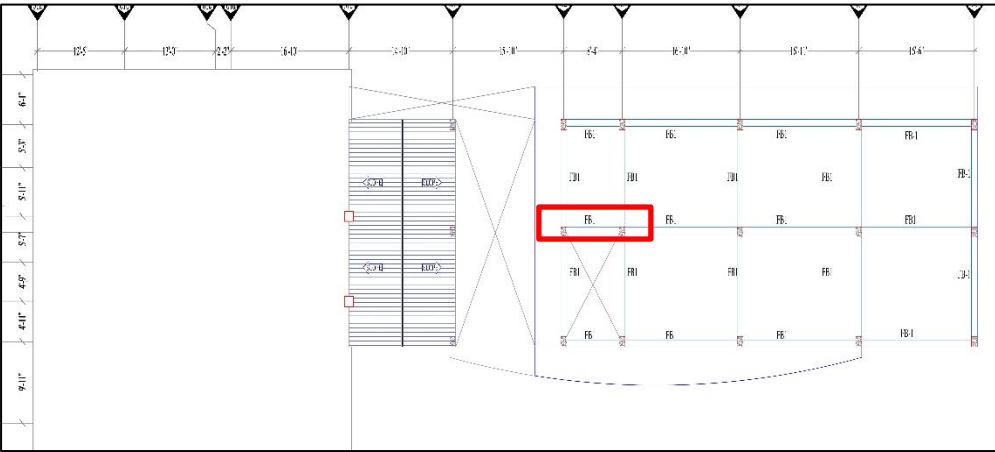
Missing beam

Marked beam in the 2nd floor beam layout was missing onsite.

Marked beam in the 3rd floor beam layout was found missing onsite.

Some beams were missing physically at several locations which were shown in provided drawing. Factory engineer is required to survey the whole structures and produce as-built drawing for this structure. Also, review the adequacy of the structural system considering the missing beams.

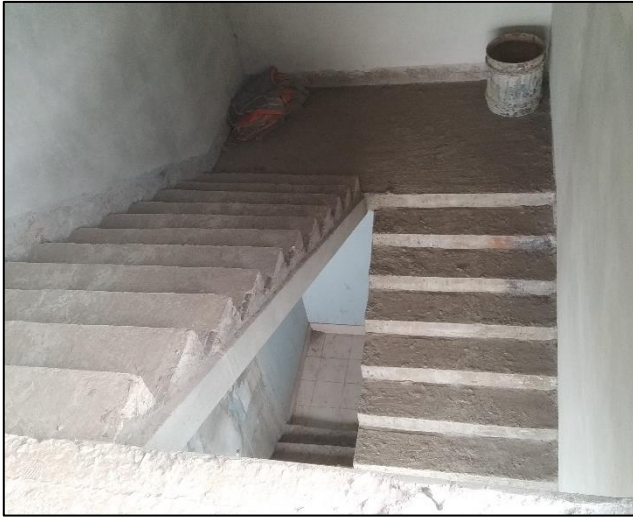
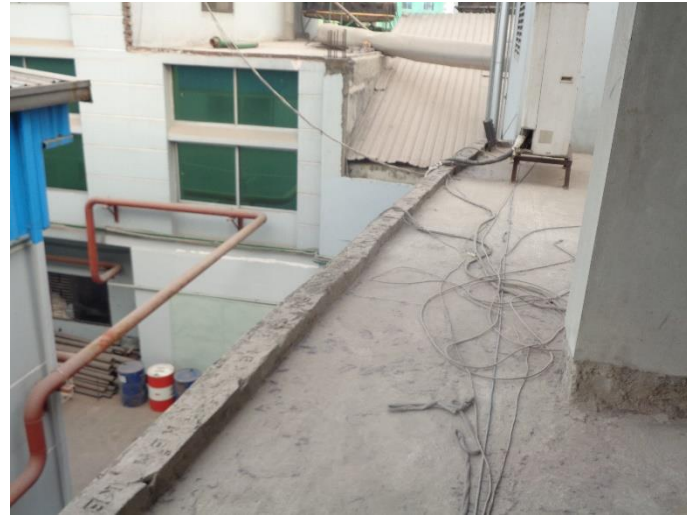
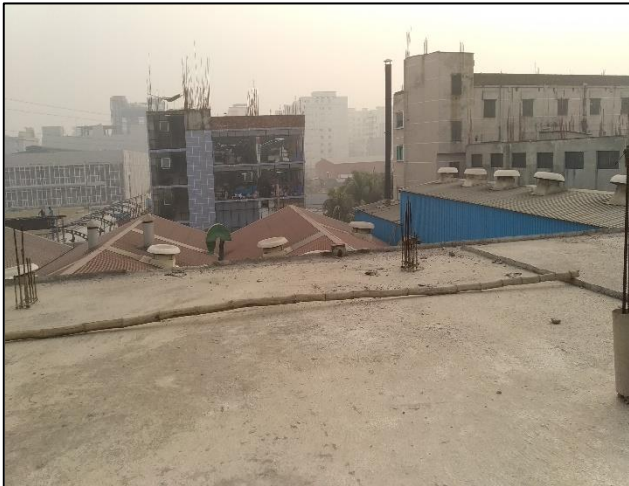
Falling hazard at roof level and stair area

Railing is missing at staircase

Cantilever portion has no railing

Roof has no parapet wall

Railing was missing at staircase, cantilevered areas and roof level which is prone to falling hazard. Factory is required to provide railing/parapet to prevent those areas from falling hazard.

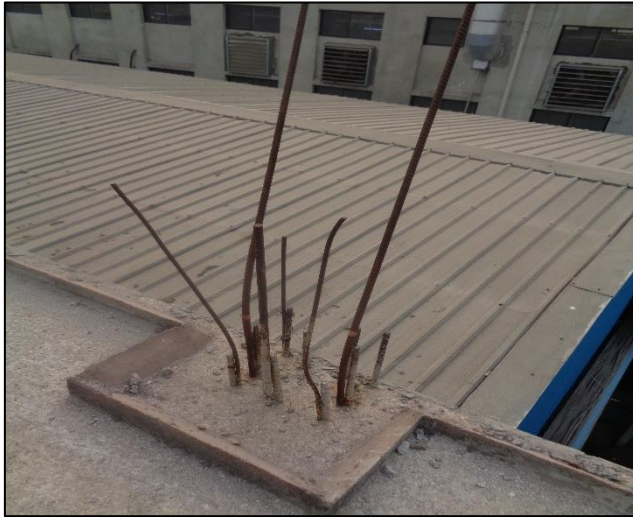
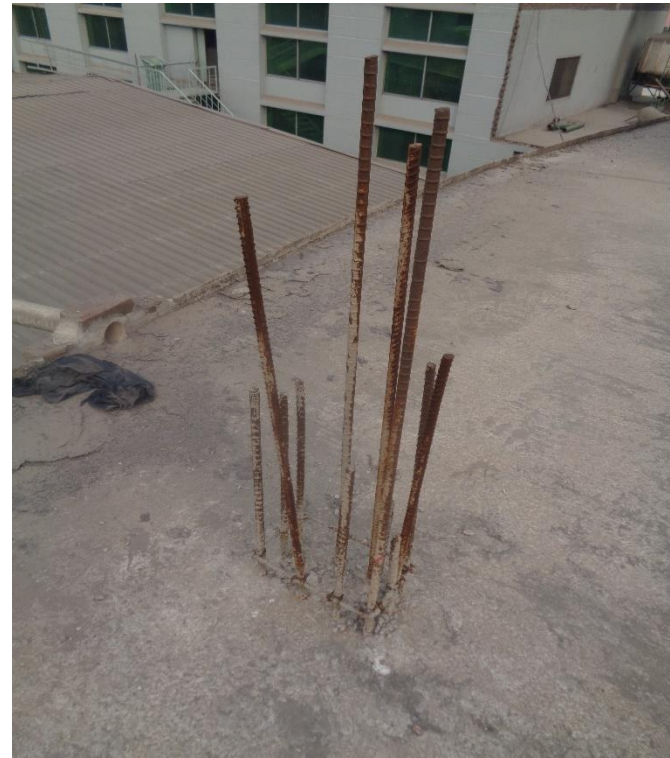
Exposed Rebar at roof level

Exposed rebar

Exposed rebar was found at roof level which is prone to corrosion. Factory is required to provide rust proof paint on all exposed rebar to protect from corrosion. Otherwise remove all the exposed rebar.

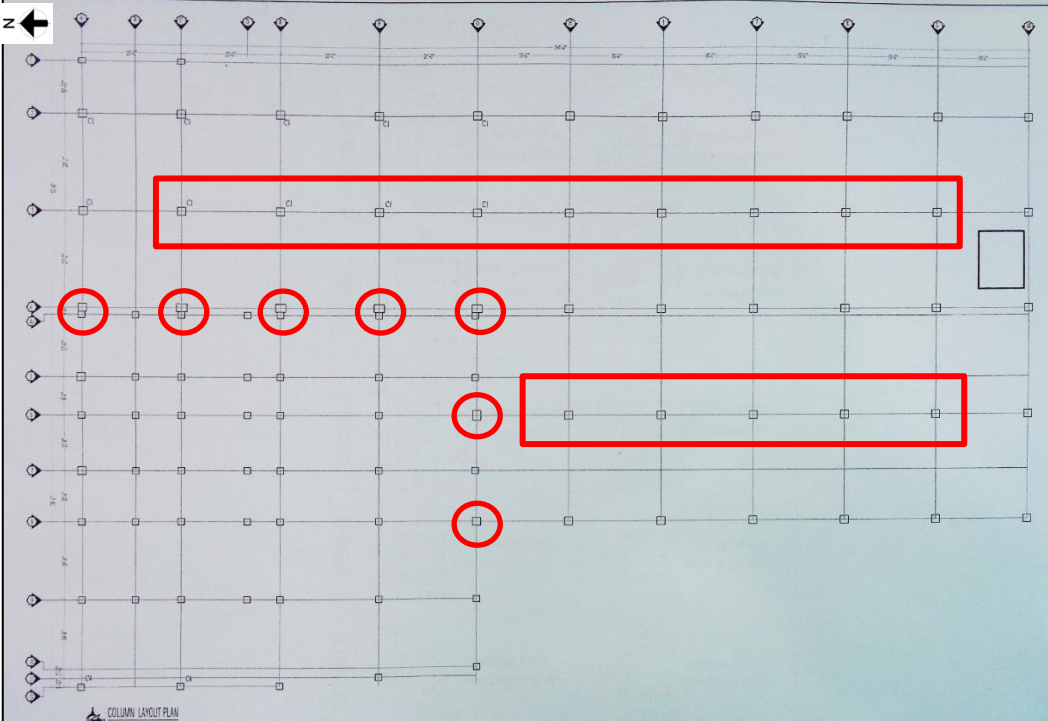
Column was found 600X400mm. Re-bar: #16Ø20mm

Column ID of highlighted columns is not mentioned in layout.

The columns of the marked locations (Rectangle) were only found at ground floor. These columns were not extended at upper floors. Also, columns at circular marked location was found 600X400 mm. Neither column ID for those columns shown in column layout nor dimension of those columns matched with any type of column shown in column schedule. Factory engineer is required to survey the whole structure and update as-built drawing as per onsite condition.

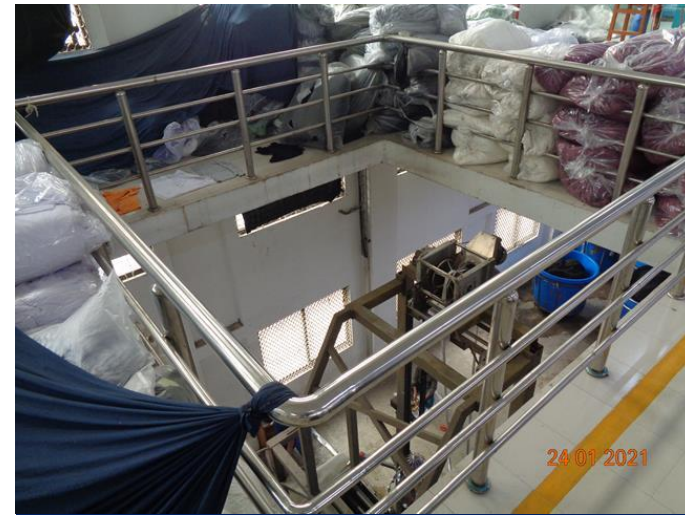
Slab perforation was found at 1st floor at marked location in layout. No information has been provided in as-built drawing. Size of the perforation was found 3.05X3.05 m.

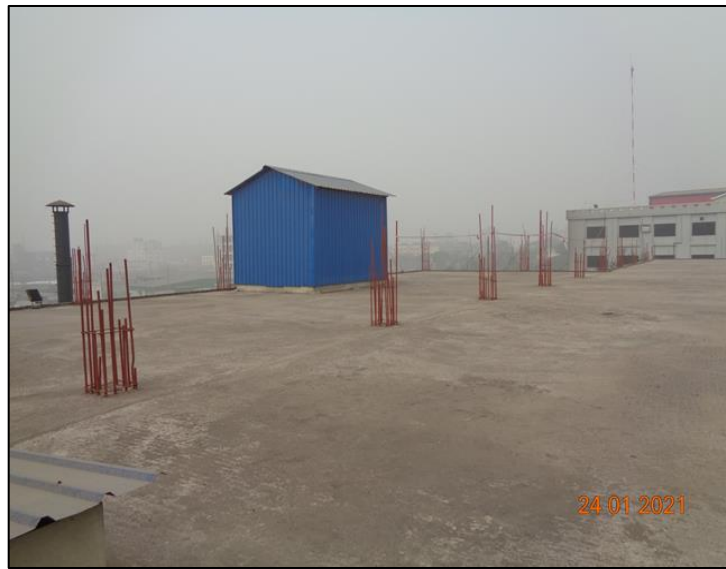
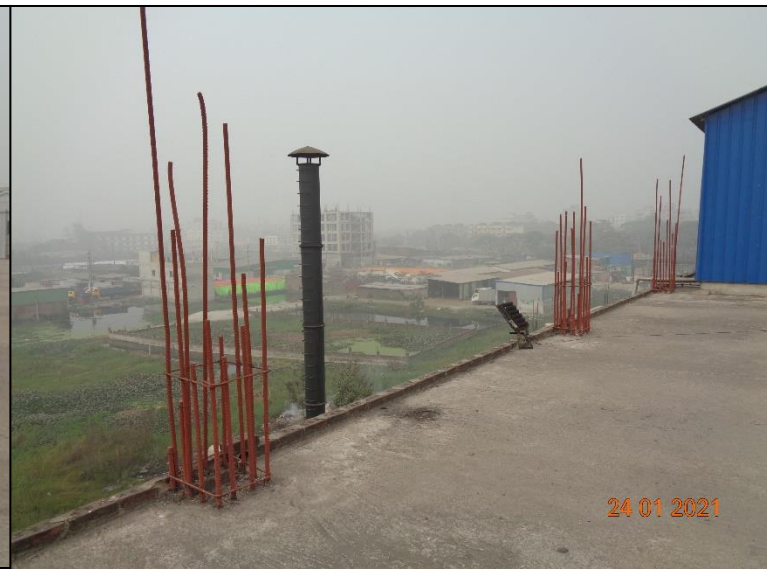
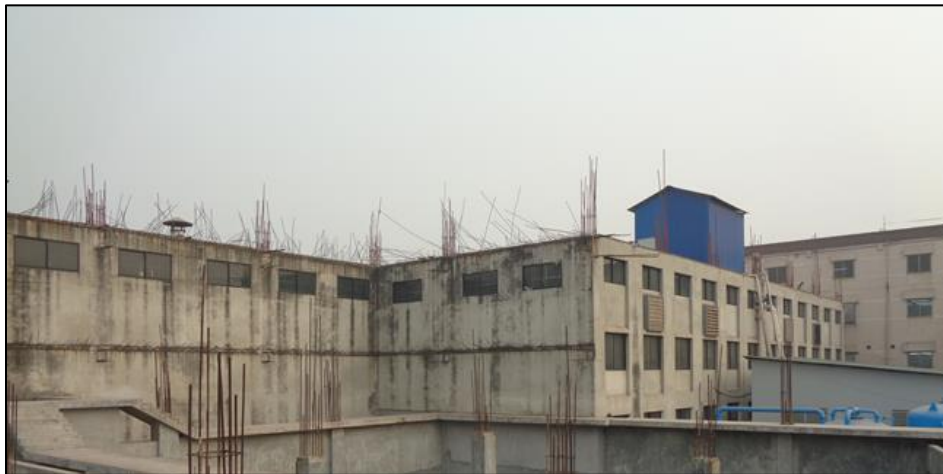
Future Vertical Extension

Building was found constructed up-to two storied. Factory authority has verbally informed that they are intended to extend the building vertically in future. Also, extended column, beam and slab rebar was found for future extension. Architectural and Structural drawing were found only for the two storied. Factory engineer is required to prepare Detail Engineering Assessment (DEA) including full set of as-built drawing for the structure prior to commencement of further extension work.

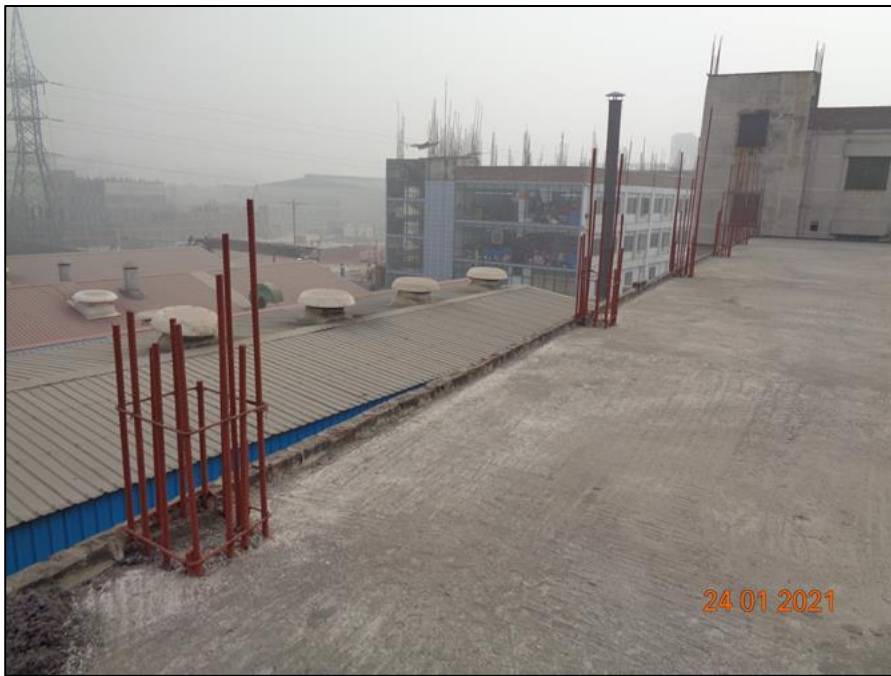
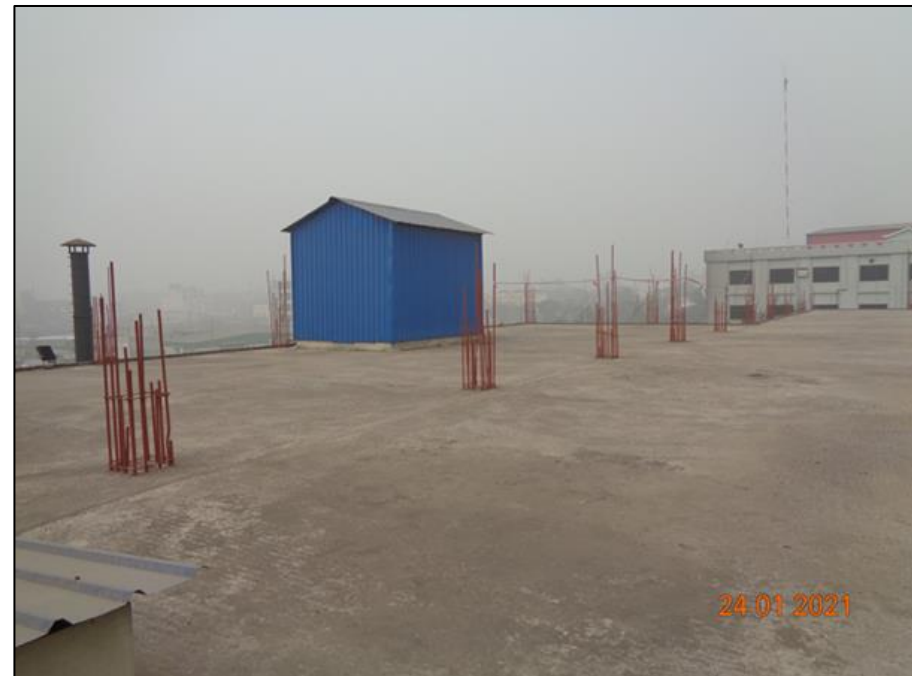
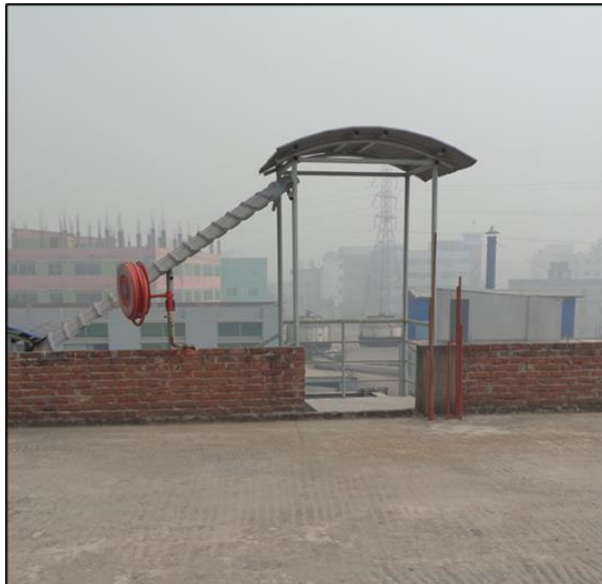
Falling hazard at Roof level

No parapet/railing was found at roof level but access to roof was still available which prone to possible falling hazard. Factory is required to provide parapet or railing at roof level to prevent possible falling hazard otherwise restrict all access to roof.

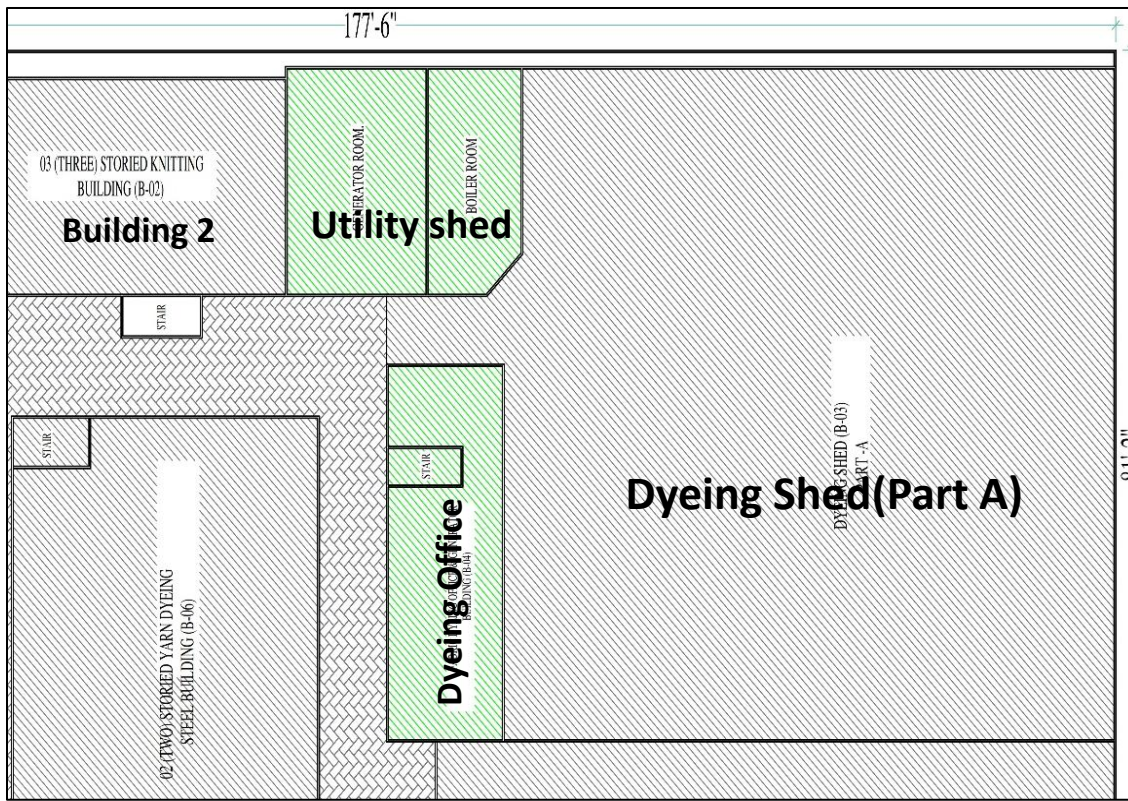
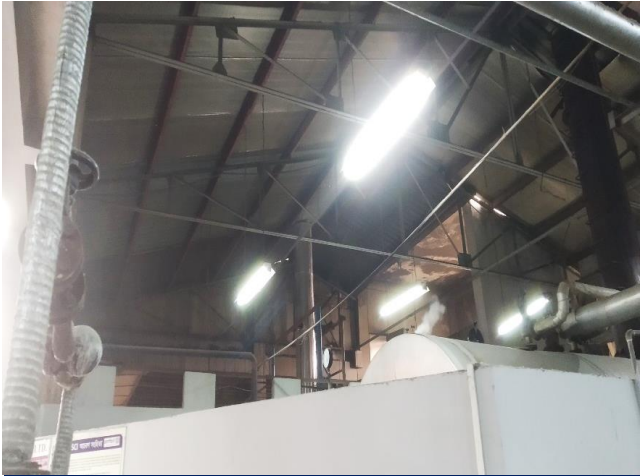
Structural connections need to be verified

Building 03-dyeing shed (part-A) was found structurally connected with Dyeing Office and Utility shed. Also, Utility Shed was found structurally connected with Building 02 (knitting building). Factory engineer is required to survey the whole structure and update the as-built drawing as per on-site condition. Also, analyze these structures separately as independent structure.

Utility shed connected with Building 03-Dyeing Shed (Part-A) by continuous truss

Slab of dyeing office appears to be connected with column of dyeing shed (part-A)

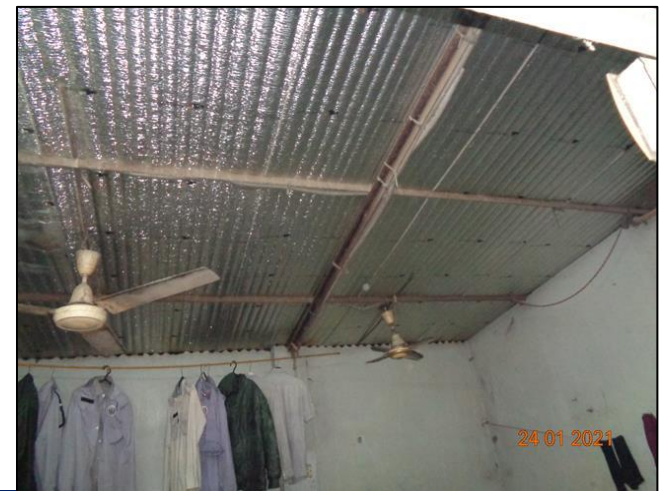
Interior part of the Security
Dormitory shed

The connections of these sheds appear to be non engineered and steel members appear to be undersized. Building engineer is required to check the adequacy of the sheds or Replace with the engineered sheds.
