# Triple Apparels Ltd.

Kewa, Sreepur, Gazipur  
(24.213105, 90.432718)

24<sup>th</sup> September 2020

# Observations

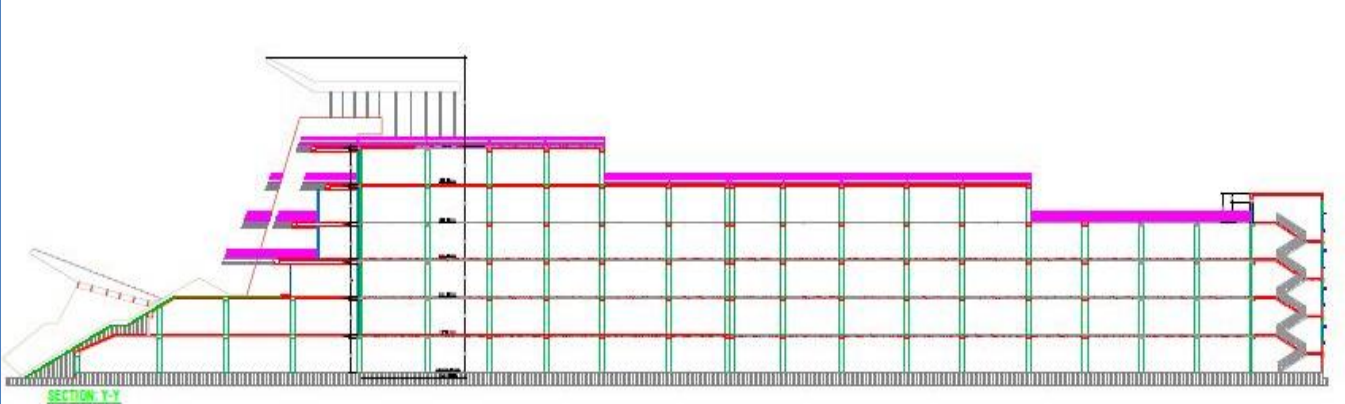
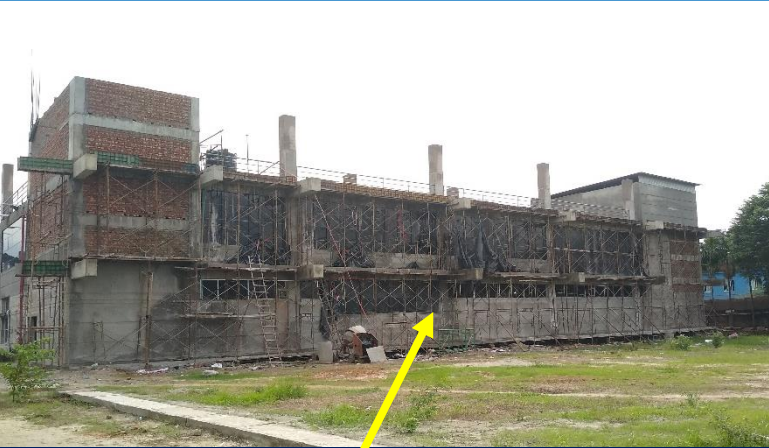
**Prepared design report required to  
be revised**

This building is permitted for 6 (G+5) storied from local authority. Currently, the building is partial 3 storied. Factory has provided a proposed drawings and design report for six storied building.

Shear wall adequacy check was not provided in the design report. Also, No irregularity check was provided in the design report. Incorporate all kinds of irregularity (Torsional, mass, Diaphragm Discontinuity, stiffness, etc.) check in design report according to BNBC.

| Item No. | Observation | Recommended Action Plan | Recommended Timeline |
|---|---|---|---|
| 01 | Prepared design report required to be revised. | Factory is required to check the adequacy of shear wall and incorporate all kinds of irregularity (Torsional, mass, diaphragm discontinuity, stiffness, etc.) check in design report according to BNBC. | 6-weeks |
| 02 | Prepared design report required to be revised. | Produce and actively manage a loading plan for all floor plates within the factory, considering floor, column and foundation capacity. | 6-weeks |
| 03 | Prepared design report required to be revised. | Complete implementation of any remedial works deemed necessary by the design report. | 6-months |
| 04 | Prepared design report required to be revised. | Continue to implement loading plan. | 6-months |

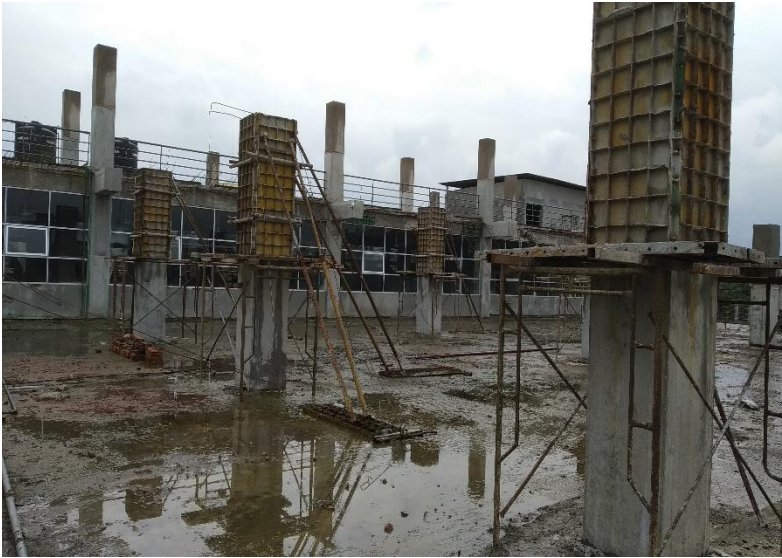
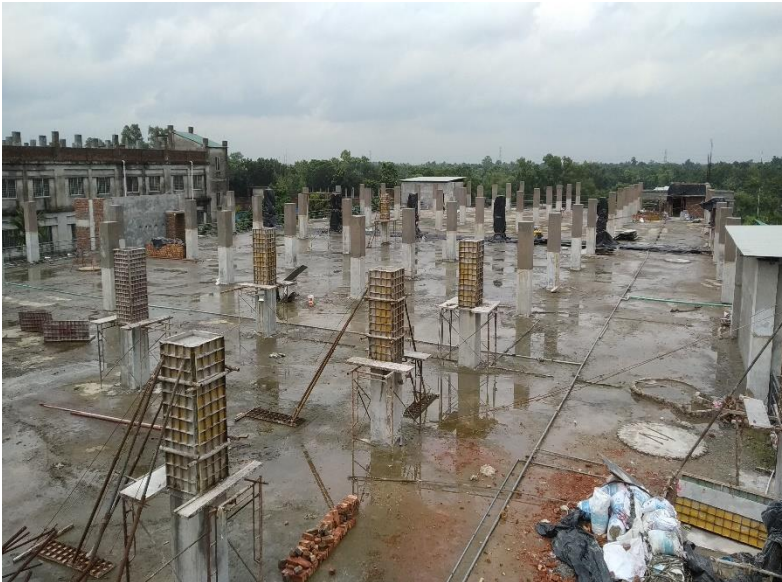
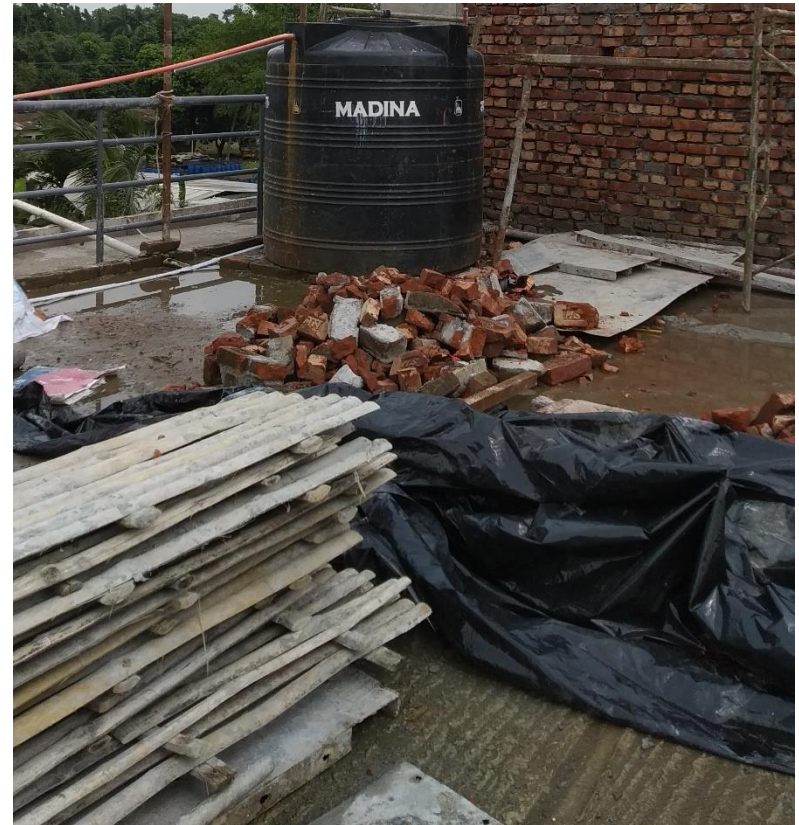
# **Improper drainage and stacking of construction material on existing roof**

Proper drainage system has not applied at current roof of the main factory building. Also, stacking of construction materials were found at roof.

| Item No. | Observation | Recommended Action Plan | Recommended Timeline |
|---|---|---|---|
| 05 | Improper drainage and stacking of construction material on existing roof. | Factory is required to improve the water drainage system to avoid water clogging in future. | 6-weeks |
| 06 | Improper drainage and stacking of construction material on existing roof. | Remove construction materials from roof top. | 6-weeks |

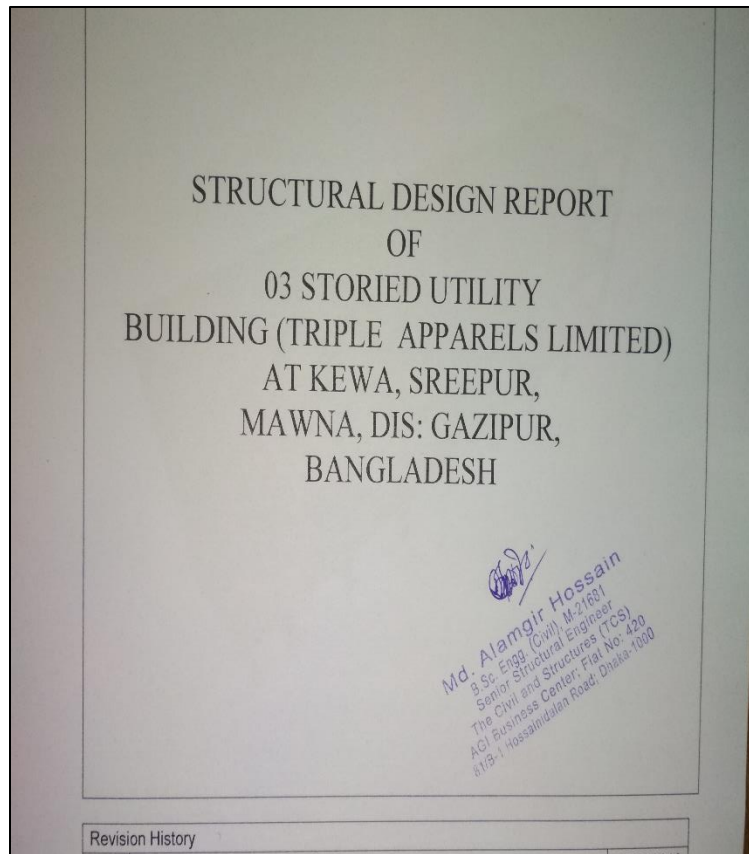
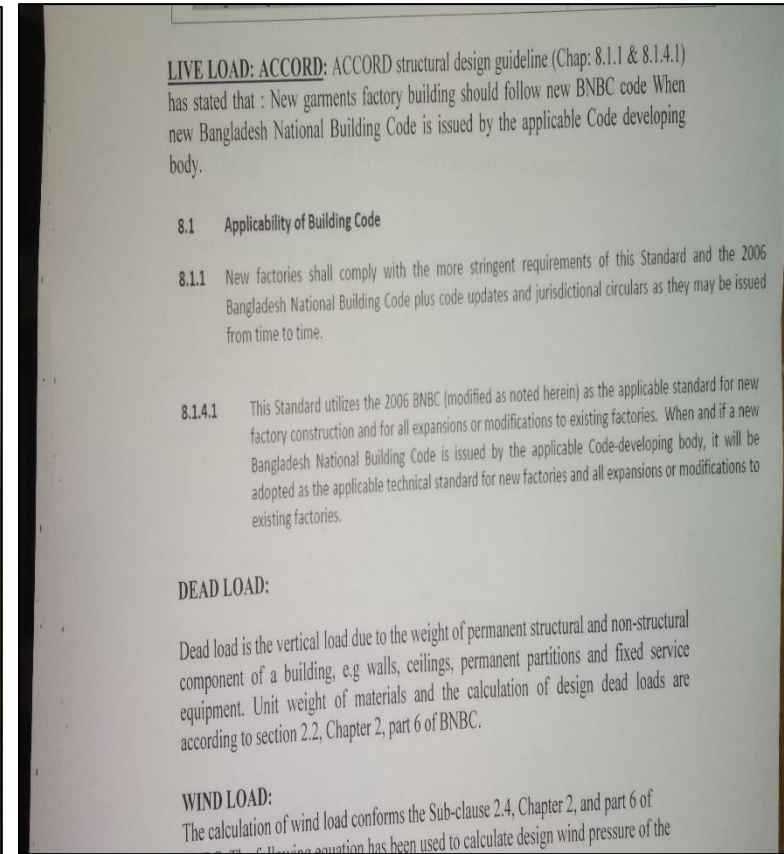
# Incomplete Design Report

According to BNBC 2006 Part 6 Section 1.9.1.1 , Design Report must include computer model analysis results including all axial force, shear force, bending moment etc. But in the Design report of the Utility building, only the deflections have been listed. Moreover, responsible engineer's statement about the validity of the design also wasn't available in the design report

| Item No. | Observation | Recommended Action Plan | Recommended Timeline |
|---|---|---|---|
| 07 | Incomplete Design Report. | Factory Engineer is required to complete design report as per BNBC Part 6 Sec 1.9.1.1 requirements and submit for review along with other relevant documents. | 6-weeks |
| 08 | Incomplete Design Report. | Produce and actively manage a loading plan for all floor plates within the factory, considering floor, column and foundation capacity. | 6-weeks |
| 09 | Incomplete Design Report. | Complete remedial works if arising from design report after reviewed by RSC. | 6-months |
| 10 | Incomplete Design Report. | Implement floor loading plan after getting acceptance. | 6-months |

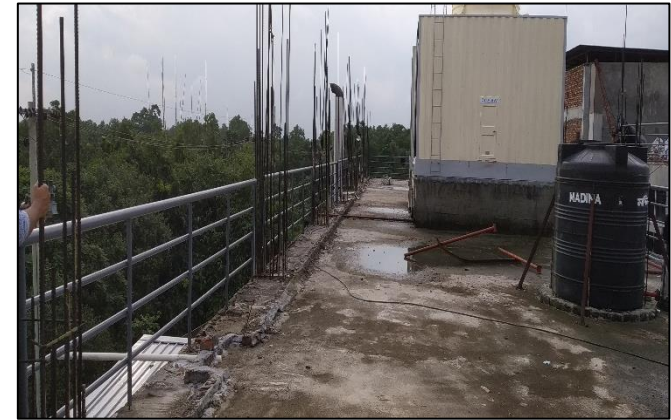
**2<sup>nd</sup> floor**

In the Design Report a live load of 20 kPa is considered for ground floor and 12kPa is considered for 1<sup>st</sup> floor. But slab adequacy check for this heavy loading is not included in the design report.

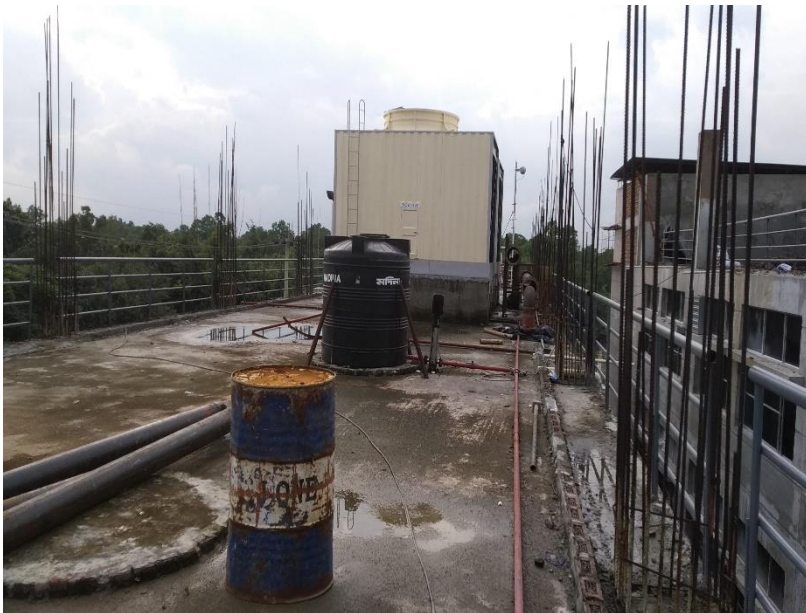
Corrosion was observed on all exposed reinforcement on existing roof top columns. Factory must provide adequate protection to the structural elements from corrosion.

Exposed rebar at Column

| Item No. | Observation | Recommended Action Plan | Recommended Timeline |
|---|---|---|---|
| 11 | Corroded and exposed rebar at roof. | All exposed reinforcement is to be protected from corrosion which may cause degradation of the concrete. | 6-weeks |

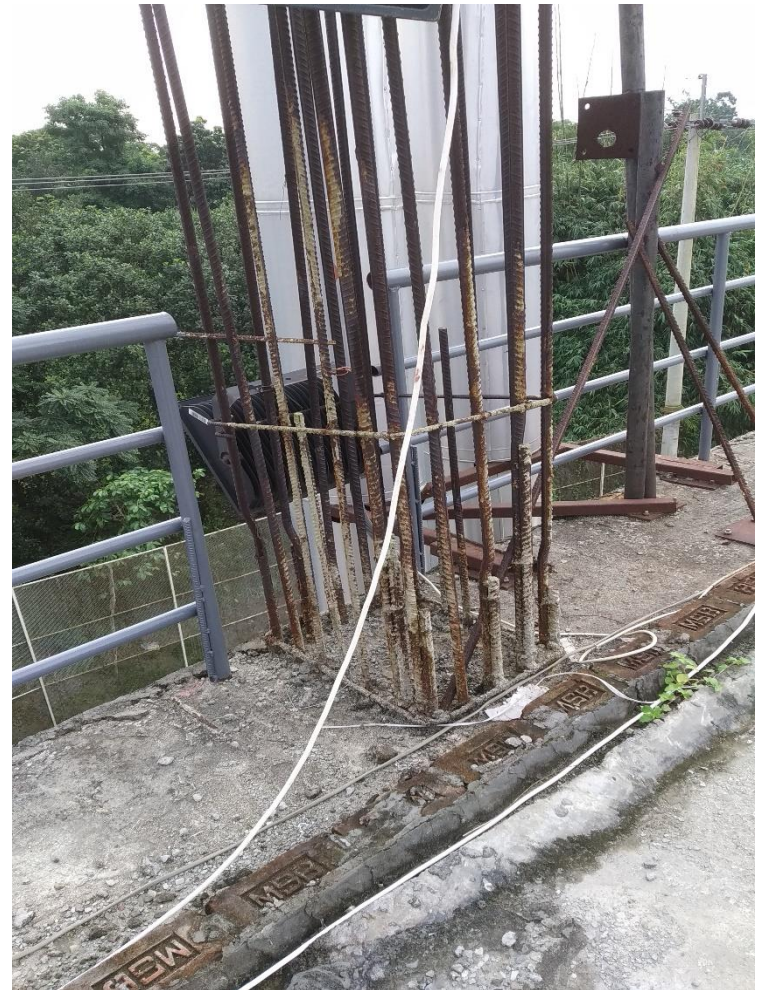
Exposed rebar at Column

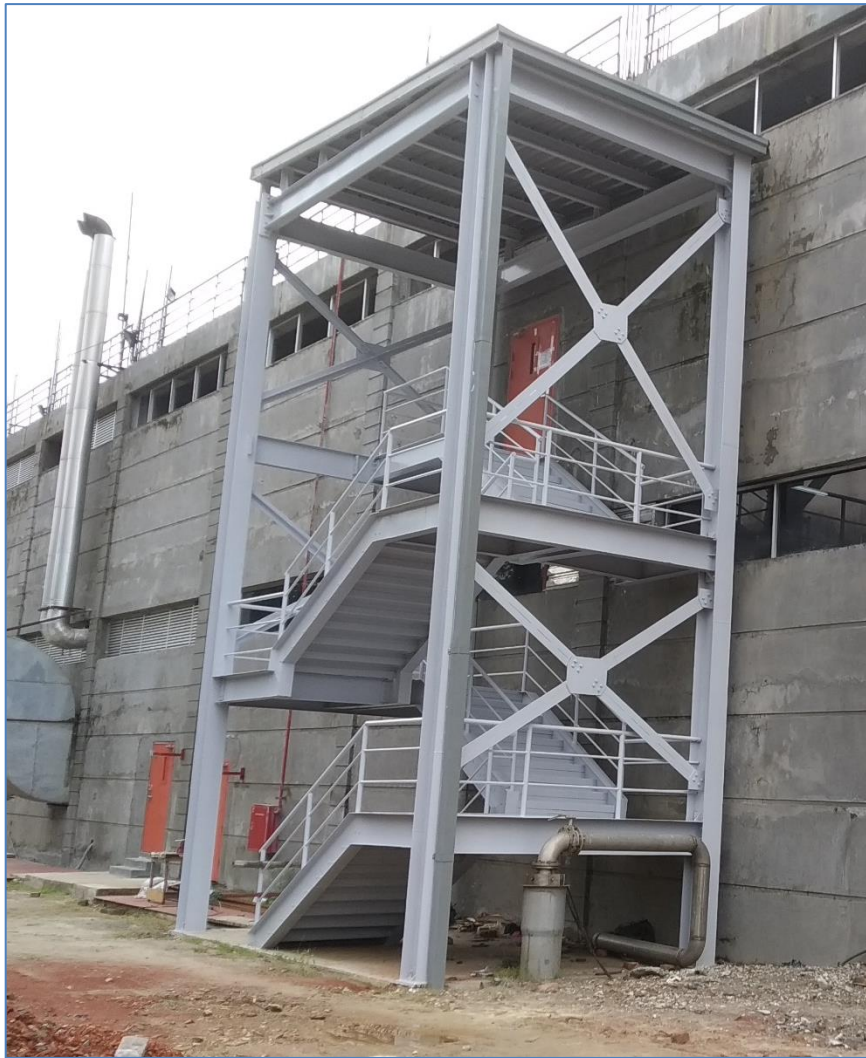
Steel stair

# **Incomplete as-built drawings of external steel stair**

During inspection, flange width of steel column was found 240 mm instead of 250 mm. On the other hand, connection details were not found in provided drawings.

| Item No. | Observation | Recommended Action Plan | Recommended Timeline |
|---|---|---|---|
| 12 | Incomplete as-built drawings of external steel stair. | Prepare “as constructed” drawings which reflect the actual site dimensions and provide connection details with complete structural information. | 6-weeks |
