# Lida Textile & Dyeing Limited- Extended Buildings- new unit

Shaheed Mosharaf Hossain Road, Purbo chandora, Shofipur, Kaliakoir, Gazipu  
(24.038054, 90.272752)

20<sup>th</sup> October 2020

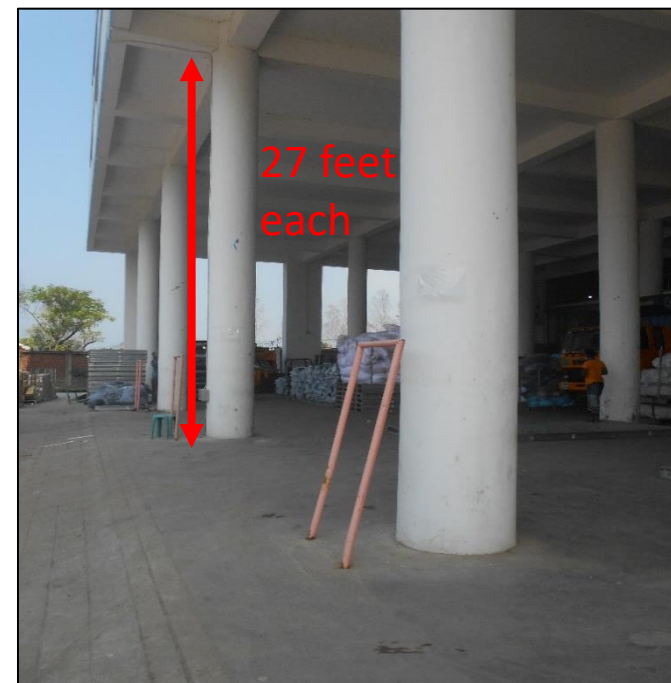
Ground floor columns are susceptible to long column effect

Ground floor column are 27 feet in dimension (length), marking the possibility of slenderness effect. Only the columns are carrying the total suspended loads. Factory is required to address these issues in the design report.

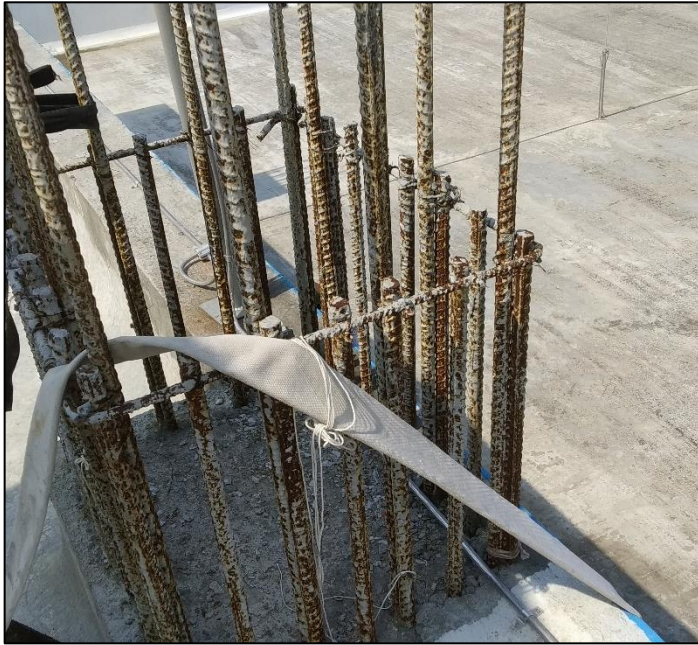
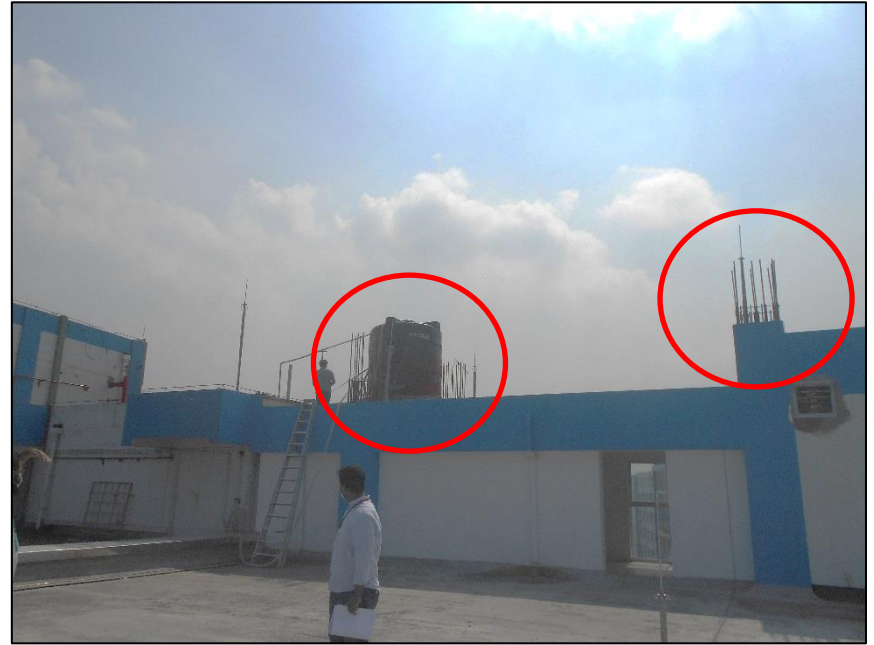
Exposed rebar at roof prone to corrosion

Exposed rebar was found at roof where the overhead water tank supposed to be constructed. The factory engineer is required to take necessary measures to prevent the corrosion in exposed re-bar.

| Item No. | Observation | Recommended Action Plan | Recommended Timeline |
|---|---|---|---|
| 04 | Exposed rebar at roof prone to corrosion (Automated Warehouse Extension Building) | The factory engineer is required to take necessary measures to prevent the corrosion in exposed re-bar. | 6-weeks |

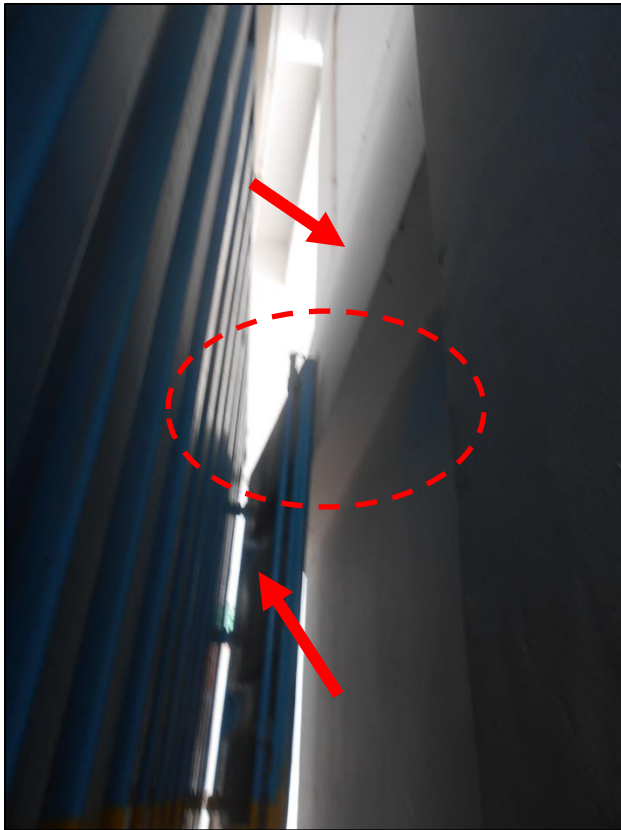
Ground floor stair beam is being impacted by the truck door

Structural members were found adjacent to the driveway of loading-unloading platform. These column are susceptible to vehicle impact. The factory engineer is required to take necessary measures to prevent the vehicle impact by providing the barrier around the structural members.

| Item No. | Observation | Recommended Action Plan | Recommended Timeline |
|---|---|---|---|
| 05 | Structural members susceptible to vehicular impact (Automated Warehouse Extension Building) | The factory engineer is required to take necessary measures to prevent the vehicle impact by providing the barrier around the structural members. | 6-weeks |

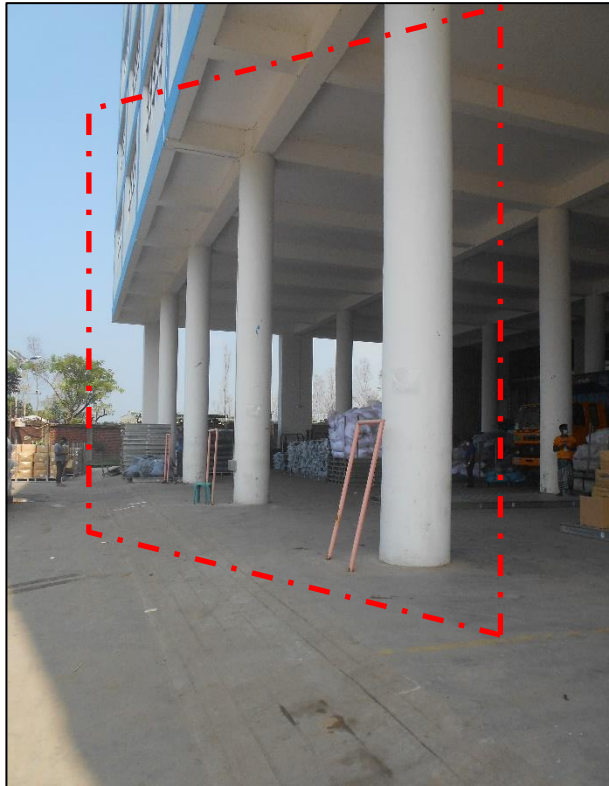
Insufficient column guard on ground floor exterior column only

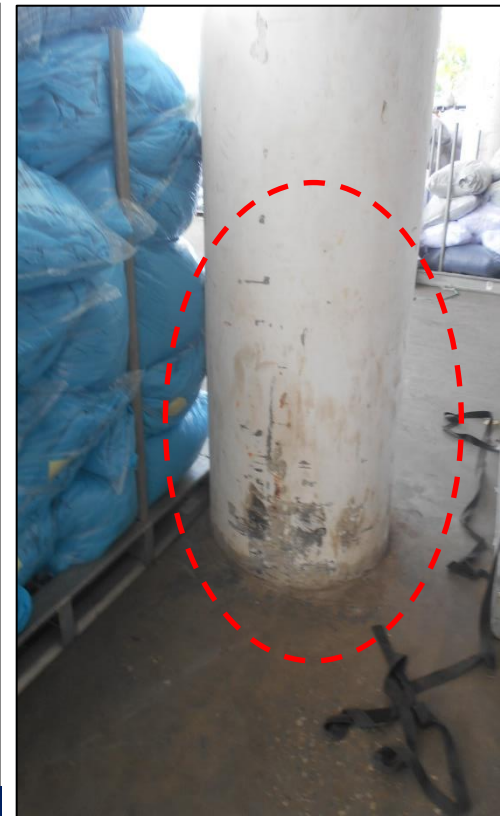
Sign of impact on ground floor internal column

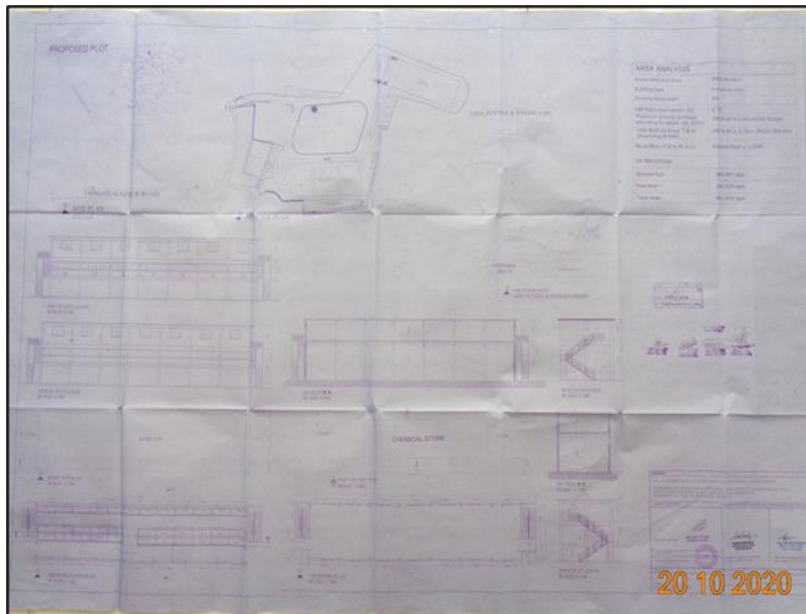
Approved layout plan from Pourashava

There were no credible as-built drawings and documents to review except permit drawing from Pourashava and Industrial layout from DIFE. Provided drawings were insufficient to represent the as-built structures. Factory engineer is required to survey the structures and prepare as-built drawings that are in compliance with section 1.9.1.2 as per BNBC.

| Item No. | Observation | Recommended Action Plan | Recommended Timeline |
|---|---|---|---|
| 06 | Lack of as-built drawings (Chemical Store) | Building Engineer to survey the structure and prepare accurate as-built (both architectural & structural) drawings. | 6-weeks |

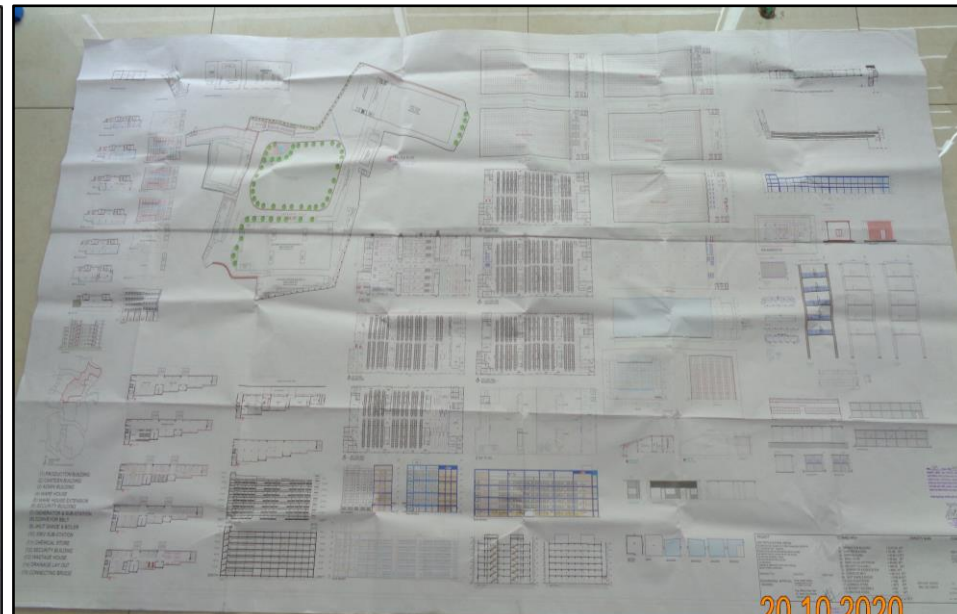
Approved layout plan from DIFE

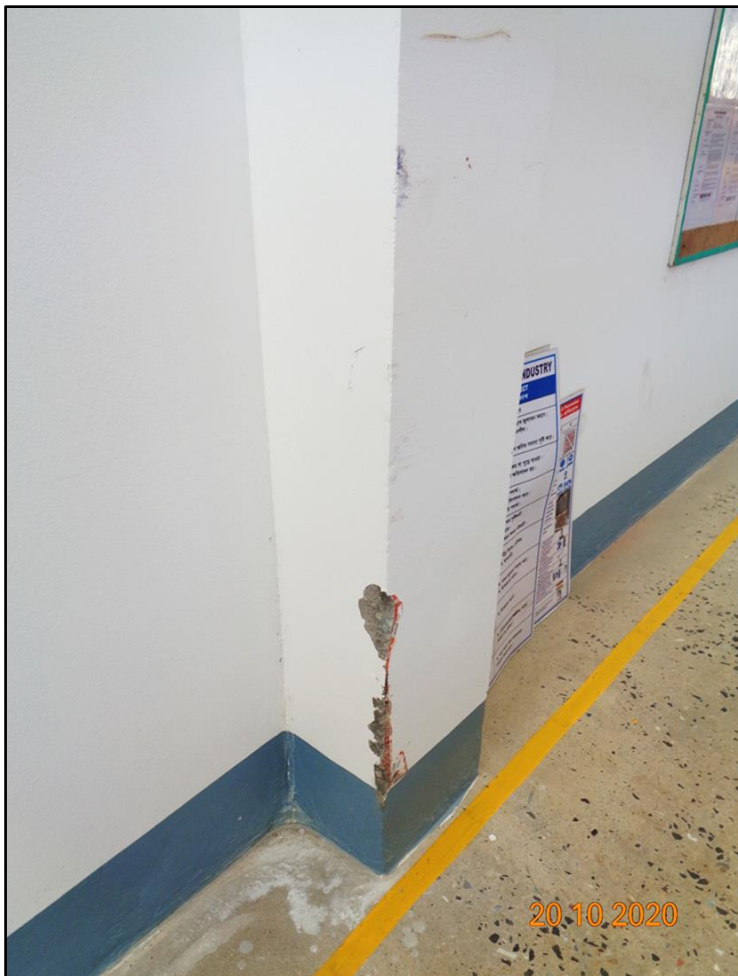
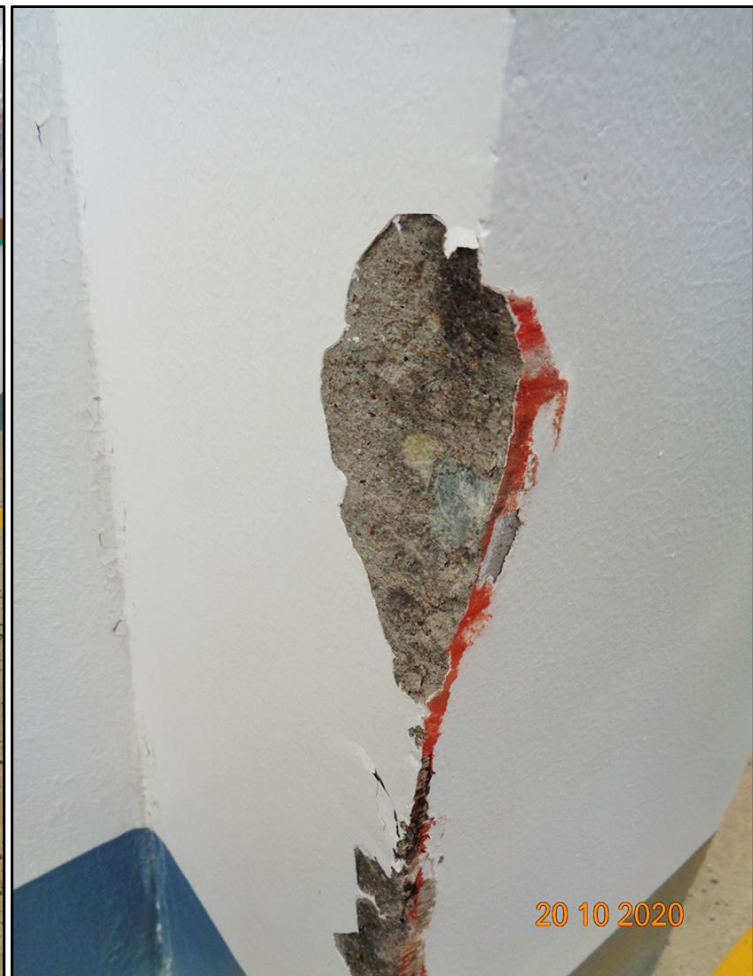
Column damaged due to trolley impact

Column adjacent to aisle was found damaged due to impact from trolley. The factory engineer is required to take necessary measures to repair the damage and to prevent the trolley impact by providing the barrier around the column.

| Item No. | Observation | Recommended Action Plan | Recommended Timeline |
|---|---|---|---|
| 09 | Susceptible to Trolley impact in column (Chemical Store) | The factory engineer is required to take necessary measures to repair the damage and to prevent the trolley impact by providing the barrier around the column. | 6-months |

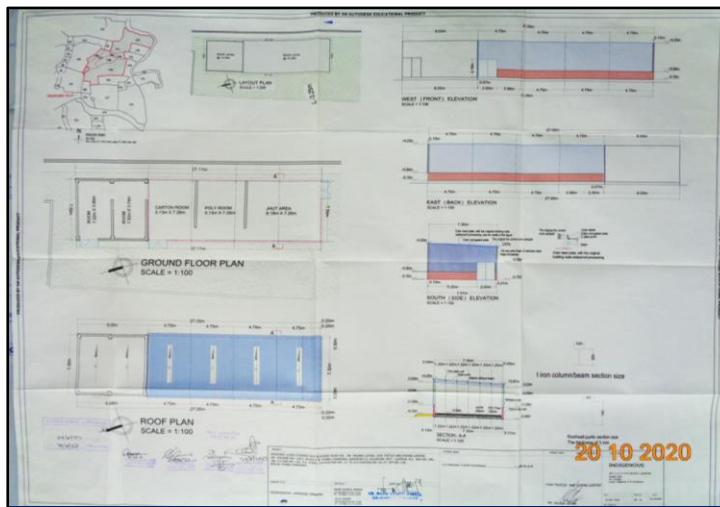
Approved layout plan from Pourashava

There were no credible as-built drawings and documents to review except permit drawing from Pourashava and Industrial layout from DIFE. Provided drawings were insufficient to represent the as-built structures. Factory engineer is required to survey the structures and prepare as-built drawings that are in compliance with section 1.9.1.2 as per BNBC.

| Item No. | Observation | Recommended Action Plan | Recommended Timeline |
|---|---|---|---|
| 10 | Lack of as-built drawings (Boiler & Jhut Building) | Building Engineer to survey the structure and prepare accurate as-built (both architectural & structural) drawings. | 6-weeks |

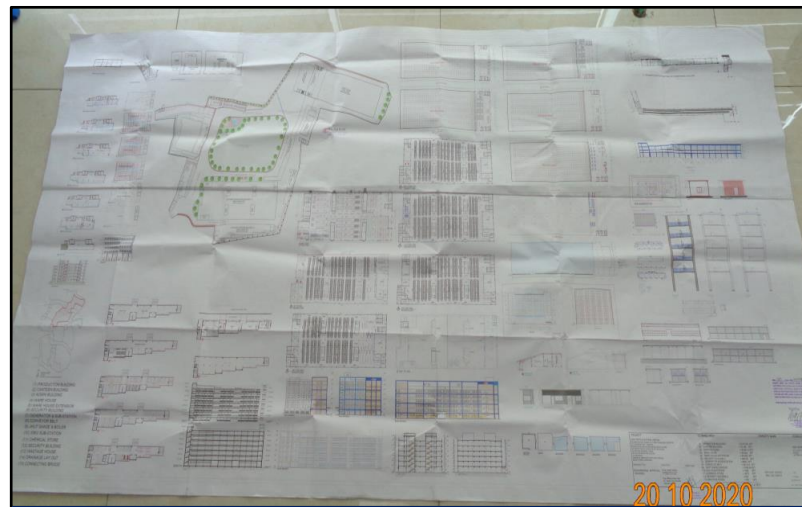
Approved layout plan from DIFE
