# Entrust Fashions Ltd. (Extended Building)

46/1, Nayanagar, Main Road, Chairmanbari Mor, Nayanagar, Turag ,Dhaka-1230  
(23.886710, 90.373640)  
12<sup>th</sup> January 2021

1. Shed-3 (G+1)

# Observations

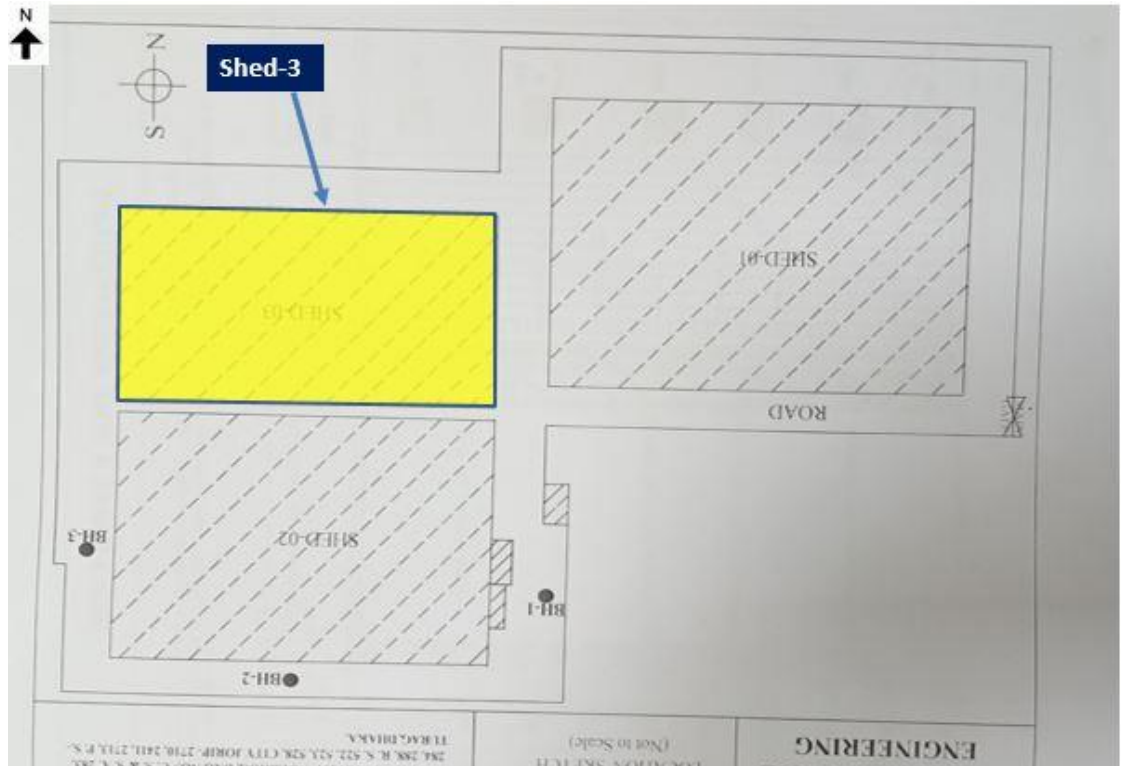
Bore hole layout in soil test report

In addition, all the bore hole locations in the soil test report were found far away from the shed-3. The bearing capacity of soil under shed-3 needs to be checked by conducting more test as per BNBC.

| Item No. | Observation | Recommended Action Plan | Recommended Timeline |
|---|---|---|---|
| 02 | Prepared design report required to be revised and submitted to RSC. | The bearing capacity of soil under shed-3 needs to be checked by conducting more test as per BNBC. | 6-weeks |

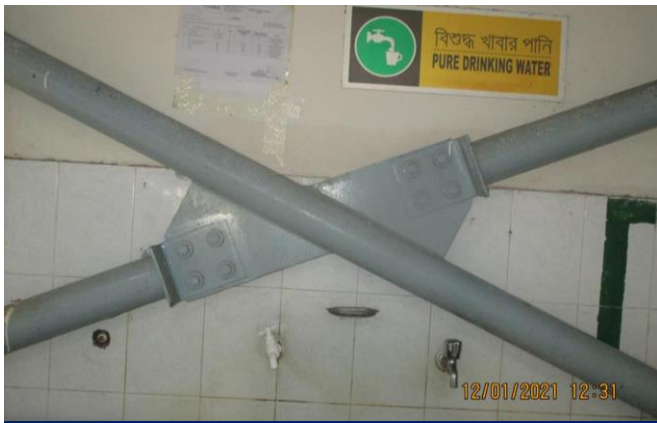
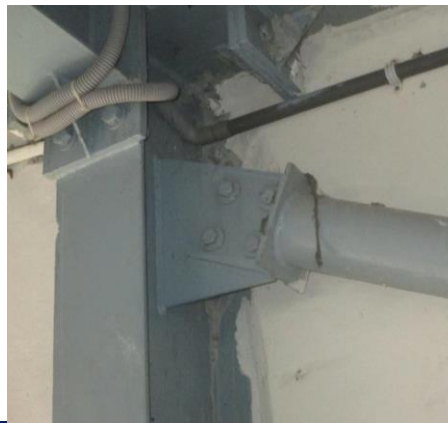
Connections of bracings observed on site

No connection details of the vertical bracings was provided in the as-built structural drawing of Shed-3.

| Item No. | Observation | Recommended Action Plan | Recommended Timeline |
|---|---|---|---|
| 04 | Incomplete as-built drawing. | Factory engineer is required to survey the whole structure and prepare “as constructed” drawings which reflect the actual site dimensions. | 6-weeks |

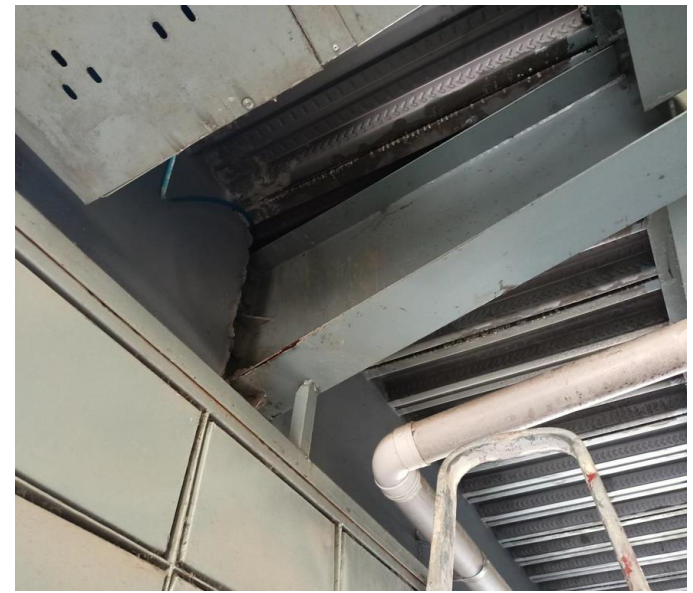
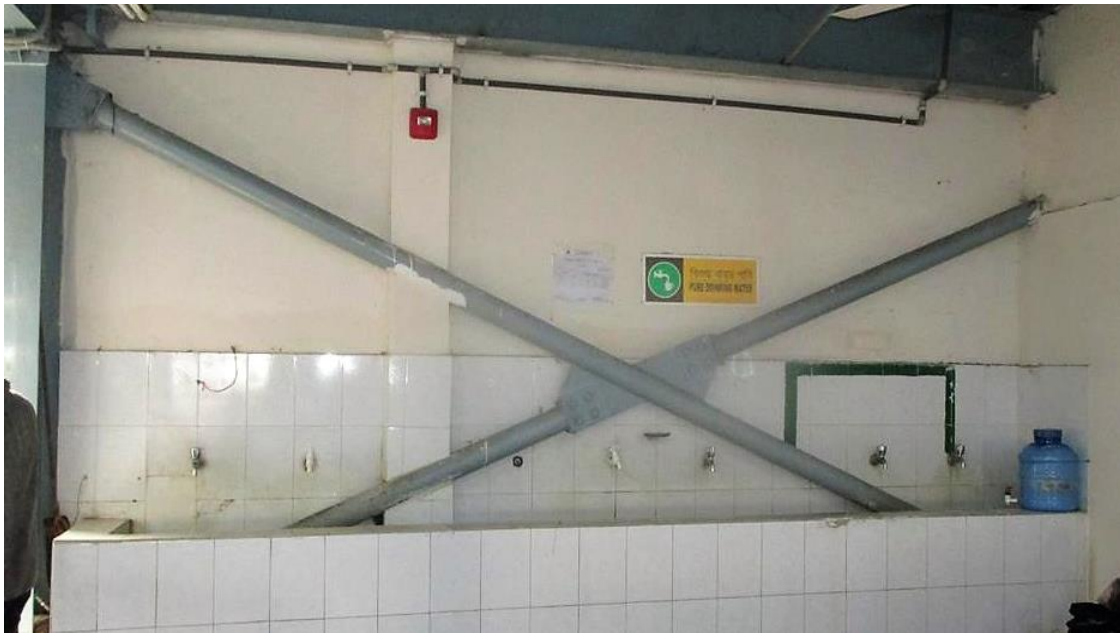
Connection details was not provided for the cantilever areas.

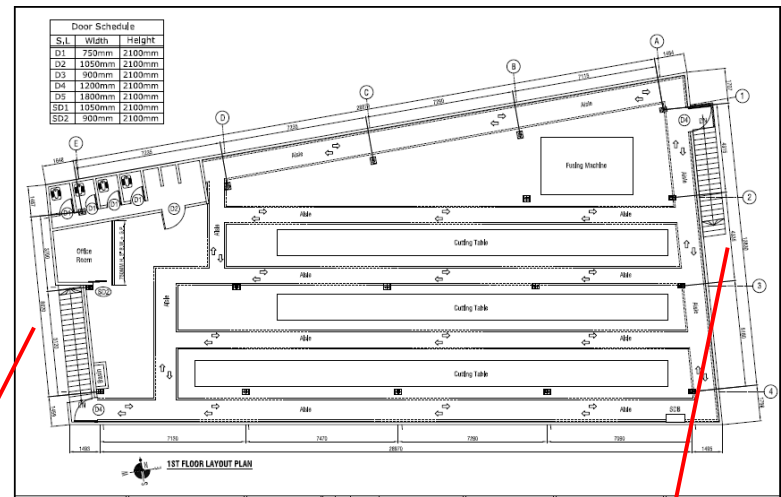
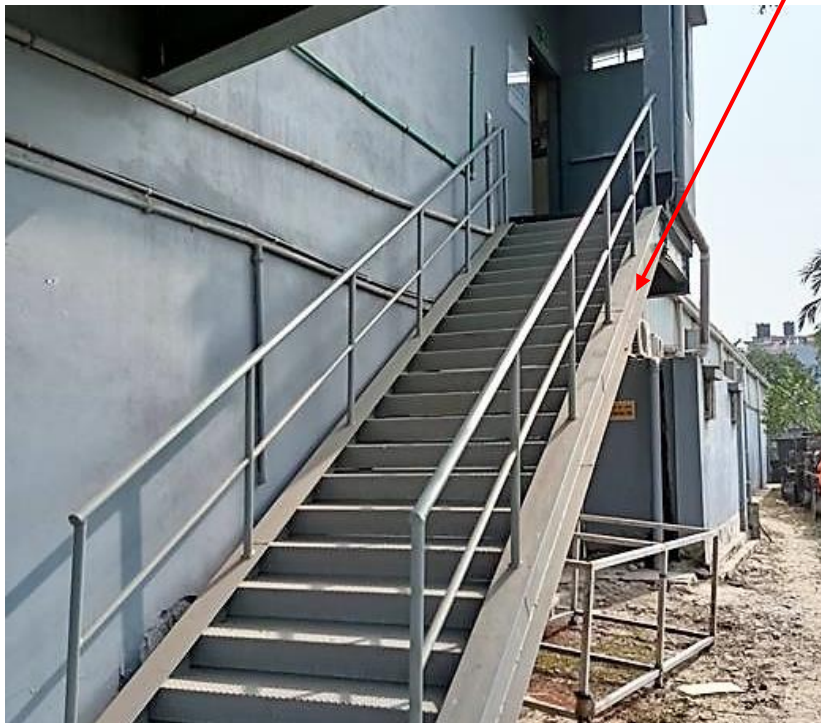
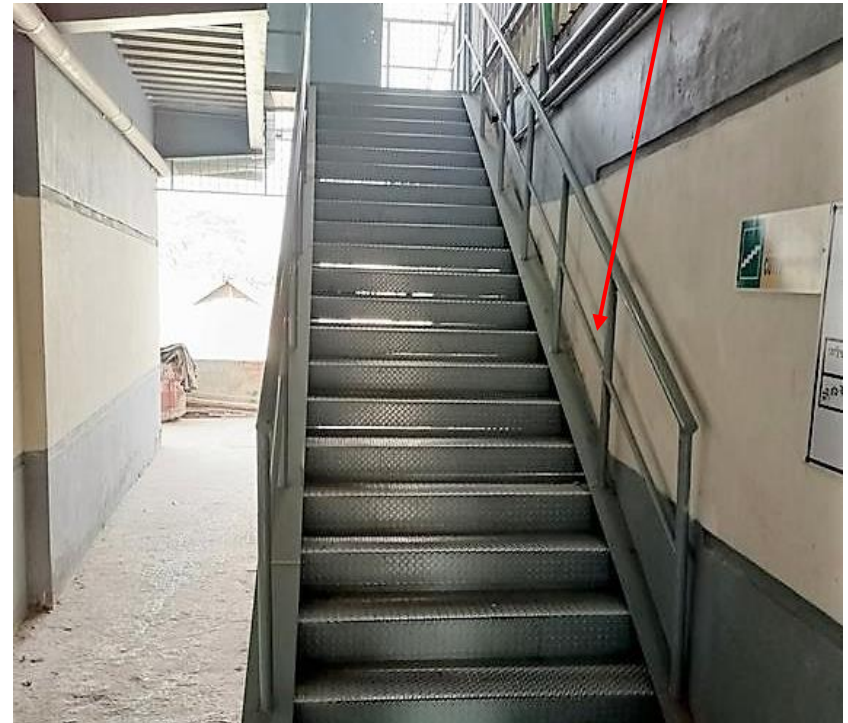
There are two steel stairs on east and west side of the shed. No details of the stairs was provided in the as-built structural drawing.

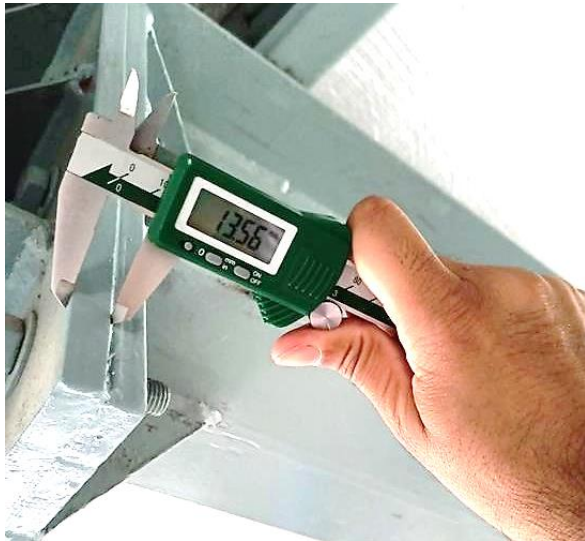
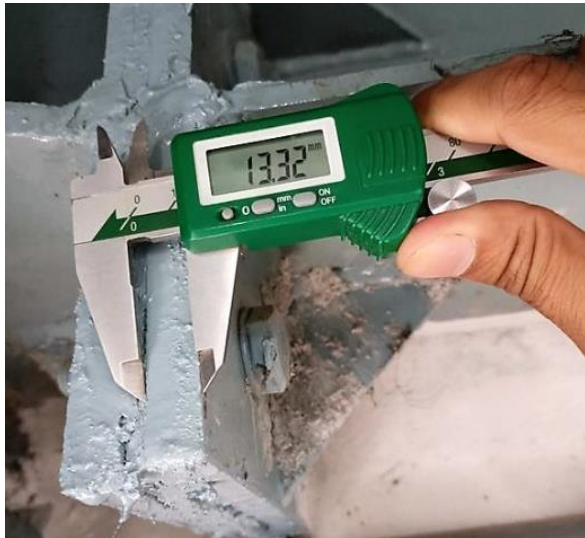
Joint plate thickness was found different with drawings in several locations. Also, no connection adequacy check was provided in the design report. Connection adequacy, lateral displacement and vertical deflection check required to be incorporated in design report in accordance with BNBC requirement.

Joint plate thickness was found  
13mm at several locations

| Item No. | Observation | Recommended Action Plan | Recommended Timeline |
|---|---|---|---|
| 01 | Prepared design report required to be revised and submitted to RSC. | Connection adequacy check required to be incorporated in design report. Also, Provide lateral displacement and vertical deflection check in report. | 6-weeks |

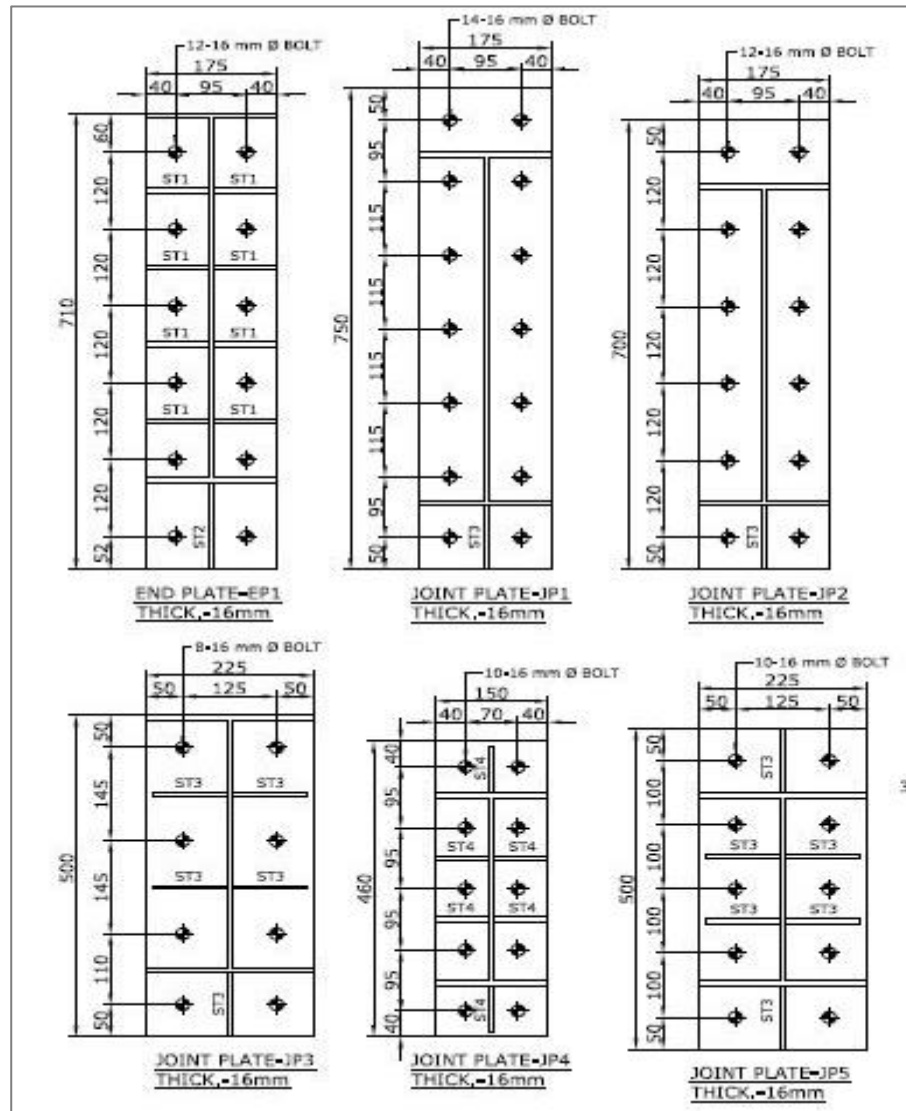
In connection details drawing all the joint plate thickness were mentioned as 16 mm.

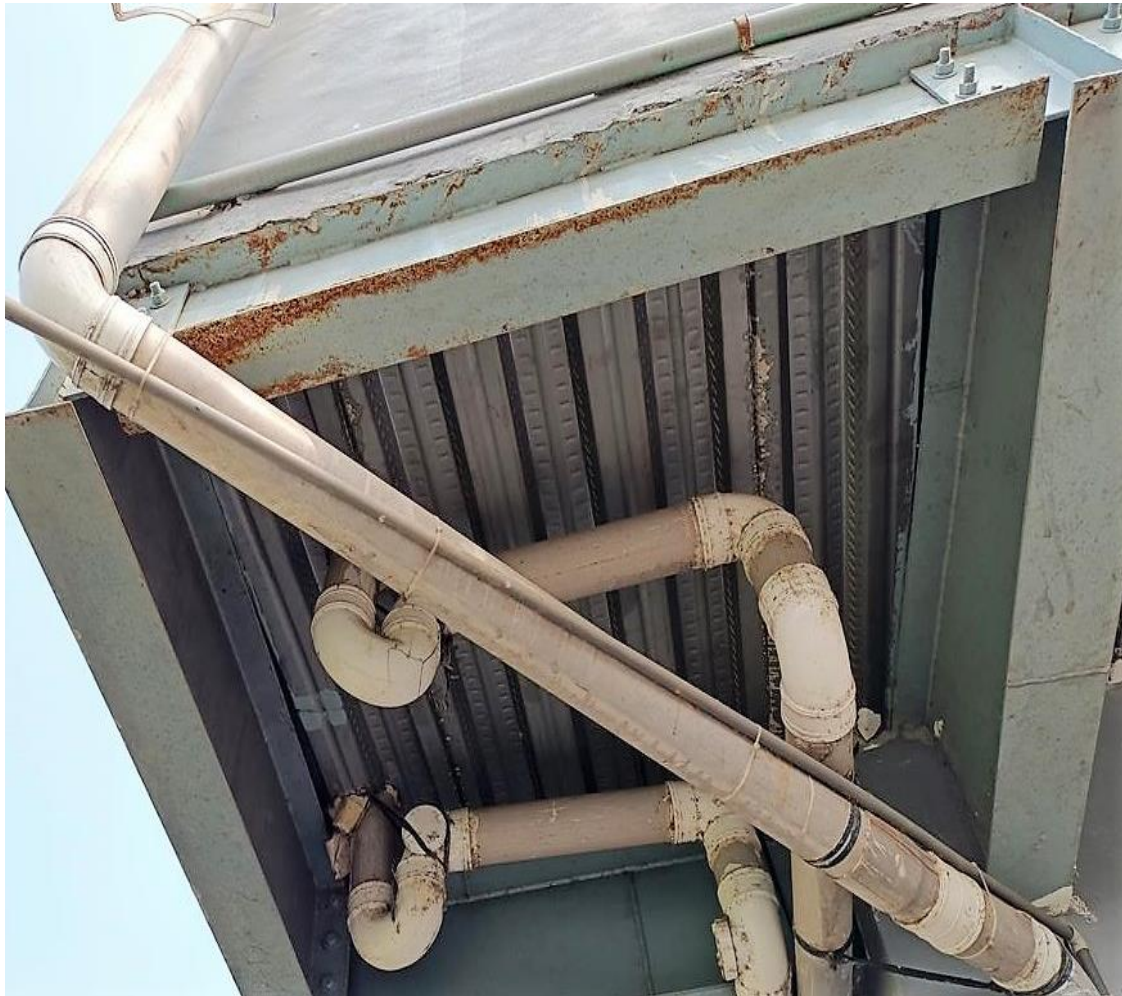
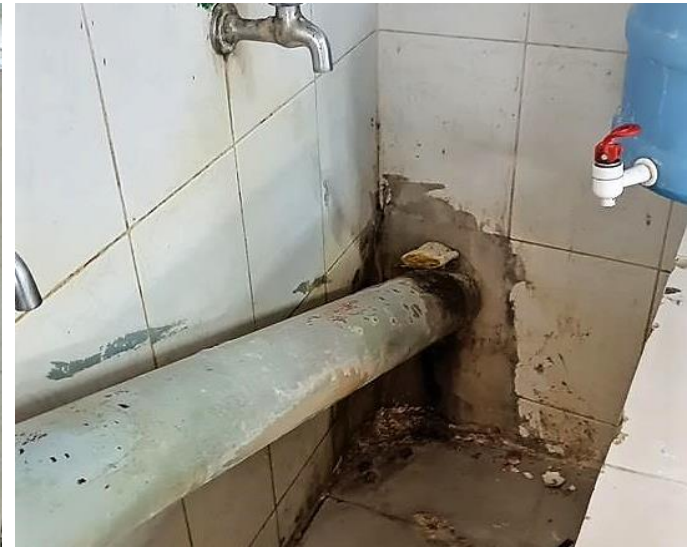
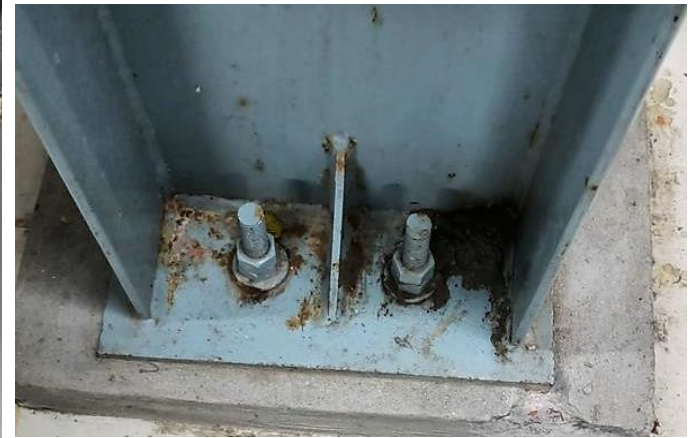
Corrosions were observed on several structural members (Beams, columns & bracings).

| Item No. | Observation | Recommended Action Plan | Recommended Timeline |
|---|---|---|---|
| 05 | Corrosion on structural members. | Factory engineer is required to take remedial measures to protect the structural members from corrosion. | 6-weeks |
