# Crown Exclusive Wears Ltd. (Extended Building)

Mawna, Sreepur, Gazipur Bangladesh

2<sup>nd</sup> December 2020

# Building Information

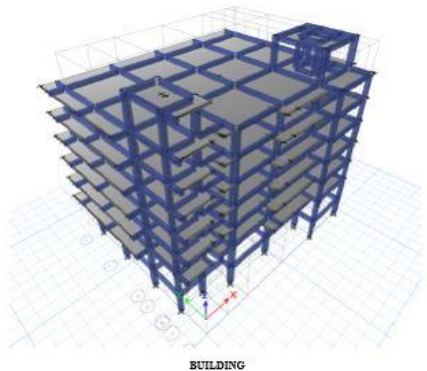
**Prepared design report not compliant with  
BNBC**

Serviceability checks as per BNBC were not provided in the design report. Also, brick wall load was not assigned in FEM model. Building engineer is required to check the serviceability issues as per BNBC and incorporate proper loading assignment in the design report.

| Item No. | Observation | Recommended Action Plan | Recommended Timeline |
|---|---|---|---|
| 01 | Prepared design report not compliant with BNBC | Building engineer is required to check the serviceability issues as per BNBC and incorporate proper loading assignment in the design report. | 6-weeks |
| 02 | Prepared design report not compliant with BNBC | Complete implementation of any remedial works deemed necessary by the design report. | 6-months |

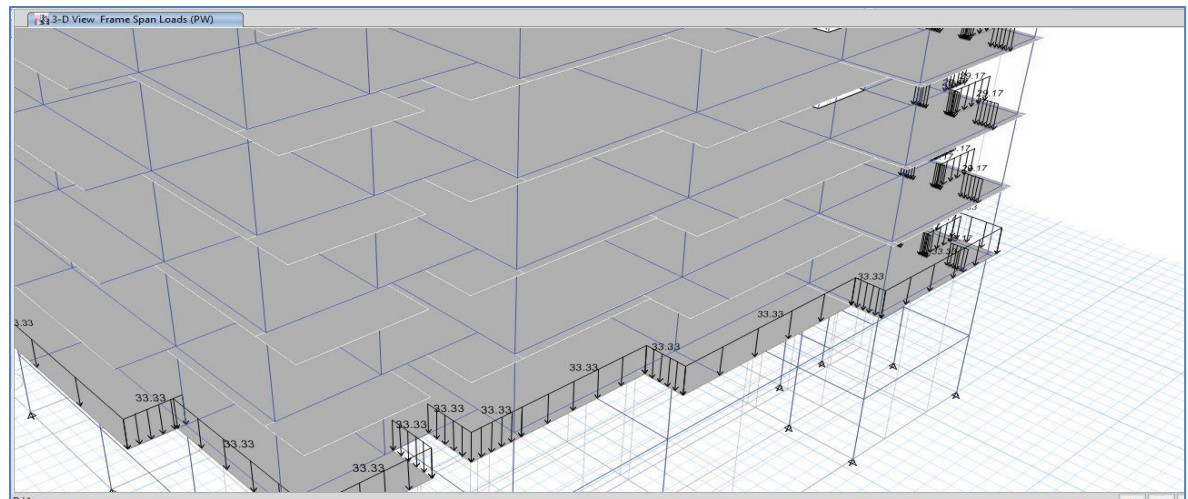
Design report

As per BNBC every building or structure designed shall have its design documents prepared in accordance with the provision of Section 1.9.1. The design document shall include a design report, and a set of structural drawings, which shall be prepared in compliance with section 1.9.1.1 and section 1.9.1.2 as per BNBC.

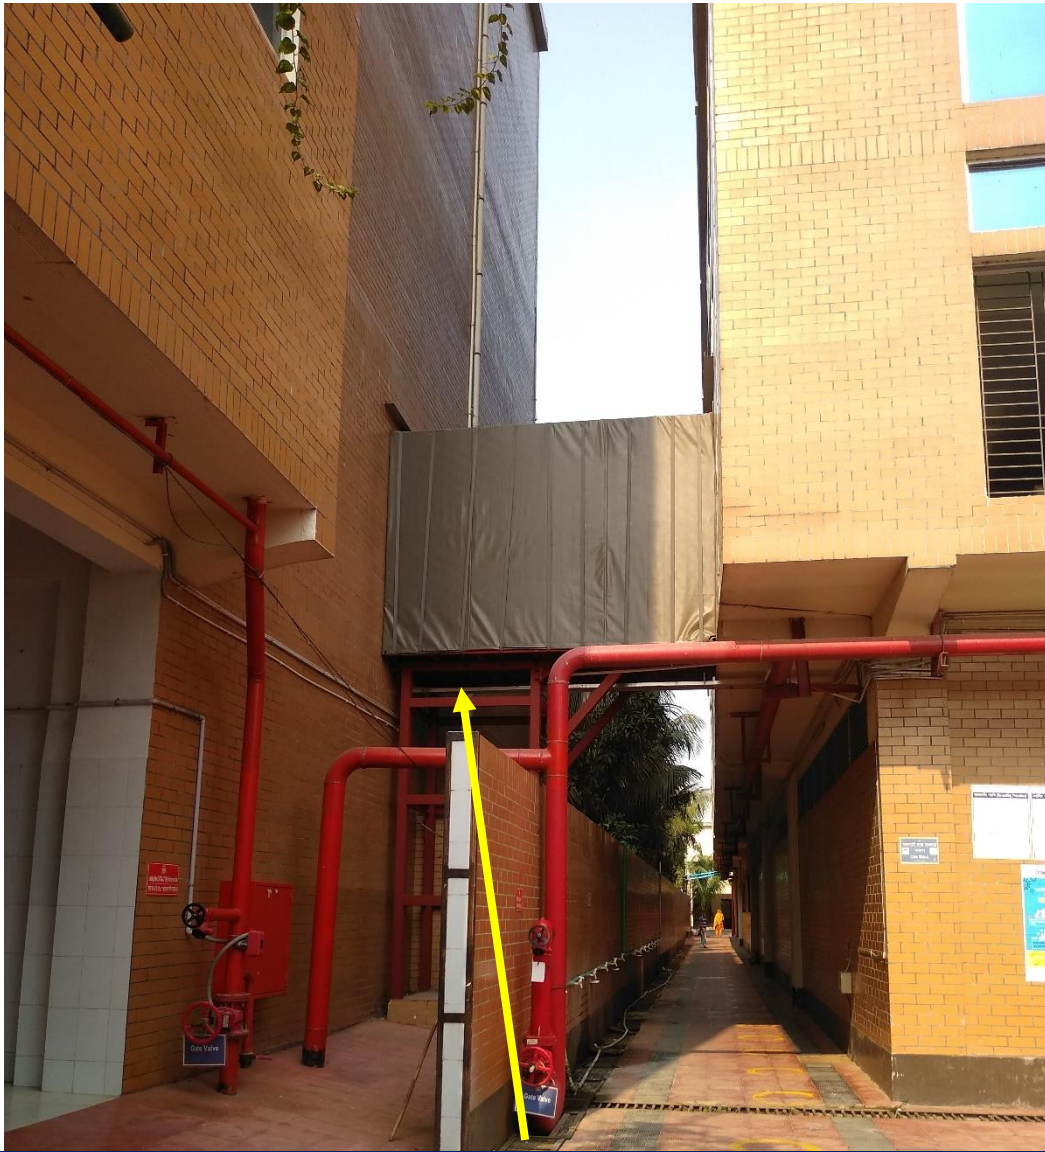
Connection bridge

# **Lack of information in as-built drawing of connection bridge**

Connection details are not provided in as-built drawing of connection bridge. Building engineer is required to prepare proper as-built drawings.

| Item No. | Observation | Recommended Action Plan | Recommended Timeline |
|---|---|---|---|
| 03 | Lack of information in as-built drawing of connection bridge. | Building engineer is required to prepare full set of as-built drawing including connection. | 6-weeks |

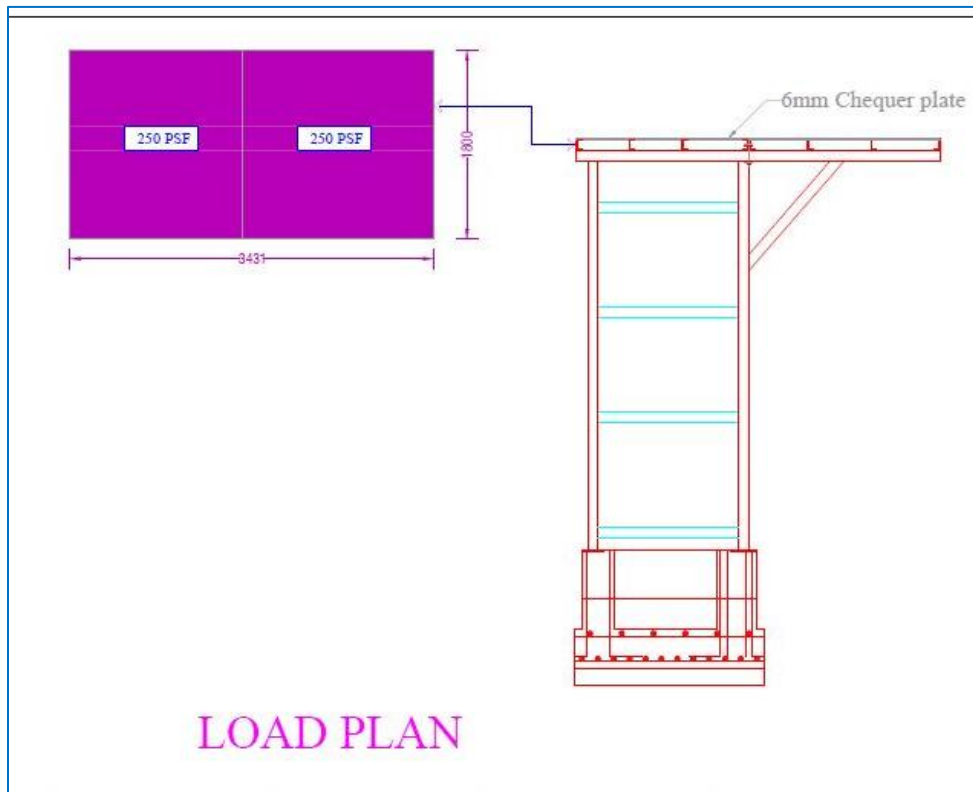
Load Plan

A set of load plan (considering 250 psf live load) has been prepared for the connecting bridge. But no deflection check and connection adequacy have been provided in the design report. Building engineer is required to check the serviceability issues as per BNBC and incorporate proper loading assignment in the design report.

| Item No. | Observation | Recommended Action Plan | Recommended Timeline |
|---|---|---|---|
| 04 | Design report required to be revised. | Building Engineer is required to incorporate the deflection check and connection adequacy in design report as per BNBC-2006. | 6-weeks |
| 05 | Design report required to be revised. | Complete implementation of any remedial works deemed necessary by the design report. | 6-months |
