# KM Nobely Garments Ltd.

Zorun, Konabari Gazipur-1702.

21<sup>st</sup> December 2020

# Observations

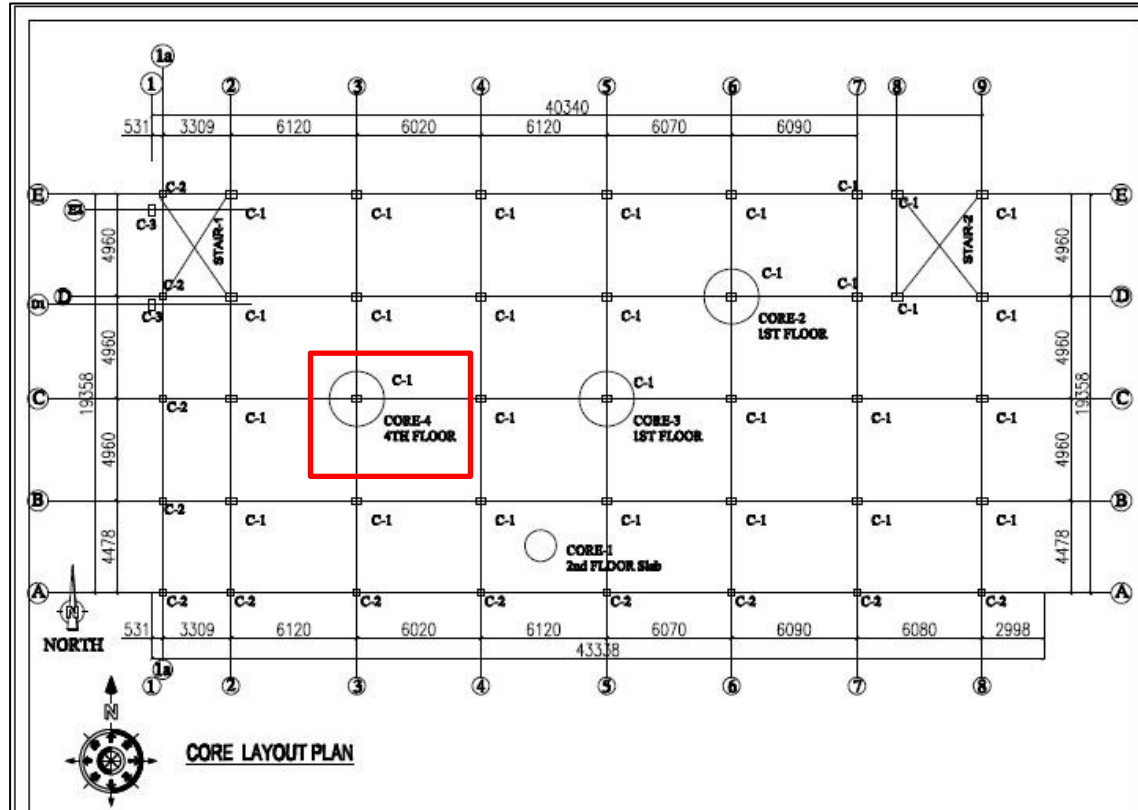
Core layout plan

Total four number of concrete core samples are taken, three samples taken from column & one sample taken from slab. As per core layout plan one core sample was taken from the 4<sup>th</sup> floor column which is actually constructed for encasing the steel column for fire protection. Factory engineer is required to take minimum number of core samples from columns to evaluate concrete strength.

| Item No. | Observation | Recommended Action Plan | Recommended Timeline |
|---|---|---|---|
| 02 | Design report not fully comply as per BNBC. (Production Building) | Verify in situ concrete strength by taken 100 mm diameter cores (minimum 4 nos.) from lower tier columns. | 6-weeks |

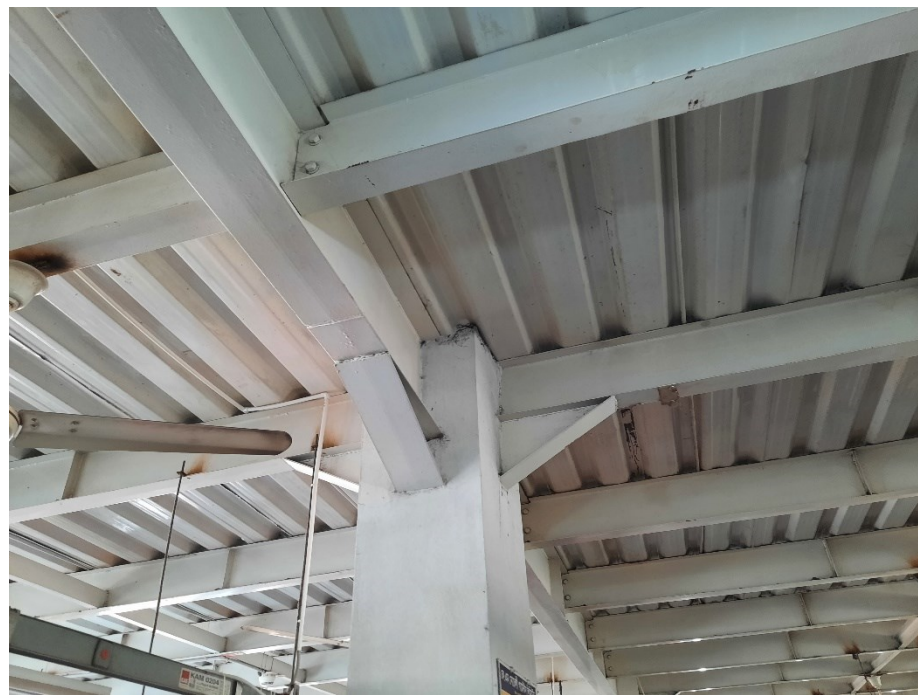
Overall stability of 3<sup>rd</sup> & 4<sup>th</sup> floor achieved by the frame action (Main beam in long direction, Sub-beam in short direction) & vertical bracings.

The connection of the frame could not be confirmed due to the RC encasement. Building engineer is required to check the connection type & requirement of any additional features. Serviceability and stability check in the design report is required to comply with BNBC.

| Item No. | Observation | Recommended Action Plan | Recommended Timeline |
|---|---|---|---|
| 03 | Design report not fully comply as per BNBC. (Production Building) | Building engineer is required to check the connection type & requirement of any additional features. | 6-weeks |

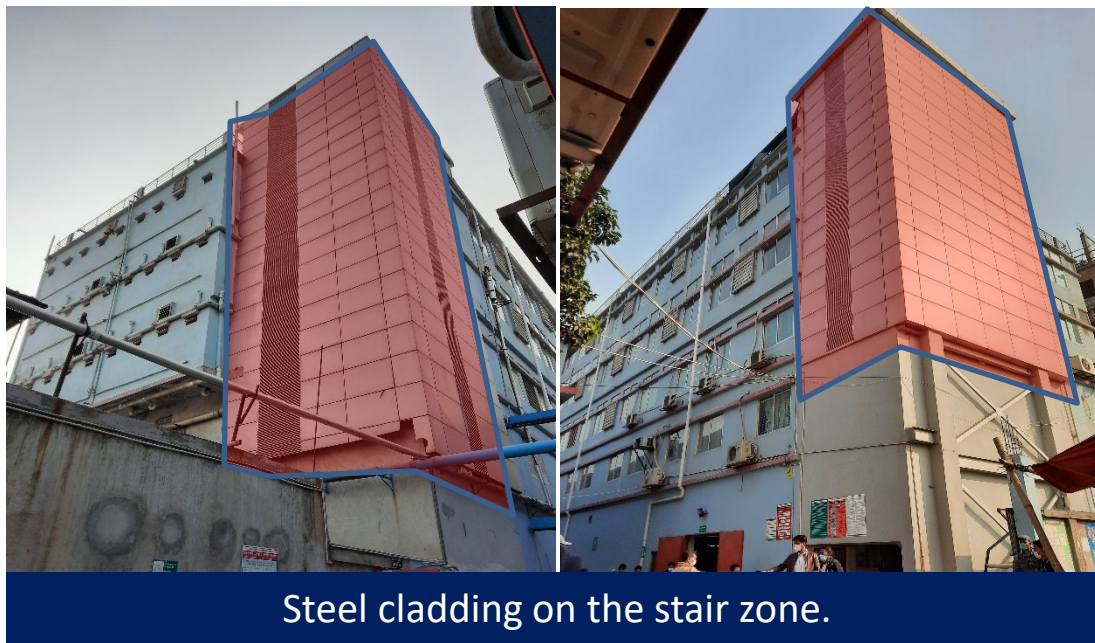
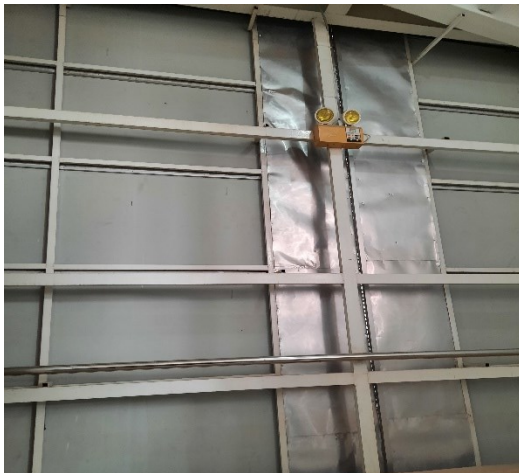
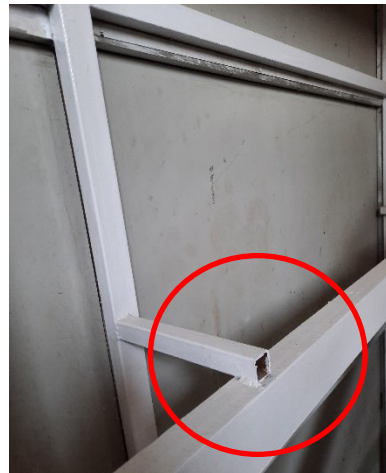
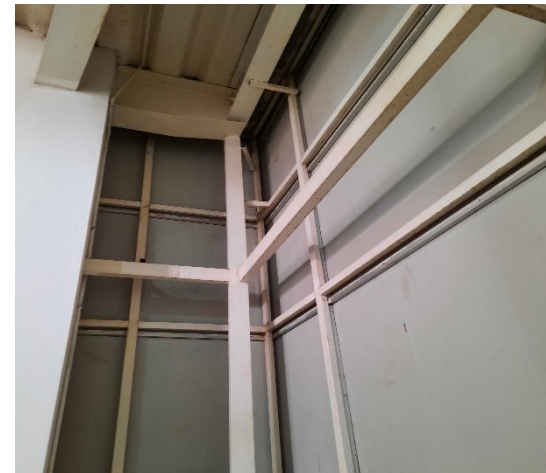
**Apparently inadequate connection of steel cladding.  
(Production Building)**

Apparently poor connection in the steel cladding system. Building engineer is required to check the connection adequacy against the wind loading.

| Item No. | Observation | Recommended Action Plan | Recommended Timeline |
|---|---|---|---|
| 06 | Apparently inadequate connection of steel cladding. (Production Building) | Building engineer is required to check the connection adequacy against the wind loading. | 6-weeks |
| 07 | Apparently inadequate connection of steel cladding. (Production Building) | Complete implementation of any remedial works where necessary. | 6-months |

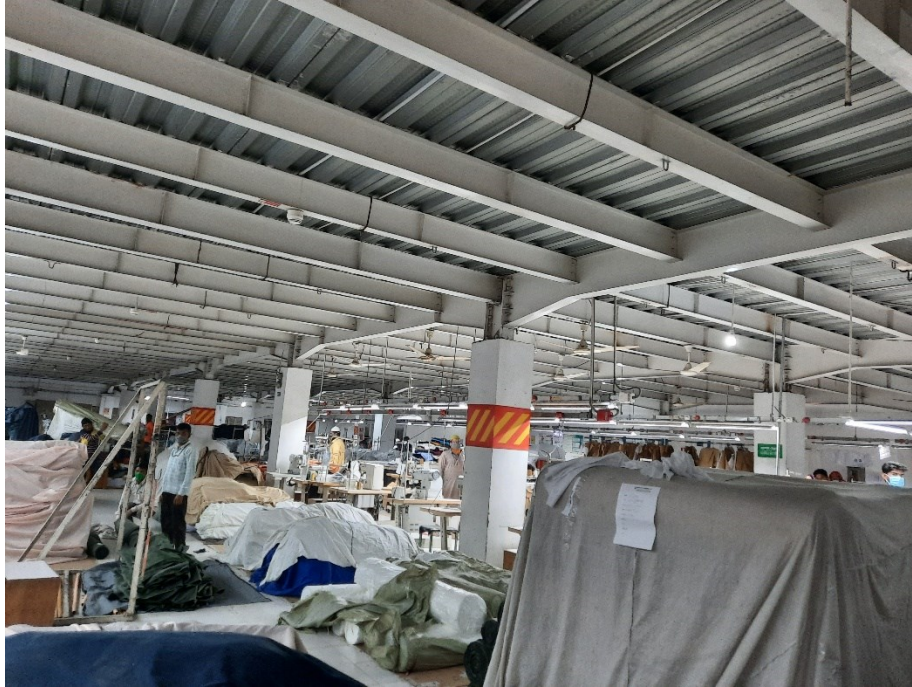
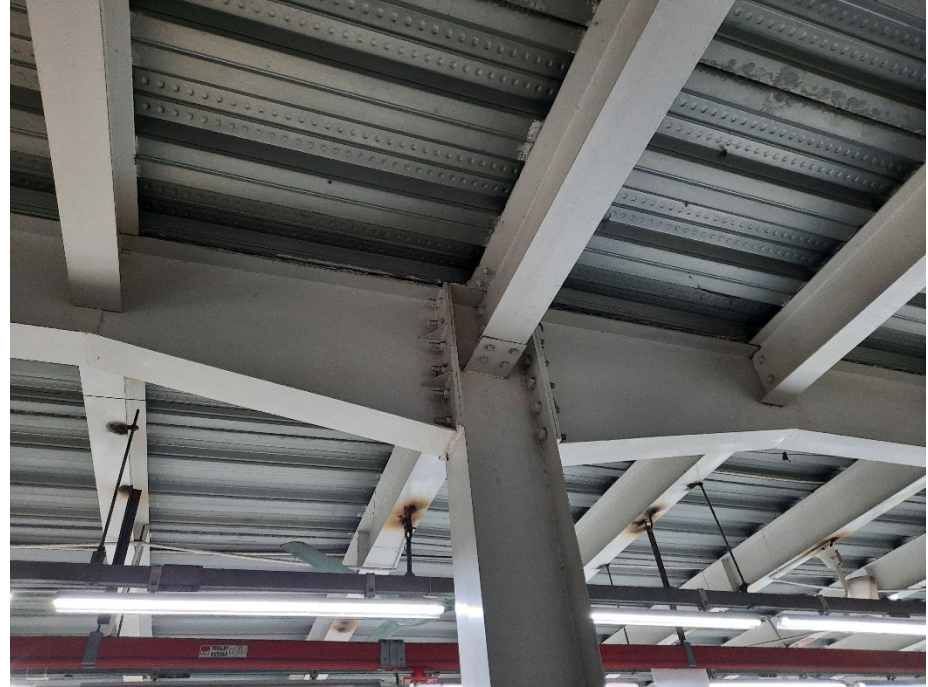
**Apparently partial rigidity in the frame connection.  
(Production Shed)**

Partially fixed connection was observed at beams and column joint connected by bolts. Apparently partial moment resisting frame action may govern that can affect the stability. Building engineer is required to review the connection adequacy and overall stability system in the design report.

| Item No. | Observation | Recommended Action Plan | Recommended Timeline |
|---|---|---|---|
| 08 | Apparently partial rigidity in the frame connection. (Production Shed) | Building engineer is required to review the connection adequacy and overall stability system in the design report. | 6-weeks |

| Item No. | Observation | Recommended Action Plan | Recommended Timeline |
|---|---|---|---|
| 10 | Apparently partial rigidity in the frame connection. (Production Shed) | Carryout remedial works where necessary. | 6-months |

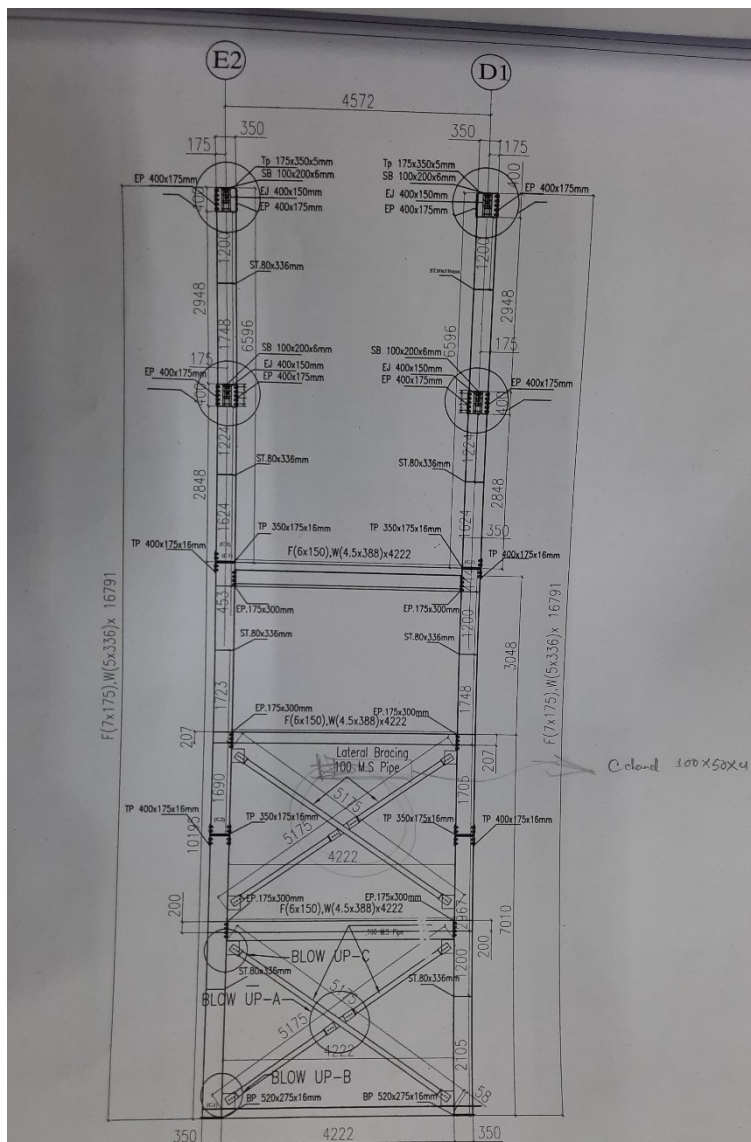
Bracing elevation on drawing

100 mm diameter pipe bracing shown on drawing, onsite C channel of 100 mm X 50 mm X 4 mm bracing was found.

| Item No. | Observation | Recommended Action Plan | Recommended Timeline |
|---|---|---|---|
| 11 | Inconsistency in the drawings. (Production Building & Shed) | Building engineer is required to survey the both structures and prepared as constructed drawings. | 6-weeks |

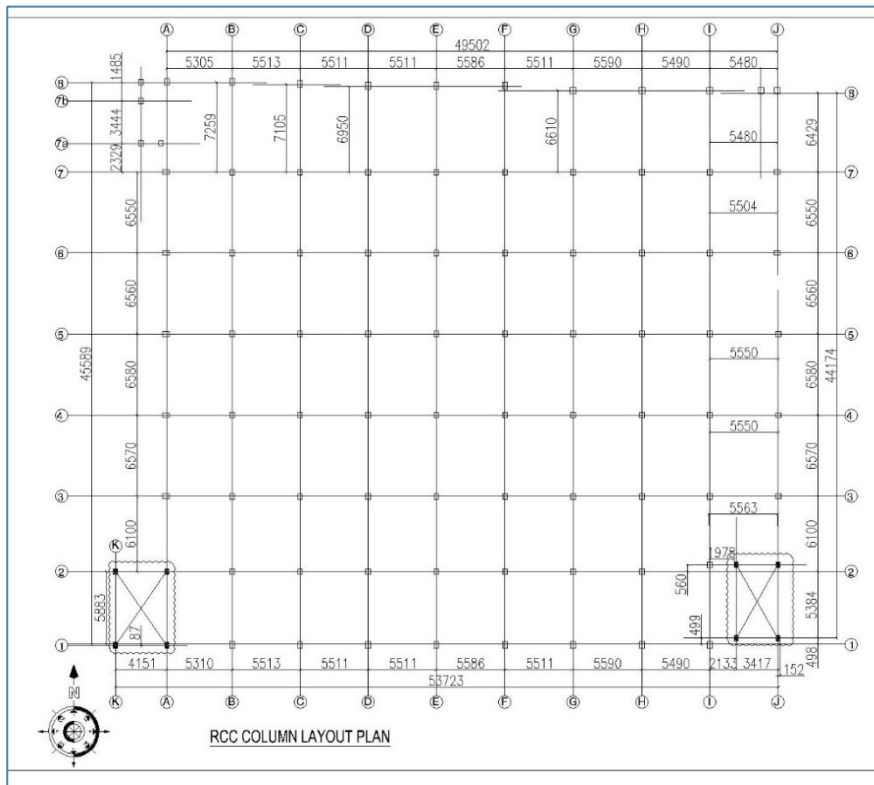
RC column layout plan

As-built drawing shows 12 number of rebars in the C5 column. But on site 8 number of rebars were counted by ferro scanning.
