# Multifabs Ltd (New Building)

Nayapara, Kashimpur, Gazipur.

01<sup>st</sup> December 2020

## 1. New Building (G+7)

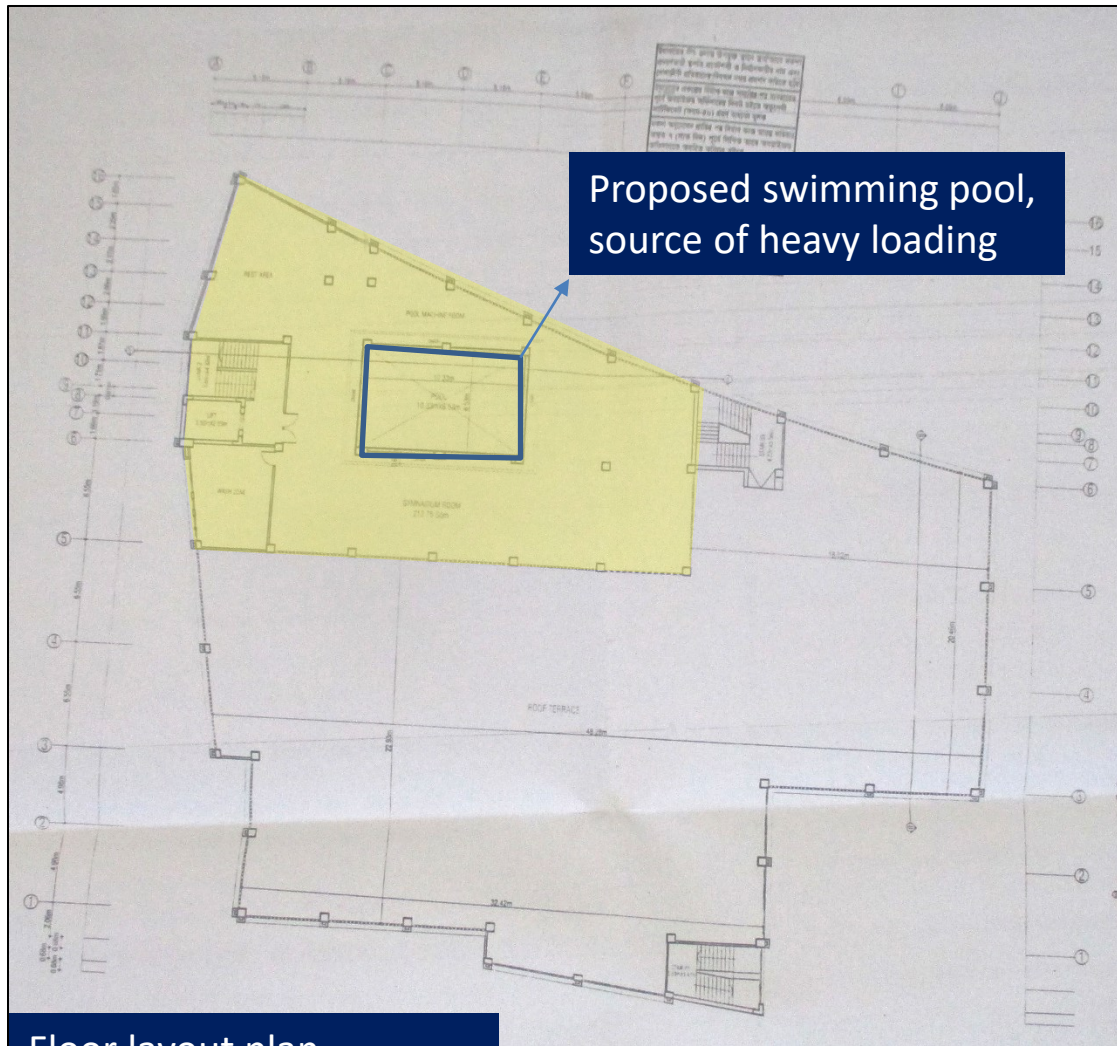
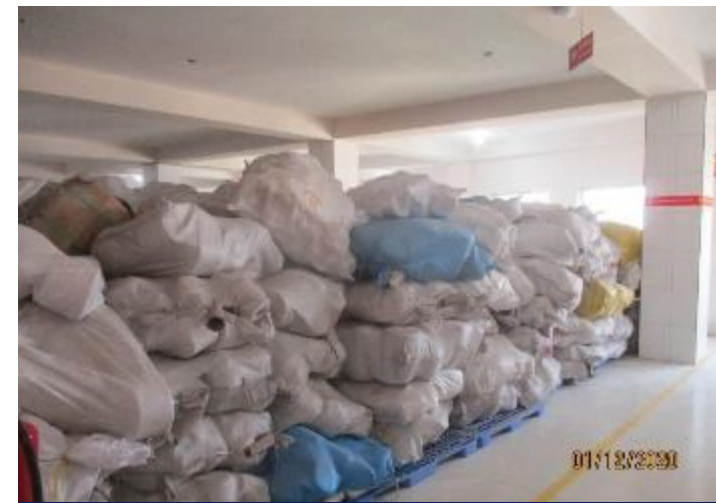
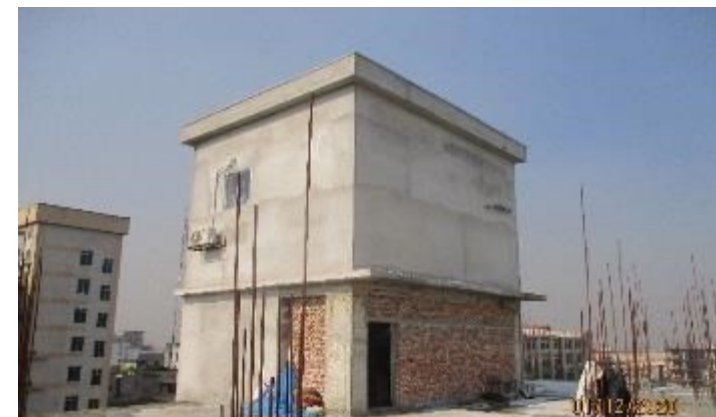
**Column to be stressed above normal design limit  
considering full construction**

Cursory calculation indicates that the marked columns are stressed above normal design limit considering prepared live load plan and equivalent concrete strength from concrete core test value. Factory engineer is required to review design, load & column stress in the area identified above.

| Item No. | Observation | Recommended Action Plan | Recommended Timeline |
|---|---|---|---|
| 01 | Column to be stressed above normal design limit considering full construction. | Factory Engineer to review design, loads and columns stresses in area identified above. | 6-weeks |
| 02 | Column to be stressed above normal design limit considering full construction. | Produce and actively manage a loading plan for all floor plates within the factory, considering floor, column and foundation capacity. | 6-weeks |
| 03 | Column to be stressed above normal design limit considering full construction. | Complete implementation of any remedial works deemed necessary by the Engineering Assessment (EA). | 6-months |
| 04 | Column to be stressed above normal design limit considering full construction. | Continue to implement loading plan. | 6-months |

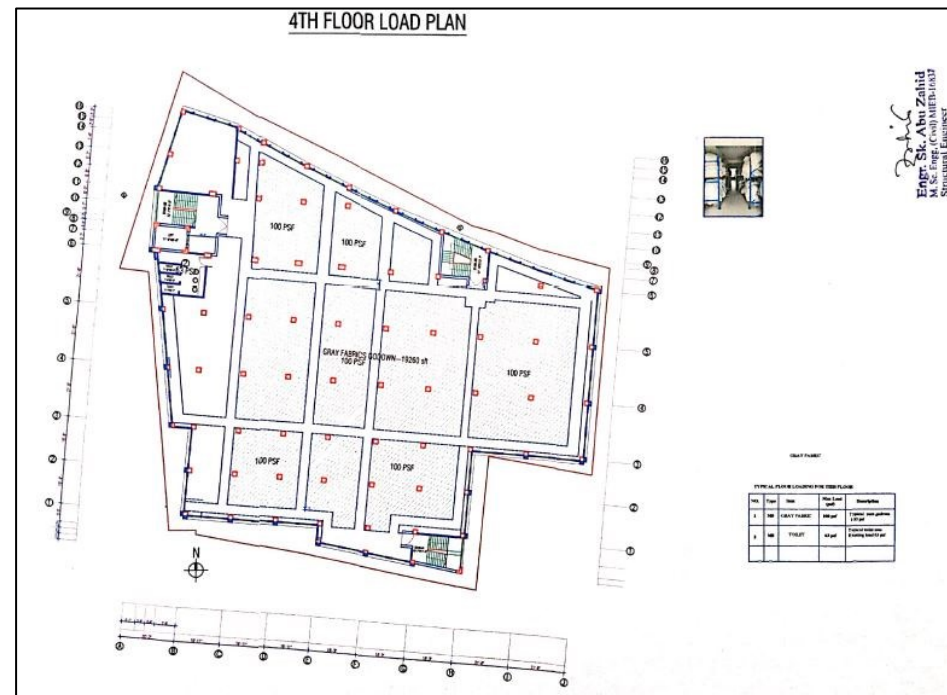
## 4<sup>th</sup> floor load plan

Load bearing certificate do not match with the prepared load plan. Also, equivalent concrete strength do not match with core test values and load bearing certificates.

**Engineering Assessment (EA) requires to be prepared**

| Item No. | Observation | Recommended Action Plan | Recommended Timeline |
|---|---|---|---|
| 05 | Engineering Assessment (EA) requires to be prepared. | Factory engineer to prepare the Engineering Assessment (EA) including a design report, and a set of structural drawings in compliance with section 1.9.1.1 and section 1.9.1.2 as per BNBC. | 6-weeks |

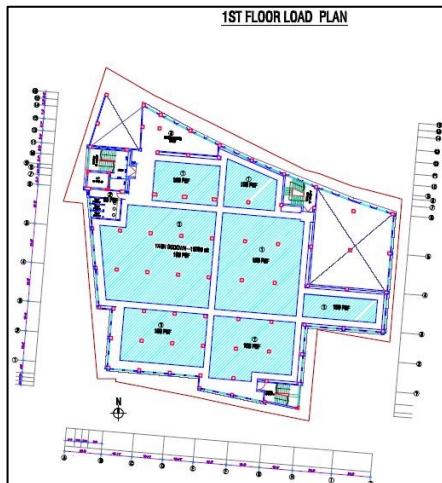
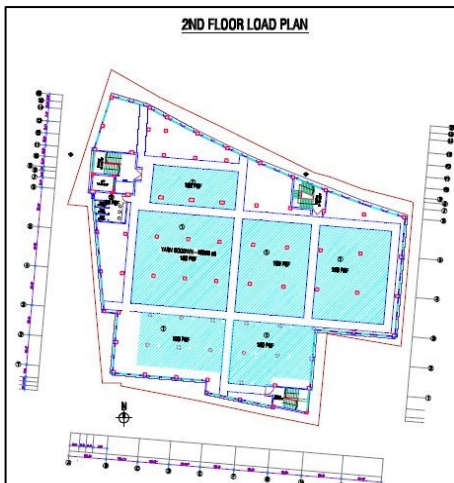
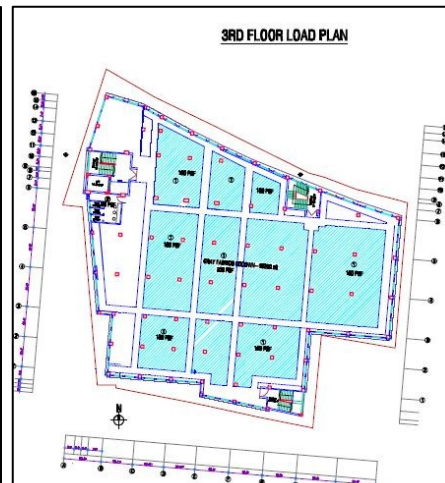
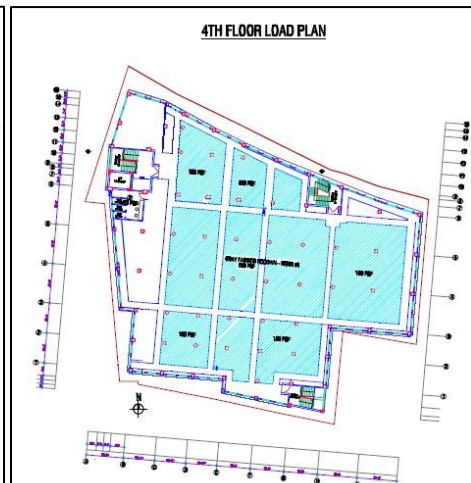
Load plan for 1<sup>st</sup> to 4<sup>th</sup> floor. - Floor loading has been shown (100 psf) 4.79 kPa.

As per BNBC, 6 kPa is required to consider as floor loading for the light storage facilities. During inspection, load plan was found posted considering (100 psf) 4.79 kPa from 1<sup>st</sup> to 4<sup>th</sup> floor and 3kpa for 5<sup>th</sup> floor.

| Item No. | Observation | Recommended Action Plan | Recommended Timeline |
|---|---|---|---|
| 06 | Engineering Assessment (EA) requires to be prepared. | Produce and actively manage a loading plan for all floor plates within the factory, considering floor, column and foundation capacity. | 6-weeks |

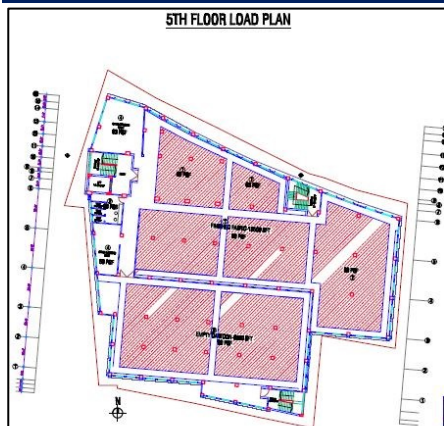
Load plan for 5<sup>th</sup> Floor loading has been shown 3 kPa.

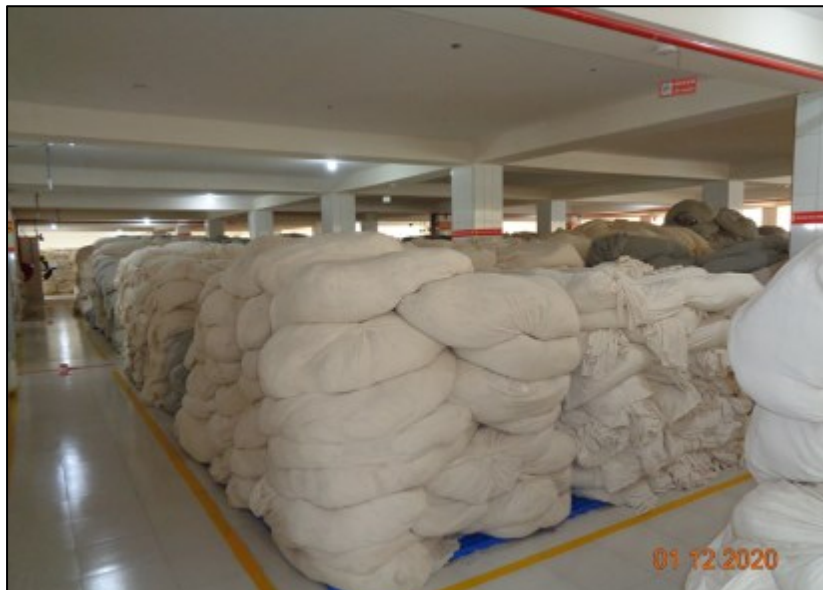
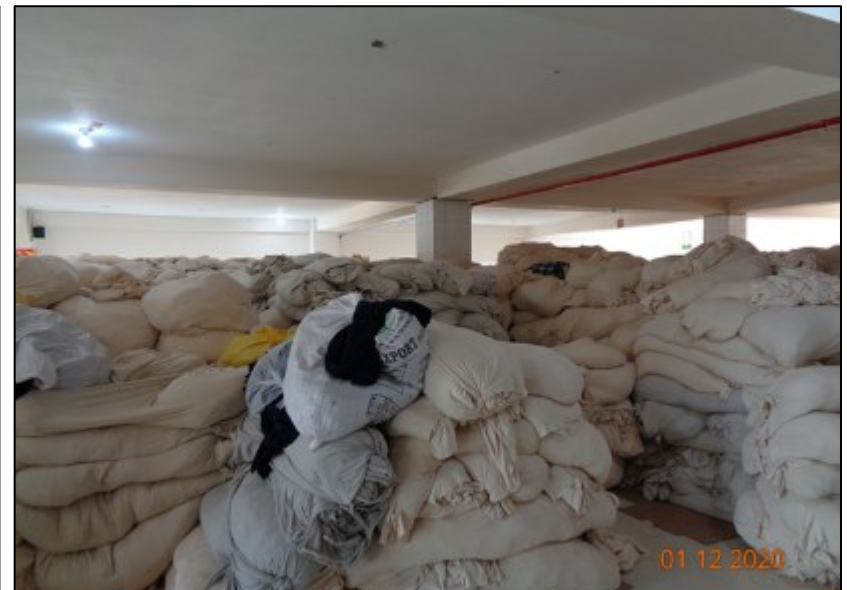
Floor loading at 5<sup>th</sup> floor.

The loading capacity of the 5<sup>th</sup> floor has been shown 3kpa in loading plan. During inspection, loading was found more than 3 kPa. Floor loading is not being maintain as per posted load plan. Factory engineer is required to develop a load monitoring system and maintain accordingly.

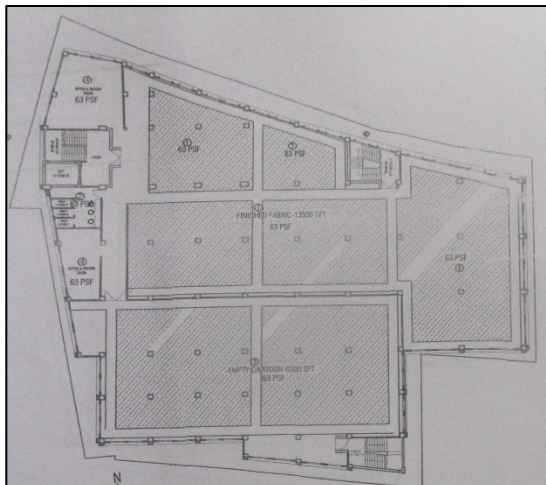
5<sup>th</sup> floor load plan- Load capacity 3kpa

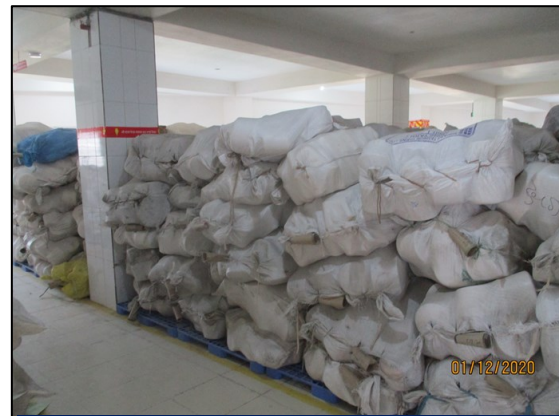
Yarn storage at 5<sup>th</sup> floor.

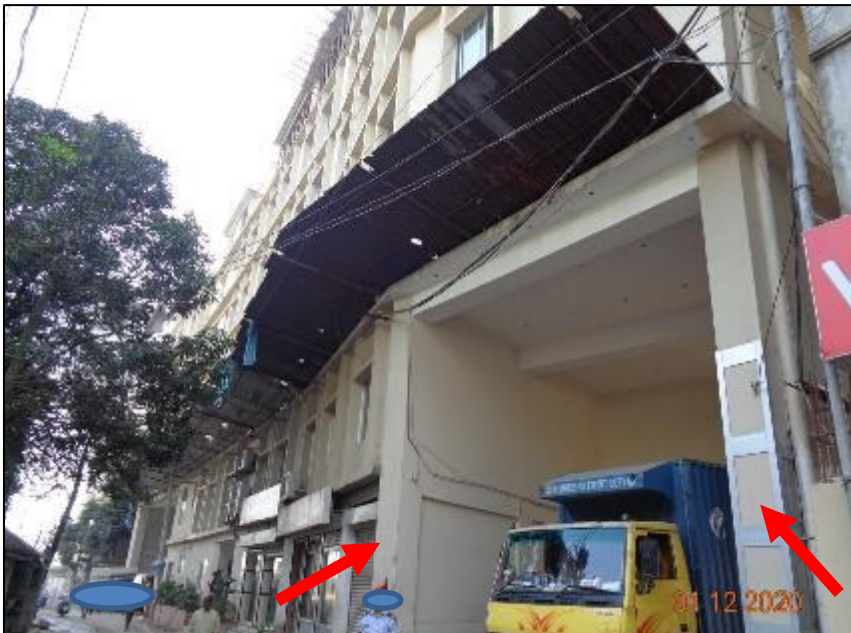
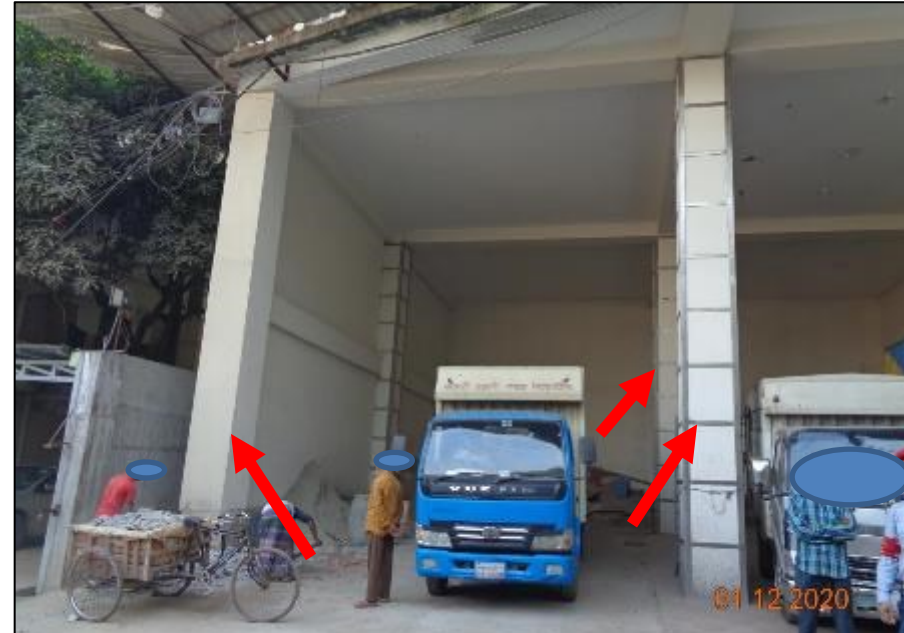
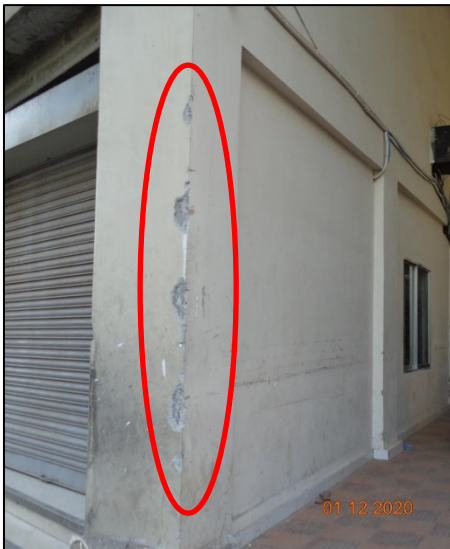
Column susceptible to vehicle impact

Some of the columns were found adjacent of driveway of parking & loading unloading platform. These column are susceptible to vehicle impact. The factory engineer is required to take necessary measures to prevent the vehicle impact by providing the barrier around the columns.

| Item No. | Observation | Recommended Action Plan | Recommended Timeline |
|---|---|---|---|
| 08 | Column susceptible to vehicle impact. | The factory engineer is required to take necessary measures to prevent the vehicle impact by providing barrier around the column. | 6-weeks |

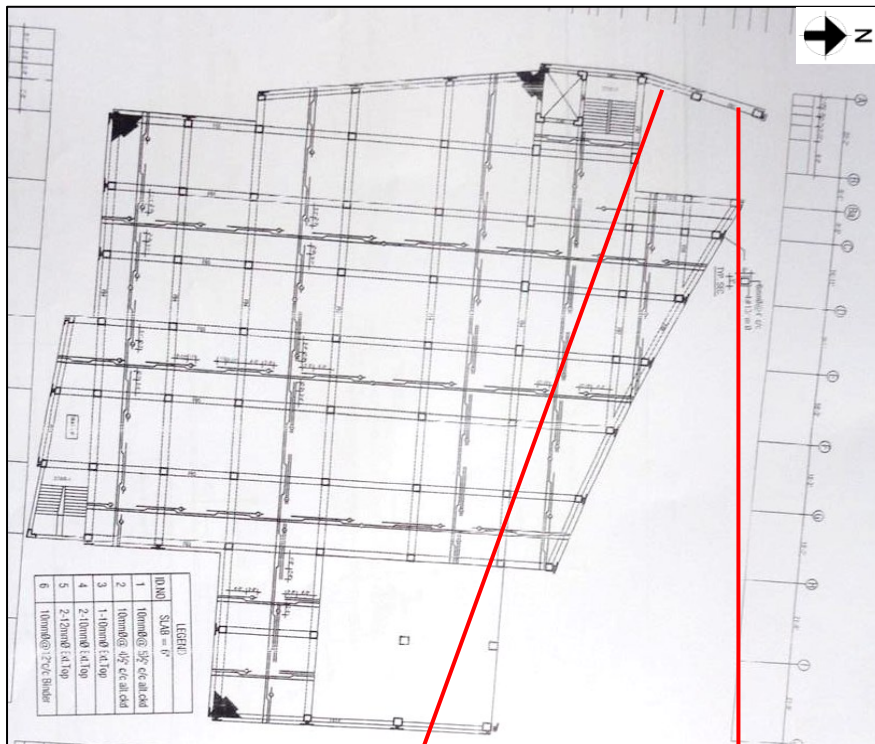
1<sup>st</sup> floor Beam Layout plan

Beams adjacent of driveway of loading unloading platform were found partial damaged due to vehicle impact. The factory engineer is required to investigate the extent of the damage and take necessary measures to repair the damage. Also, the factory engineer is required to take necessary action to prevent the vehicle impact in the beams.

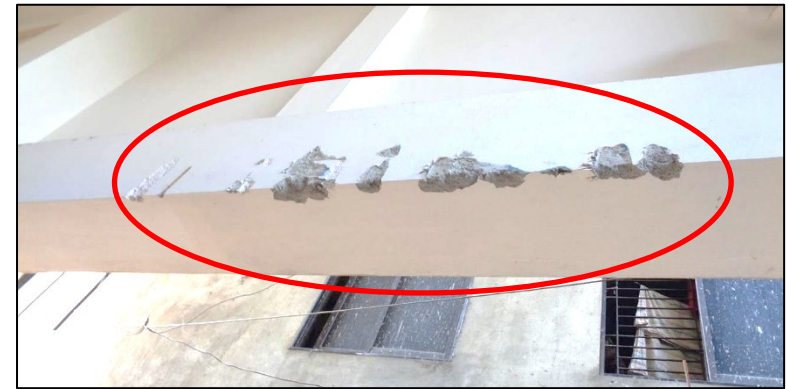
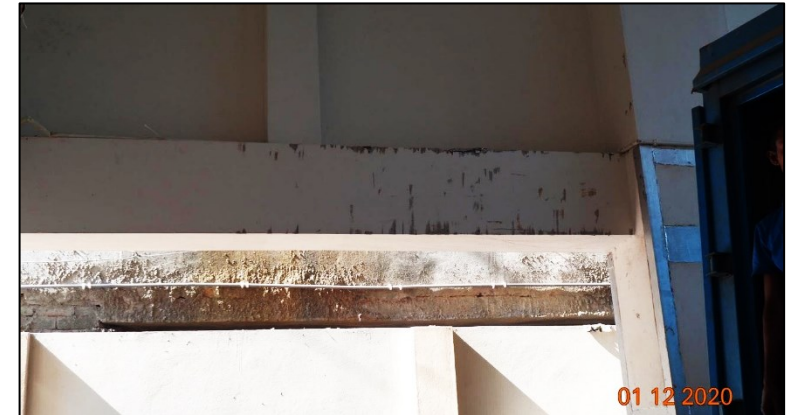
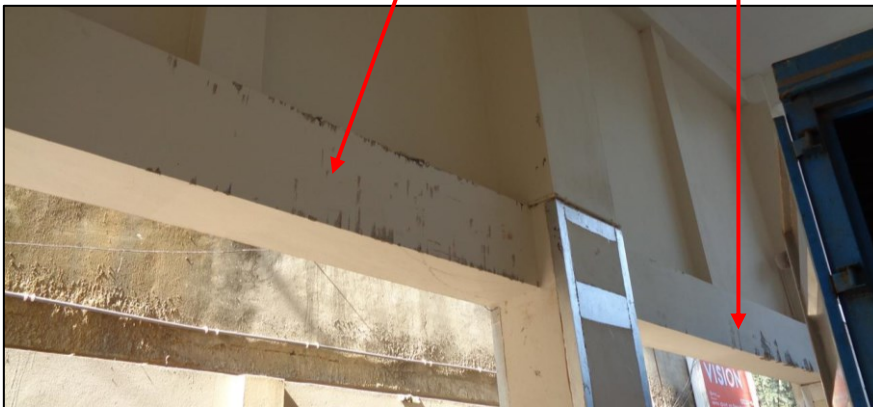
Partial damaged beam

| Item No. | Observation | Recommended Action Plan | Recommended Timeline |
|---|---|---|---|
| 09 | Partial damaged Beam. | The factory engineer is required to investigate the extent of the damage and take necessary measures to repair the damage | 6-weeks |
| 10 | Partial damaged Beam. | The factory engineer is required to take necessary action to prevent the vehicle impact in the beams. | 6-weeks |

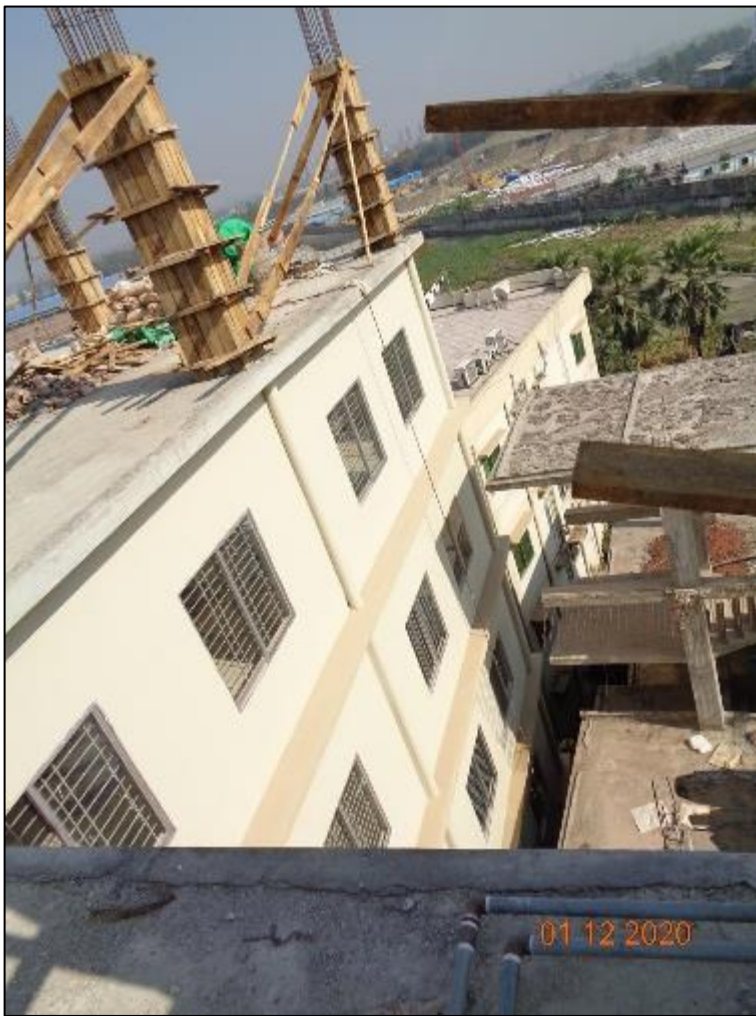
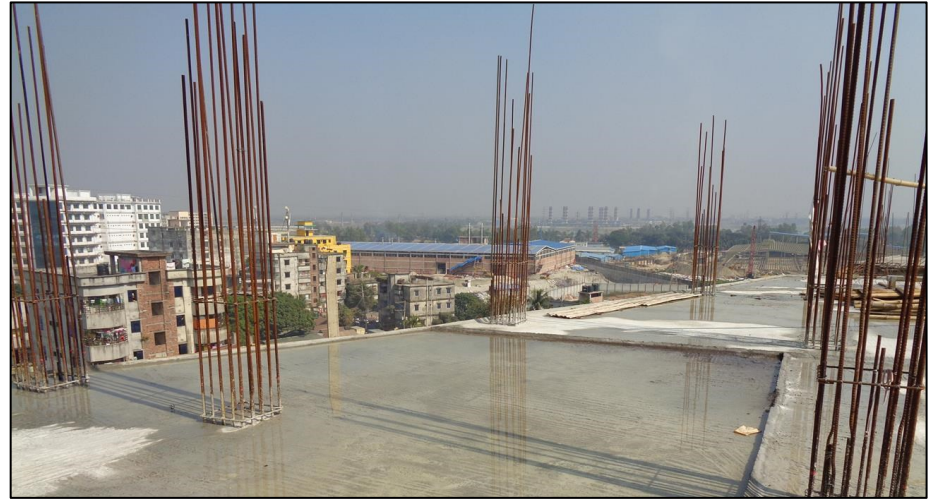
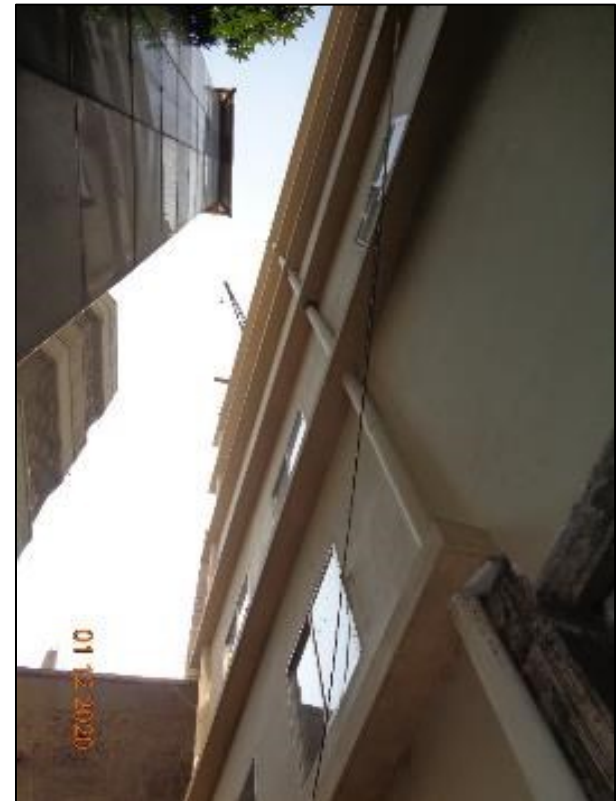
# **Lack of construction safety measures**

Necessary safety measures were not observed at the construction site. No barrier was provided at east side to mitigate the falling hazard. The factory engineer is required to take necessary measures to provide and install construction safety barrier.

| Item No. | Observation | Recommended Action Plan | Recommended Timeline |
|---|---|---|---|
| 11 | Lack of construction safety measures. | The factory engineer is required to take necessary measures to provide and install construction safety barrier as per standard. | 6-weeks |
