# Al-Muslim Washing Ltd. & Al-Muslim Garments Accessories Ltd.

14 No. Gedda, Karnapara, Ulail, Savar.  
(23.8276, 90.2586)

24<sup>th</sup> February & 29<sup>th</sup> March 2021

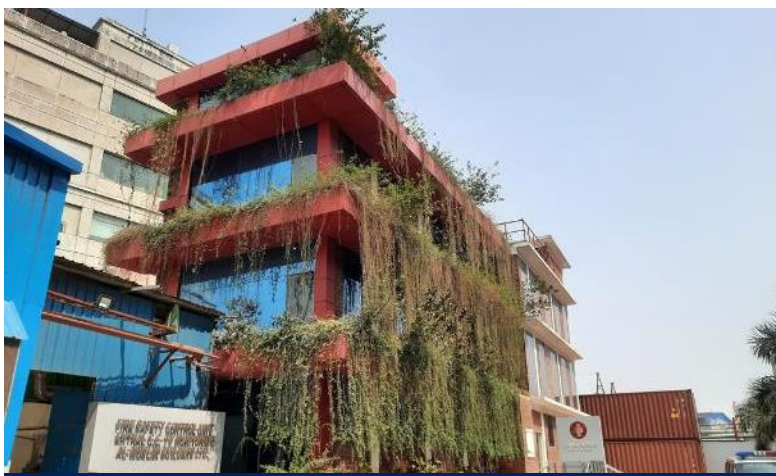
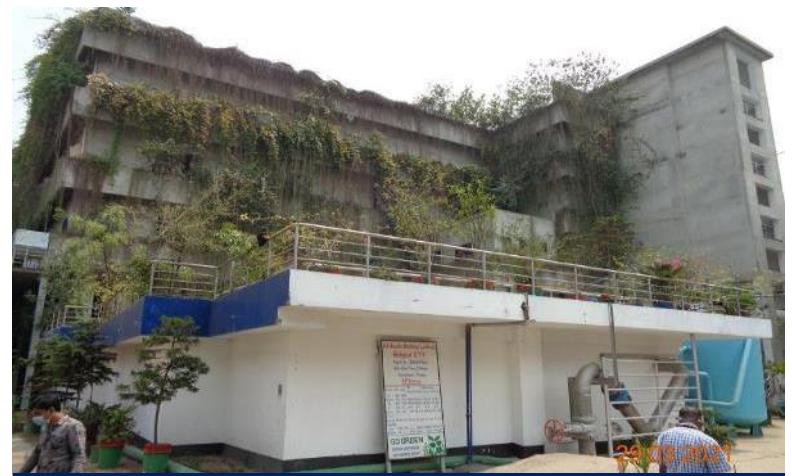
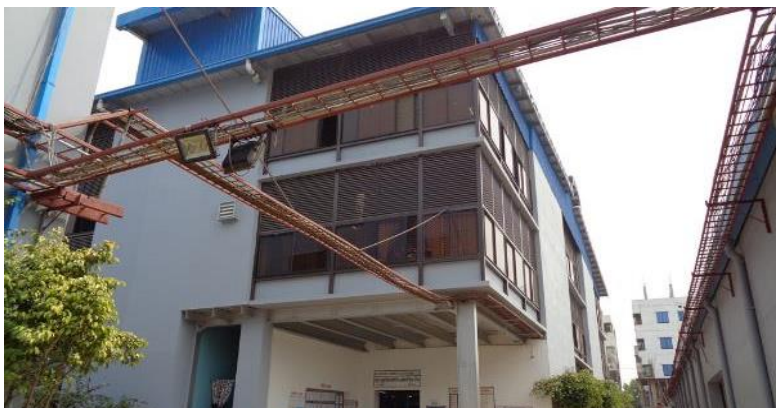
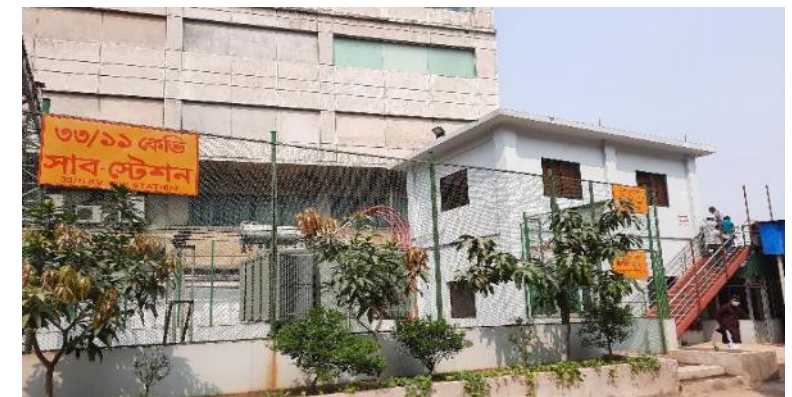
As per BNBC, building or structure shall have its design documents prepared in accordance with the provision of Section 1.9.1. The design document shall include a design report and a set of structural drawings which shall be prepared in compliance with section 1.9.1.1 and section 1.9.1.2 as per BNBC. The design report of the mentioned structures was not found which is required to be prepared in compliance with section 1.9.1.1 (part-6, BNBC).

| Item No. | Observation | Recommended Action Plan | Recommended Timeline |
|---|---|---|---|
| 01 | Unavailable structural design report. (Building 1, 2, 3 & 4) | Building engineer to prepare the design document including a design report and a set of structural drawings in compliance with section 1.9.1.1 and section 1.9.1.2 as per BNBC. | 6-weeks |
| 02 | Unavailable structural design report. (Building 1, 2, 3 & 4) | Complete implementation of any remedial works deemed necessary by the design review. | 6-months |

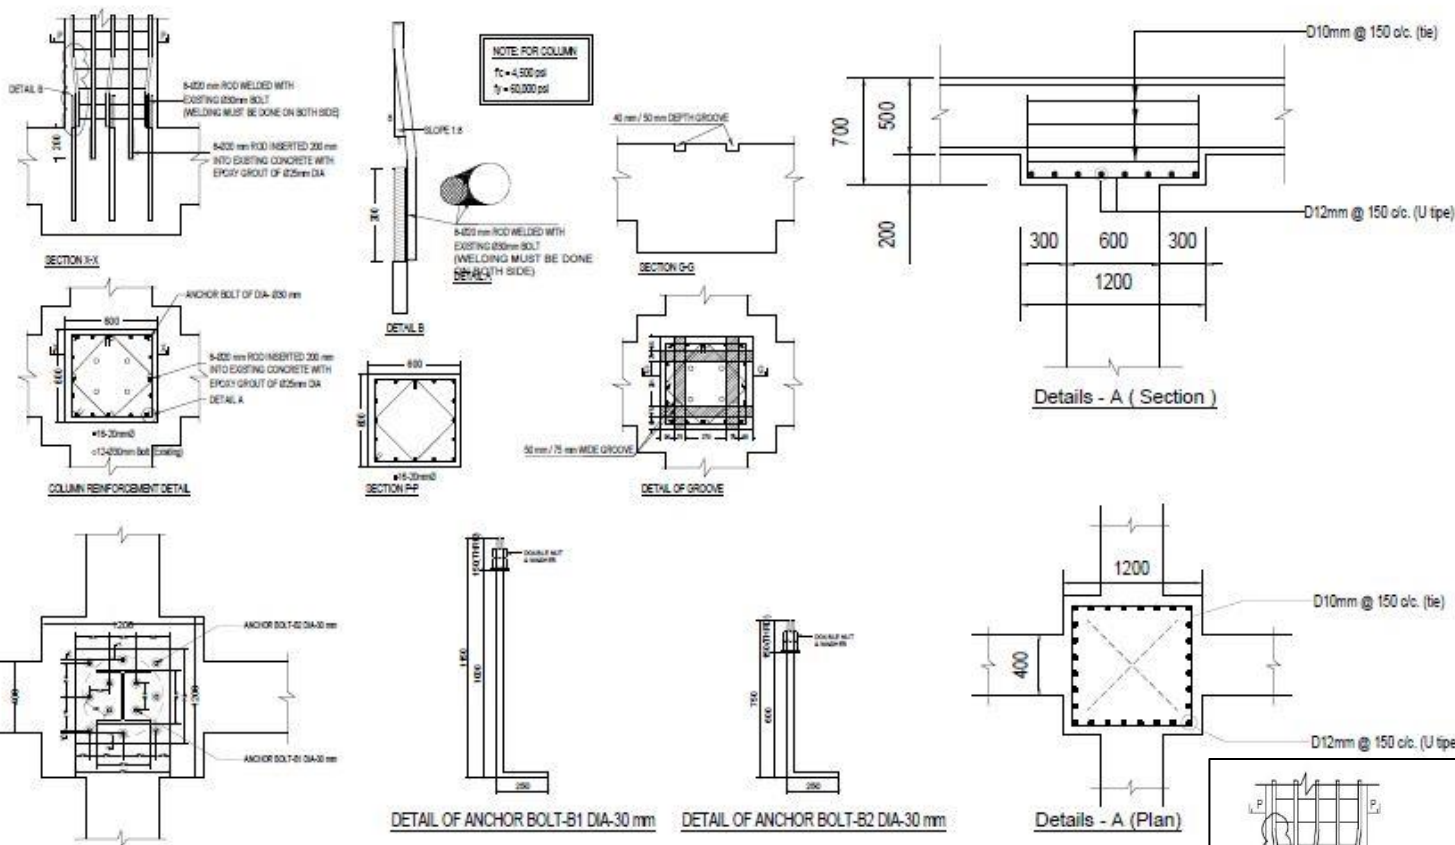
## Anchorage details of the rebar

Building was initially design for the steel shed but eventually it is constructed 4-storied RCC building. Main rebars are anchored with the royal bolts. Building engineer is required to check whether the main rebar from ground floor to top floors are sufficiently having development lengths and anchorages.

| Item No. | Observation | Recommended Action Plan | Recommended Timeline |
|---|---|---|---|
| 03 | Adequacy of the rebar anchorage needs to be checked. (Building 2) | Building engineer is required to check whether the main rebar from ground floor to top floors are sufficiently having development lengths and anchorages. | 6-weeks |

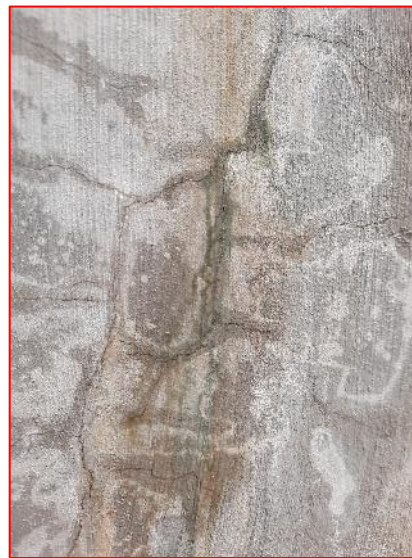
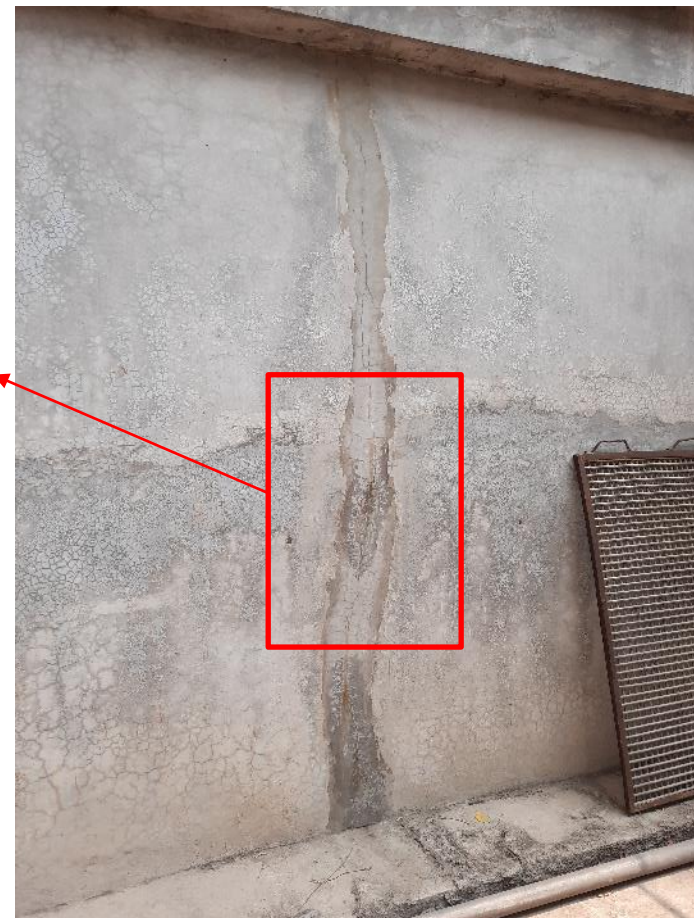
Water seeping and formation of cracks

Water seeping observed through the retaining walls. Building engineer is required to investigate the cause of the water ingress and check whether the retaining walls have sufficient structural capacity. Also check the extent & formation of the cracks.

| Item No. | Observation | Recommended Action Plan | Recommended Timeline |
|---|---|---|---|
| 04 | Water leakage & crack on the retaining wall. (Building 2) | Building engineer is required to investigate the reason of water seepage and prepare an investigation report with proper remedial actions. | 6-weeks |
| 05 | Water leakage & crack on the retaining wall. (Building 2) | Check the structural adequacy of the retaining walls. | 6-weeks |

| Item No. | Observation | Recommended Action Plan | Recommended Timeline |
|---|---|---|---|
| 06 | Water leakage & crack on the retaining wall. (Building 2) | Carry out remedial works where necessary. | 6-months |

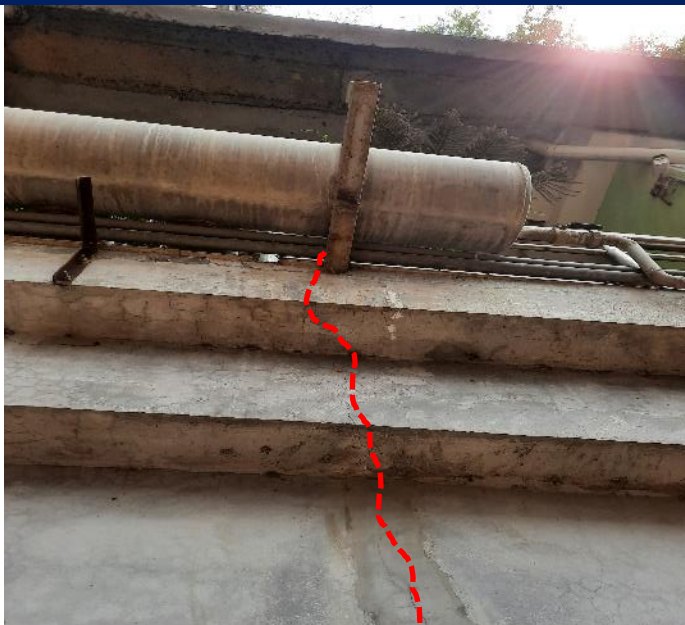
Formation of vertical cracks

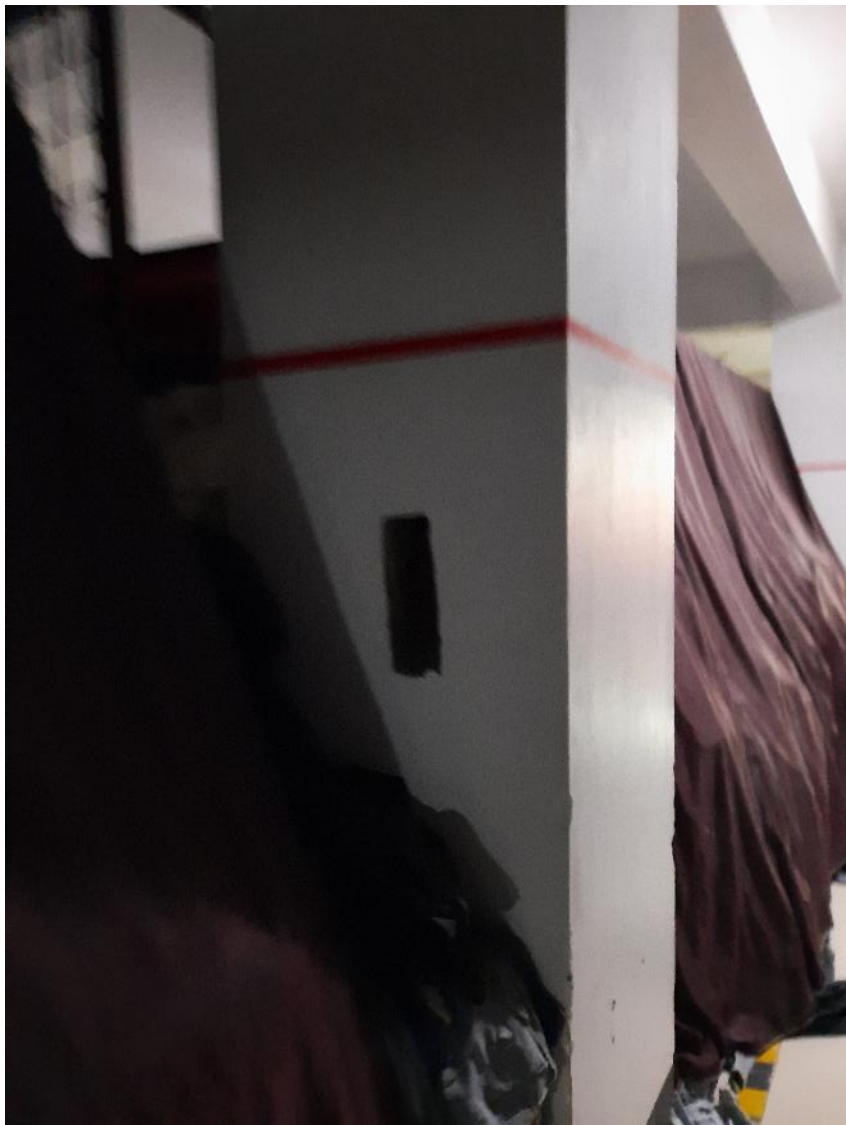
Electrical cable hole

Electrical cables holes are made on columns. Building engineer to Investigate and report on this matter to verify the structural integrity of the columns are not compromised.

| Item No. | Observation | Recommended Action Plan | Recommended Timeline |
|---|---|---|---|
| 07 | Electrical cable hole on columns. (Building 2) | Building engineer to Investigate and report on this matter to verify the structural integrity of the columns are not compromised. | 6-weeks |
| 08 | Electrical cable hole on columns. (Building 2) | Carry out remedial works where necessary. | 6-weeks |

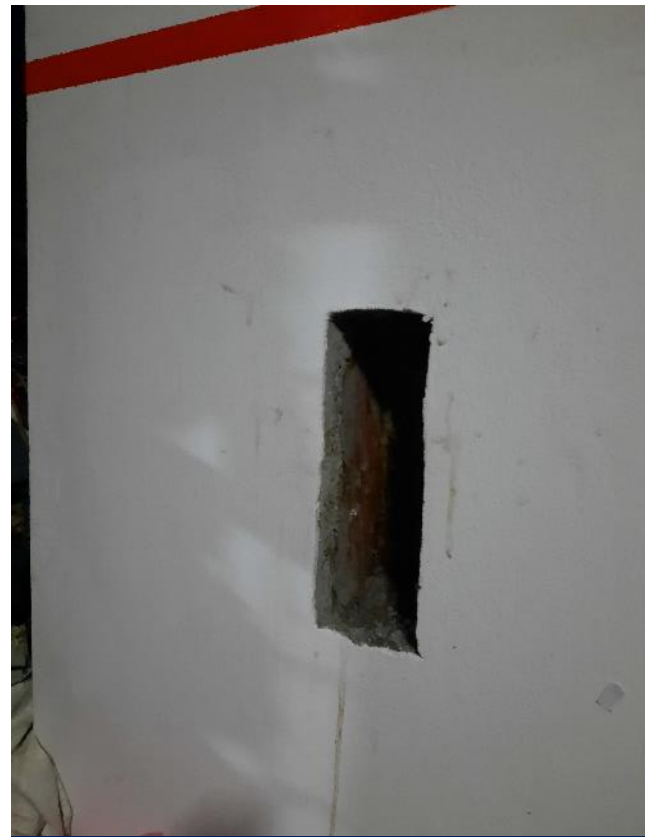
Hole of 250mm (L) X 80 mm (W) X 150 mm (T)

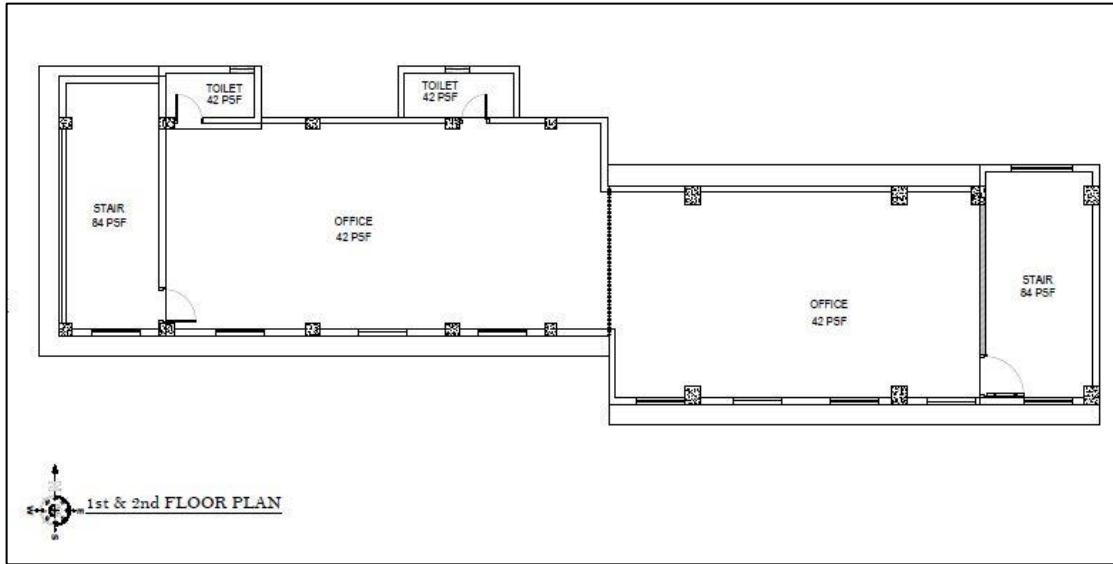
Floor load plan prepared considering 2 kPa (42 psf) for building 1

The load plan of building 1 & 4 was prepared as per the NTPA guideline. BNBC minimum floor loading not followed. Building engineer is required to prepare a load plan considering BNBC.

| Item No. | Observation | Recommended Action Plan | Recommended Timeline |
|---|---|---|---|
| 09 | Load plan not comply BNBC. (Building 1,4) | Building engineer is required to prepare live load plan as per BNBC. | 6-weeks |
| 10 | Load plan not comply BNBC. (Building 1,4) | Produce and actively manage a loading plan for all floor plates within the factory Building considering floor, column and foundation capacity. | 6-weeks |

| Item No. | Observation | Recommended Action Plan | Recommended Timeline |
|---|---|---|---|
| 11 | Load plan not comply BNBC. (Building 1,4) | Continue to implement floor loading plan. | 6-months |

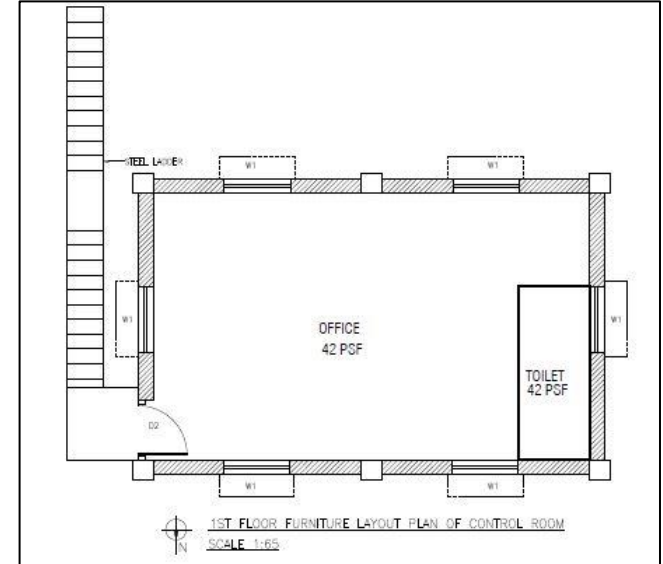
Floor load plan prepared considering 2 kPa (42 psf) for building 4

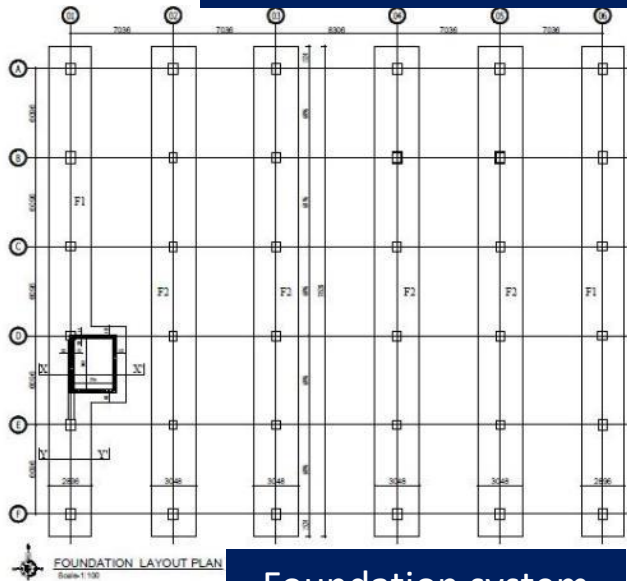
## Foundation system

The geotechnical investigation report recommends pile foundation. The foundation system of the building is combined footing. The ground bearing capacity for the isolated footing varies a lot for BH to BH (13.93 ton/m<sup>2</sup> to 3.8 ton/m<sup>2</sup>, FS 3) in the geotechnical investigation report. If the lowest value considered the footings are found stressed above normal design limit. Building engineer is required to check the considered ground bearing capacity & foundation adequacy.

| Item No. | Observation | Recommended Action Plan | Recommended Timeline |
|---|---|---|---|
| 12 | Ground bearing capacity & foundation adequacy to be reviewed. (Building 3) | Building engineer is required to check the considered ground bearing capacity. | 6-weeks |
| 13 | Ground bearing capacity & foundation adequacy to be reviewed. (Building 3) | Building engineer is required to check the adequacy of the foundation system. | 6-weeks |
| 14 | Ground bearing capacity & foundation adequacy to be reviewed. (Building 3) | Carry out remedial works where necessary. | 6-months |

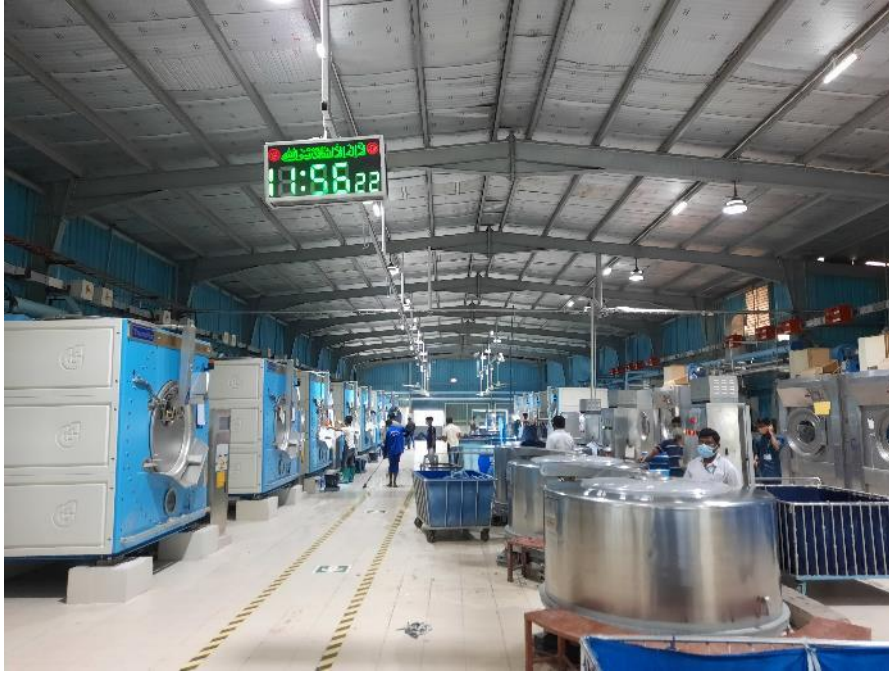
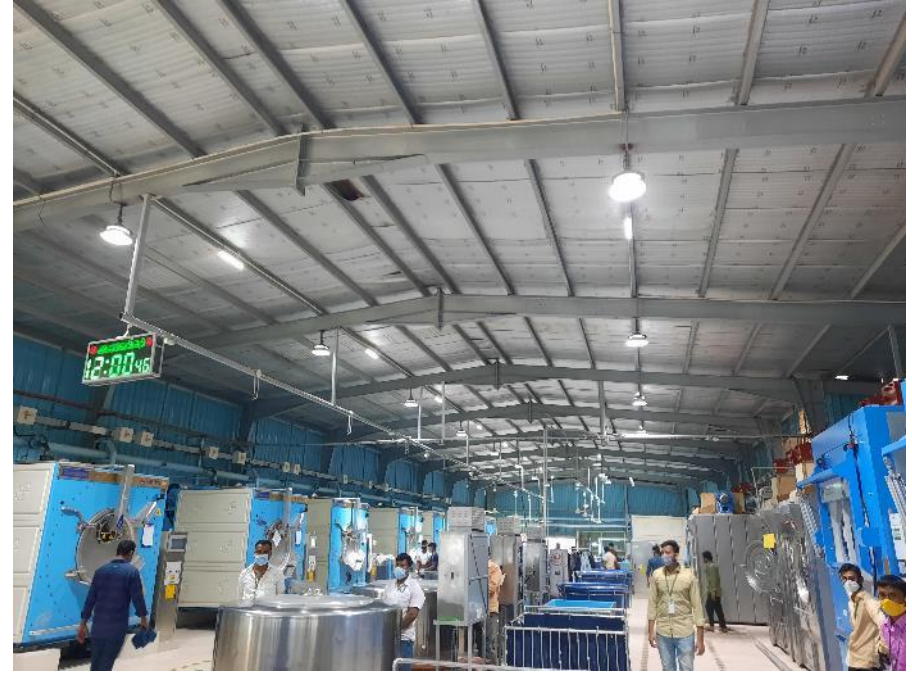
Apparently lack of lateral load resisting system was observed . Wall & roof bracings are not provided.  
Building engineer is required to check the lateral load resisting system of the shed.

| Item No. | Observation | Recommended Action Plan | Recommended Timeline |
|---|---|---|---|
| 15 | Apparently lack of lateral load resisting system. (Shed 1) | Building engineer is required to check the lateral load resisting system of the shed. | 6-weeks |

| Item No. | Observation | Recommended Action Plan | Recommended Timeline |
|---|---|---|---|
| 16 | Apparently lack of lateral load resisting system. (Shed 1) | Carry out remedial works where necessary. | 6-months |

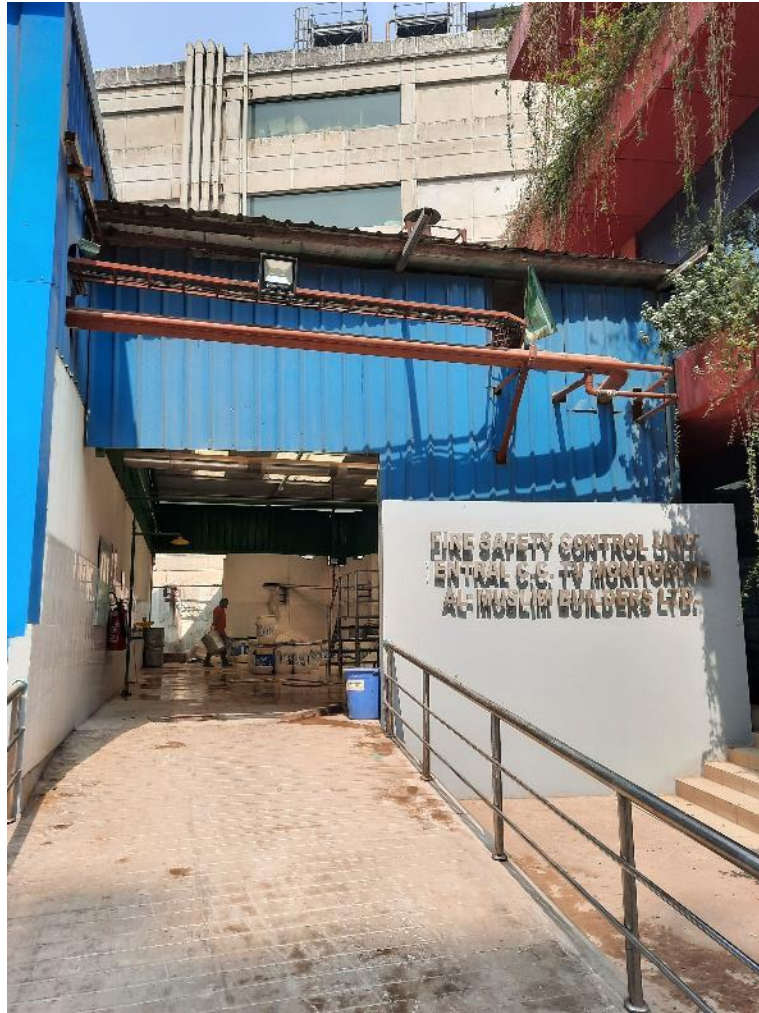
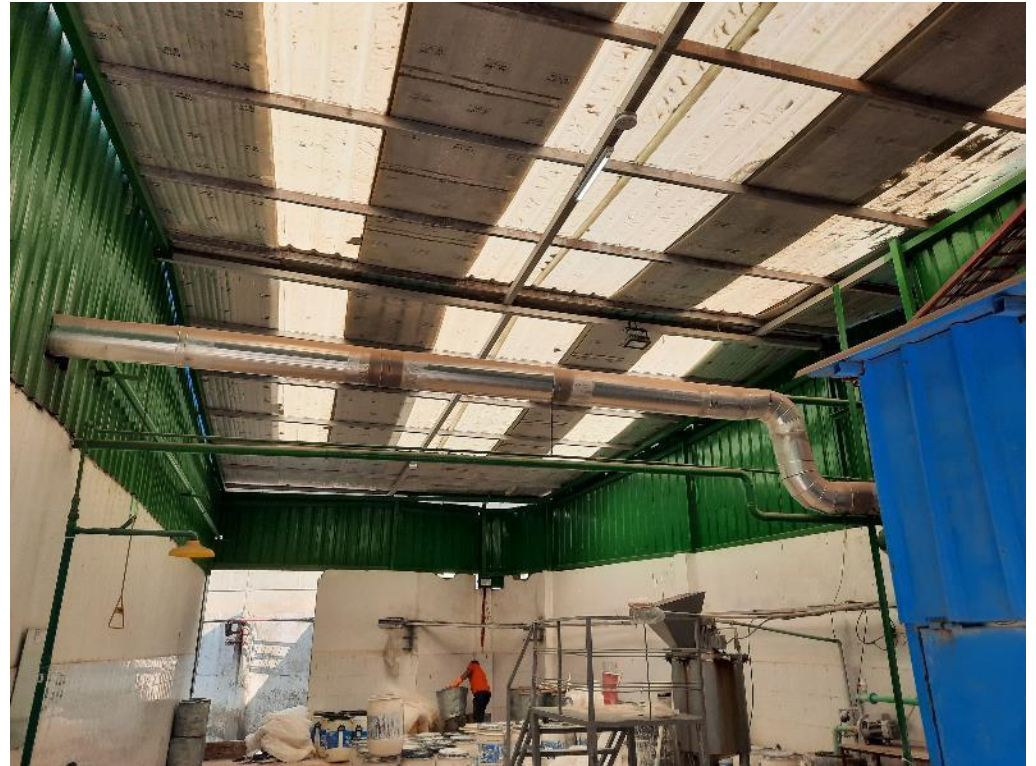
An extension of the shed was observed on the East side. The structural system of the extension is non-engineered. Building engineer is required check the structural integrity and adequacy of the non engineered extension of the shed.

| Item No. | Observation | Recommended Action Plan | Recommended Timeline |
|---|---|---|---|
| 17 | Non-engineered extension at East. (Shed 1) | Check the structural integrity and adequacy of the non-engineered extension of the shed. | 6-weeks |
| 18 | Non-engineered extension at East. (Shed 1) | Carry out remedial works where necessary. | 6-months |

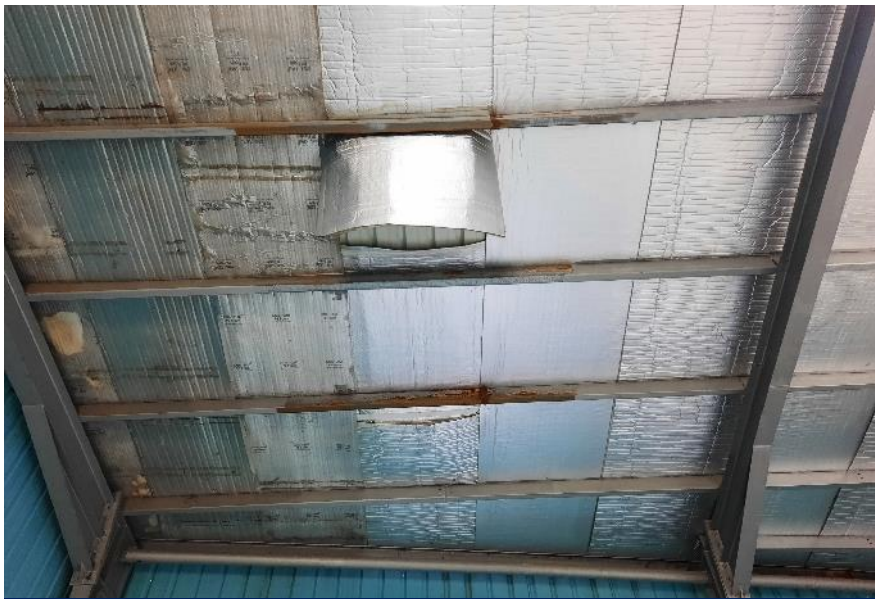
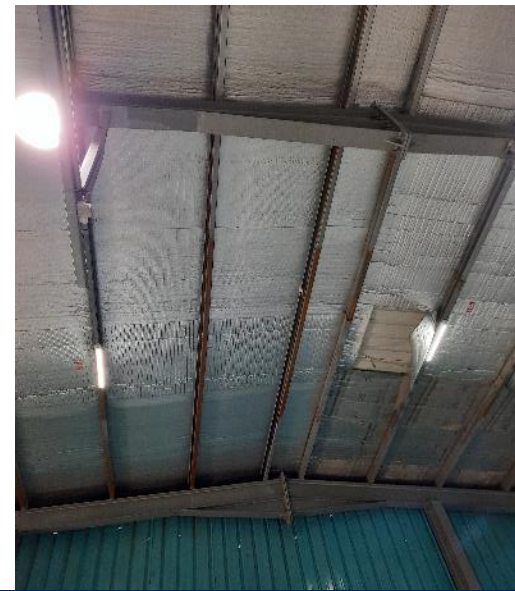
Corroded roof purlin

| Item No. | Observation | Recommended Action Plan | Recommended Timeline |
|---|---|---|---|
| 19 | Corroded purling & damaged rafter. (Shed 1) | Remove rust from the corroded purlin and apply rust proofing. | 6-weeks |

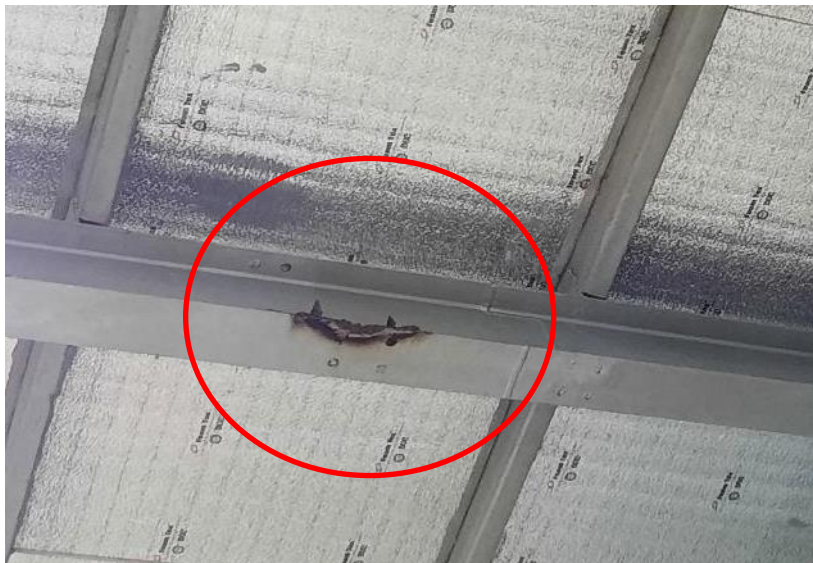
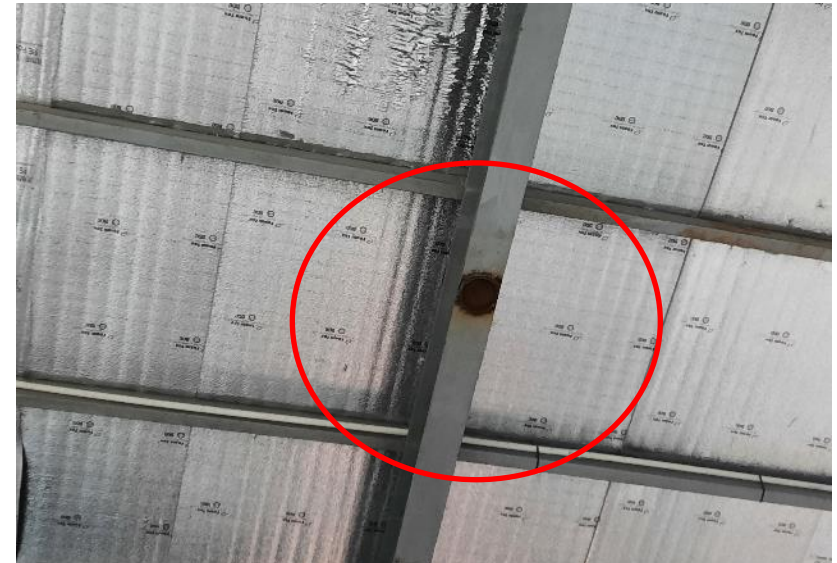
Some damaged rafter observed

| Item No. | Observation | Recommended Action Plan | Recommended Timeline |
|---|---|---|---|
| 20 | Corroded purling & damaged rafter. (Shed 1) | Building engineer is required investigate the damage rafter and suggest a suitable repair method. | 6-weeks |

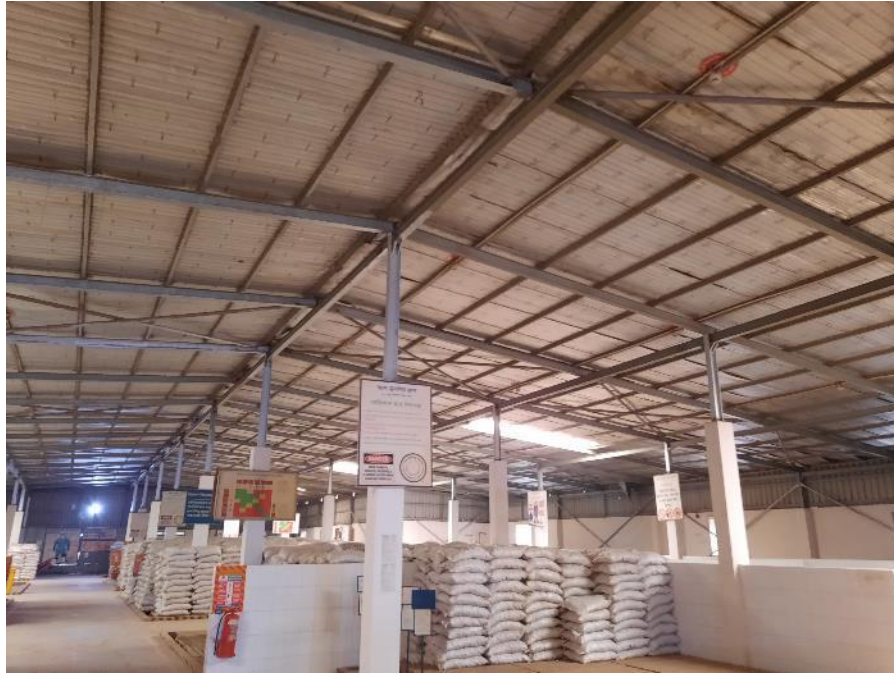
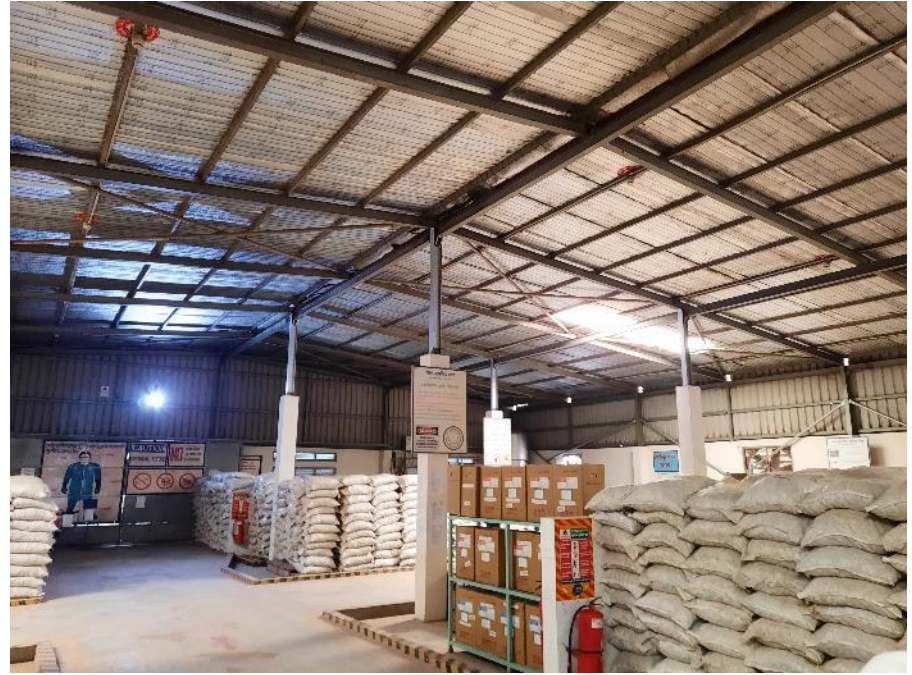
Apparently inadequate structural member observed for resisting vertical & lateral loading as per BNBC. Building engineer is required to check the lateral & vertical stability of the shed.

| Item No. | Observation | Recommended Action Plan | Recommended Timeline |
|---|---|---|---|
| 21 | Inadequate structural member. (Shed 2) | Building engineer is required to check the adequacy of the structural members for lateral & vertical stability. | 6-weeks |
| 22 | Inadequate structural member. (Shed 2) | Carry out remedial works where necessary. | 6-months |

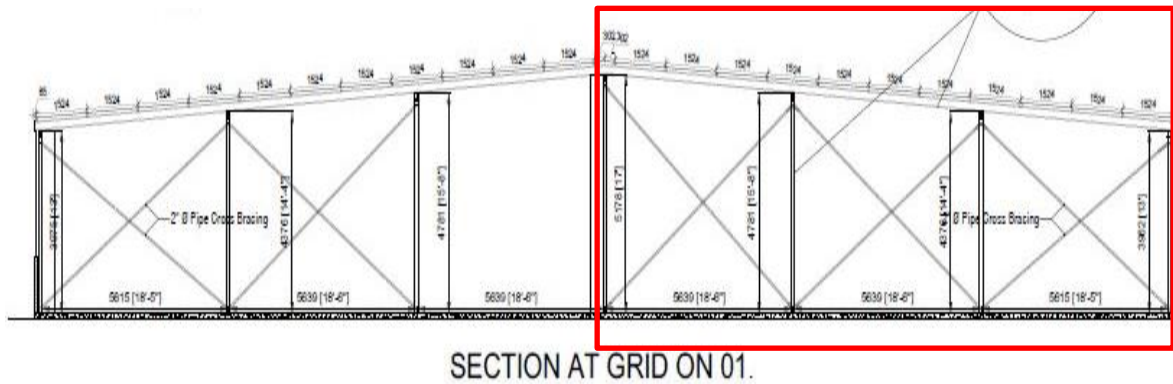
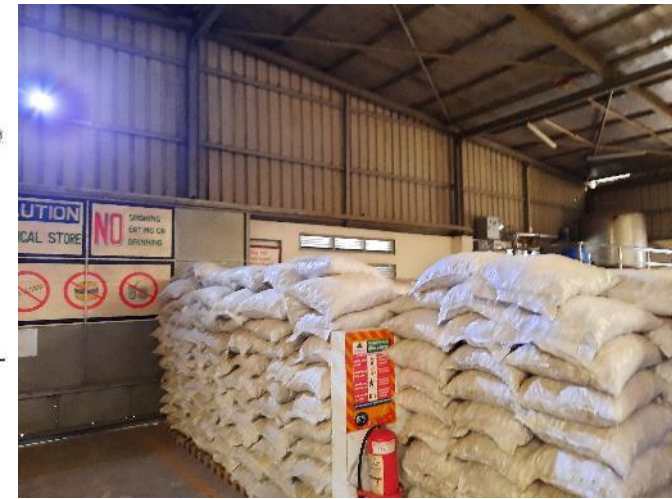
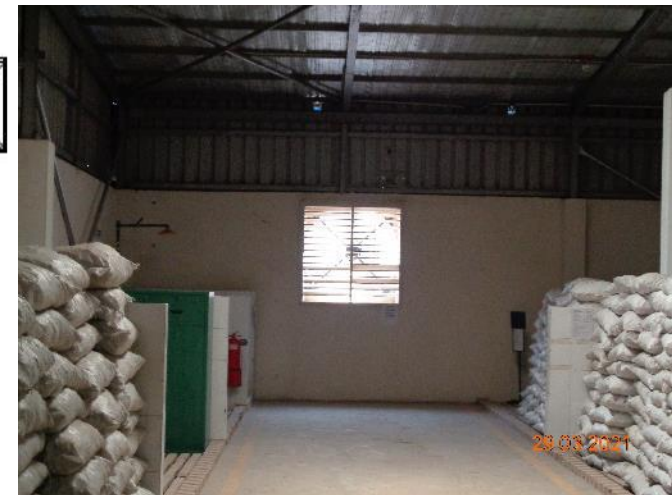
Vertical bracings in several location found missing.

| Item No. | Observation | Recommended Action Plan | Recommended Timeline |
|---|---|---|---|
| 23 | Vertical bracing missing in several location. (Shed 2) | Install the missing bracing. | 6-weeks |

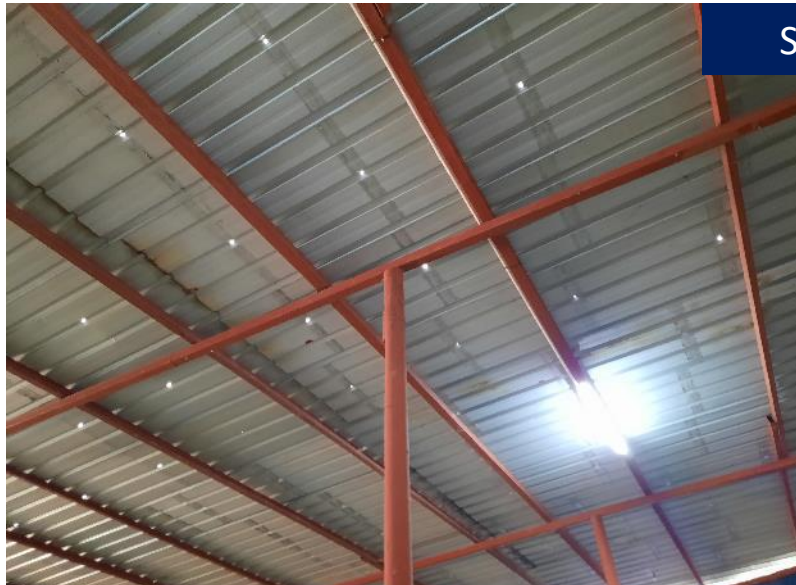
Shed 3

Poor connection details

Poor connection details,  
Inadequate structural members.  
Apparently non-engineered shed.

| Item No. | Observation | Recommended Action Plan | Recommended Timeline |
|---|---|---|---|
| 24 | Non-Engineered structure. (Shed 3,4,6,7 & 10) | Building engineer is required to check the adequacy of the sheds for gravity and lateral forces.<br>or<br>Replace with the engineered sheds. | 6-weeks |
| 25 | Non-Engineered structure. (Shed 3,4,6,7 & 10) | Carry out remedial works where necessary. | 6-months |

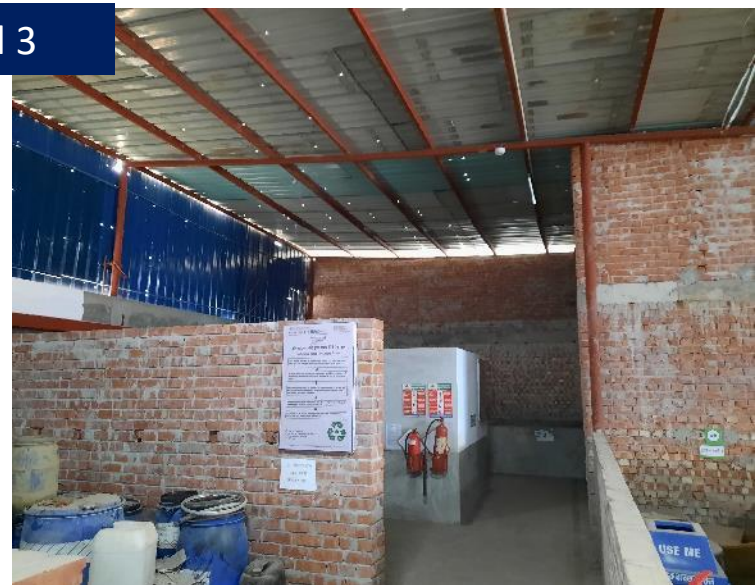
Inadequate structural members

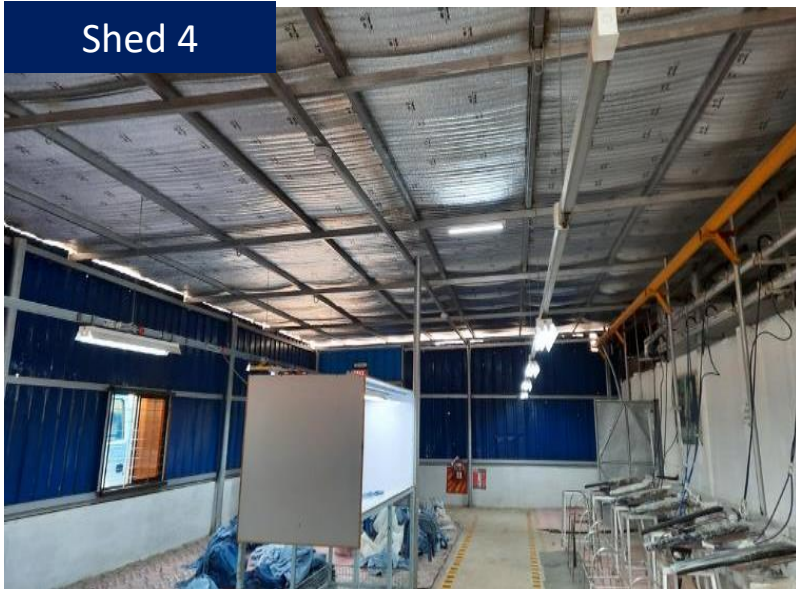
Shed 4

Inadequate structural members

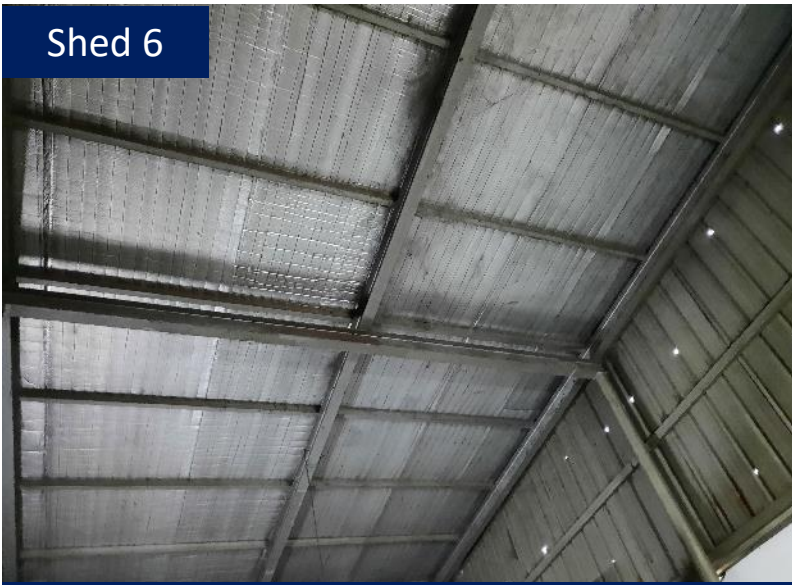
Shed 6

Inadequate structural members

Poor connection details,  
Inadequate structural members.  
Apparently non-engineered shed.

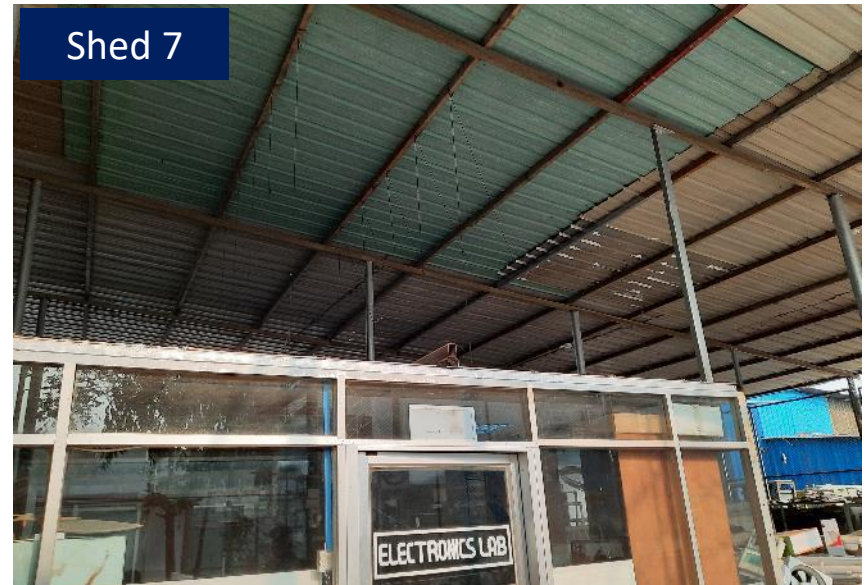
Shed 7

Inadequate structural members

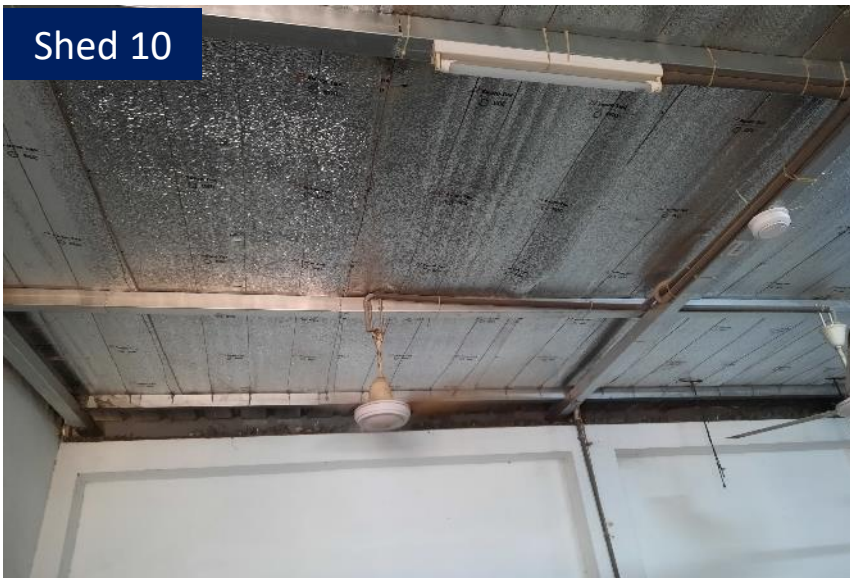
Shed 10

Inadequate structural members

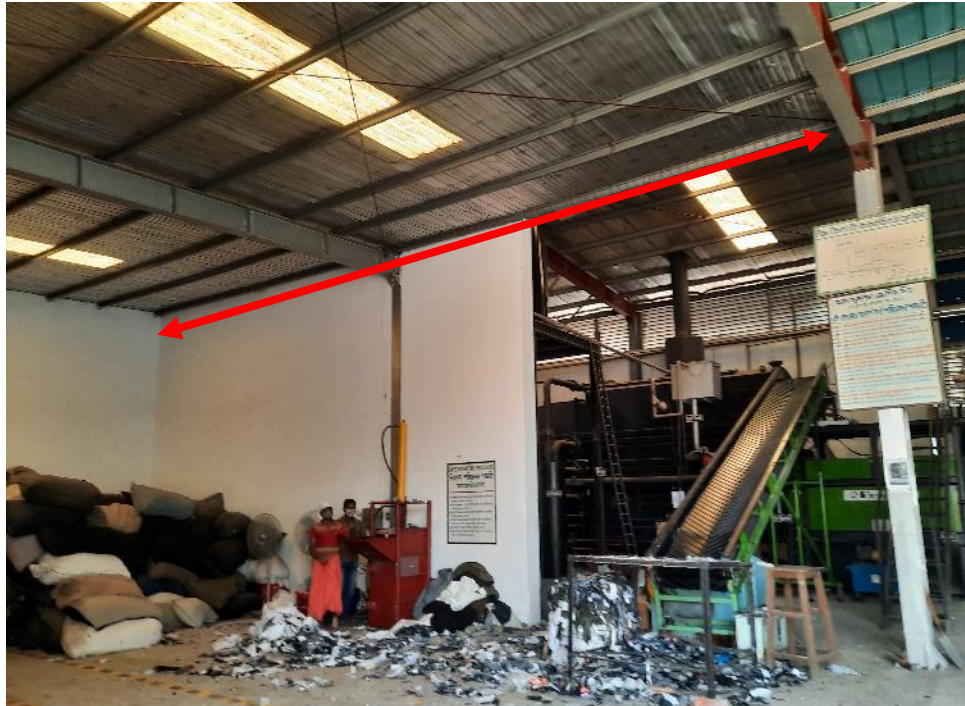
Missing compression member in long direction

Apparently lack of lateral load resisting system was observed. Building engineer is required to check the lateral load resisting system of the shed.

| Item No. | Observation | Recommended Action Plan | Recommended Timeline |
|---|---|---|---|
| 26 | Apparently lack of lateral load resisting system. (Shed 5) | Building engineer is required to check the lateral load resisting system of the shed. | 6-weeks |
| 27 | Apparently lack of lateral load resisting system. (Shed 5) | Carry out remedial works where necessary. | 6-months |

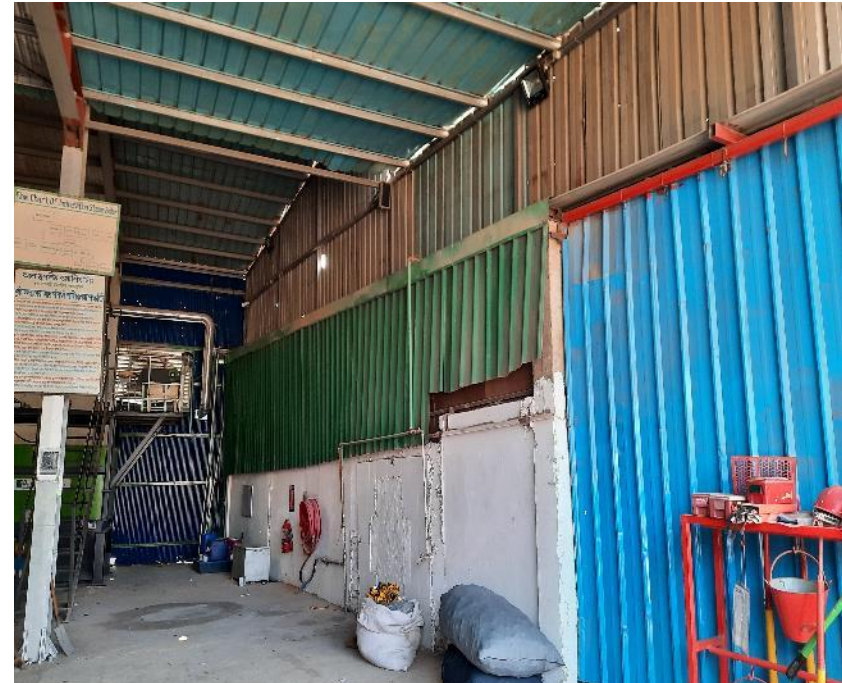
Cantilever portion of the shed not adequately connected
