# TM Textiles & Garments Limited (Expansion Unit)

Kashor, Post: Hobibari, Thana: Bhaluka, Mymensingh  
(24.293696, 90.365797)

15<sup>th</sup> March, 29<sup>th</sup> September & 13<sup>th</sup> October 2020

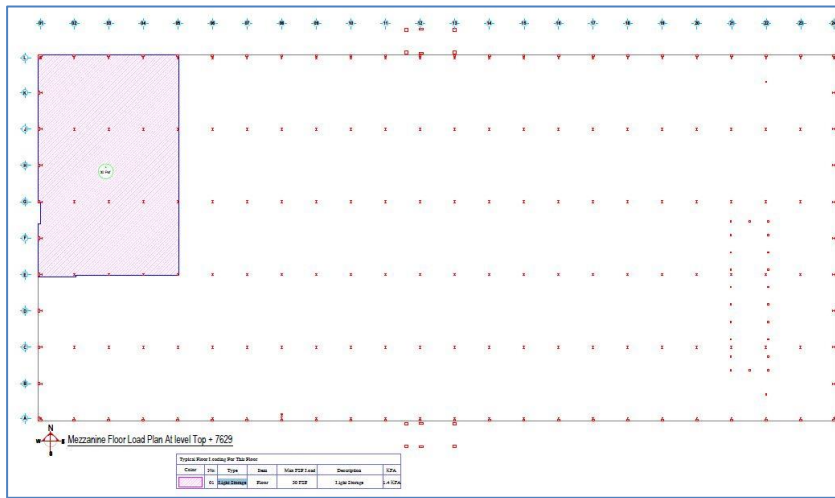
Floor load Plan of mezzanine

**Column stressed above normal design limits**

A set of load plan has been prepared for the main building considering 30psf live load for light storage on mezzanine floor. Which is not comply with BNBC. Prepared load plan need to be revised based on floor, column and foundation capacity.

| Item No. | Observation | Recommended Action Plan | Recommended Timeline |
|---|---|---|---|
| 02 | Column stressed above normal design limits (Main Building). | Produce and actively manage a loading plan for all floor plates within the factory, considering floor, column and foundation capacity. | 6-weeks |

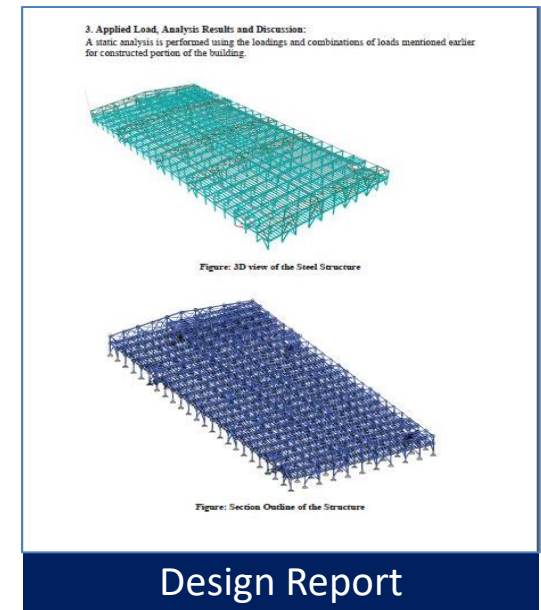
A set of design report has been prepared for the main building considering 5 KPa (1<sup>st</sup> floor) live loading. Cursory calculation indicates that few columns under mezzanine floor are stressed above normal design limits considering 5 kPa live load on typical floor. On the other hand the material specification of steel member is not mentioned in the (provided PDF copy) design report as per BNBC section 1.9.1.1. Factory is required to revise and submit the design report with analysis file to RSC for further review.

| Item No. | Observation | Recommended Action Plan | Recommended Timeline |
|---|---|---|---|
| 01 | Column stressed above normal design limits (Main Building). | Factory Engineer to review design, loads, columns and footings stresses. | 6-weeks |
| 03 | Column stressed above normal design limits (Main Building). | Complete implementation of any remedial works deemed necessary by the design report. | 6-months |

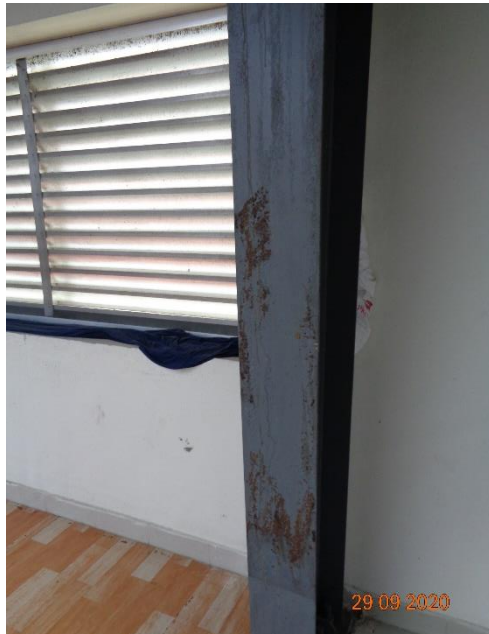
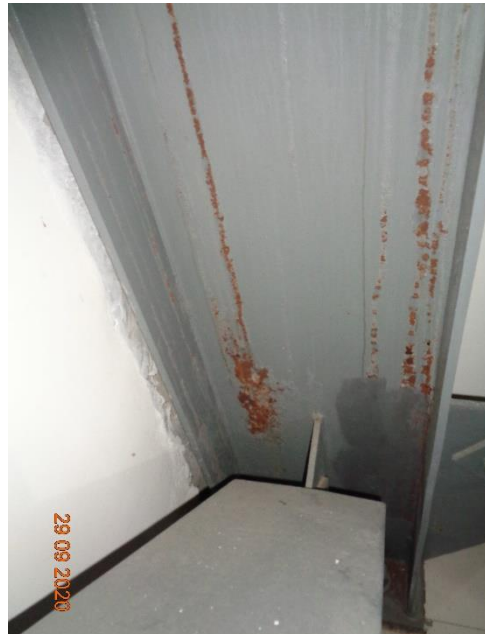
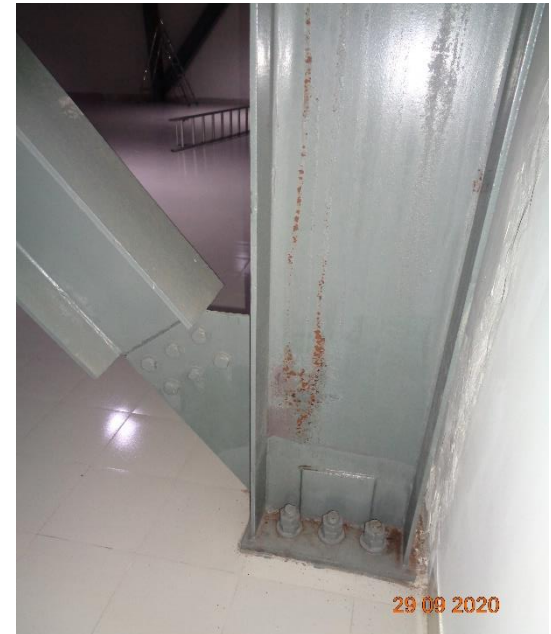
Corrosion in steel column

Corrosion in steel member was observed in various locations. The building engineer to investigate the reason of corrosion and suggest proper remedial measure accordingly.

| Item No. | Observation | Recommended Action Plan | Recommended Timeline |
|---|---|---|---|
| 05 | Corrosion in steel member (Main Building) | The building engineer to investigate the reason of corrosion and suggest proper remedial measure accordingly. | 6-weeks |

| Item No. | Observation | Recommended Action Plan | Recommended Timeline |
|---|---|---|---|
| 06 | Column stressed above normal design limits (Main Building). | Take necessary measures to prevent further corrosion and repair the corroded steel members as per engineer's suggestion. | 6-months |

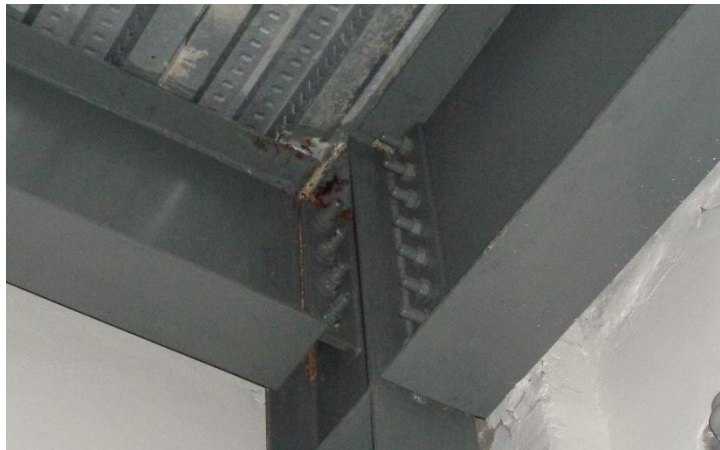
Corrosion in steel beam

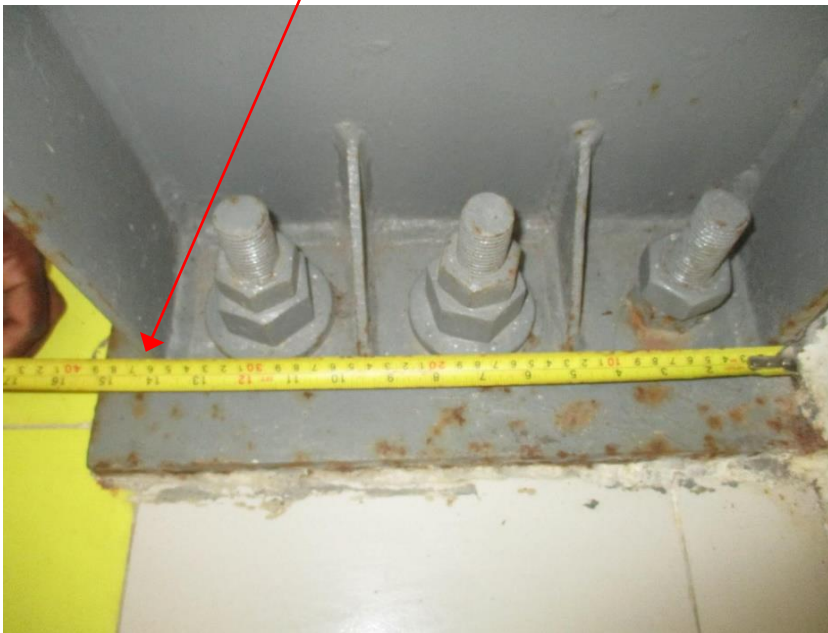
Edge steel column web measured 350mm which was 300mm in the drawing.

The building engineer is required to update the as-built drawings.

| Item No. | Observation | Recommended Action Plan | Recommended Timeline |
|---|---|---|---|
| 07 | Inconsistencies in the drawing. (Canteen Building) | The building engineer to survey the structure and update the as-built drawings accordingly. | 6-weeks |

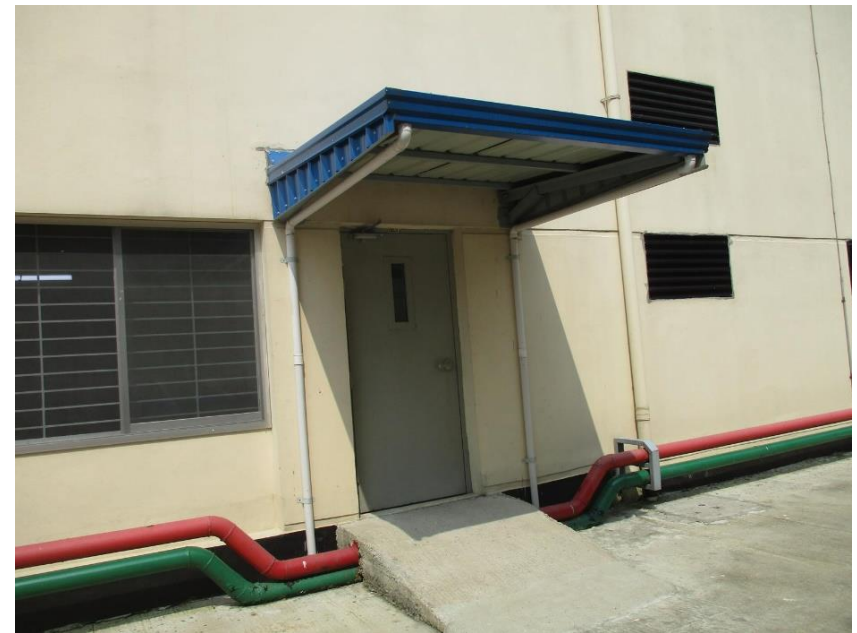
Details of this canopy was not available in the provided drawings.

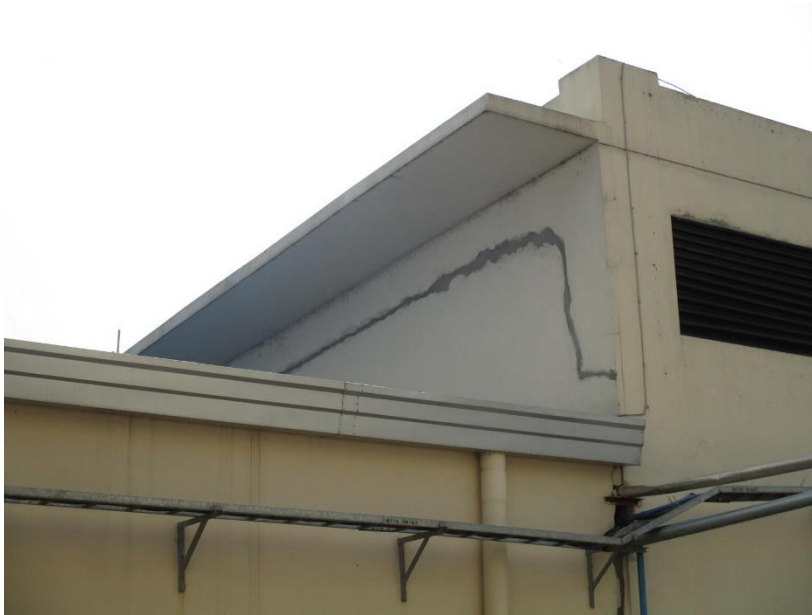
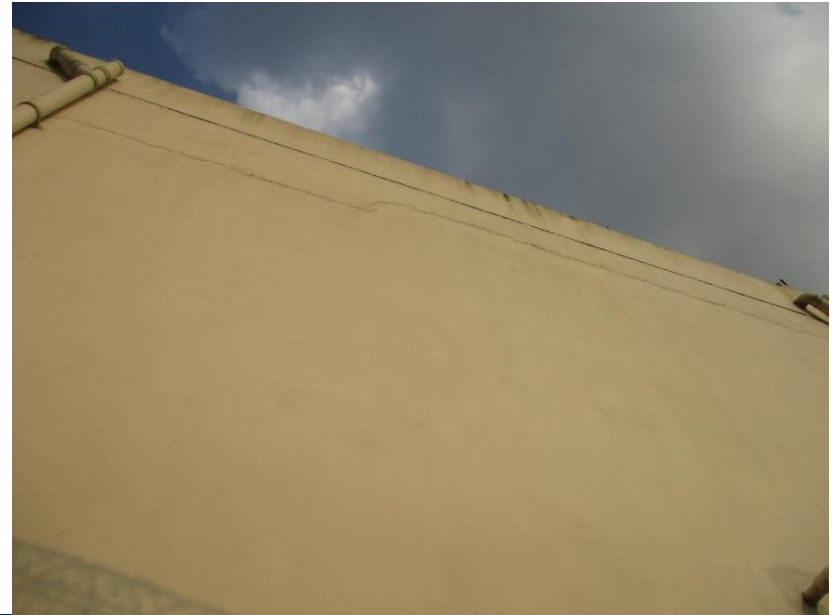
Cracks were observed on the exterior face of brick walls.

The building engineer is required to investigate the reasons of cracks and suggest proper remedial actions accordingly.

| Item No. | Observation | Recommended Action Plan | Recommended Timeline |
|---|---|---|---|
| 08 | Cracks on the exterior walls. (Canteen Building) | The building engineer to investigate the reason of cracks and suggest proper remedial measure accordingly. | 6-weeks |
| 09 | Cracks on the exterior walls. (Canteen Building) | Carry out repair works as per engineer's suggestion. | 6-months |

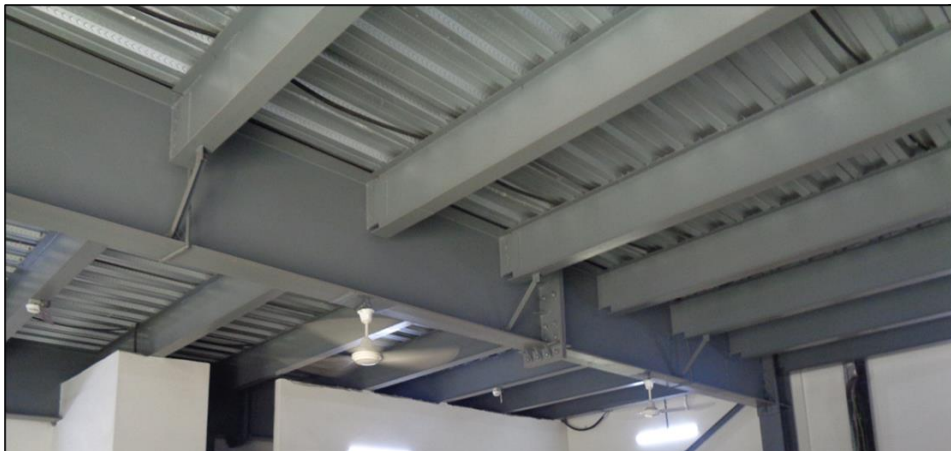
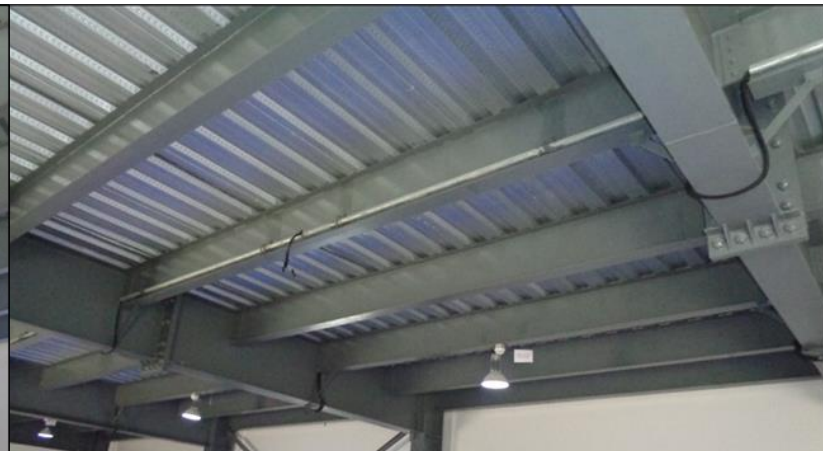
Deck Slab from ground floor

Information regarding the details of the deck slab was not available in the as-built drawings. The factory engineer is required to survey the structures and prepare as-built drawings complying with section 1.9.1.2 of BNBC.

| Item No. | Observation | Recommended Action Plan | Recommended Timeline |
|---|---|---|---|
| 10 | Lack of information in as built drawings. (Fabric Building) | The building engineer to survey the structure and update the as-built drawings accordingly. | 6-weeks |

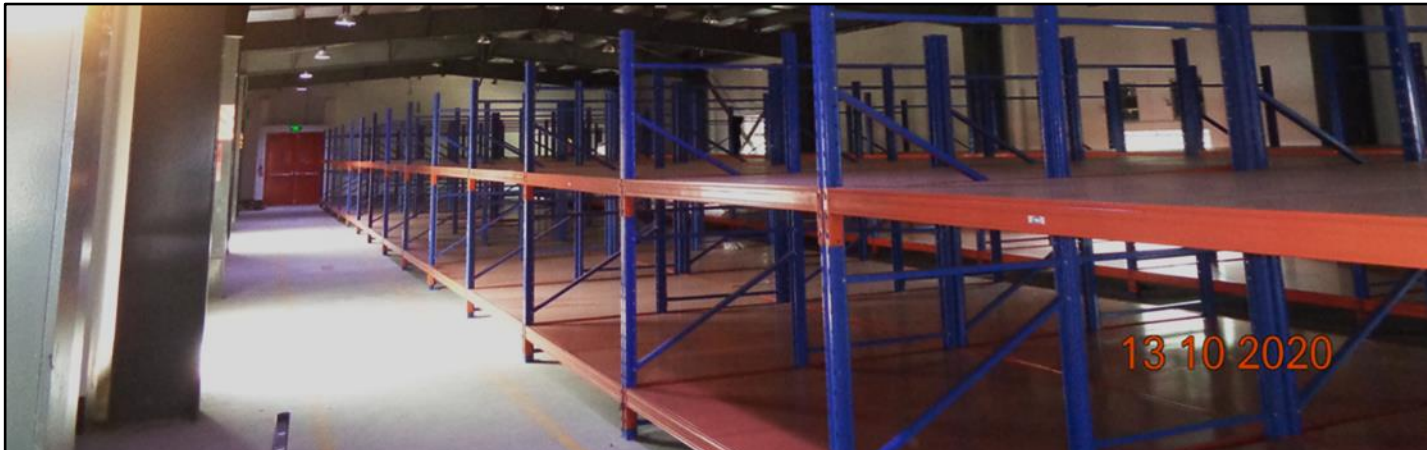
Deck Slab-1<sup>st</sup> floor

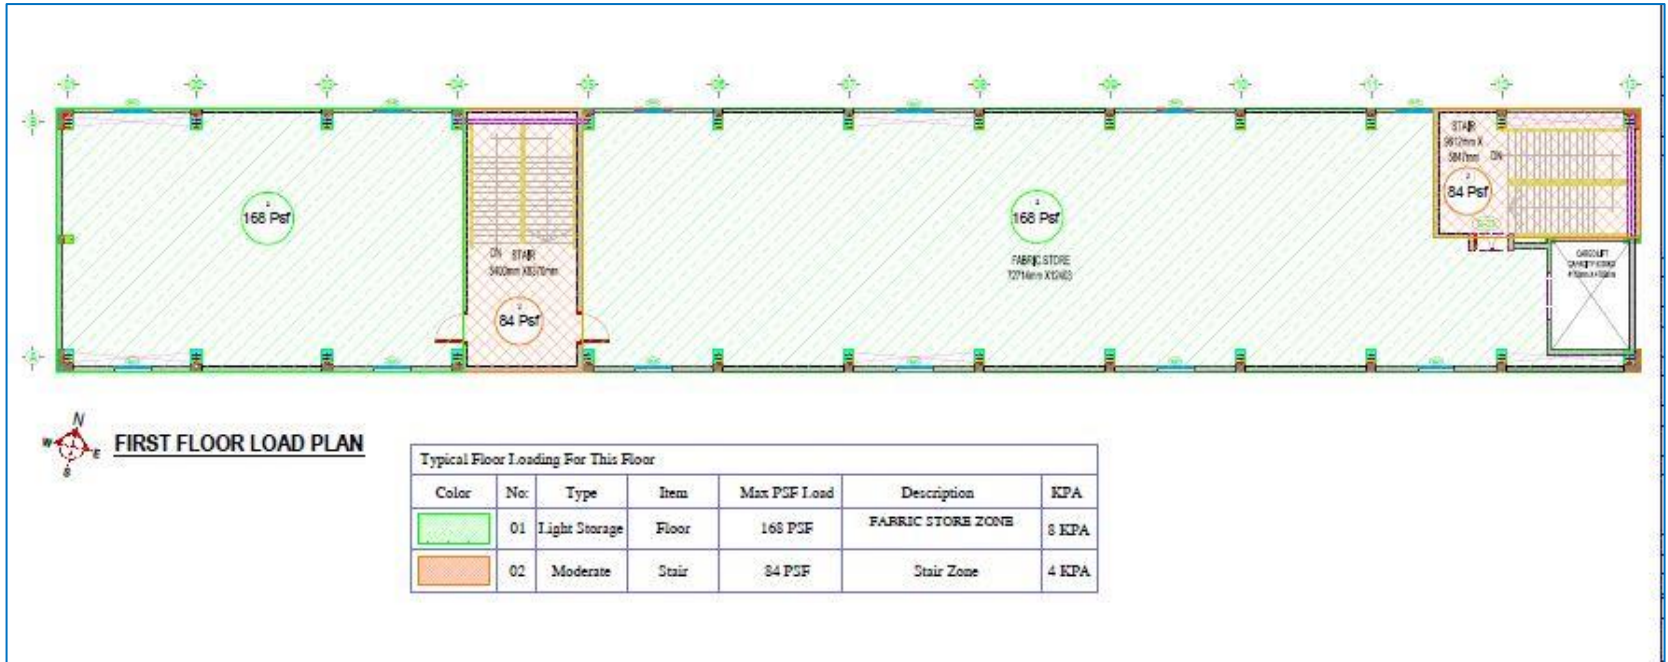
The 1st of the building is designed for 8 kPa live load. But floor beam deflection check has not been provided in the design report.

The building engineer is required to include the beam deflection check in the design report and submit to RSC for further review.

| Item No. | Observation | Recommended Action Plan | Recommended Timeline |
|---|---|---|---|
| 12 | Design report required to be reviewed by RSC (Fabric Building) | Revise the prepared design report and Submit to RSC. | 6-weeks |

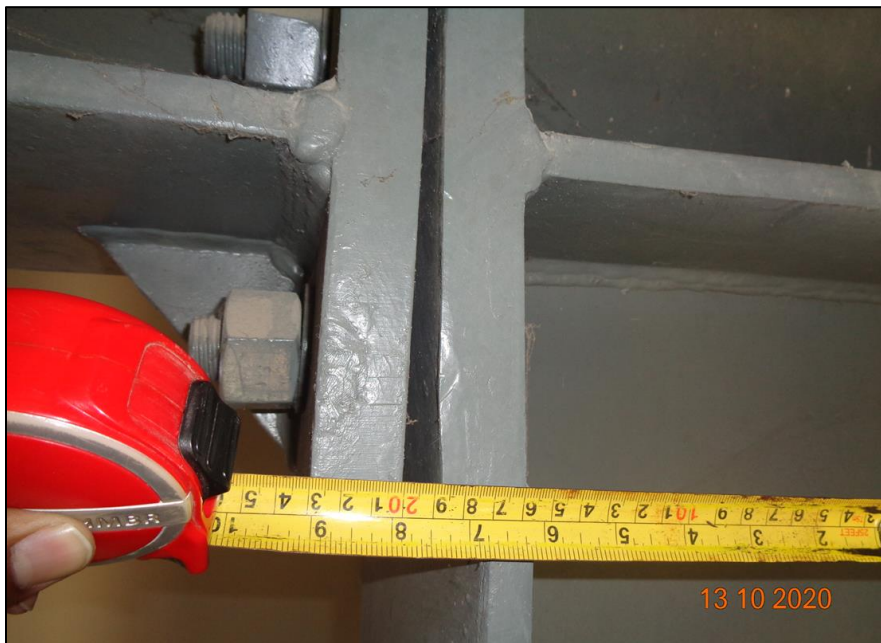
Gap observed in Beam- Column connection

Significant gaps observed at column-rafter & beam joint at several location. Factory engineer is required to carry out suitable remedial works.

| Item No. | Observation | Recommended Action Plan | Recommended Timeline |
|---|---|---|---|
| 15 | Significant connection gap at several location (Fabric Building). | Identify the locations and carryout suitable repair works where necessary. | 6-weeks |

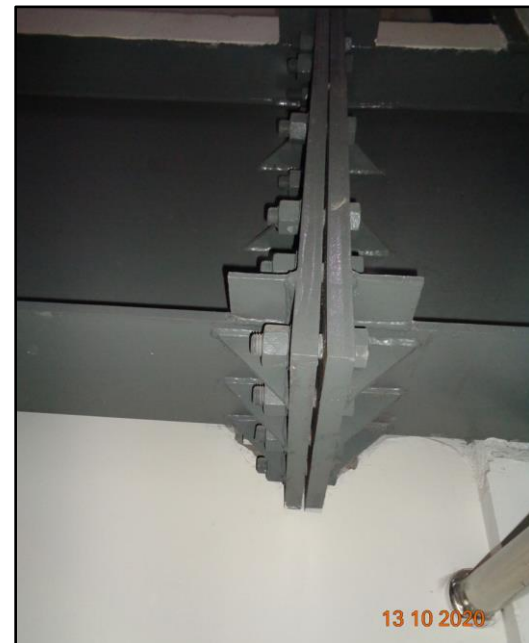
Connection Gap in Rafter

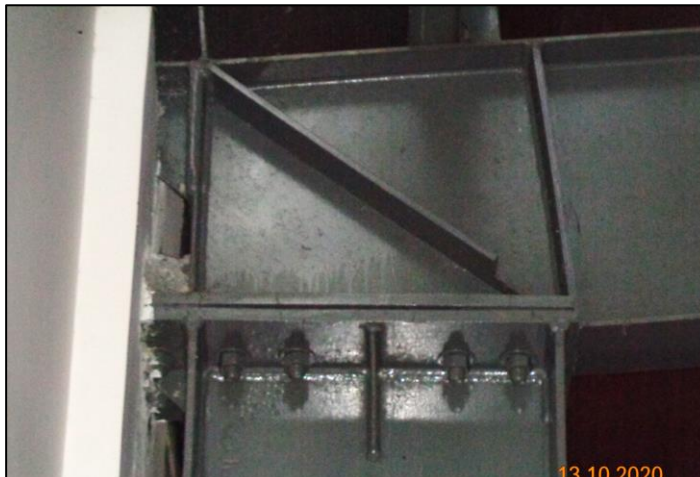
Gap observed in Rafter-Column connection

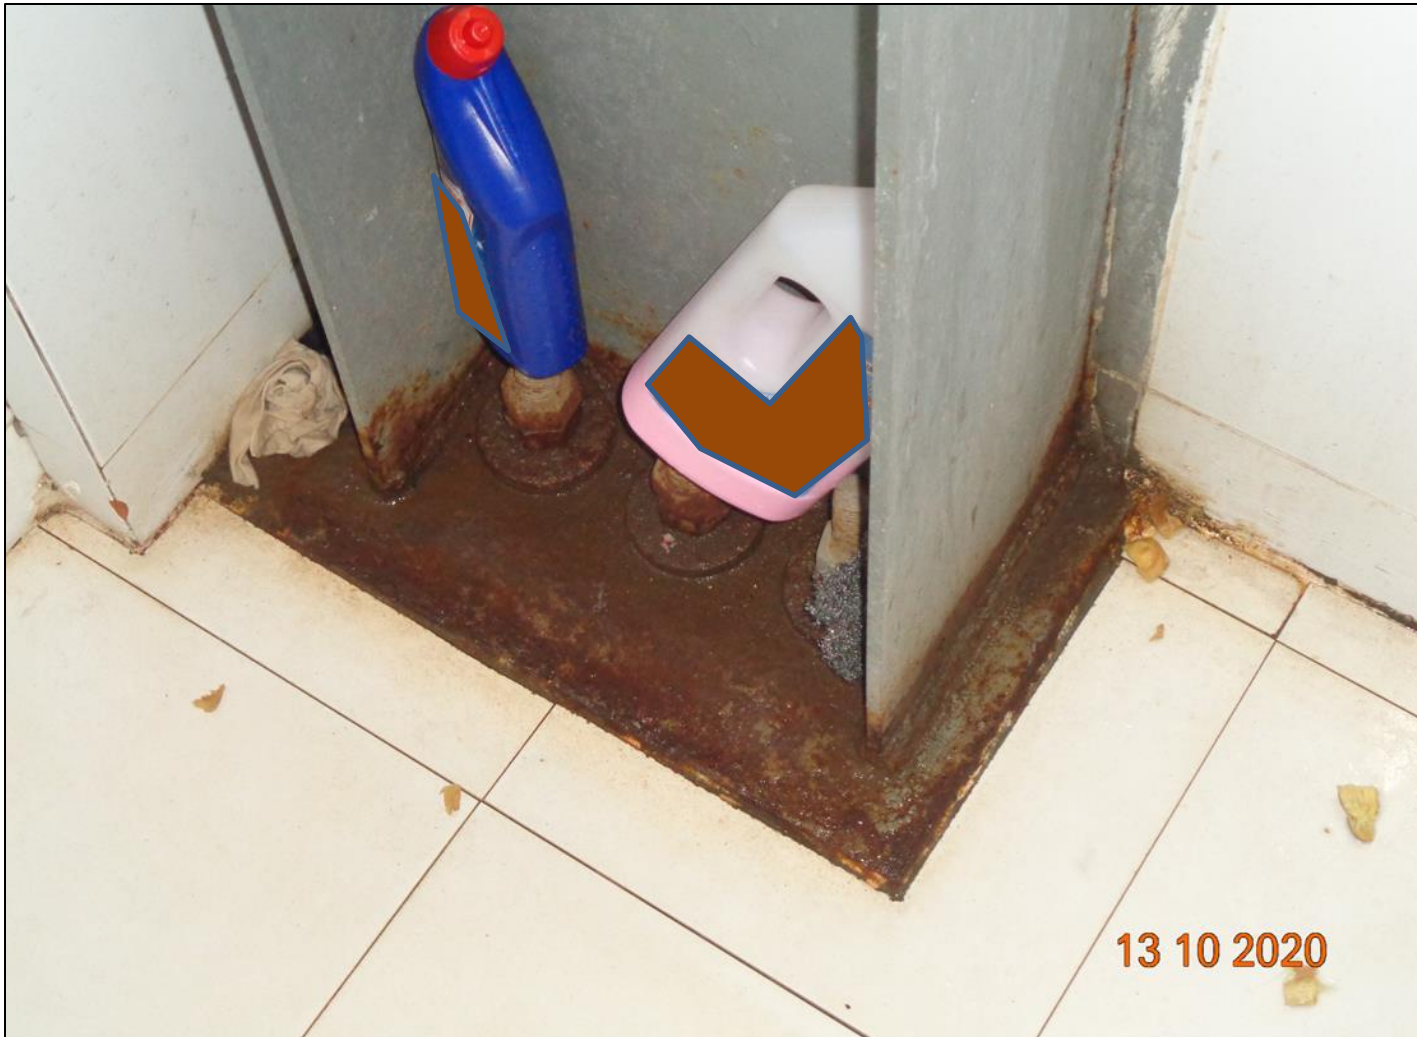
Corrosion was observed on steel column in toilet zone. Factory is required to identify the corroded locations and take proper remedial measures.

| Item No. | Observation | Recommended Action Plan | Recommended Timeline |
|---|---|---|---|
| 16 | Corrosion observed on steel sections (Fabric Building) | The building engineer to investigate the reason & extent of corrosion and suggest proper remedial measure accordingly. | 6-weeks |
| 17 | Corrosion observed on steel sections (Fabric Building) | Take necessary measures to prevent further corrosion and repair the corroded steel members as per engineer's suggestion. | 6-months |
