# Faiza Industries Ltd. Extended Building

R.S - 425, Baimail, Konabari, P.O.- Kashem Cotton Mill, Thana- Joydebpur, Gazipur  
(24.006853, 90.337155)  
1st October 2020

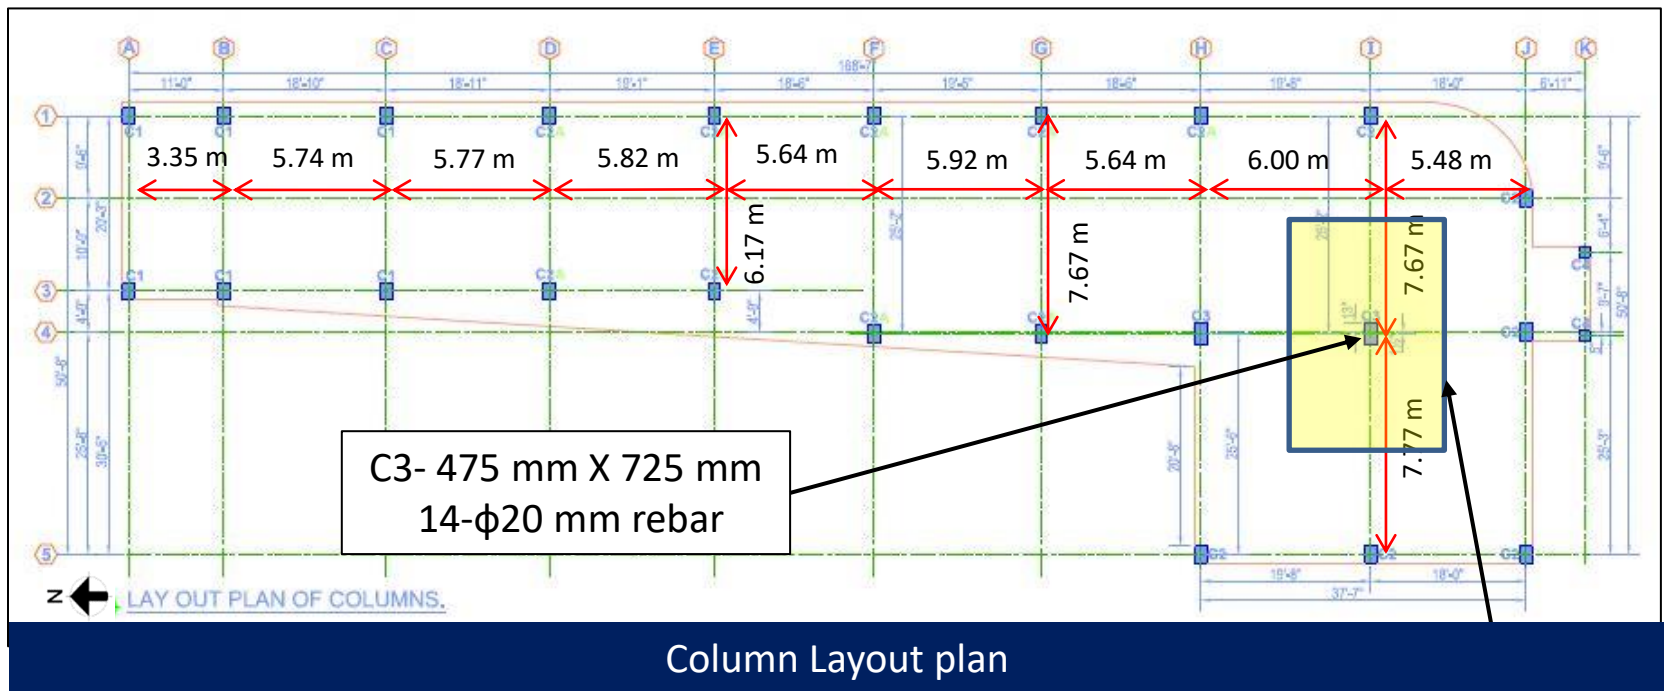
Cursory calculation indicates that column is stressed above normal design limits considering 5 kPa live load on typical floor & minimum concrete strength for stone chips. Building Engineer to review design, loads and columns stresses. Also, prepared load plan need to be revised based on floor, column and foundation capacity.

| Item No. | Observation | Recommended Action Plan | Recommended Timeline |
|---|---|---|---|
| 01 | Column and Footing stressed above normal design limits. | Factory Engineer to review design, loads, columns and footings stresses. | 6-weeks |
| 02 | Column and Footing stressed above normal design limits. | Verify in-situ concrete strength and aggregate type by taken min. 4 nos. 100mm dia. core samples or existing cylinder test reports from ground floor columns & foundation. | 6-weeks |
| 03 | Column and Footing stressed above normal design limits. | Produce and actively manage a loading plan for all floor plates within the factory, considering floor, column and foundation capacity. | 6-weeks |

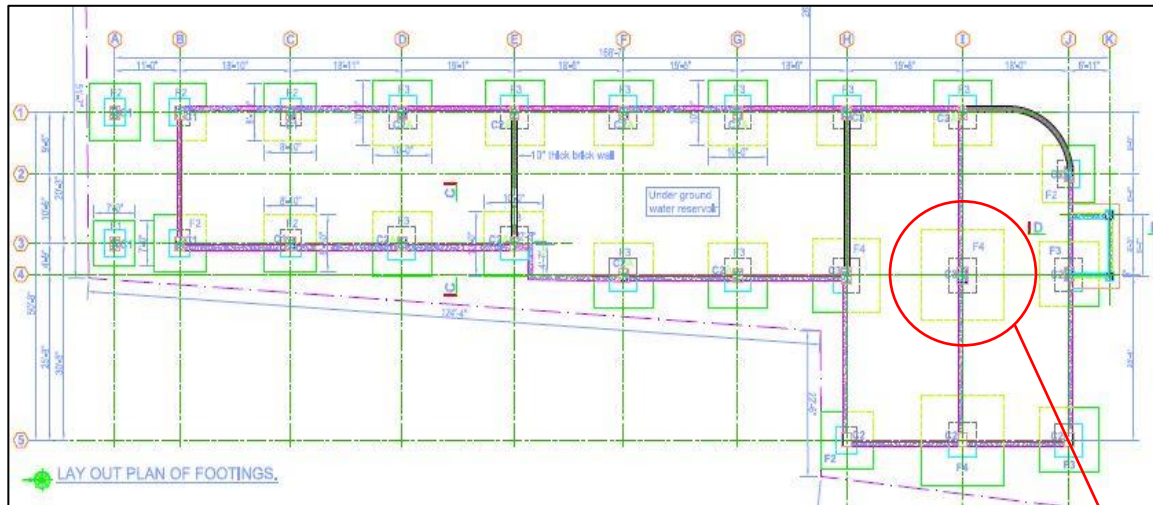
Footing Layout Plan.

Punching shear capacity check was performed for the footing-F4. Footing thickness is 750 mm (at punching critical zone). Column size 525X775 mm (below ground level).

Cursory calculation indicates that footing thickness is inadequate to resist punching shear considering minimum concrete strength for stone chips. Factory engineer is required to review the adequacy of footings and comply with BNBC.

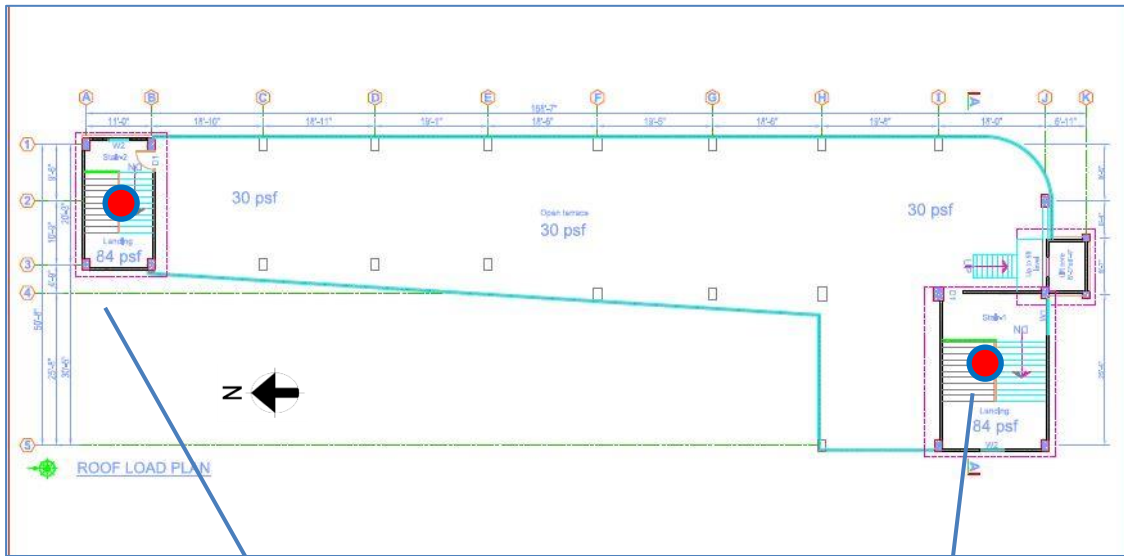
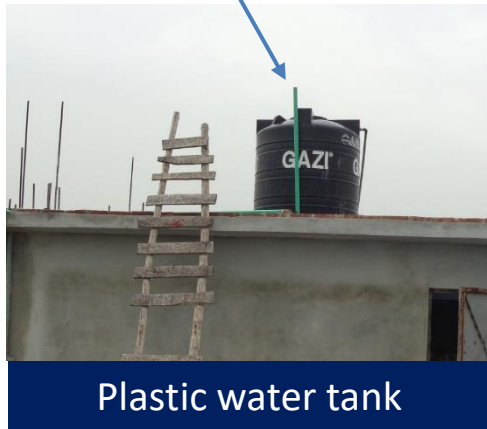
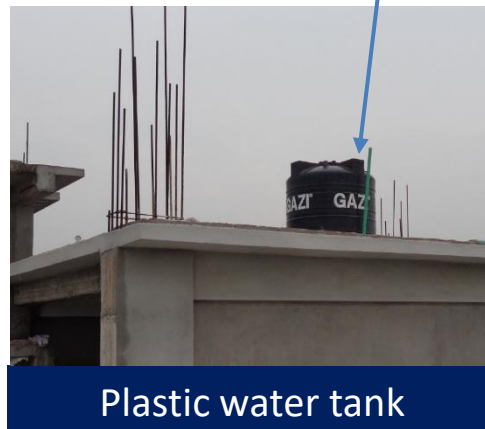
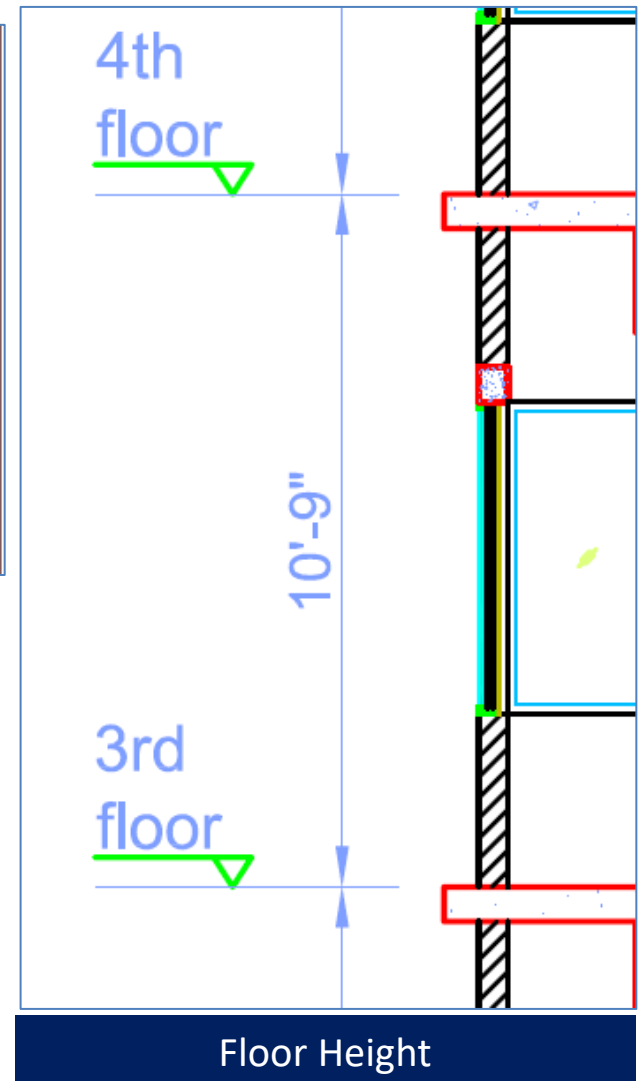
Floor to floor height including slab thickness has been shown 10 feet 9 inches on drawings. But onsite floor to floor height excluding slab thickness was measured 10 feet 9 inches. Also at stair roof, plastic water tanks are not shown in load plan and architectural drawing.

| Item No. | Observation | Recommended Action Plan | Recommended Timeline |
|---|---|---|---|
| 06 | Discrepancy in as-built drawing | Prepare “as constructed” drawings which reflect the actual site dimensions and complete structural information. | 6-weeks |
| 07 | Discrepancy in as-built drawing | Mention plastic water tank’s size and locations on load pan and architectural drawings. | 6-weeks |

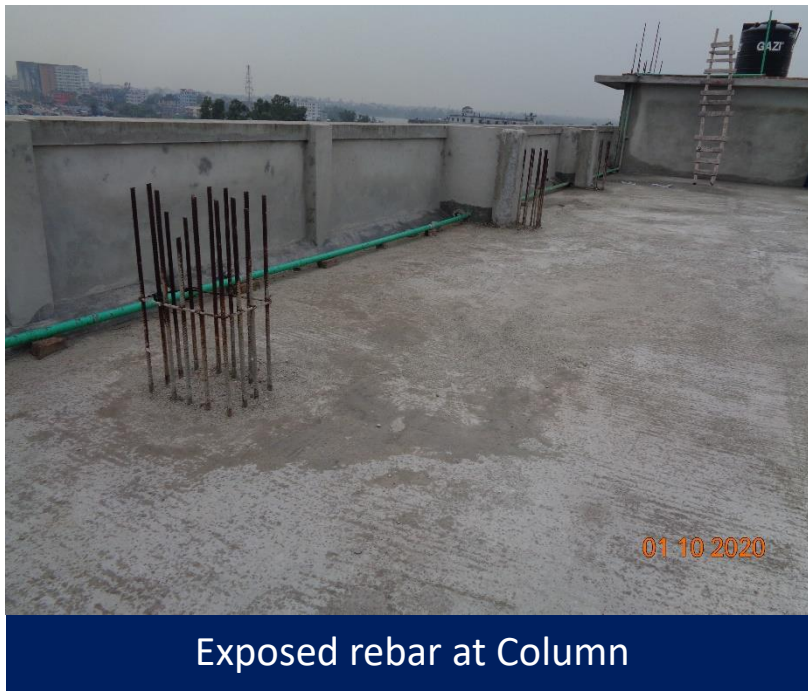
Corrosion was observed on all exposed reinforcement on existing roof top columns. Factory must provide adequate protection to the structural elements from corrosion.

Exposed rebar at Column

| Item No. | Observation | Recommended Action Plan | Recommended Timeline |
|---|---|---|---|
| 08 | Corroded and exposed rebar at roof. | All exposed reinforcement is to be protected from corrosion which may cause degradation of the concrete. | 6-weeks |

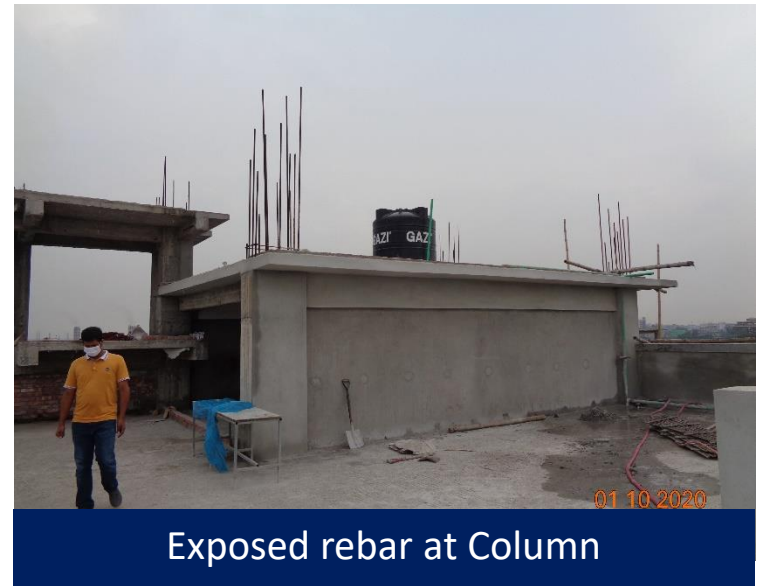
Exposed rebar at Column

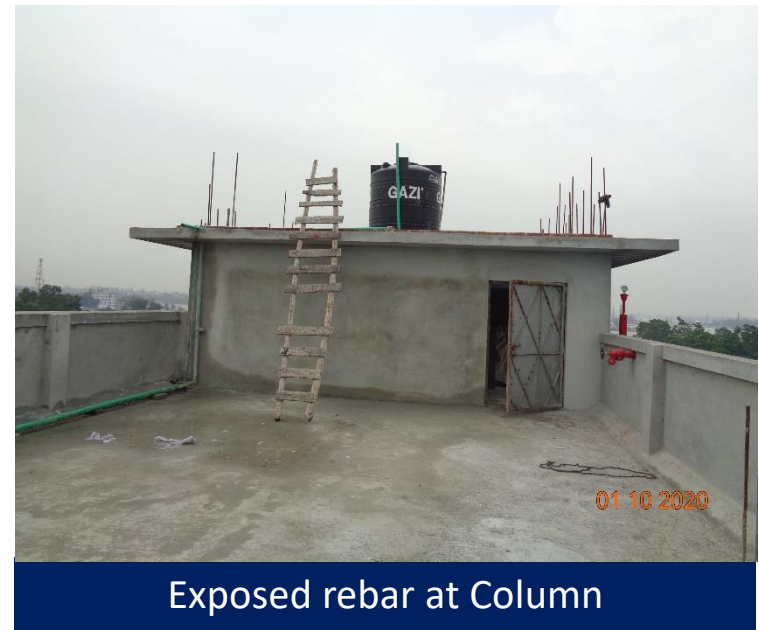
Exposed rebar at Column
