# Ibrahim Knit Garments Pvt. Ltd. Extension-1

Ailpara Pathantoli, Siddirganj, Naranganj

16th February 2021

1. Building-4 (G+5)
2. Building-5 (Proposed G+5) (Completed G+2)

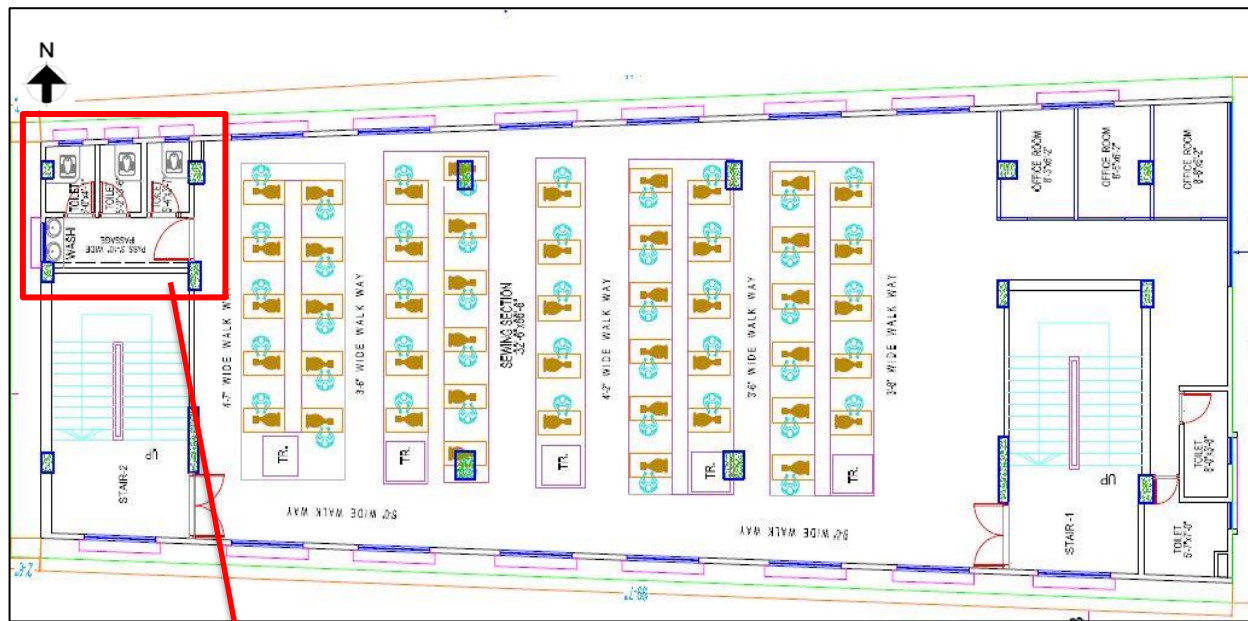
Floor layout plan & blow up of toilet zone area.

Floor build up and wall height not shown in as-built drawing

In as-built architectural drawing, the height of the toilet partition wall and floor build up were not shown. However, the height of the partition wall was found 1.98 m and floor build up was found 100 mm.

Factory engineer is required to survey the whole structure and update the as-built drawing. Also, Factory engineer to update the design document including in compliance with section 1.9.1 as per BNBC 2006.

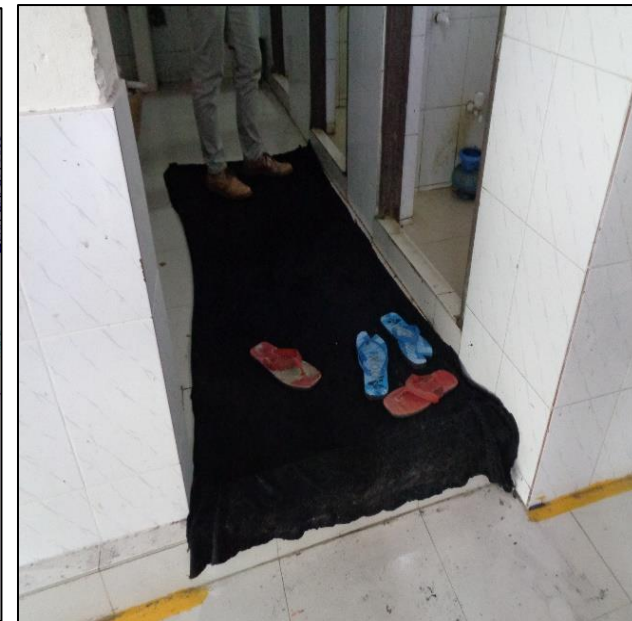
Floor build up found 100 mm

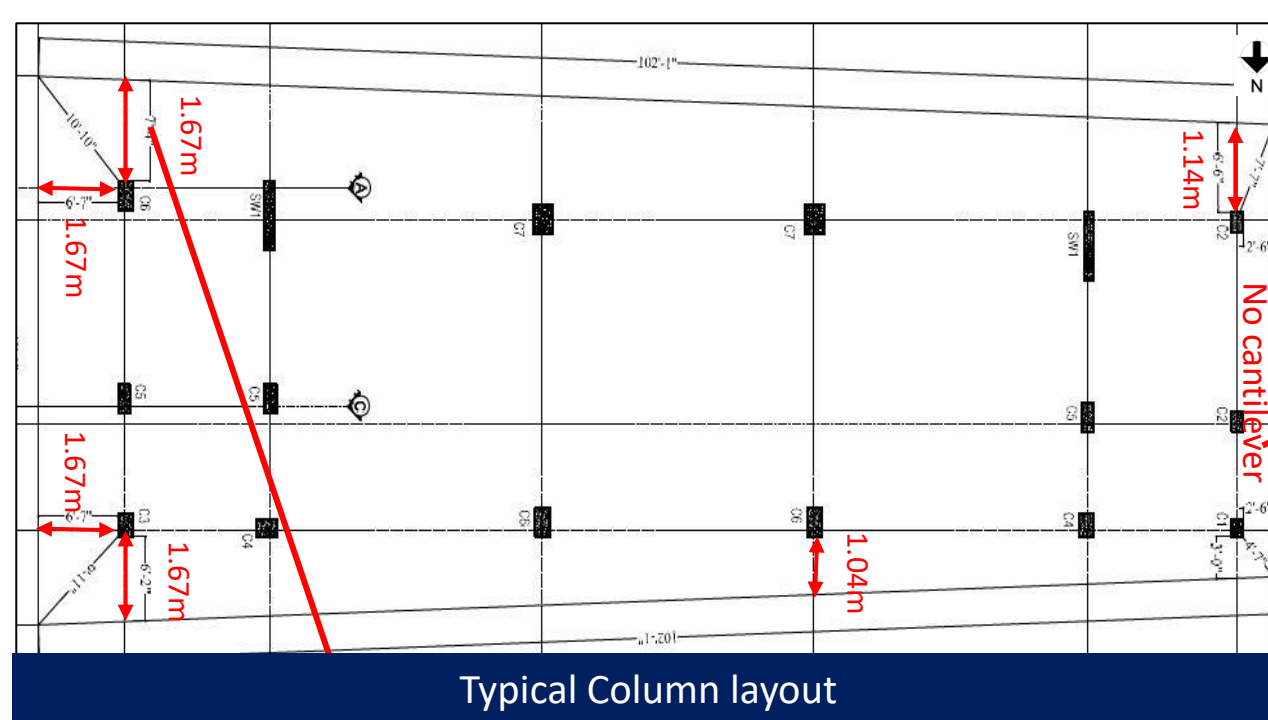
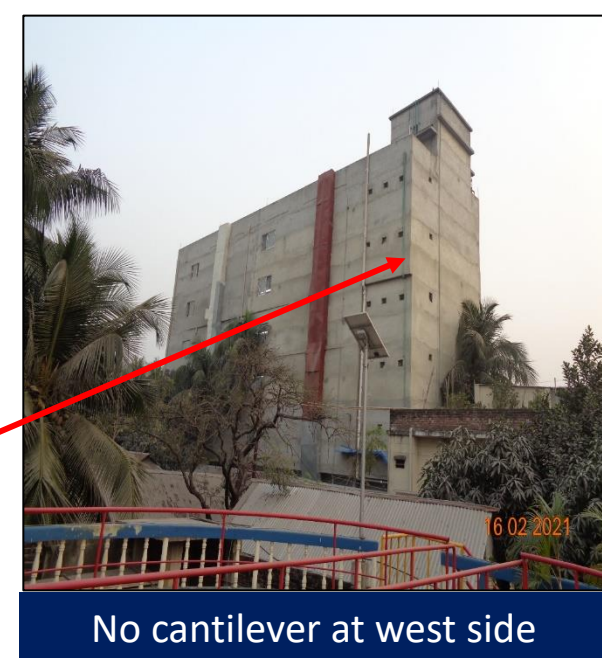
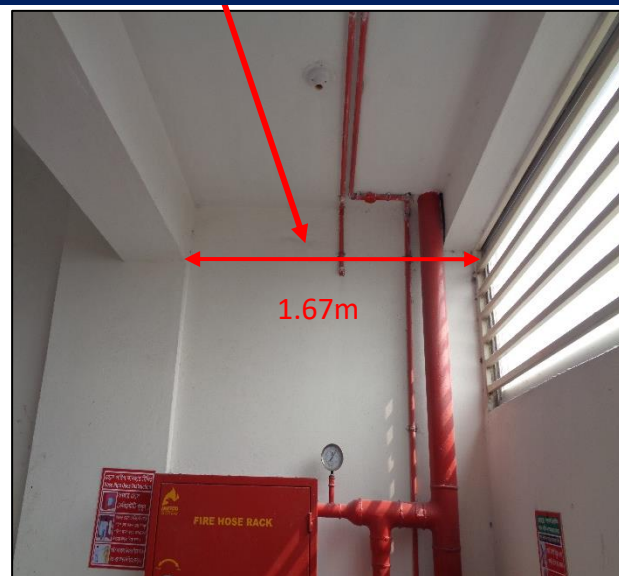
Dimension of cantilever was not found as per provided drawing with on-site condition. Also, cantilever has been shown in drawing at west side of the building but cantilever was not found at site condition. Factory engineer is required to survey the whole structure and update the as-built drawing as per on-site condition in accordance with section 1.9.1.2 (BNBC Part-6).

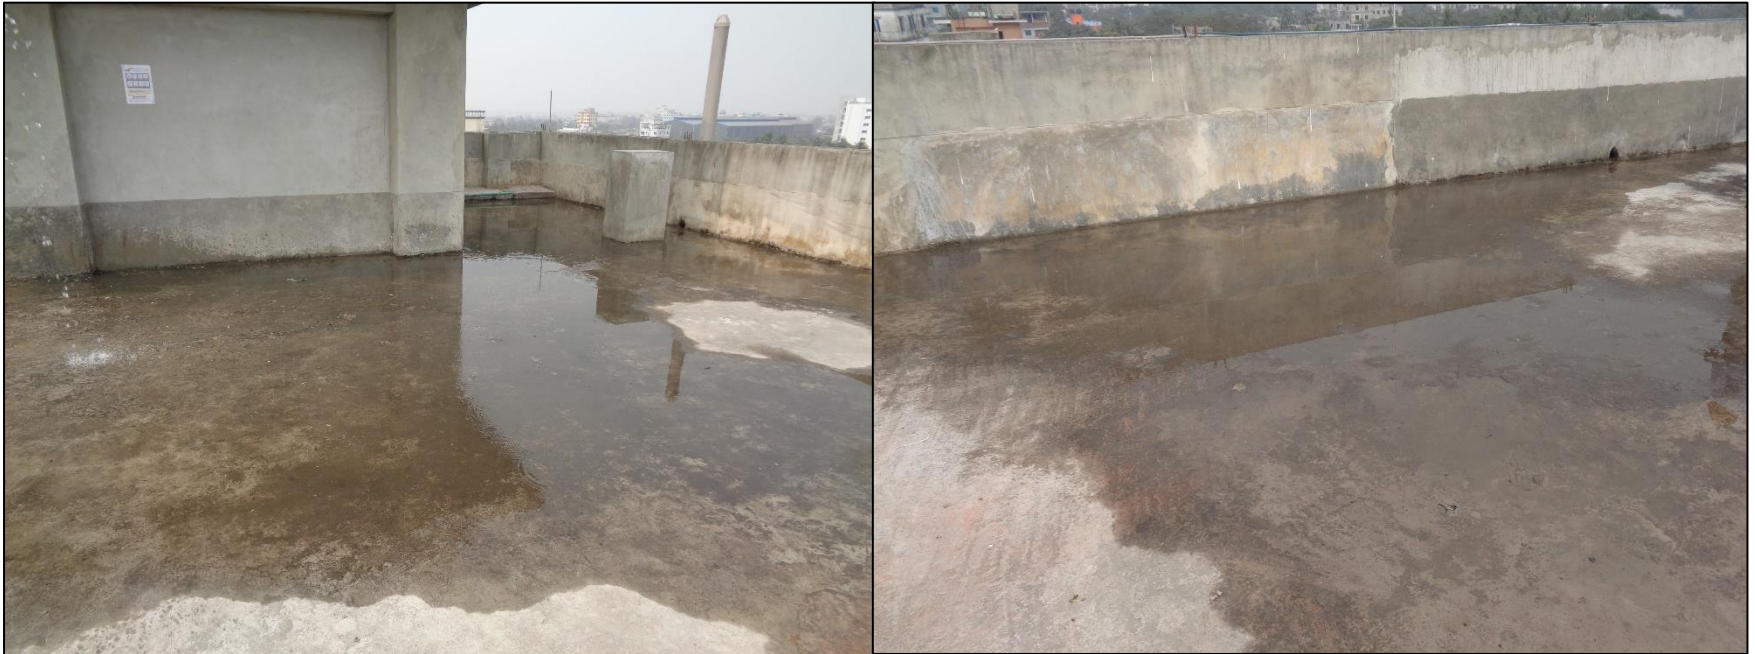
Water ponding on roof slab

Water ponding was found on roof slab due to improper slope. Any cracks or damage on the roof surface will allow water to seep into the concrete slab beneath the finishes and cause long term soaking of the slab and corrosion of the rebar. Factory is required to provide necessary slope and improve drainage system to prevent water ponding.

| Item No. | Observation | Recommended Action Plan | Recommended Timeline |
|---|---|---|---|
| 05 | Water ponding on roof slab (Building-4) | Factory is required to develop proper slope and improve drainage system to prevent water ponding. | 6-weeks |

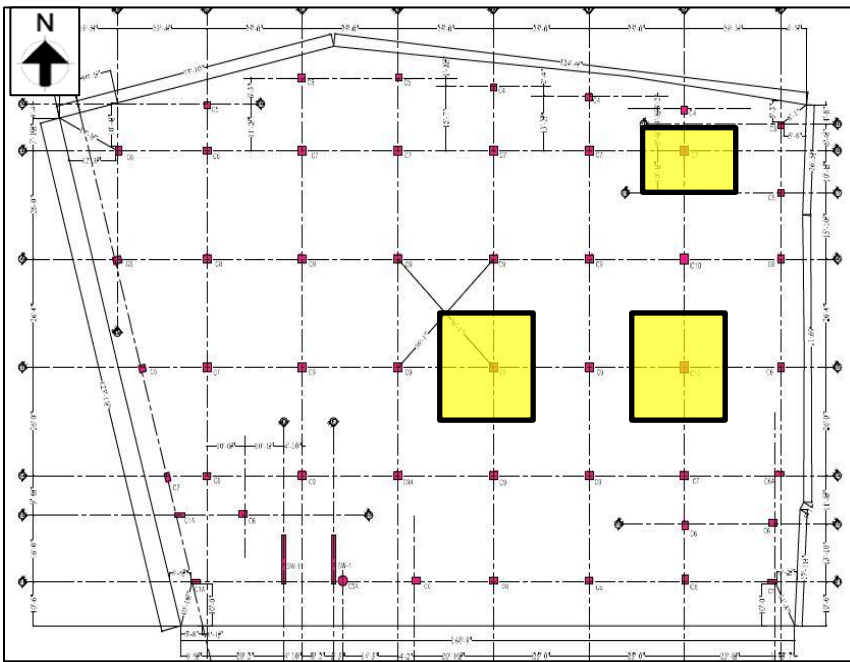
Column Layout Plan

**Column to be stressed above normal design limit considering possible vertical extension**

Cursory calculation indicates that the marked columns are stressed above normal design limit considering prepared live load plan (5 KPa for typical floor and 1.5 KPa for roof) and minimum concrete strength based on aggregate type for the 6 storied building. Factory engineer is required to carry out a Detail Engineering Assessment (DEA) in compliance with section 1.9.1 BNBC 2006 prior to any vertical extension.

| Item No. | Observation | Recommended Action Plan | Recommended Timeline |
|---|---|---|---|
| 06 | Column to be stressed above normal design limit considering possible vertical extension (Building-5) | Factory engineer is required to carry out a Detail Engineering Assessment (DEA) in compliance with BNBC 2006 prior to any vertical extension. | 6-weeks |

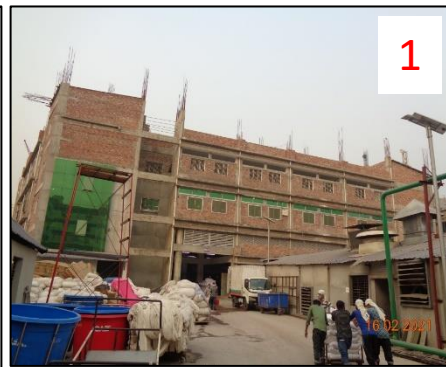
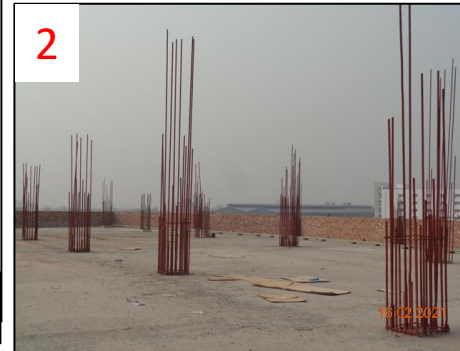
1. Building is currently three storied 2. Extended re-bar at roof for vertical extension 3. Design report prepared for 6 storied structure.

This building is permitted for 6 storied (G+5) storied from local authority. Currently, the building is three storied (G+2). Design documents of the structure has been prepared considering 6 storied building. Also, extended portion of column rebar was found at roof level which indicates the possibility of vertical extension.

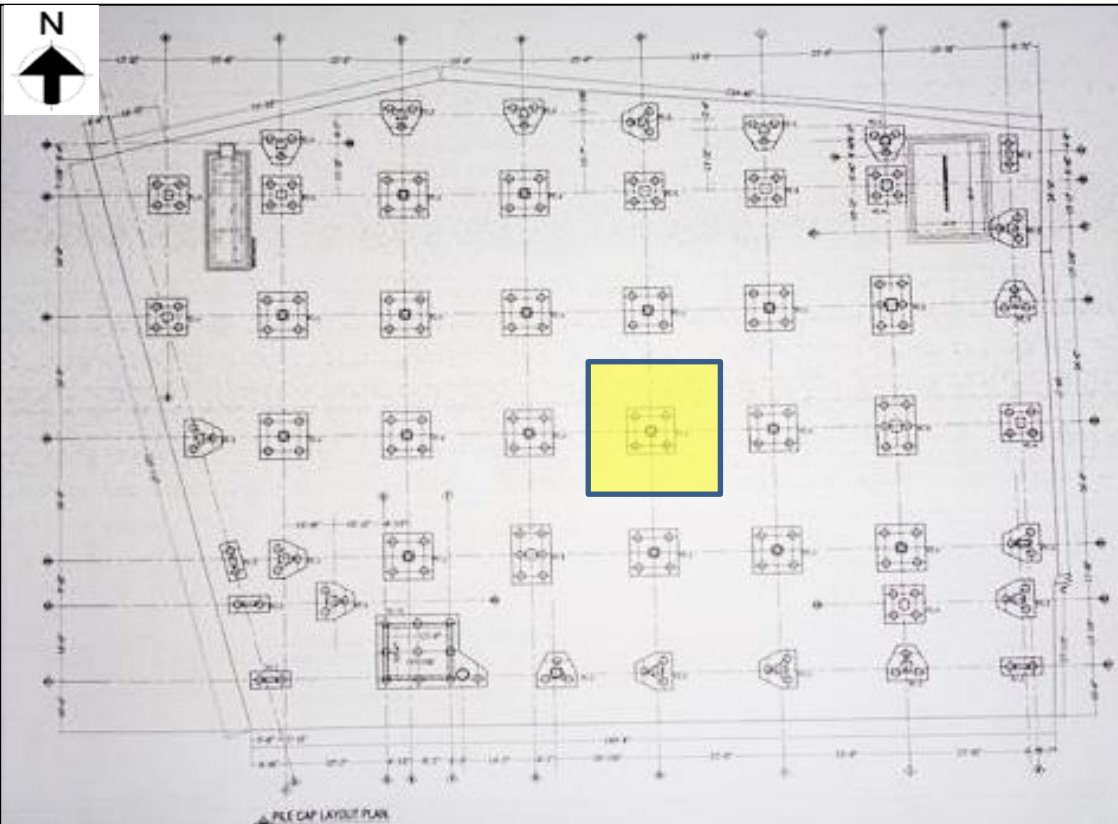
Pile Layout plan

**Foundation to be stressed above normal design limit considering possible vertical extension**

Cursory calculation indicates that the marked foundation is stressed above normal design limit considering prepared live load plan (5 KPa for typical floor and 1.5 KPa for roof).  
Factory engineer is required to carry out a Detail Engineering Assessment (DEA) complying with BNBC prior to any vertical extension.

| Item No. | Observation | Recommended Action Plan | Recommended Timeline |
|---|---|---|---|
| 07 | Foundation to be stressed above normal design limit considering possible vertical extension (Building-5) | Factory engineer is required to carry out a Detail Engineering Assessment (DEA) in compliance with BNBC 2006 prior to any vertical extension. | 6-weeks |

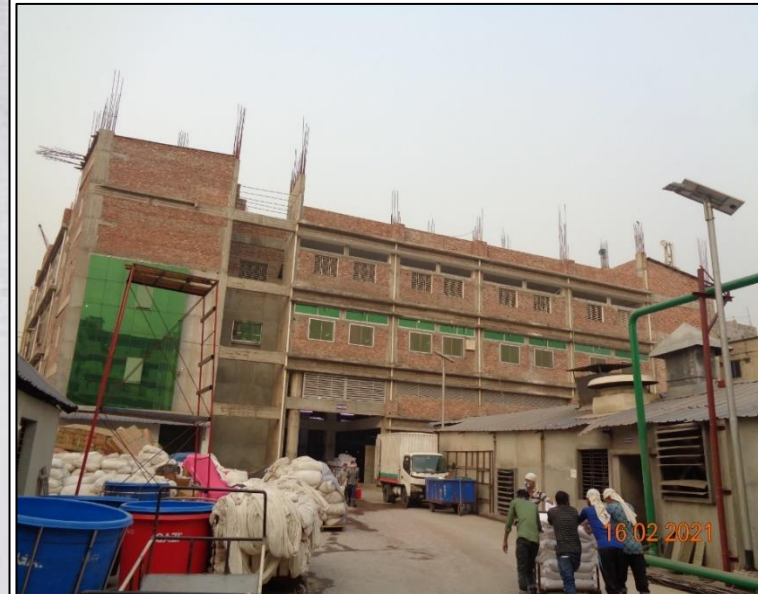
Building is currently three storied

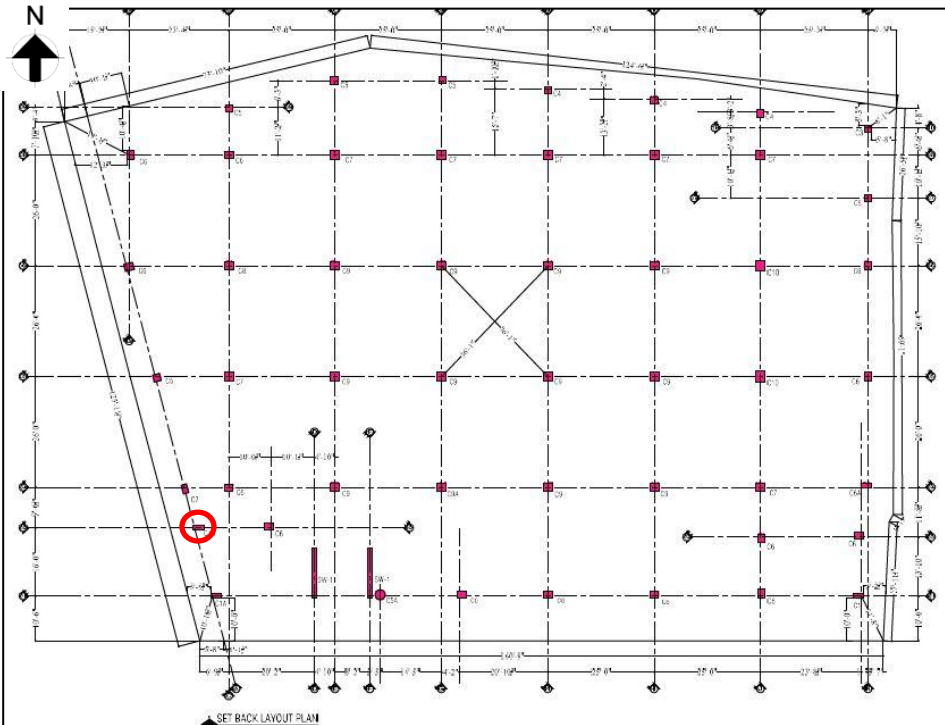
Column layout

Dimension of the highlighted column (C-1A) was found 350mmX625mm instead of 300mmX750mm. Factory engineer is required to survey the whole structure and update the as-built drawing in compliance with the section 1.9.1.2 (Part-6; BNBC 2006).

Dimension shown in schedule-300mmX750mm

| Item No. | Observation | Recommended Action Plan | Recommended Timeline |
|---|---|---|---|
| 08 | Discrepancies in as built drawing with on site condition (Building-5) | Factory engineer is required to survey the whole structure and update the as-built drawing as per on-site condition in compliance with section 1.9.1.2 (Part-6; BNBC 2006). | 6-weeks |

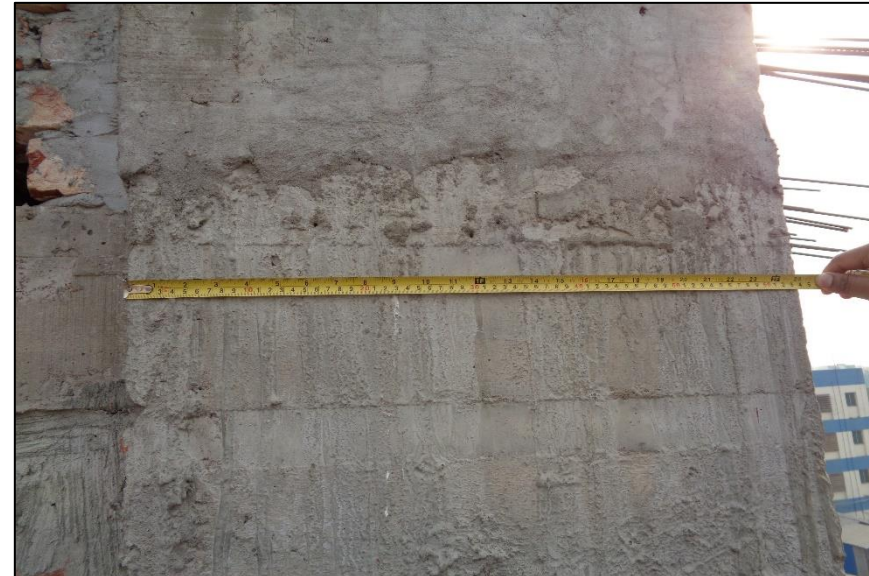
Dimension found -350mmX625mm

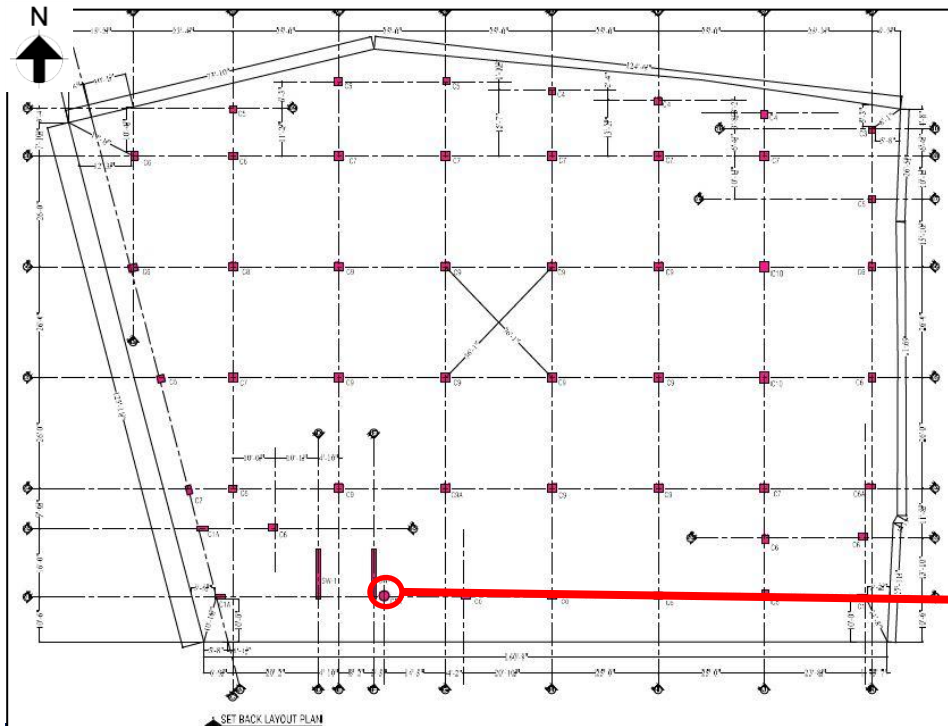
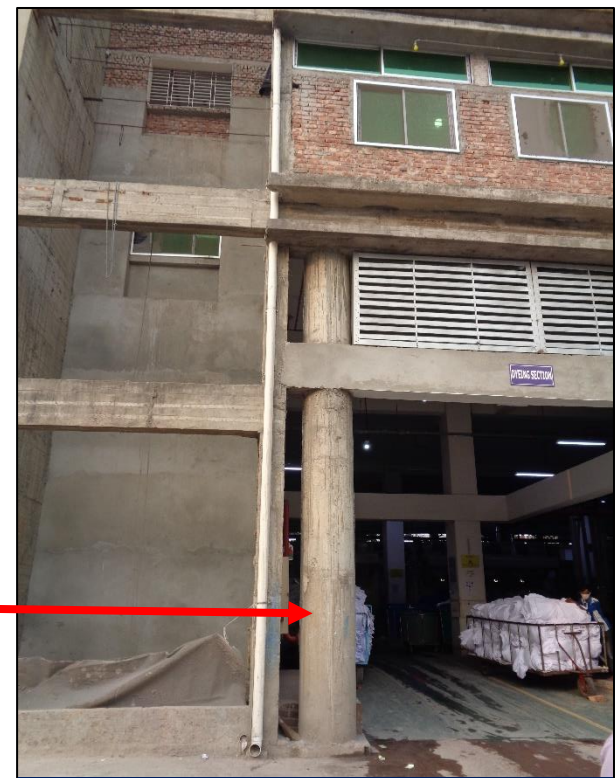
Circular column

Dimension shown in schedule- 750mm

Dimension of the highlighted column (C-5A) was found 700mm (diameter) instead of 750mm. Factory engineer is required to survey the whole structure and update the as-built drawing as per on-site condition in accordance with section 1.9.1.2 (BNBC Part-6).

Also, building engineer to update the design document including a design report in compliance with section 1.9.1.1 as per BNBC.

| Item No. | Observation | Recommended Action Plan | Recommended Timeline |
|---|---|---|---|
| 09 | Discrepancies in as built drawing with on site condition (Building-5) | Building engineer to update the design document including a design report, and a set of structural drawings in compliance with section 1.9.1.1 and section 1.9.1.2 as per (Part-6; BNBC 2006). | 6-weeks |

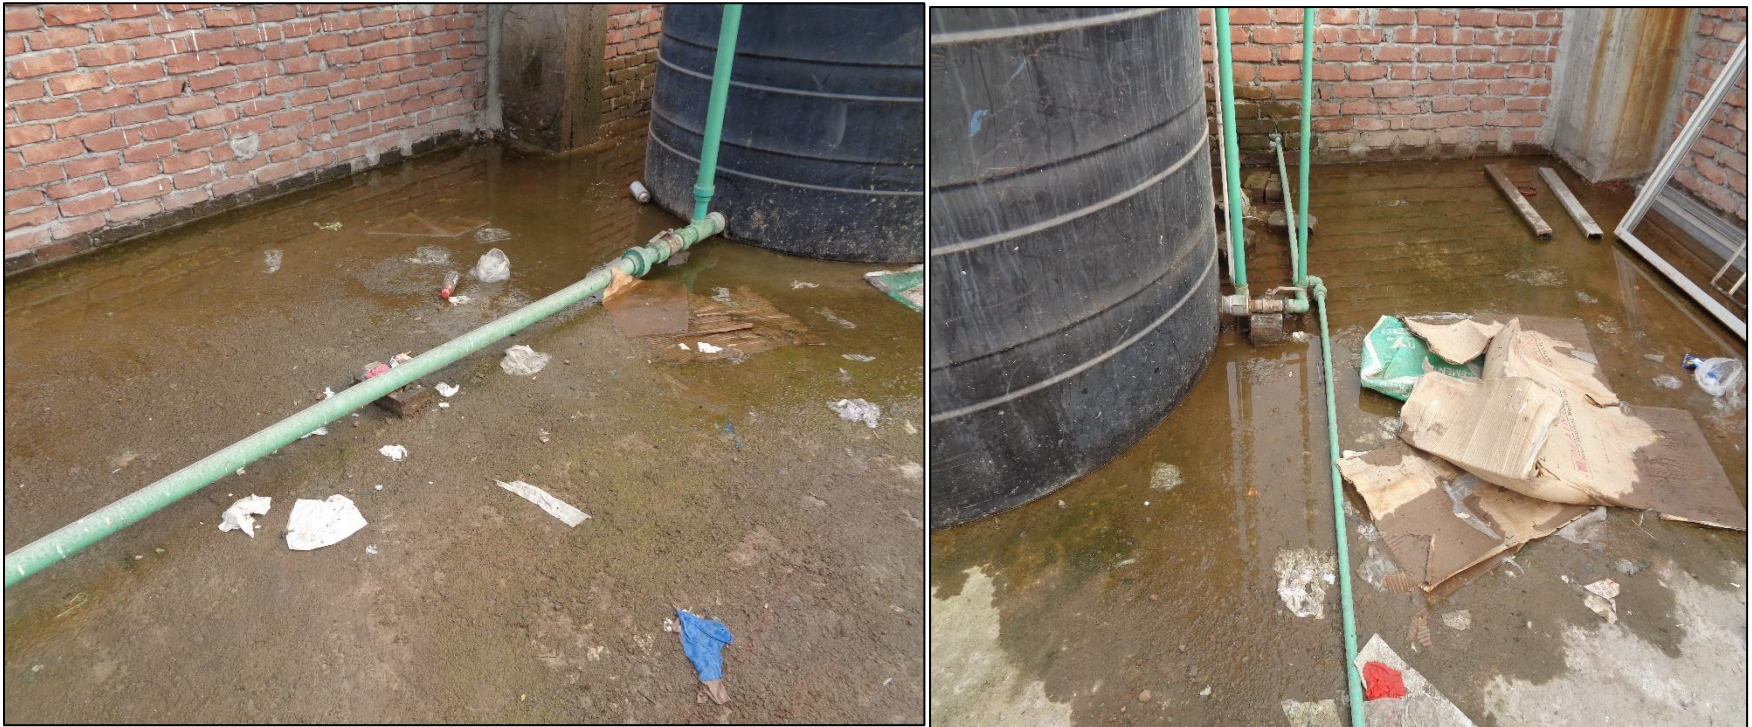
Water ponding on roof slab

Water ponding was found on roof slab due to improper slope. Any cracks or damage on the roof surface will allow water to seep into the concrete slab beneath the finishes and cause long-term soaking of the slab and corrosion of the rebar. The factory is required to provide the necessary slope and improve the drainage system to prevent water ponding.

| Item No. | Observation | Recommended Action Plan | Recommended Timeline |
|---|---|---|---|
| 10 | Water ponding on roof slab (Building-5) | Factory is required to develop proper slope and improve drainage system to prevent water ponding. | 6-weeks |
