# Snowtex Sportswear Ltd.

B-65/4, Lakuriapara, Dhulivita, Dhamrai  
(23.910371, 90.206833)  
3<sup>rd</sup> March 2021

# Building Information

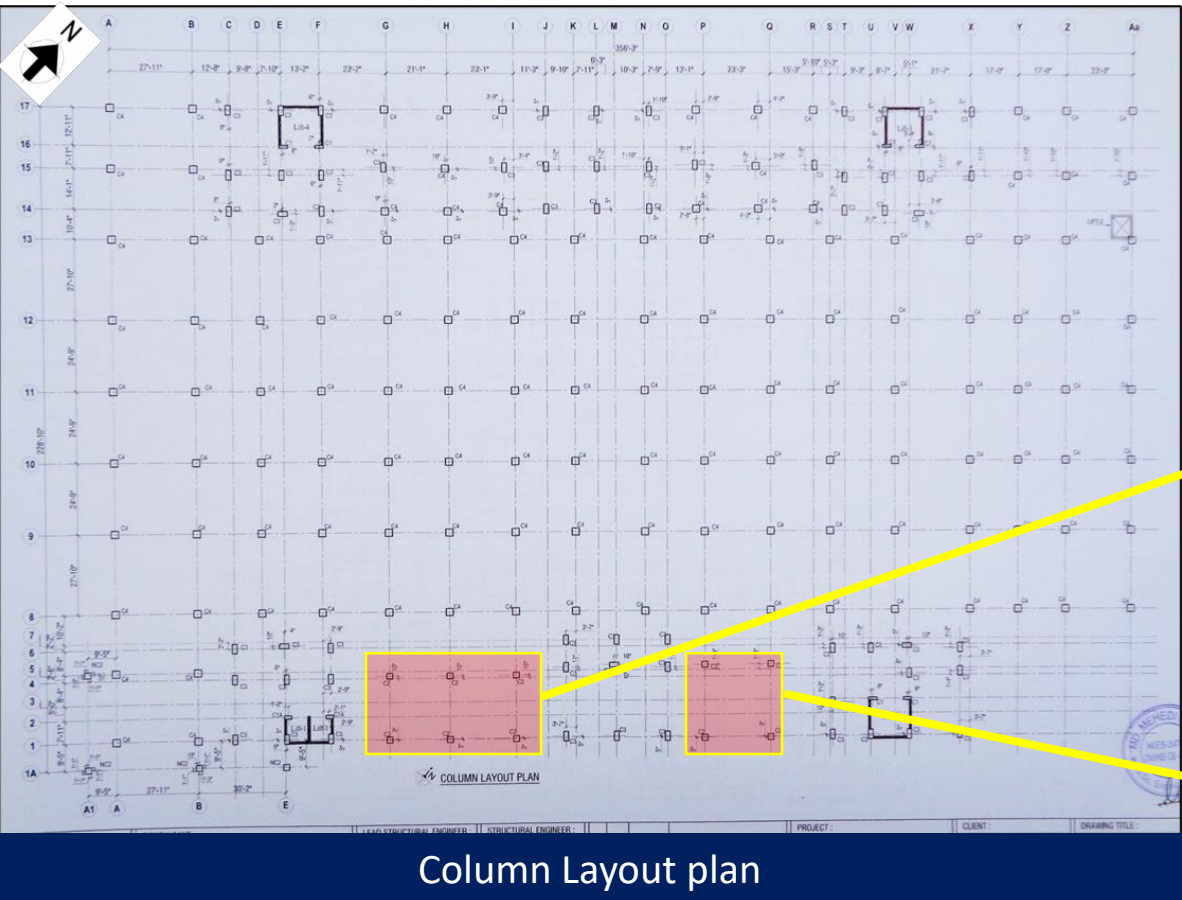
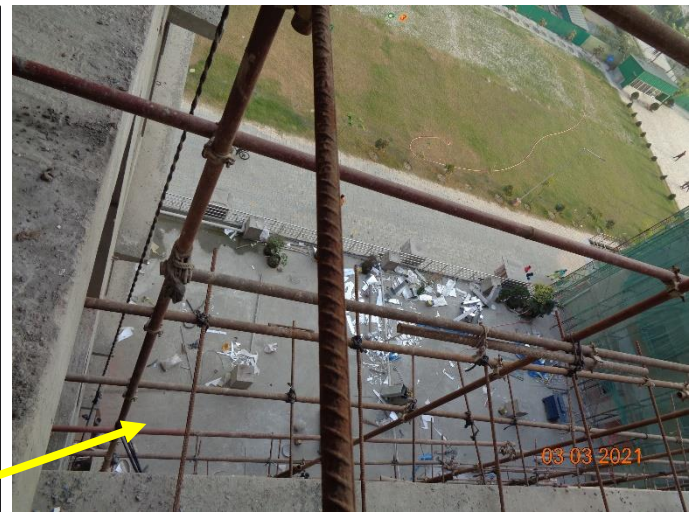
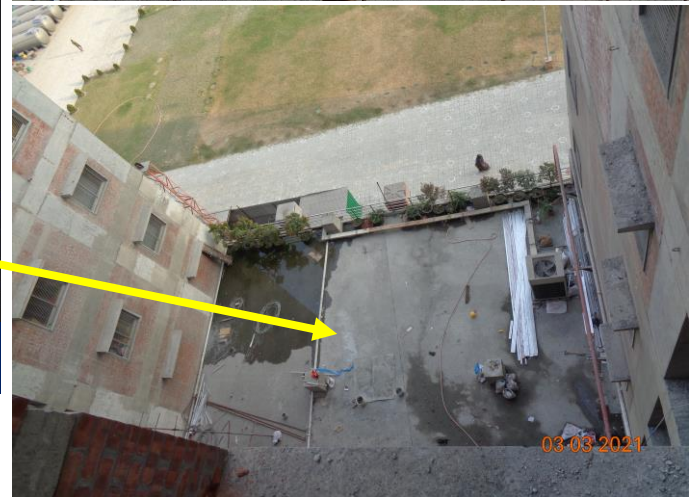
Column Layout plan

Column at the marked location was found only at ground floor. But in drawing, these columns have been shown up to top floor.  
 Factory engineer is required to survey the structures and prepare accurate as-built drawings in compliance with section 1.9.1.2 (Part-6;BNBC)

| Item No. | Observation | Recommended Action Plan | Recommended Timeline |
|---|---|---|---|
| 01 | Discrepancies in provided drawing (Building -1: Main Production Building) | Building Engineer to survey the structure and prepare accurate as-built (both architectural & structural) drawings in compliance with section 1.9.1.2 as per BNBC. | 6-weeks |

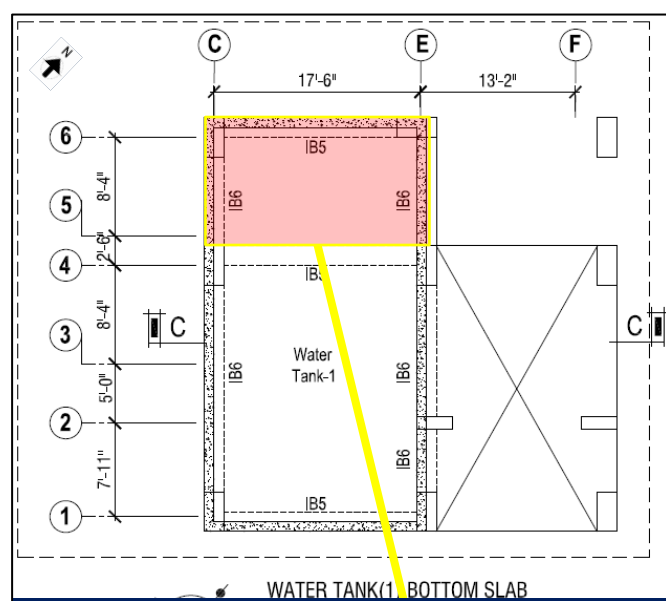
Overhead water tank -1

Over head water tank was not constructed as per drawing at the marked location. Factory engineer is required to survey the structures and prepare accurate as-built drawings in compliance with section 1.9.1.2 (Part-6;BNBC).

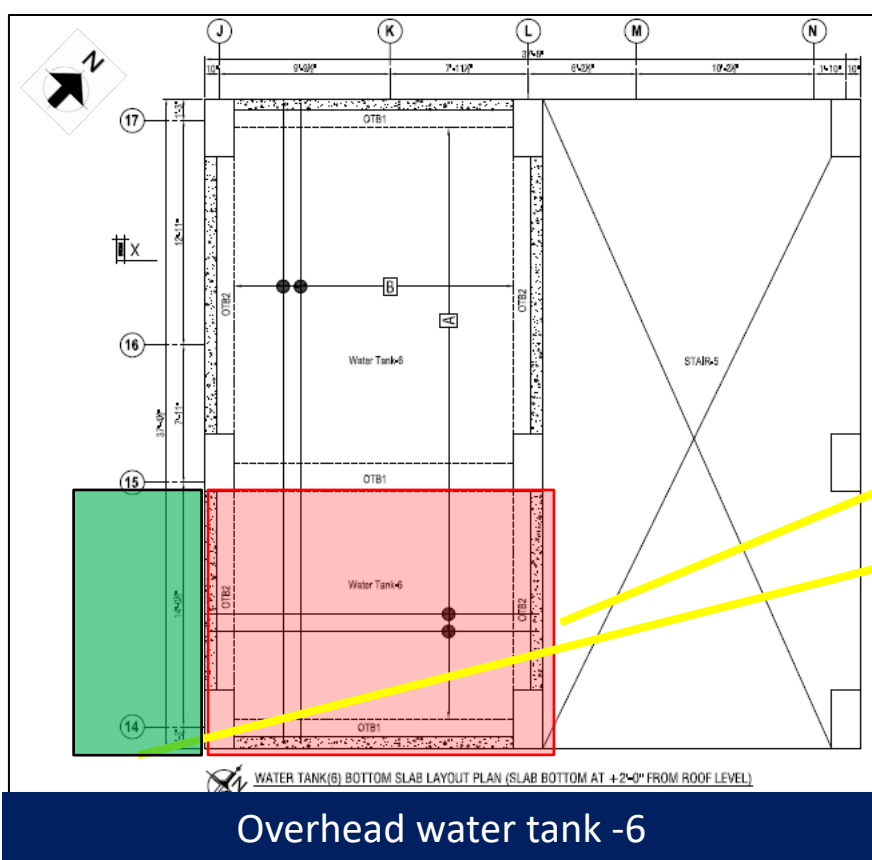
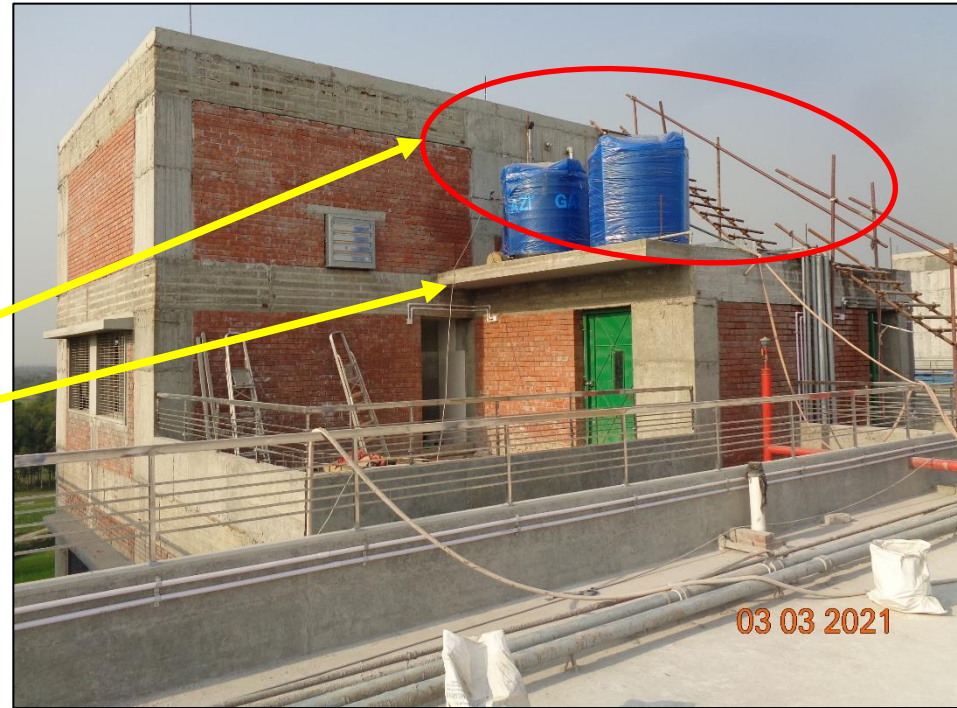
Over head water tank was not constructed as per drawing at the marked location. Factory engineer is required to survey the structures and prepare accurate as-built drawings in compliance with section 1.9.1.2 (Part-6;BNBC)

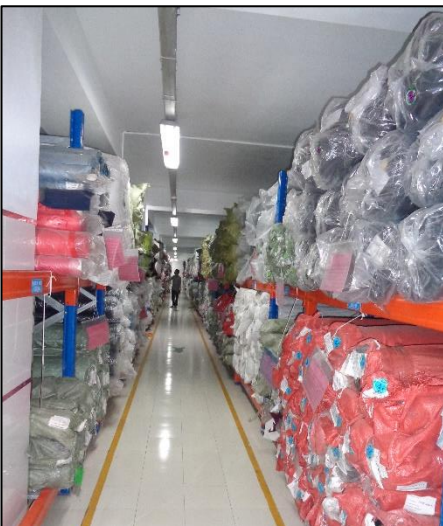
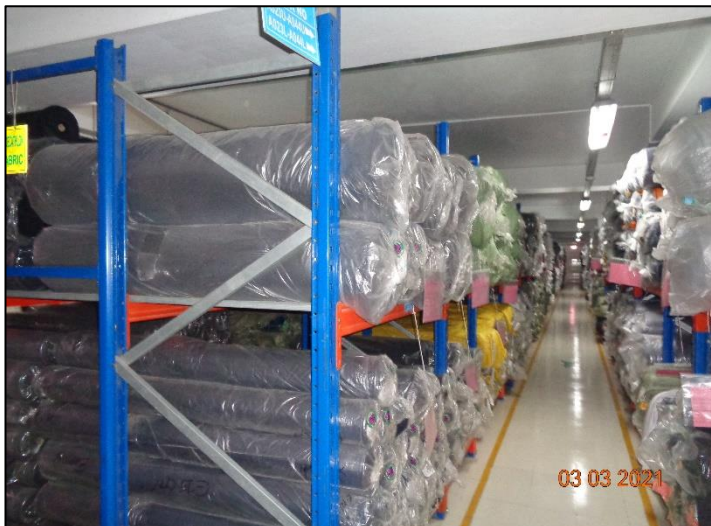
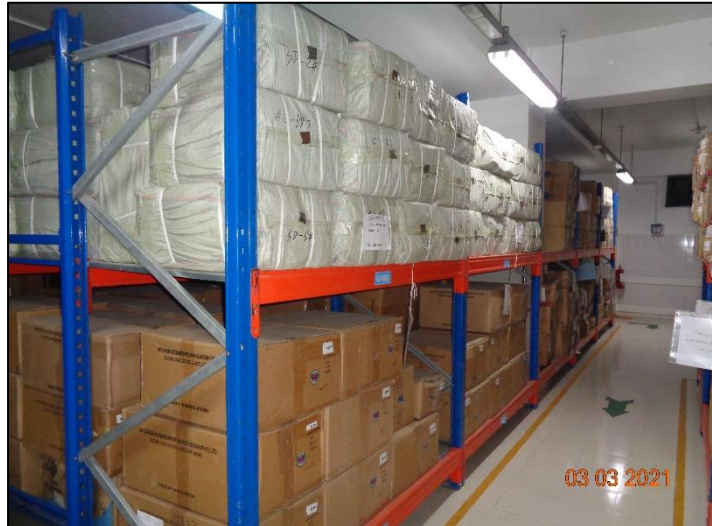
Storage Floor loading

As per BNBC every building or structure designed shall have its design documents prepared in accordance with the provision of Section 1.9.1. The design document shall include a design report, and a set of structural drawings, which shall be prepared in compliance with section 1.9.1.1 and section 1.9.1.2 as per BNBC. During the inspection, the design report was not found which is required to be prepared in compliance with section 1.9.1 (part-6, BNBC).

| Item No. | Observation | Recommended Action Plan | Recommended Timeline |
|---|---|---|---|
| 02 | Design report needs to be prepared (Building -1 : Main Production Building) | Building engineer to prepare the design document including a design report, and a set of structural drawings in compliance with section 1.9.1.1 and section 1.9.1.2 as per BNBC. | 6-weeks |

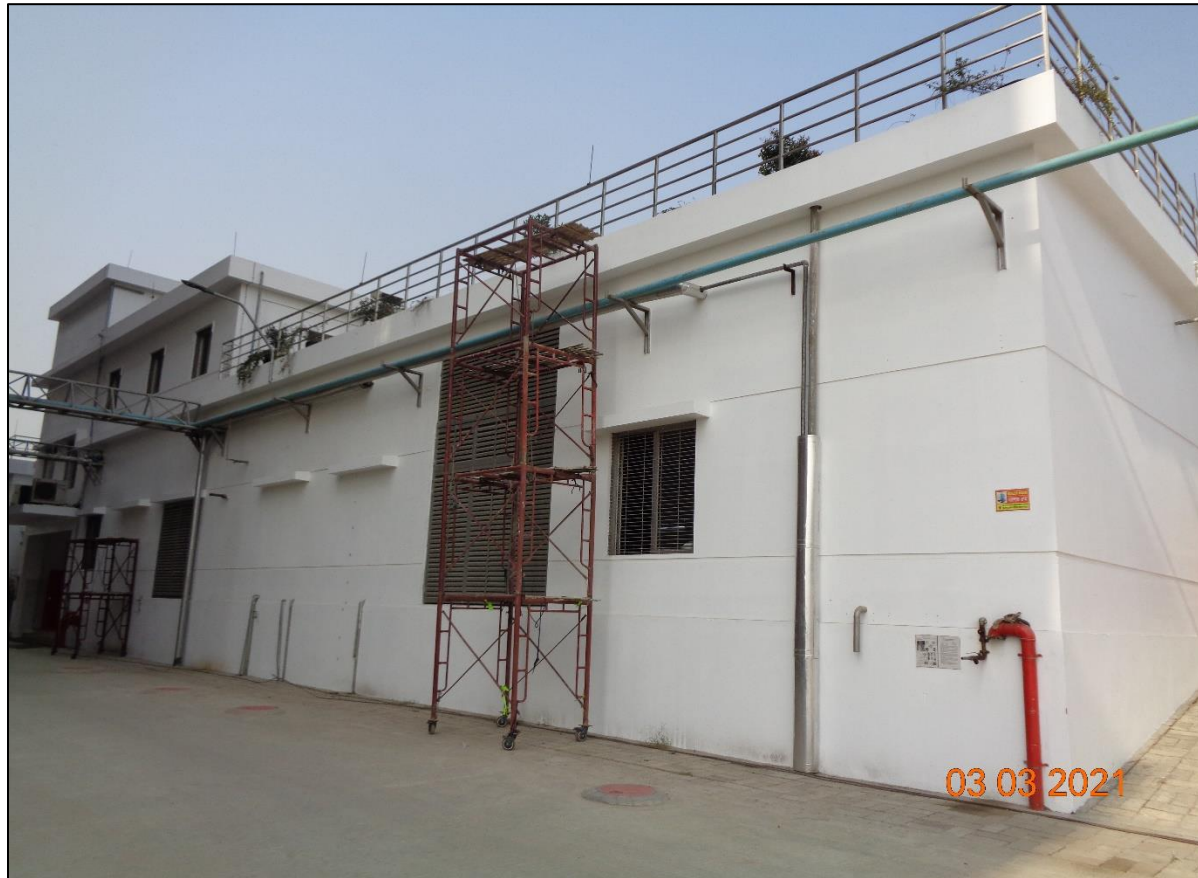
Boiler and pump room Building

As per BNBC, every building or structure designed shall have its design documents prepared in accordance with the provision of Section 1.9.1. The design document shall include a design report, and a set of structural drawings, which shall be prepared in compliance with section 1.9.1.1 and section 1.9.1.2 as per BNBC. At the time of inspection, only provided drawing was available, but no design report and load plan were available which is required to be prepared in compliance with section 1.9.1.1 (part-6, BNBC).

| Item No. | Observation | Recommended Action Plan | Recommended Timeline |
|---|---|---|---|
| 04 | Design report needs to be prepared (Building-3 : Boiler & Fire pump room) | Factory engineer is required to prepare the design documents including a design report and update the structural drawings in compliance with section 1.9.1.1 and section 1.9.1.2 as per BNBC part 6 and submit to RSC for review. | 6-weeks |

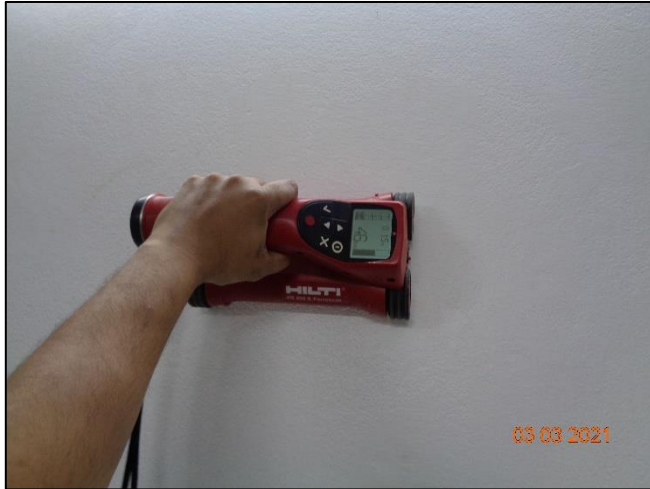
Tie-Beam confirming by ferro-scanner

An Additional tie-beam (300mmX550mm) along grid 5A to 5B was found on-site. But no details has been found in provided drawing. Factory engineer is to survey the whole structure and update as-built drawings representing accurate site condition.

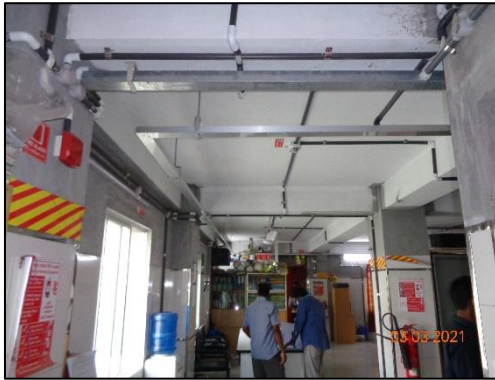
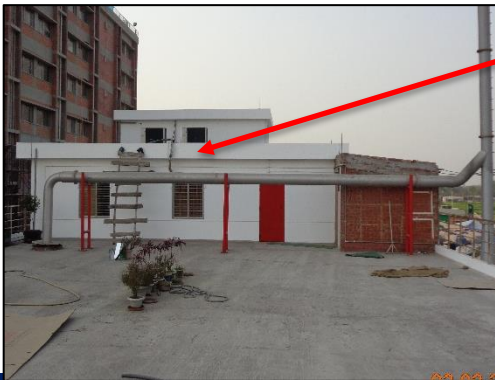
Office room at 1<sup>st</sup> floor

The marked beams detail has not been shown in provided drawing for 1<sup>st</sup> floor roof level. Also, an undocumented toilet has been found on roof. Factory Engineer is to survey the whole structure and update as-built drawings representing accurate site condition.

| Item No. | Observation | Recommended Action Plan | Recommended Timeline |
|---|---|---|---|
| 08 | Missing information in as-built drawing (Building-3 : Boiler & Fire pump room) | Building Engineer to survey the structure and prepare accurate as-built (both architectural & structural) drawings in compliance with section 1.9.1.2 as per BNBC. | 6-weeks |

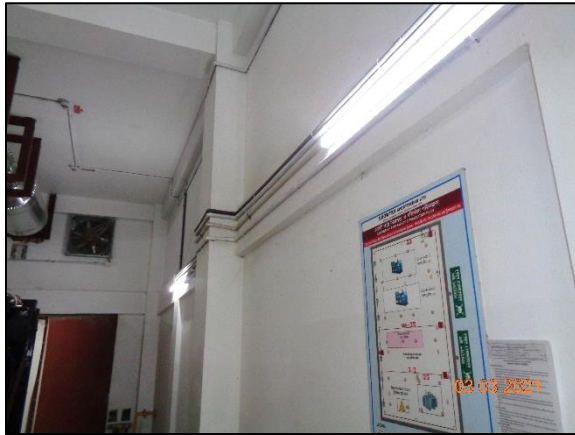
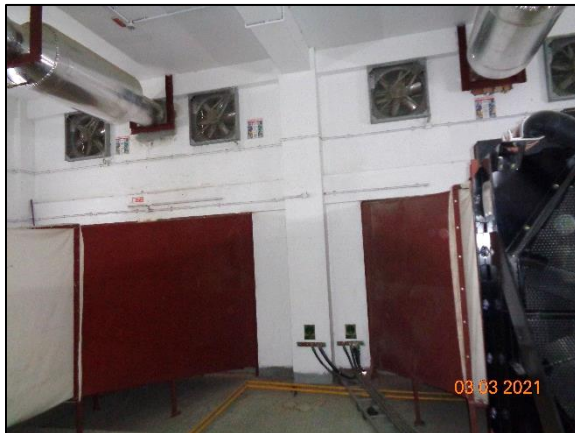
Tie-Beam connection system

No tie-beam details was found in provided drawing. But on-site 300mmX375mm tie-beam was found all over the periphery. Factory engineer is to survey the whole structure and update as-built drawings representing accurate site condition.

| Item No. | Observation | Recommended Action Plan | Recommended Timeline |
|---|---|---|---|
| 09 | Missing information in as-built drawing (Building-4 : Substation & Generator) | Building Engineer to survey the structure and prepare accurate as-built (both architectural & structural) drawings in compliance with section 1.9.1.2 as per BNBC. | 6-weeks |
