# Standard Stitches Ltd. Woven Unit (Extended Building)

FF TOWER, BAIMAIL, KONABARI, GAZIPUR SADAR, BANGLADESH  
(24.008554, 90.330263)  
9<sup>th</sup> February 2021

## 1. Warehouse Building (G+9)

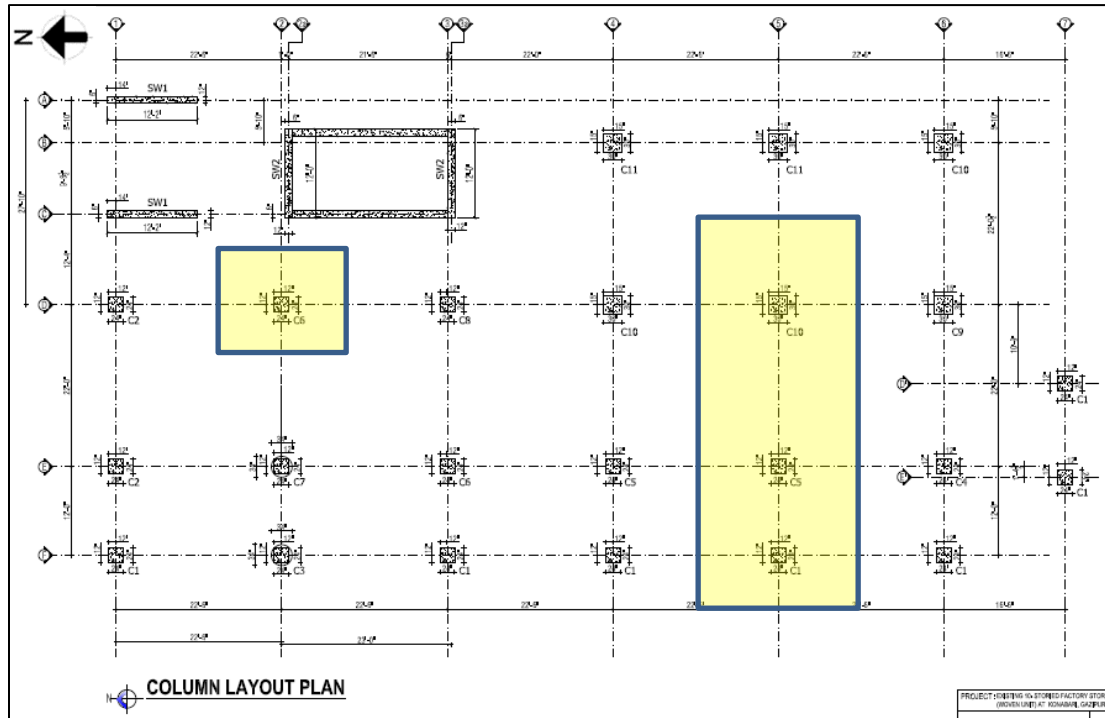
Column Layout Plan

**Column stress exceeds normal design limit**

Cursory calculation indicates that the marked columns are stressed above normal design limit considering live load (6 kPa) and minimum concrete strength based on aggregate type. Factory engineer is required to review design, load & column stress in the area identified above.

| Item No. | Observation | Recommended Action Plan | Recommended Timeline |
|---|---|---|---|
| 01 | Column to be stressed exceeds normal design limit | Factory Engineer to review design, loads and columns stresses. | 6-weeks |
| 02 | Column to be stressed exceeds normal design limit | Verify in-situ concrete stresses by 100mm diameter cores. | 6-weeks |
| 03 | Column to be stressed exceeds normal design limit | Carry out remedial works if required. | 6-weeks |
| 04 | Column to be stressed exceeds normal design limit | Produce and actively manage a loading plan for all floor plates within the factory giving consideration to floor capacity and column capacity. | 6-months |

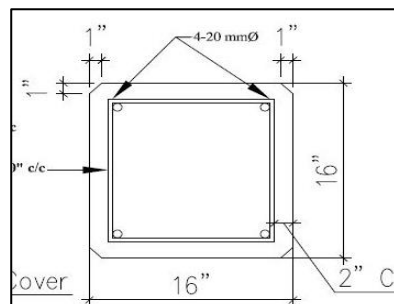
### DETAIL OF HYDRAULIC DRIVEN PRE CAST PILE

400X400 mm pre-cast pile has been shown in as-built drawing with load bearing capacity of 135 ton. But no calculation has been provided regarding the 400X400mm precast pile of capacity 135 ton.

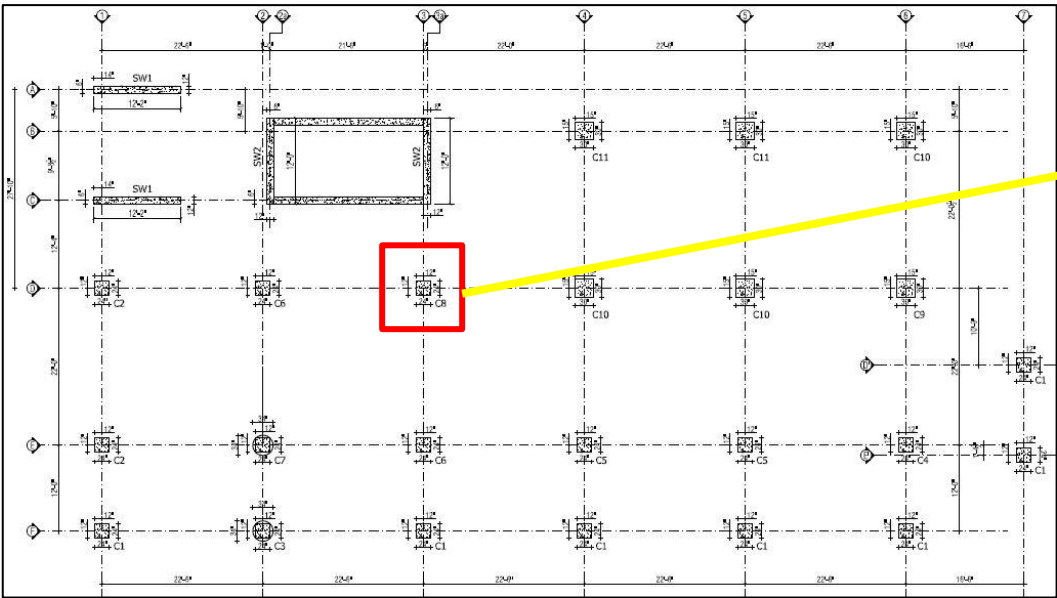
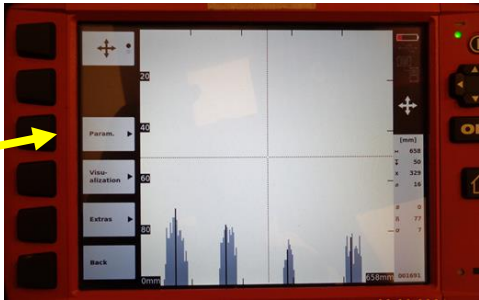
In column schedule, 5 number of re-bar shown at each side for Column C8 (5th floor)

At 9<sup>th</sup> floor (Grid-D/3) the number of re-bar for column C8 was found 4 at one side by ferro-scanning. Therefore, variation in rebar inside the columns has been confirmed among the stories.

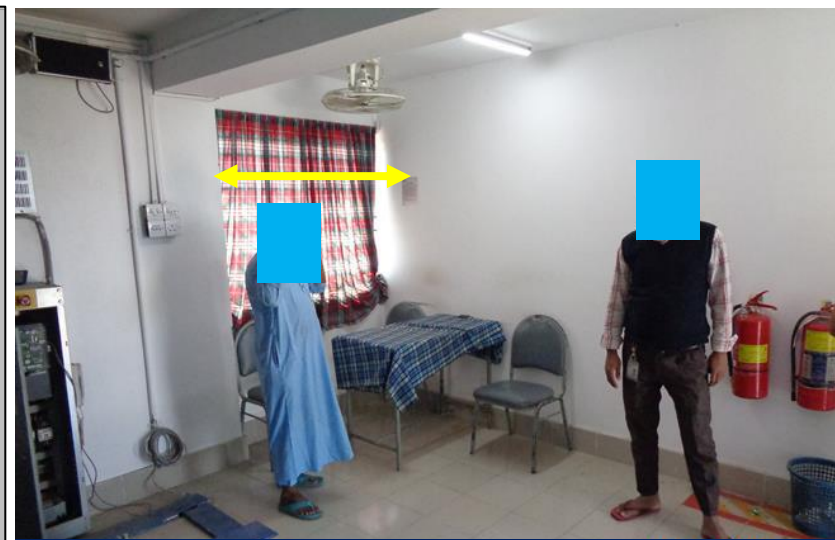
Interior of the lift machine room. Marked location is Cantilever.

Undocumented cantilever was found extended from the floor slab of lift machine room. No details was shown in drawing. Also, the details of the roof top beam & slab of lift machine room were not shown in as-built drawing.

Factory engineer is required to survey the structures and prepare as-built drawings.

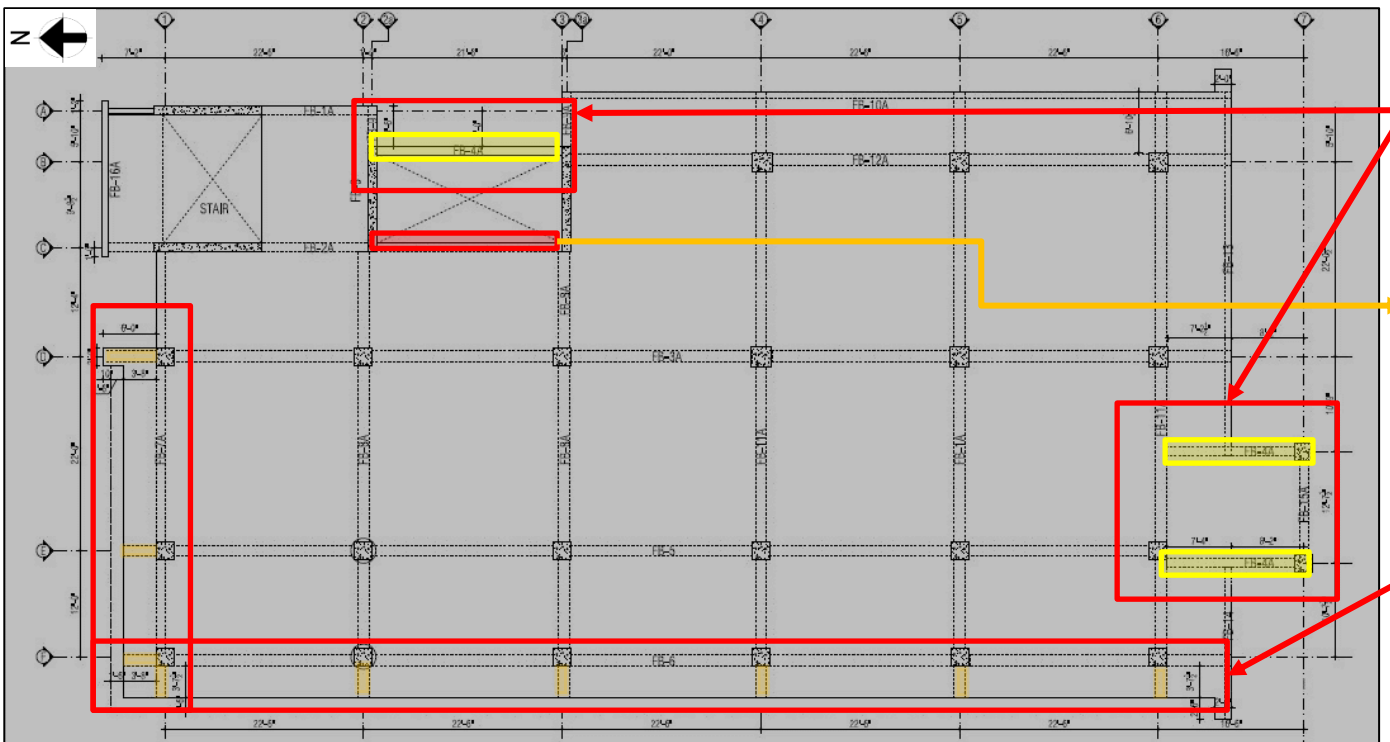
Beam Layout plan

The details of the Beam (FB-4A) has not been provided in as-built drawing.

The Beam ID has not been written at the marked location.

These Cantilever Beam were not found at site but shown in as-built drawing.

Factory engineer is required to survey the whole structure and prepare accurate as-built drawings that are compliance with section 1.9.1.2 as per BNBC (Part-06).

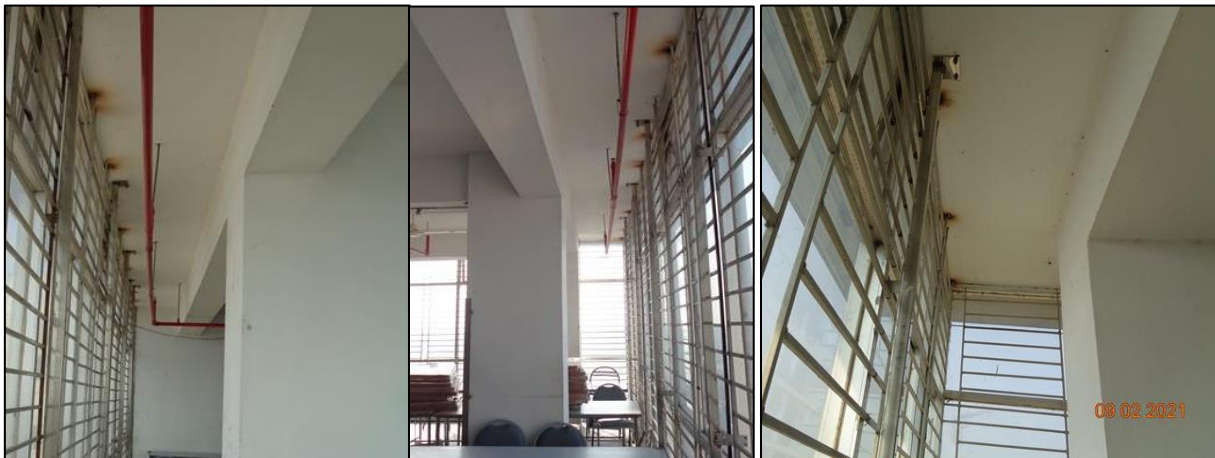
Cantilever Beam not found at site

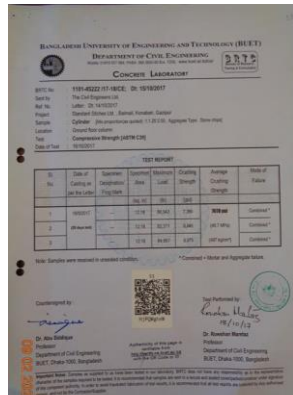
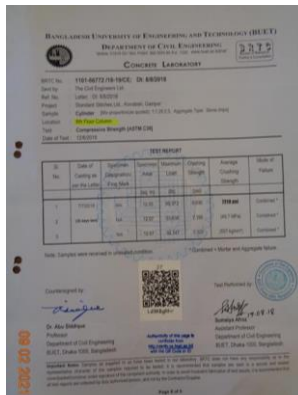
Cylinder test Report

In prepared Detail Engineering Assessment (DEA) of the building, the concrete strength has been considered 6076.72 psi. This resultant strength has been obtained from cylinder test report considering ACI 562-13 Code. But this code is applicable for the concrete core that extracted from the structural members of existing building.

Moreover only two set of the cylinder test report found for the columns which do not meet the requirement for frequency of cylinder test as per BNBC.

As per BNBC every building or structure shall have its design documents prepared in accordance with the provision of Section 1.9.1. The design document shall include a design report, and a set of structural drawings, which shall be prepared in compliance with section 1.9.1.1 and section 1.9.1.2 as per BNBC. Now factory engineer is required to revise the DEA which is in compliance with section 1.9.1 (part-6, BNBC).

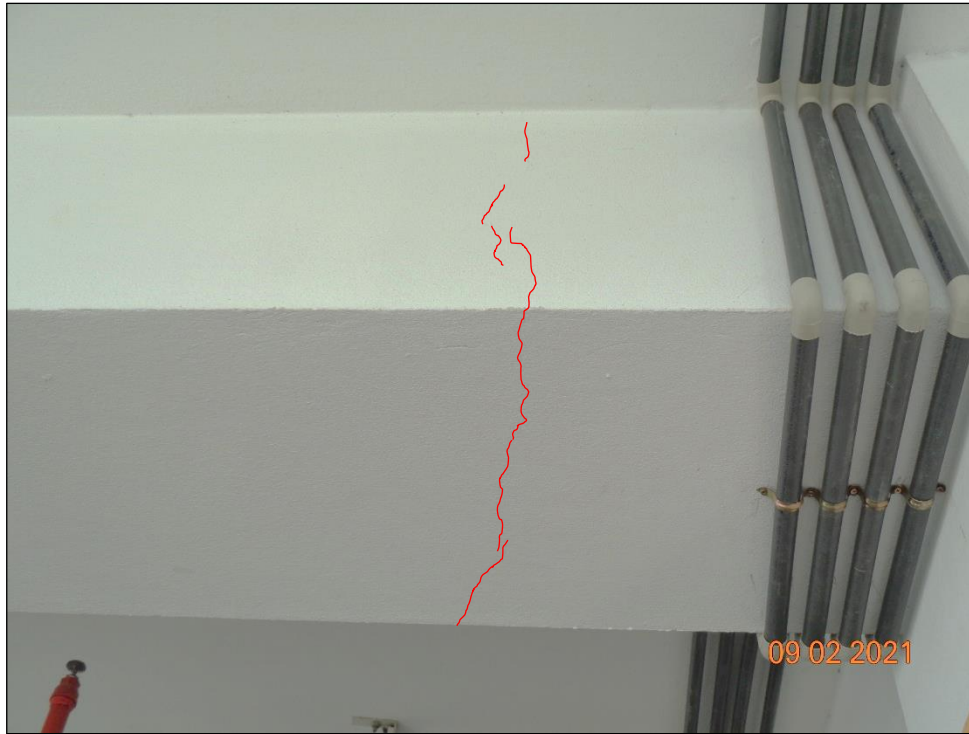
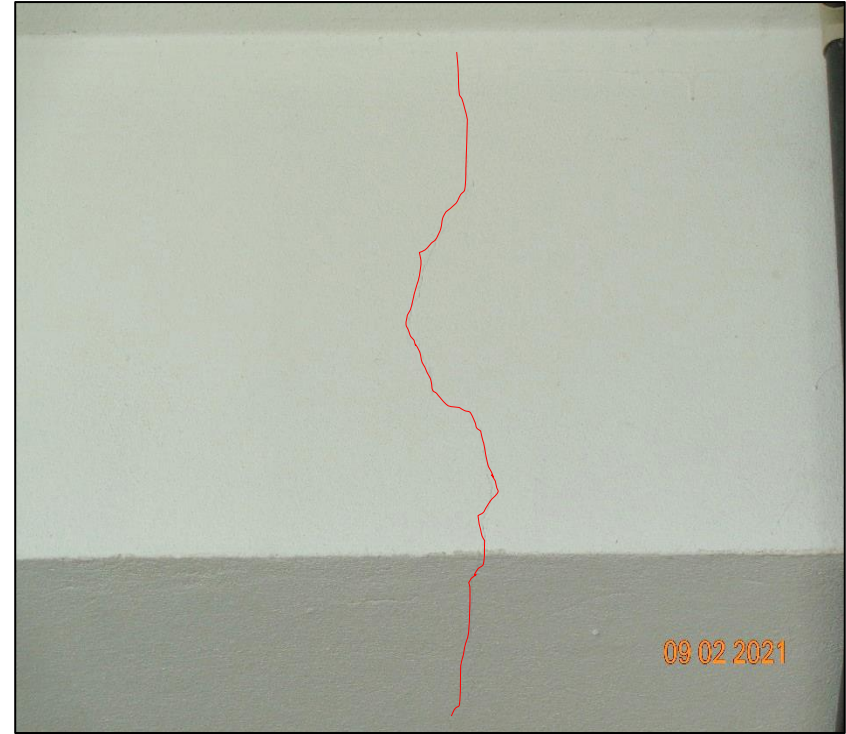
Hairline cracks in beam

Hairline crack was found in the several beams throughout the building. Factory engineer is required to investigate the cause of crack and repair the cracks as per investigation report.

| Item No. | Observation | Recommended Action Plan | Recommended Timeline |
|---|---|---|---|
| 10 | Hairline cracks in beams. | Factory engineer is required to investigate the cause of crack and repair the crack as per recommendation from investigation report. | 6-weeks |

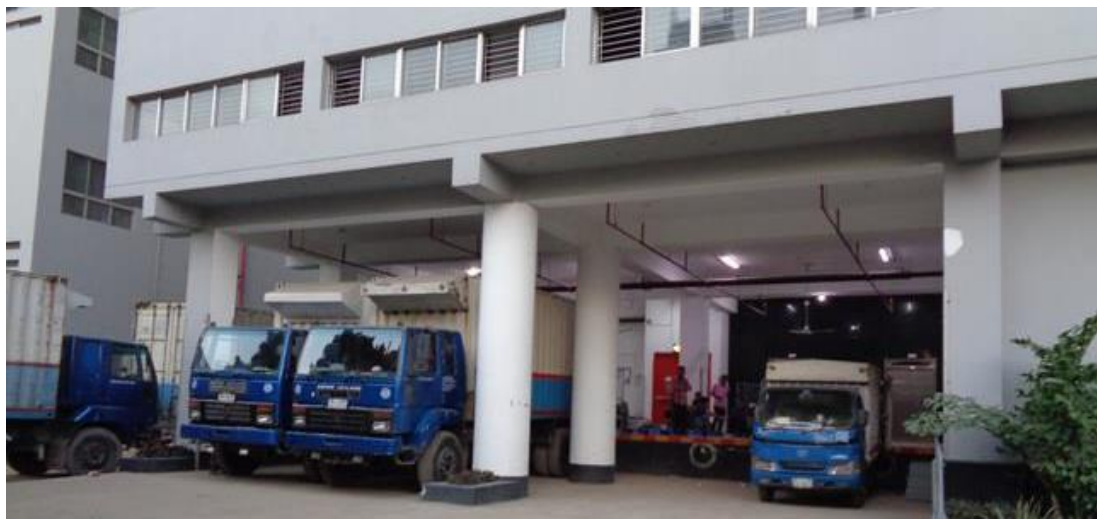
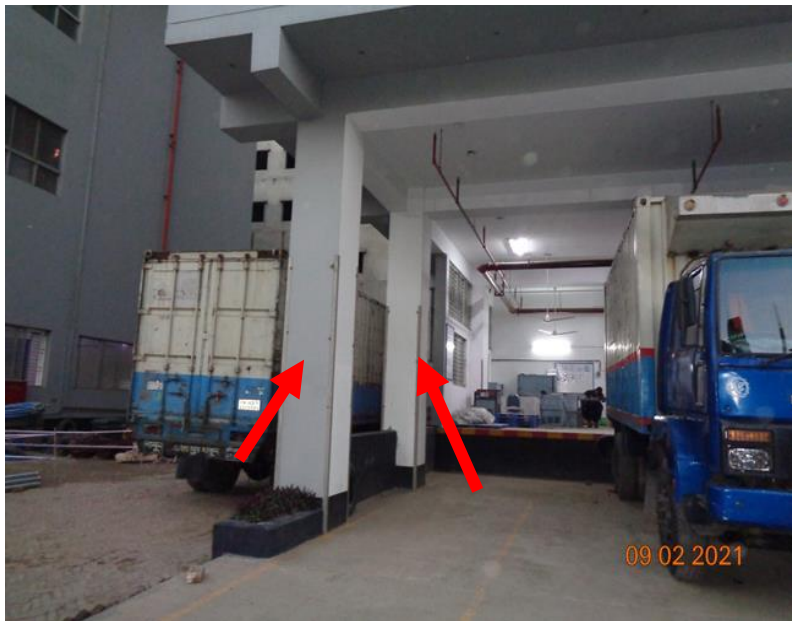
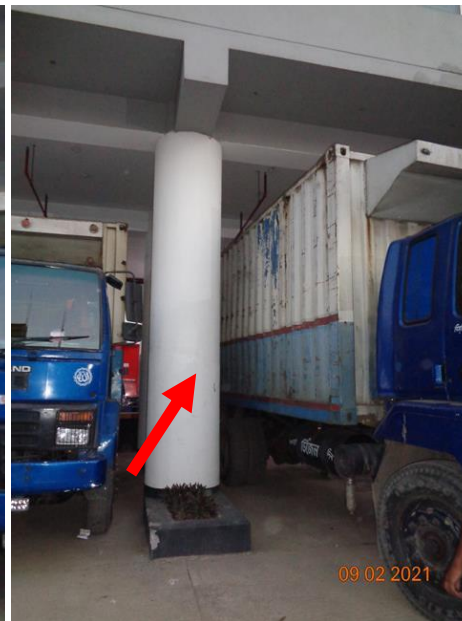
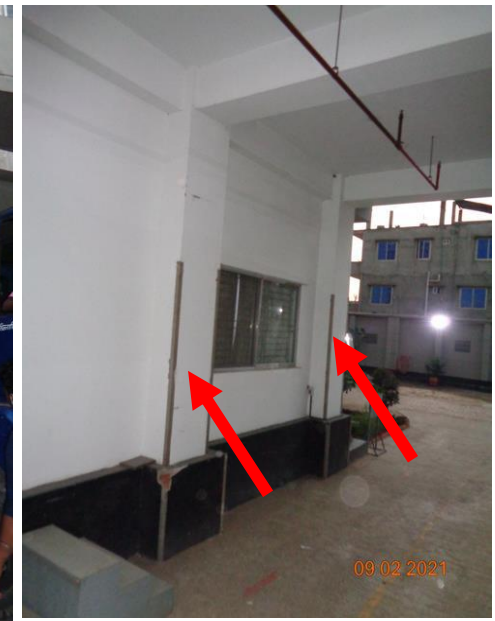
Columns having no barrier/protection at ground floor

Columns at loading unloading area are susceptible to vehicle impact. The factory is required to take necessary measures to prevent the vehicle impact by providing the barrier around the columns.

| Item No. | Observation | Recommended Action Plan | Recommended Timeline |
|---|---|---|---|
| 11 | Column susceptible to vehicle impact. | The factory is required to take necessary measures to prevent the vehicle impact by providing barrier around the columns. | 6-weeks |

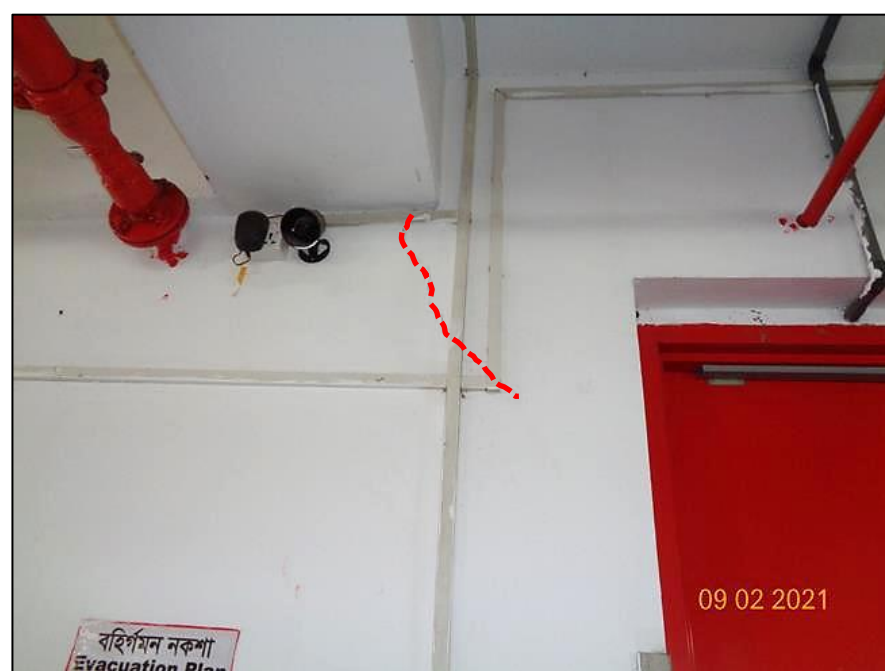
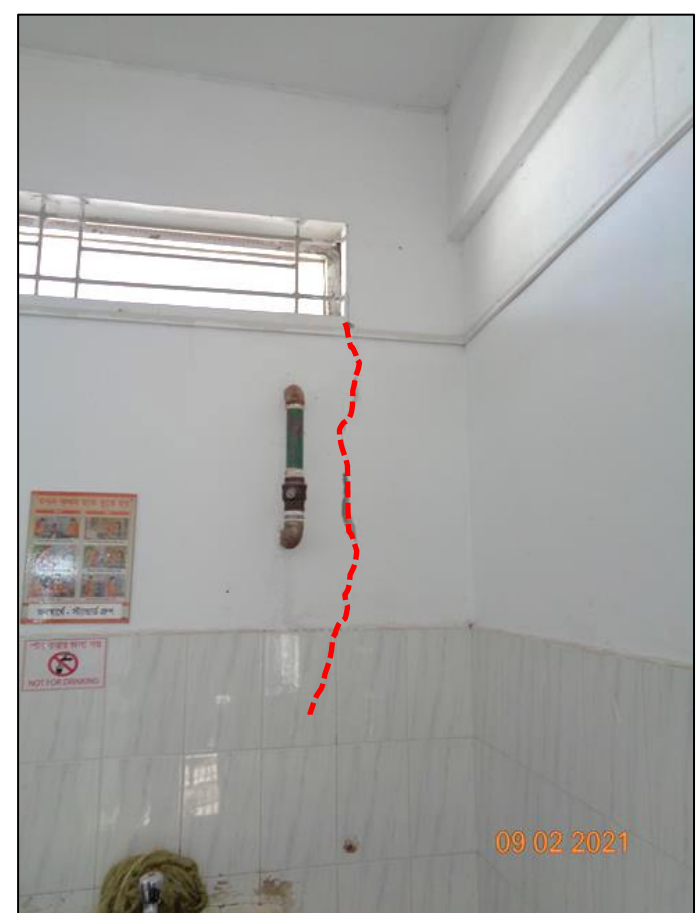
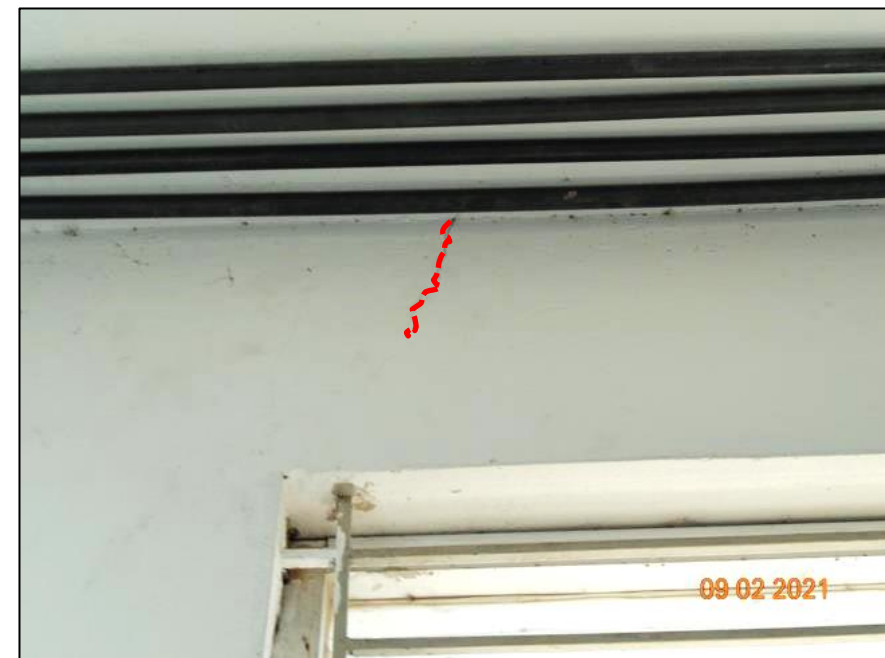
Crack in brick wall

Cracks were found at several locations in brick wall at 9<sup>th</sup> floor. Factory engineer is required to investigate the cause of crack and repair the crack as per recommendation from investigation report.

| Item No. | Observation | Recommended Action Plan | Recommended Timeline |
|---|---|---|---|
| 12 | Cracks in brick wall. | Factory engineer is required to investigate the cause of crack and repair the crack as per recommendation from investigation report. | 6-weeks |
