UTAH Fashions Ltd. (Extension)

South Salna, Salna Bazar, Gazipur

10th February 2021

7 Observation: Building-2

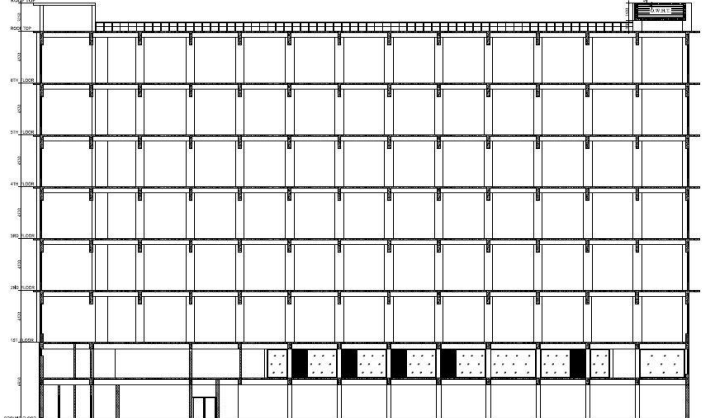
Sectional elevation for 8 storied Building

DEA documents need to be reviewed by RSC

The building permission layout and drawing is for 8 storied structure. Also, the Detail Engineering Assessment (DEA) was prepared for the structure 8 storied structure where retrofitting has been suggested for footing, column and grade beam. Till the date of this inspection, Building was constructed up-to three storied. Hence, there is a possibility of future vertical extension. Also, factory authority verbally confirmed that they are intended to conduct vertical extension. Factory is required to submit the DEA documents to RSC for further review.

Item No.	Observation	Recommended Action Plan	Recommended Timeline
01	DEA documents need to be reviewed by RSC (Building-2)	Factory engineer is required to produce Detailed Engineering Assessment(DEA) of the structure according to BNBC 2006 and submit to RSC for review.	6-weeks
02	DEA documents need to be reviewed by RSC (Building-2)	Carry out recommendation as outcome of the DEA.	6-months
03	Column to be stressed above normal design limit considering possible vertical extension (Building-2)	The factory engineer is required to carry out a Detail Engineering Assessment considering BNBC 2006 provision prior to any extension work.	6-weeks
04	Column to be stressed above normal design limit considering possible vertical extension (Building-2)	Produce and actively manage a loading plan for all floor plates within the factory, considering floor, column and foundation capacity.	6-weeks

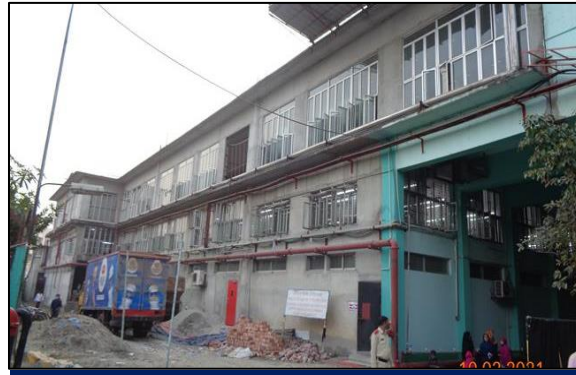
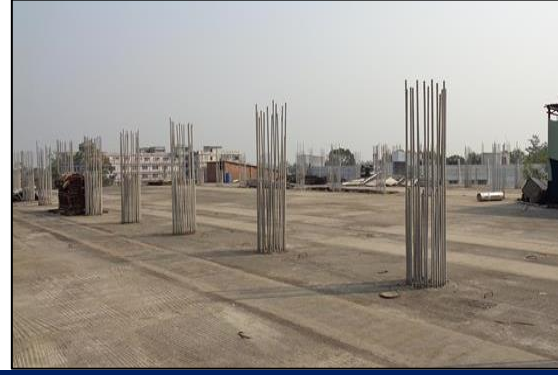
The building constructed up-to three storied and column re-bar was found extended at roof for the future vertical extension.

Retrofitting drawing cover-page, retrofitting column & footing schedule.

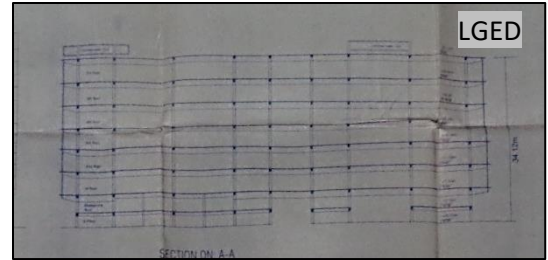
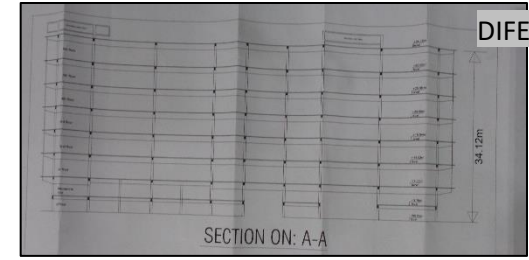
Sectional elevation of permit layout drawing from LGED & DIFE

**Column to be stressed above normal design limit
considering possible vertical extension**

This building is permitted for 8 storied (G+7) storied from local authority. Currently, the building is three storied (G+2). Extended portion of column rebar was found at roof level which indicates the possibility of vertical extension.

Cursory calculation indicates that the marked columns are stressed above normal design limit considering prepared live load plan and equivalent concrete strength from concrete core test value for the 8 storied building.

The factory engineer is required to carry out a Detail Engineering Assessment considering BNBC 2006 provision prior to any extension work.

Item No.	Observation	Recommended Action Plan	Recommended Timeline
05	Column to be stressed above normal design limit considering possible vertical extension (Building-2)	Complete implementation of any remedial works deemed necessary by the Detail Engineering Assessment (DEA).	6-months
06	Column to be stressed above normal design limit considering possible vertical extension (Building-2)	Continue to implement loading plan.	6-months
07	Uncontrolled loading at 3 rd Floor (Existing Roof) (Building-2)	Factory is required to maintain the prepared floor live load plan.	6-weeks
08	Lack of lateral stability (Building-2: Roof Shed)	Building Engineer is required to check the lateral stability of the steel shed.	6-weeks

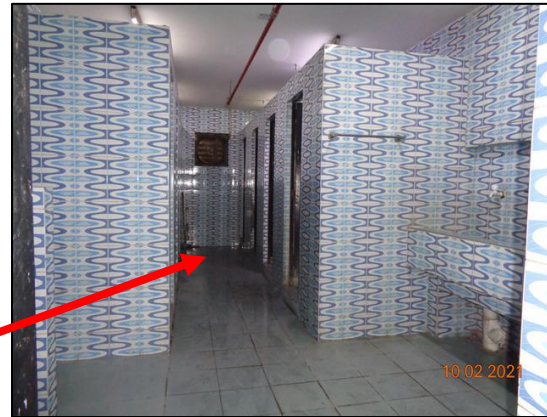
Toilet Zone area with built up at 1st floor.

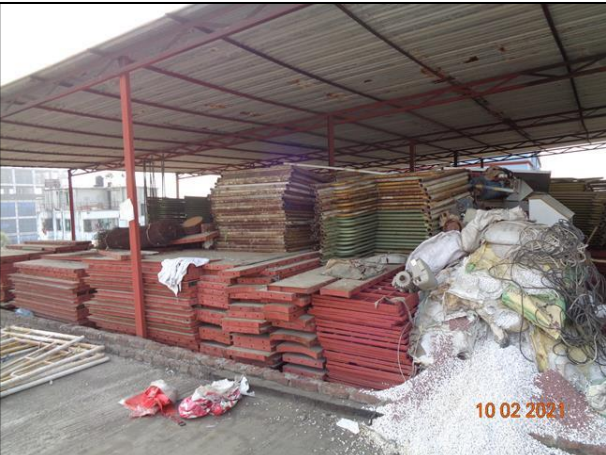
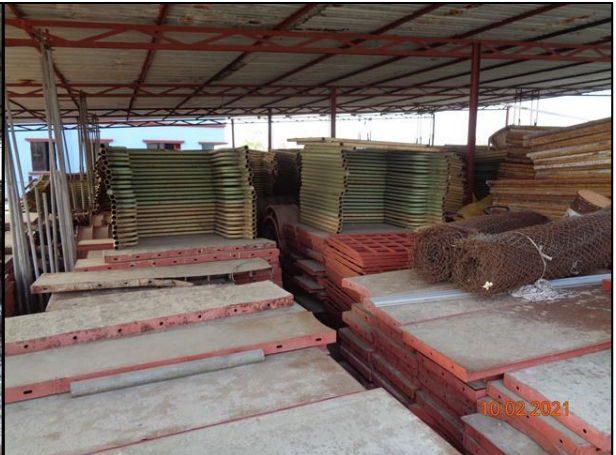
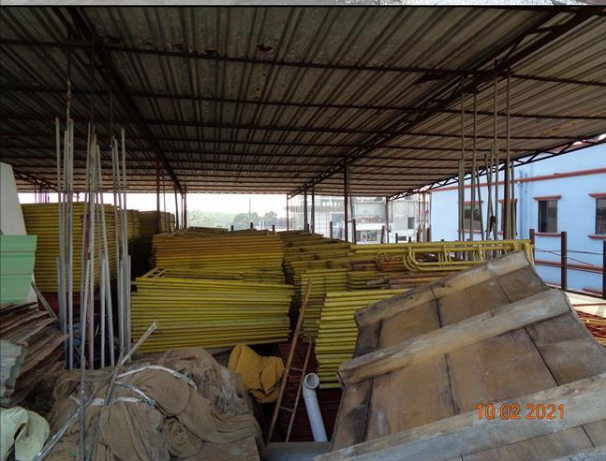
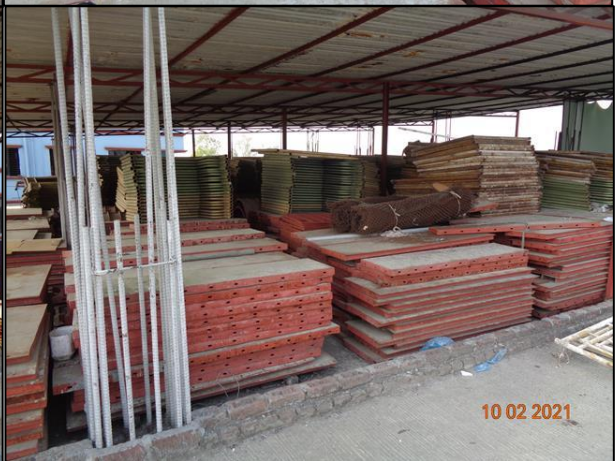
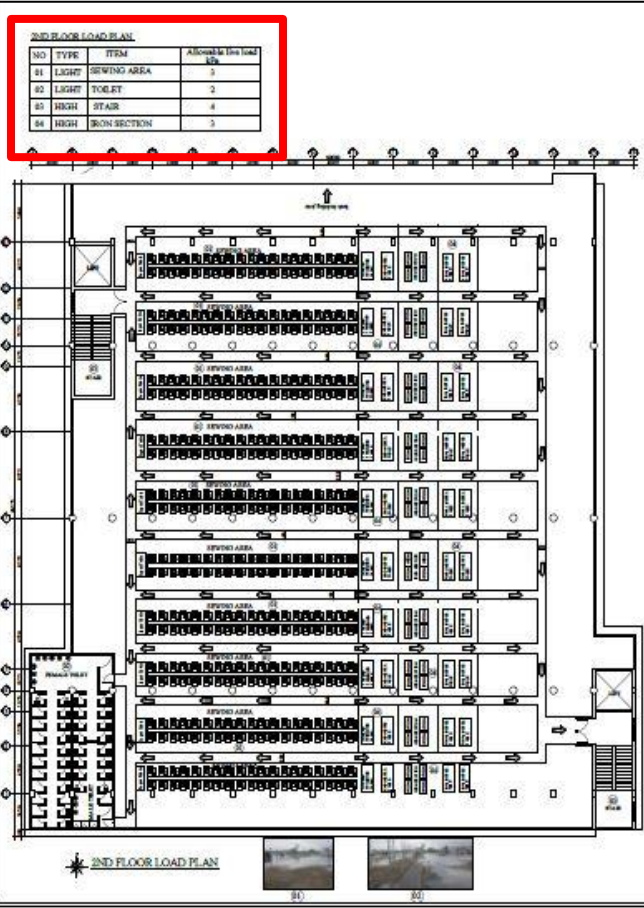
Uncontrolled loading at 3rd Floor (Existing Roof)

Overloading at Roof (3rd floor).

Uncontrolled loading was found at 3rd floor (Existing Roof) of the building due to stuck to the construction materials. Loading was found more than 3 kPa. Factory is required to maintain the floor live load within 3 kPa.

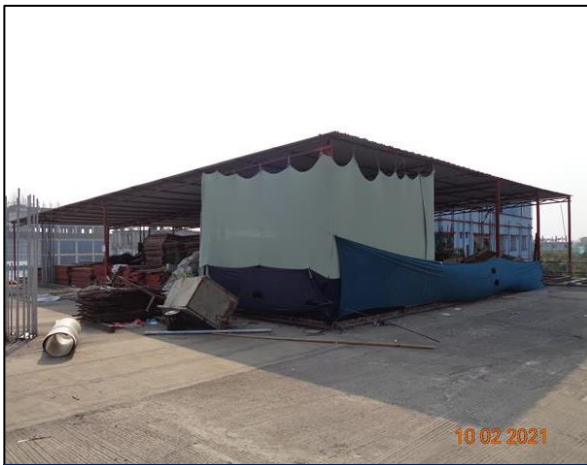
Lack of lateral stability (Roof Shed)

Steel Shed at roof

The undocumented steel shed was found at roof. The steel roof truss is supported by steel C channel and re-bar of RC column. There is no apparent load path to transfer the lateral loading along the perpendicular direction of truss. Any vertical and roof bracing is not provided. Poor connection details observed at joints. Building Engineer is required to check the lateral stability of the steel shed. During the inspection, the as built drawings & design report were not available. The building engineer is required to prepare Engineering Assessment (EA) for the structure which compliance with section 1.9.1 (part-6, BNBC-2006).

Item No.	Observation	Recommended Action Plan	Recommended Timeline
09	Lack of lateral stability (Building-2: Roof Shed)	Building engineer to prepare the Engineering Assessment (EA) including a design report, and a set of structural drawings in compliance with section 1.9.1.1 and section 1.9.1.2 as per BNBC 2006.	6-weeks
10	Lack of lateral stability (Building-2: Roof Shed)	Implement remediation works deemed necessary from EA.	6-months
11	Apparently non-engineered shed over staircase (Building-2)	Building engineer is required to check the adequacy of the rooftop sheds for gravity and lateral forces or Replace with the engineered sheds.	6-weeks
12	Apparently non-engineered shed over staircase (Building-2)	Carry out remedial works where required.	6-months

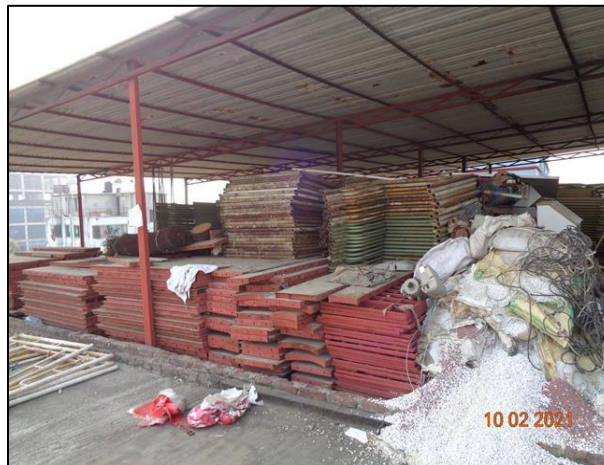
Truss roof System

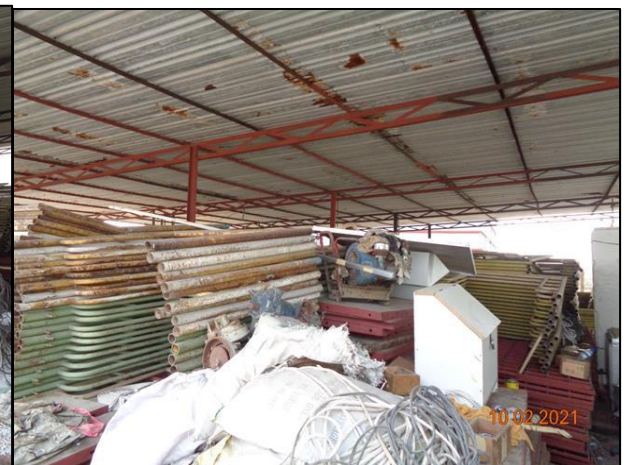
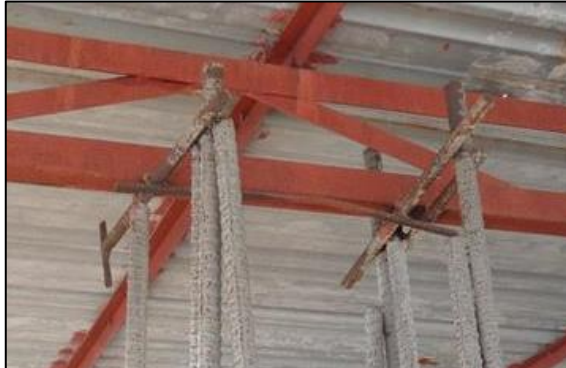
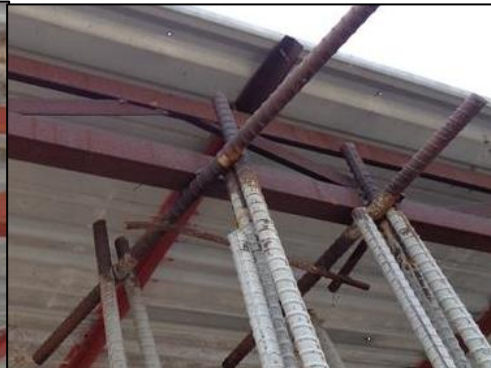
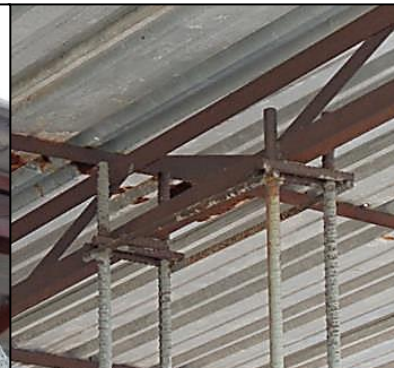
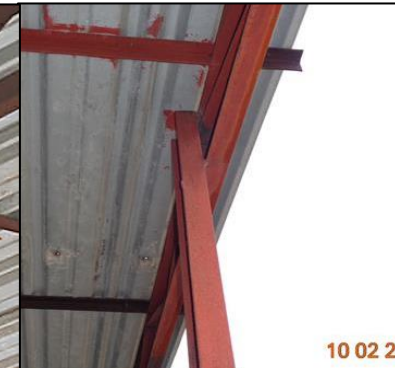
Poor connection details

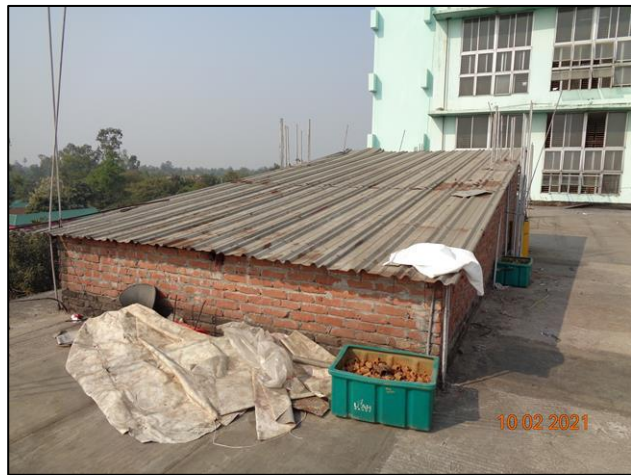
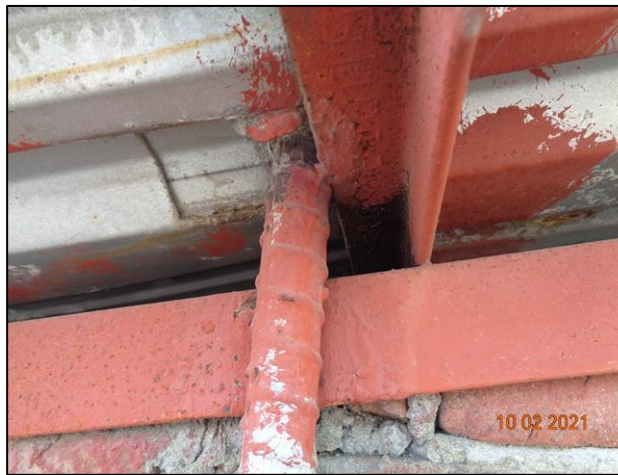
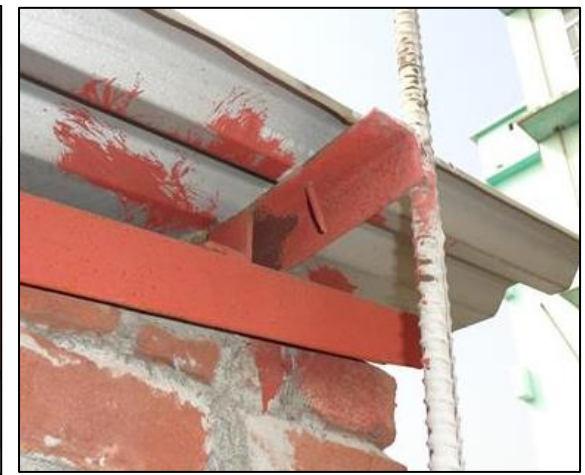
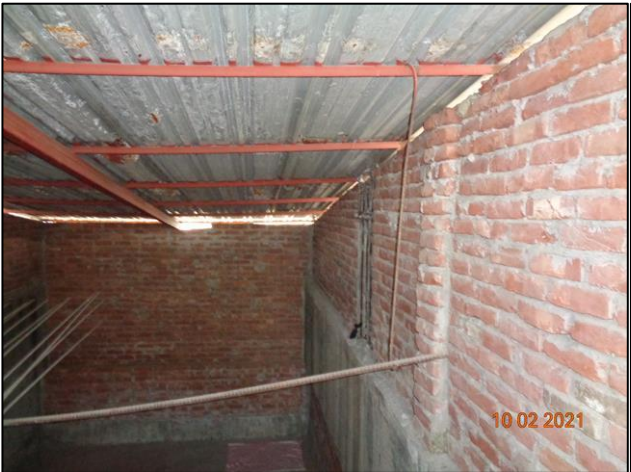
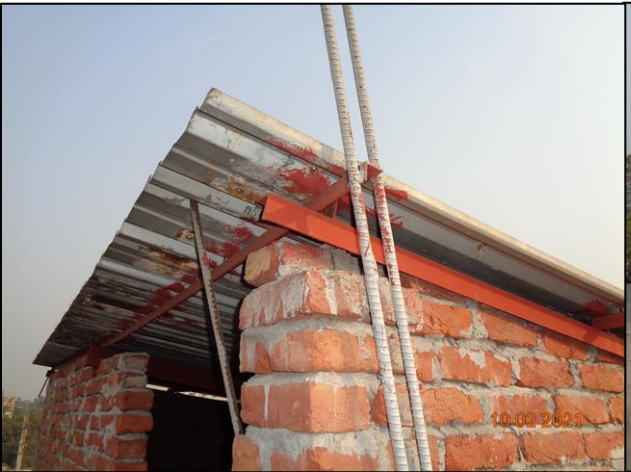
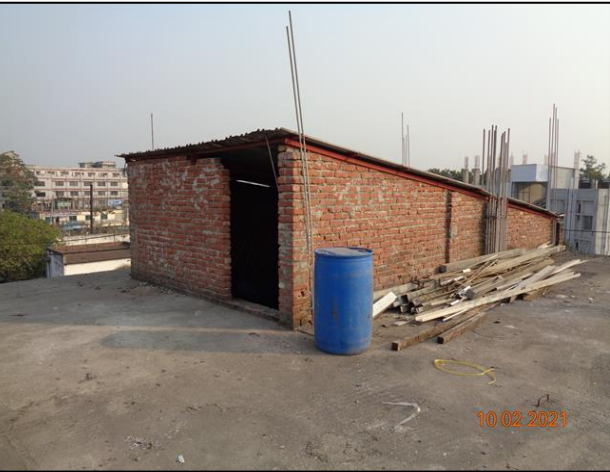
Apparently non-engineered shed over staircase

The steel roof shed made of angle section is supported by brick wall over the staircase. Inadequate structural member, poor connection details observed. Apparently non-engineered shed. Building engineer is required to check the adequacy of the rooftop sheds for gravity and lateral forces otherwise replace with the engineered sheds.

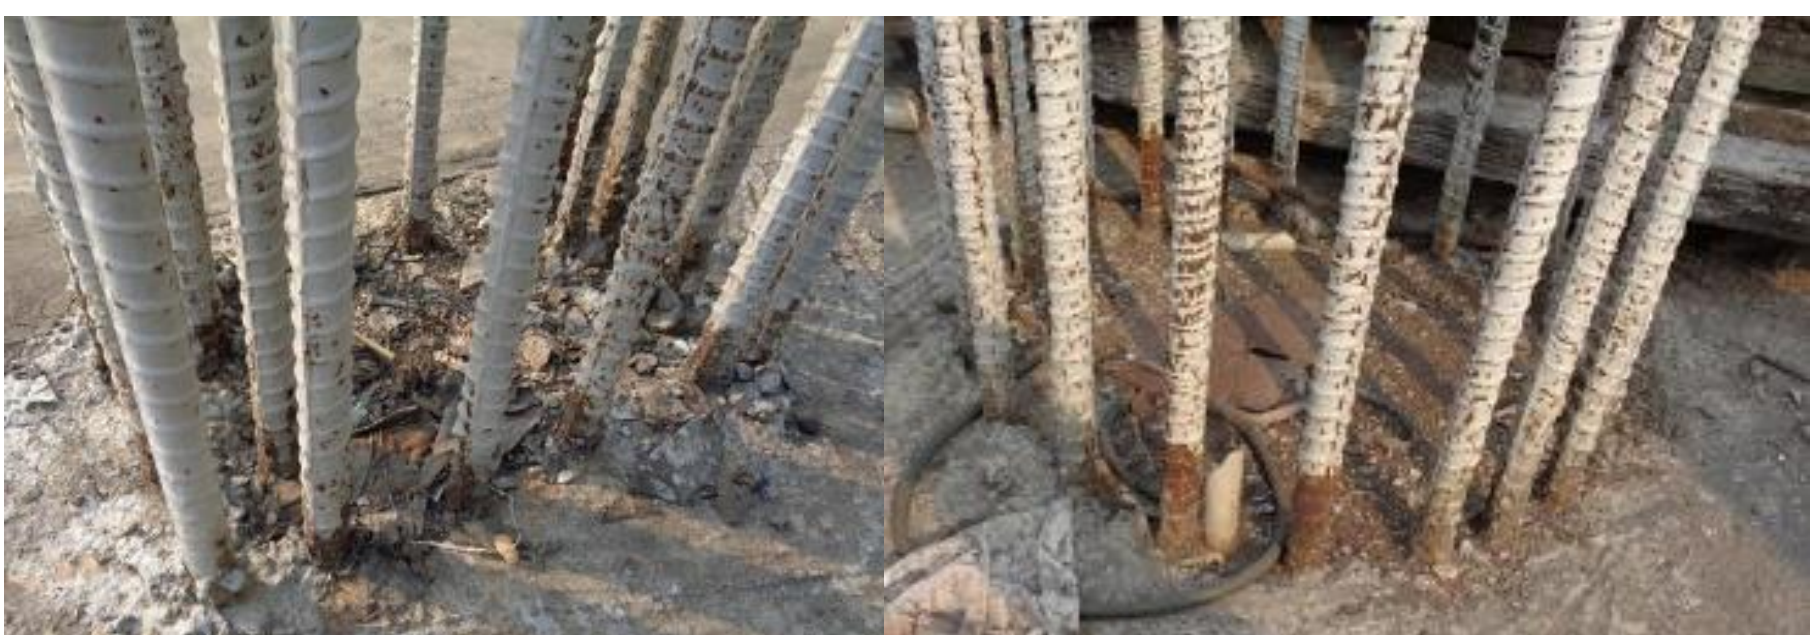
Corrosion in re-bar at roof

Corrosion in column re-bar

Column re-bar at roof exposed to environment for the further vertical extension of the building. Re-bar were found painted to prevent corrosion. But some of the re-bar were found corroded.

Factory is required to apply rust proofing on the corroded areas and do periodically maintenance to protect the re-bar from corrosion.

Item No.	Observation	Recommended Action Plan	Recommended Timeline
13	Corrosion in re-bar at roof (Building-2)	Factory is required to take necessary actions to protect the re-bar from corrosion.	6-weeks
14	Signage of dampness at slab soffit (Building-2)	Factory management is required to take necessary measures to provide water proofing with proper slope and improve drainage system.	6-weeks
15	Signage of dampness at slab soffit (Building-2)	Factory engineer is required to investigate the damp slab to verify if any damaged occurred due to the presence of the moisture.	6-weeks
16	Hairline crack in beams (Building-2)	Factory engineer is required to investigate the cause of crack and repair the crack as per recommendation from investigation report.	6-weeks
17	Dampness found in brick wall (Building-2)	Building Engineer is required to investigate the reason of dampness & apply suitable method to repair dampness.	6-weeks

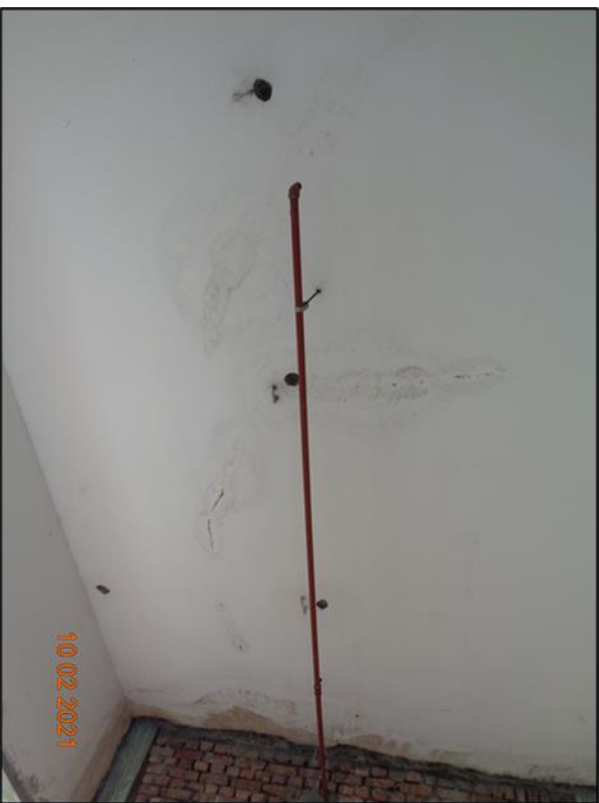
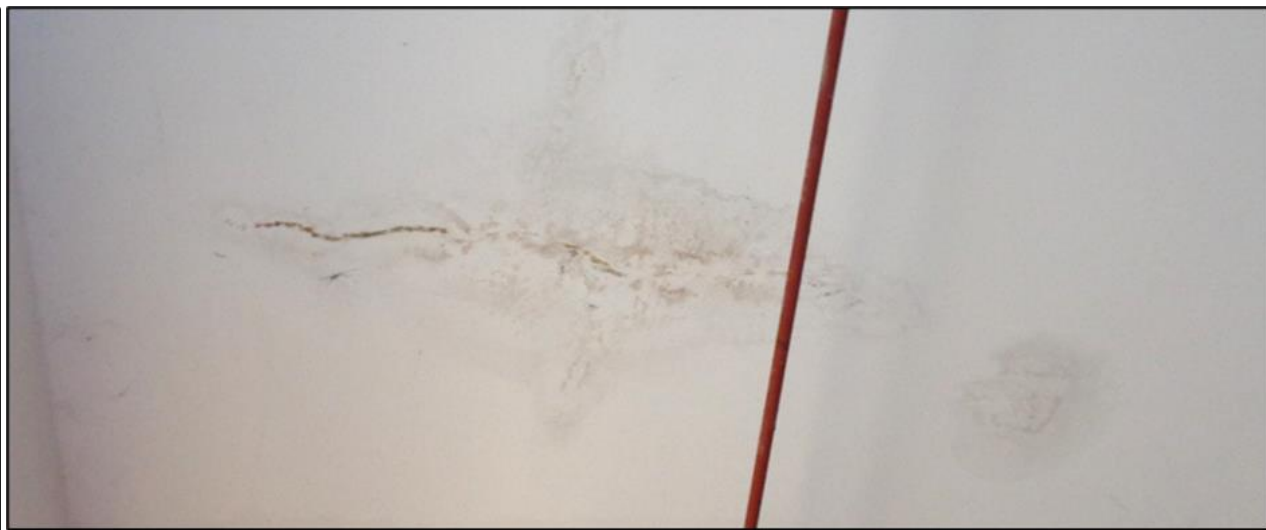
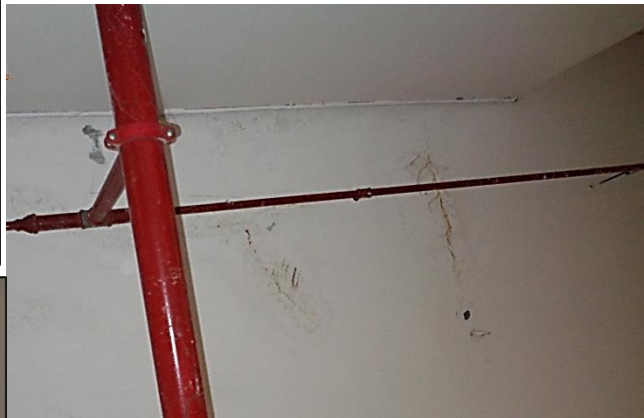
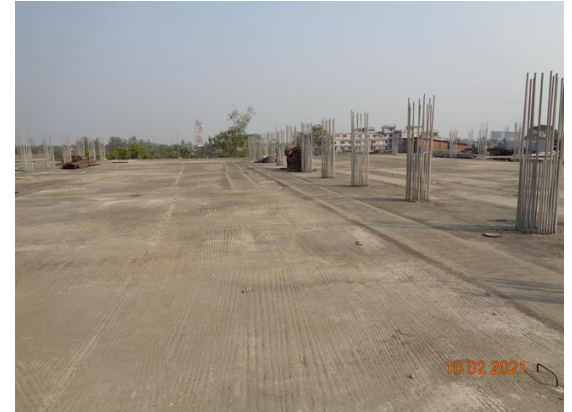
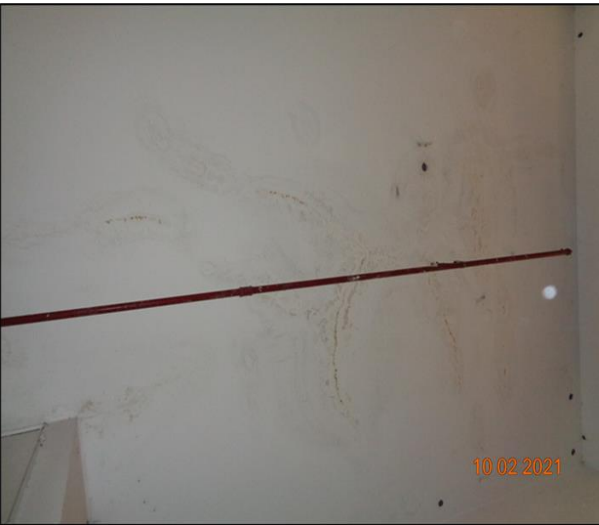
Signage of dampness at slab soffit

Dampness was found at 3rd floor (existing roof) slab soffit. Water proofing was not found at roof. So, this dampness may be due to any crack or damage in the surface on the roof allowed water to pond and seep into the concrete slab beneath the finishes and cause long-term soaking of the slab. Building engineer is required to provide water proofing at roof. Also investigate the damp area to verify if any damaged or crack occurred in slab.

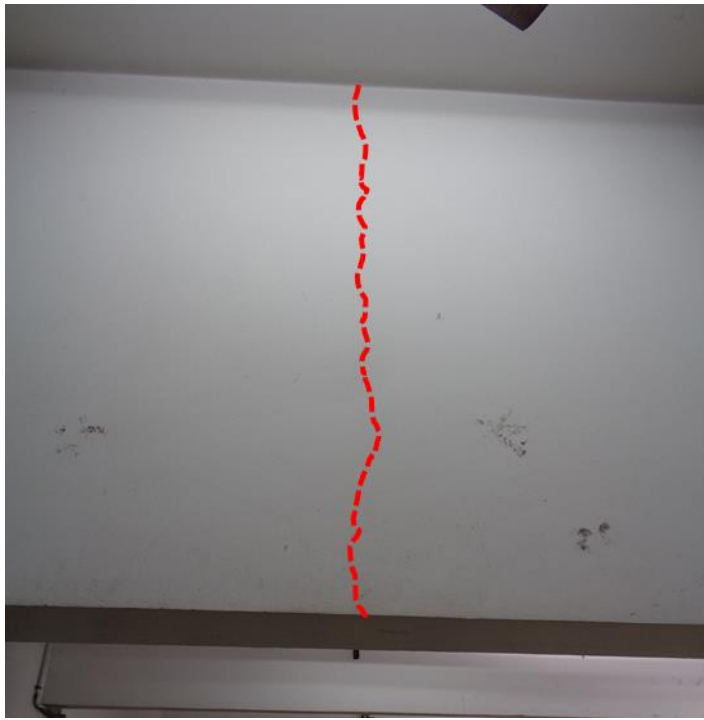
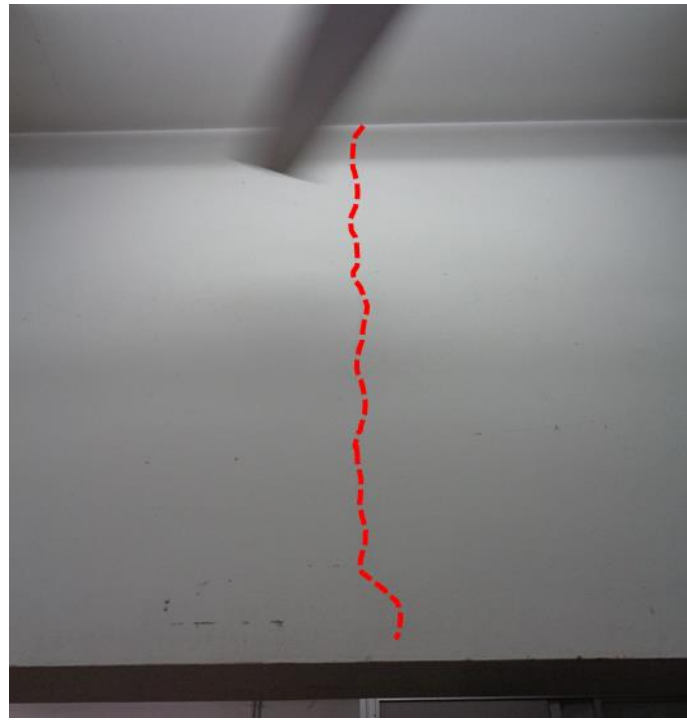
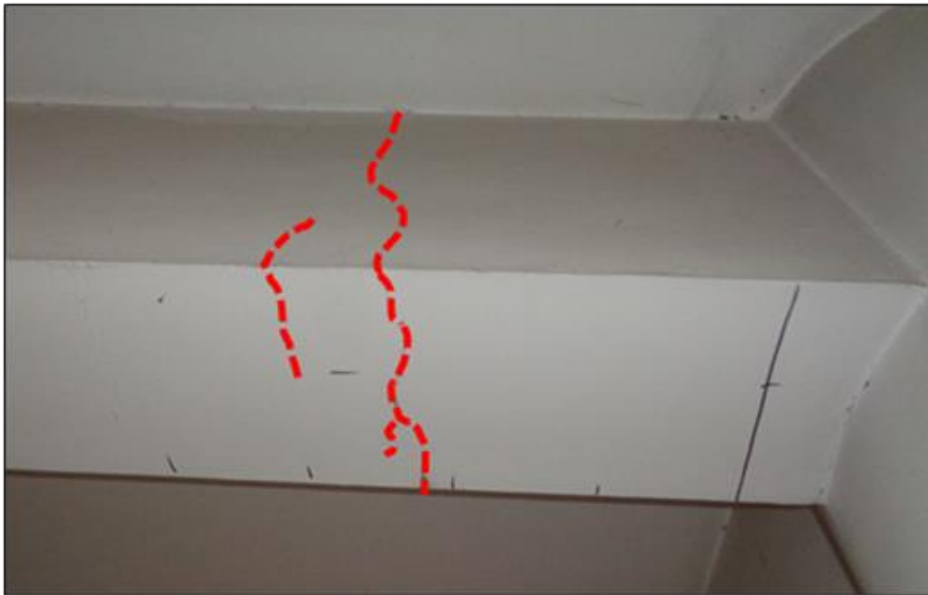
Hairline crack in beams

Hairline crack was found at several beams of 2nd floor. Building engineer is required to investigate the crack and carry out suitable repair works.

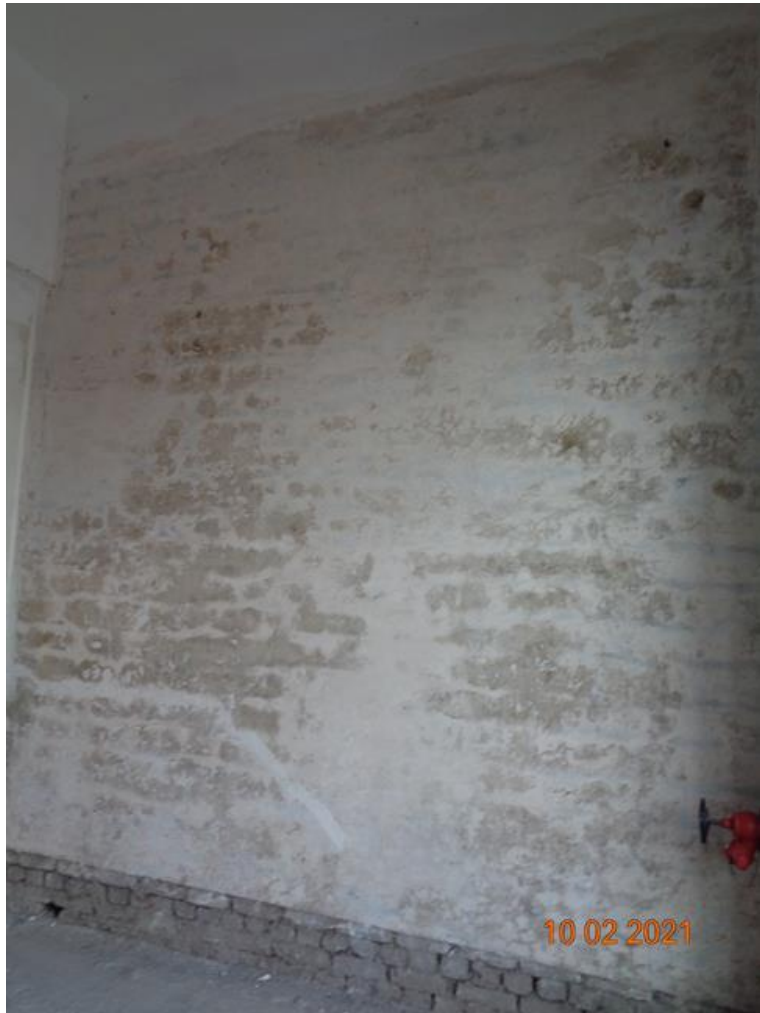
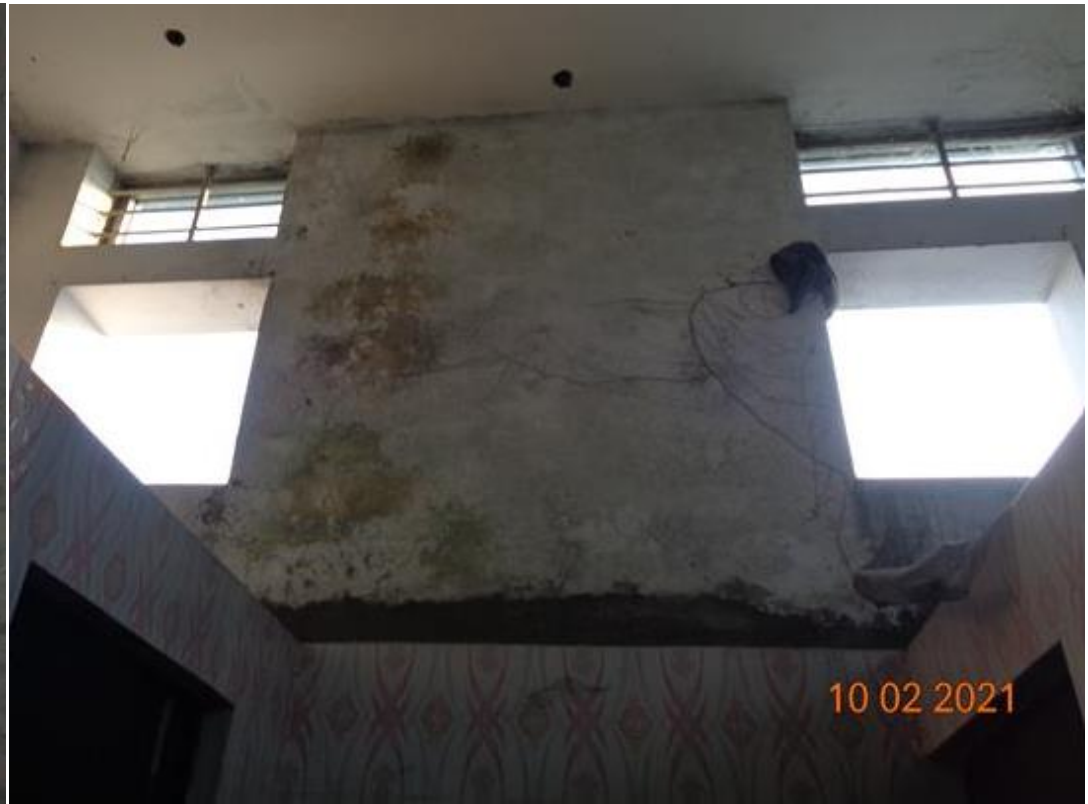
Dampness found in brick wall

Dampness was found on periphery brick wall at staircase & toilet zone.
