# Gumti Textile Ltd.

Plot # 1163, Chandra, Shafipur opp. of Ansar Academy, Kaliakoir, Gazipur, Bangladesh  
(24.029842, 90.266881)

20<sup>th</sup> December 2020 & 13<sup>th</sup> Jan 2021

# Observations

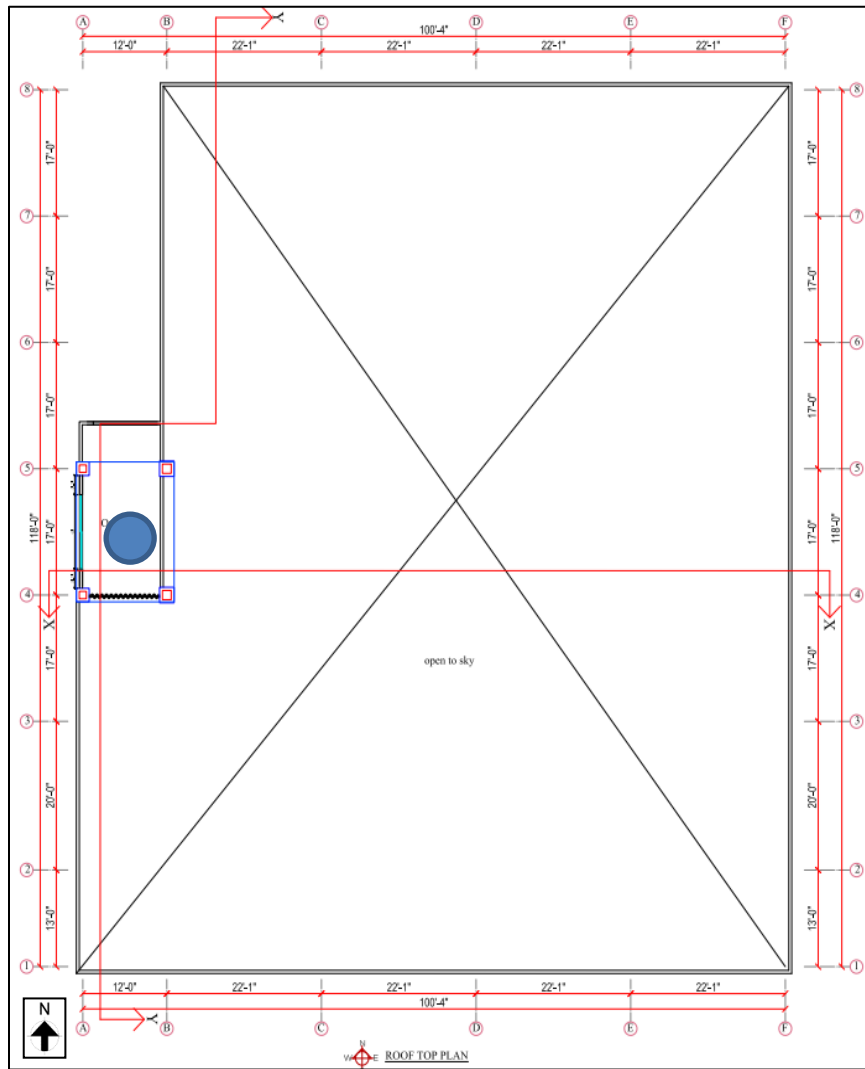
Roof layout

RCC water tank is shown on the drawing but on site there is one plastic water tanks on roof top having capacity of 3000 liters.

There is a slab cantilever area at south and west side that has not shown in the drawing. The width of the cantilever slab is approximately 600 mm.

| Item No. | Observation | Recommended Action Plan | Recommended Timeline |
|---|---|---|---|
| 01 | Discrepancies in as-built drawings with onsite condition (Building A) | Building Engineer is to survey the whole structure and update as-built drawings representing accurate site condition. | 6-weeks |

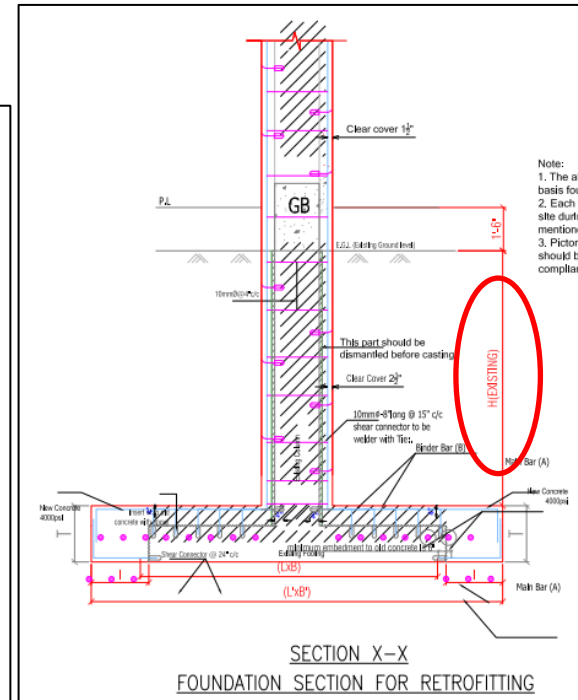
Retrofitted foundation section

The foundation depth in the structural drawing and retrofitting drawing is not specified. Thus, the govern value of the bearing capacity of soil is unknown. Also, the retrofitting material concrete test was mentioned to be 27.6 MPa, but there was no test report to confirm the strength of the retrofitted foundations.

The revision of DEA is required with provided the calculation of the foundation adequacy check for the retrofitted foundation that complies with the section 1.9.1.1 (part-6, BNBC).

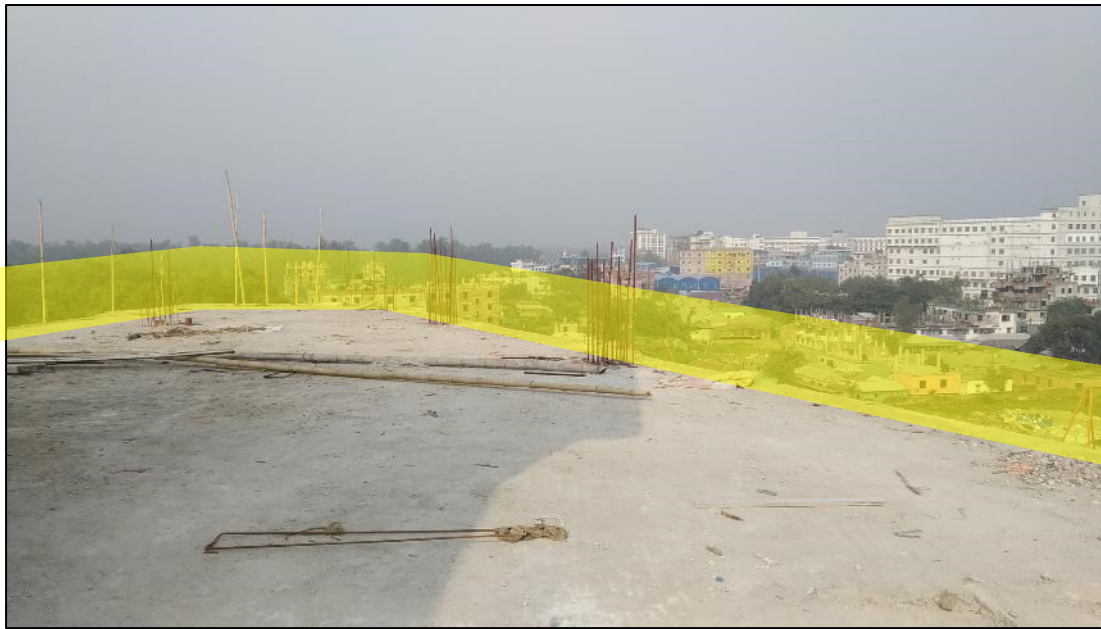
Roof without any parapet wall

Various type of falling hazard and occupational health and safety hazard present in Building E. Factory engineer is required to identify the probable area and provide barriers to the unprotected edges.

| Item No. | Observation | Recommended Action Plan | Recommended Timeline |
|---|---|---|---|
| 06 | Falling Hazard at Roof and Stair (Building E) | Provide barriers to the unprotected edges to nullify falling hazard. | Immediate - Now |

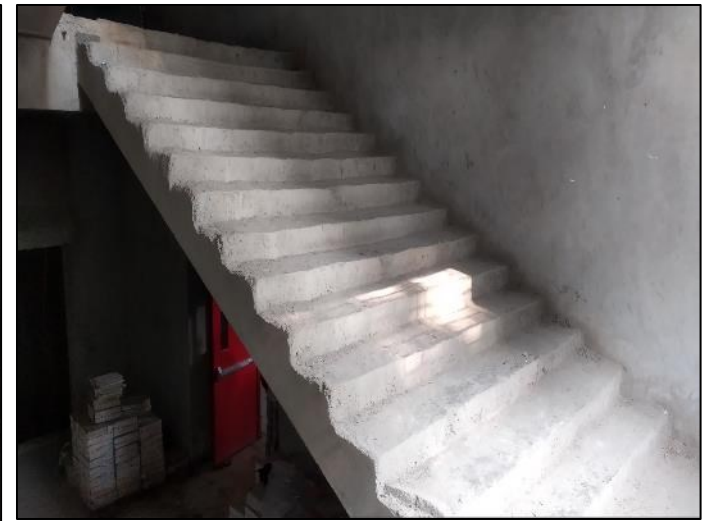
Railing missing on stair

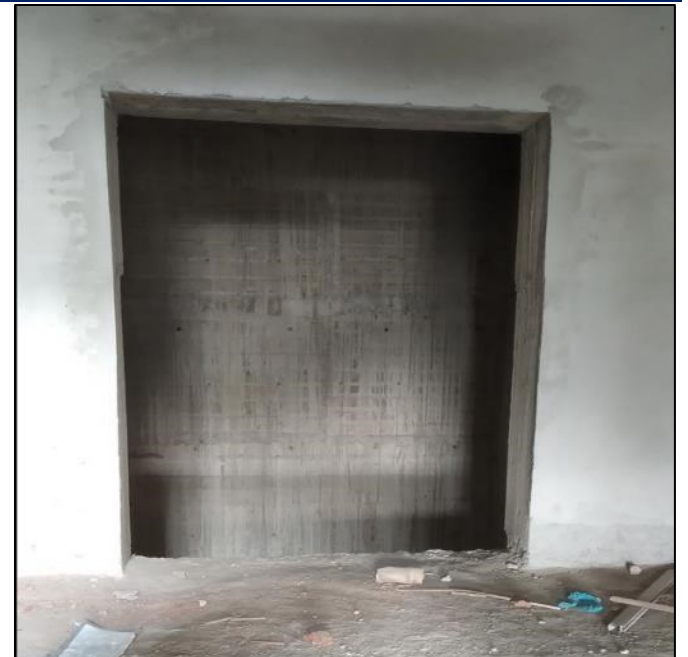
Lift core without closure

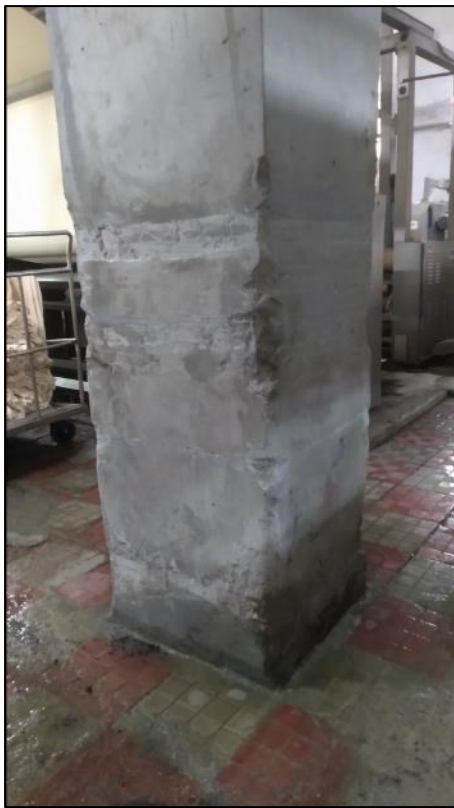
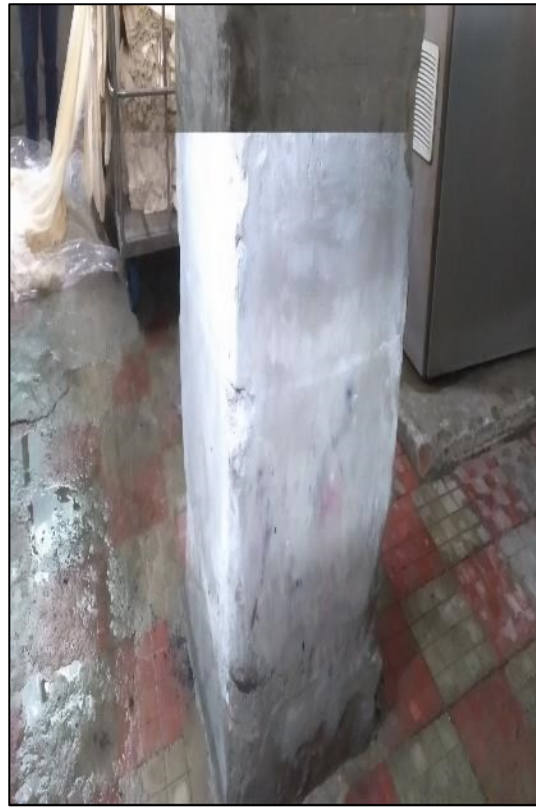
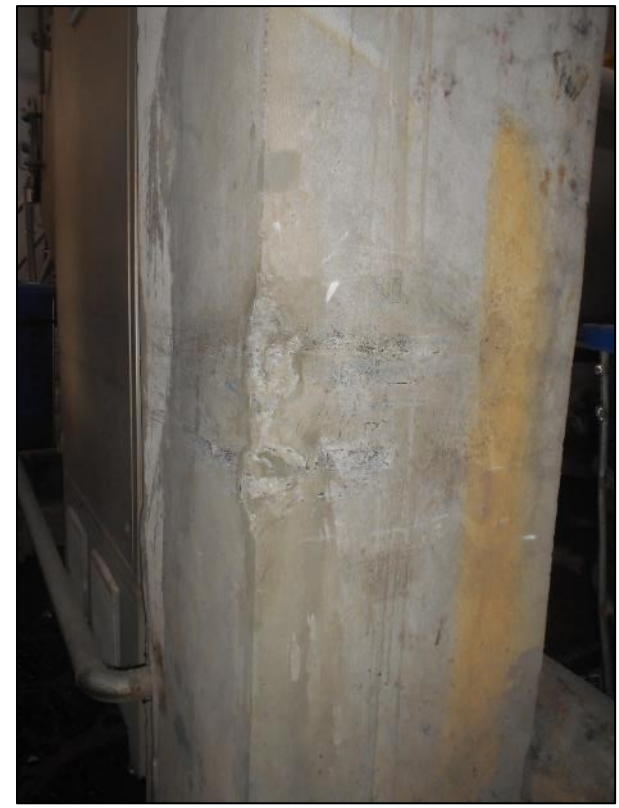
Damaged column on ground floor of Building E, susceptible to impact load

Damaged column found on the ground floor of building E. The dimension of the column is slightly reduced after continuous impact by heavily loaded trolley. Damage was done by the movement of the loaded trolley. Factory management is required to provide barrier to hinder further damage to the column.

| Item No. | Observation | Recommended Action Plan | Recommended Timeline |
|---|---|---|---|
| 07 | Column Susceptible to Impact Load on Ground Floor (Building E) | The factory engineer is required to take necessary measures to repair the damage columns and to prevent the trolley impact by providing the barrier around the columns. | 6-weeks |

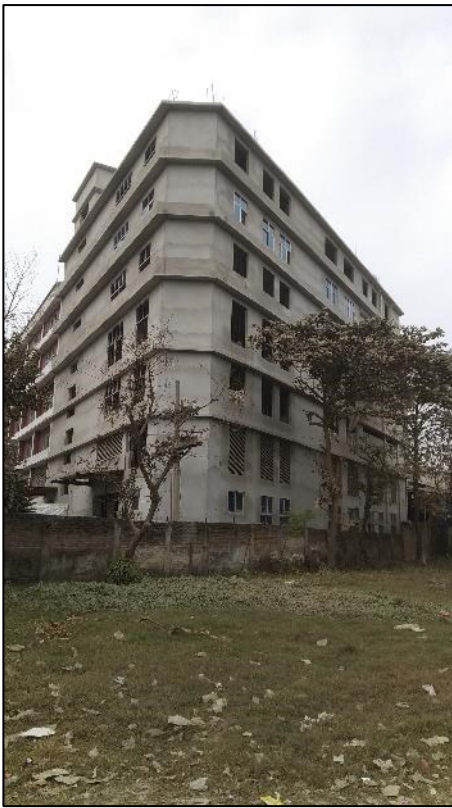
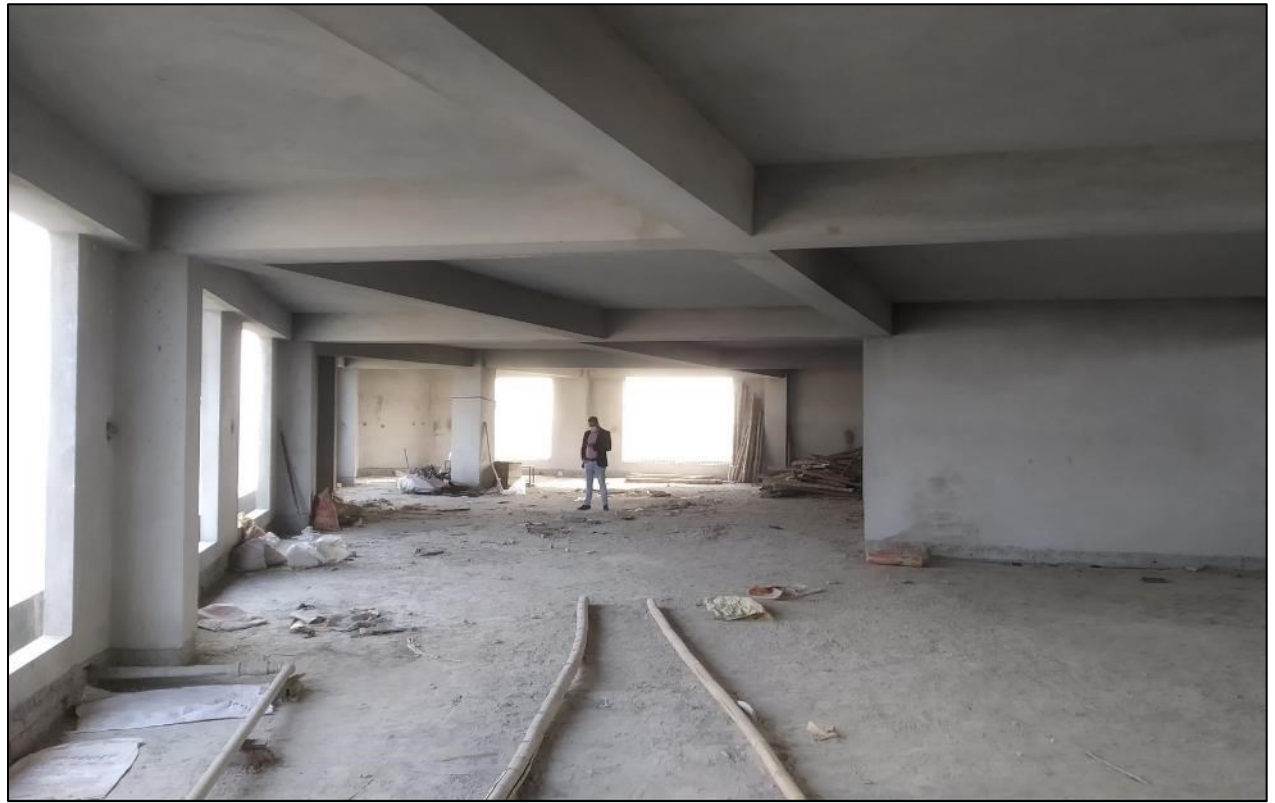
No design report was available for Building E

As per BNBC, every building or structure designed shall have its design documents prepared in accordance with the provision of Section 1.9.1. The design document shall include a design report, and a set of structural drawings, which shall be prepared in compliance with section 1.9.1.1 and section 1.9.1.2 as per BNBC. At the time of inspection, only as-built drawing and geotechnical report were available, but no design report was available which is required to be prepared in compliance with section 1.9.1.1 (part-6, BNBC).

| Item No. | Observation | Recommended Action Plan | Recommended Timeline |
|---|---|---|---|
| 08 | Absence of Design Documents (Building E) | Factory engineer is required to prepare the design documents including a design report, and a set of structural drawings in compliance with section 1.9.1.1 and section 1.9.1.2 as per BNBC part 6 and submit to RSC for review. | 6-weeks |

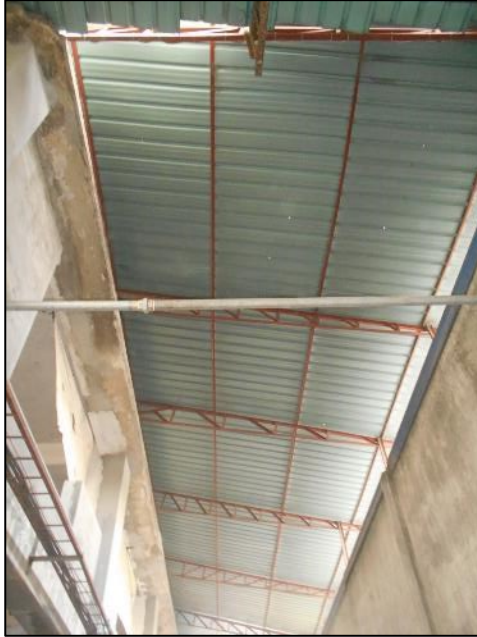
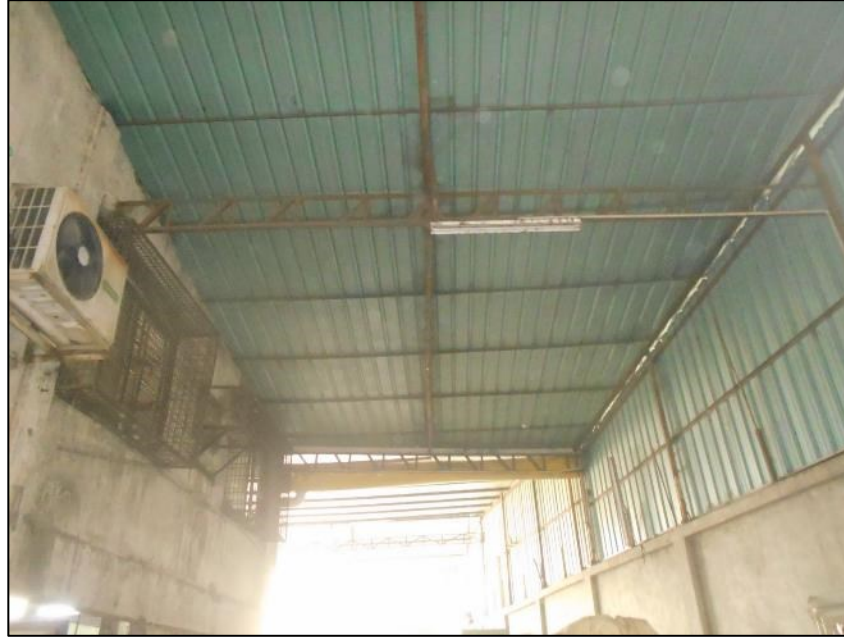
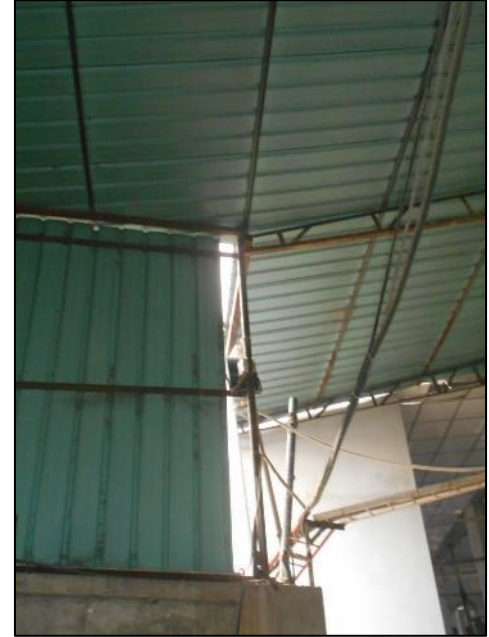
Walkway shed among the corridor of Building A, Building E, Utility building and Shed C. Mostly improper connection found on site.

No defined structural system is present on this walk way shed. The connection type is welded. No drawing was available for this non-engineered shed.

| Item No. | Observation | Recommended Action Plan | Recommended Timeline |
|---|---|---|---|
| 12 | Absence of Drawing and Lateral Stability (Walkway shed) | Repair or demolish the apparently non-engineered walkway shed in an engineered way or demolish the structure. | 6-months |

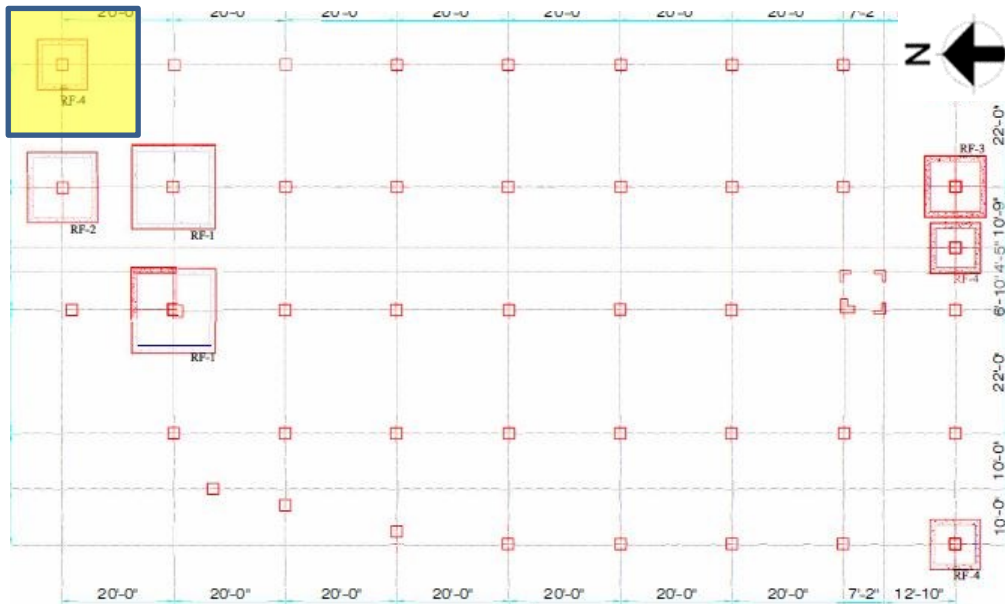
Retrofitting Foundation layout

Cursory calculation indicates that the stress in foundation exceeds normal design limit. This footing is situated at the stair area and live load for this footing is considered as 4 kPa as per provided load plan.

Dimension of this highlighted footing was initially 2.13m X2.13m and dimension became 2.74mX2.74m eventually after the retrofitting work carried out for this footing. However, considering 4 kPa live load and all source of dead load this footing has been found stressed in excess of normal design limit against the soil bearing capacity available from Geotechnical investigation report. Building engineer is required to carryout foundation adequacy check to justify the load carrying capacity.

| Item No. | Observation | Recommended Action Plan | Recommended Timeline |
|---|---|---|---|
| 13 | Stress in foundation exceeds normal design limit (Building-B) | Building engineer is required to carryout foundation adequacy check to justify the load carrying capacity. | 6-weeks |

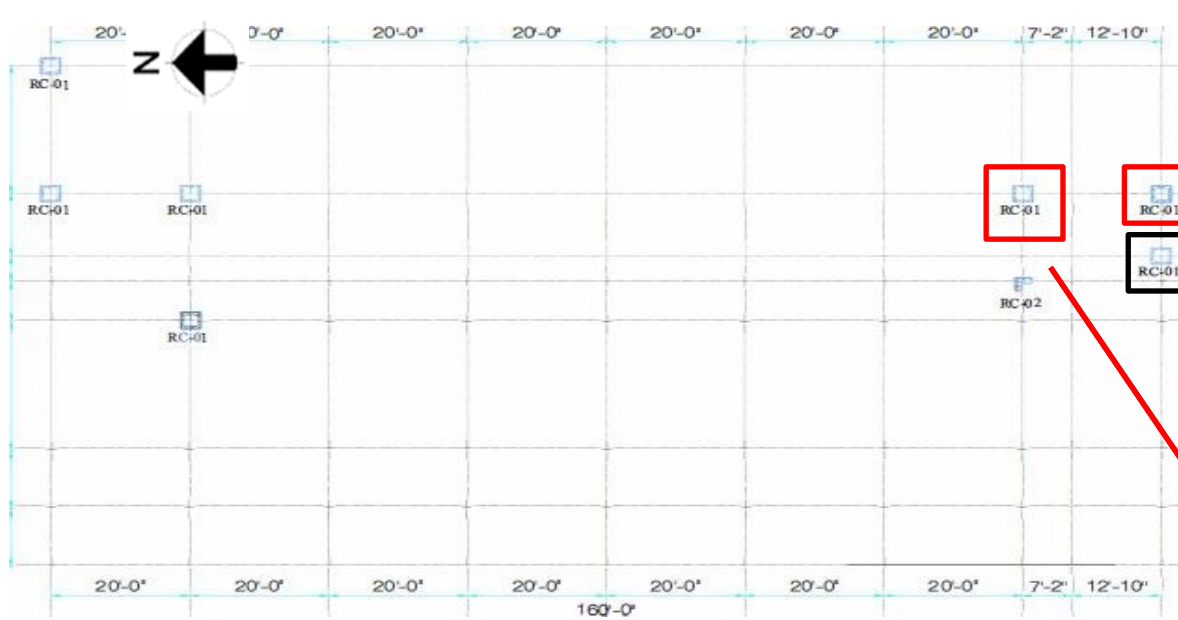
Retrofitting column layout

Highlighted red marked columns are considered as retrofitting up to 3rd floor roof in the design report & software-based analysis model but those columns were found retrofitted up to 2<sup>nd</sup> floor roof. Also, Highlighted black marked column is considered as retrofitting up to 2nd floor roof but those columns were found retrofitted up to 1<sup>st</sup> floor roof. Building engineer is required to review the strengthen scheme & carry out required strengthen works where necessary.

| Item No. | Observation | Recommended Action Plan | Recommended Timeline |
|---|---|---|---|
| 15 | Proposed retrofit strengthening not properly implemented. (Building-B) | Building engineer is required to review the strengthen scheme & carry out required strengthen works where necessary. | 6-weeks |

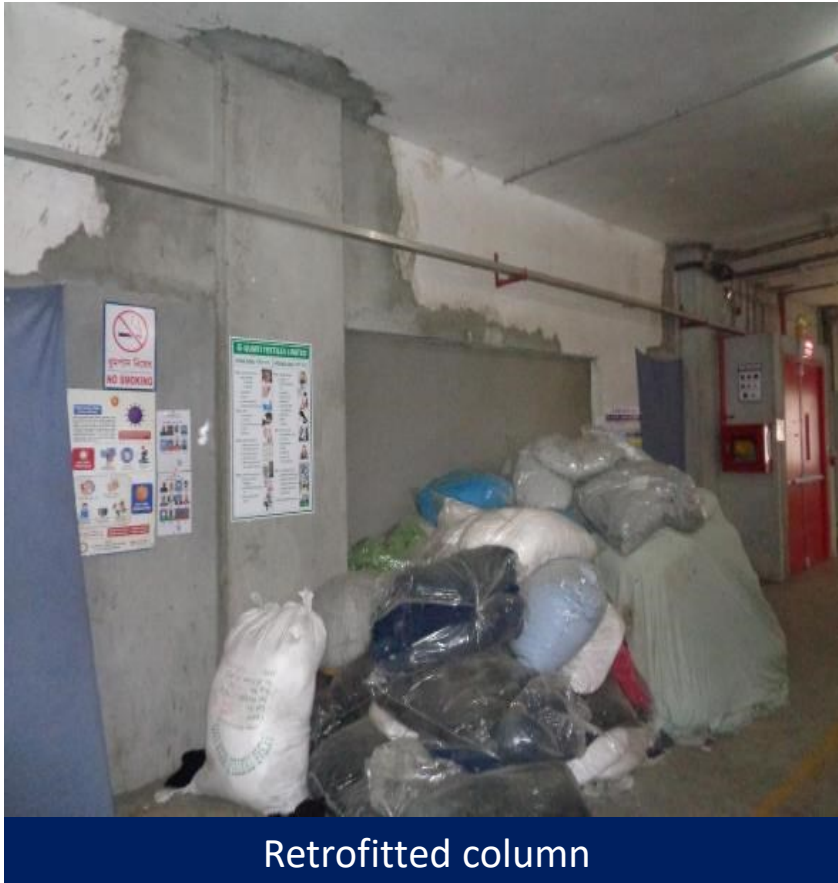
Retrofitted column

Factory has carried out some retrofitting works in columns and footing but record of material strength was not available for the retrofitted columns and footings . Building engineer is required to prepare the material test report and confirm the material strength of the retrofitting works.

| Item No. | Observation | Recommended Action Plan | Recommended Timeline |
|---|---|---|---|
| 17 | Proposed retrofit strengthening not properly implemented. (Building-B) | Verify the material strength of the retrofitting section as per design strength. | 6-weeks |

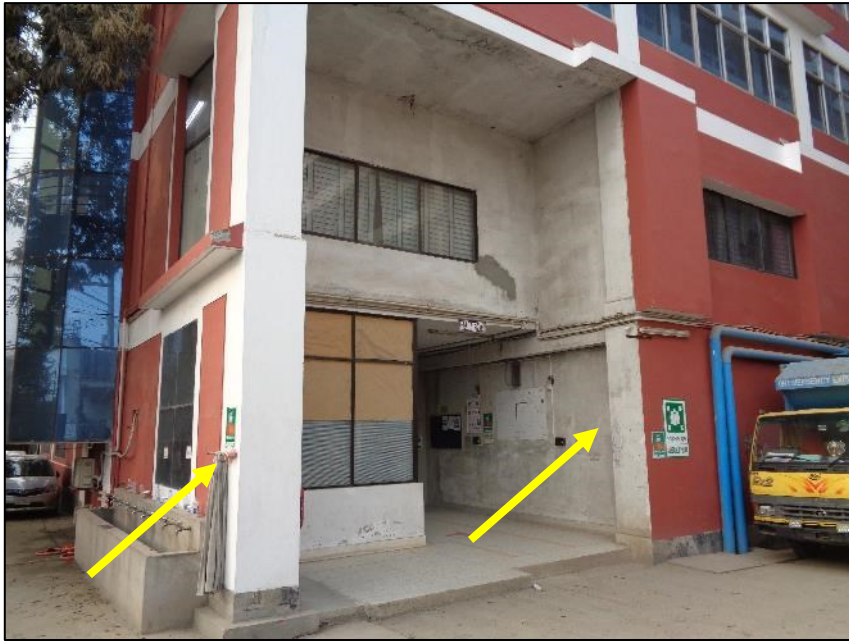
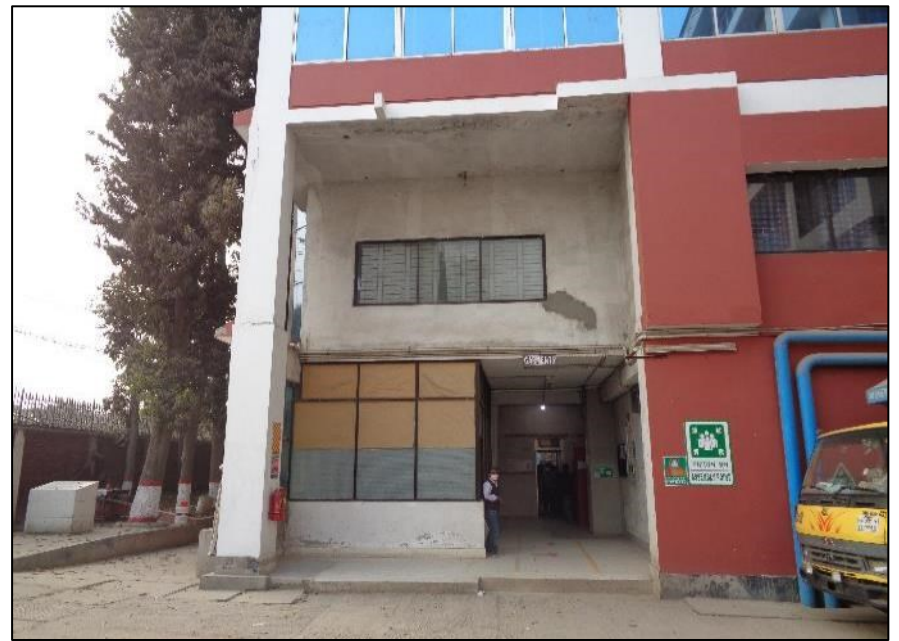
Columns were found adjacent to driveway and loading unloading platform which are susceptible to vehicle impact. Building engineer is required to take necessary measures to prevent the vehicle impact by providing the barrier around the columns.

| Item No. | Observation | Recommended Action Plan | Recommended Timeline |
|---|---|---|---|
| 20 | Column Susceptible to vehicle impact. (Building-B) | Building engineer is required to take necessary measures to prevent the vehicle impact by providing the barrier around the column. | 6-weeks |

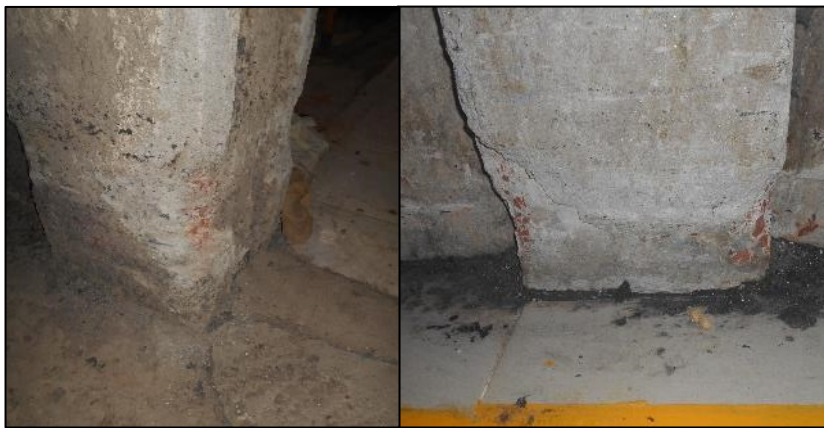
Damaged column of Shed C

Sign of damage was found in the RCC column of shed C. Corroded rebar was also found exposed in some columns. Factory engineer is required take proper remedial works for the affected columns.

| Item No. | Observation | Recommended Action Plan | Recommended Timeline |
|---|---|---|---|
| 21 | Appearance of Damaged Column and Corroded Rebar (Shed C) | The factory engineer is required to take necessary measures to repair the damage columns and to prevent the trolley impact by providing the barrier around the columns. | Immediate - Now |
| 22 | Appearance of Damaged Column and Corroded Rebar (Shed C) | Building Engineer to investigate the cause of damage and continuous monitoring the status of the columns. | 6-weeks |

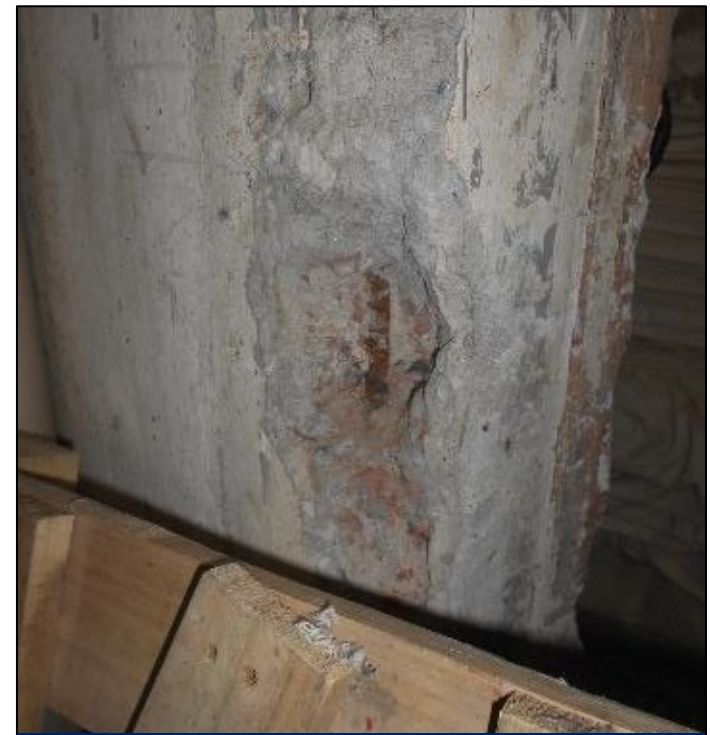
Corrode rebar in column

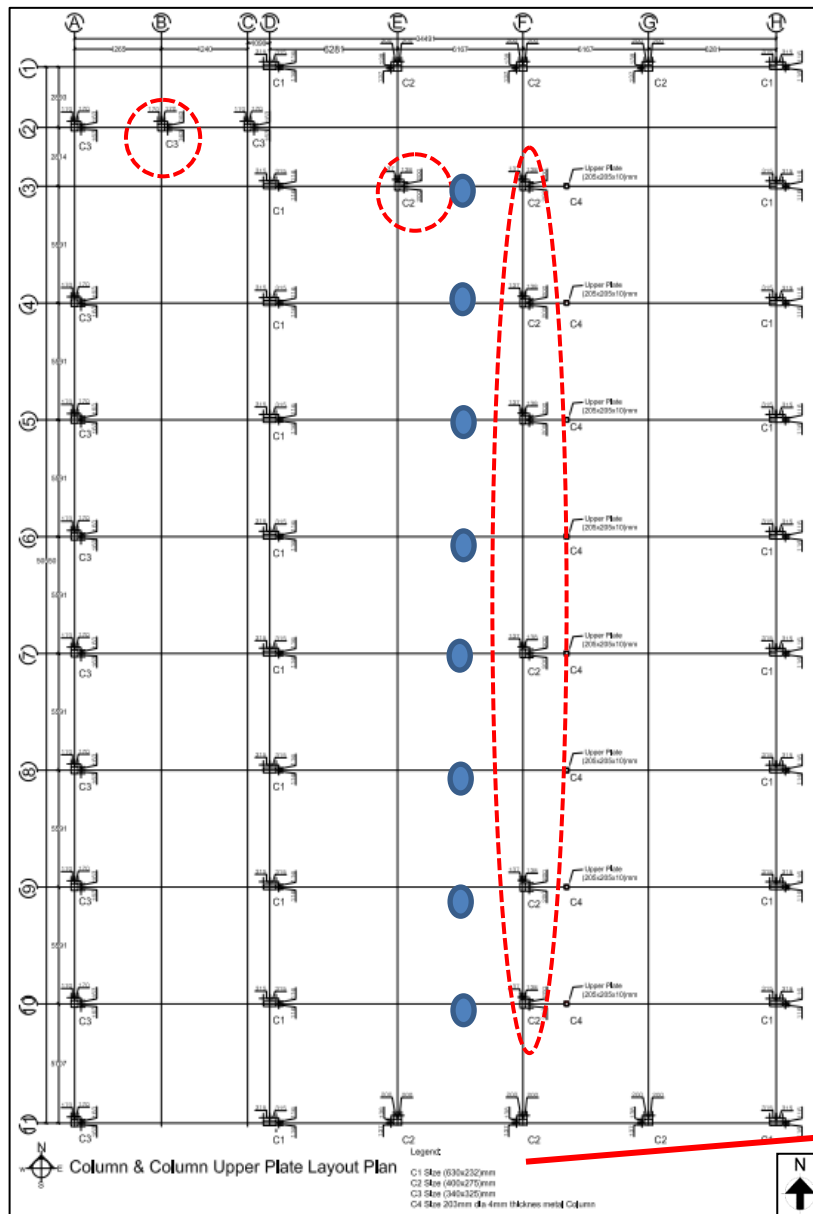
Column layout : marked (red) columns were not present

- Steel column that has not been shown on the column layout
- RC columns are along with the Grid line A , C, D H, 1, 11.

Column layout does not match with site condition. The marked (red) columns were not observed during inspection. RC Column was not found on Grid B-2, E-3, F-3~10. Additionally steel column was found on the Grid F-3~10 which was of same dimension as C4 type column. The dimension of C1 type column was found 630 mm by 210 mm instead of 630 mm by 232 mm. The dimension of C3 type column was found 300 mm by 300 mm instead of 340 mm by 325 mm. The dimension of C4 type column was found 230 mm instead of 203 mm.

| Item No. | Observation | Recommended Action Plan | Recommended Timeline |
|---|---|---|---|
| 24 | Discrepancies in as-built documents with onsite condition (Shed C) | Building Engineer is to survey the whole structure and update as-built drawings representing accurate site condition. | 6-weeks |

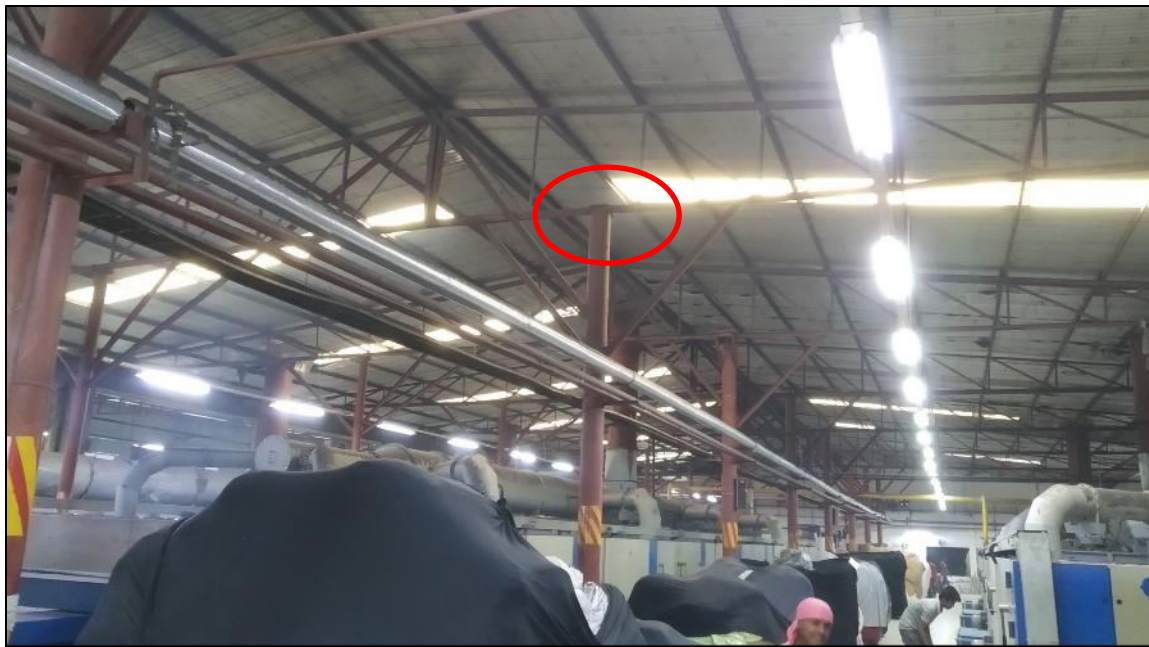
Connection of Truss to column ( Grid D~H)

No vertical or horizontal bracing was found to transfer lateral load. Lateral load transfer system is not clear. Truss is not supported by steel column at node point. In addition, no design report was available on site. Building engineer is required to check the lateral stability of the shed.

| Item No. | Observation | Recommended Action Plan | Recommended Timeline |
|---|---|---|---|
| 25 | Absence of Load Transfer Media and Design Documents (Shed C) | Building engineer is required to check the requirement of the any load transfer media or bracing system. | 6-weeks |

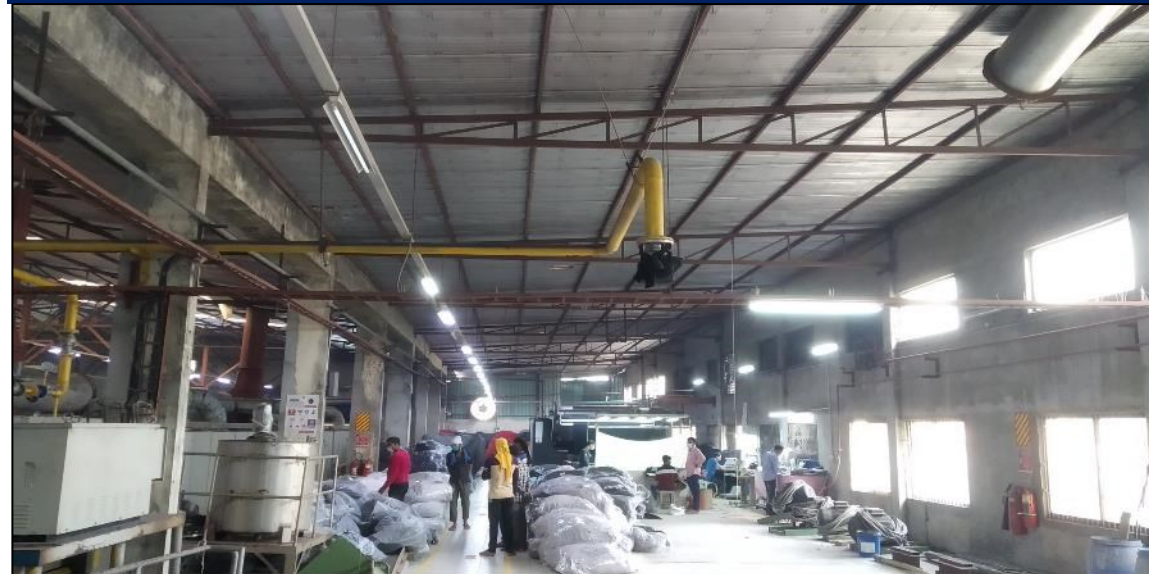
Truss system ( Grid A~D)

As per BNBC, every building or structure designed shall have its design documents prepared in accordance with the provision of Section 1.9.1. The design document shall include a design report, and a set of structural drawings, which shall be prepared in compliance with section 1.9.1.1 and section 1.9.1.2 as per BNBC. At the time of inspection, only as-built drawing and geotechnical report were available, but no design report was available which is required to be prepared in compliance with section 1.9.1.1 (part-6, BNBC).

| Item No. | Observation | Recommended Action Plan | Recommended Timeline |
|---|---|---|---|
| 26 | Absence of Load Transfer Media and Design Documents (Shed C) | Building Engineer to prepare design report as per BNBC (part-6; Article 1.9.1) by reviewing design, loads and capacity of structural members. | 6-weeks |

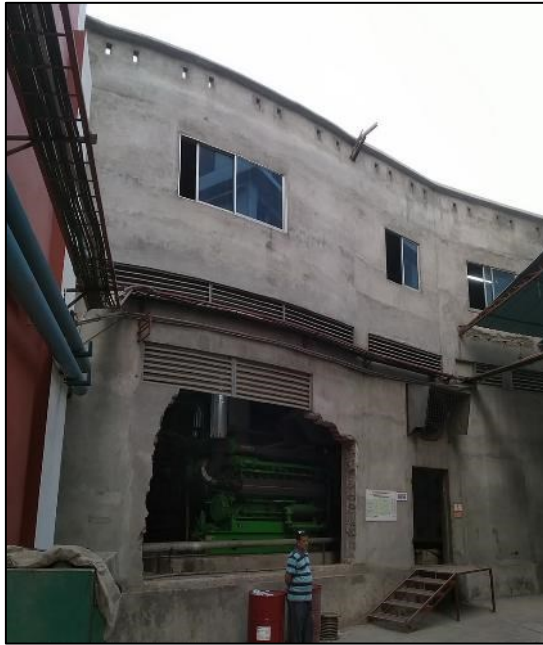
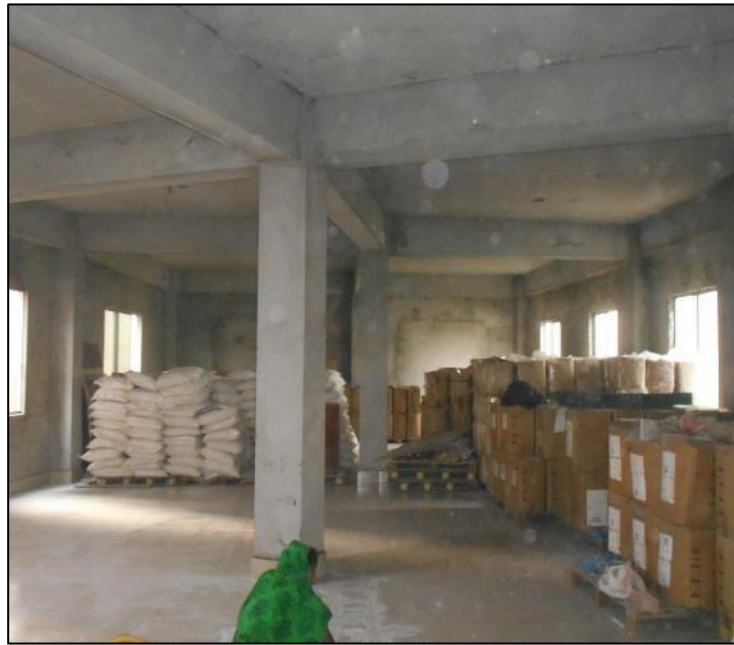
No design report was available for Utility Building

As per BNBC, every building or structure designed shall have its design documents prepared in accordance with the provision of Section 1.9.1. The design document shall include a design report, and a set of structural drawings, which shall be prepared in compliance with section 1.9.1.1 and section 1.9.1.2 as per BNBC. At the time of inspection, only as-built drawing and geotechnical report were available, but no design report was available which is required to be prepared in compliance with section 1.9.1.1 (part-6, BNBC).

| Item No. | Observation | Recommended Action Plan | Recommended Timeline |
|---|---|---|---|
| 28 | Absence of Design Documents (Utility Building) | Building Engineer to prepare design report as per BNBC (part-6; Article 1.9.1) by reviewing design, loads and capacity of structural members. | 6-weeks |

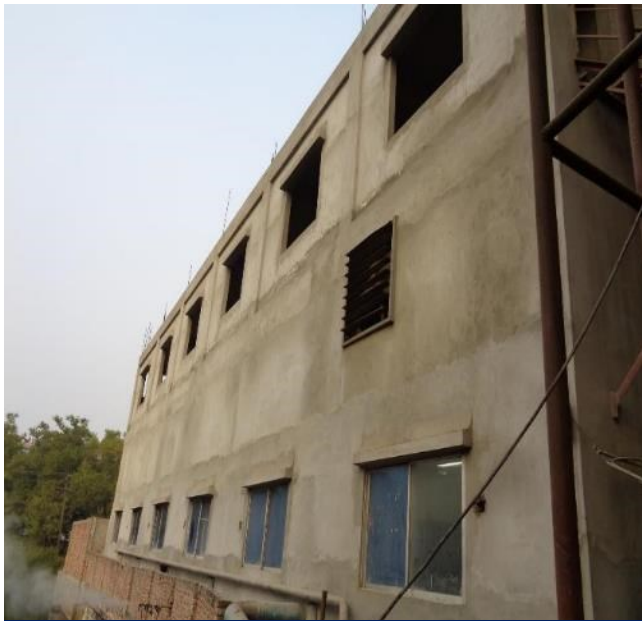
WTP building

As per BNBC, every building or structure designed shall have its design documents prepared in accordance with the provision of Section 1.9.1. The design document shall include a design report, and a set of structural drawings, which shall be prepared in compliance with section 1.9.1.1 and section 1.9.1.2 as per BNBC. At the time of inspection, only as-built drawing and geotechnical report were available, but no design report was available which is required to be prepared in compliance with section 1.9.1.1 (part-6, BNBC).

| Item No. | Observation | Recommended Action Plan | Recommended Timeline |
|---|---|---|---|
| 30 | Absence of documents as per BNBC. (WTP Building, ETP Chemical Building, Substation Building) | Building Engineer to prepare design report as per BNBC (part-6; Article 1.9.1) by reviewing design, loads and capacity of structural members. | 6-weeks |
