# Sadia Fashion Wears Ltd.

Talla Road, Khapur, Fatullah, Narayanganj.

04 February 2020

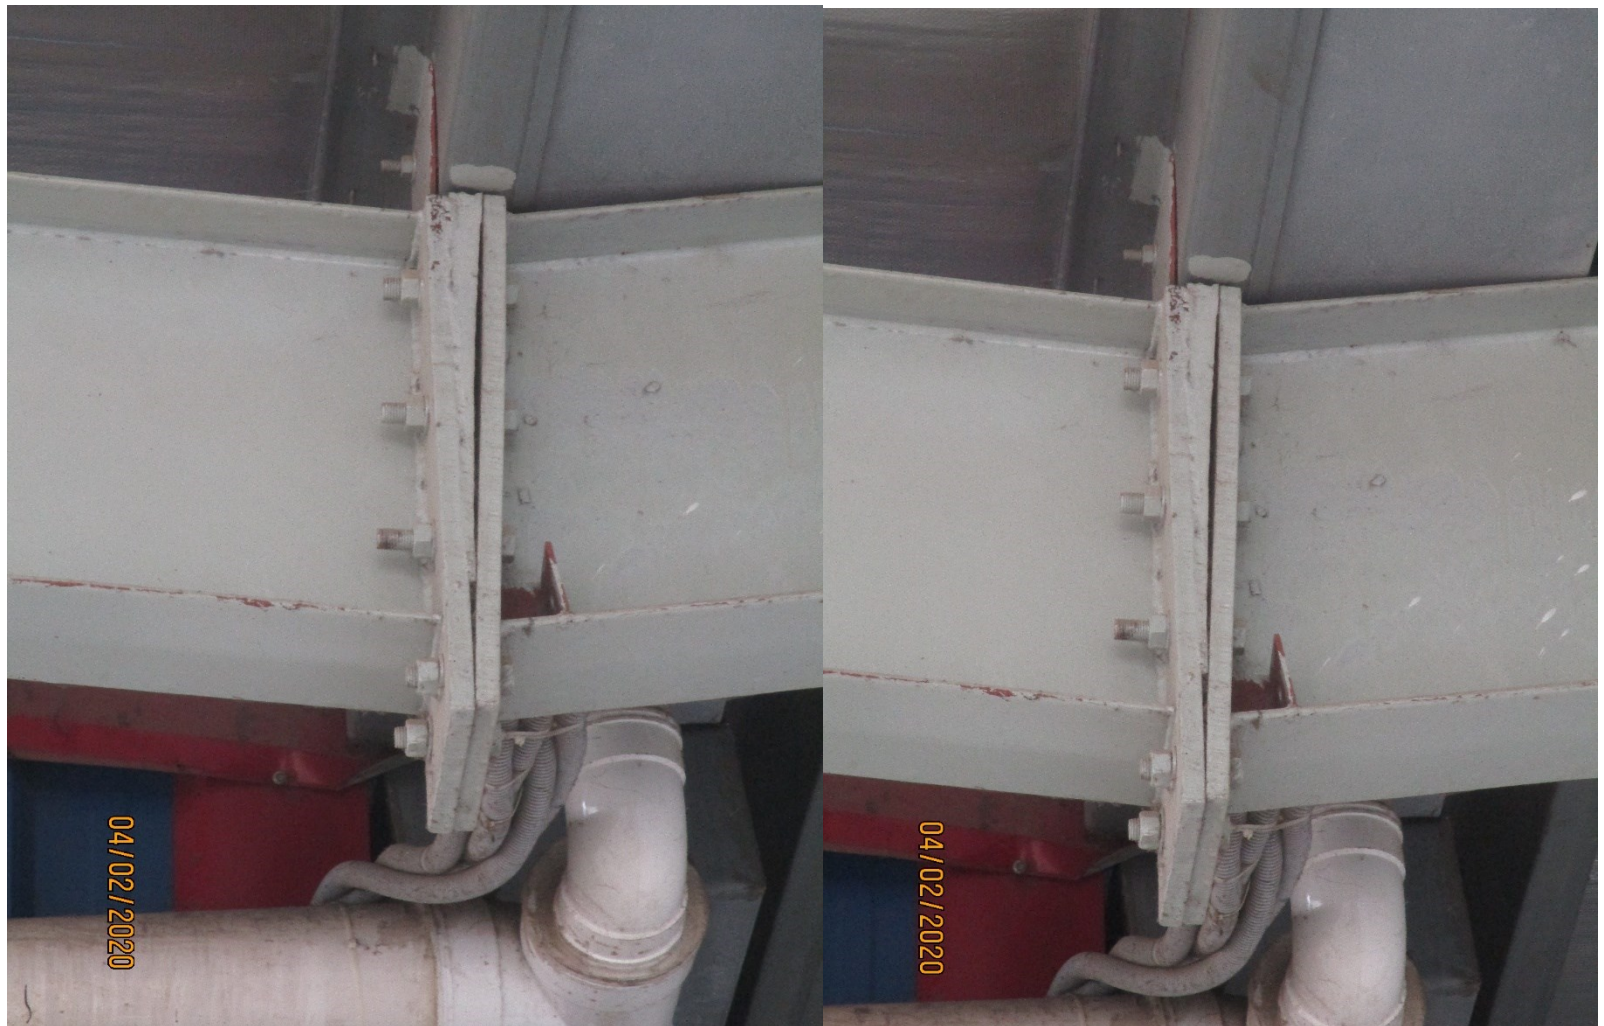
## Gap in rafter connection

Gap in rafter connection were found in several location which may reduce the moment capacity of the connections. The building engineer is required to fill the gaps with a suitable method.

| Item No. | Observation | Recommended Action Plan | Recommended Timeline |
|---|---|---|---|
| 01 | Gap in rafter connection. (Sewing & Finishing Shed) | Building engineer is required to fill the gaps with a suitable method. | 6-weeks |

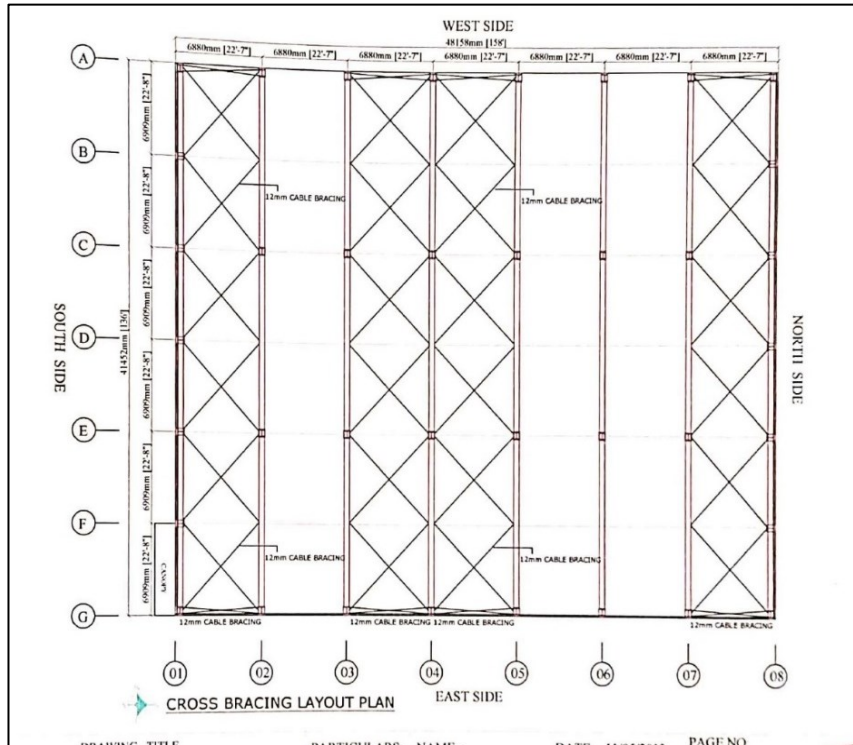
Bracing Layout Plan

**Apparently lack of load transfer media in long direction**

**Observation: Store Shed**

The stability system provided by tension cable bracing in wall & roof. No compression struts/members were provided in the long direction. Lack of lateral stability along the long direction is appeared. The building engineer is required to review the lateral stability system of the shed.

| Item No. | Observation | Recommended Action Plan | Recommended Timeline |
|---|---|---|---|
| 02 | Apparently lack of load transfer media in long direction. (Store Shed) | Building engineer is required to review the lateral stability system of the shed. | 6-weeks |
| 03 | Apparently lack of load transfer media in long direction. (Store Shed) | Carry out remedial works where necessary. | 6-months |

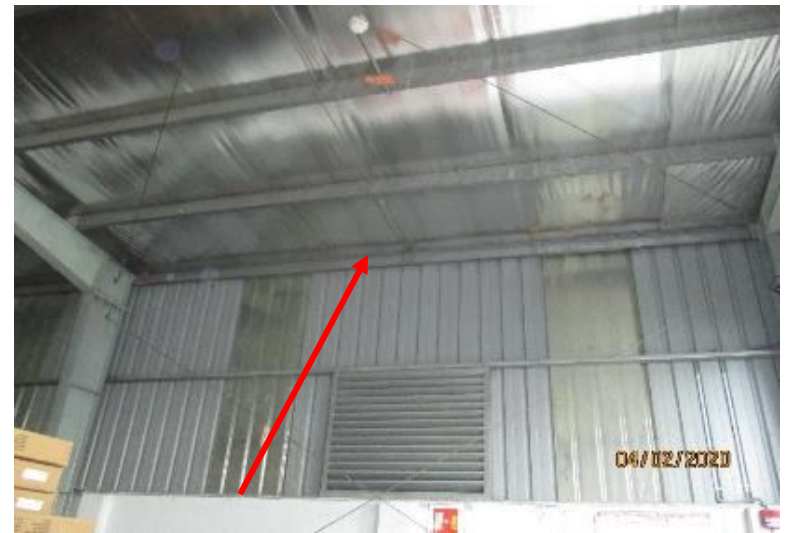
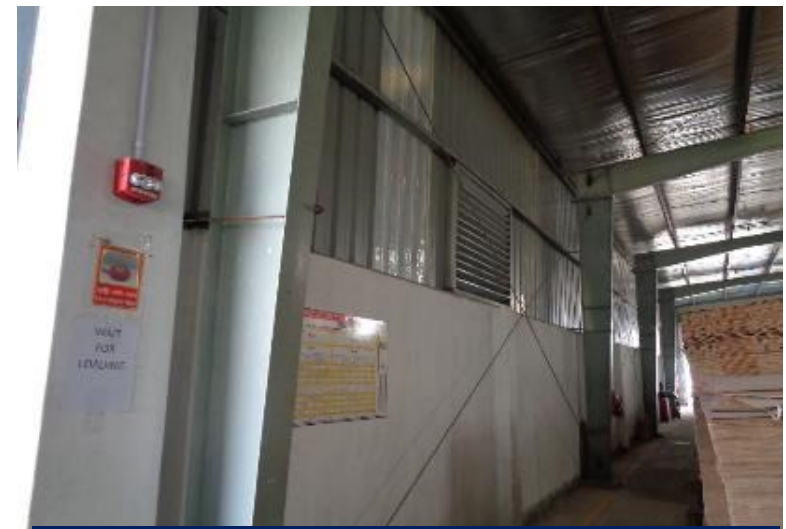
Absence of load transfer member in long direction

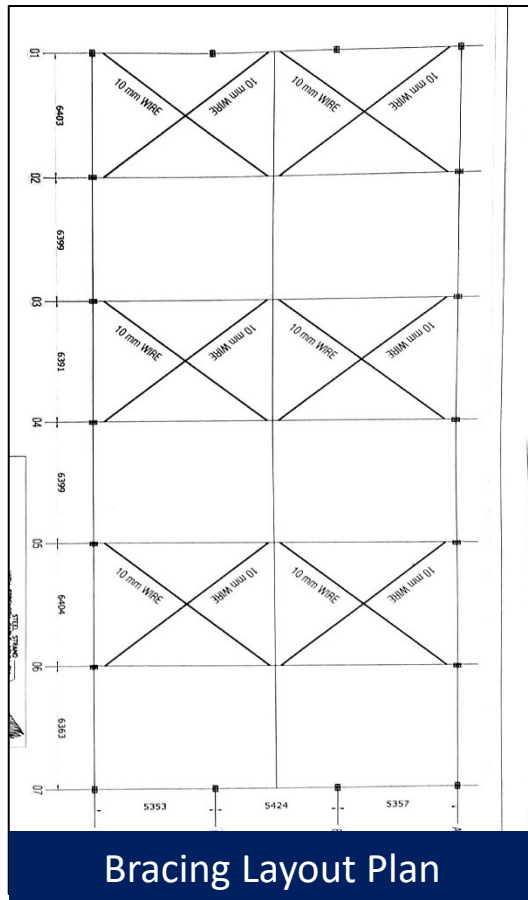
Bracing Layout Plan

**Apparently lack of load transfer media in long direction**

**Observation: Cutting Shed**

The stability system provided by tension cable bracing in wall & roof. No compression struts/members were provided in the long direction. Lack of lateral stability along the long direction is appeared. The building engineer is required to review the lateral stability system of the shed.

| Item No. | Observation | Recommended Action Plan | Recommended Timeline |
|---|---|---|---|
| 04 | Apparently lack of load transfer media in long direction. (Cutting Shed) | Building engineer is required to review the lateral stability system of the shed. | 6-weeks |
| 05 | Apparently lack of load transfer media in long direction. (Cutting Shed) | Carry out remedial works where necessary. | 6-months |

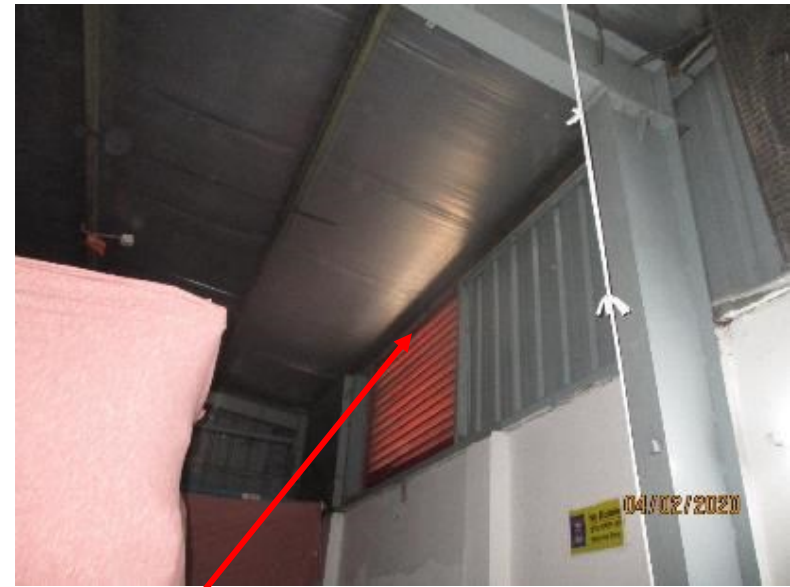
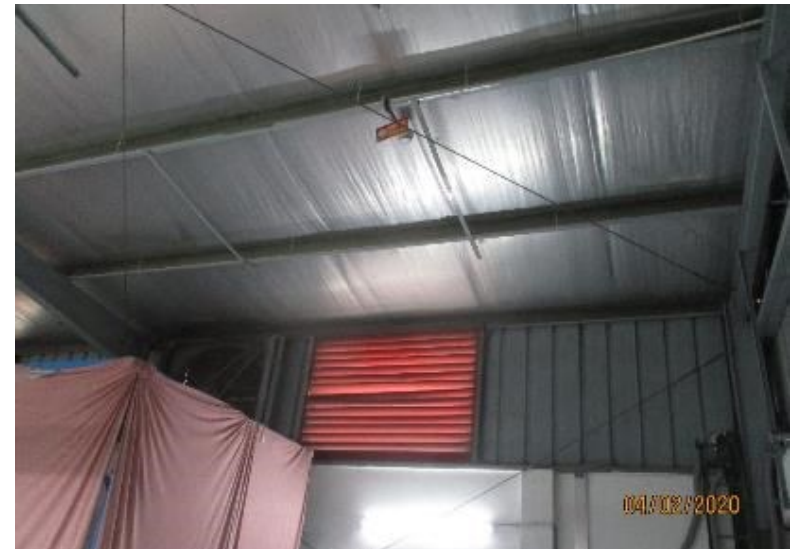
Absence of load transfer member in long direction

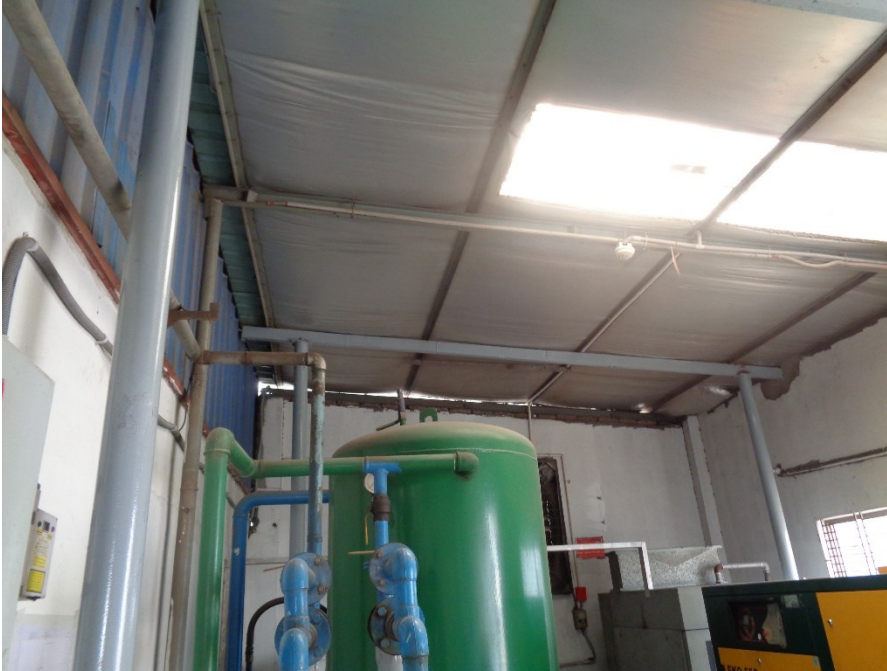
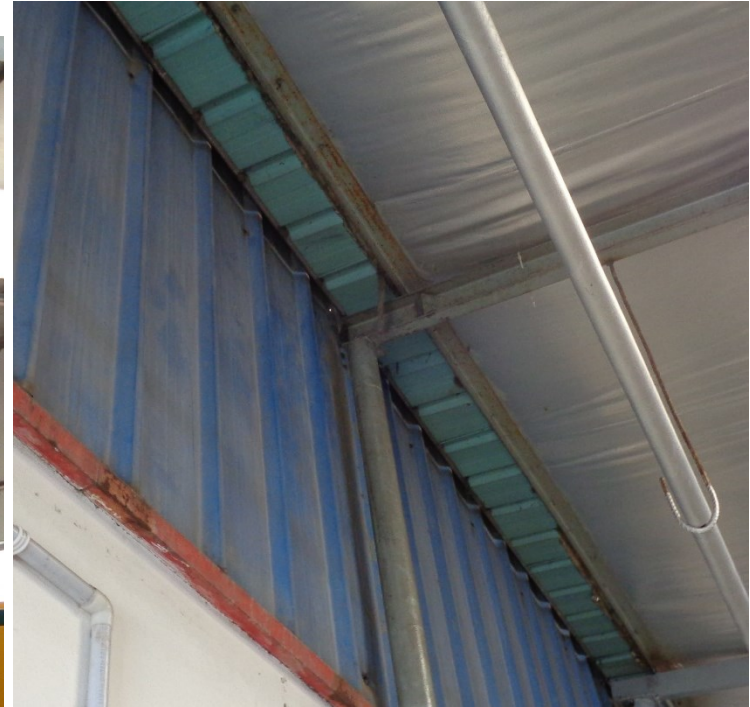
**Apparently inadequate member & connection**

**Observations: Utility Shed**

Apparently lack of lateral stability system & poor connection details were observed. Also structural members were seems/found to be inadequate. Building engineer is required to check the member, connection adequacy & stability of the shed.

| Item No. | Observation | Recommended Action Plan | Recommended Timeline |
|---|---|---|---|
| 06 | Apparently inadequate member & connection. (Utility Shed) | Building engineer is required to check the member, connection adequacy & stability of the shed. | 6-weeks |
| 07 | Apparently inadequate member & connection. (Utility Shed) | Carry out remedial works where required. | 6-months |

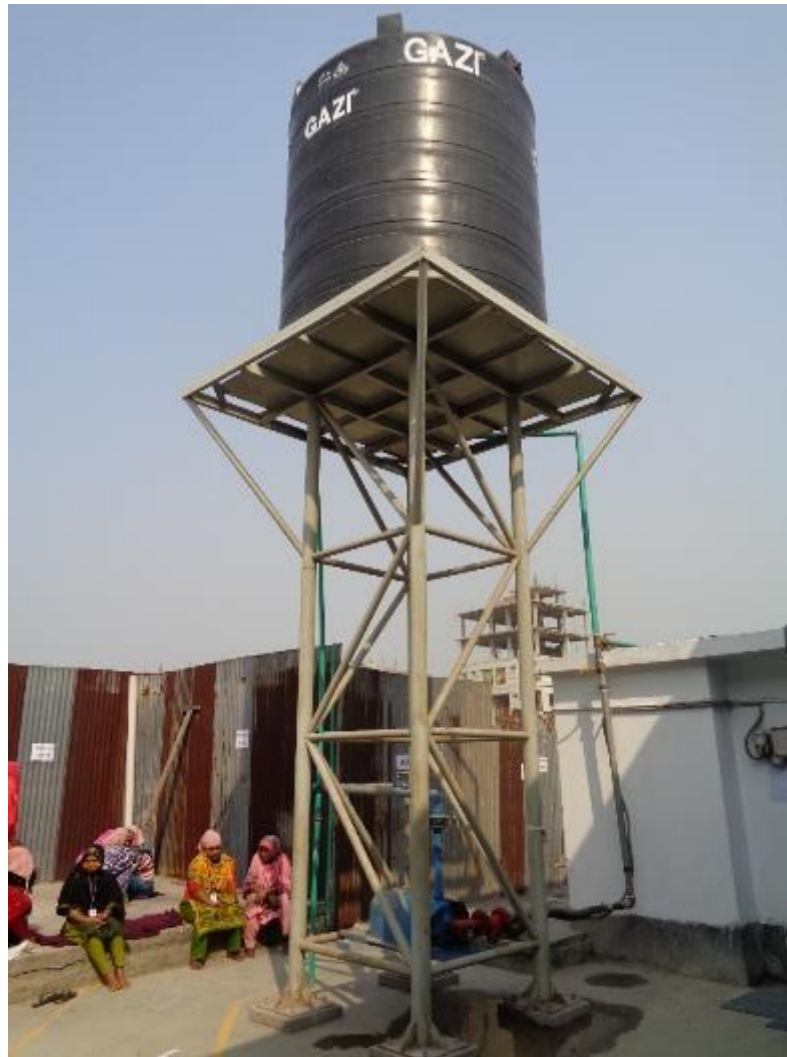
**No brace and anchorage on water tank**

Water tank was not braced and anchored to resist earthquake/lateral forces.

| Item No. | Observation | Recommended Action Plan | Recommended Timeline |
|---|---|---|---|
| 08 | No brace and anchorage on water tank. | Building engineer is required to provide the adequate anchorage and bracing to the water tank for increasing stability during earthquake/lateral loading. | 6-weeks |
