Logos Apparels Ltd. (Building 4)

Telirchala, Mouchak, Kaliakoir, Gazipur-1751.
(24.016327, 90.305253)

25th November 2020

1. Production Building (Building 4) (B+G+5)

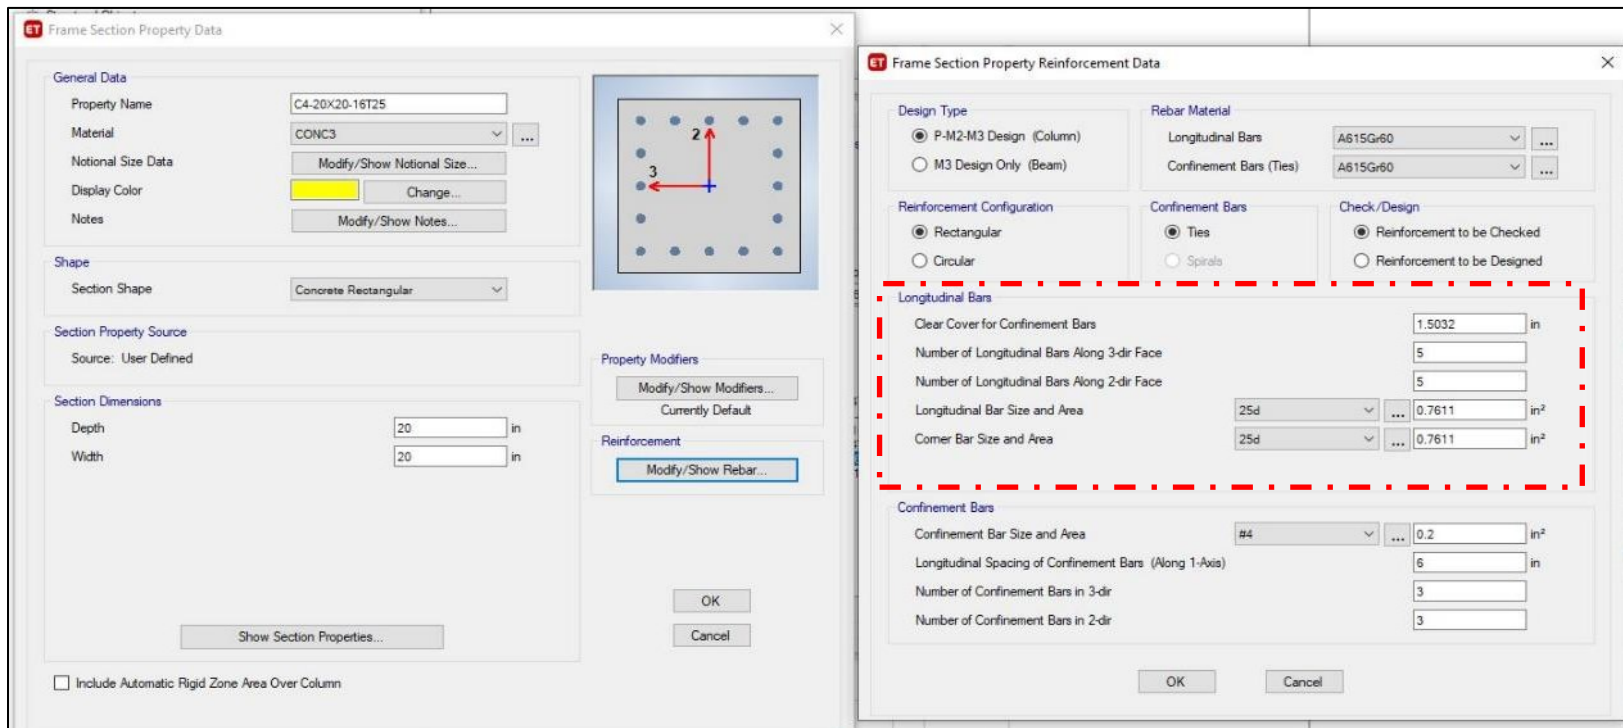
Sectional property and reinforcement data from FEM on ETABS

C04 type column rebar schedule

As per drawing the C04 column has 20 number of rebar but on the sectional property of C04 column on FEM, 14 number of rebar has been assigned.

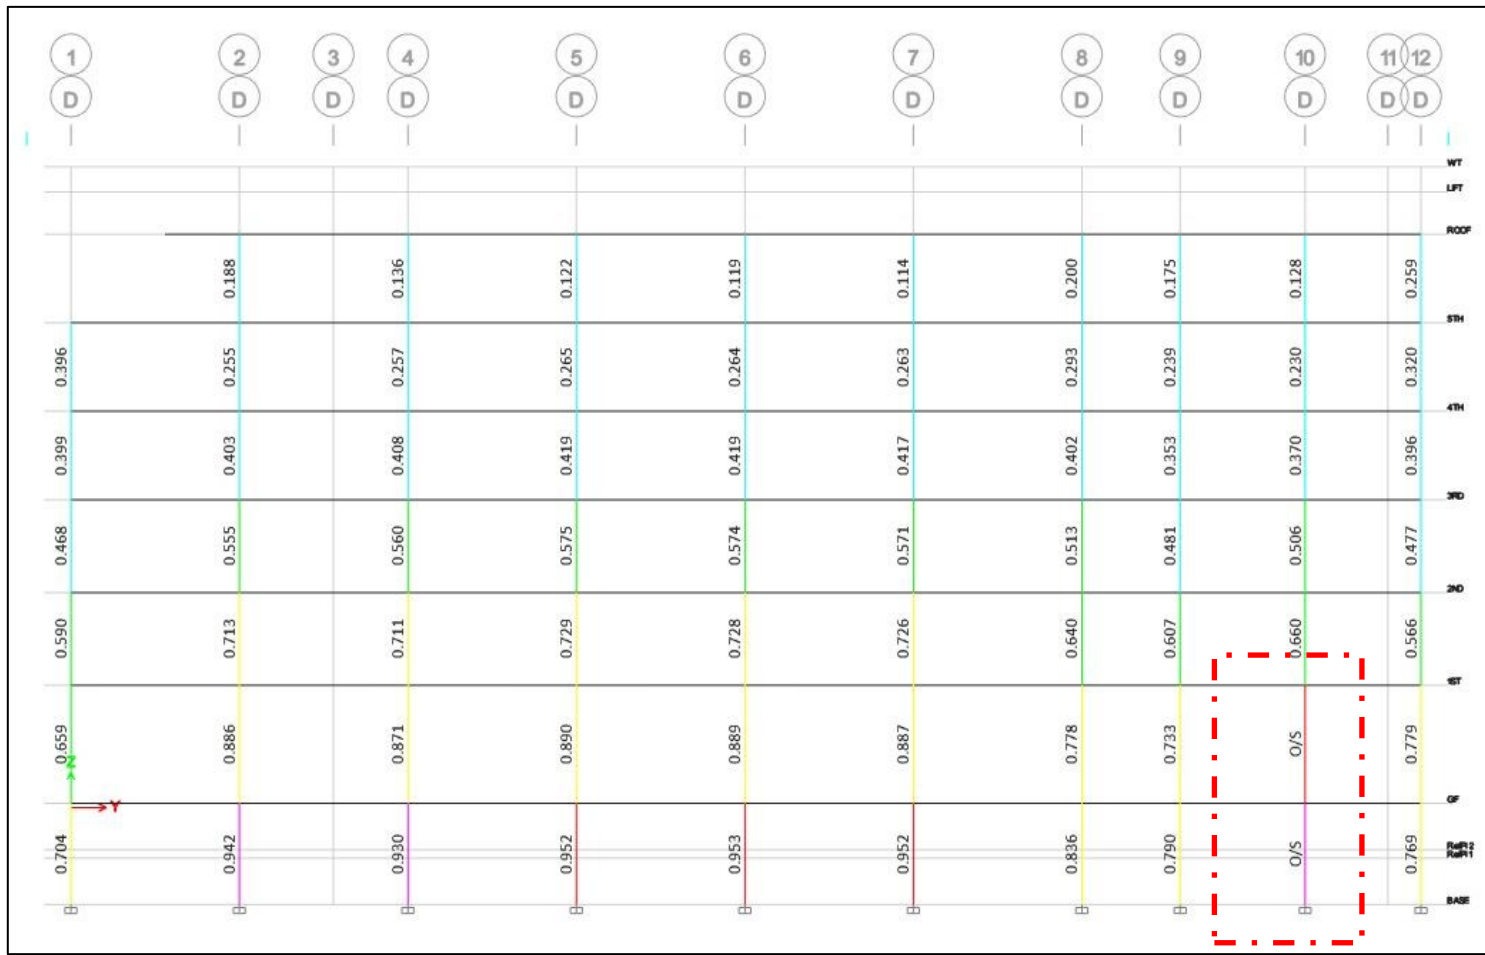
Column P-M-M interaction ratio found from FEA model on ETABS

There was no design report available for this structure on site, during inspection. Factory only provided the FEA model of this structure. During FEA model check, some columns were found overstressed. Factory is required to revise the FEA model. Also, the steel part (ACP works) loading of the roof has not been assigned. Building Engineer to prepare design report as per BNBC (part-6; Article 1.9.1) by reviewing design, loads and capacity of structural members.

Item No.	Observation	Recommended Action Plan	Recommended Timeline
01	Design report need to be prepared	Building Engineer to prepare design report as per BNBC (part-6; Article 1.9.1) by reviewing design, loads and capacity of structural members.	6-weeks
02	Design report need to be prepared	Produce and actively manage a loading plan for all floor plates within the factory, considering floor, column and foundation capacity.	6-weeks
03	Design report need to be prepared	Complete implementation of any remedial works deemed necessary by the Design Report.	6-months
04	Design report need to be prepared	Continue to implement loading plan.	6-months
05	Mismatches in As built drawings	Building Engineer to survey the structure and prepare accurate as-built (both architectural & structural) drawings.	6-weeks

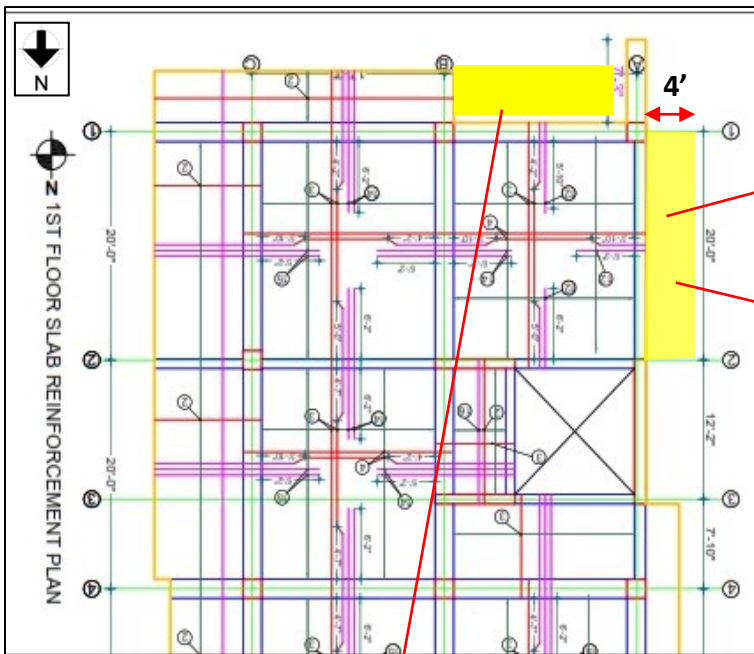
1st Floor Slab reinforcement details

During inspection, a 4' wide extra cantilever slab in the west face of the building was observed which was not present in 1st & 2nd floor slab drawings. Also, there was no slab according to A-B/01 grid of 1st floor slab drawing, but during inspection, slab was found on that location. Revision of slab layout is required. Also, the slab layout does not correlate with the load plan drawing.

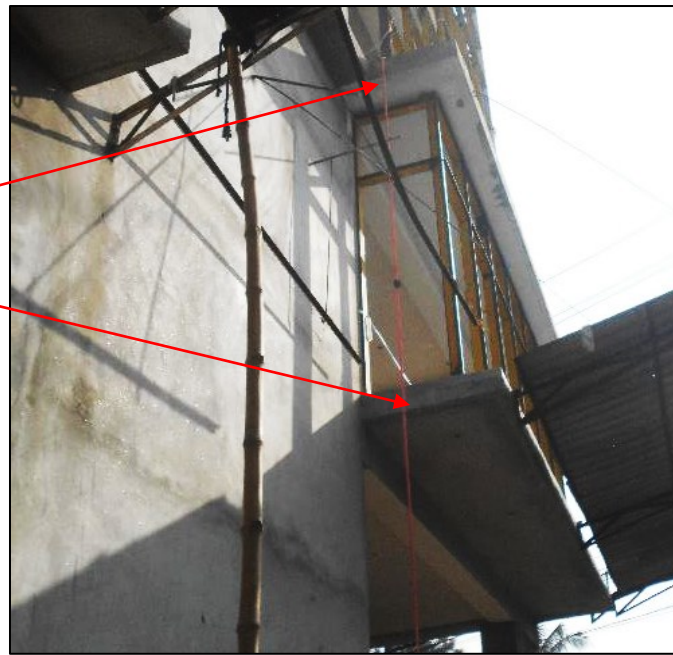
Extra cantilever on 1st and 2nd floor

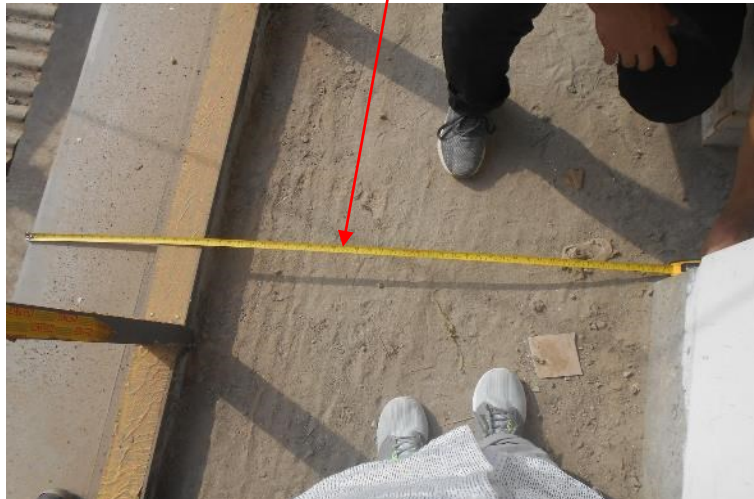
Slab continuous on A-B/01 grid

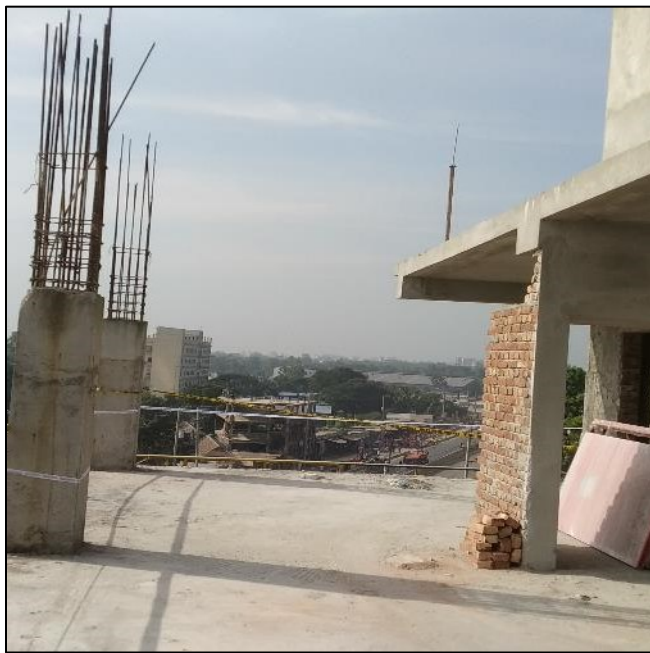
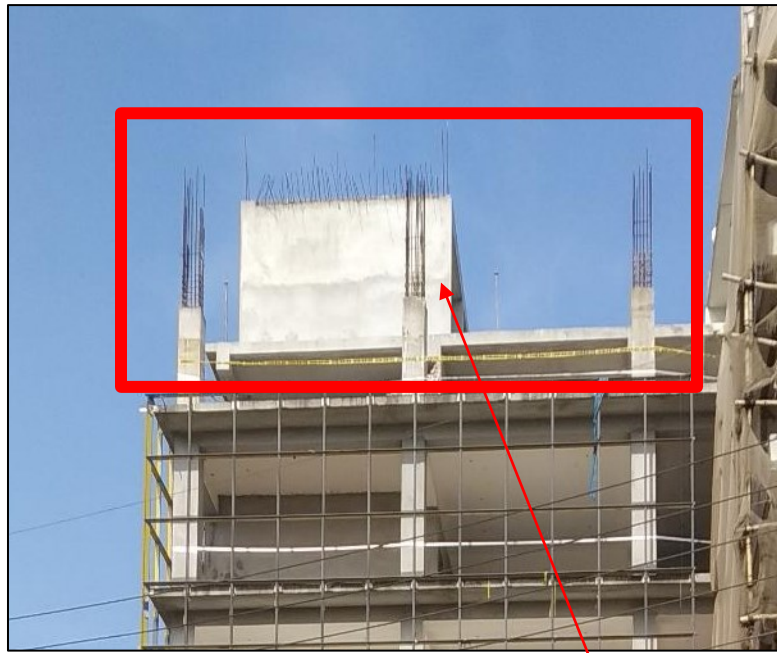
A steel canopy portion will be built in the top floor in future, as per the architectural drawing. But the detailed drawings, connection details of the steel canopy is unavailable.

Item No.	Observation	Recommended Action Plan	Recommended Timeline
06	Drawings of the steel canopy (ACP work) missing	Building Engineer is required produce detailed drawings of the steel canopy and include with as built drawings.	6-weeks
07	Corrosion in Exposed Rebars	Building Engineer is required to remove the corrosions and take preventive measures.	6-weeks

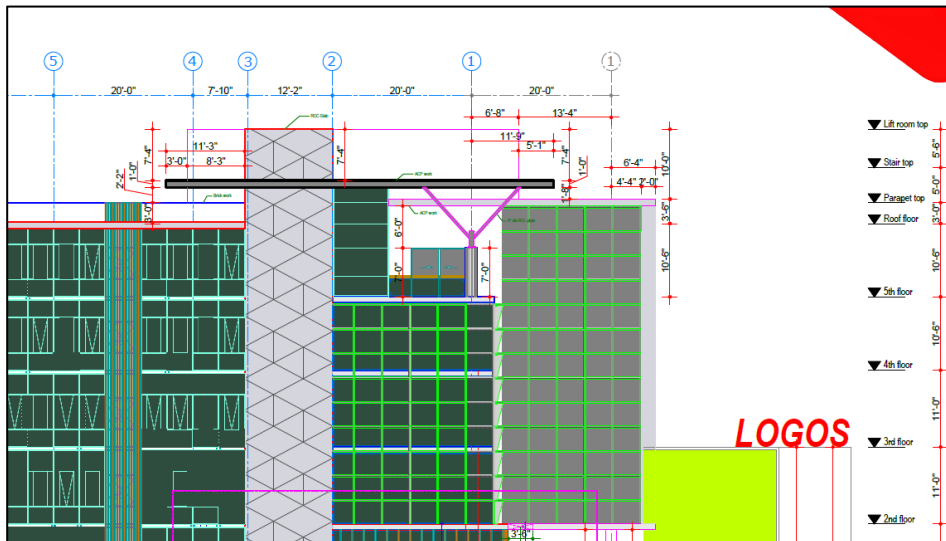
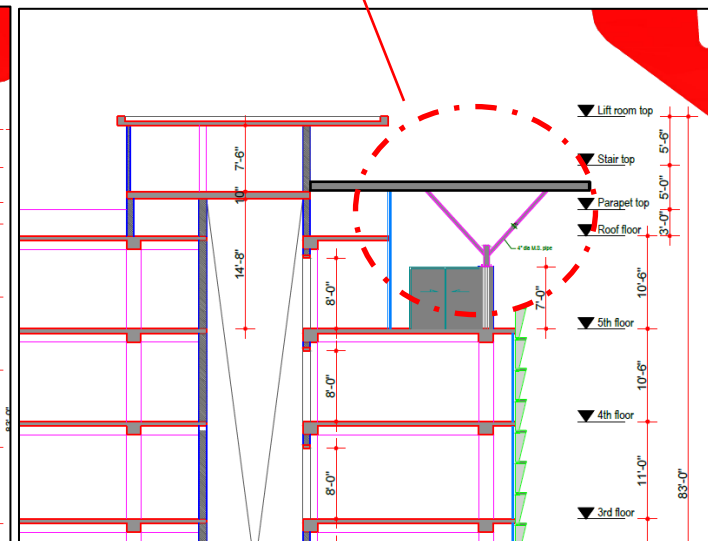
Steel Canopy will be built in the marked portion

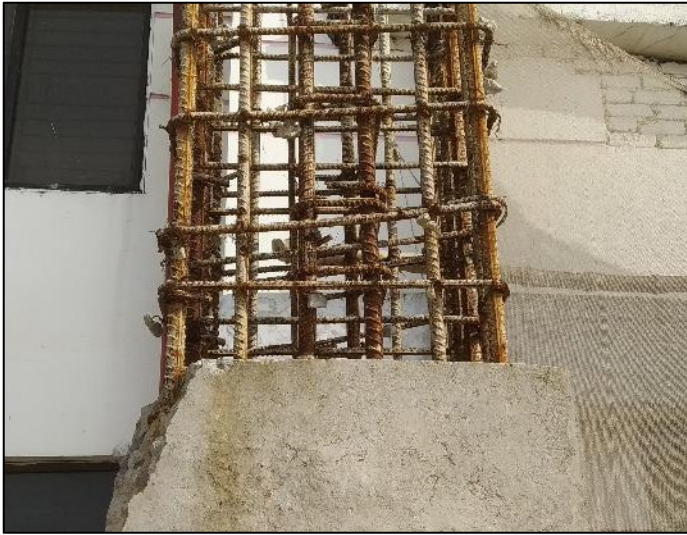
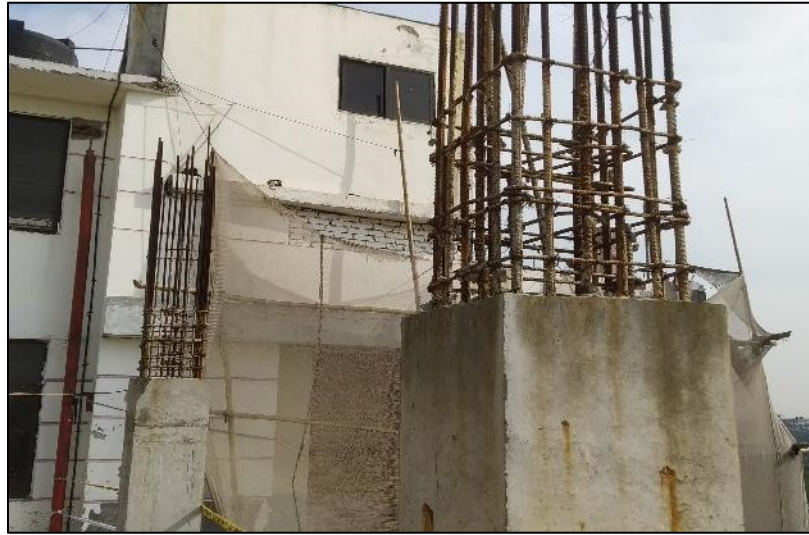
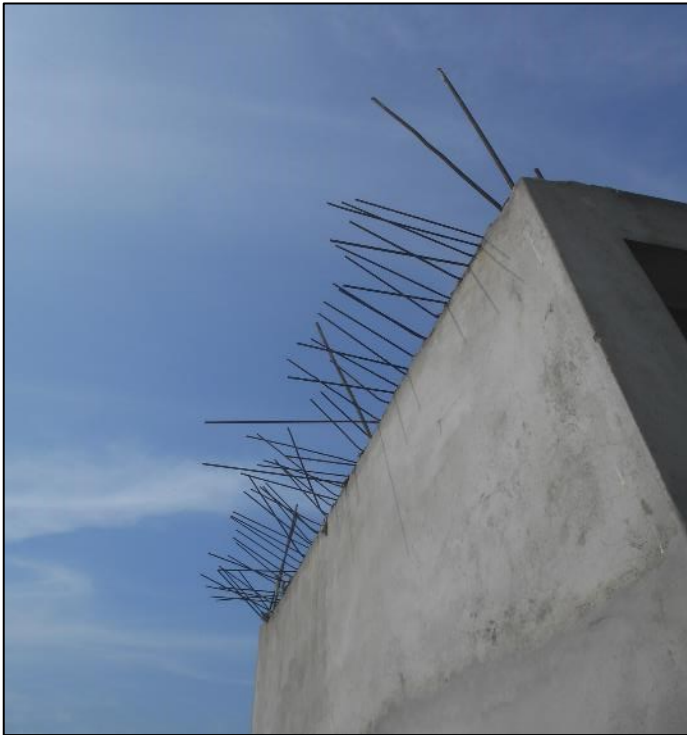
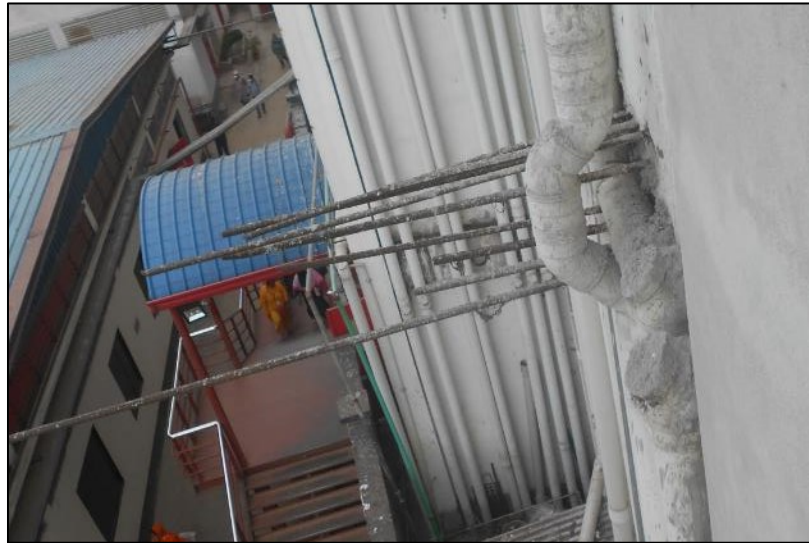
During inspection, corrosion was observed in the exposed rebars.
