# Four H Fashions Ltd.

2852/A Chandgaon I/A, Mohora, Kalurghat, Chandgaon  
(22.396692, 91.864365)

16<sup>th</sup> February 2021

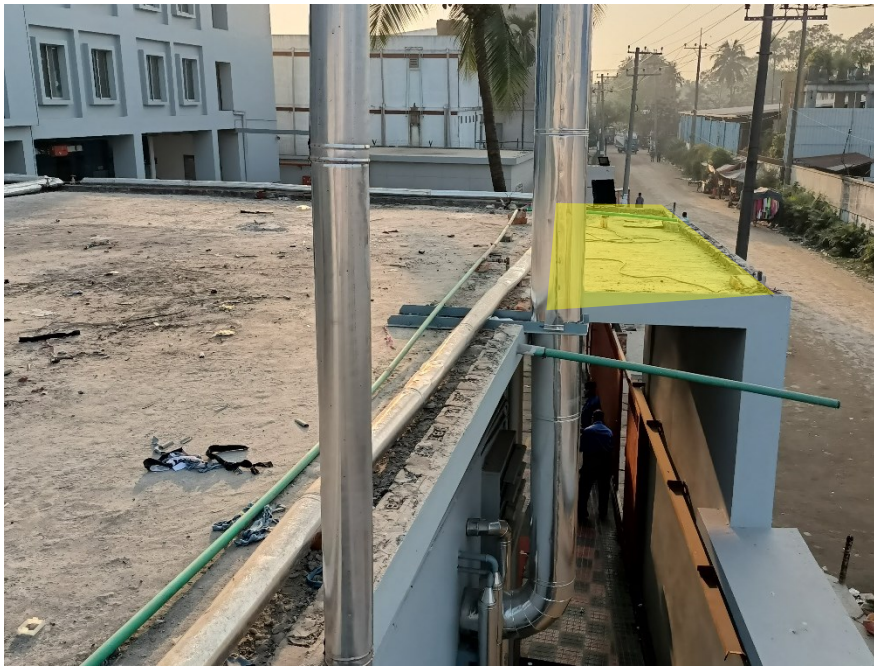
Extended slab (marked as yellow)

The slab of Utility Building extended to the boundary wall at North-west corner. Which is not mentioned in the drawings. Also, the down stand of the beam were found 300 mm instead of 400 mm at security portion of the building.

| Item No. | Observation | Recommended Action Plan | Recommended Timeline |
|---|---|---|---|
| 01 | Lack of information and discrepancies in as-built drawings (Utility Building). | Building Engineer is to survey the whole structure and update as-built drawings representing accurate site condition. | 6-weeks |

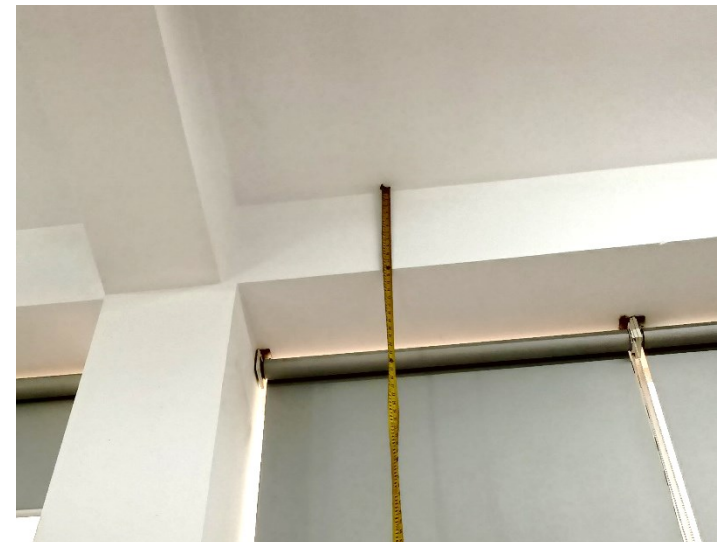
300 mm down stand

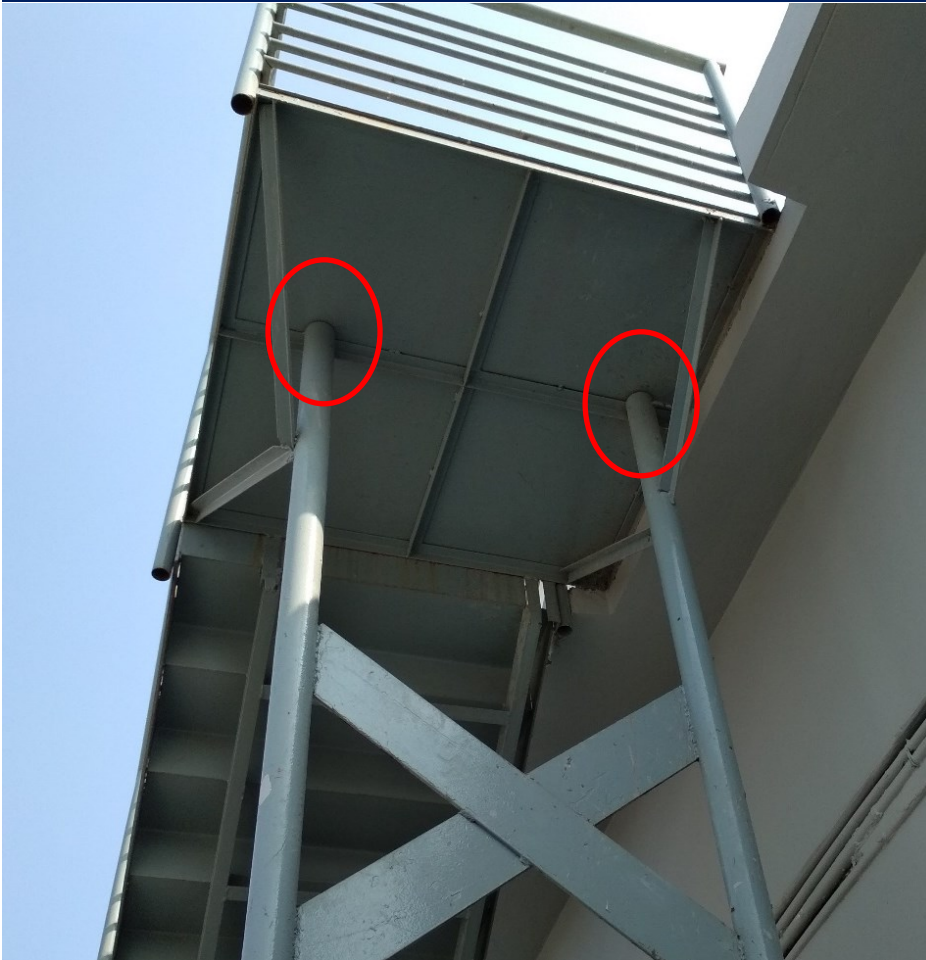
Apparently inadequate member and poor connection was observed at external steel stair of Utility Building

Poor Connection

| Item No. | Observation | Recommended Action Plan | Recommended Timeline |
|---|---|---|---|
| 05 | Undocumented external steel stair, apparently inadequate connection. | Factory engineer is required to carry out member adequacy, connection adequacy & lateral stability check of the steel stair. | 6-weeks |
| 06 | Undocumented external steel stair, apparently inadequate connection. | Implement remediation work where necessary. | 6-months |

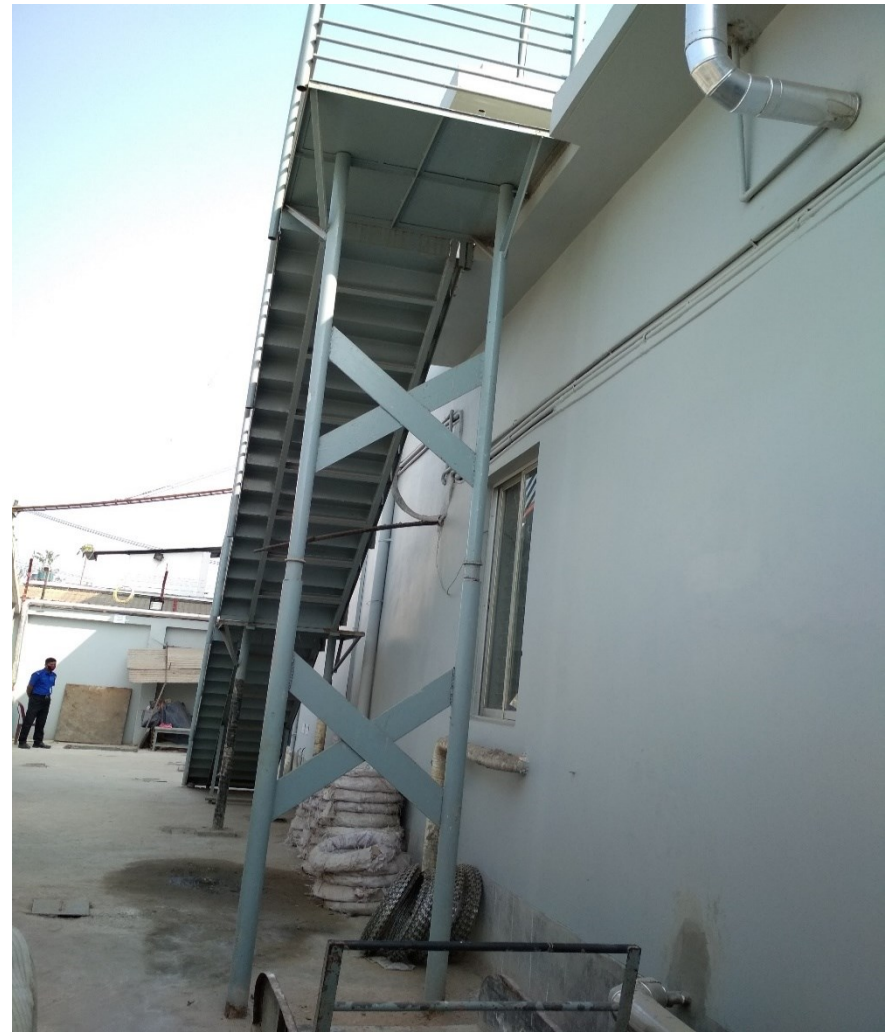
External Steel Stair

Undocumented steel stair was found at North side of the building.

| Item No. | Observation | Recommended Action Plan | Recommended Timeline |
|---|---|---|---|
| 04 | Undocumented external steel stair, apparently inadequate connection. | The building engineer to check the structure, collect information and produce accurate as-built structural documentations. | 6-weeks |

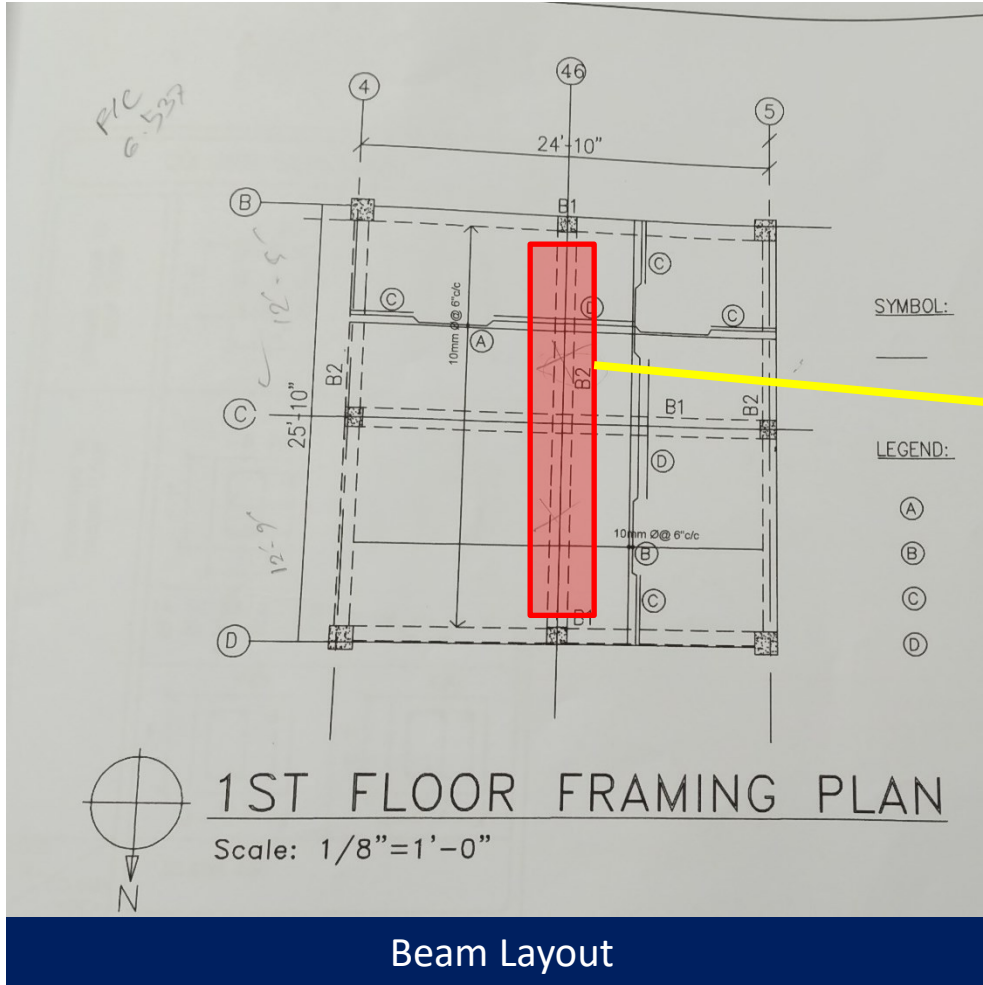
The first-floor beam layout did not match with on site condition. Floor beam along North-south (marked as red on drawing) at first floor level was found missing.

| Item No. | Observation | Recommended Action Plan | Recommended Timeline |
|---|---|---|---|
| 07 | Discrepancies in as-built drawings (Fire Pump Room). | Building Engineer is to survey the whole structure and update as-built drawings representing accurate site condition. | 6-weeks |
