# Universal Jeans-3

Plot # 69, Sector # 7, Export Processing Zone, Chattogram -4223  
(22.300516, 91.776743)  
17<sup>th</sup> February 2021

# Observations

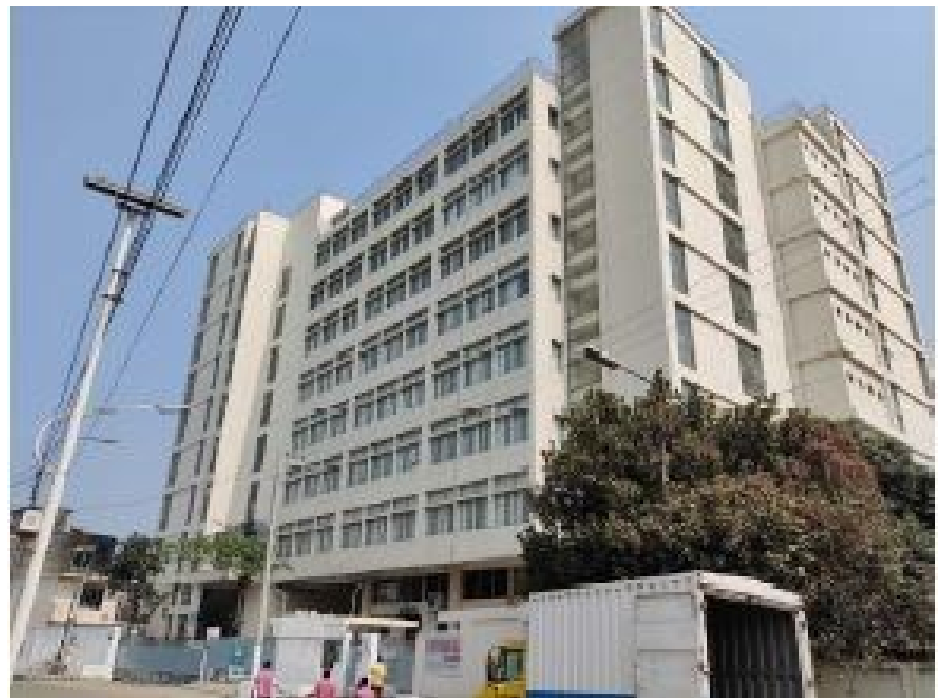
Design report

A Design Report was provided for the Main Building at the time of inspection which is prepared based on software analysis. But no software analysis (FEA) model was provided to review the Design report. Moreover, serviceability checks as per BNBC were not provided in the design report.

| Item No. | Observation | Recommended Action Plan | Recommended Timeline |
|---|---|---|---|
| 01 | Information missing in the design report. | Building engineer is required to check the serviceability issues as per BNBC and incorporate proper loading assignment in the design report. | 6-weeks |

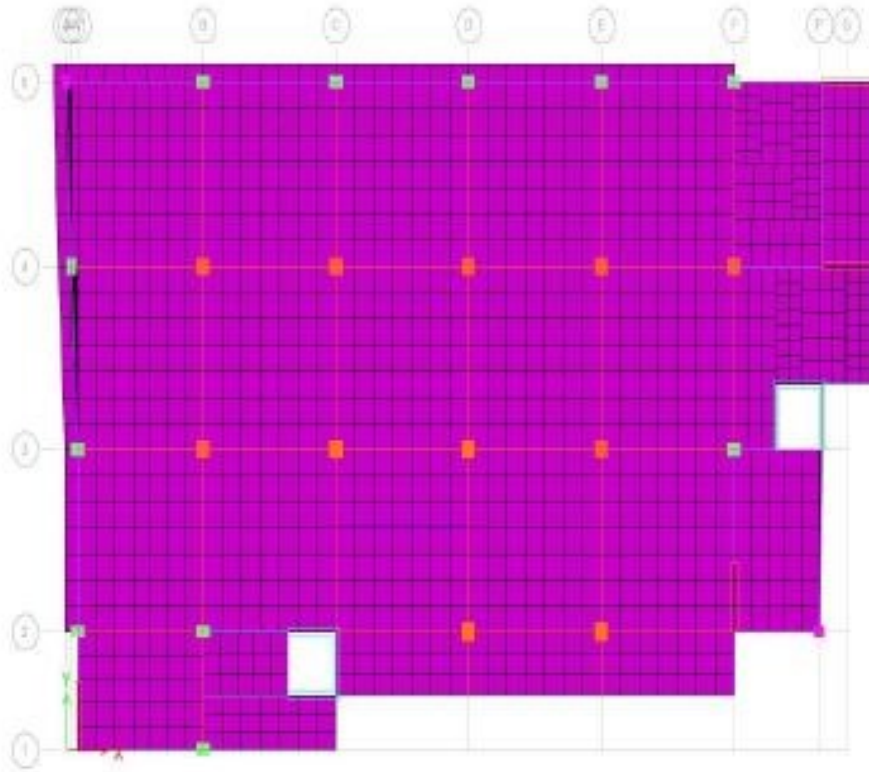
Figure: First Floor Slab Check

Slab adequacy check not provided in the design report. Building engineer is required to provide slab adequacy check for 6 kPa live load.

| Item No. | Observation | Recommended Action Plan | Recommended Timeline |
|---|---|---|---|
| 02 | Information missing in the design report. | Building engineer is required to provide slab adequacy check for 6 kPa live load. | 6-weeks |

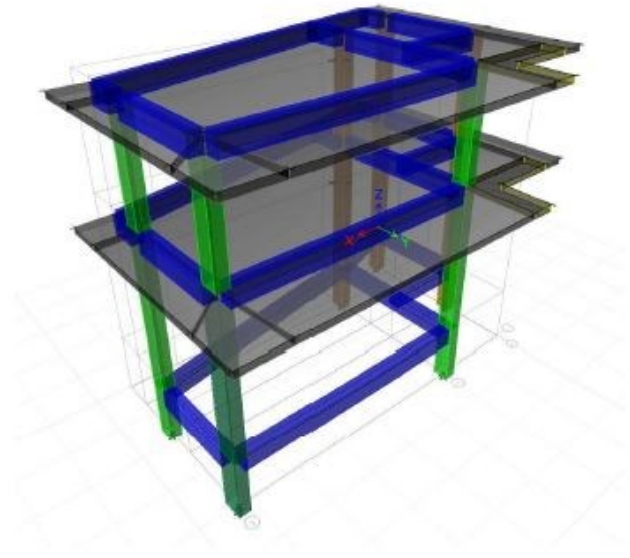
Figure 3.3.1: 3D View of Analytical Model

A Design Report was provided for the Fire Control Room and Pump House at the time of inspection which is prepared based on software analysis. However, no software analysis (FEA) model was provided to review the Design report. Factory is required to submit the full set of Design Report with software-based analysis model for review.

| Item No. | Observation | Recommended Action Plan | Recommended Timeline |
|---|---|---|---|
| 06 | Incomplete Design Report. | Factory is required to submit the design report with analysis model for review. | 6-weeks |

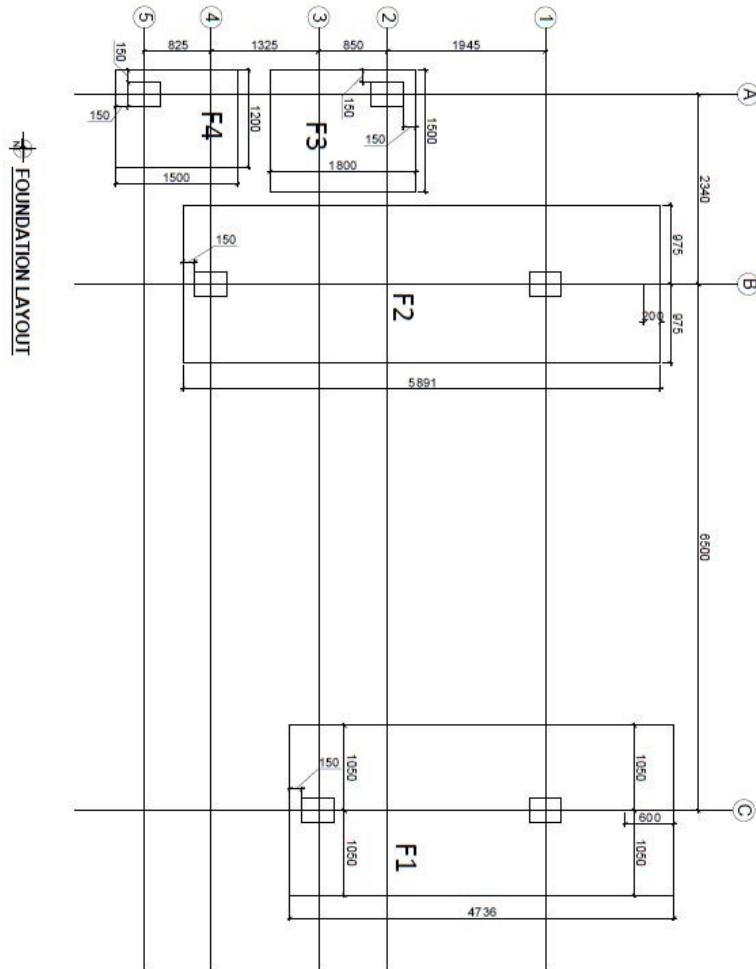
Footing Layout

As per provided structure drawings few columns are found eccentric with the isolated footing. Building engineer is to provide necessary calculation regarding the eccentric loading on the footing and make sure the center of column and center of footing coincide.

| Item No. | Observation | Recommended Action Plan | Recommended Timeline |
|---|---|---|---|
| 07 | Incomplete Design Report. | Provide necessary calculation/explanation (with reference) regarding the eccentric loading on the footing and make sure the center of column and center of footing coincide. | 6-weeks |

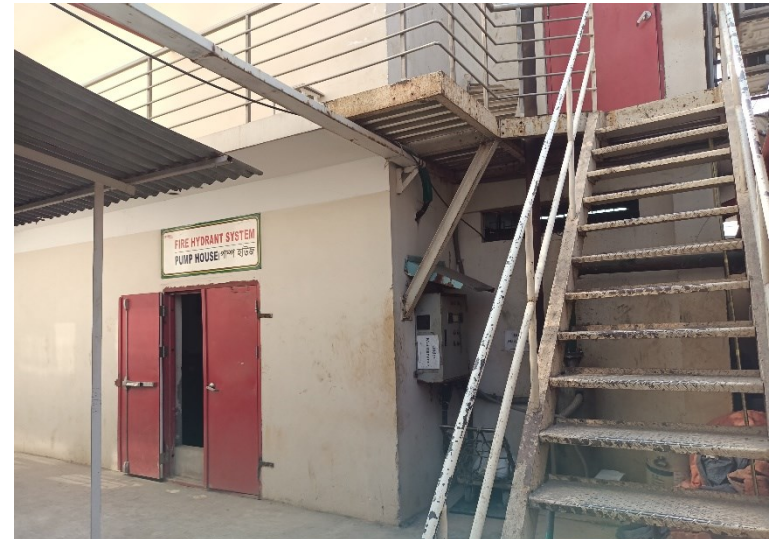
External Steel Stair

Apparently inadequate connection was observed at external steel stair of Utility Building. Factory engineer is required to carry out connection adequacy & lateral stability check of the steel stair.

| Item No. | Observation | Recommended Action Plan | Recommended Timeline |
|---|---|---|---|
| 09 | Non engineered external steel stair. | Factory engineer is required to carry out connection adequacy & lateral stability check of the steel stair. | 6-weeks |
| 10 | Non engineered external steel stair. | Implement remediation work where necessary. | 6-months |

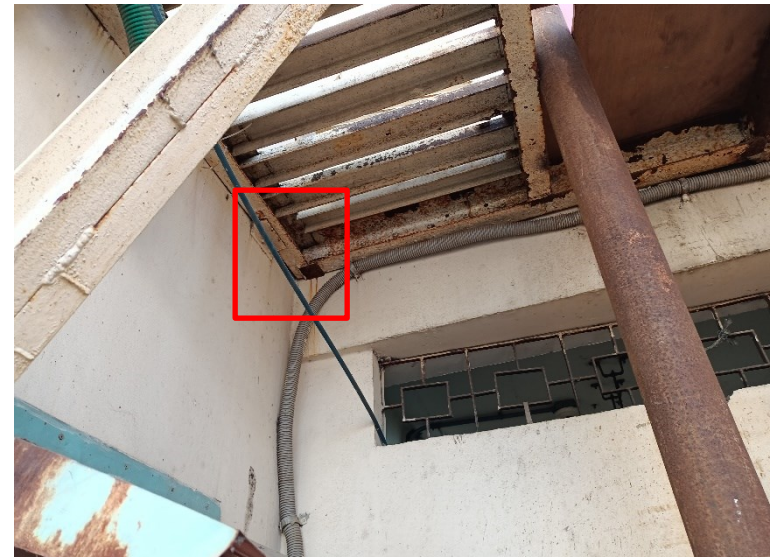
Inadequate Connection

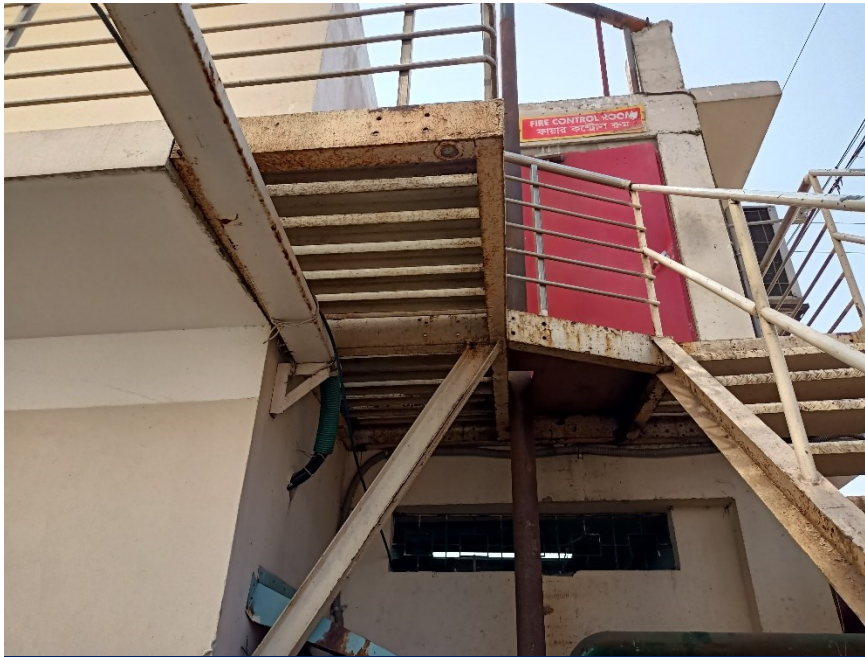
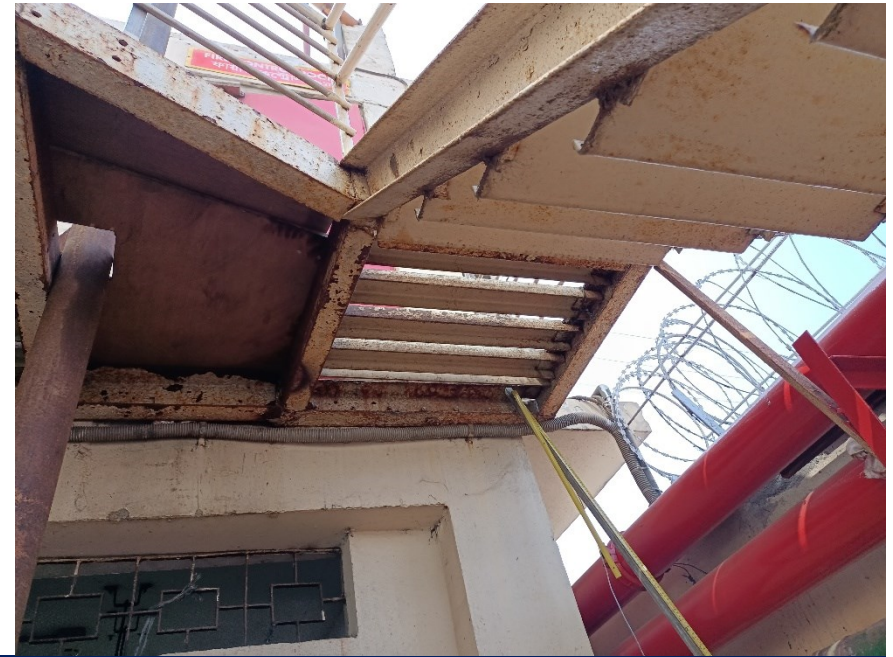
Excessive corrosion was found in steel member of External Steel Stair. The building engineer to investigate the reason & extent of corrosion and suggest proper remedial measure accordingly.

Corrosion at Stair

| Item No. | Observation | Recommended Action Plan | Recommended Timeline |
|---|---|---|---|
| 11 | Corrosion found on steel member of External Steel Stair. | The building engineer to investigate the reason & extent of corrosion and suggest proper remedial measure accordingly. | 6-weeks |
| 12 | Corrosion found on steel member of External Steel Stair. | Take necessary measures to prevent further corrosion and repair the corroded steel members as per engineer's suggestion. | 6-months |
