# Marma Composite Ltd. (extension 2)

Tongabari, Ashulia, Savar, Dhaka.

3rd November 2020

# Observations

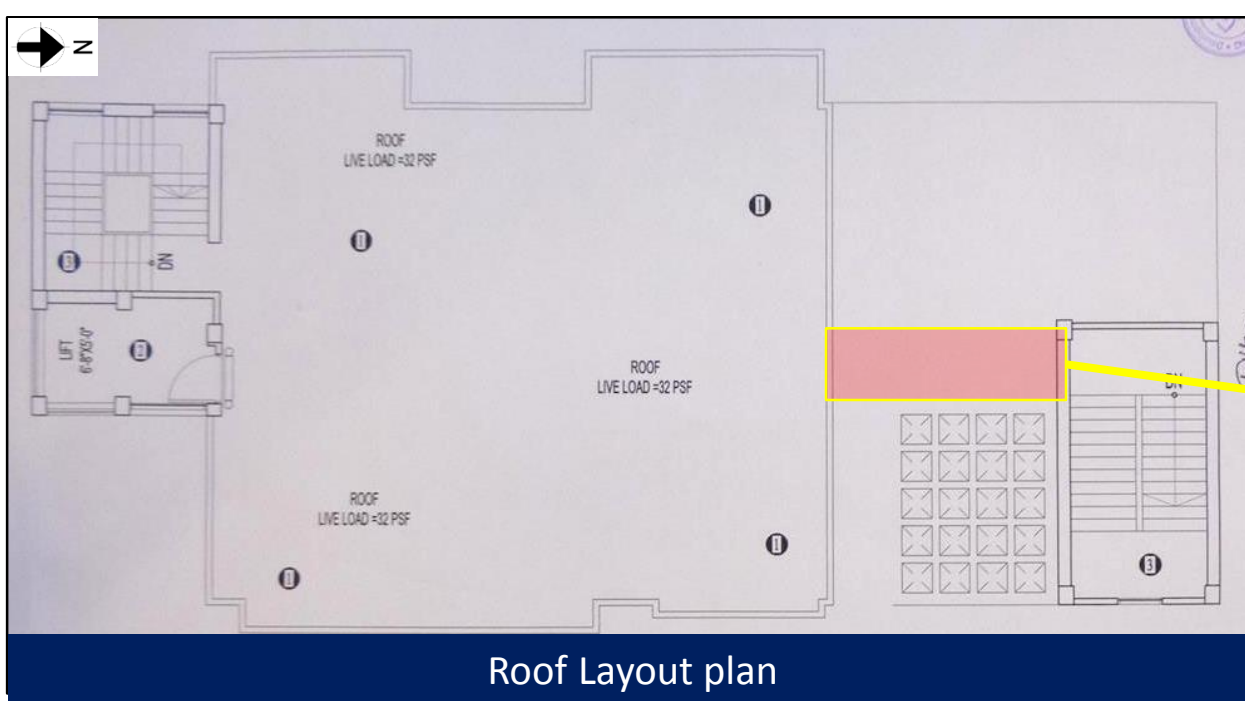
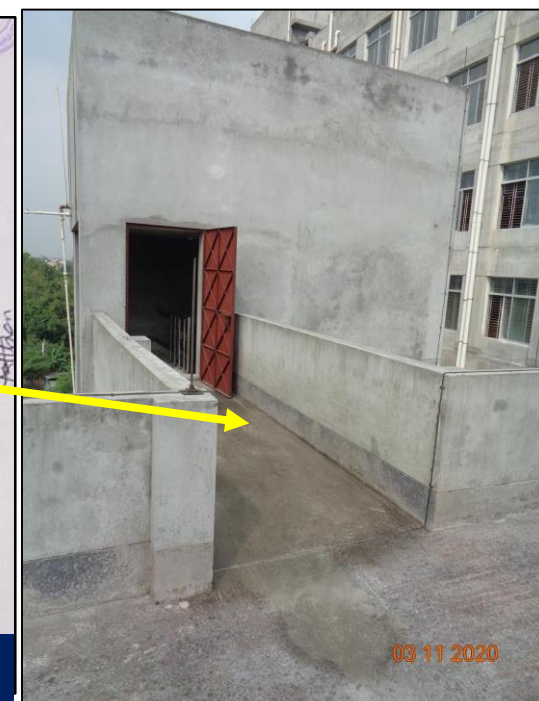
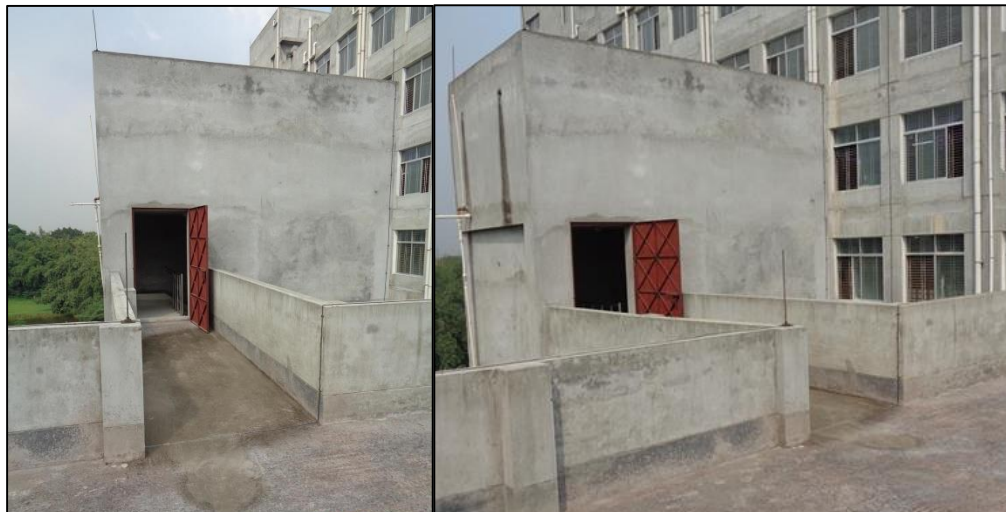
Passage from stair to roof slab

Roof plan does not match with the as-built drawing. A Passage was found from stair to floor. But in roof plan layout of as-built drawing the passage has not been shown. Factory engineer is required to survey the structures and prepare as-built drawings.

| Item No. | Observation | Recommended Action Plan | Recommended Timeline |
|---|---|---|---|
| 1 | Discrepancy in as-built drawing (Admin Building) | Building Engineer to survey the structure and prepare accurate as-built (architectural and structural) drawings. | 6-weeks |

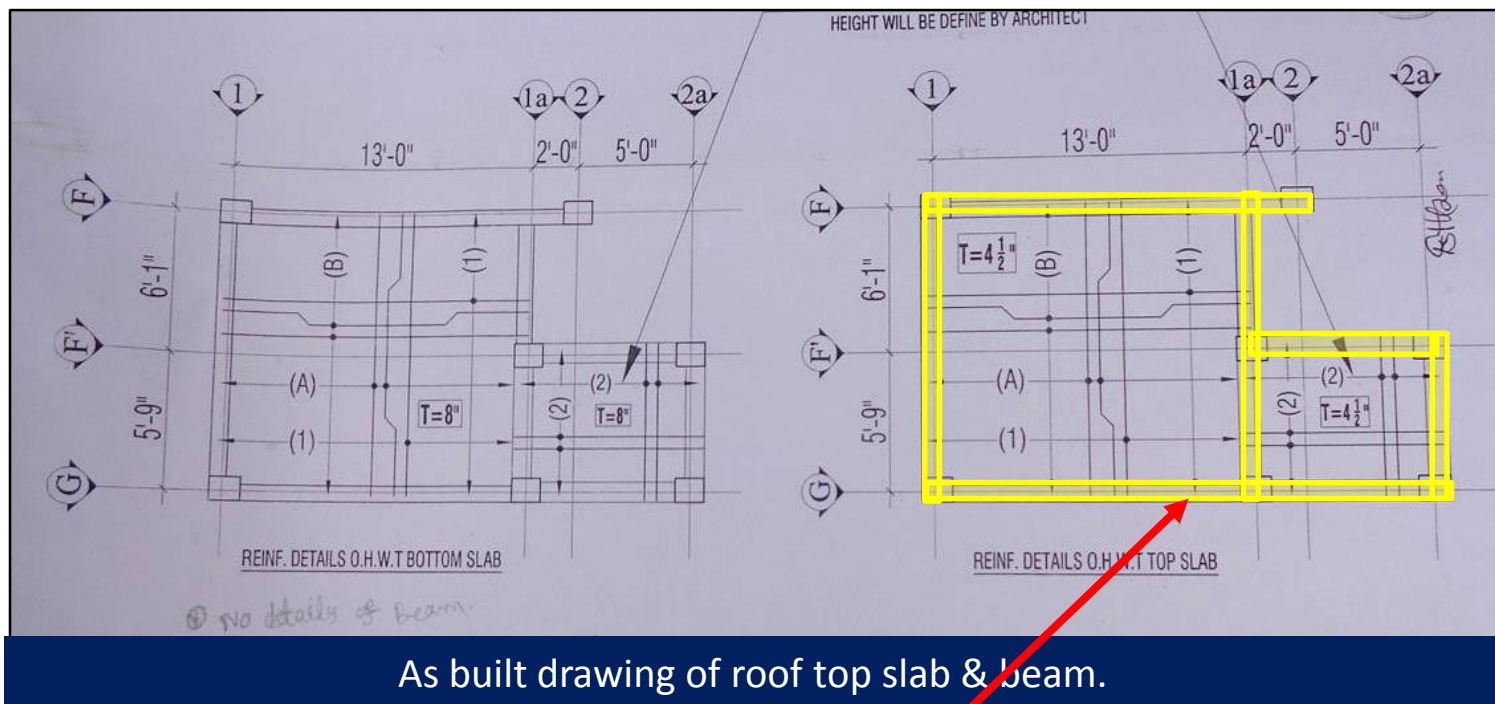
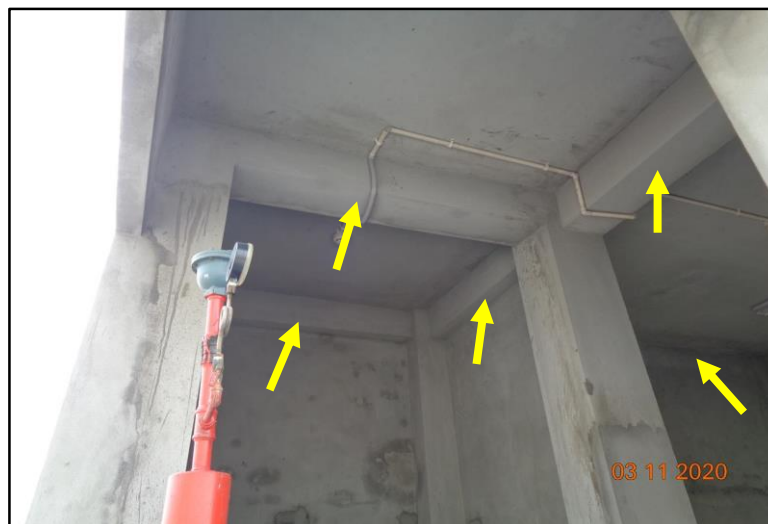
Roof top beam-slab

The details of the roof top beam over the stairs & lift core has not been provided in as built drawing. Factory engineer is required to survey the structures and prepare as-built drawings.

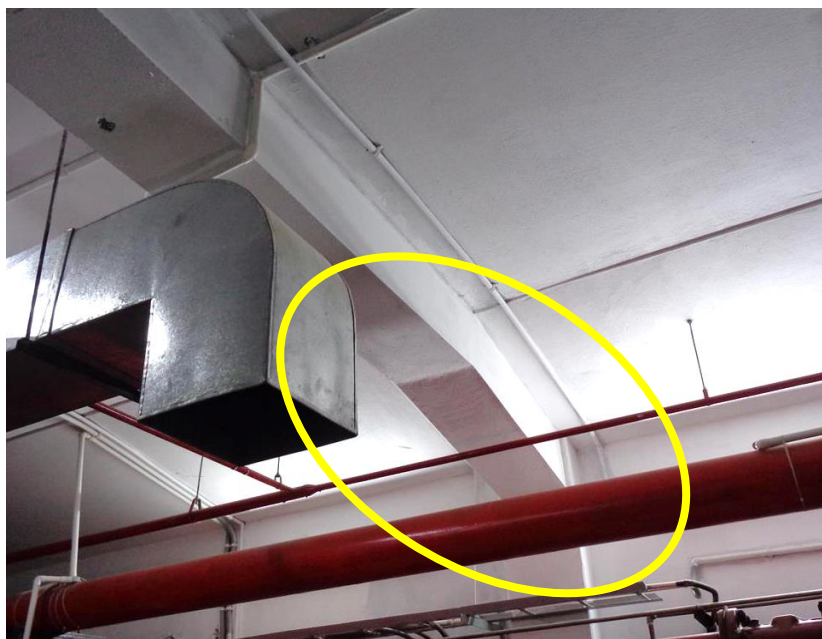
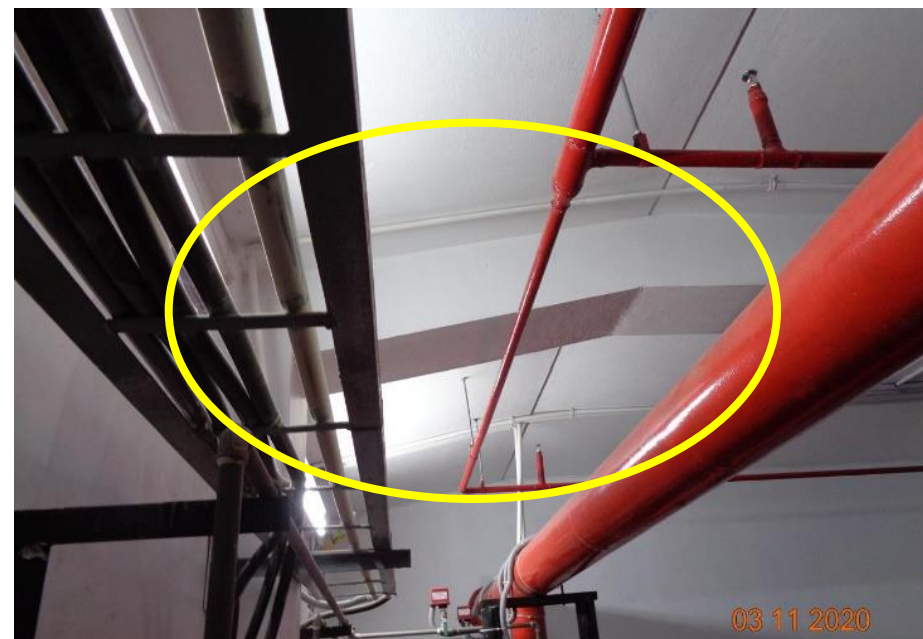
Ground floor slab & beam was found in inclined alignment.

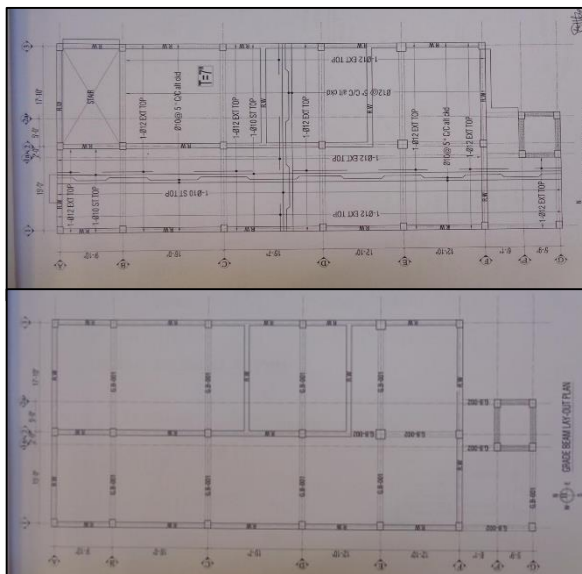
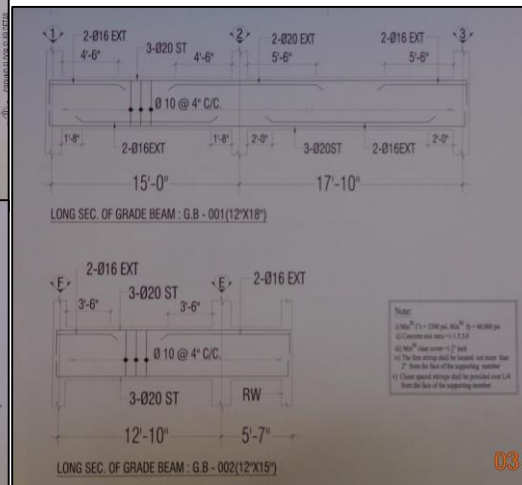
Ground floor slab, beam layout and beam details

Ground floor slab & beam over the fire pump room was found in inclined alignment but no structural details have been provided in as-built drawing. Factory engineer is required to survey the structures and prepare as-built drawings that are compliance with section 1.9.1.2 as per BNBC

| Item No. | Observation | Recommended Action Plan | Recommended Timeline |
|---|---|---|---|
| 2 | Design report need to be revised (Admin Building) | Building engineer to update the design document including a design report, and a set of structural drawings in compliance with section 1.9.1.1 and section 1.9.1.2 as per BNBC. | 6-weeks |

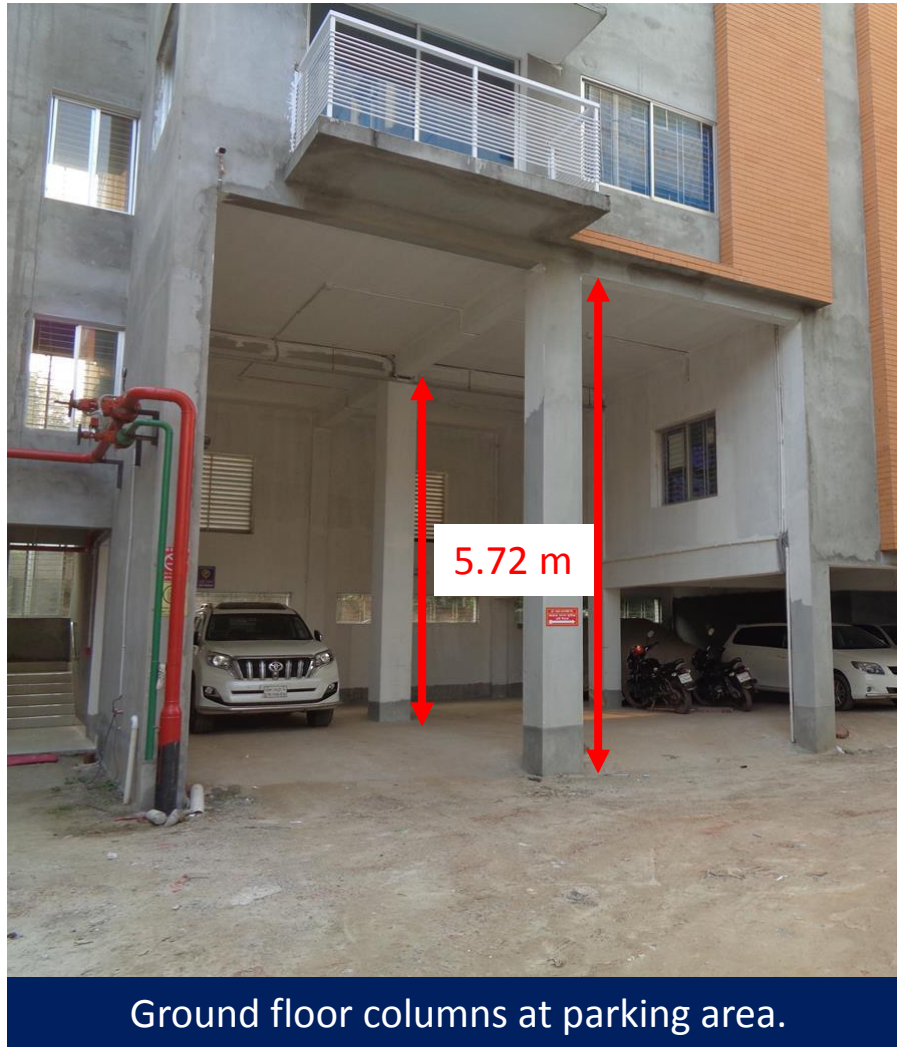
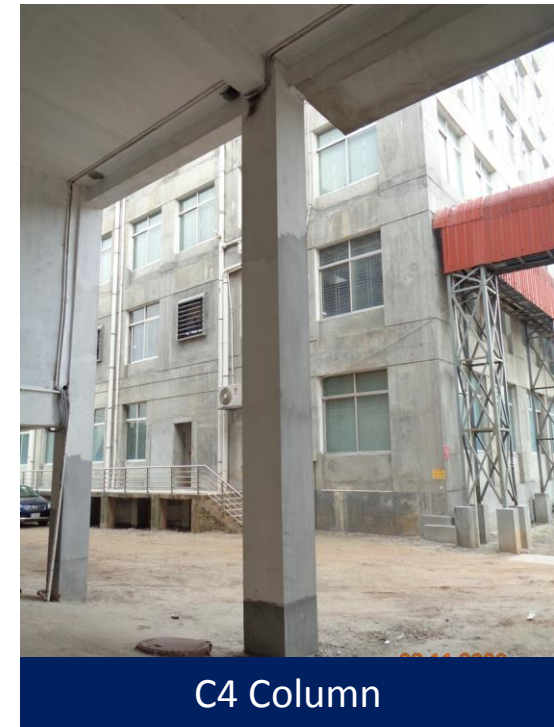
C4 Column

Ground floor columns at parking area.

Ground floor column are 5.72 m in length and 450X450 mm in size. The length/width=12.7 indicate that the columns are critical for slenderness effect. So, the factory engineer is required to check and address this issue in the design report.

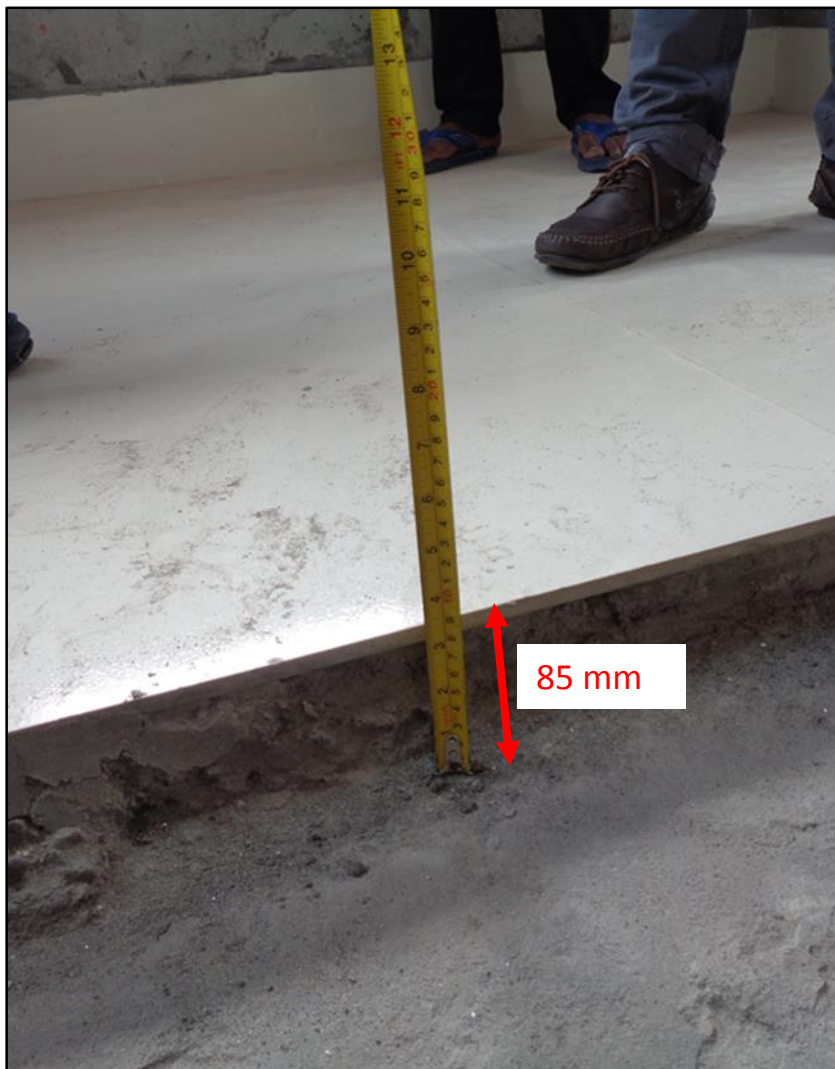
Floor Finishes was found 85 mm at 2<sup>nd</sup> floor.

During inspection, Floor finishes was found 85 mm. In the software analysis, 25 psf (1.2 kPa) has been considered as super imposed dead load which is equivalent to 50mm floor finishes. Factory engineer to revised the analysis and design report for actual floor finish loads.

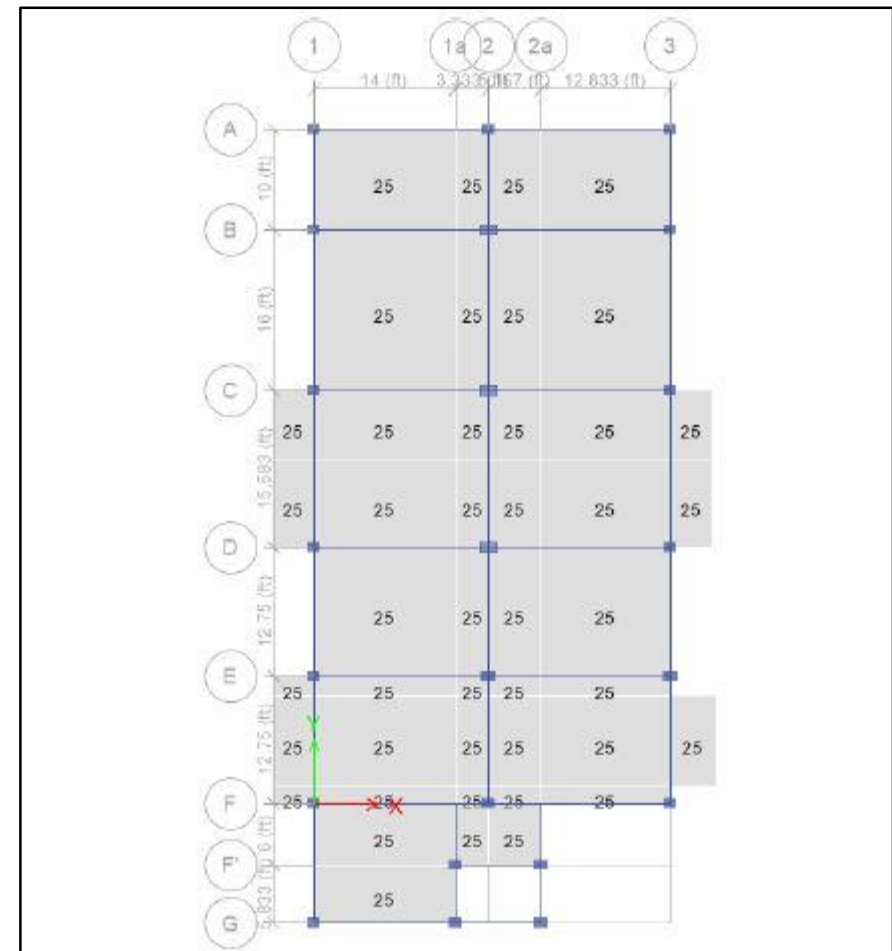
Figure 3-4: SDL in ETABS on 2<sup>nd</sup> floor (unit = psf)

Super imposed Dead Load was found 25 psf.

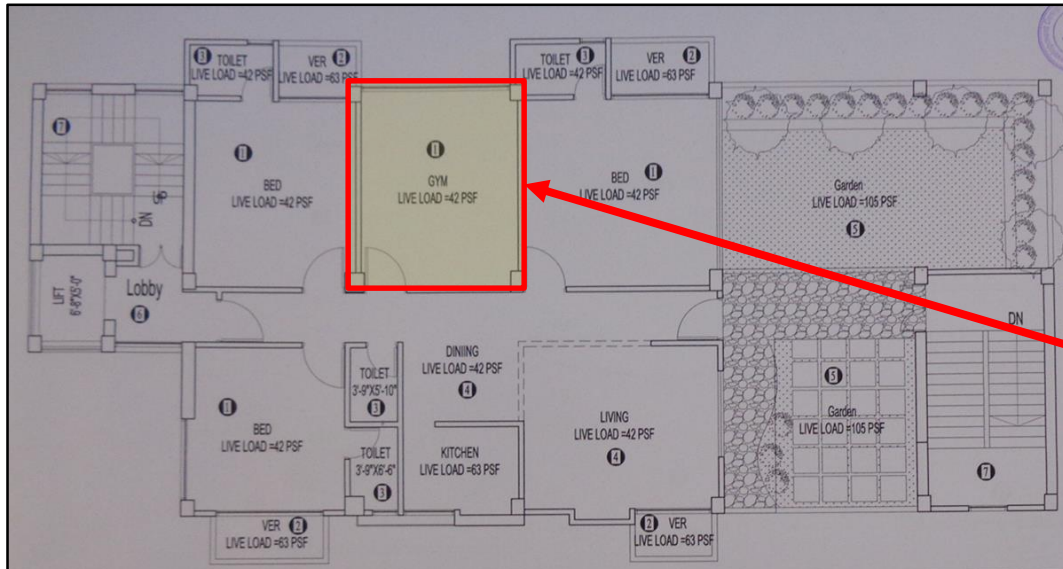
2<sup>nd</sup> floor Layout Plan. Proposed for gym at marked area.

Gymnasium has been proposed at 2<sup>nd</sup> floor at marked area. The live load of that area has been considered 42 psf (2 kPa). As per BNBC, minimum loading 3 Kpa is required for the fixed seat gymnasium. Factory engineer is required to update the floor loading plan, software-based analysis and design report following BNBC loading requirement.

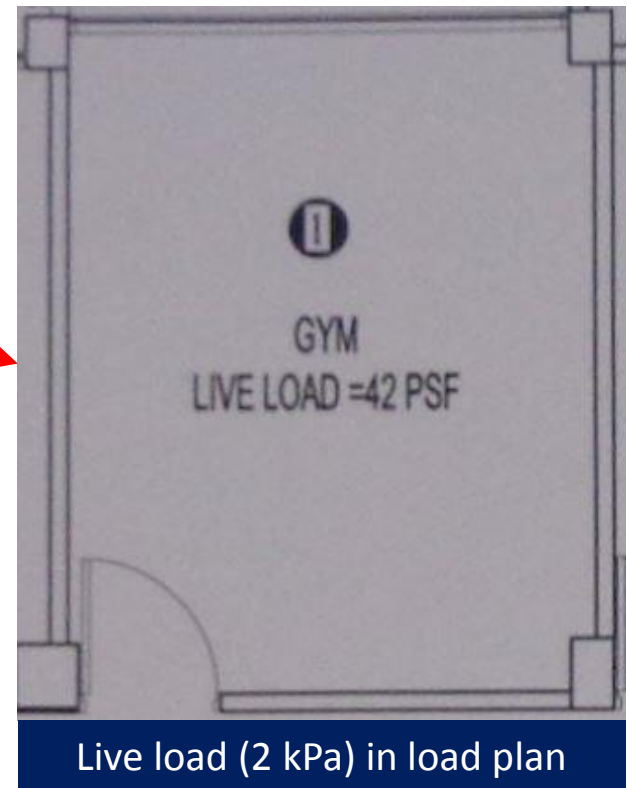
Live load (2 kPa) in load plan

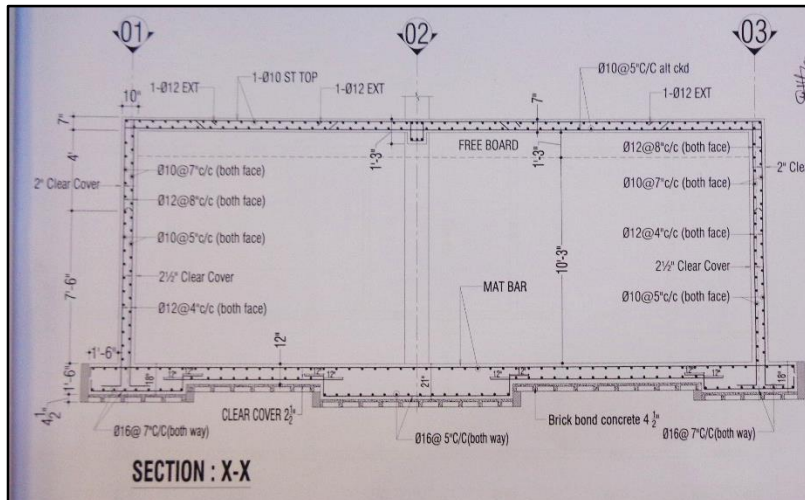
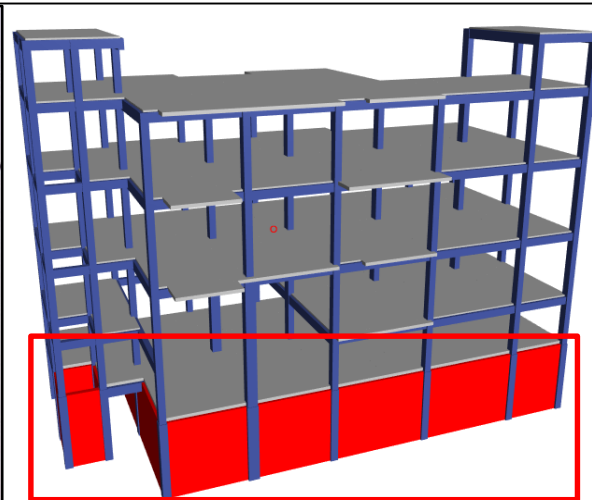
In design report, adequacy of the retaining wall has not been mentioned.

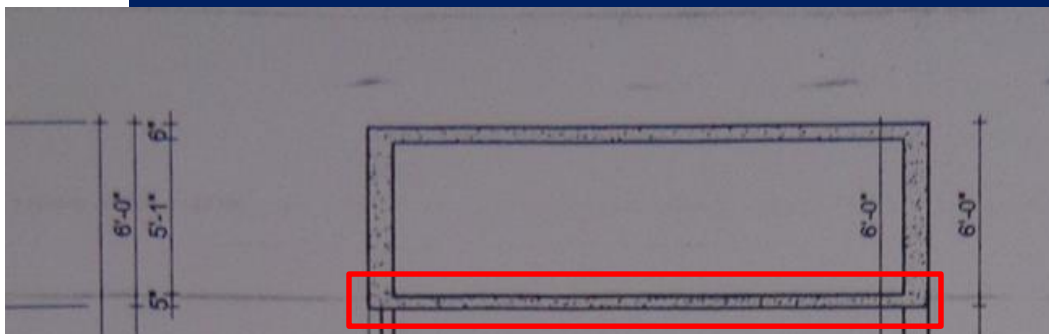
Bottom slab of the water tank is 125mm

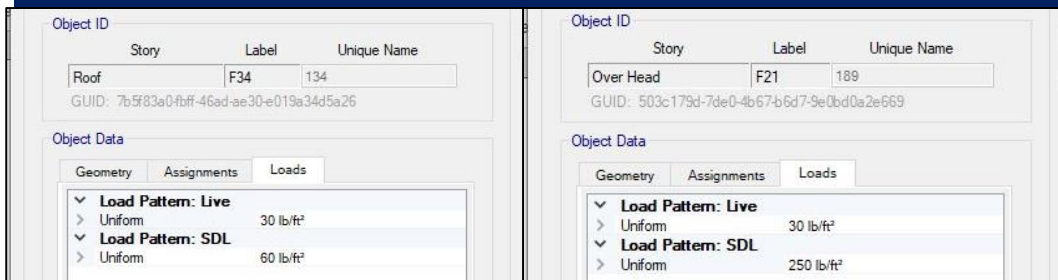
Dead load of the bottom slab has not been assigned in FEA model.

As per BNBC, every building or structure designed shall have its design documents prepared in accordance with the provision of Section 1.9.1. The design document shall include a design report, and a set of structural drawings, which shall be prepared in compliance with section 1.9.1.1 and section 1.9.1.2 as per BNBC. Revise the software-based analysis model, design report and load plan following BNBC requirements.

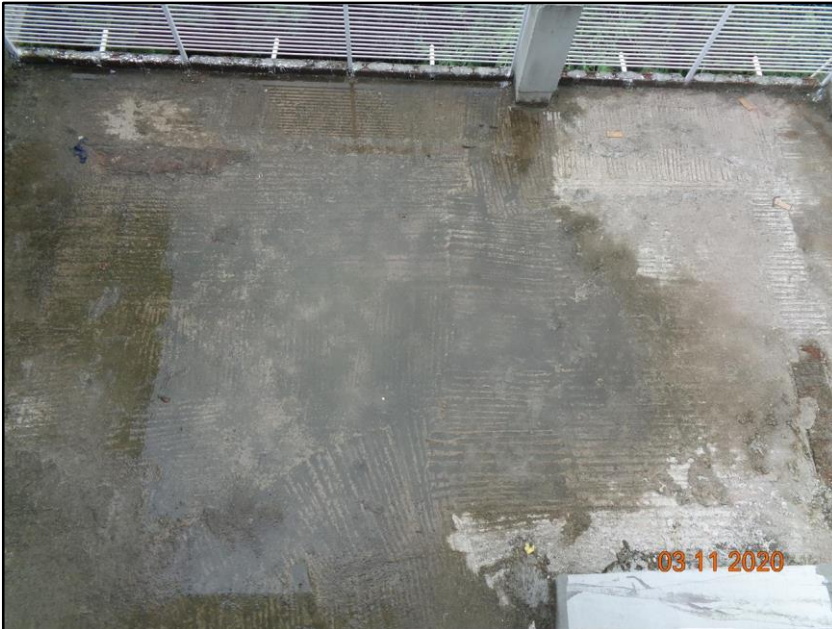
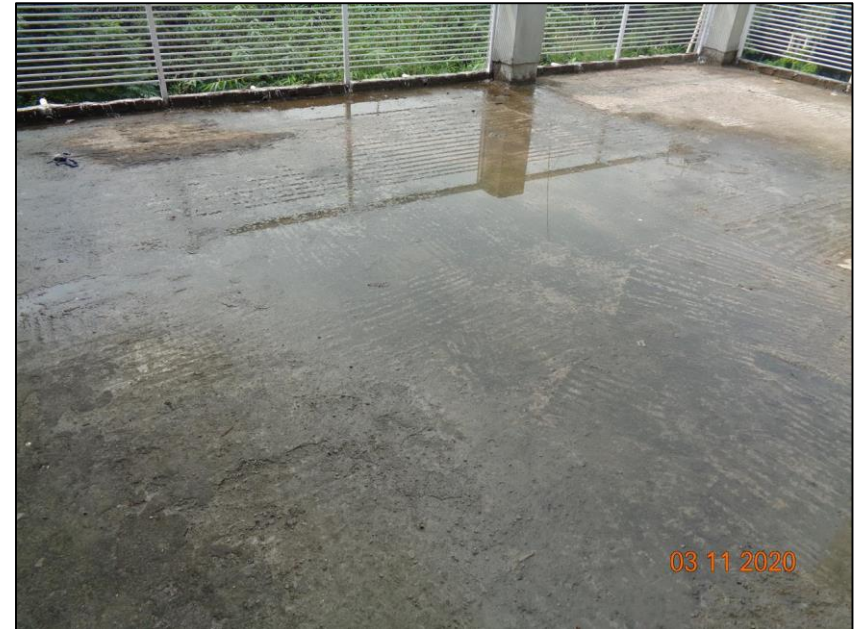
Water ponding at 2<sup>nd</sup> floor (open to sky area)

Water ponding was found at 2<sup>nd</sup> floor open area. The water drainage system and adequate sloping was not found. And there is no water proofing layer on this area. The factory engineer is required to develop proper drainage system with adequate sloping on the mentioned area.

| Item No. | Observation | Recommended Action Plan | Recommended Timeline |
|---|---|---|---|
| 4 | Water ponding (Admin Building) | The factory engineer to develop proper drainage system with adequate sloping to resist water ponding on roof. | 6-months |

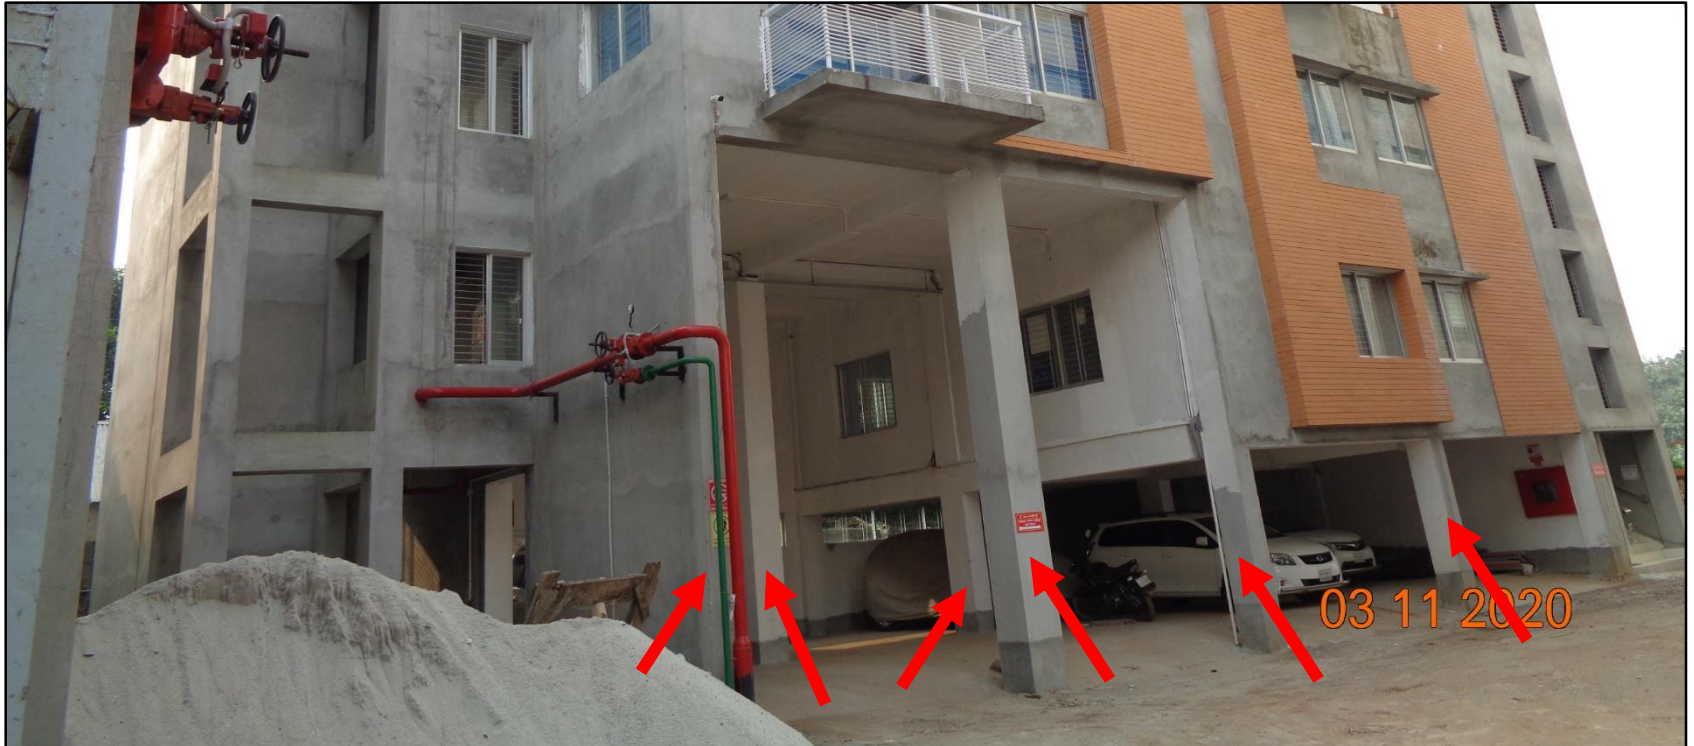
Columns having no barrier/protection at ground floor

Columns of the parking area are susceptible to vehicle impact. The factory engineer is required to take necessary measures to prevent the vehicle impact by providing the barrier around the columns.

| Item No. | Observation | Recommended Action Plan | Recommended Timeline |
|---|---|---|---|
| 5 | Column susceptible to vehicle impact (Admin Building) | The factory engineer is required to take necessary measures to prevent the vehicle impact by providing barrier around the columns. | 6-months |

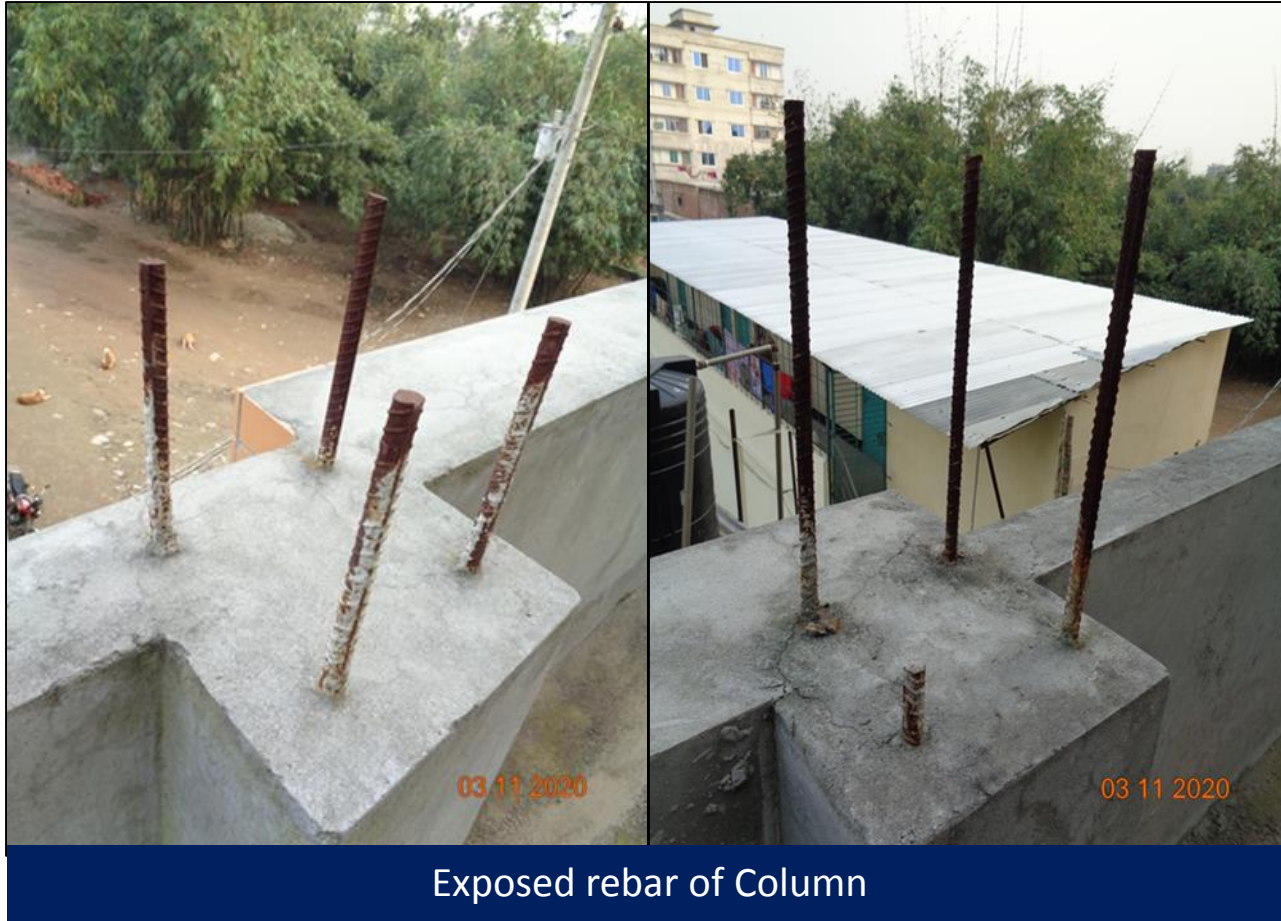
Exposed reinforcement was found on roof top columns. Factory engineer is required to take necessary measures to prevent the corrosion in exposed rebar.

| Item No. | Observation | Recommended Action Plan | Recommended Timeline |
|---|---|---|---|
| 6 | Corroded and exposed rebar at roof (Security Building) | All exposed reinforcement is to be protected from corrosion which may cause degradation of the concrete. | 6-weeks |
