Shanta Washworks Limited

Plot No. 219,DEPZ (Extension Area), Ganakbari, Ashulia, Dhaka-1349
(23.942745, 90.282229)
3rd March 2021

Building Information

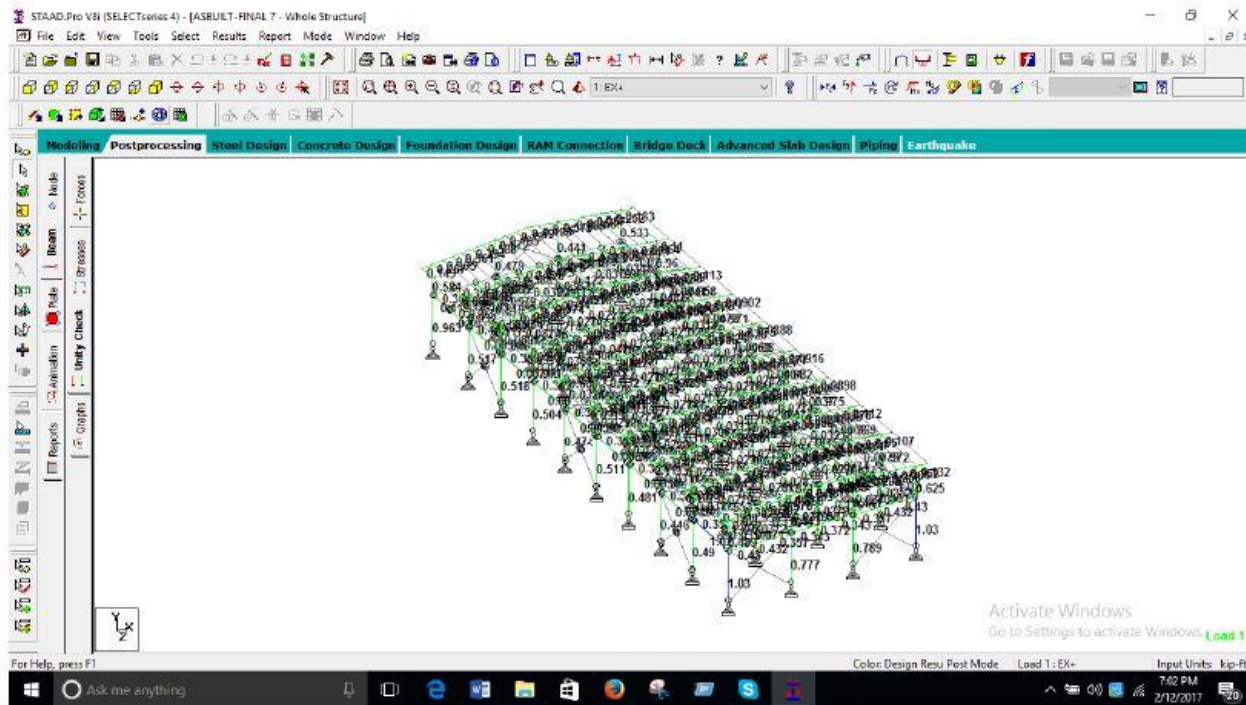
Fig: Stress Ratio is <1.05

Stress ratio of structural members shown in drawing

In provided Engineering Assessment (EA) report, only stress ratio of structural members are shown but no displacement and connection adequacy check have been provided. Factory engineer is required to update the prepared EA report.

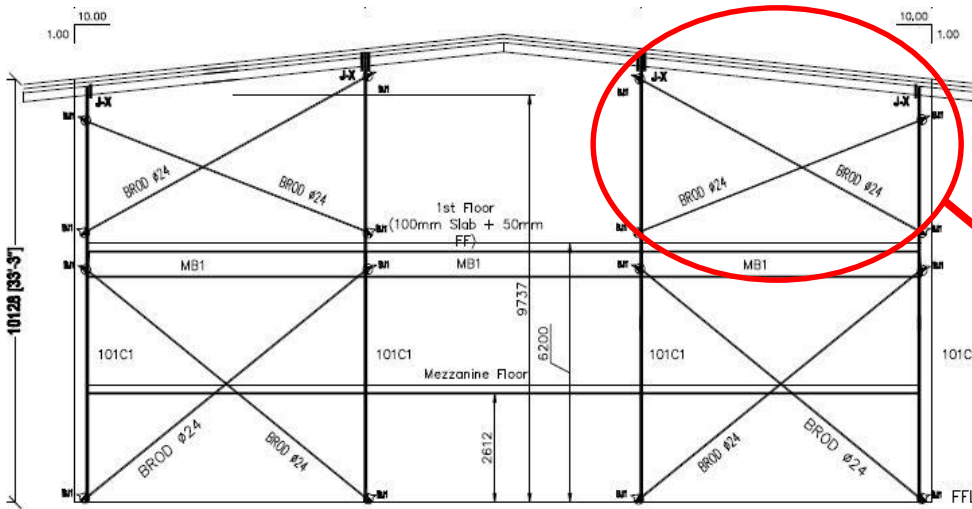
Missing bracing at first floor Grid 10 (C-D)

Vertical bracing was missing at first floor north-west corner (along grid-10 and between grid C and D). Factory is required to install the missing bracing as per drawing.

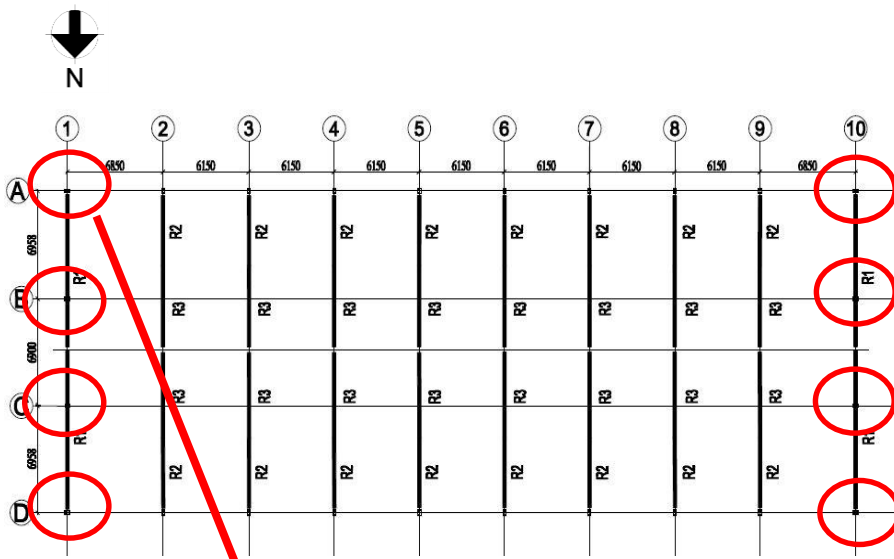
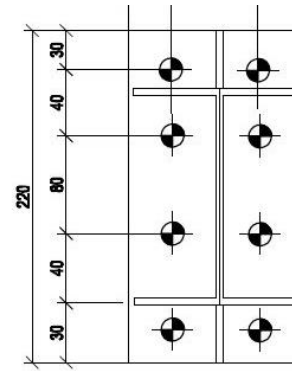
Rafter layout

DETAILS OF J-X
 THICKNESS=10 mm
 8-20 mm Ø BOLT
 8-22 mm Ø NUT

8-Bolts shown in drawing

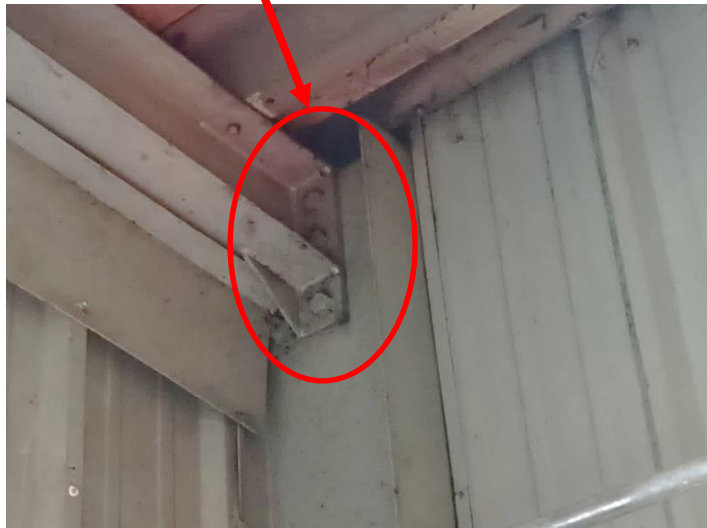
6-Bolts found physically

8-No of bolts were shown in the marked locations whereas physically 6-No of bolts were found. Factory engineer is required to survey the whole structure and update the as-built drawing as per onsite condition.

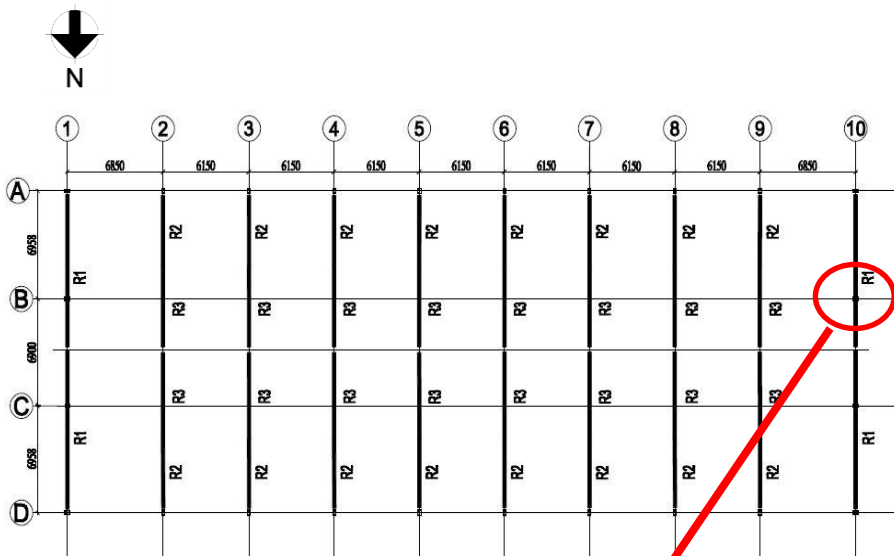
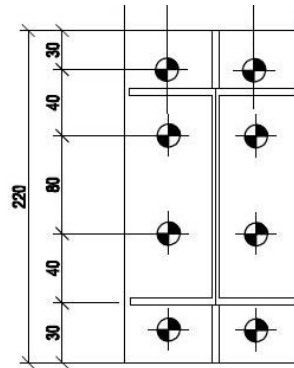
Rafter layout

THICKNESS=10 mm
 8-20 mm Ø BOLT
 8-22 mm Ø NUT

8-20mm diameter bolts shown in drawing

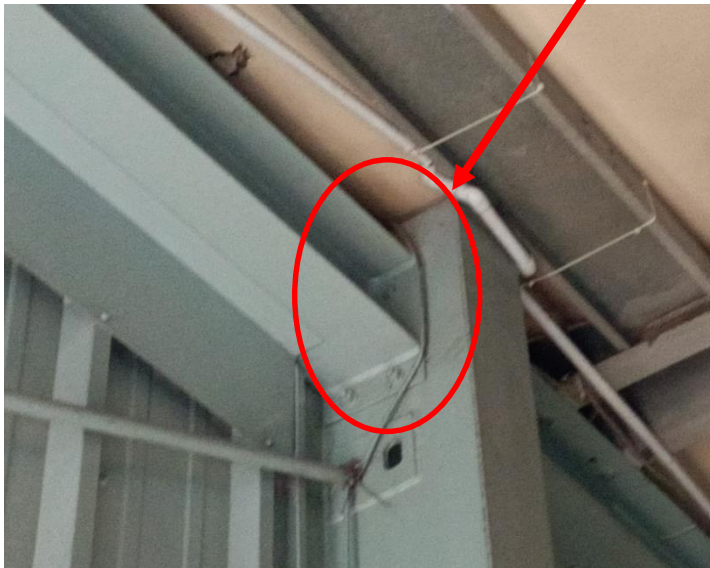
6-Bolts diameter less than 20mm

8-20mm diameter bolts were shown in the marked locations whereas physically 6-no of bolts were found which diameter less than shown in drawing (diameter couldn't be measured due to height). Factory engineer is required to survey the whole structure and update the as-built drawing as per onsite condition.

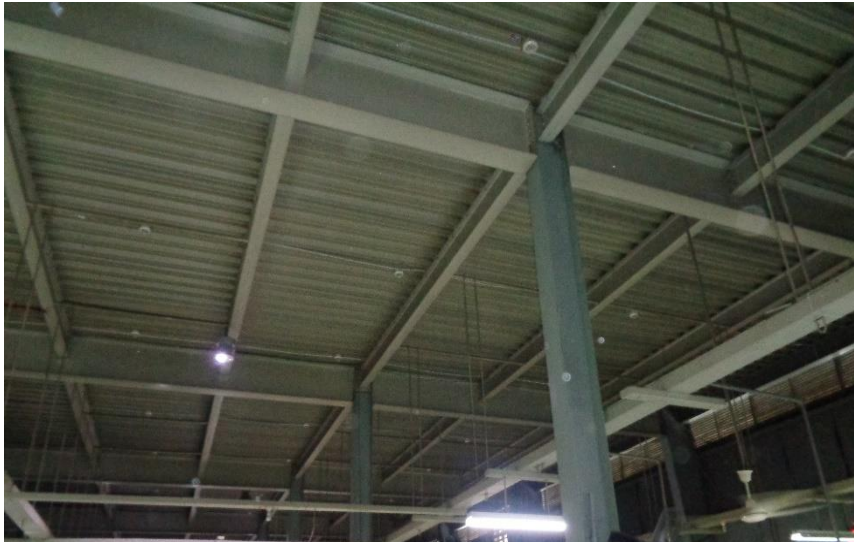
First floor found with steel deck slab

First floor is a steel deck slab with 125mm thickness but no slab detail was shown in provided drawing. Factory engineer is required to update the as-built drawing with onsite condition including the deck slab details.

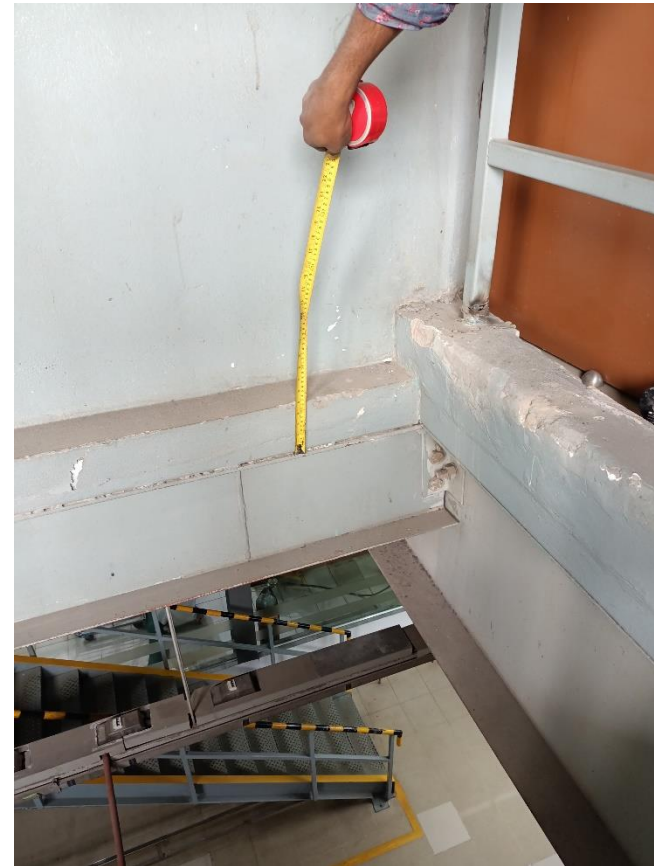
Deck slab thickness measured 125mm

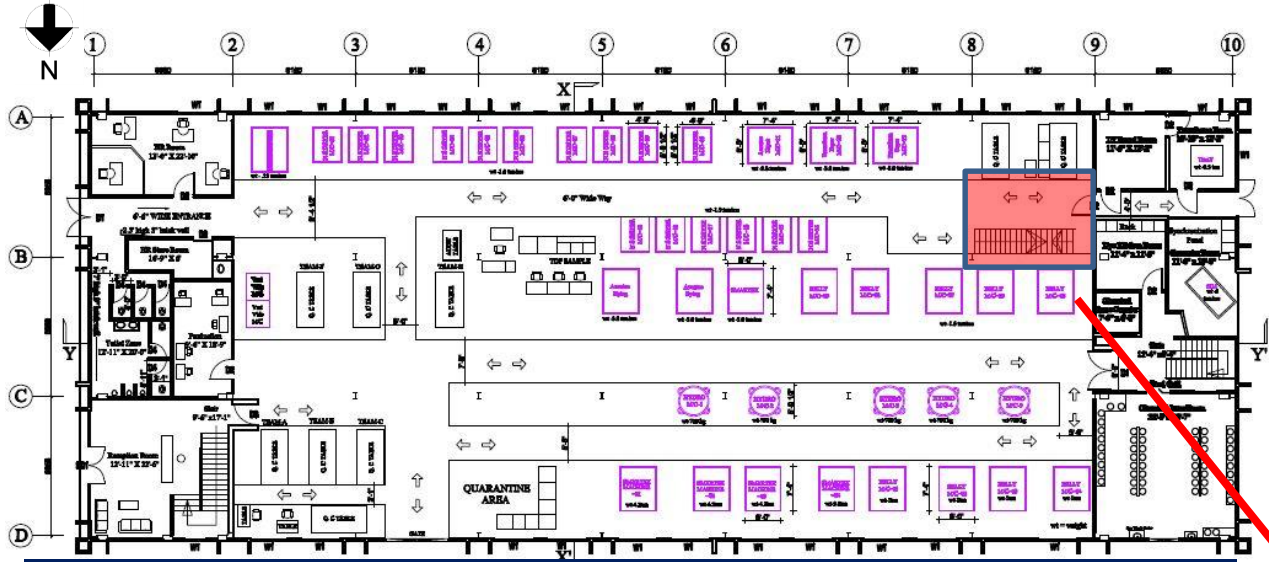
Typical floor plan

Steel stair with single landing was shown in architectural drawing at Ground floor but no detailing was shown in structural drawing. Factory is required to produce as-built structural drawing for this steel stair.

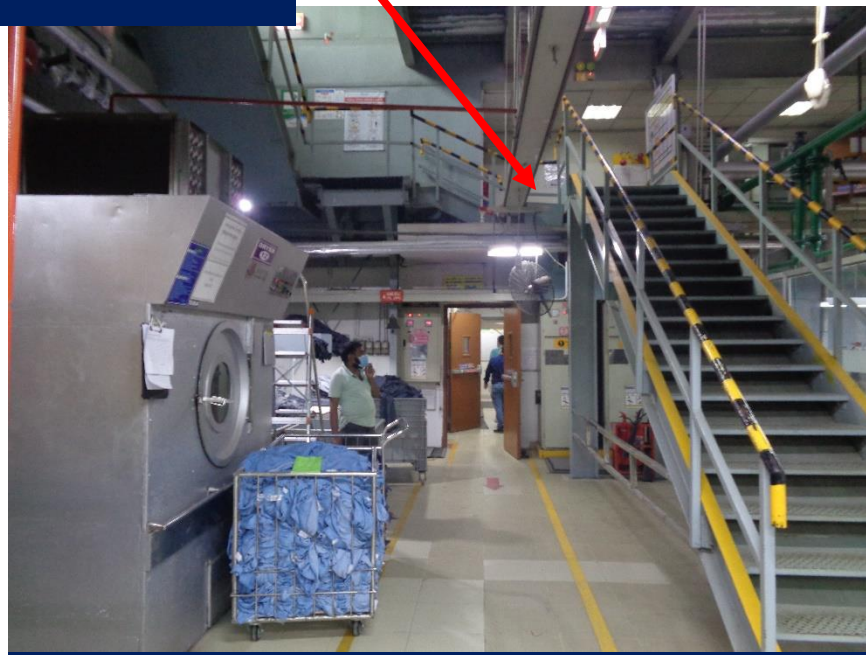
Steel stair at Ground floor

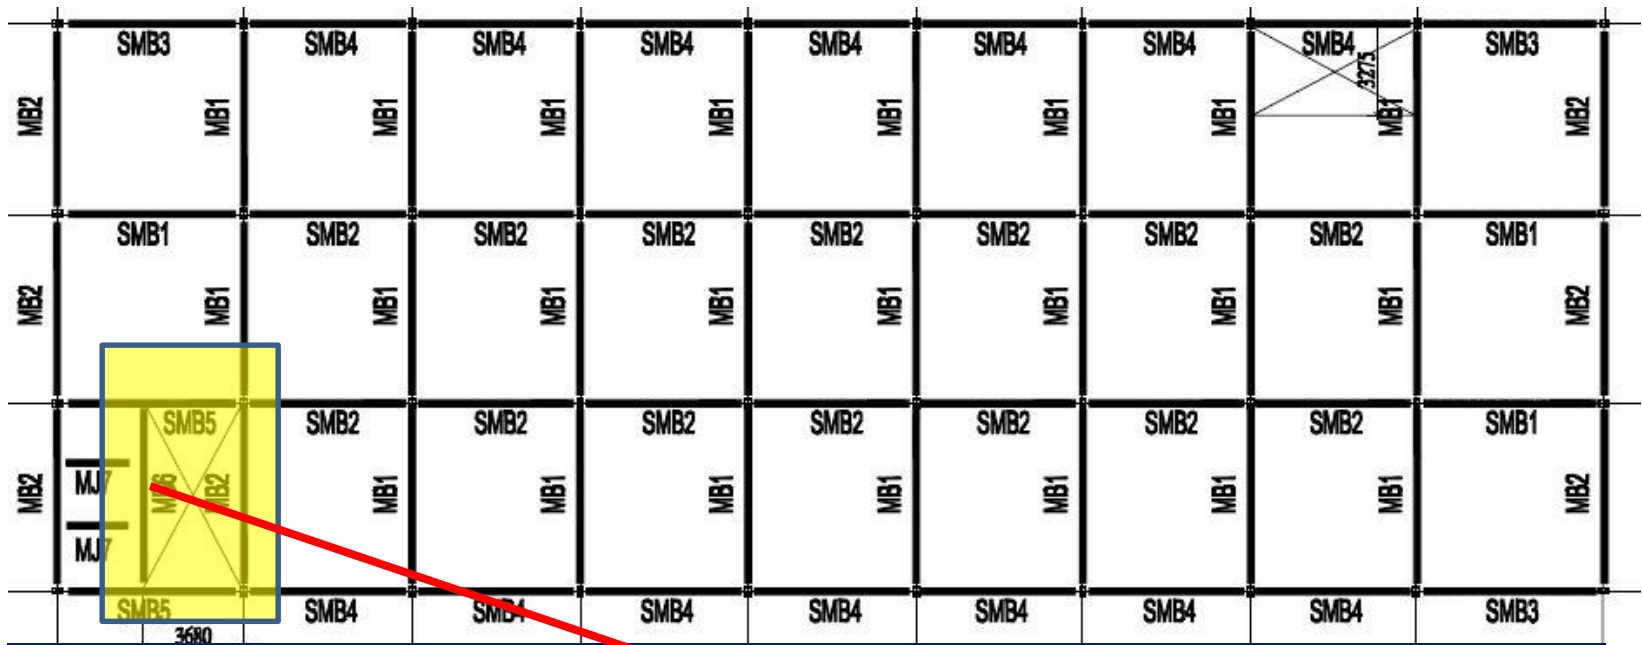
First floor beam layout

As per provided drawing, Mezzanine part is a RC structure and Main Production Building is a steel structure with deck slab. However, separation of Mezzanine part and Main production Building was not clear. Factory engineer is required to investigate the area and establish separation between the two structures. Otherwise analyze the two structures as a whole.

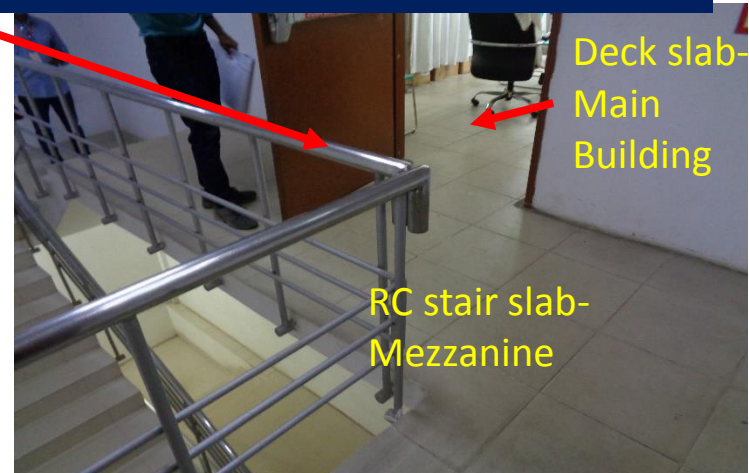
No separation was visible between RC and Deck slab

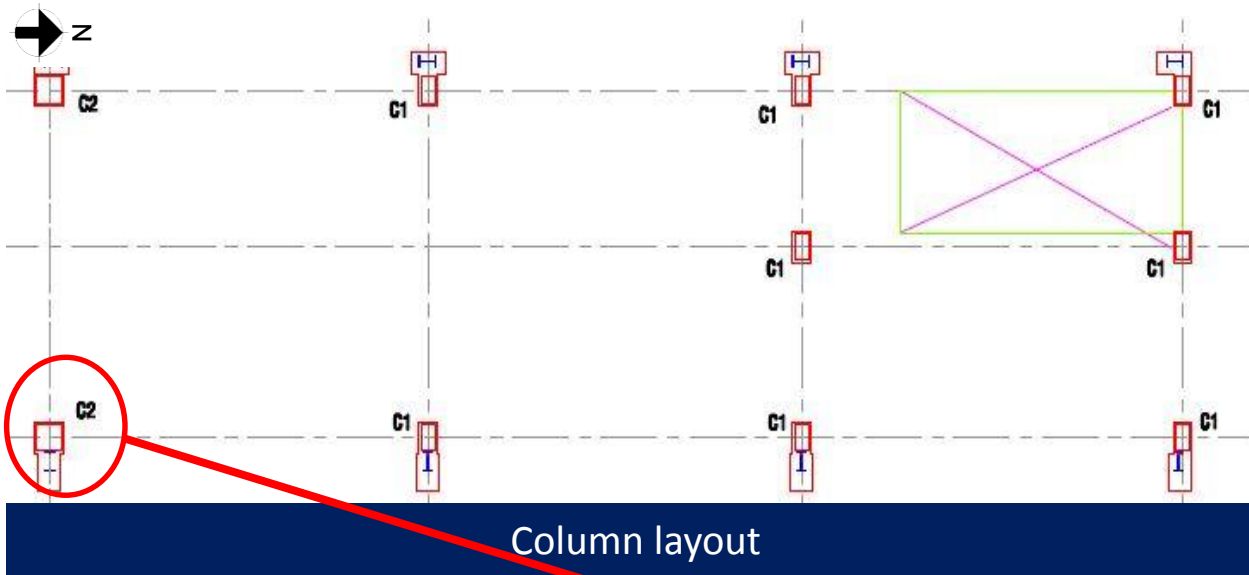
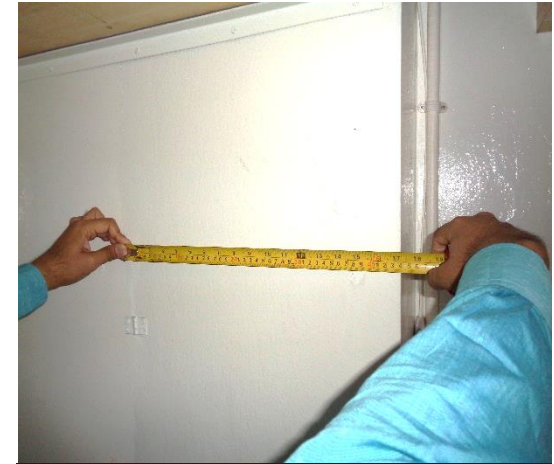
Column C-2 measured
450mmX450mm

Dimension of column C-2 at highlighted location was measured 400mmX400mm instead of 450mmX450mm. Factory engineer is required to update the as-built drawing with onsite condition.

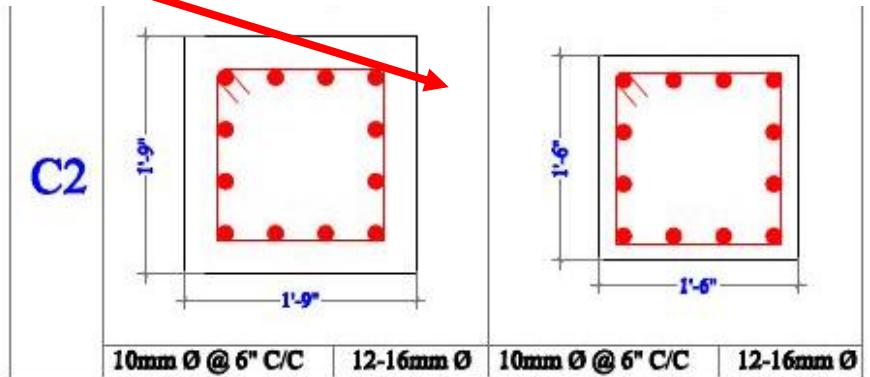
Dimension of column C2 shown
450mmX450mm

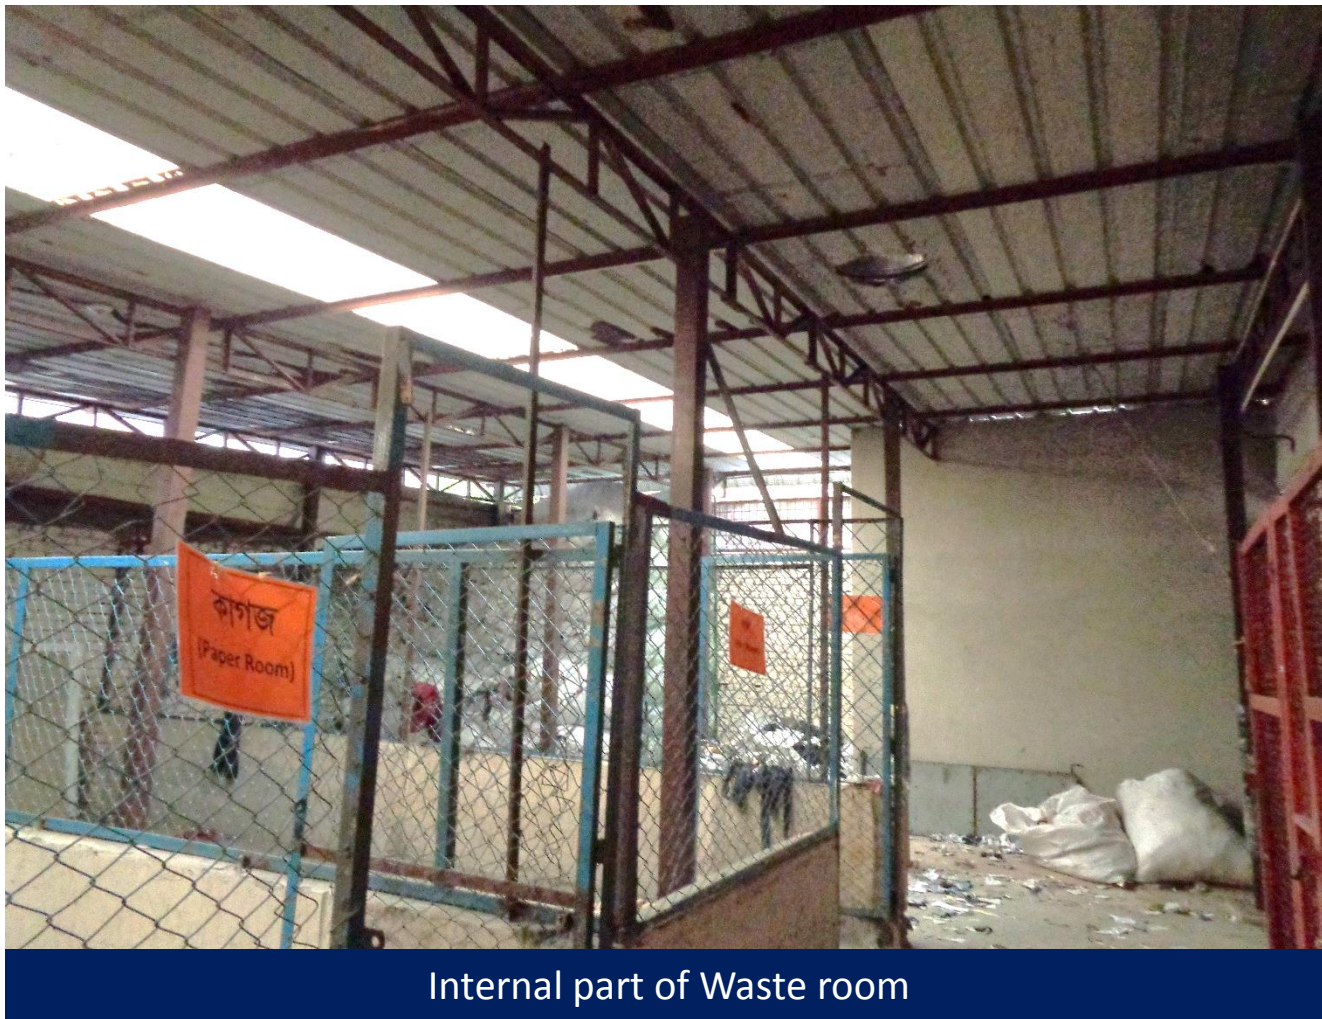
Internal part of Waste room

Connection of the steel members appears to be non engineered and there was no framing along short direction. Factory engineer is required to check the adequacy of the shed otherwise replace with an engineered one.

Item No.	Observation	Recommended Action Plan	Recommended Timeline
6	Apparently non engineered ancillary structure (Wastage Shed)	Factory engineer is required to check the adequacy of the shed otherwise replace with an engineered one.	within 6-weeks
7	Apparently non engineered ancillary structure (Wastage Shed)	Implement remediation work deemed necessary.	within 6-months
