Chaity Composite Ltd.- Annex building

Chotto Shilmondi, Tripurdi, Sonargaon

15th March 2021

Observations

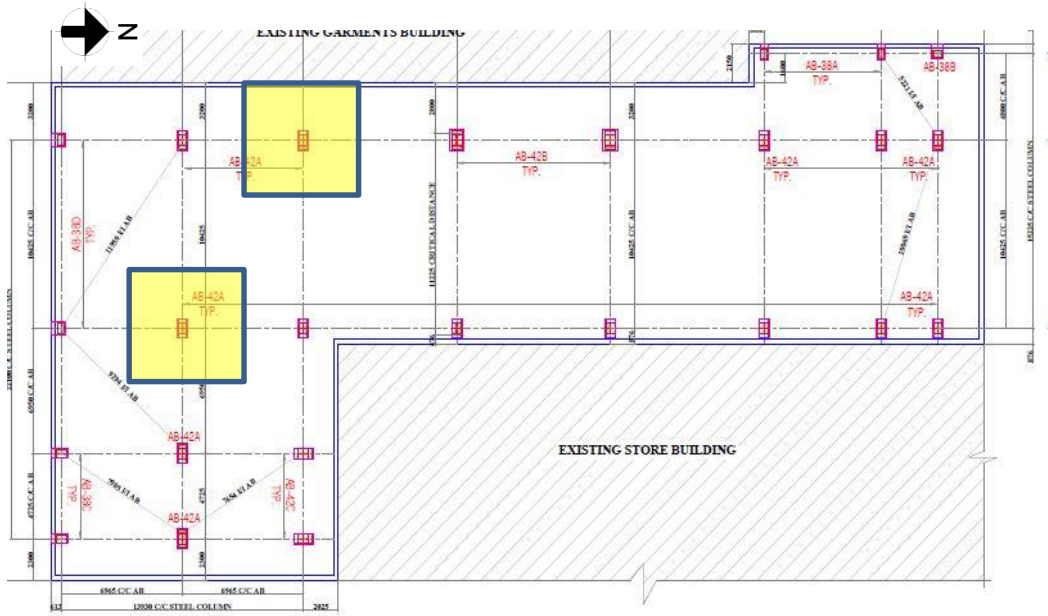
Column Layout plan

Column and Footing stressed above normal design limits

Cursory calculation indicates that columns are stressed above normal design limits at the marked locations considering 5 kPa live load on typical floor. Factory Engineer to review design, loads and columns stresses. Also produce and actively manage loading plan according to the floor capacity.

Item No.	Observation	Recommended Action Plan	Recommended Timeline
1	Column and foundation stressed above normal design limits	Factory Engineer to review design, loads, columns and footings stresses.	within 6-weeks
2	Column and foundation stressed above normal design limits	Factory engineer is required to verify the steel members by conducting a tensile strength test.	within 6-weeks
3	Column and foundation stressed above normal design limits	Produce and actively manage a loading plan for all floor plates within the factory, considering floor, column and foundation capacity.	within 6-weeks

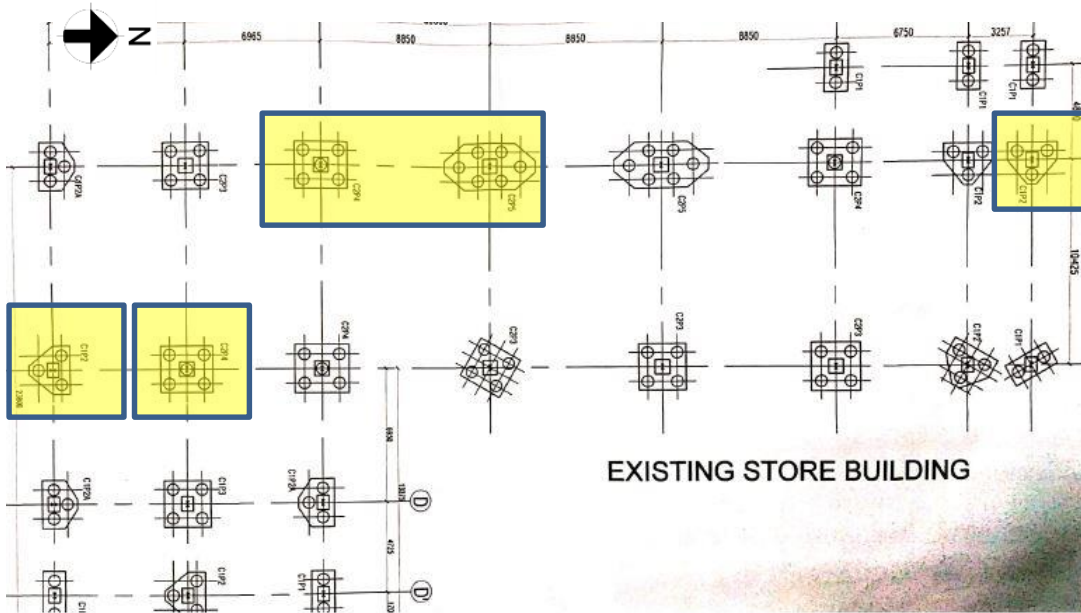
Column Layout plan

Cursory calculation indicates that foundation is stressed above normal design limits at the marked locations considering 5 kPa live load on typical floor. Factory Engineer to review design, loads and columns stresses. Also produce and actively manage loading plan according to the floor capacity.

Item No.	Observation	Recommended Action Plan	Recommended Timeline
4	Column and foundation stressed above normal design limits	Complete implementation of any remedial works deemed necessary by the Engineering assessment.	within 6-months
5	Column and foundation stressed above normal design limits	Continue to implement loading plan.	within 6-months
6	Discrepancies in as-built drawing with onsite-condition	Factory engineer is required to survey the whole structure and update the as-built drawing as per on-site condition.	within 6-weeks

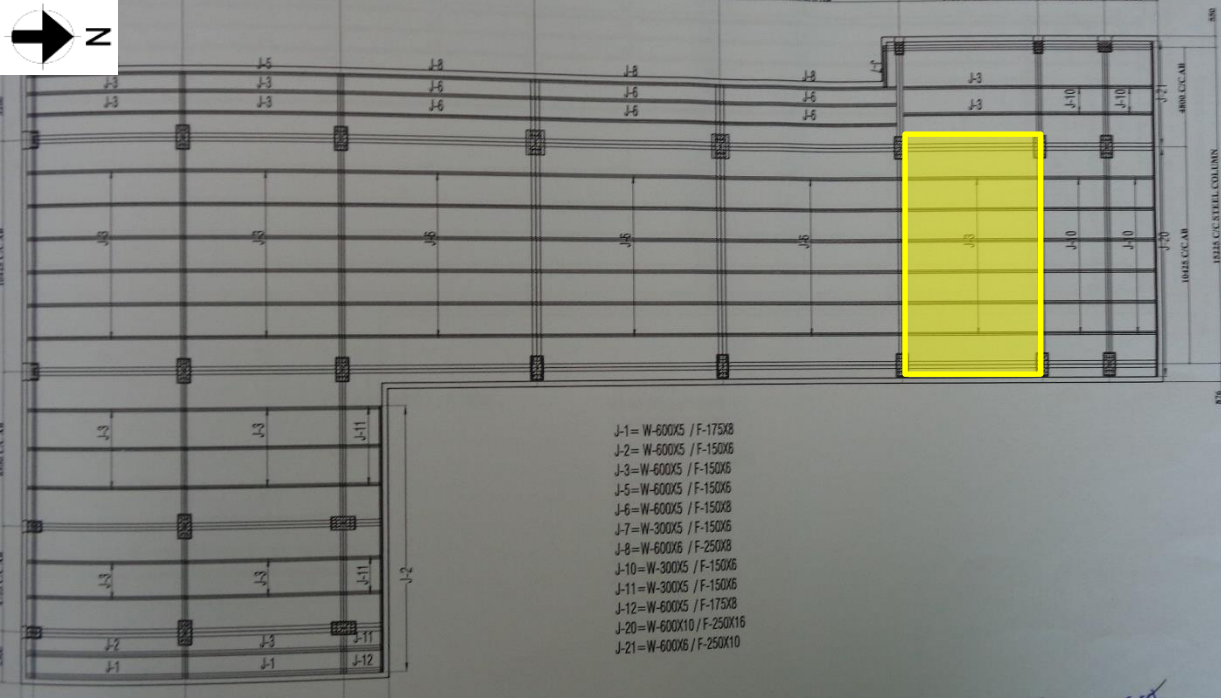
Typical sub-beam layout

Discrepancies in as-built drawing with onsite-condition

Depth of sub-beam (J-3) was shown as 600 mm in provided drawing for the marked area but the depth was measured as 500mm for those beams at all floor level. Factory engineer is required to survey the whole structure and update the as-built drawing as per on-site condition.

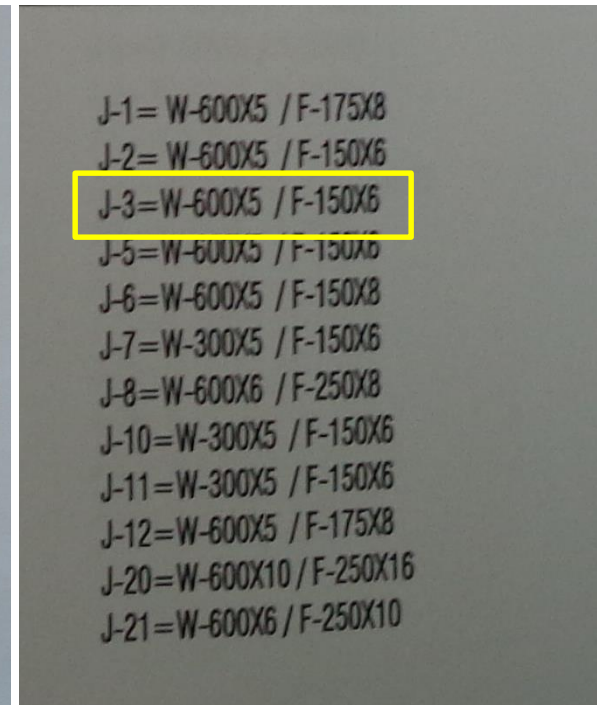
Depth of J-3 shown 600 mm

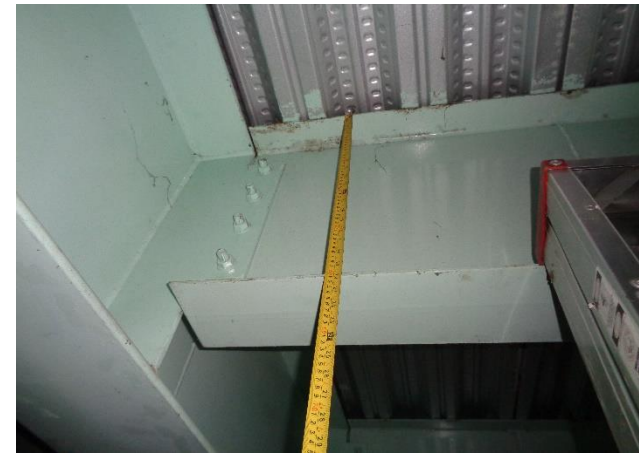
Depth of J-3 measured 500 mm

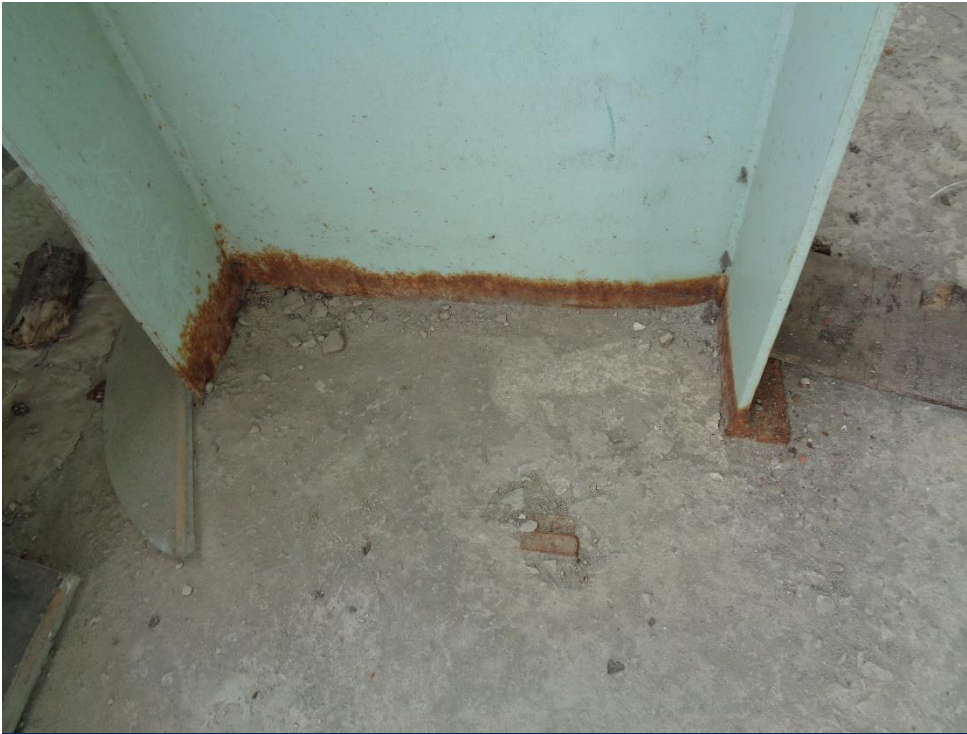
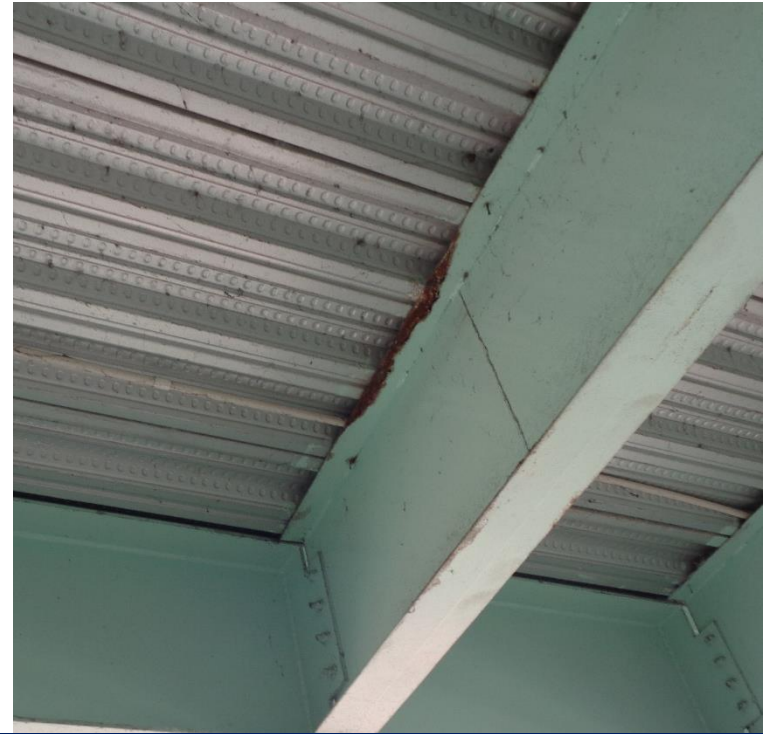
Steel column & I joist corrosion at top floor

Corrosion in steel member was found in various locations. Factory is required to identify the corroded locations and investigate the reason of corrosion and suggest proper remedial measure accordingly.

Item No.	Observation	Recommended Action Plan	Recommended Timeline
7	Corrosion in steel member	The building engineer to investigate the reason & extent of corrosion and suggest proper remedial measure accordingly.	within 6-weeks
8	Corrosion in steel member	Take necessary measures to prevent further corrosion and repair the corroded steel members as per engineer's suggestion.	within 6-months
