# Fashion Asia Ltd. (New Unit)

Tepirbari, Mawna, Sreepur, Gazipur.

3<sup>rd</sup> December 2020

# Observations

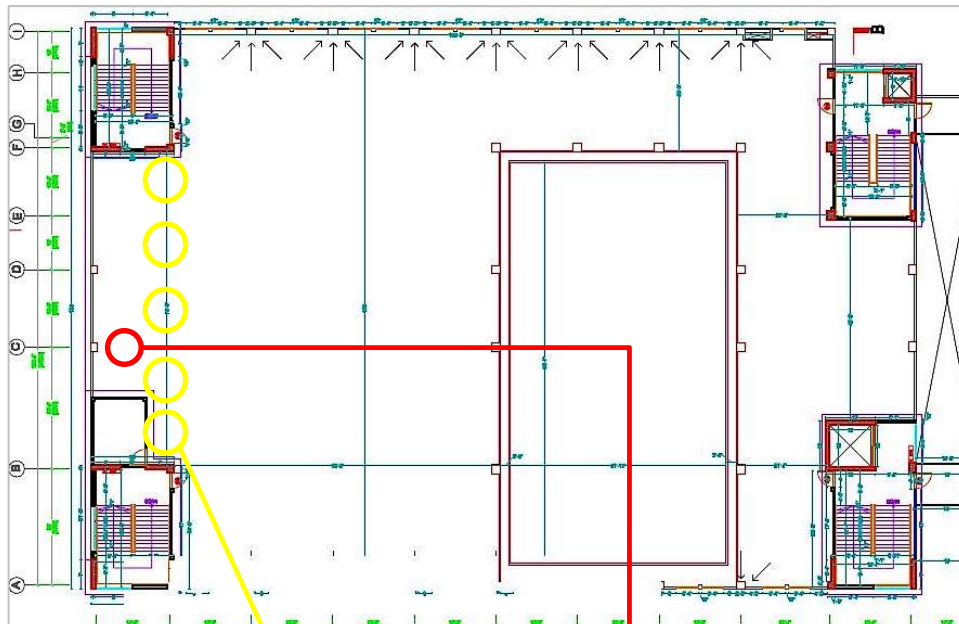
Roof layout

- 10,000 Litres plastic water tanks
- 5,000 Litres plastic water tank

There are five 10,000 liters and one 5,000 liters plastic water tanks on roof top. There are 190 mm built up beneath all the water tanks. But these are not included in the provided As-built drawings and load plan.

| Item No. | Observation | Recommended Action Plan | Recommended Timeline |
|---|---|---|---|
| 01 | Discrepancies in as-built drawings with onsite condition (Production Building) | Building Engineer is to survey the whole structure and update as-built drawings representing accurate site condition. | 6-weeks |

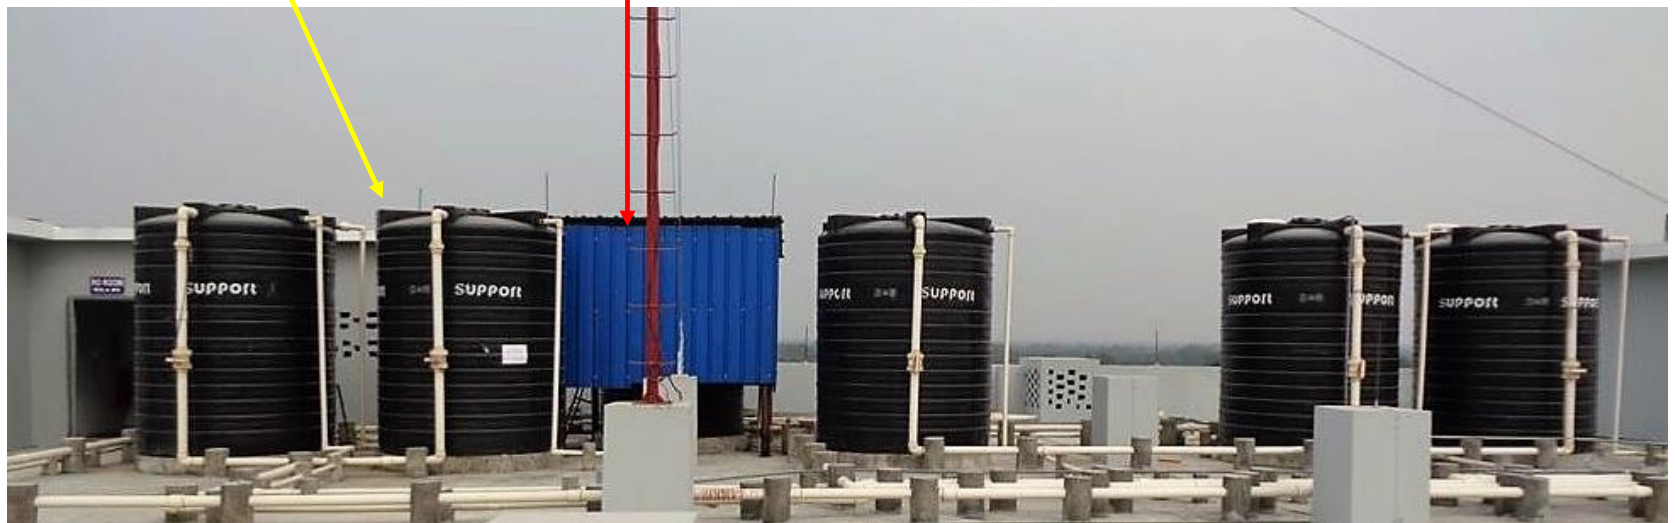
Plastic water tanks on roof top

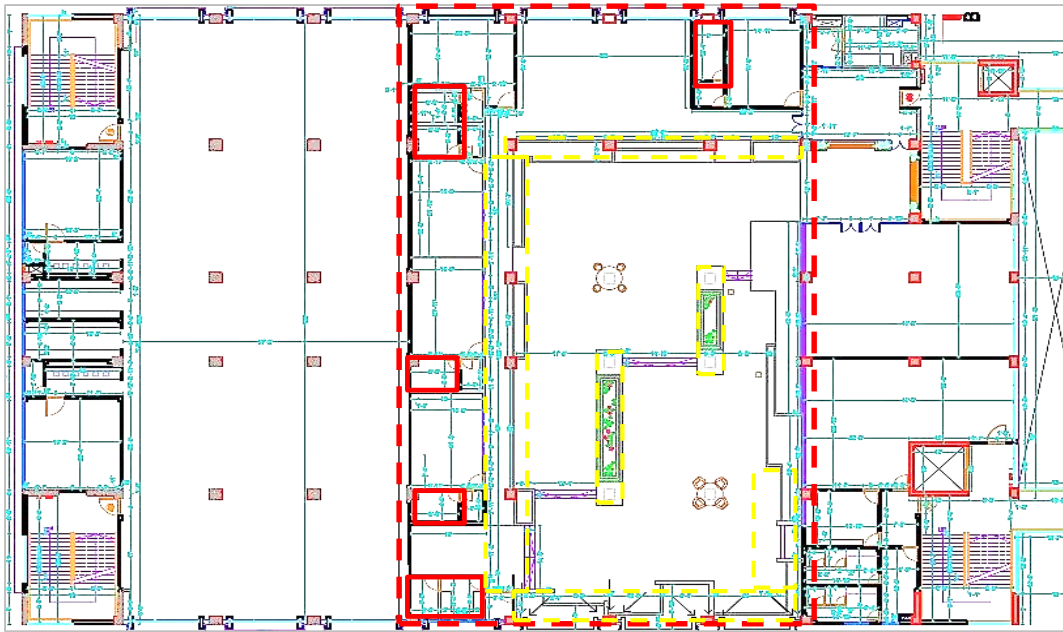
Forth floor layout

4<sup>th</sup> floor central area is being decorated with flower beds of variable heights (300~400 mm). Also, toilet areas have variable built-ups (190~240 mm). These built-up areas are not included in the provided as-built drawings.

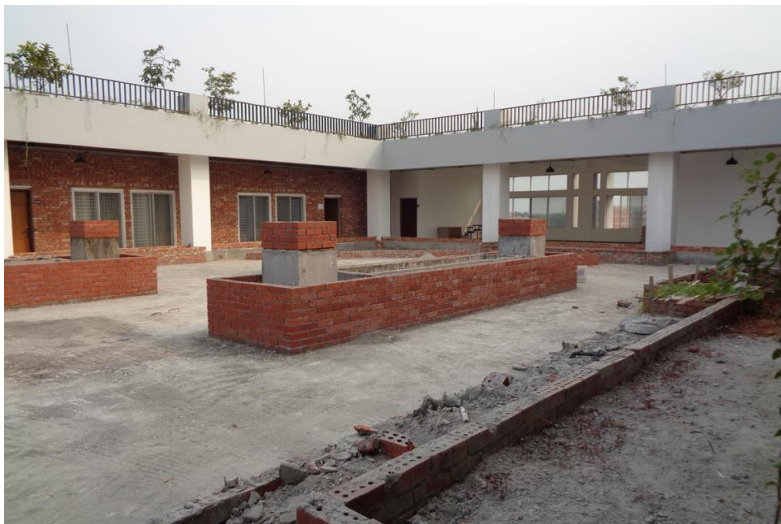
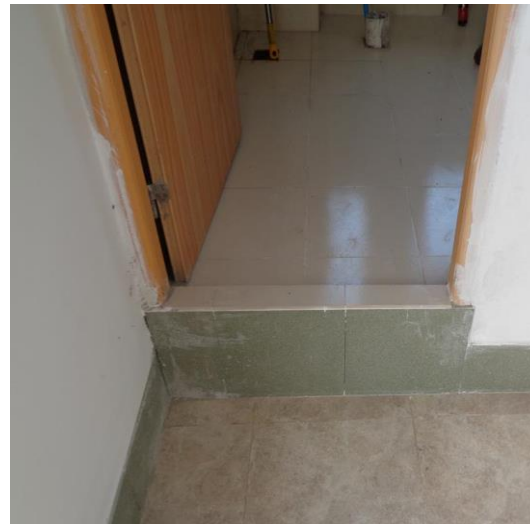
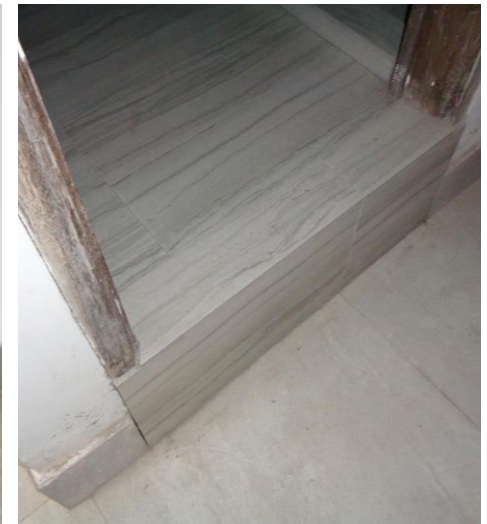
Variable flower bed and built up areas in toilet areas on 4<sup>th</sup> floor

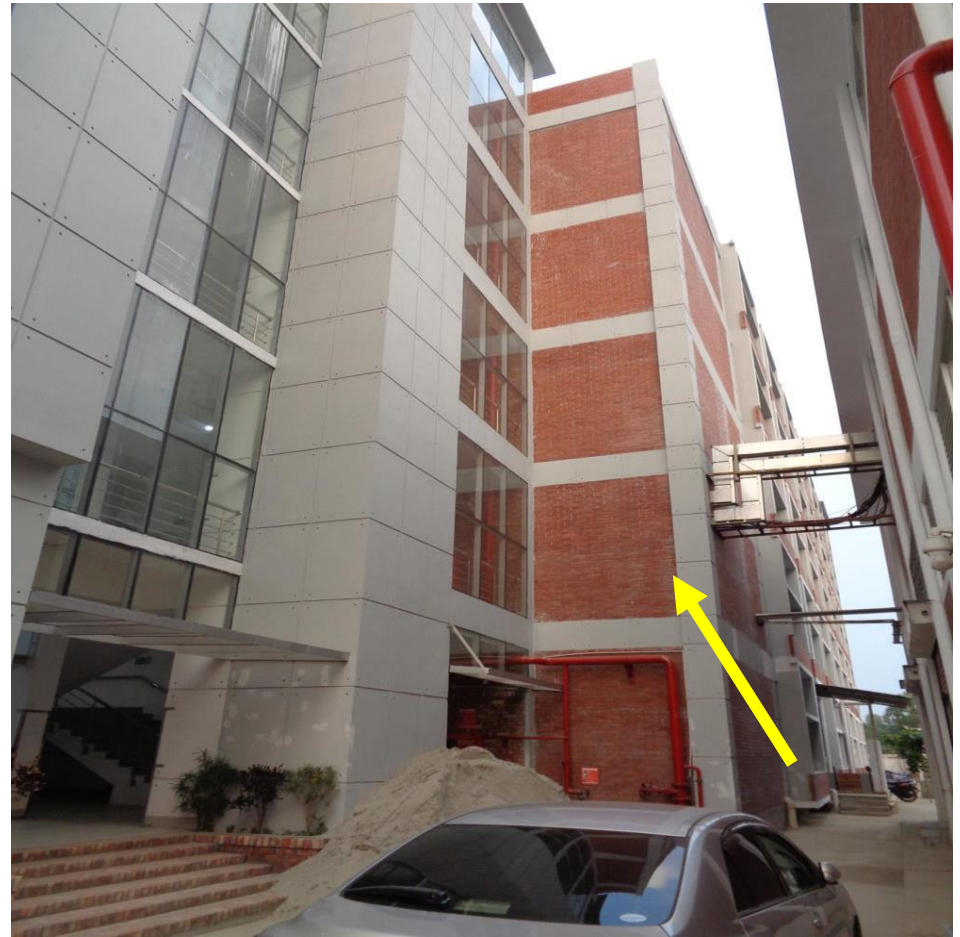
As per BNBC, every building or structure designed shall have its design documents prepared in accordance with the provision of Section 1.9.1. The design document shall include a design report, and a set of structural drawings, which shall be prepared in compliance with section 1.9.1.1 and section 1.9.1.2 as per BNBC. At the time of inspection, only as-built drawing, load plan and geotechnical report were available, but no design report was available which is required to be prepared in compliance with section 1.9.1.1 (part-6, BNBC).

No design report was available for Production Building

| Item No. | Observation | Recommended Action Plan | Recommended Timeline |
|---|---|---|---|
| 02 | Absence of design documents (Production Building) | Factory engineer is required to prepare the design documents including a design report, and a set of structural drawings in compliance with section 1.9.1.1 and section 1.9.1.2 as per BNBC part 6 and submit to RSC for review. | 6-weeks |
| 03 | Absence of design documents (Production Building) | Verify and actively manage prepared load plan for all floors considering floor, column and foundation capacity. | 6-weeks |
| 04 | Absence of design documents (Production Building) | Complete remedial works arising from design report after reviewed by RSC. | 6-months |

| Item No. | Observation | Recommended Action Plan | Recommended Timeline |
|---|---|---|---|
| 05 | Absence of design documents (Production Building) | Implement floor loading plan. | 6-months |

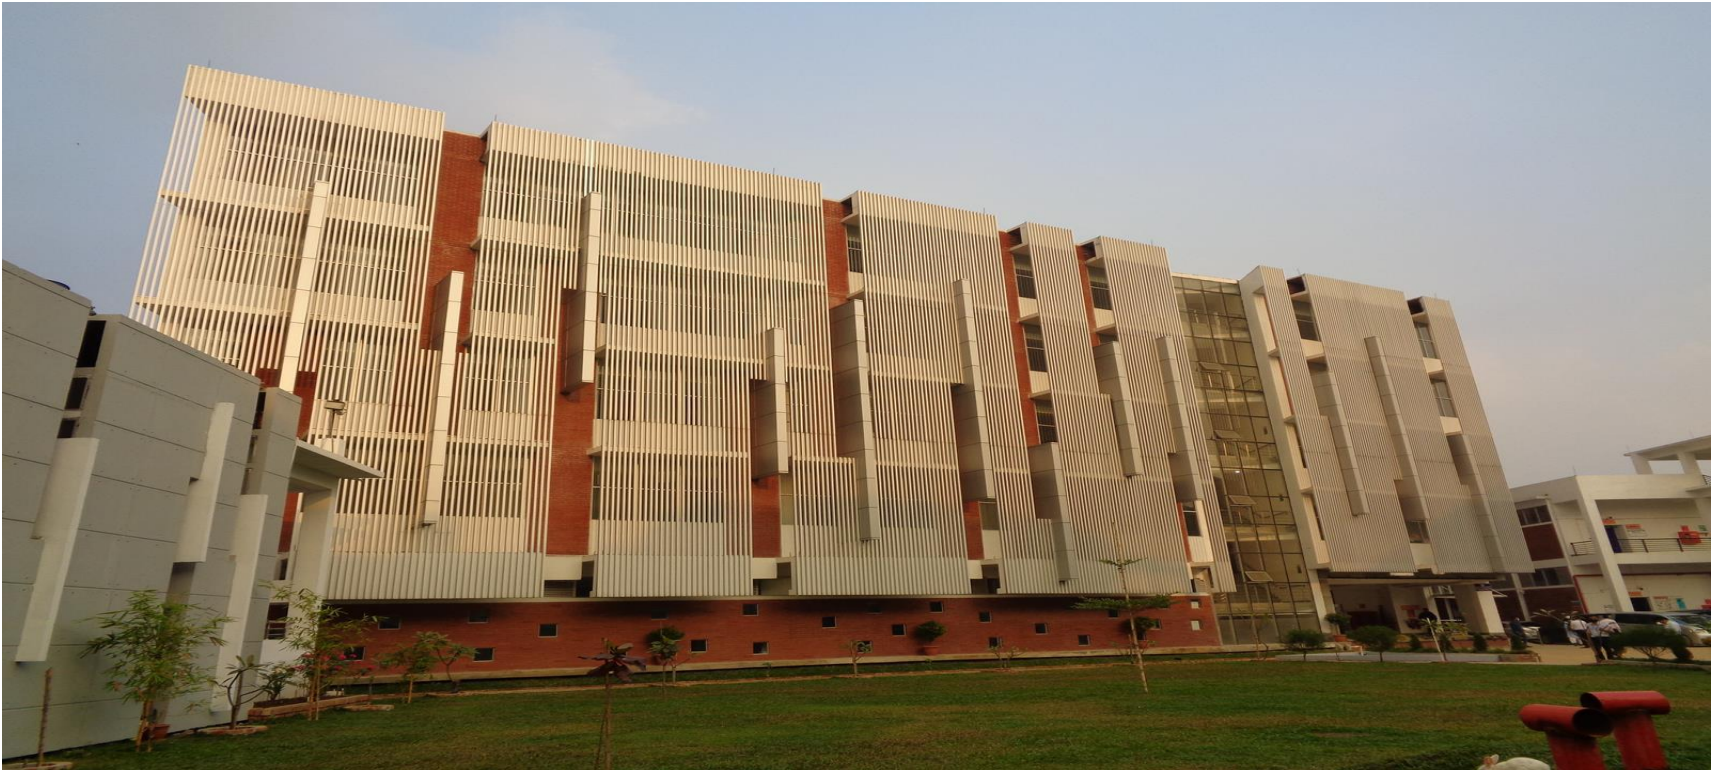
No design report was available for Warehouse Building

As per BNBC, every building or structure designed shall have its design documents prepared in accordance with the provision of Section 1.9.1. The design document shall include a design report, and a set of structural drawings, which shall be prepared in compliance with section 1.9.1.1 and section 1.9.1.2 as per BNBC. At the time of inspection, only as-built drawing, load plan and geotechnical report were available but no design report was available which is required to be prepared in compliance with section 1.9.1.1 (part-6, BNBC).

| Item No. | Observation | Recommended Action Plan | Recommended Timeline |
|---|---|---|---|
| 06 | Absence of design documents (Warehouse Building) | Factory engineer is required to prepare the design documents including a design report, and a set of structural drawings in compliance with section 1.9.1.1 and section 1.9.1.2 as per BNBC part 6 and submit to RSC for review. | 6-weeks |
| 07 | Absence of design documents (Warehouse Building) | Verify and actively manage prepared load plan for all floors considering floor, column and foundation capacity. | 6-weeks |
| 08 | Absence of design documents (Warehouse Building) | Complete remedial works if arising from design report after reviewed by RSC. | 6-months |

| Item No. | Observation | Recommended Action Plan | Recommended Timeline |
|---|---|---|---|
| 09 | Absence of design documents (Warehouse Building) | Implement floor loading plan. | 6-months |

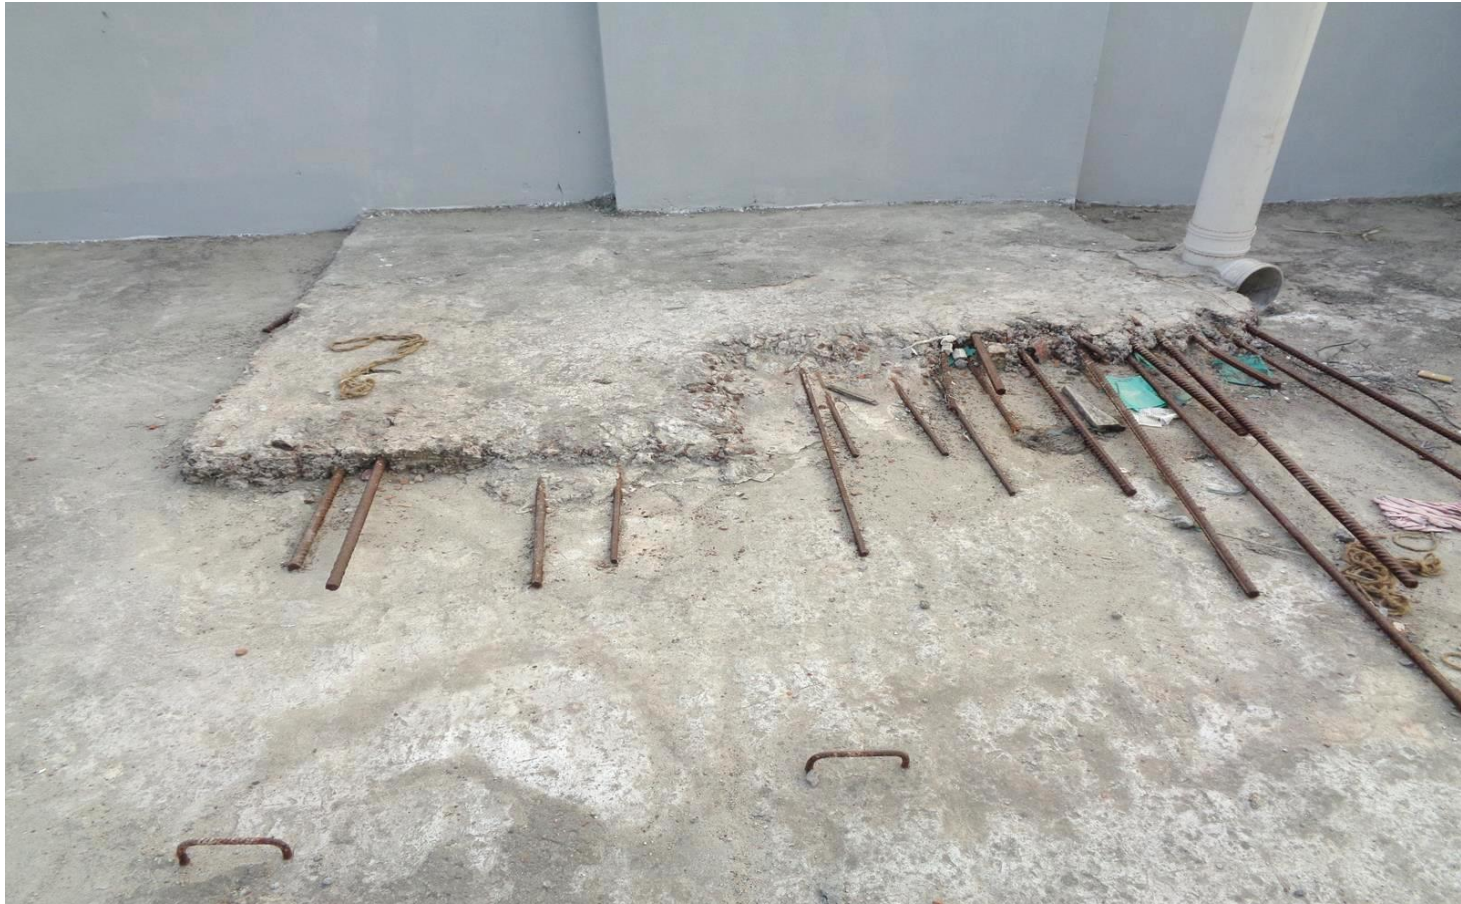
Exposed reinforcement at roof level

Exposed reinforcement found left at roof level. Factory is required to remove the exposed rebar otherwise provide rust proof paint to protect future corrosion.

| Item No. | Observation | Recommended Action Plan | Recommended Timeline |
|---|---|---|---|
| 10 | Exposed reinforcements left at roof level (Warehouse Building) | Factory is required to remove the exposed rebar otherwise provide rust proof paint to protect future corrosion. | 6-weeks |

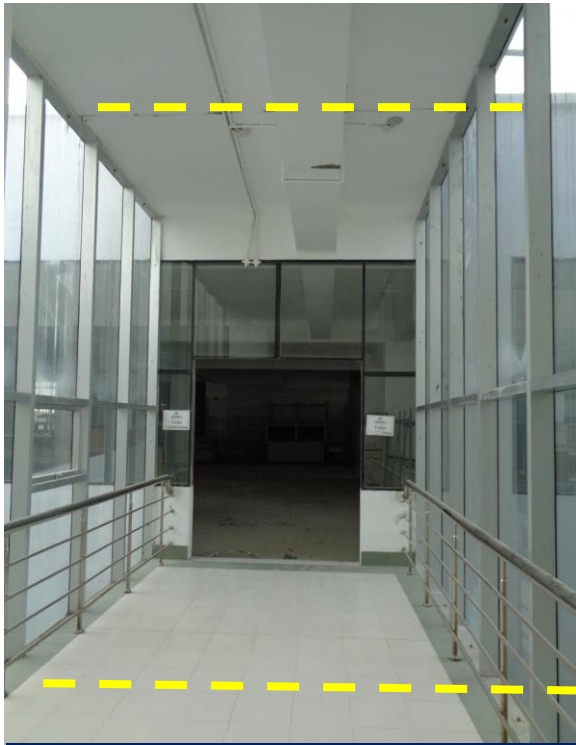
Two cantilevers are separated by a joint but filled with rigid materials at top

Warehouse Building and Production Building Both are cantilevered at north and south side which are being used as a walkway are separated by a movement joint. However, the joint is filled with rigid material at top which may obstruct the building movement and crack may be developed. Factory is required to fill the joint with any flexible material suggested by the factory consultant.

| Item No. | Observation | Recommended Action Plan | Recommended Timeline |
|---|---|---|---|
| 11 | Movement joints filled with rigid material (Production Building & Warehouse Building) | Factory is required to fill the joints with flexible materials recommended by the factory consultant. | 6-weeks |

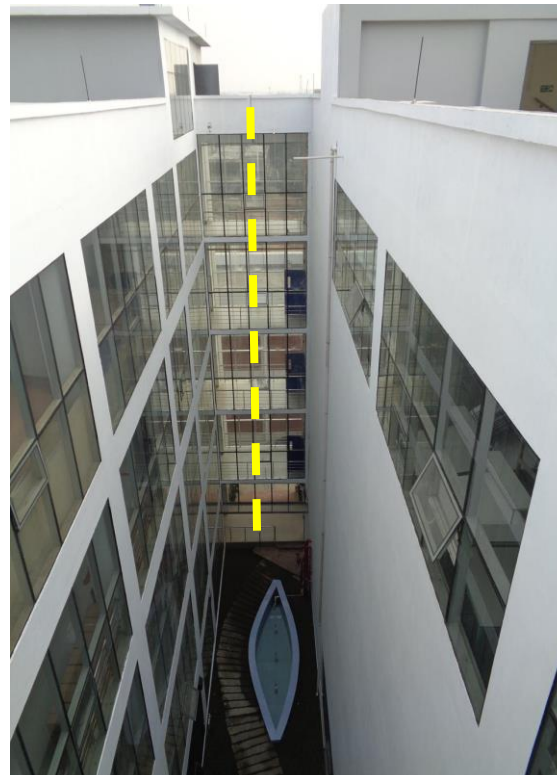
Two Buildings are cantilevered at North

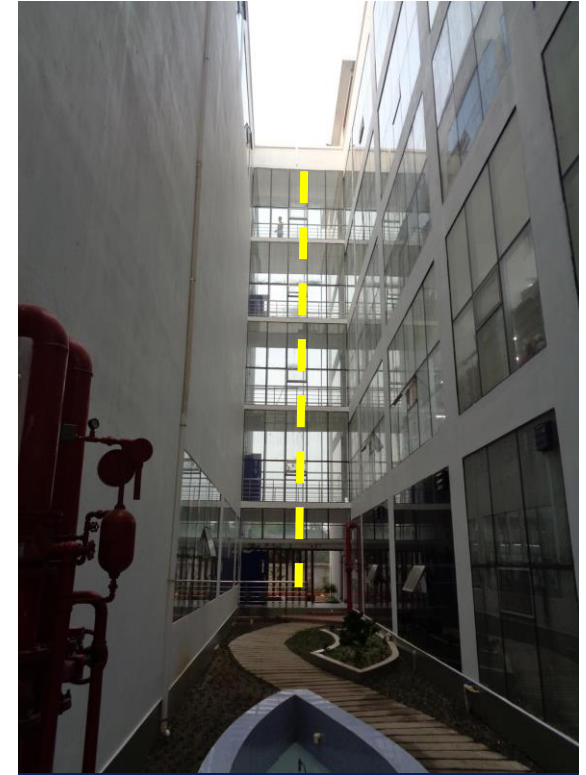
Two Buildings are cantilevered at south

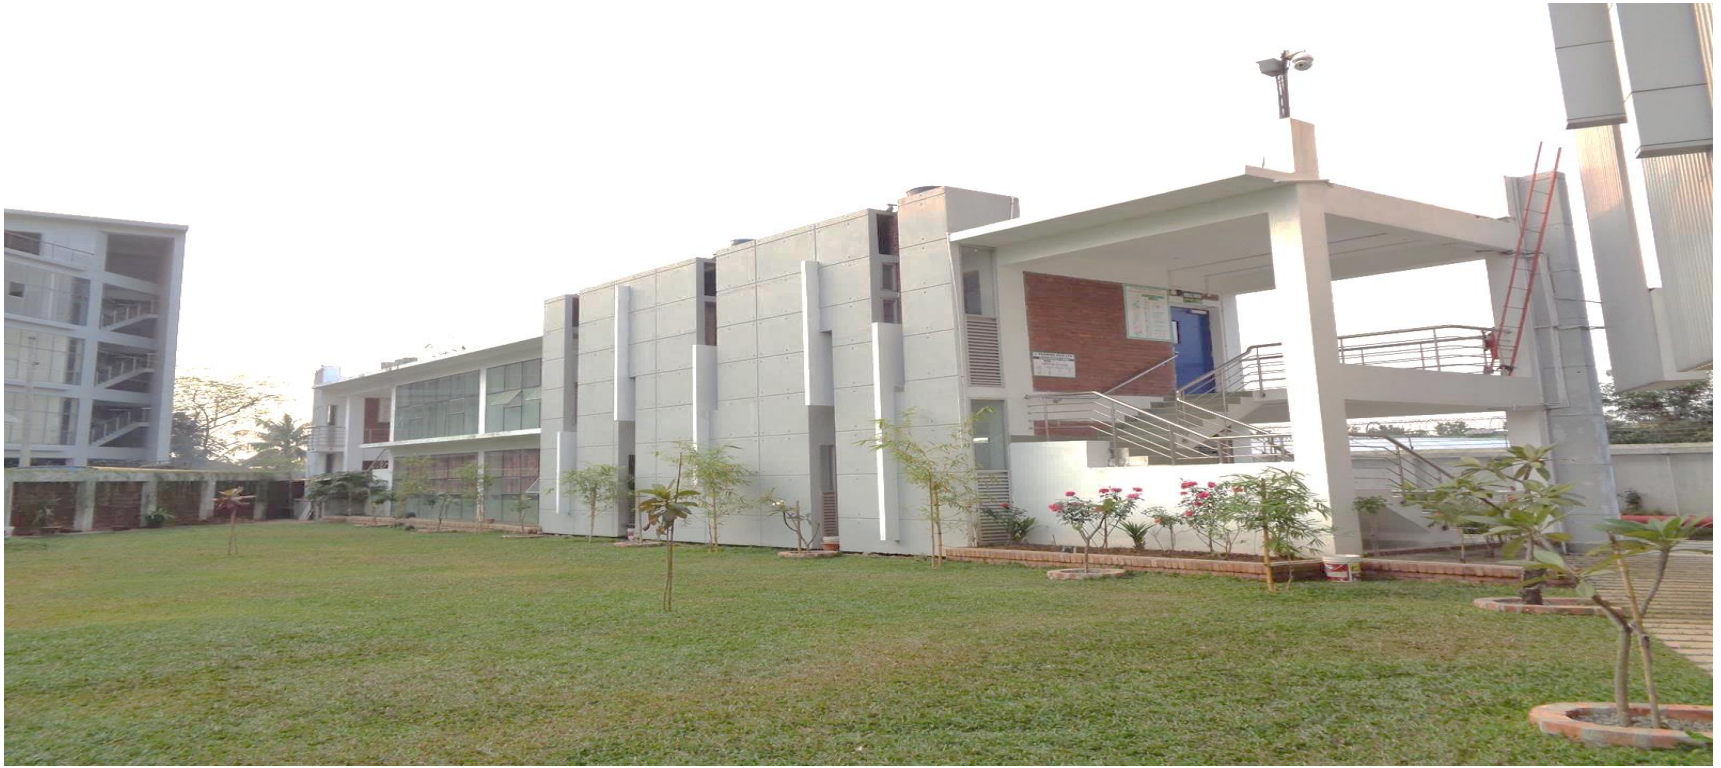
No Design report was available in the factory site for Amenities Building

As per BNBC, every building or structure designed shall have its design documents prepared in accordance with the provision of Section 1.9.1. The design document shall include a design report, and a set of structural drawings, which shall be prepared in compliance with section 1.9.1.1 and section 1.9.1.2 as per BNBC. At the time of inspection, only as-built drawing and geotechnical report were available but no design report was available which is required to be prepared in compliance with section 1.9.1.1 (part-6, BNBC).

| Item No. | Observation | Recommended Action Plan | Recommended Timeline |
|---|---|---|---|
| 13 | Absence of design documents (Amenities Building) | Factory engineer is required to prepare the design documents including a design report, and a set of structural drawings in compliance with section 1.9.1.1 and section 1.9.1.2 as per BNBC part 6 and submit to RSC for review. | 6-weeks |
| 14 | Absence of design documents (Amenities Building) | Verify and actively manage prepared load plan for all floors considering floor, column and foundation capacity. | 6-weeks |
| 15 | Absence of design documents (Amenities Building) | Complete remedial works arising from design report after reviewed by RSC. | 6-months |
| 16 | Absence of design documents (Amenities Building) | Implement floor loading plan. | 6-months |

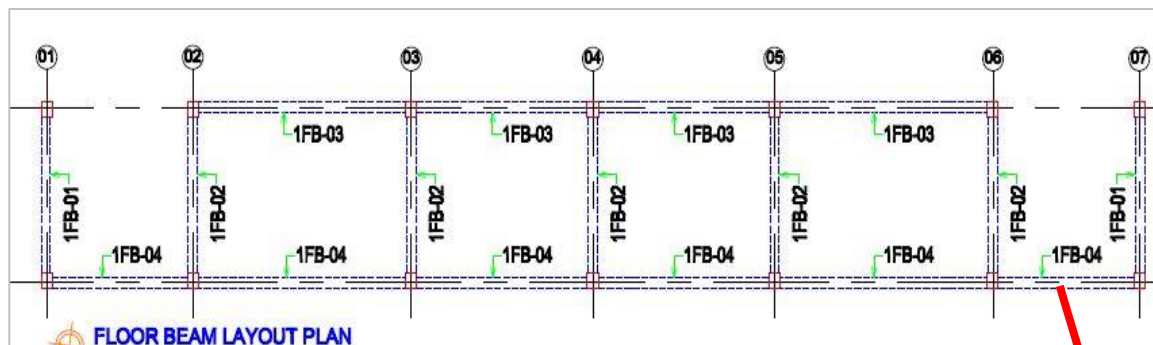
Beam layout of Amenities building

As-built structural drawing of Amenities Building and security-2 are produced separately but in reality two Buildings are found as one building and structurally connected. Factory is required to update the as-built structural drawing and prepare design report as a whole.

| Item No. | Observation | Recommended Action Plan | Recommended Timeline |
|---|---|---|---|
| 12 | Discrepancies in as-built drawings with onsite condition (Amenities Building) | Factory engineer is required to update the as-built structural drawing. | 6-weeks |

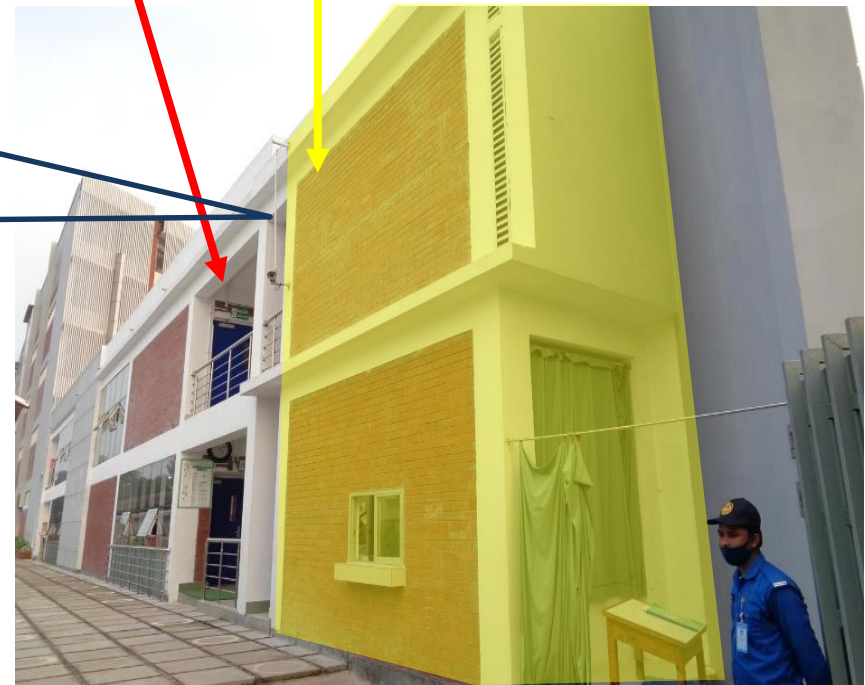
Two buildings are found structurally connected.

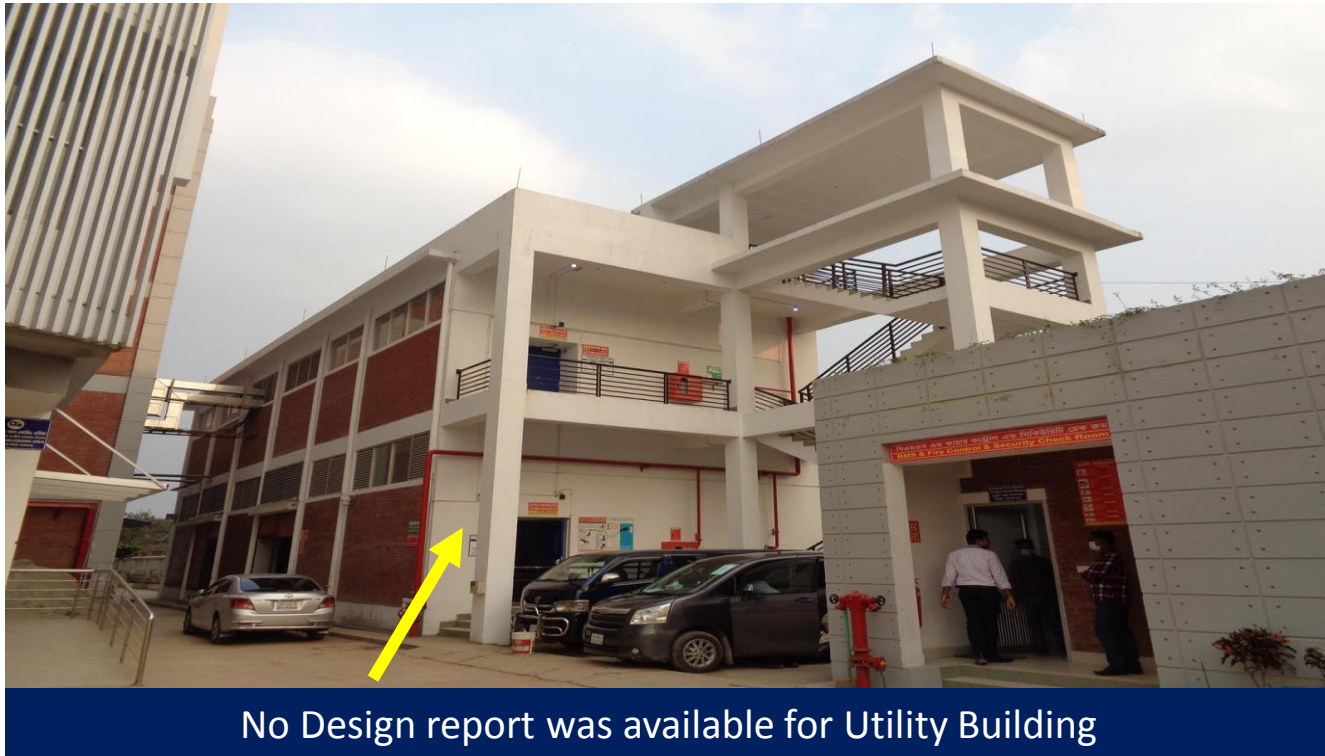
As per BNBC, every building or structure designed shall have its design documents prepared in accordance with the provision of Section 1.9.1. The design document shall include a design report, and a set of structural drawings, which shall be prepared in compliance with section 1.9.1.1 and section 1.9.1.2 as per BNBC. At the time of inspection, only as-built drawing, load plan and geotechnical report were available but no design report was available which is required to be prepared in compliance with section 1.9.1.1 (part-6, BNBC).

| Item No. | Observation | Recommended Action Plan | Recommended Timeline |
|---|---|---|---|
| 17 | Absence of design documents (Utility Building) | Factory engineer is required to prepare the design documents including a design report, and a set of structural drawings in compliance with section 1.9.1.1 and section 1.9.1.2 as per BNBC part 6 and submit to RSC for review. | 6-weeks |
| 18 | Absence of design documents (Utility Building) | Verify and actively manage prepared load plan for all floors considering floor, column and foundation capacity. | 6-weeks |
| 19 | Absence of design documents (Utility Building) | Complete remedial works if arising from design report after reviewed by RSC. | 6-months |
| 20 | Absence of design documents (Utility Building) | Implement floor loading plan. | 6-months |
