# Al-Muslim Apparels Ltd.

12 Nishchintapur, Ashulia, Savar, Dhaka  
(23.92470, 90.30938)  
10<sup>th</sup> November 2020

# Building Information

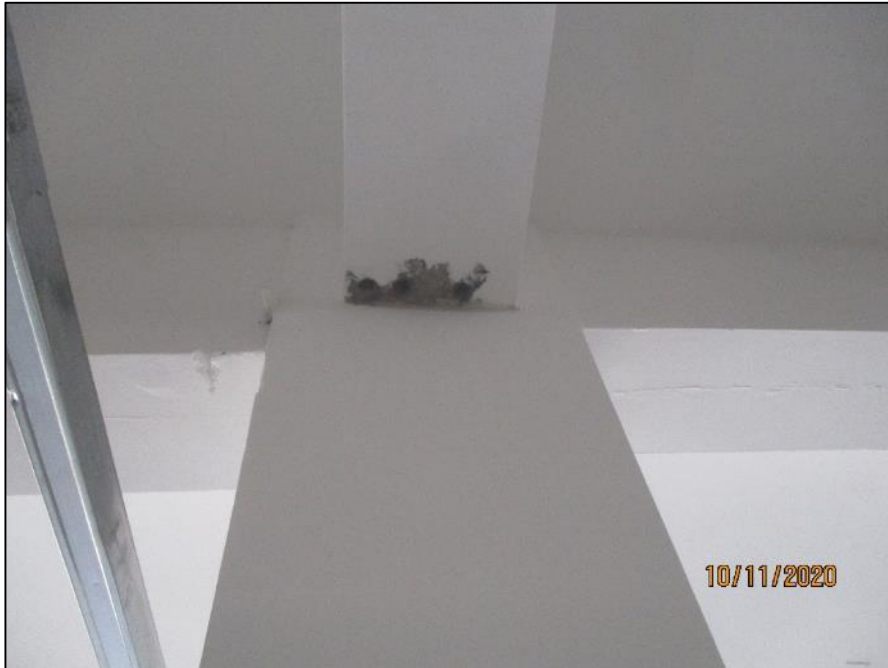
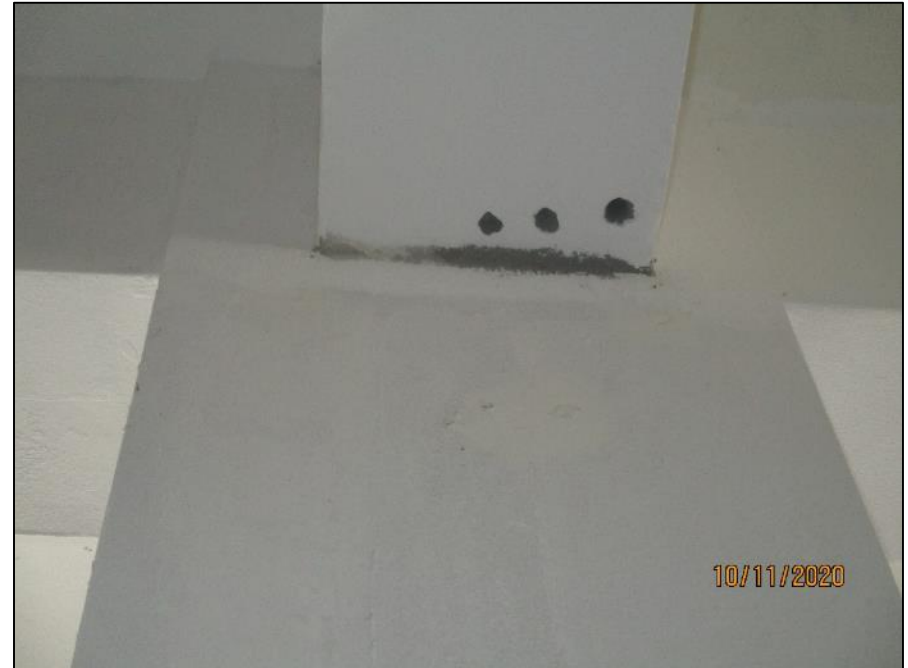
**Electrical Cables have been cut into and pass through main structural beams**

Electrical cables have been cut into and pass through main structural beams. Structural Engineer to Investigate and report on this matter to verify the Structural Integrity of the beams are not compromised

| Item No. | Observation | Recommended Action Plan | Recommended Timeline |
|---|---|---|---|
| 04 | Electrical Cables have been cut into and pass through main structural beams. (Main Building) | Building Engineer to Investigate and report on this matter to verify the Structural Integrity of the beams are not compromised. | 6-weeks |

| Item No. | Observation | Recommended Action Plan | Recommended Timeline |
|---|---|---|---|
| 05 | Electrical Cables have been cut into and pass through main structural beams. (Main Building) | Carry out any remedial works where necessary. | 6-months |

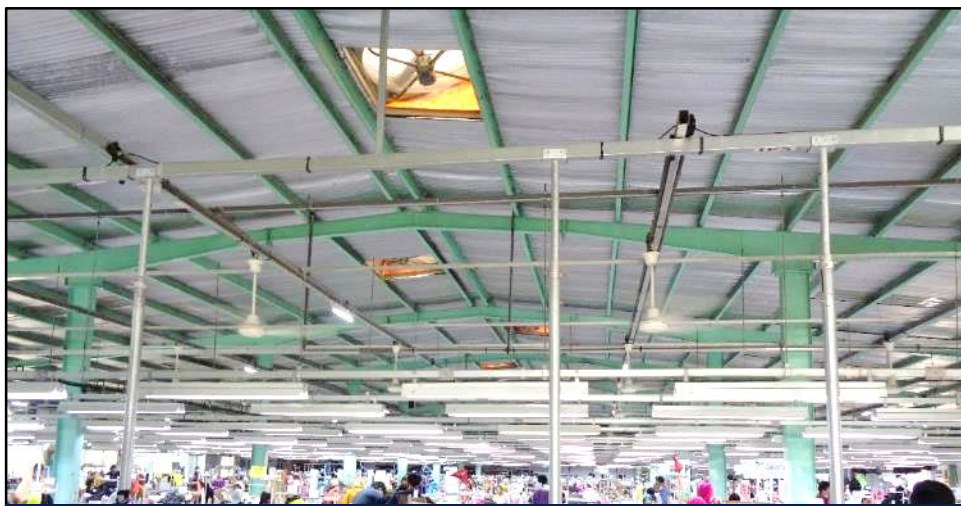
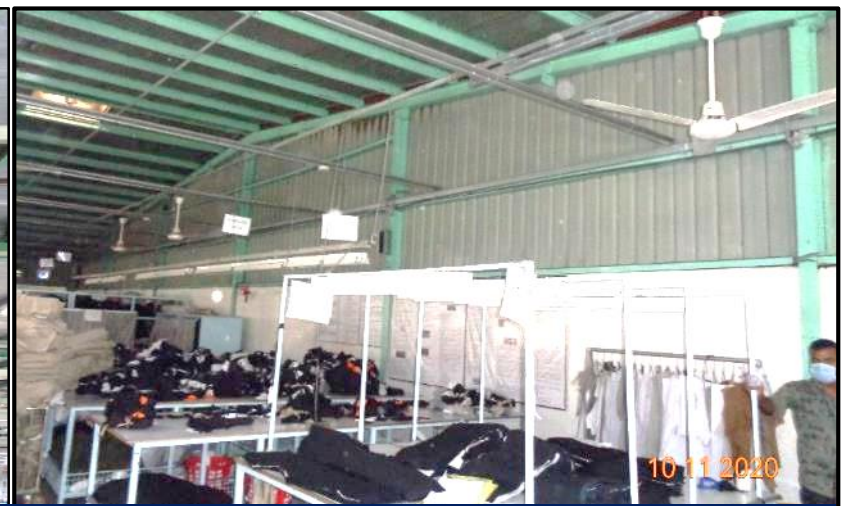
Compression strut in long direction was not observed. Also Roof & wall bracing was found missing

Roof and wall bracing were not found to resist lateral loading along the long direction. Also, few non-engineered connection was found in between rafter & Column.

Factory engineer is required to check the stability of the structure for lateral loading and to check the connection adequacy accordingly.

| Item No. | Observation | Recommended Action Plan | Recommended Timeline |
|---|---|---|---|
| 06 | Lack of lateral stability system. (Shed-1) | Building engineer to prepare the design document including a design report, and a set of structural drawings in compliance with section 1.9.1.1 and section 1.9.1.2 as per BNBC. | 6-weeks |
| 07 | Lack of lateral stability system. (Shed-1) | Complete implementation of any remedial works deemed necessary by the Design Report. | 6-months |

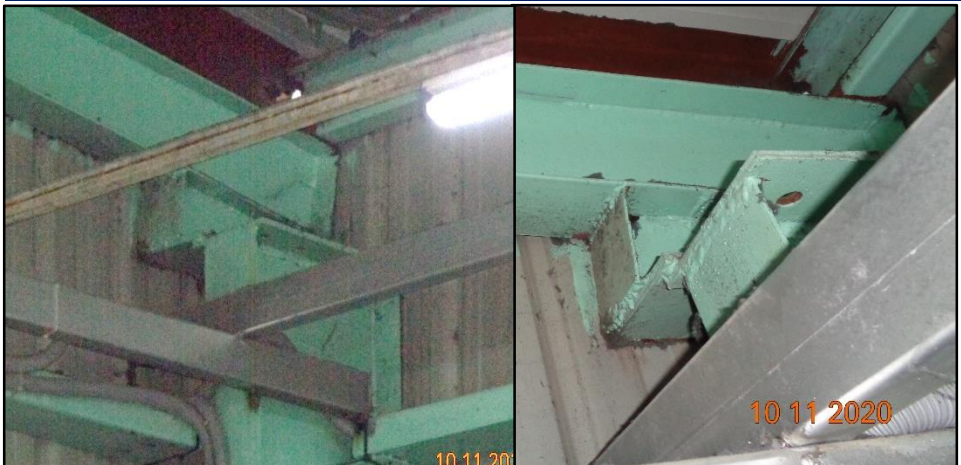
Non-engineered connection

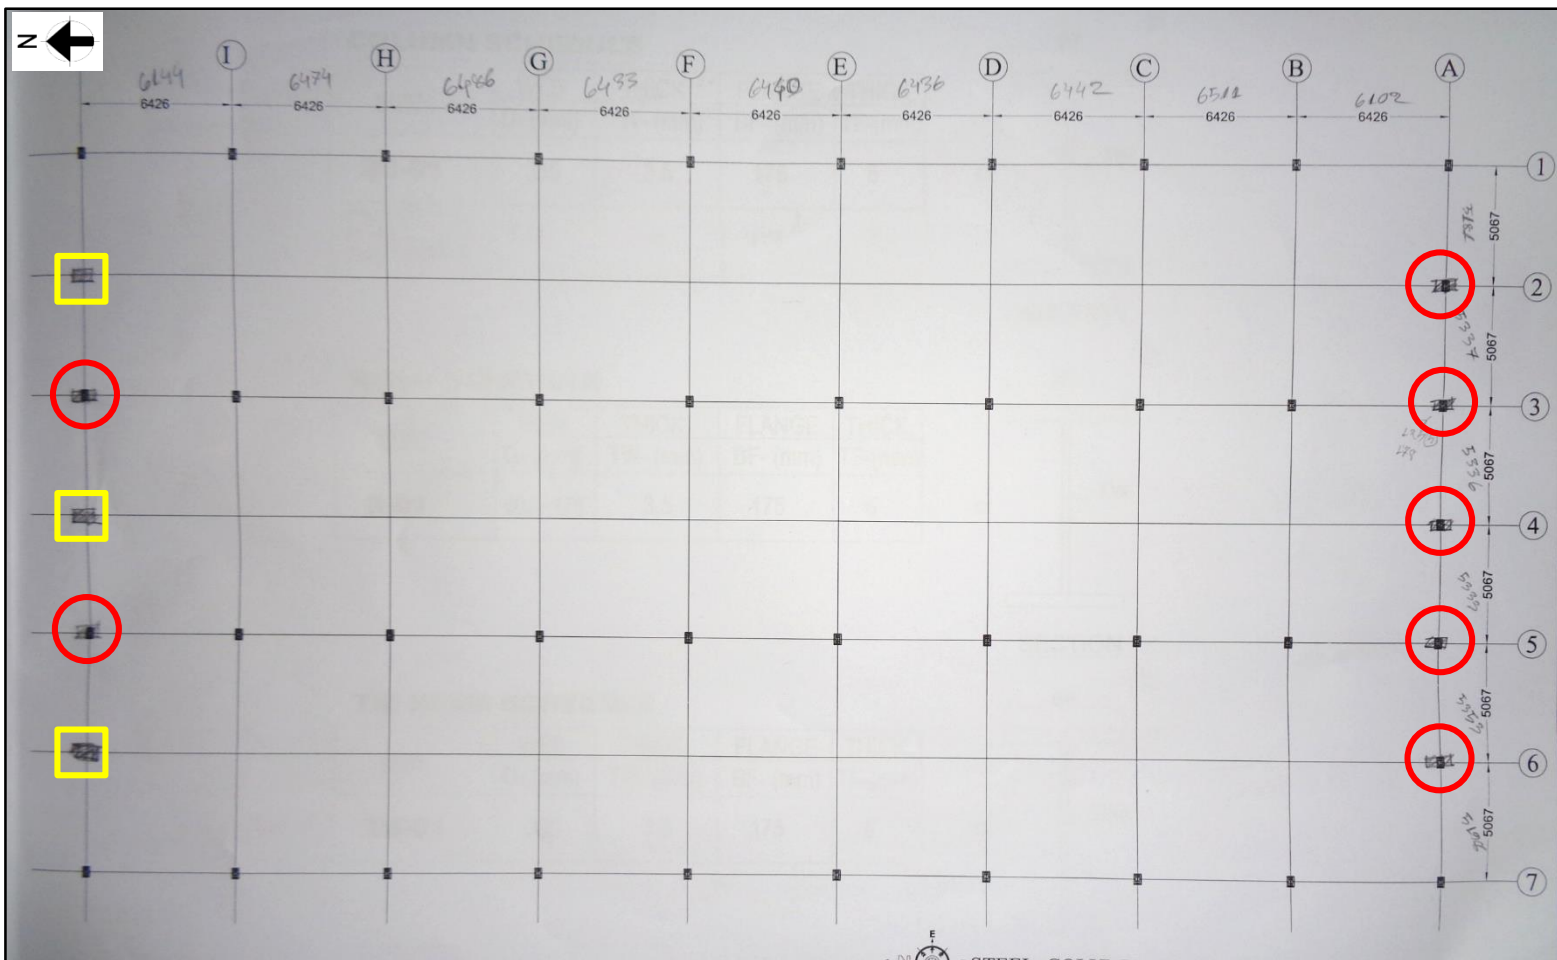
Column Layout Plan

Orientation of the steel column found different between as built drawing and actual site condition at circle marked location.

Three numbers of extra columns were found at actual site condition which are not mentioned in as-built drawing. Mismatches are shown in rectangle marked at column layout.

Factory engineer is required to survey the structures and prepare as-built drawings that are compliance with section 1.9.1.2 as per BNBC.

| Item No. | Observation | Recommended Action Plan | Recommended Timeline |
|---|---|---|---|
| 08 | Discrepancies in as-built drawing. (Shed-1) | Building Engineer to survey the structure and prepare accurate as-built (both architectural & structural) drawings. | 6-weeks |

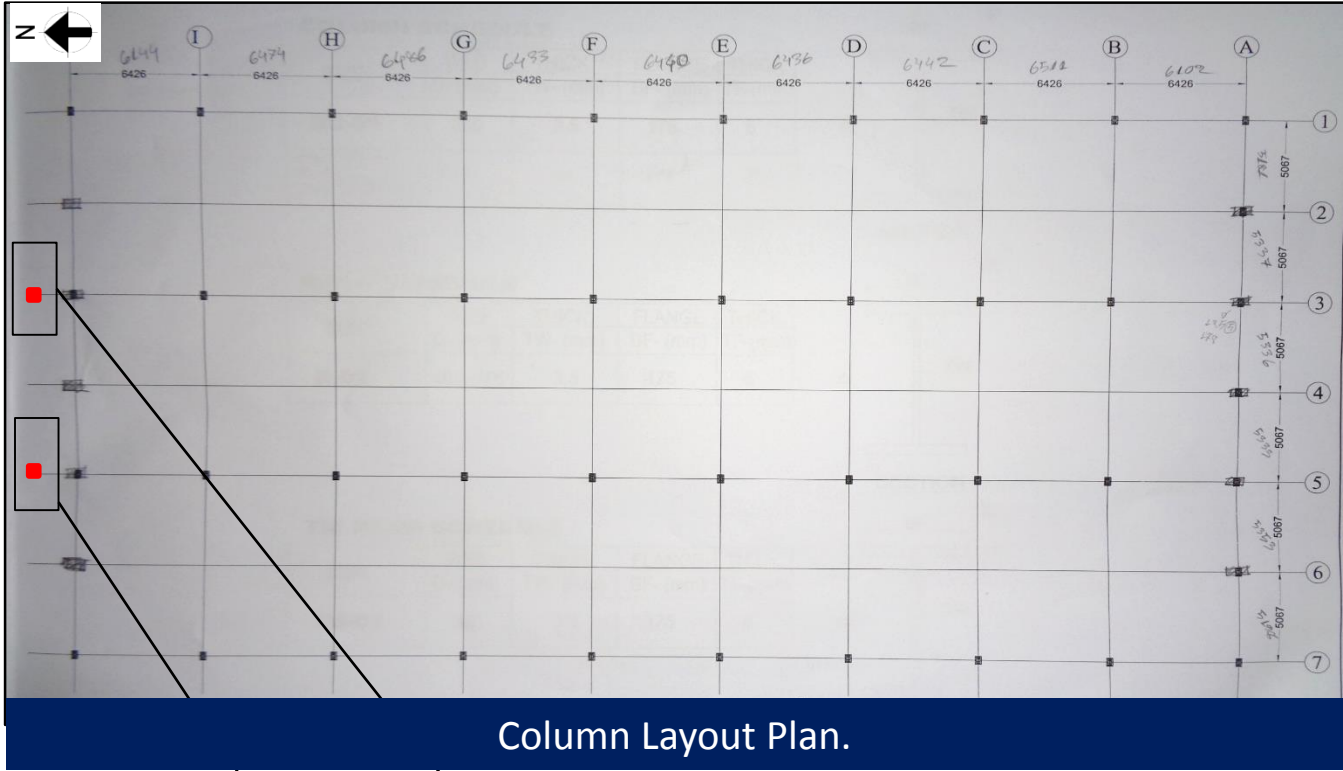
Column Layout Plan.

Canopy was found at north side of the structure. The column of the canopy has not been shown in as-built column layout plan. The marked locations denotes the canopy column location.

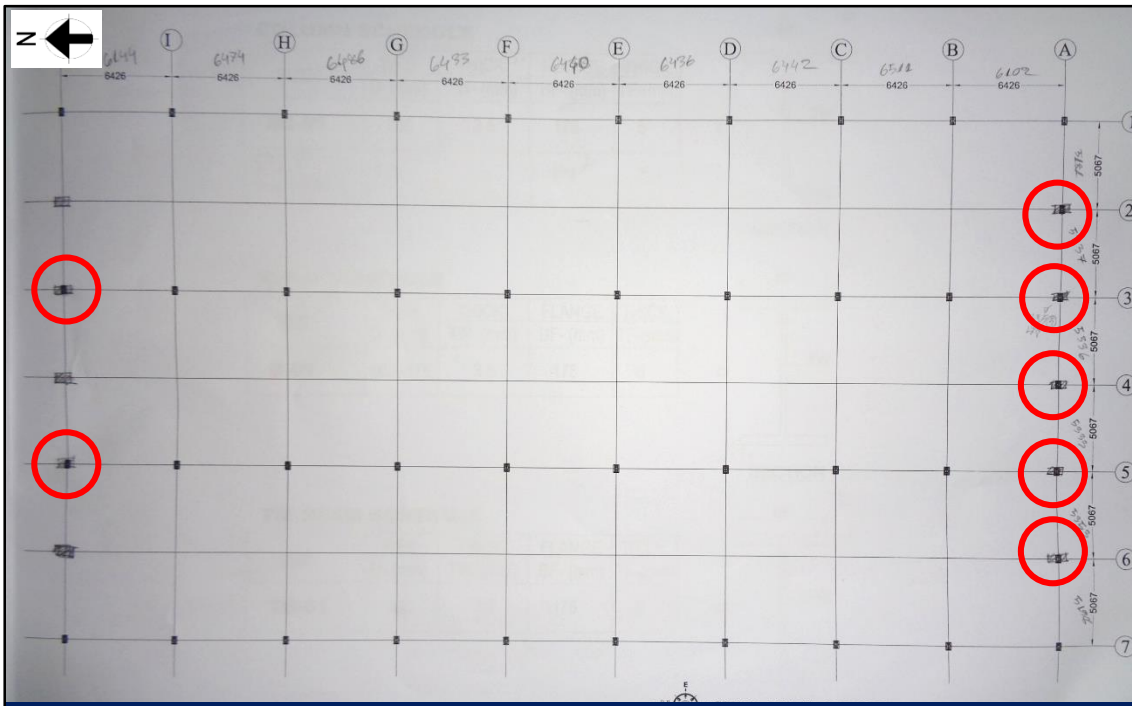
Column Layout Plan

Column size at marked location was found mismatched with as-built drawing. During inspection, column size was found Web: 175 & Flange: 125X5. In as-built drawing the column size has been shown Web: 350X3.5 & Flange: 175X5.

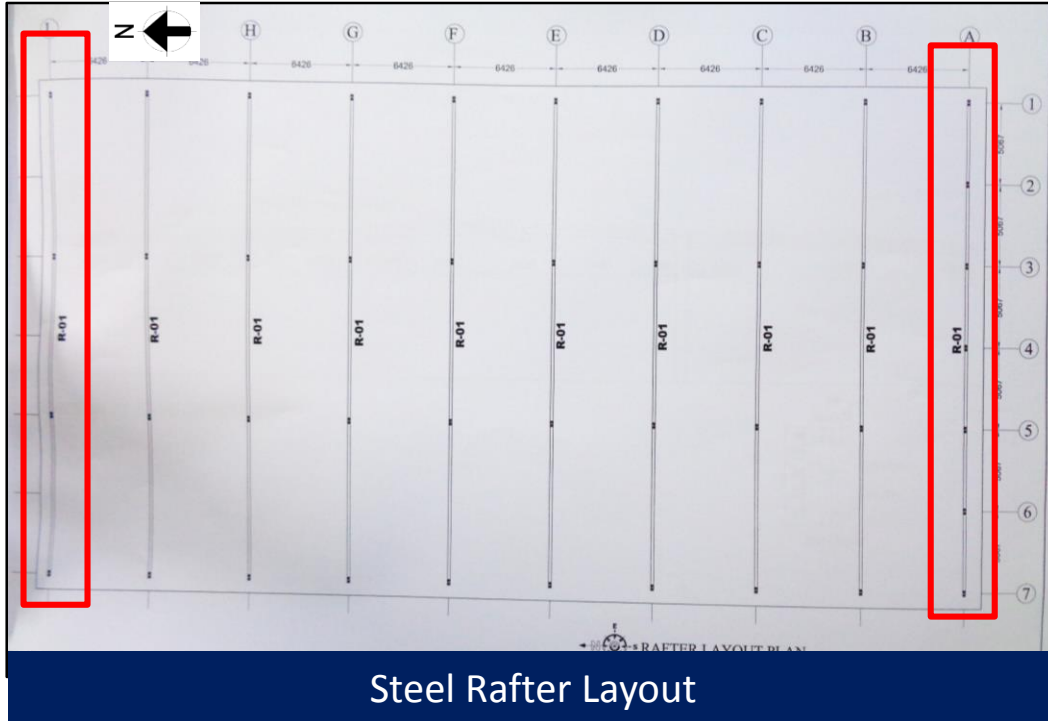
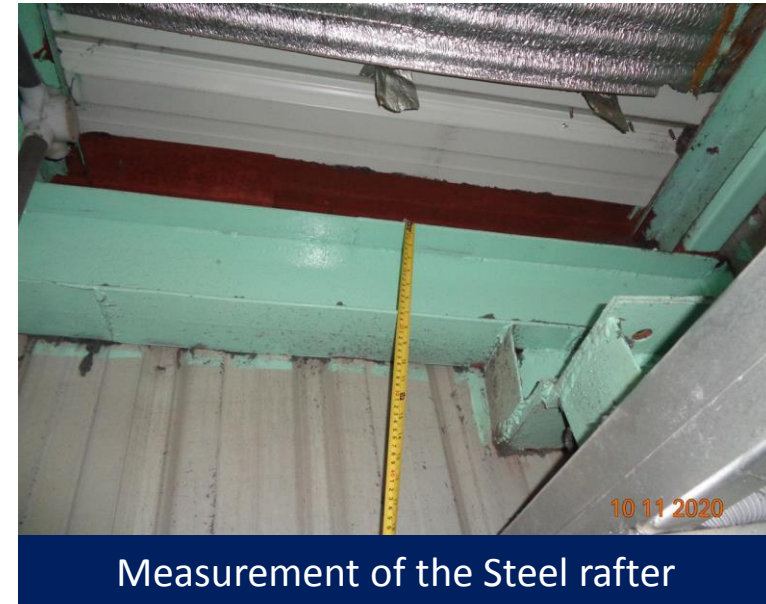
Rafter size at marked location was found mismatched with as-built drawing. During inspection, Rafter size was found Web: 175 & Flange: 125X5. In as-built drawing the Rafter size has been shown Web: 400~175X3.5 & Flange: 175X5.

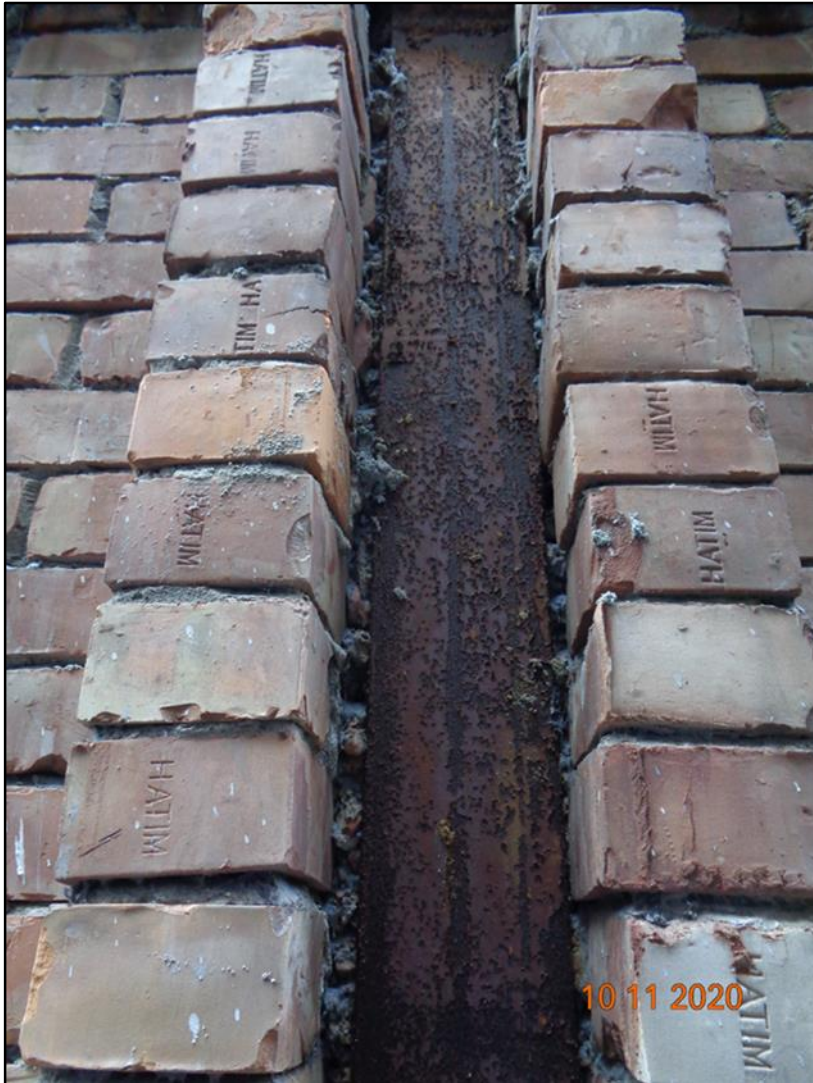
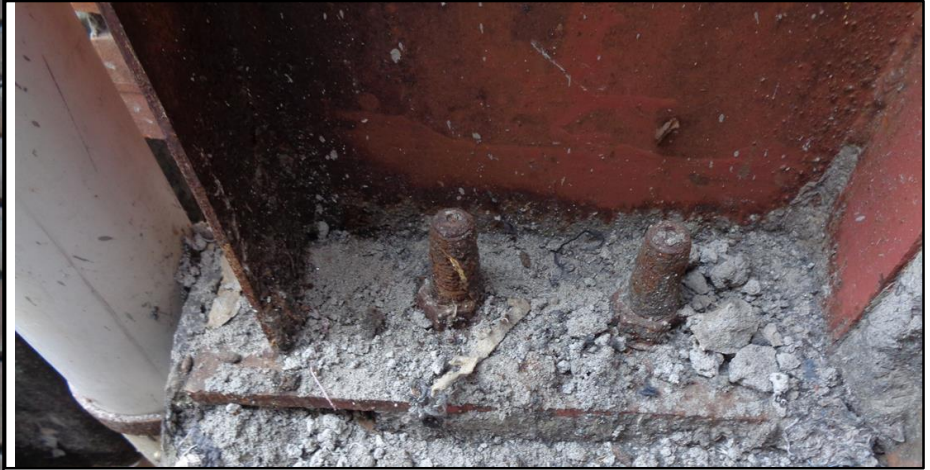
**Observations: Shed-1**

Corrosion in steel member was found in various locations. Factory is required to identify the corroded locations and investigate the reason of corrosion and suggest proper remedial measure accordingly.

| Item No. | Observation | Recommended Action Plan | Recommended Timeline |
|---|---|---|---|
| 09 | Corrosion in steel member. (Shed-1) | The building engineer to investigate the reason & extent of corrosion and suggest proper remedial measure accordingly. | 6-weeks |
| 10 | Corrosion in steel member. (Shed-1) | Take necessary measures to prevent further corrosion and repair the corroded steel members as per engineer's suggestion | 6-months |

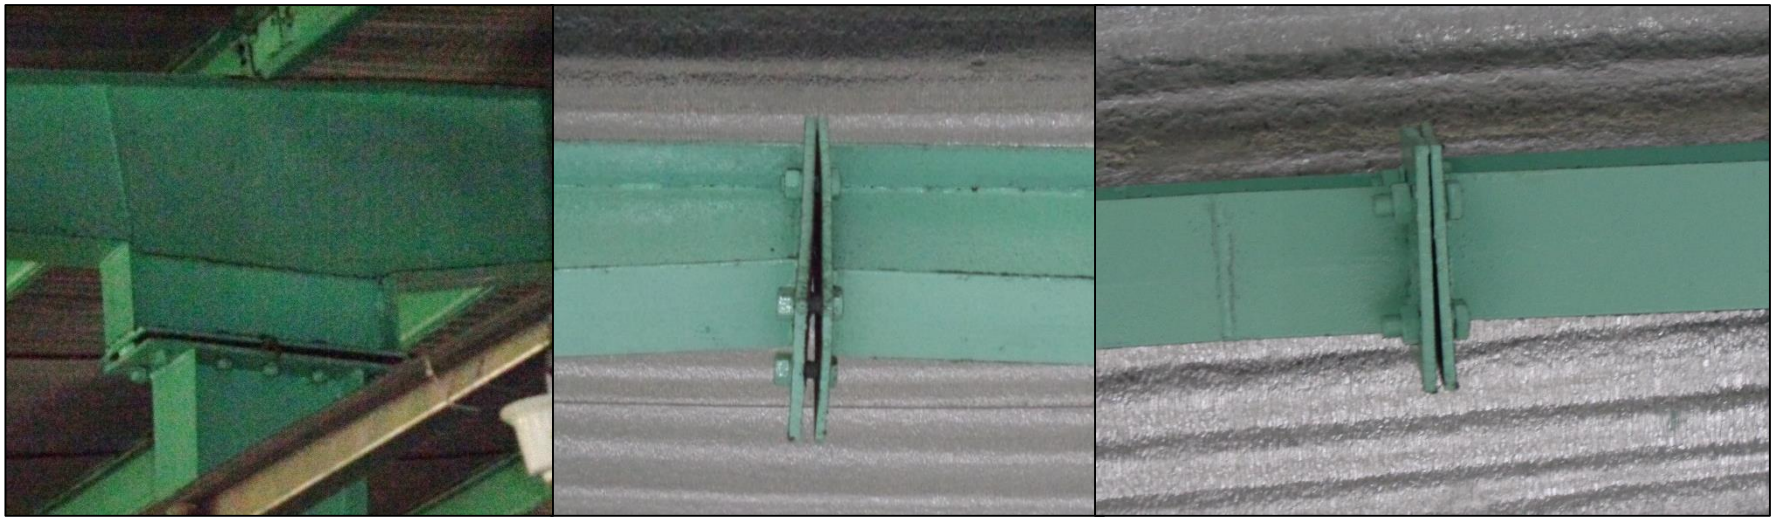
Gap observed at several locations in connection of rafter-rafter & column-rafter.

Significant gaps and bolts missing observed at column rafter joint at several location. Factory engineer is required to install missing bolts and carry out suitable remedial works for connection gap.

| Item No. | Observation | Recommended Action Plan | Recommended Timeline |
|---|---|---|---|
| 11 | Significant gap and bolt missing at several location. (Shed-1) | Identify the locations and carryout suitable repair works for connection gap. | 6-weeks |

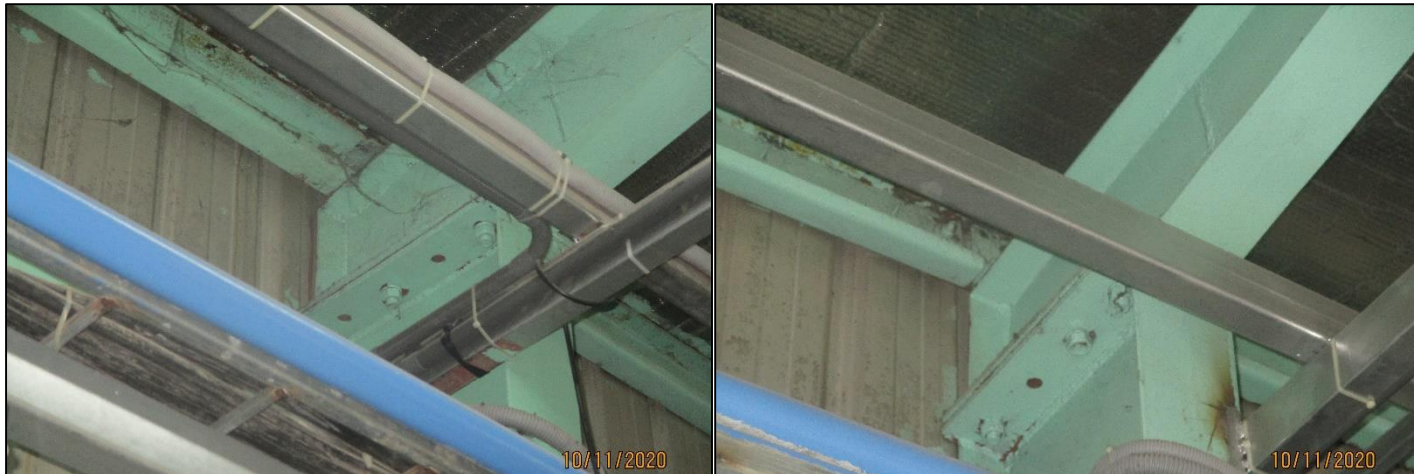
Bolt missing observed in several locations.

| Item No. | Observation | Recommended Action Plan | Recommended Timeline |
|---|---|---|---|
| 12 | Significant gap and bolt missing at several location. (Shed-1) | Install missing bolts where necessary. | 6-weeks |

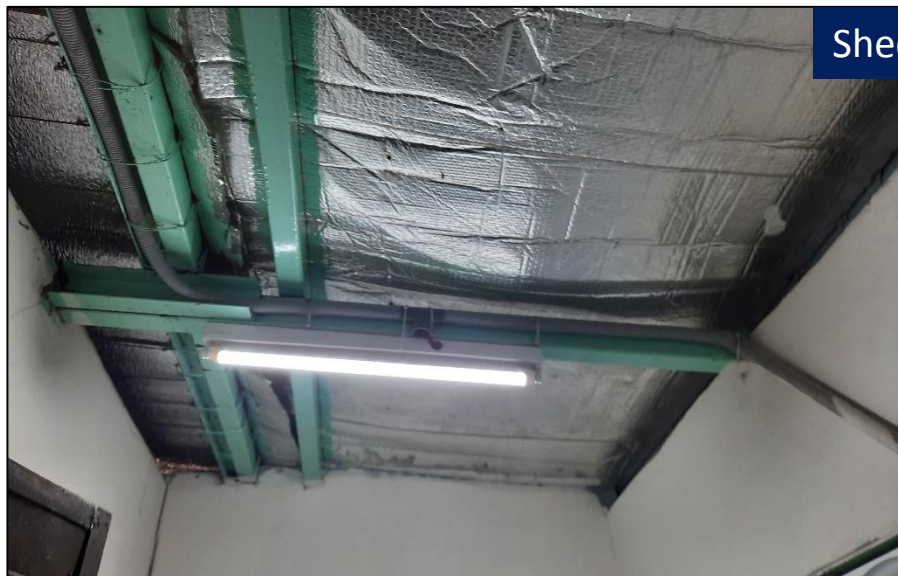
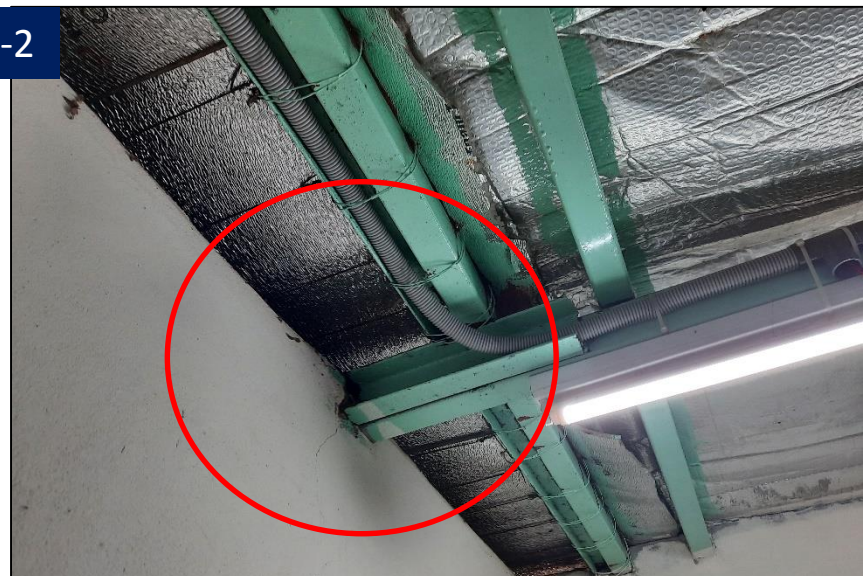
Shed-2

Inadequate structural member, poor connection details observed. Apparently non-engineered shed.

| Item No. | Observation | Recommended Action Plan | Recommended Timeline |
|---|---|---|---|
| 13 | Apparently non-engineered shed.<br>(Shed 2 & 3) | Building engineer is required to check the adequacy of the rooftop sheds for gravity and lateral forces.<br>or<br>Replace with the engineered sheds. | 6-weeks |
| 14 | Apparently non-engineered shed.<br>(Shed 2 & 3) | Carry out remedial works where required. | 6-months |

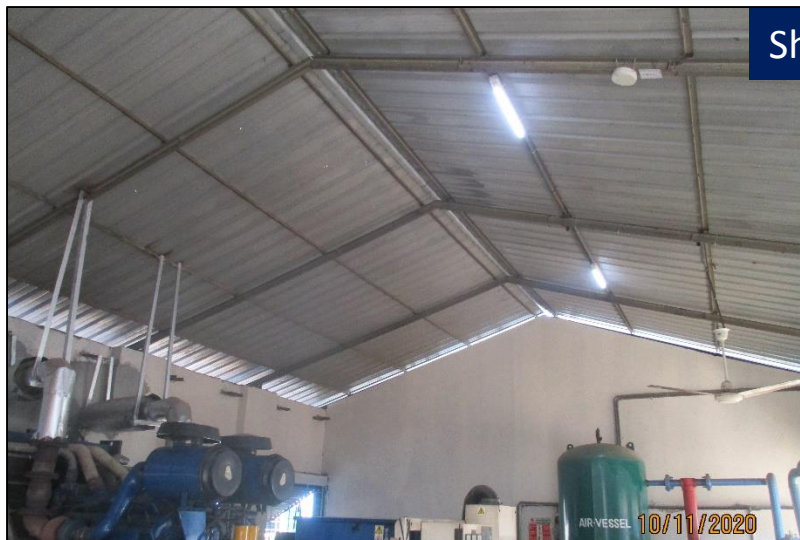
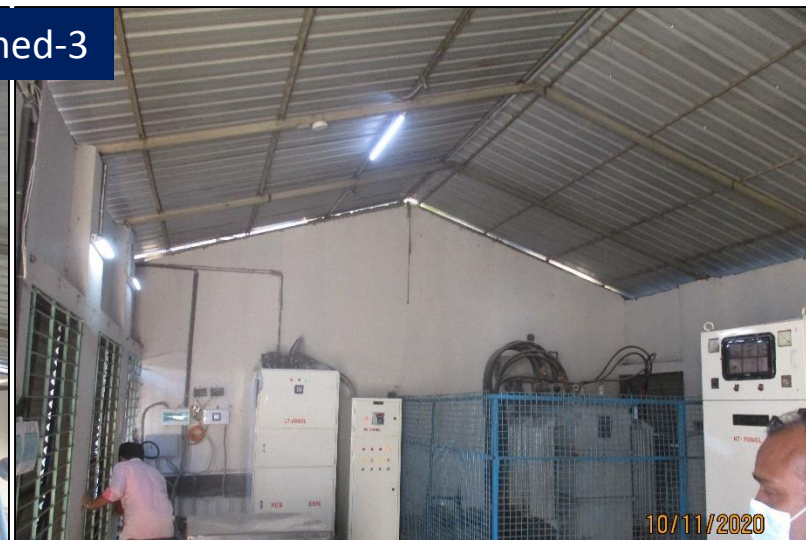
Shed-3

Inadequate structural member, poor connection details, unrestraint gable wall observed. Apparently non-engineered shed.
