# A M Fashion

Mazu Khan Bazar, Harbaid, Gazipur-1710.

1<sup>st</sup> February 2021

# Building Information

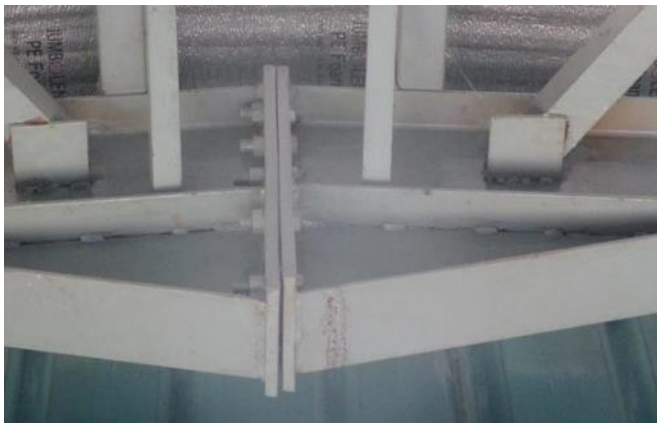
Bolted connections of Part - A

Connections of Part-A were found both bolted & welded. In Part-B, connections were found as welded. But in structural drawing, no connection details was provided.

| Item No. | Observation | Recommended Action Plan | Recommended Timeline |
|---|---|---|---|
| 01 | Lack of information in drawing. (Production Building) | Factory engineer is required to survey the whole structure and prepare “as constructed” drawings (Architectural & Structural), in compliance with section 1.9.1.2 as per BNBC 2006. | 6-weeks |
| 02 | Lack of information in drawing. (Production Building) | Building engineer to prepare the design document including a design report for the full structure, in compliance with section 1.9.1.1 as per BNBC 2006. | 6-weeks |

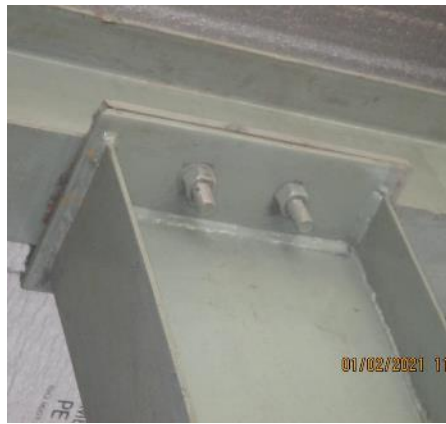
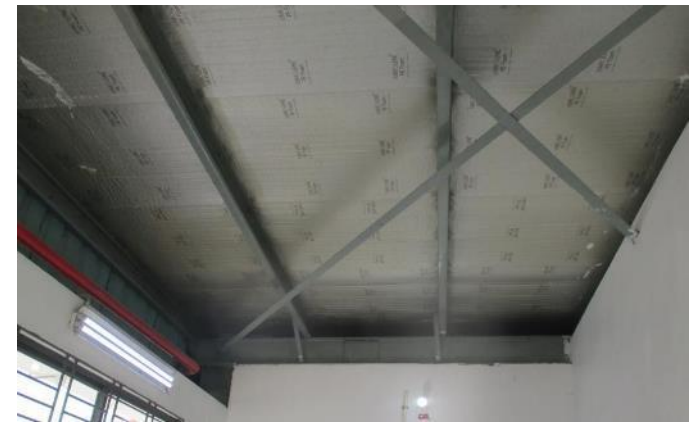
Welded connection of roof bracings  
(Part - A)

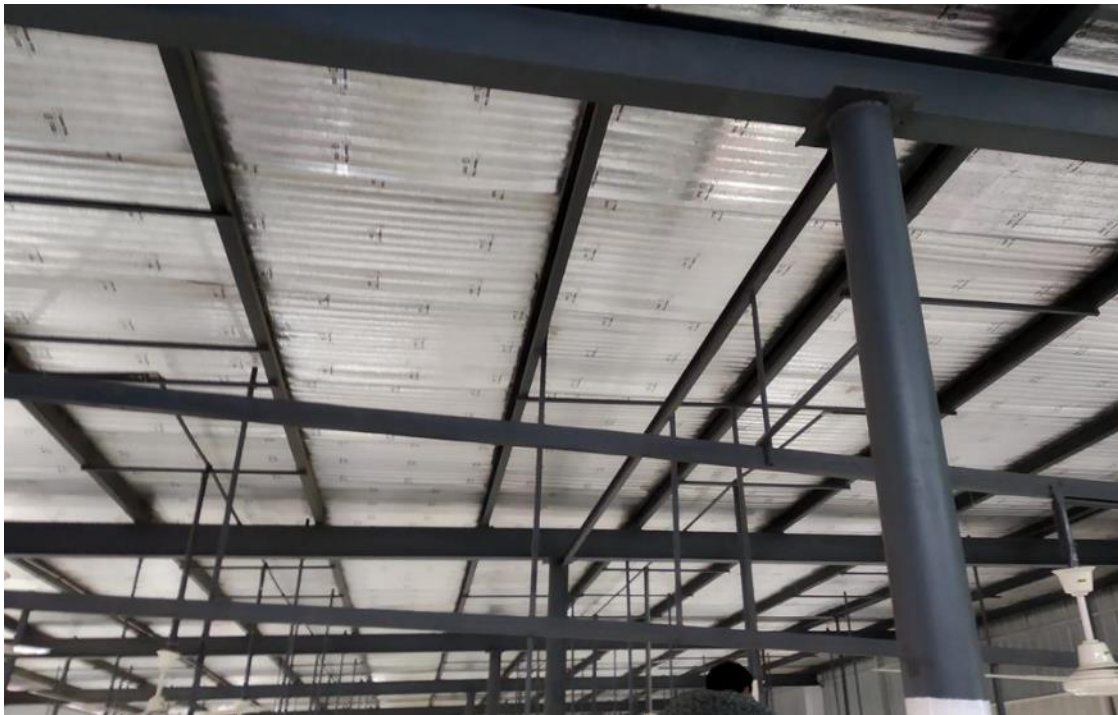
Welded connections of Part - B

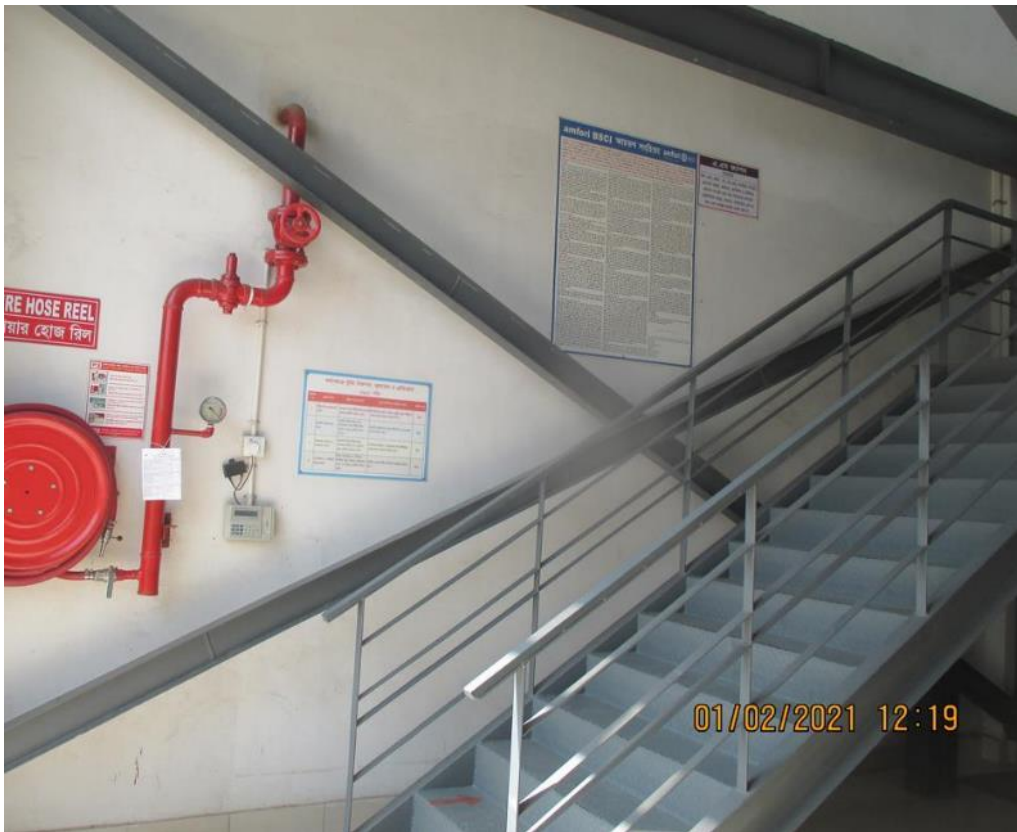
Stair on south-west side

There are two steel stairs on North-West and South-West side of Part – A of the structure. No details of any of the stairs was provided in the drawing. Moreover, bracing layout and bracing details were not incorporated in the drawing.

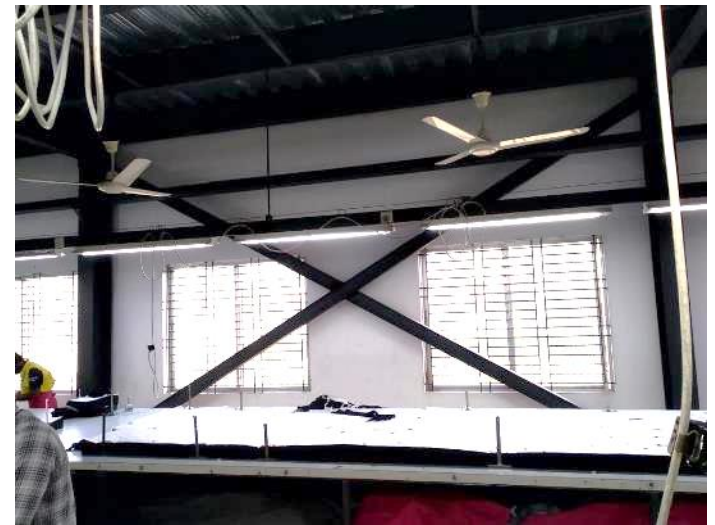
Vertical bracing at GF of Part - A

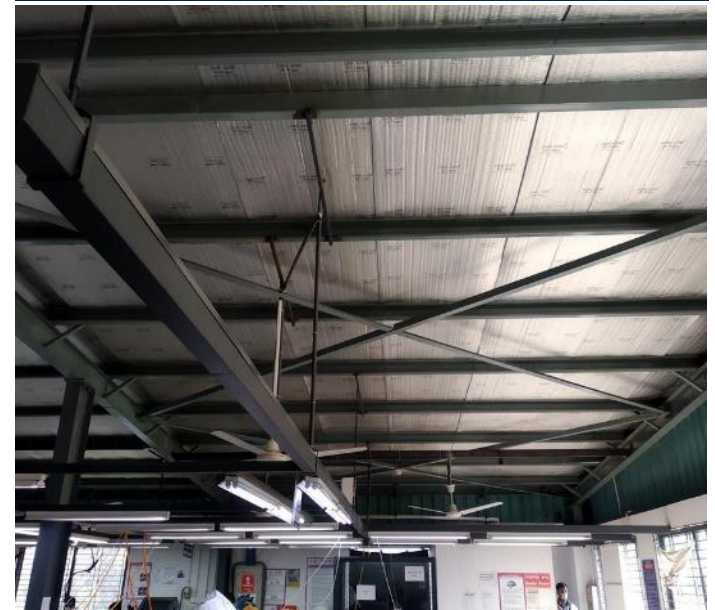
Roof bracing on Part - A

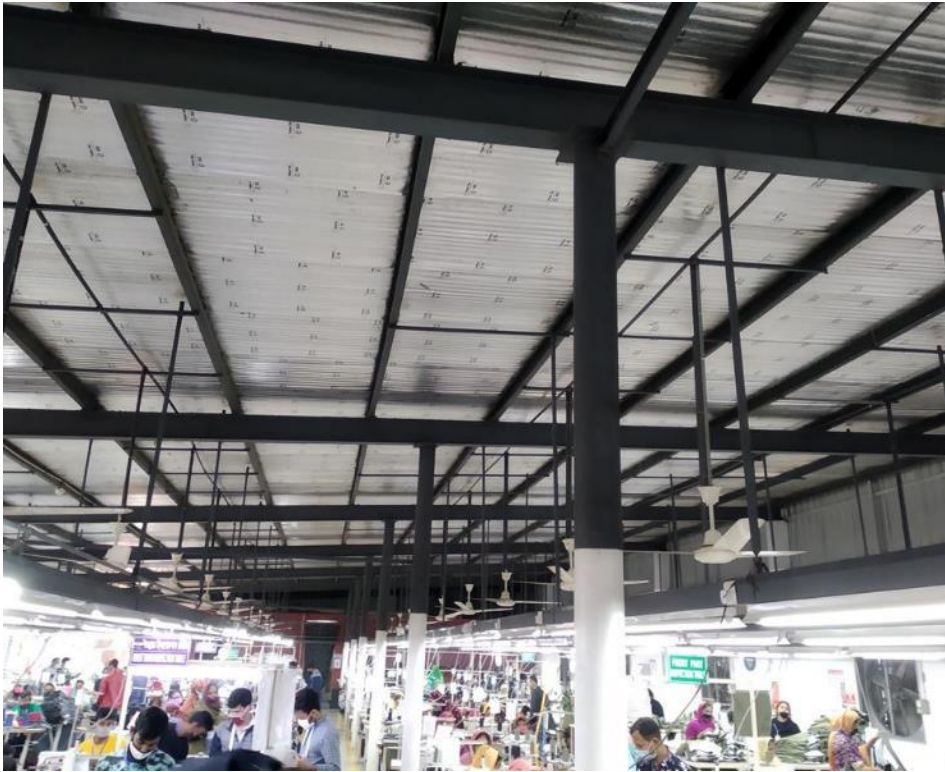
Framing system of Part - B

The provided section of Part – B has no dimensions mentioned. Moreover, section of grid- 1, 7 & 15 was not included in the provided as-built drawings.

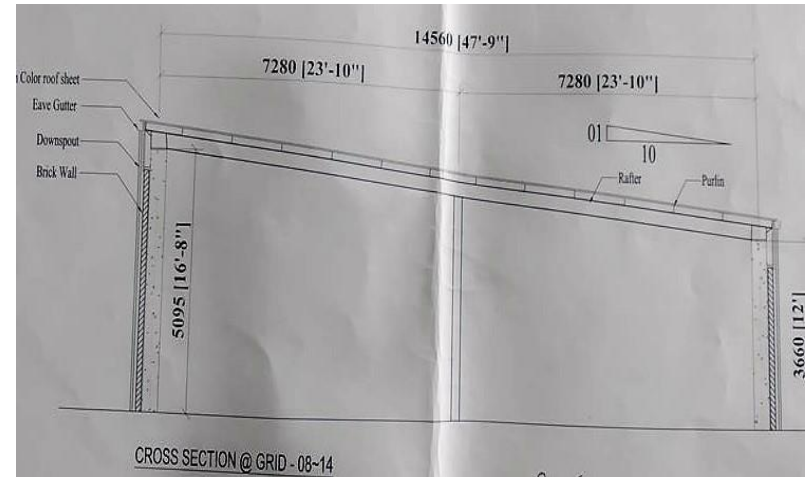
Section of Part – B without any dimensions

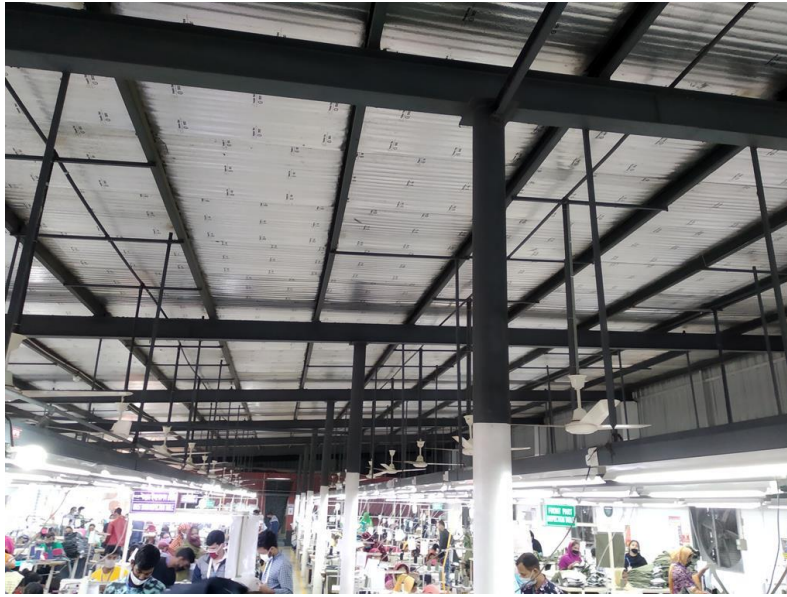
Interior of the building

The steel roof shed did not have specified load path to transfer lateral loading. Also, apparently unclear connection between RC column to rafter was found. Factory engineer is required to specify the load path and connection of the structure. Moreover, check the lateral stability of the shed as well as the adequacy of the connection.

| Item No. | Observation | Recommended Action Plan | Recommended Timeline |
|---|---|---|---|
| 03 | Lack of lateral stability system. (Production Building Part-B) | Factory engineer is required to check the lateral stability of the structure and adequacy of the connections as part of Engineering Assessment (EA) in compliance with section 1.9.1 (part-6, BNBC 2006). | 6-weeks |
| 04 | Lack of lateral stability system. (Production Building Part-B) | Complete implementation of any remedial works deemed necessary by the Engineering Assessment (EA). | 6-months |

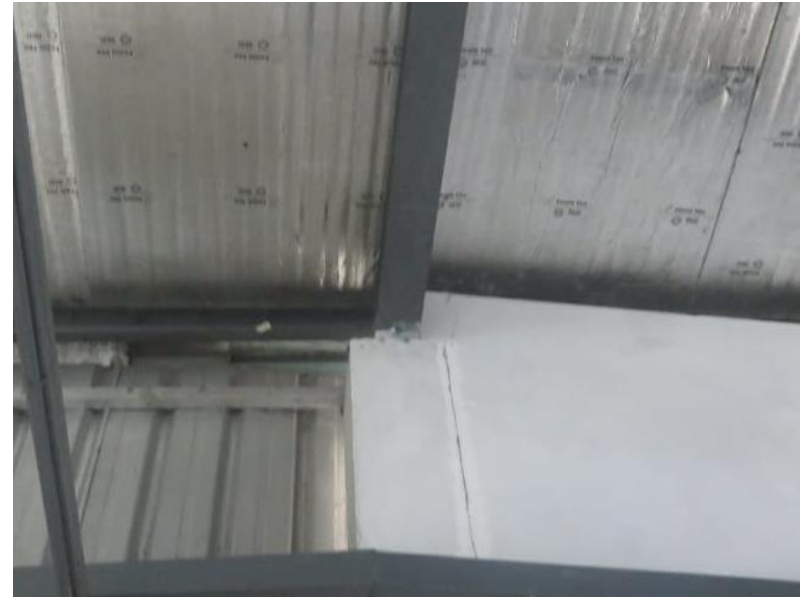
RC column to rafter connection

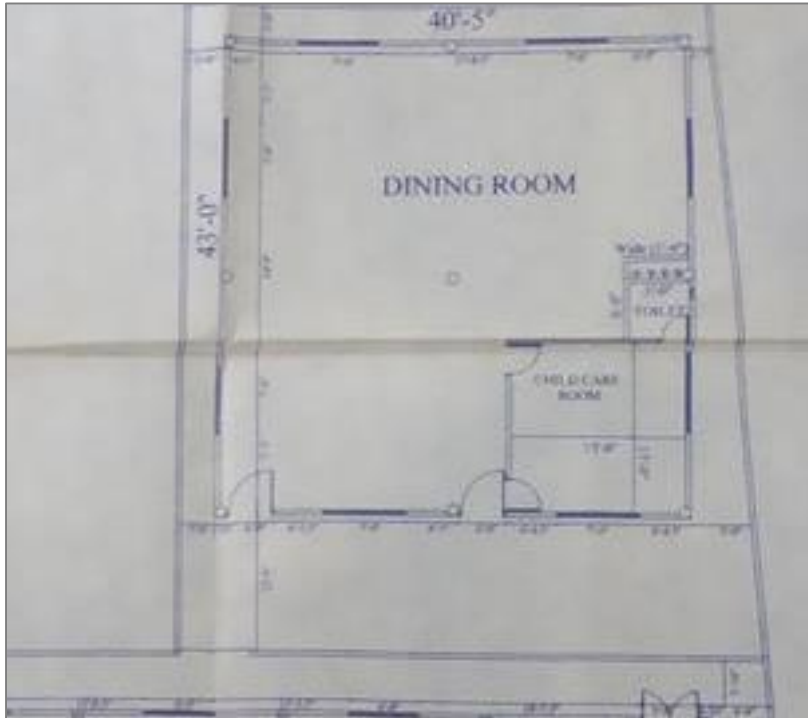
Approved layout plan from DIFE

There were no credible as-built drawings and documents to review except permit drawing of Industrial layout from DIFE. Provided drawings were insufficient to represent the as-built structure. Factory engineer is required to survey the structures and prepare as-built drawings, in compliance with section 1.9.1.2 as per BNBC 2006.

| Item No. | Observation | Recommended Action Plan | Recommended Timeline |
|---|---|---|---|
| 05 | Lack of as-built drawings. (Dining Shed) | Building Engineer to survey the whole structure and prepare accurate as-built drawings in compliance with section 1.9.1.2 as per BNBC. | 6-weeks |
| 06 | Lack of as-built drawings. (Dining Shed) | Building engineer to prepare the design document including a design report, and a set of structural drawings in compliance with section 1.9.1.1 and section 1.9.1.2 as per BNBC. | 6-weeks |

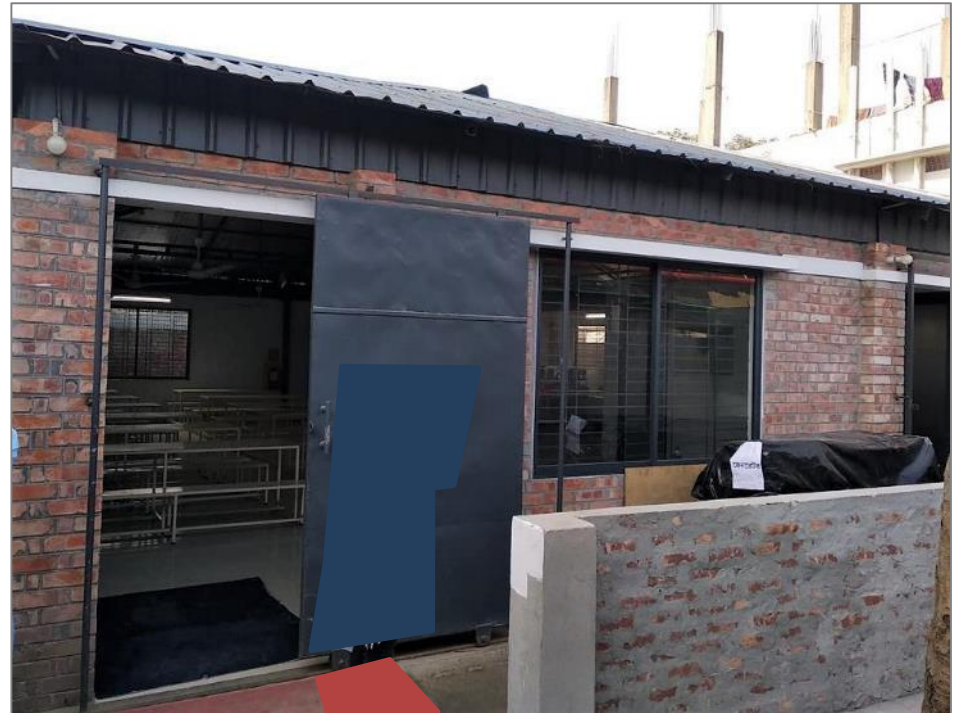
Dining Shed

| Item No. | Observation | Recommended Action Plan | Recommended Timeline |
|---|---|---|---|
| 07 | Lack of as-built drawings. (Dining Shed) | Complete implementation of any remedial works deemed necessary by the Design Report. | 6-months |

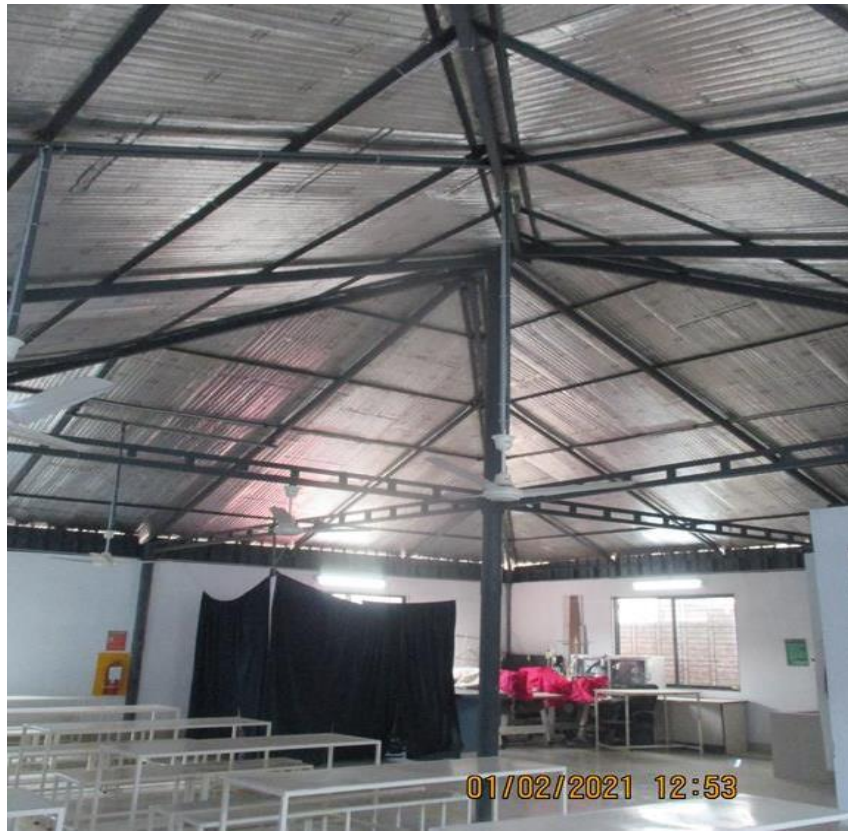
Interior of the building

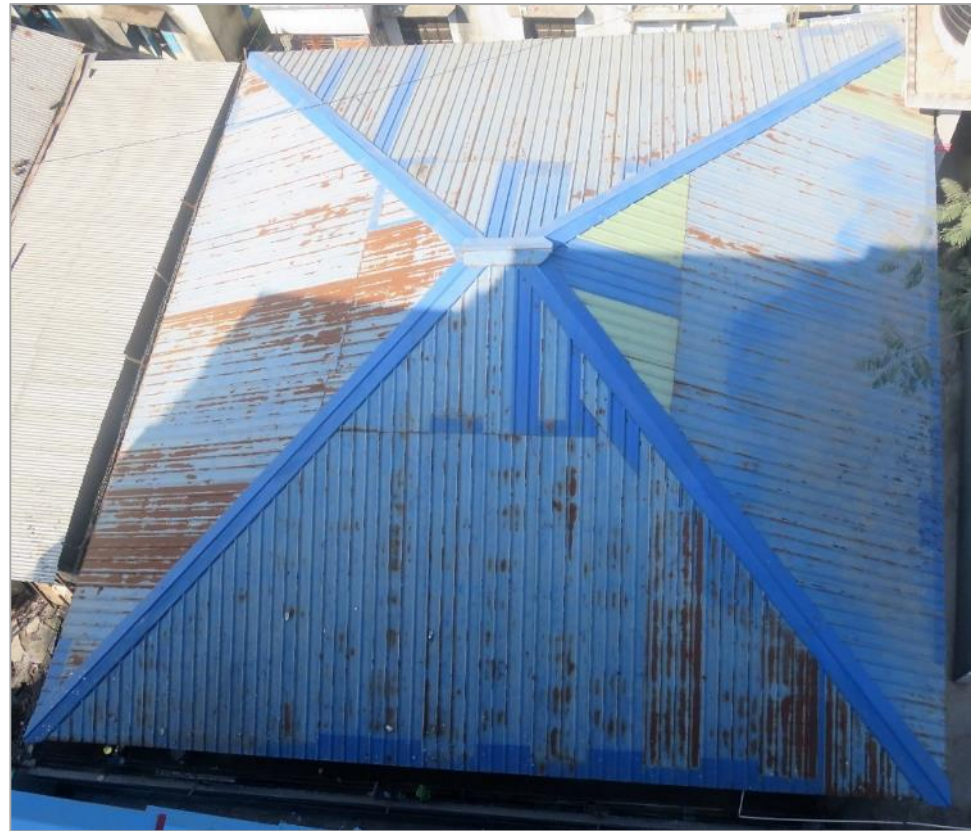
Ariel view
