Next Export Zone Ltd.

105/4, Adaboi, Peara Bagan, Joydebpur, Gazipur, Bangladesh
(23.970740, 90.425149)

24th Feb 2020

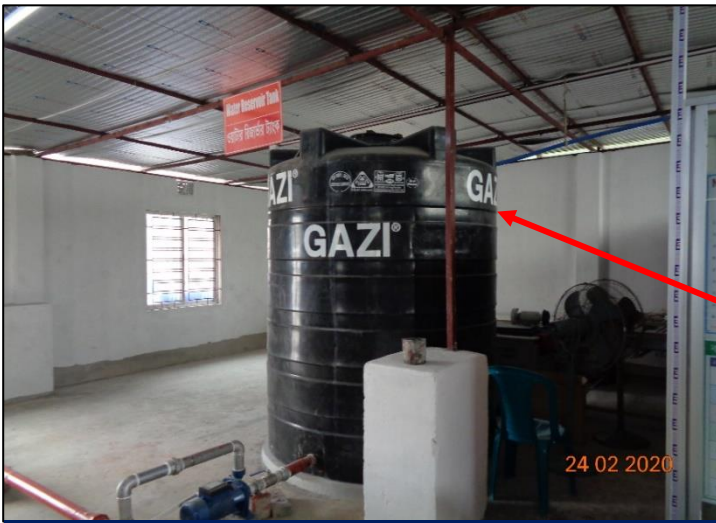
Undocumented 5000 Ltr water tank

Undocumented water tanks were found on existing roof. Also a non-engineered supporting structure was found at roof level. Factory engineer is required to survey and update the as-built condition.

Item No.	Observation	Recommended Action Plan	Recommended Timeline
01	Undocumented water tanks and apparently non-engineered supporting structure on the roof. (Main Building)	Building Engineer is required to relocate the existing water tanks as per accepted load plan. Also, survey the supporting structure and take necessary remedial actions.	6-weeks
02	Mismatches in the design report and software analysis file. (Main Building)	The building engineer to update the engineering assessment (structural design) report including the software analysis file and submit to Accord for further review.	6-weeks
03	Mismatches in the design report and software analysis file. (Main Building)	Update and active manage the floor loading plans based on the column and floor capacity of the building.	6-weeks
04	Mismatches in the design report and software analysis file. (Main Building)	Complete remedial works arising from engineering assessment.	6-months

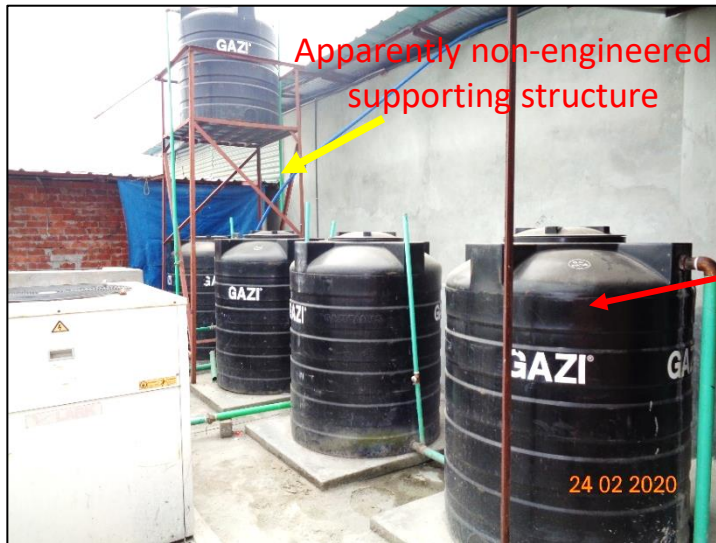
Undocumented 4 nos 1000 Ltr and 1 no 750 Ltr water Tank

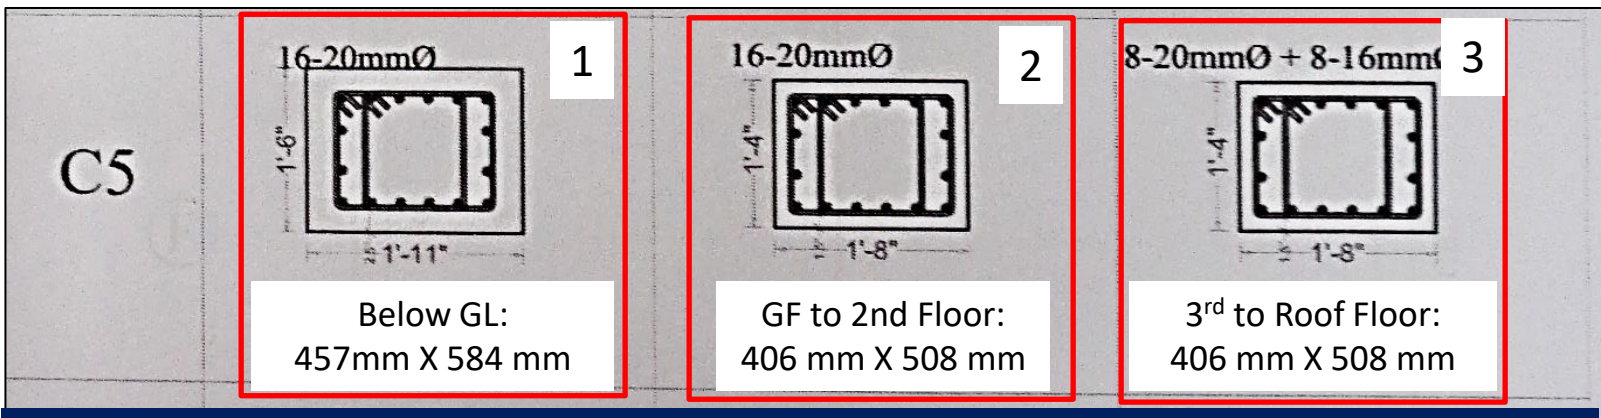
Column size has been shown in drawing: 1- 457mm X 584mm; 2 & 3 – 406mm X 508 mm

C5 Column Size found in FEA model:
1- 457 mm X 685 mm; 2 & 3- 406 mm X 609 mm.
The column sizes in the FEA model are greater than sizes shown in the provided drawings.
The factory engineer to verify the actual sizes of columns and re-check the capacity accordingly.

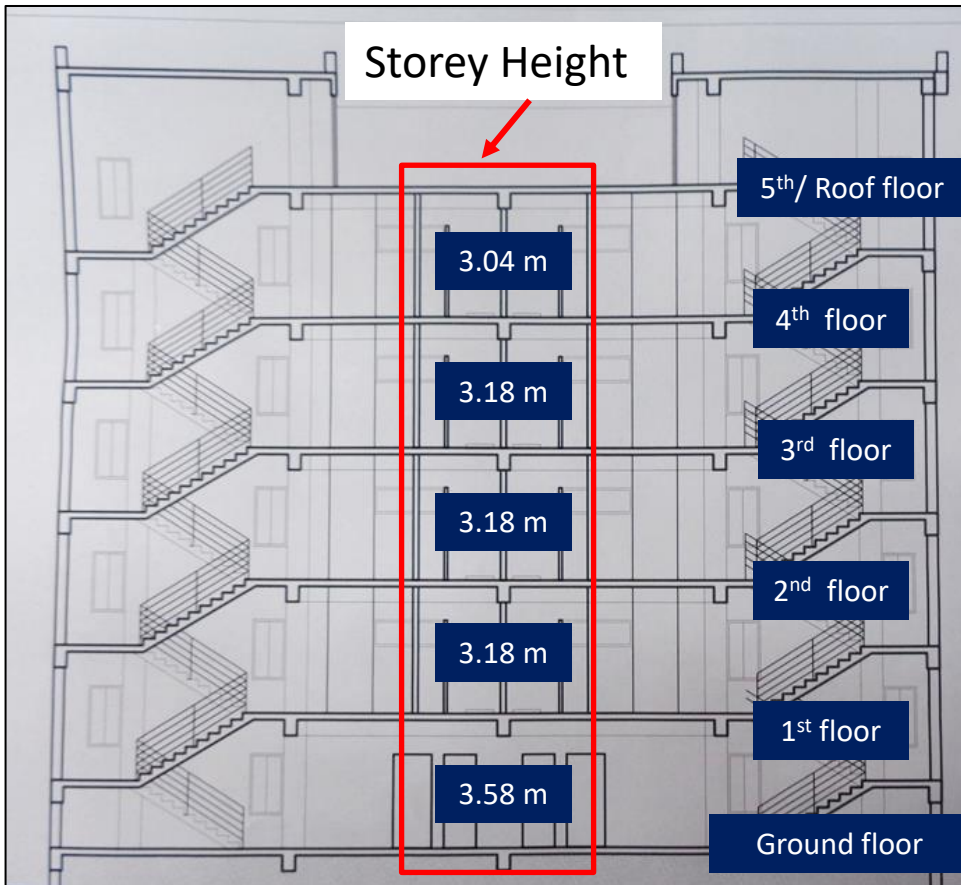
Sectional elevation of 5 storey building

Storey height and number of the storey found mismatch in between FEA model and as-built drawing. Also, in the as-built drawings, the structure has been shown as 5 storied RC structure where 6 storied in the FEA model.

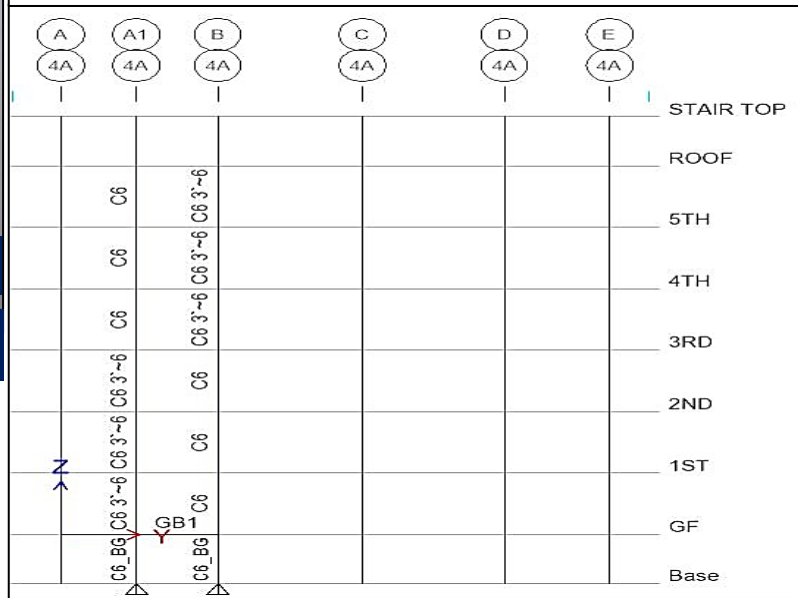
Storey Height of 6 storied building in E-tabs

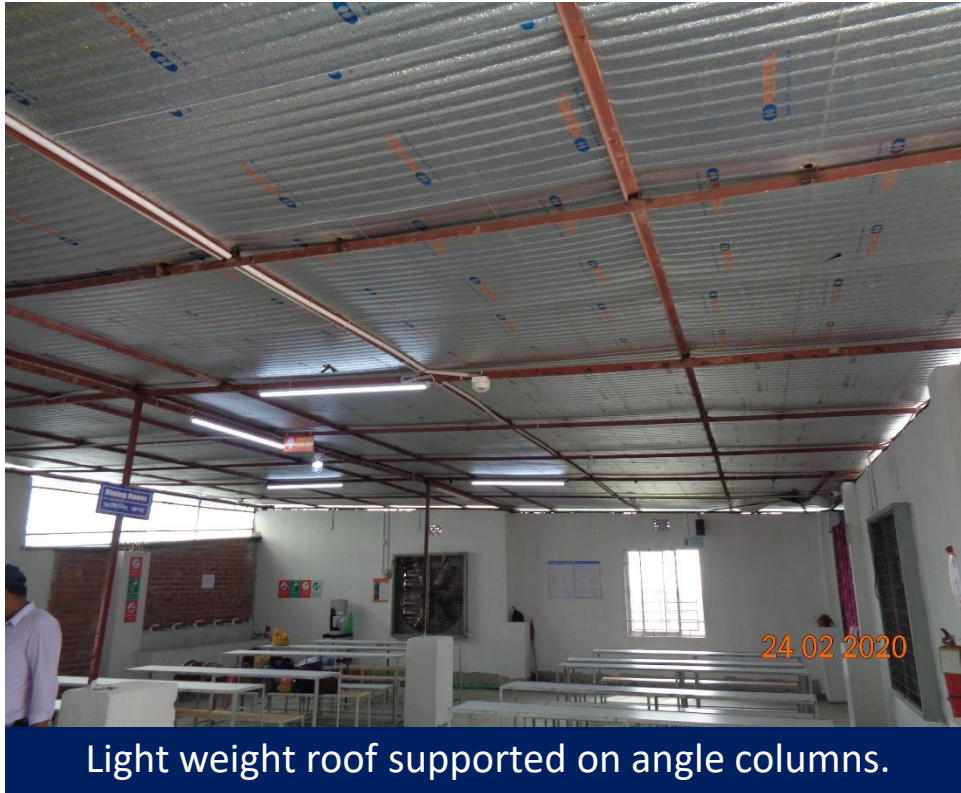
Light weight roof supported on angle columns.

Non-engineered shed was found at roof level. Light weight roof structure supported on box columns made by two 38 mm X 38 mm angles. The connections were non-engineered. On the other hand, no structural documentation was available onsite for the shed.

Item No.	Observation	Recommended Action Plan	Recommended Timeline
05	Mismatches in the design report and software analysis file. (Main Building)	Continue to implement load plan.	6-months
06	Non-engineered shed at roof (Main Building).	Remove or demolish the temporary shed. Otherwise, replace the existing shed with an engineered structure.	6-weeks
07	Lack of as-built documents (Ancillary Structures).	The building engineer to survey the structure and produce as-built drawings with complete structural information.	6-weeks
08	Non-engineered connection on Medical & Childcare shed.	Building engineer to check the connections and capacity of the lightweight roof structure against lateral loading.	6-weeks
09	Non-engineered connection on Medical & Childcare shed.	Carry out remedial works resulting from engineering assessment.	6-months

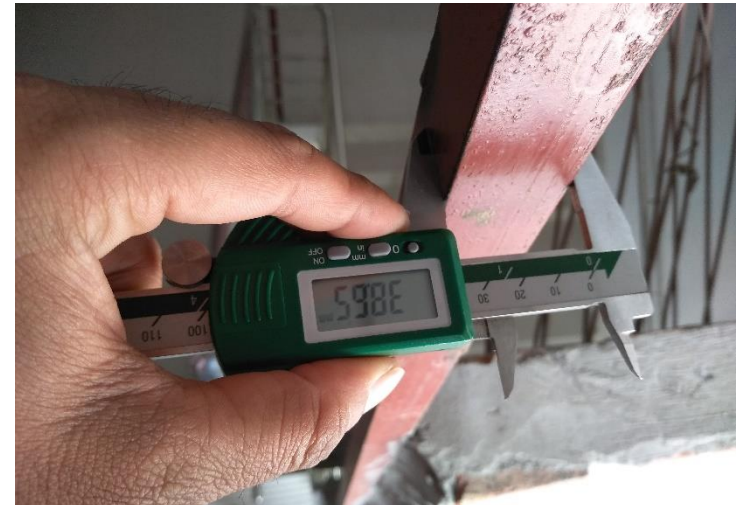
38 mm X 38 mm box

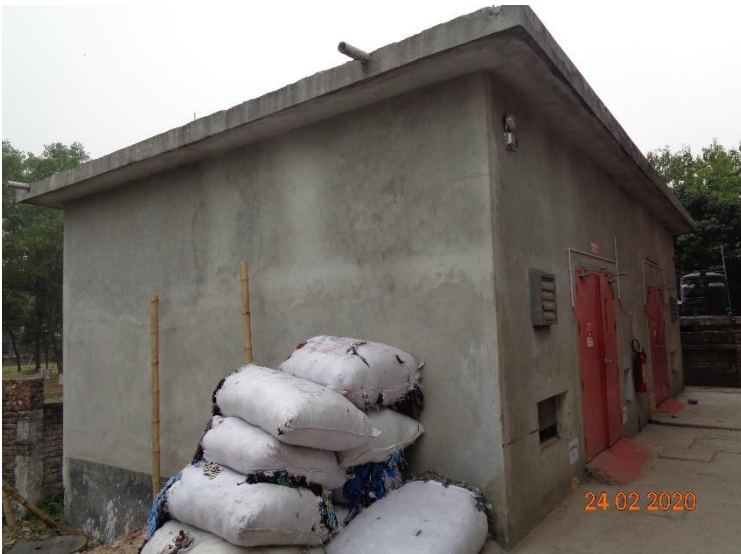
Generator & Sub-station room

No documents were available for Boiler room, Generator & Sub-station room, Medical & Childcare shed.

Building engineer is required to prepare “as constructed” drawings that includes connection details which reflect the actual site dimensions with complete structural information.

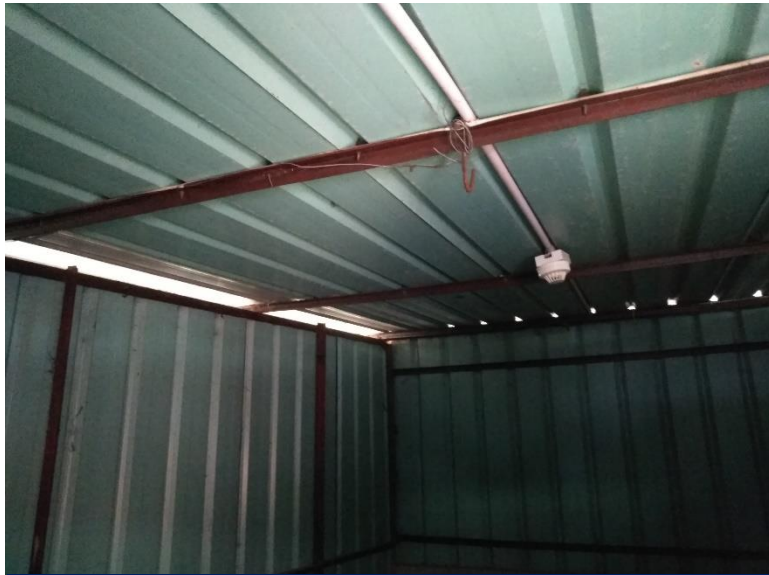
Non-engineered connections

Light weight roof structure supported on 37 mm X 37 mm angle. The connections appeared to be non-engineered. Building engineer to check the capacity of the lightweight roof structure against lateral loading.
