# MANTA APPARELS LTD (Extended Building)

DIAKHALI, YEARPUR, JAMGARA, SAVAR, DHAKA.

4<sup>th</sup> March 2021

**Design report needs to be revised**

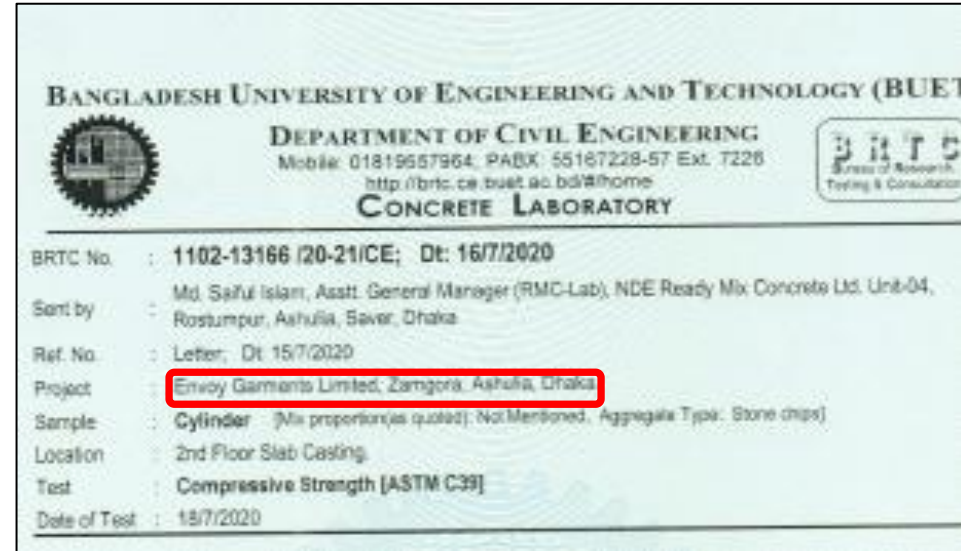
Material strength (3500 psi) considered in Design report

In cylinder test report the name of the factory building has not been mentioned. So the cylinder test report do not represent the factory building.

Design strength 3500 psi is considered in design report for material specification. Eight sets of concrete cylinder test report for Extension Building-1: Two sets from foundations, five sets from slabs and one set from unknown location but no cylinder test report for column was available. Therefore, the available sets of test reports do not meet the requirement for frequency of cylinder test report for any structural member as per BNBC.

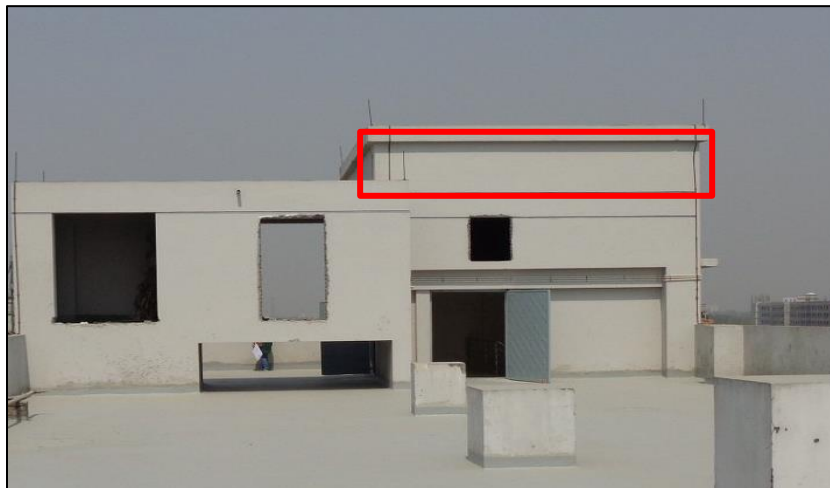
In as-built structural drawing information of the roof top water reservoir has not been provided. Factory Engineer is required to incorporate details drawing of the overhead water tank in as-built structural drawing and revise the design report accordingly.
