Manel Fashion Ltd.

79/1, Bason, Viti Para, Gazipur.
(23.962769N, 90.357361E)
26th January 2021

Buildings Information

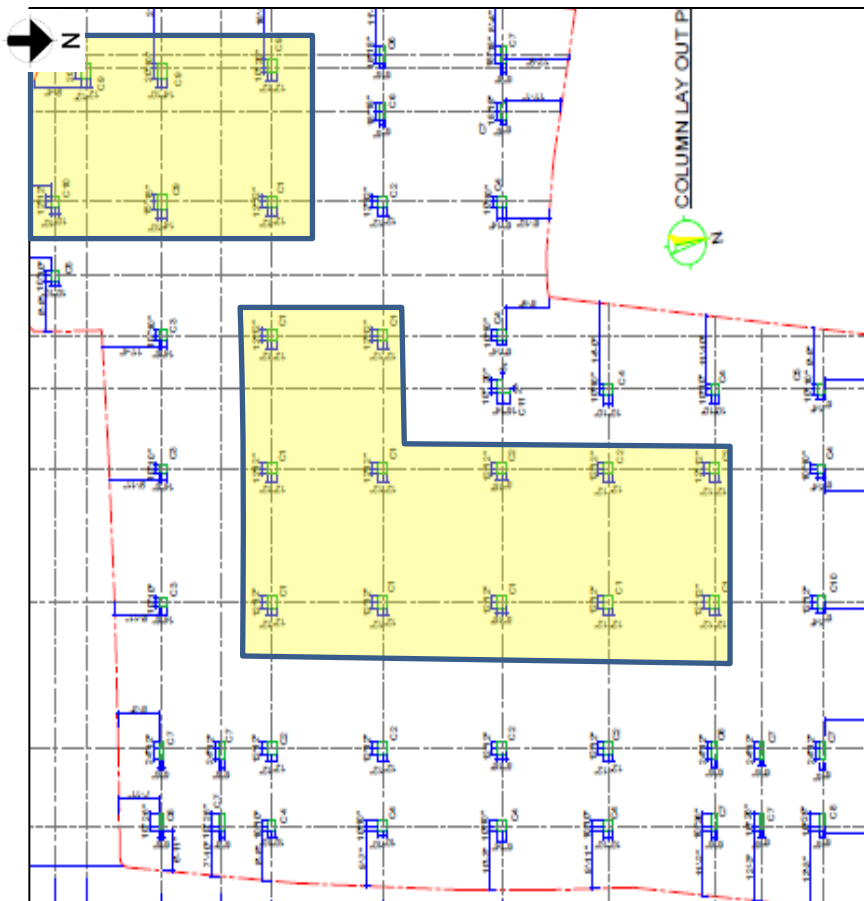
Column Layout Plan

Column to be stressed above normal design limit

Cursory calculation indicates that the working stress of ground floor column exceeds the design limits and that requires immediate design review. 6 kPa live load (As per provided load plan) on typical floor & 2 kPa live load on roof top and minimum concrete strength for stone chips are considered. Factory engineer is required to review design, load & column stress in the area identified above.

Item No.	Observation	Recommended Action Plan	Recommended Timeline
01	Column to be stressed above normal design limit. (Production Building)	Factory Engineer to review design, loads and columns stresses in area identified above.	6-weeks
02	Column to be stressed above normal design limit. (Production Building)	Verify in-situ concrete strength and aggregate type by taken min. 4 nos. 100mm dia. core samples from ground floor columns.	6-weeks
03	Column to be stressed above normal design limit. (Production Building)	Factory engineer to prepare Engineering Assessment (EA) including a design report, and a set of structural drawings in compliance with section 1.9.1.1 and section 1.9.1.2 as per BNBC.	6-weeks
04	Column to be stressed above normal design limit. (Production Building)	Produce and actively manage a loading plan for all floor plates within the factory, considering floor, column and foundation capacity.	6-weeks

05	Column to be stressed above normal design limit. (Production Building)	Complete implementation of any remedial works deemed necessary by the design review.	6-months

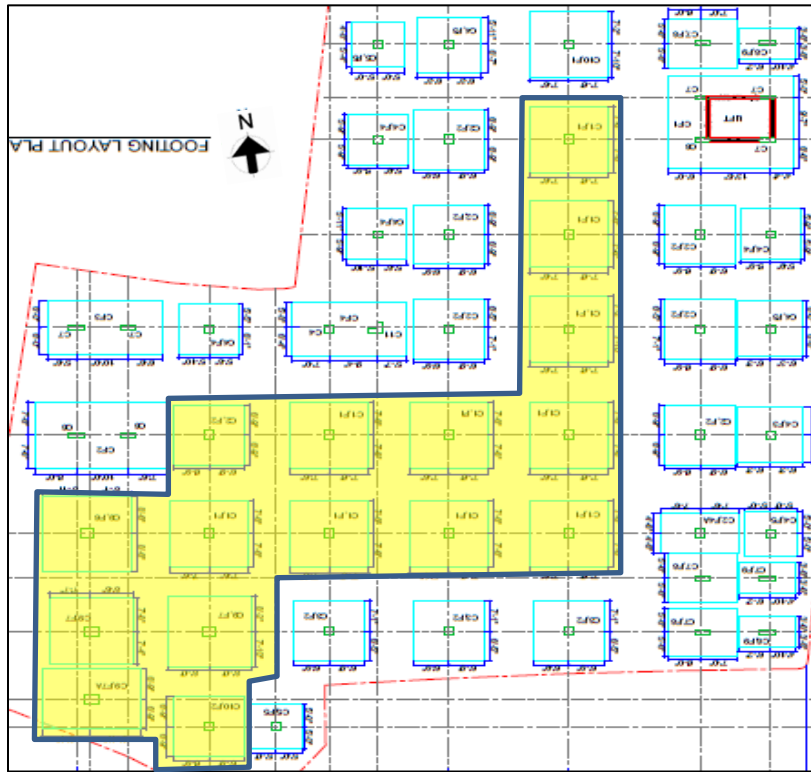
Foundation layout

Stress in foundation exceeds normal design limit

Cursory calculation indicates that the stress in foundations of the highlighted area exceeds normal design limit. Considering 6 kPa live load on typical floor & 2 kPa live load on roof top (As per provided load plan) and minimum concrete strength for stone chips, these footings have been found stressed in excess of normal design limit against the soil bearing capacity available from Geotechnical investigation report. Building engineer is required to carryout foundation adequacy check to justify the load carrying capacity.

Item No.	Observation	Recommended Action Plan	Recommended Timeline
06	Column to be stressed above normal design limit. (Production Building)	<ul style="list-style-type: none"> Continue to implement loading plan. 	6-months
07	Stress in foundation exceeds normal design limit (Production Building)	Building engineer is required to carryout foundation adequacy check to justify the load carrying capacity.	6-weeks
08	Stress in foundation exceeds normal design limit (Production Building)	Implement any remediation work if required.	6-months
09	No design report was available. (Utility Building)	Building engineer to prepare the design documents including a design report for the full structure, in compliance with section 1.9.1.1 as per BNBC	6-weeks
10	Corroded and exposed rebar at roof. (Utility Building)	All exposed reinforcements are to be protected from corrosion.	6-weeks

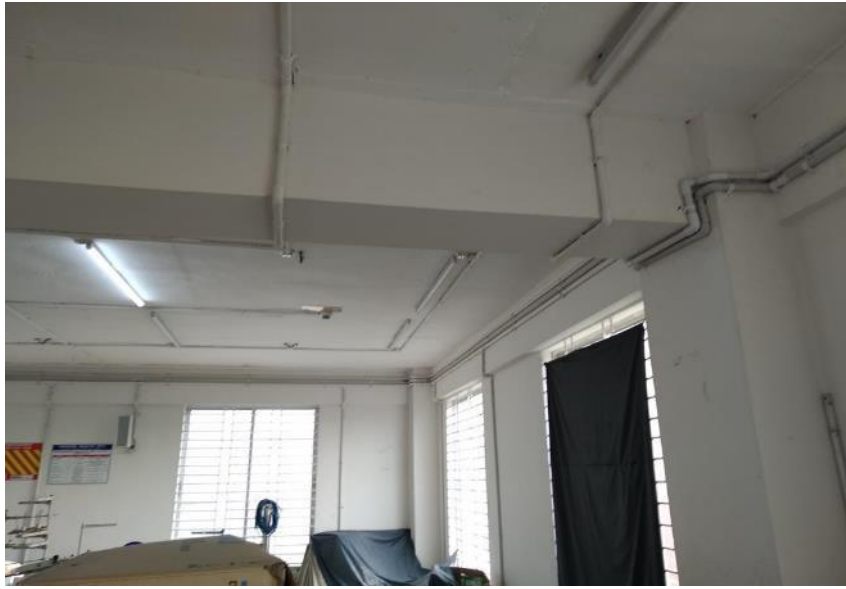
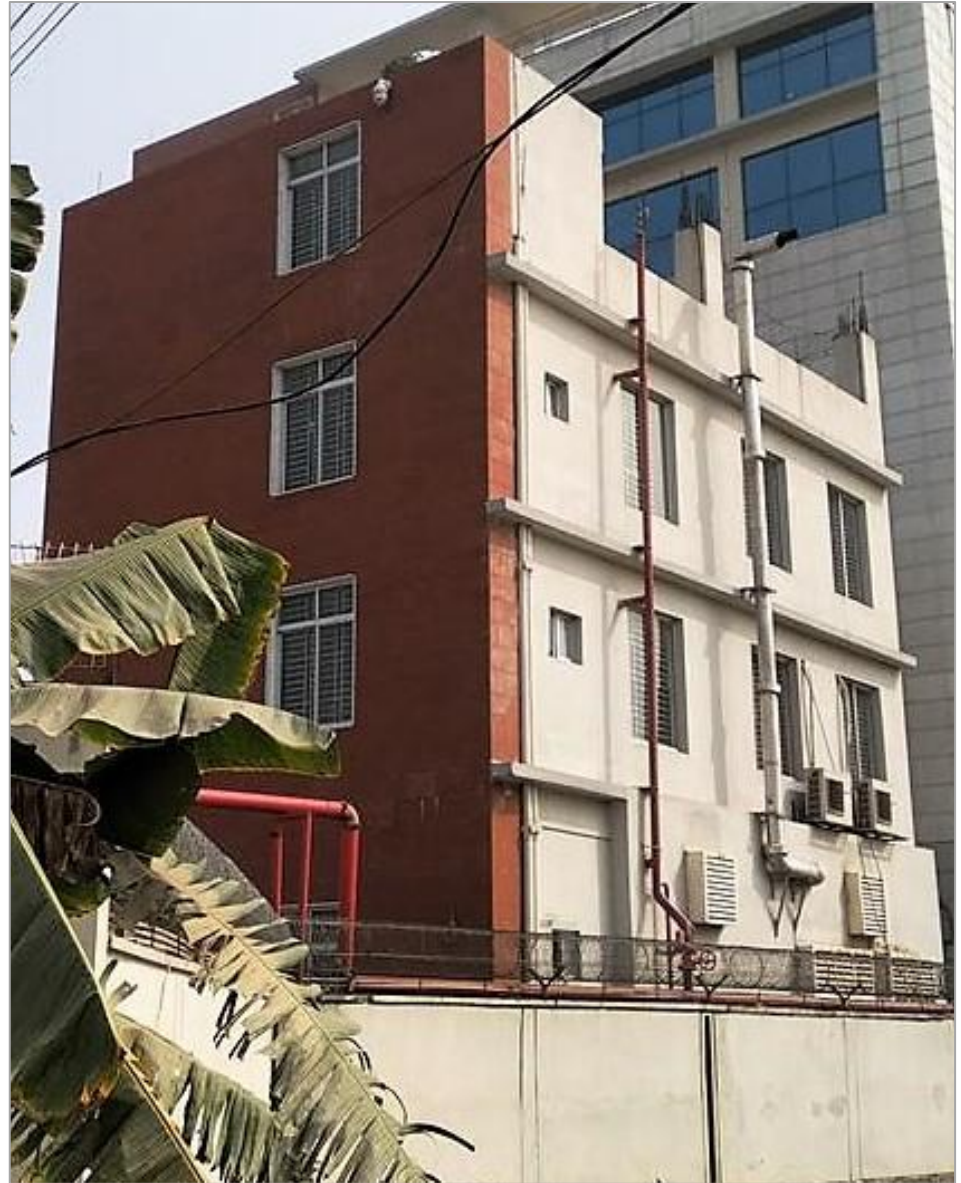
No design report was available

As per BNBC every building or structure designed shall have its design documents prepared in accordance with the provision of Section 1.9.1. The design document shall include a design report, and a set of structural drawings, which shall be prepared in compliance with section 1.9.1.1 and section 1.9.1.2 as per BNBC. During the inspection, design report was not available which is required to be prepared in compliance with section 1.9.1 (part-6, BNBC).

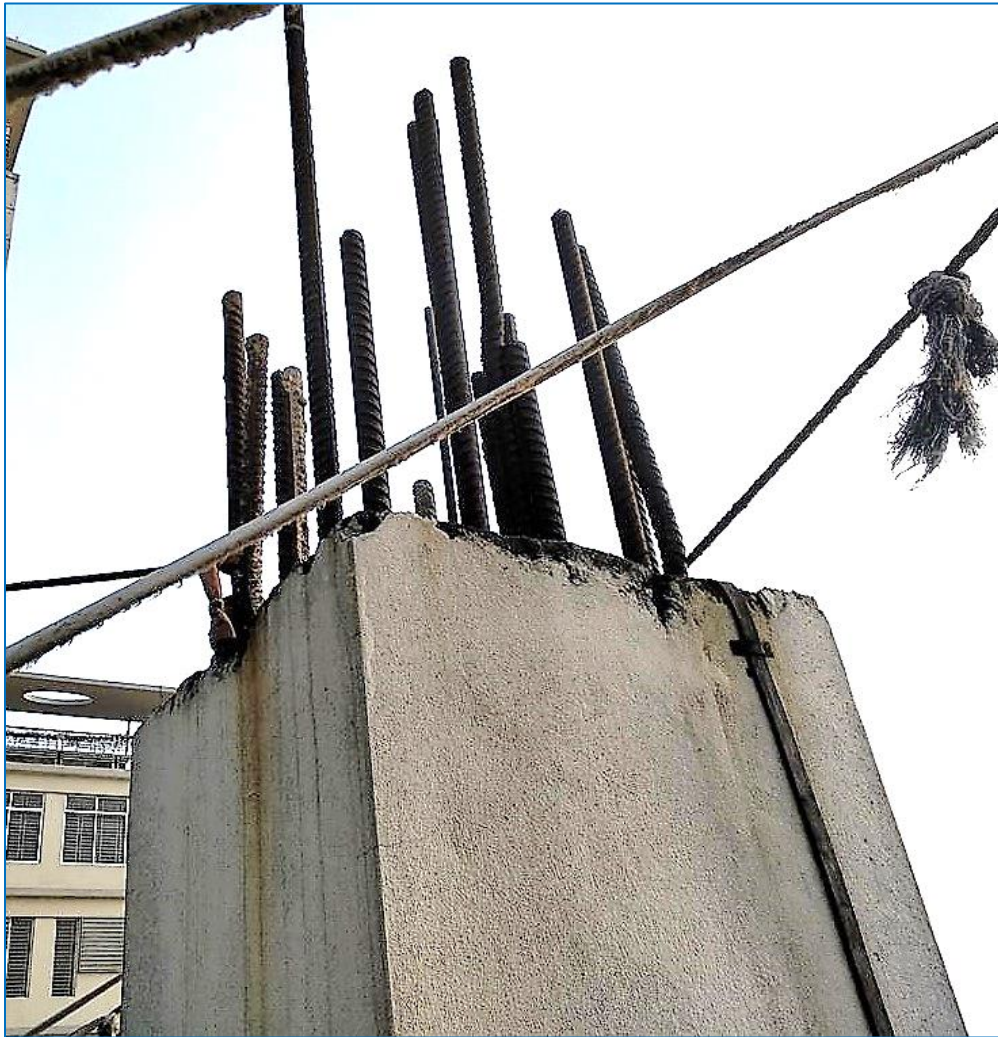
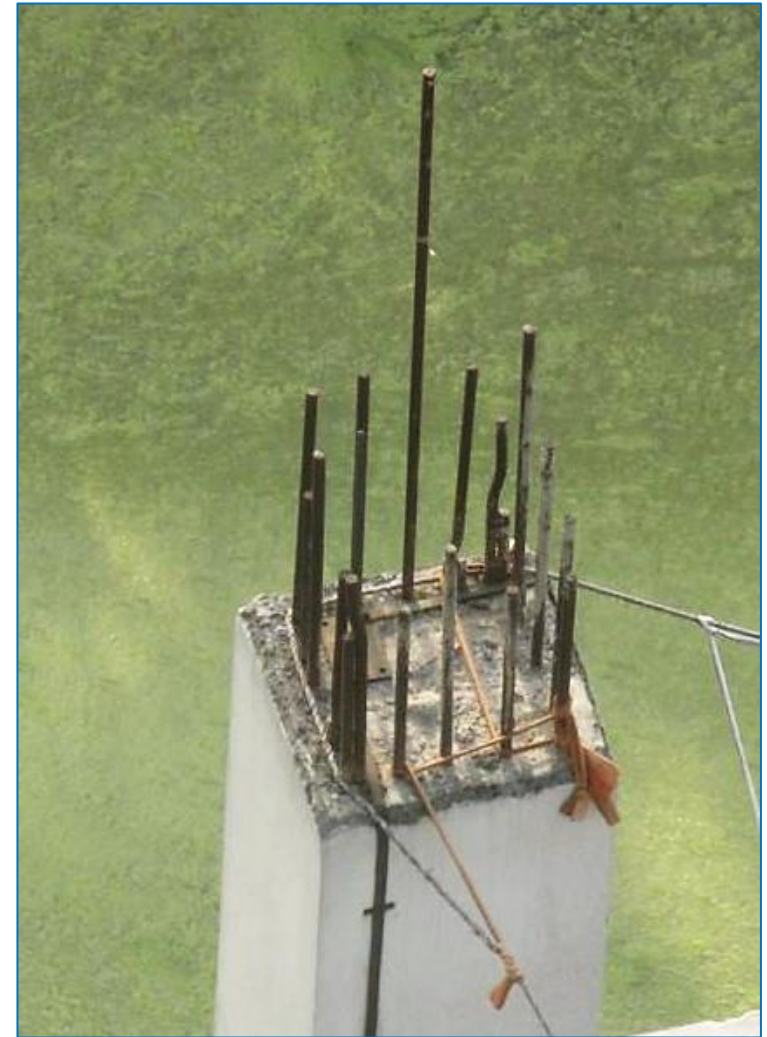
Corroded and exposed rebar at roof

Corrosion was observed on exposed reinforcements on roof top columns. All exposed reinforcements are to be protected from corrosion which may cause degradation of the concrete.

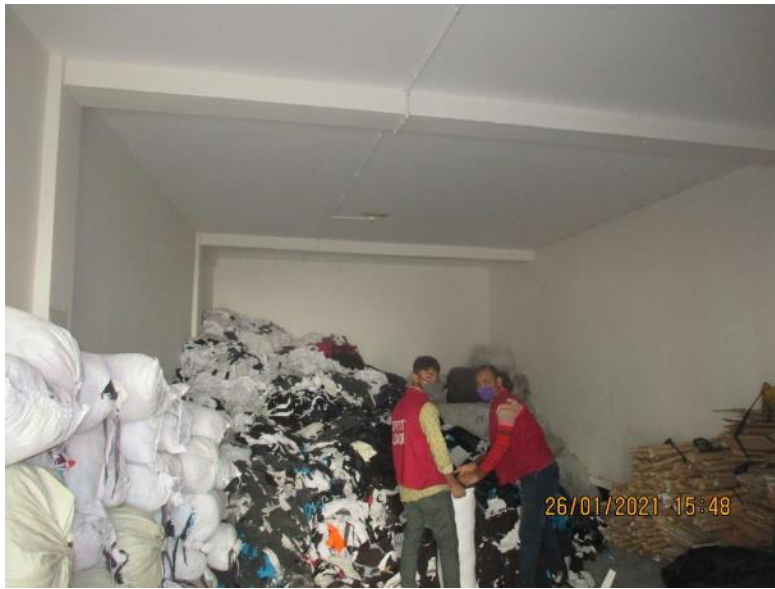
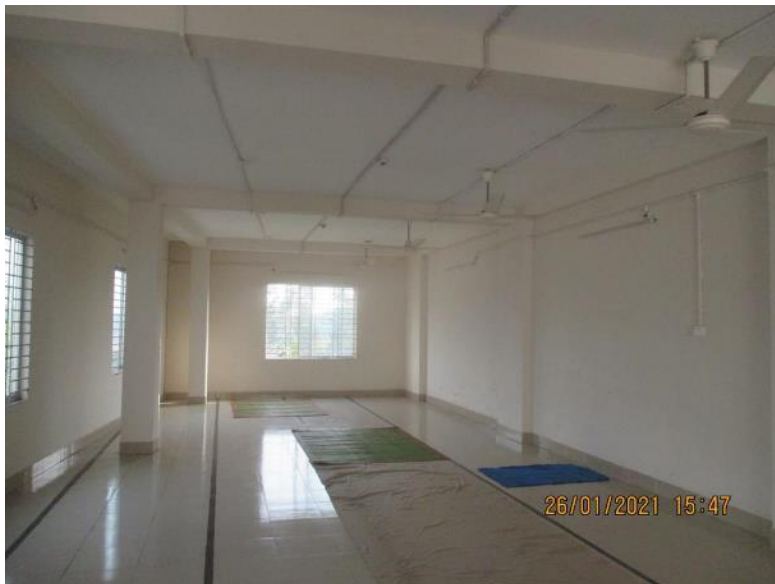
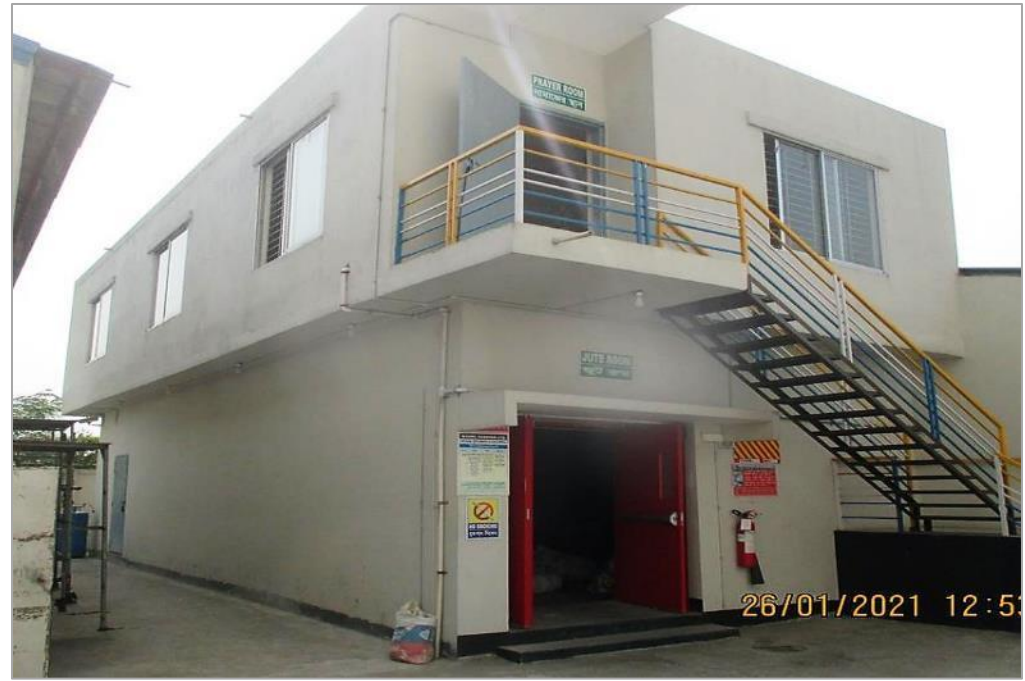
No design report was available

As per BNBC every building or structure designed shall have its design documents prepared in accordance with the provision of Section 1.9.1. The design document shall include a design report, and a set of structural drawings, which shall be prepared in compliance with section 1.9.1.1 and section 1.9.1.2 as per BNBC. During the inspection, as-built drawings and design report were not available which is required to be prepared in compliance with section 1.9.1 (part-6, BNBC).

Item No.	Observation	Recommended Action Plan	Recommended Timeline
11	Carryout Detail Engineering Assessment (Wastage Store Building)	Factory Engineer to review design, loads, column and foundation stresses.	6-weeks
12	Carryout Detail Engineering Assessment (Wastage Store Building)	A Detail Engineering Assessment to be commenced.	6-weeks
13	Carryout Detail Engineering Assessment (Wastage Store Building)	Verify in-situ concrete strength and aggregate type by taken min. 4 nos. 100mm dia. core samples or existing cylinder test reports from ground floor columns.	6-weeks
14	Carryout Detail Engineering Assessment (Wastage Store Building)	Produce and actively manage a loading plan for all floor plates within the factory, considering floor, column and foundation capacity.	6-weeks
15	Carryout Detail Engineering Assessment (Wastage Store Building)	Complete implementation of any remedial works deemed necessary by the Detail Engineering Assessment (DEA).	6-months

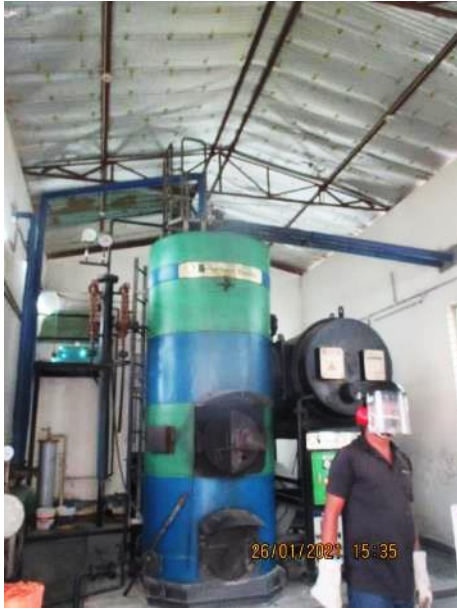
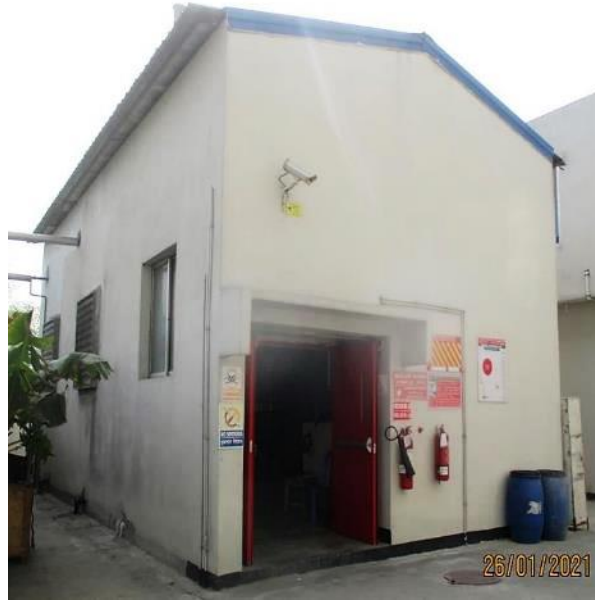
No design reports were available and apparently non-engineered connection at roof shed

As per BNBC every building or structure designed shall have its design documents prepared in accordance with the provision of Section 1.9.1. The design document shall include a design report, and a set of structural drawings, which shall be prepared in compliance with section 1.9.1.1 and section 1.9.1.2 as per BNBC. During the inspection, as-built drawings and design report were not available which is required to be prepared in compliance with section 1.9.1 (part-6, BNBC).

Item No.	Observation	Recommended Action Plan	Recommended Timeline
16	Carryout Detail Engineering Assessment (Wastage Store Building)	Continue to implement loading plan.	6-months
17	No design reports were available and apparently non-engineered connection at roof shed. (Boiler Shed)	Building Engineer to survey the whole structure and prepare accurate as-built drawings in compliance with section 1.9.1.2 as per BNBC.	6-weeks
18	No design reports were available and apparently non-engineered connection at roof shed. (Boiler Shed)	Building engineer to prepare the Engineering Assessment including a design report for the full structure, in compliance with section 1.9.1.1 as per BNBC.	6-weeks
19	No design reports were available and apparently non-engineered connection at roof shed. (Boiler Shed)	Building engineer is required to check the connection adequacy of the steel roof shed against the up-lift pressure of wind.	6-weeks

20	No design reports were available and apparently non-engineered connection at roof shed. (Boiler Shed)	Complete implementation of any remedial works deemed necessary by the Design Report.	6-months

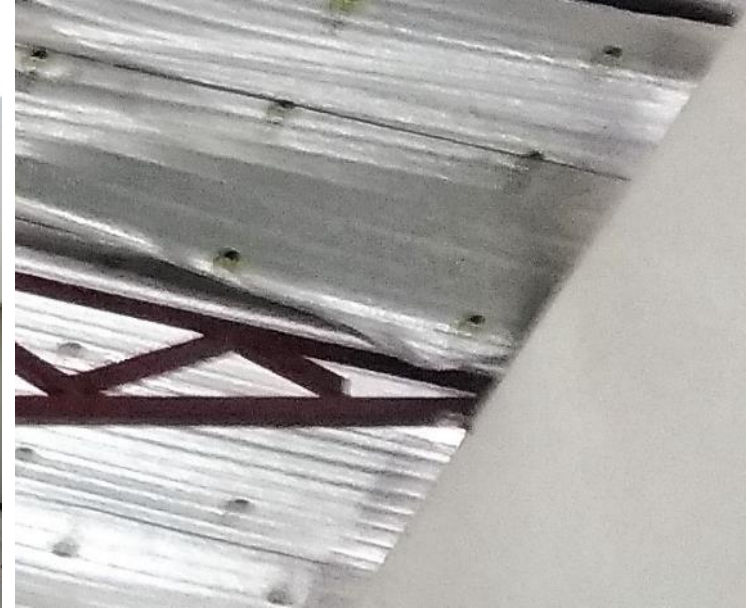
Non engineered connection

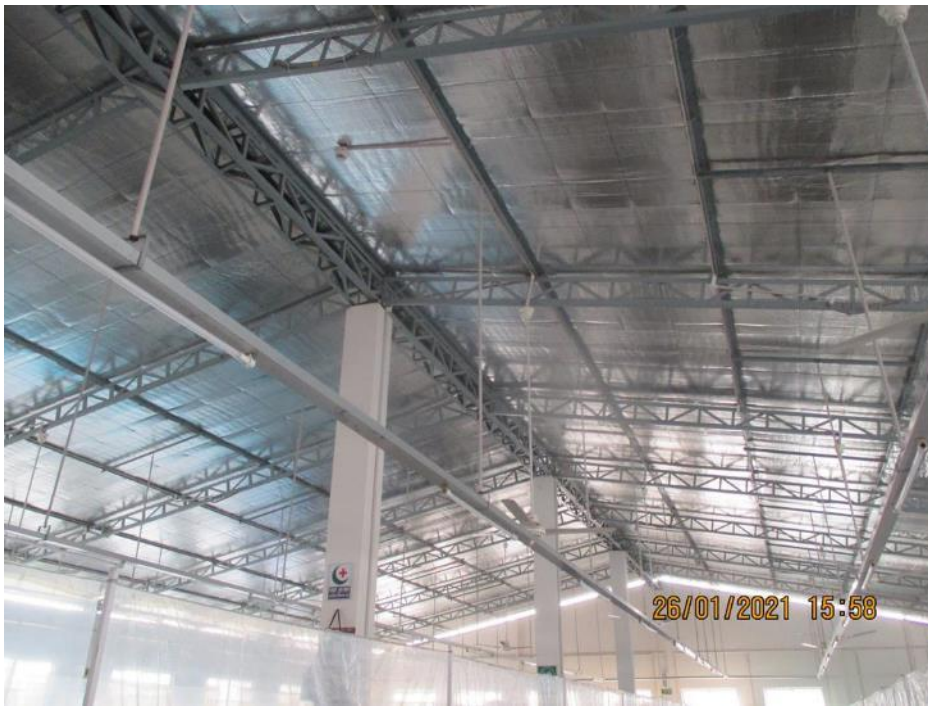
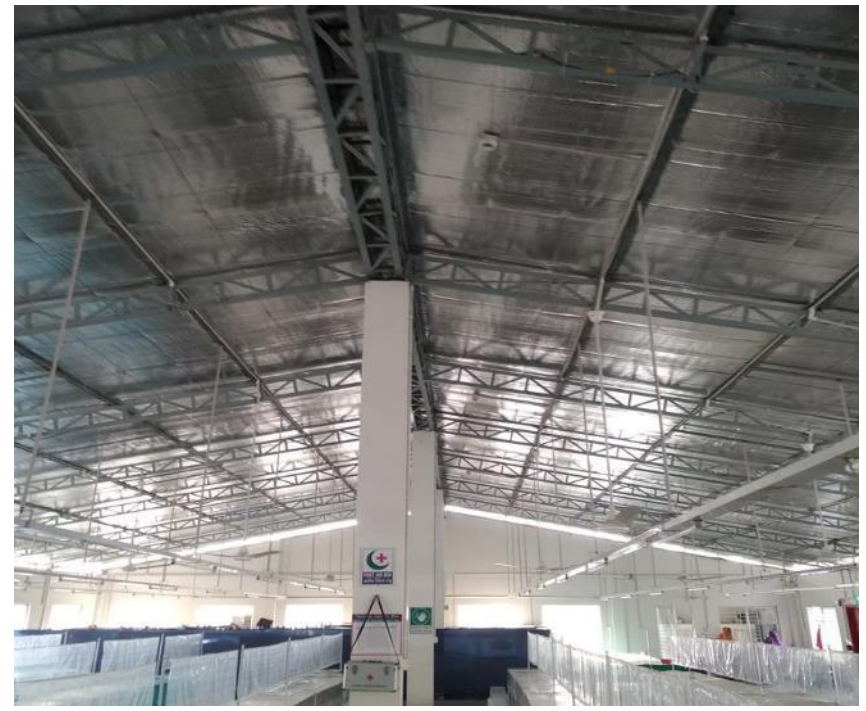
Interior of the shed

Lack of lateral stability system

Apparently improper connection was observed in roof shed. Also, the stability system observed was found to be inadequate. Building engineer is required to check the lateral stability of the shed and prepare design report in compliance with section 1.9.1 (part-6, BNBC).

Item No.	Observation	Recommended Action Plan	Recommended Timeline
21	Lack of lateral stability system. (Canteen Shed)	Building Engineer to survey the whole structure and prepare accurate as-built drawings in compliance with section 1.9.1.2 as per BNBC.	6-weeks
22	Lack of lateral stability system. (Canteen Shed)	Building engineer is required to check the lateral stability and prepare Engineering Assessment drawings in compliance with section 1.9.1 as per BNBC.	6-weeks
23	Lack of lateral stability system. (Canteen Shed)	Building engineer is required to check the connection adequacy as part of Engineering Assessment (EA) drawings in compliance with section 1.9.1 as per BNBC.	6-weeks
24	Lack of lateral stability system. (Canteen Shed)	Implement the remedial works deemed necessary by the Engineering Assessment (EA).	6-months
25	Structural connection between Wastage Store Building and Canteen Shed. (Canteen Shed)	Factory engineer is required to specify the load path of the structure and check the adequacy of the connection	6-weeks

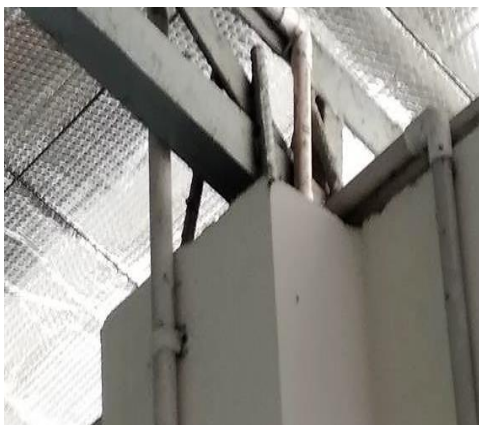
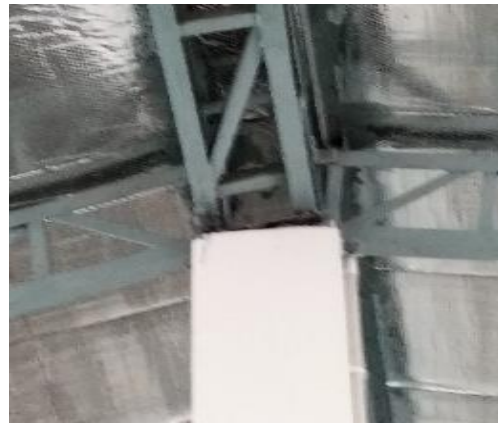
Non engineered connections

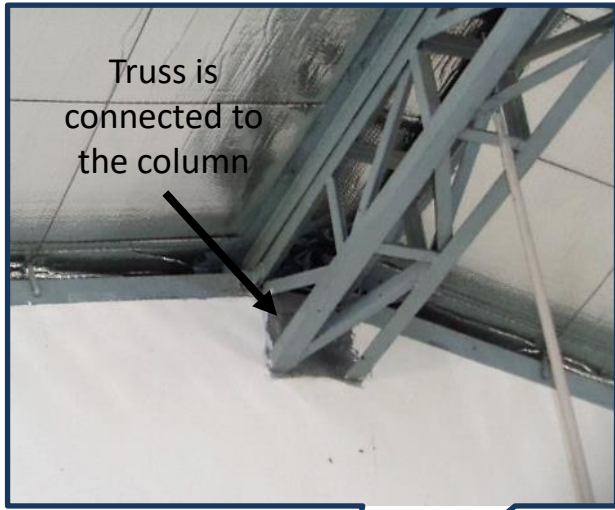
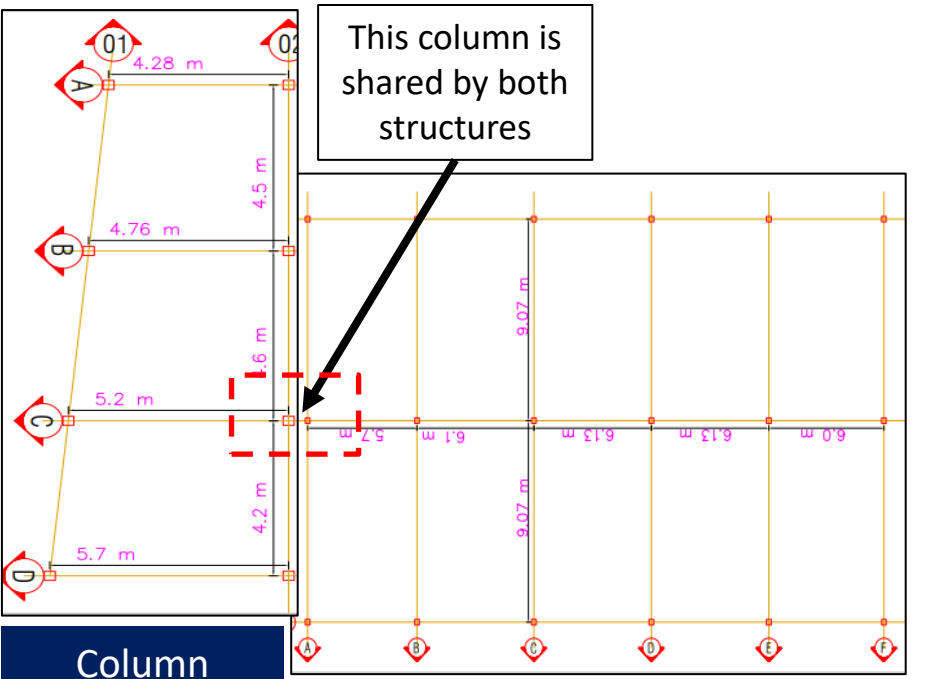
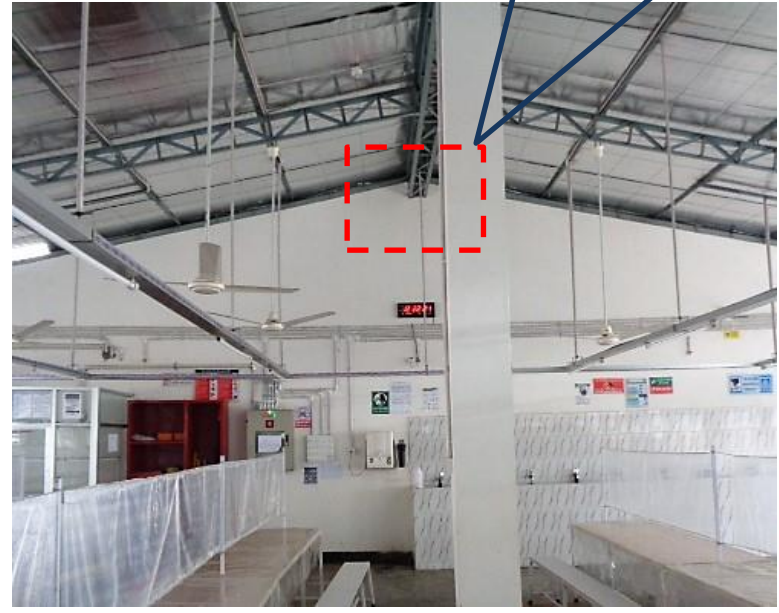
Structural connection between Wastage Store Building and Canteen Shed

During inspection, it was found that the central roof truss of the Canteen Shed is supported by the column of the Wastage Store Building. Therefore, the structures are found to be structurally connected. Factory is required to consider two structures as one and prepare design report accordingly.

Two buildings are found structurally connected.

Item No.	Observation	Recommended Action Plan	Recommended Timeline
26	Structural connection between Wastage Store Building and Canteen Shed. (Canteen Shed)	Factory Engineer is required to prepare Engineering Assessment report in compliance with section 1.9.1 (part-6, BNBC).	6-weeks
27	Structural connection between Wastage Store Building and Canteen Shed. (Canteen Shed)	Carryout remedial works where necessary.	6-months
