# Scandex (Bd) Ltd.

6<sup>th</sup> January 2021

# Buildings Information

1. Production Building (G+4)
2. Utility building (G+1)

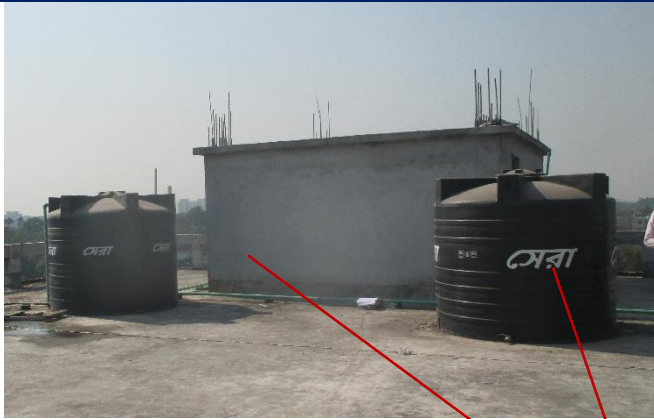
Two RCC O.H.W.T is shown in architectural drawing however 2 nos P.V.C water tanks are present at different locations.

Plastic water tank

| Item No. | Observation | Recommended Action Plan | Recommended Timeline |
|---|---|---|---|
| 02 | Discrepancy in as-built drawing. (Production Building) | Mention plastic water tank’s size and locations on load plan and architectural drawings. Building engineer is required to check the lift core foundation and incorporate details in the as-built drawing. | 6-weeks |

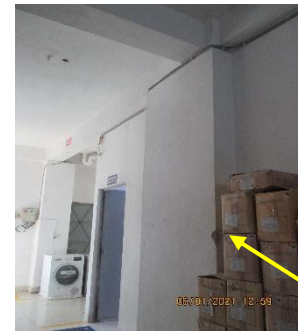
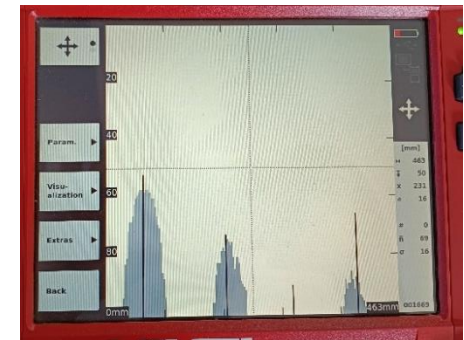
Rebar numbers of C3 column did not match with structural drawing. On long face (450 mm) 6 numbers of rebars were shown in column section, whereas 4 numbers of rebars were found by ferro scanning. Moreover, the size of the column was found different in column schedule.

4 numbers of rebar in long face of C3 Column

| Item No. | Observation | Recommended Action Plan | Recommended Timeline |
|---|---|---|---|
| 01 | Discrepancy in as-built drawing. (Production Building) | Prepare “as constructed” drawings which reflect the actual site dimensions and complete structural information. | 6-weeks |

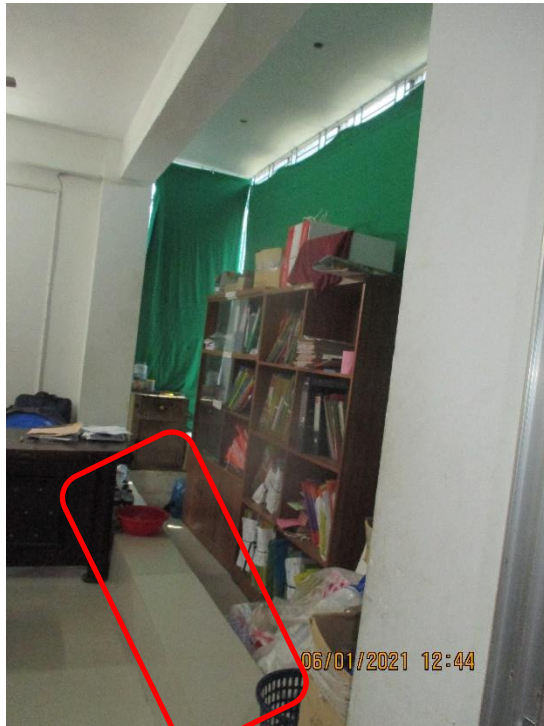
There is an inverted beam on ground floor roof level of grid 1/K-L which is not mentioned in as built drawing.

Inverted beam on site

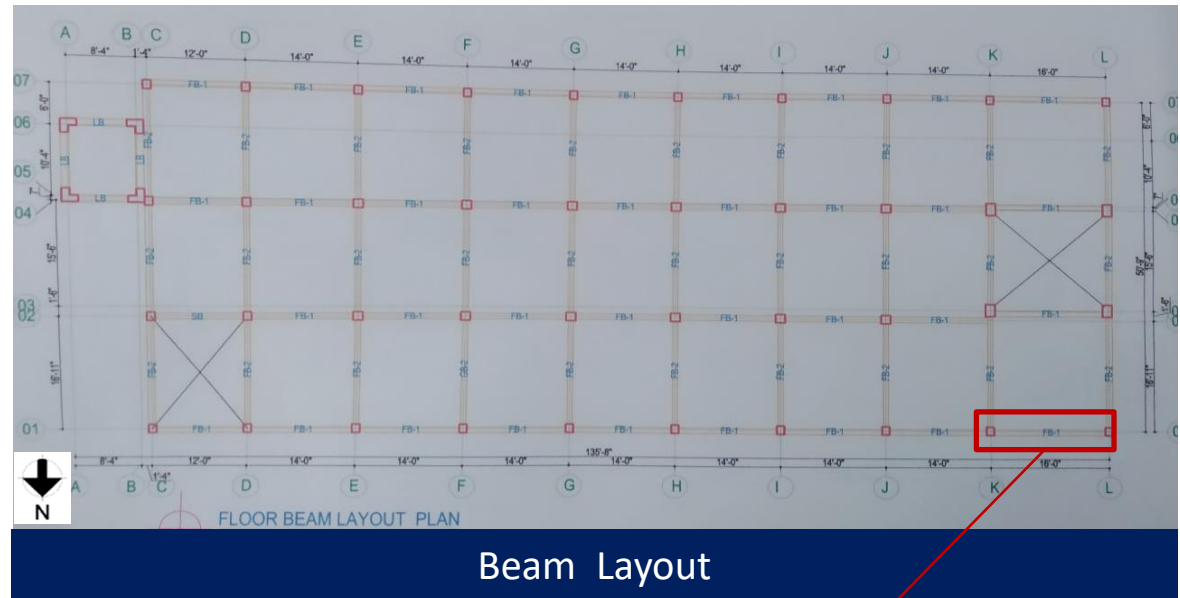
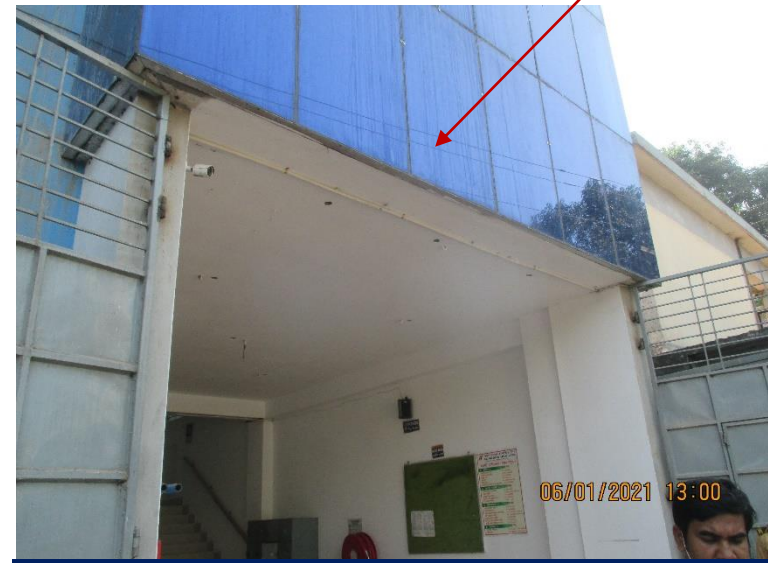
Inverted beam on GF roof level

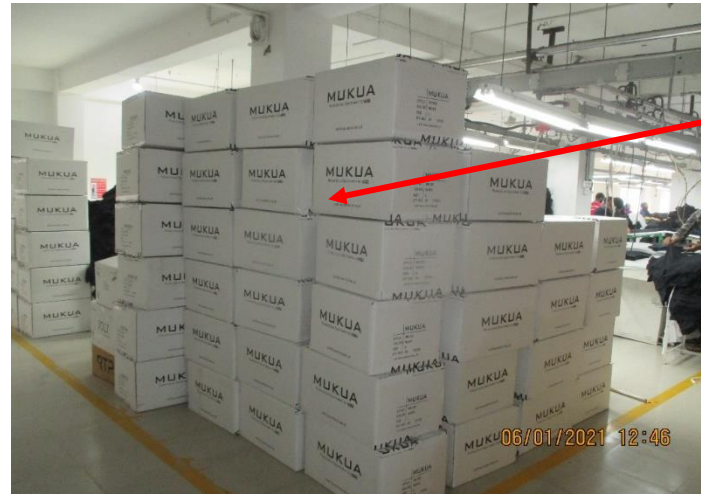
No load plan has been prepared for the production building, besides localized high loading surrounding the column was observed in 1<sup>st</sup> floor. Moreover, in sufficient concrete test report was found for 2<sup>nd</sup> phase of construction. No test report found for 1<sup>st</sup> phase of construction.

Localized high loading

| Item No. | Observation | Recommended Action Plan | Recommended Timeline |
|---|---|---|---|
| 05 | Lack of Design report and localized high loading surrounding the column. (Production Building) | Produce and actively manage a loading plan for all floor plates within the factory, considering floor, column and foundation capacity. | 6-weeks |

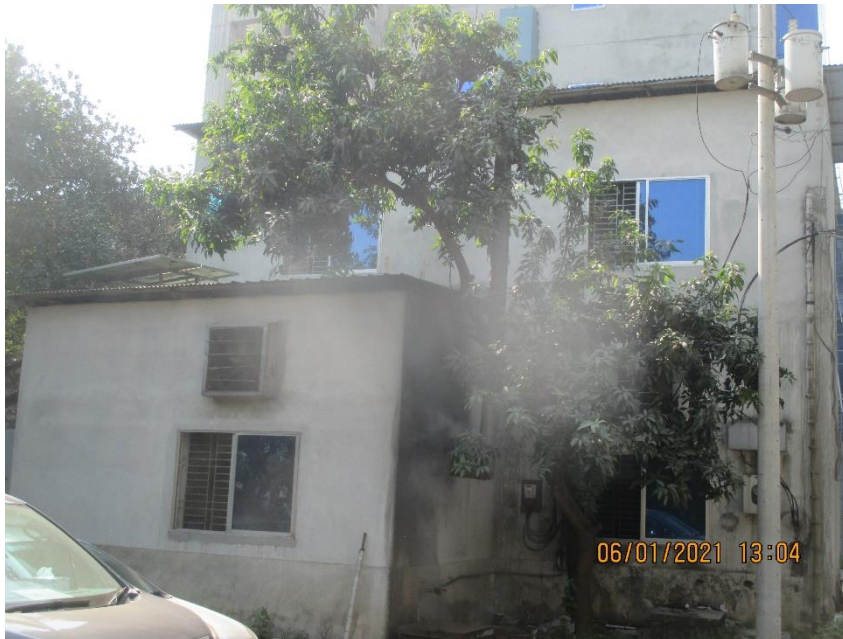
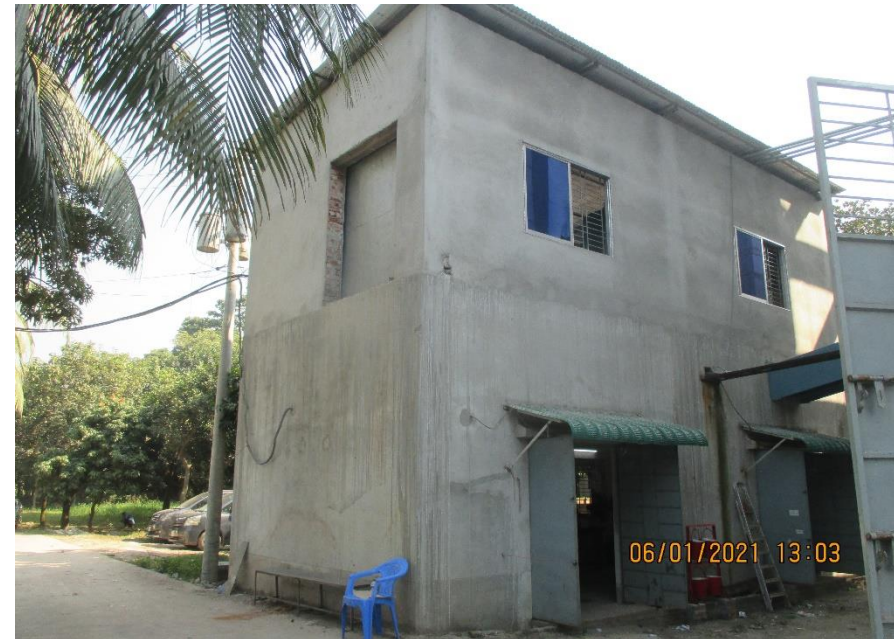
Isometric view of Utility Building

There was no credible approved drawing from concerned authority and DIFE. In addition, no as-built drawings were available. Factory engineer is required to survey the structure and prepare as-built drawings that are in compliance with section 1.9.1.2 as per BNBC.

| Item No. | Observation | Recommended Action Plan | Recommended Timeline |
|---|---|---|---|
| 08 | No as built drawings were available.(Utility Building) | Building Engineer to survey the structure and prepare accurate as-built (both architectural & structural) drawings. | 6-weeks |

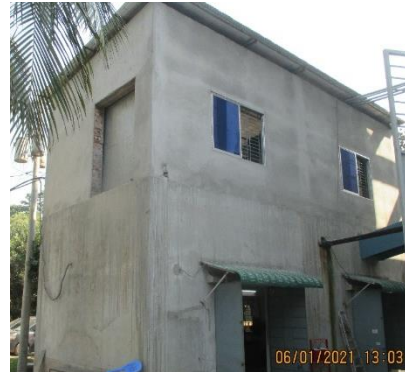
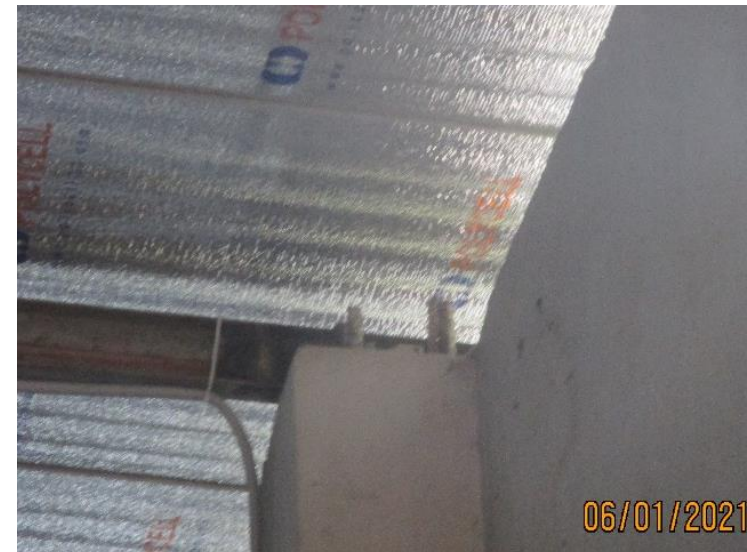
Non engineered connections were observed at light weight roof. Factory engineer is required to check the connection of the roof for the up-lift pressure of wind.

Non engineered connection  
(1<sup>st</sup> floor roof)

| Item No. | Observation | Recommended Action Plan | Recommended Timeline |
|---|---|---|---|
| 10 | No design reports were available and apparently non-engineered connection at roof shed.(Utility Building) | Building engineer is required to check the connection of the steel roof shed for the up-lift pressure of wind. | 6-weeks |

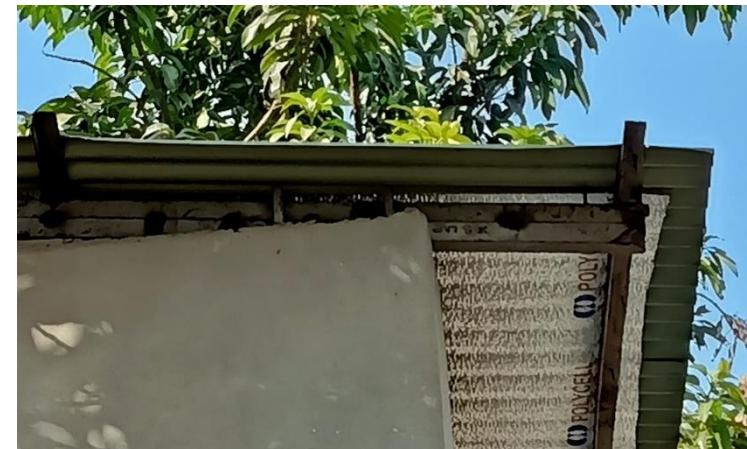
Non engineered connections  
(GF roof-East side)

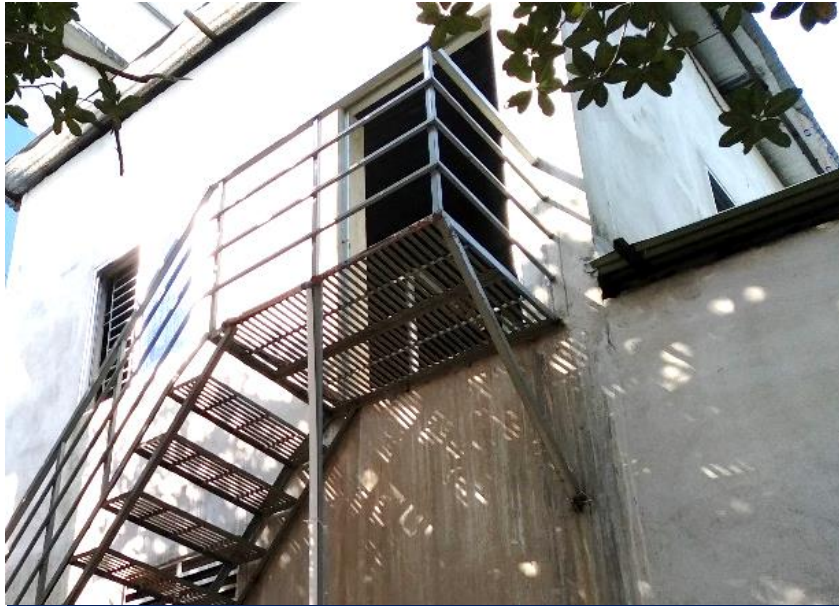
Non engineered connections

Factory engineer is required to carry out the member adequacy & stability and implement remediation where required.

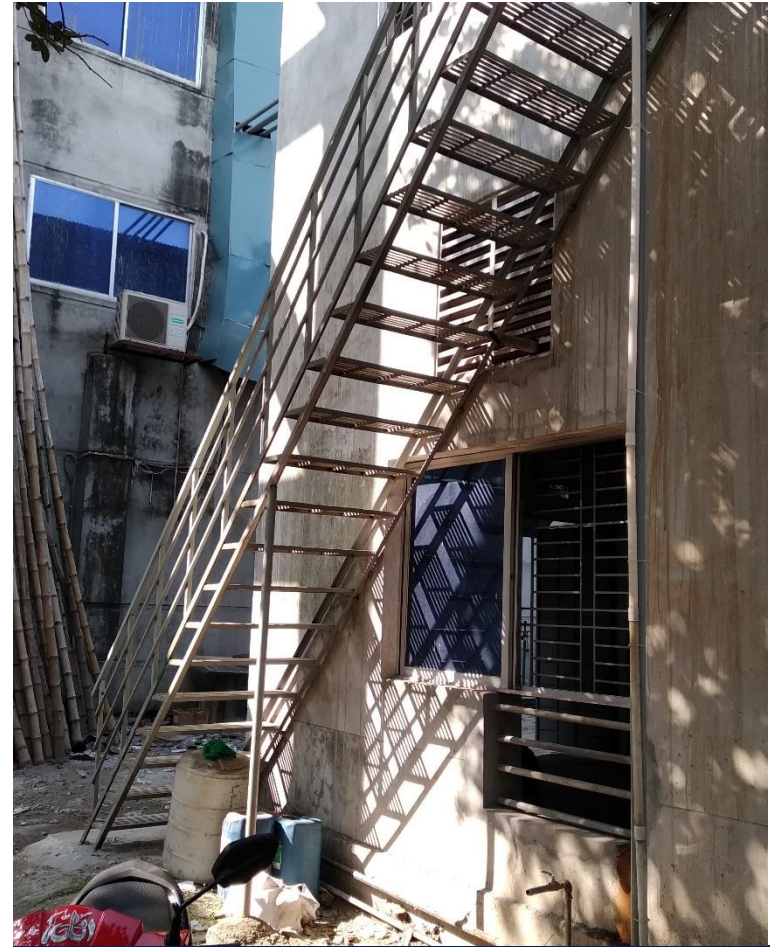
**Non engineered steel stair, apparently  
inadequate member& lack of lateral stability**

Apparently inadequate steel member size and no stability system provided.

| Item No. | Observation | Recommended Action Plan | Recommended Timeline |
|---|---|---|---|
| 12 | Non engineered steel stair, apparently inadequate member & lack of lateral stability. (Utility Building) | Factory engineer is required to carry out member adequacy & lateral stability check of the steel stair. | 6-weeks |
| 13 | Non engineered steel stair, apparently inadequate member & lack of lateral stability. (Utility Building) | Replace the existing stair with a properly designed stair or implement remediation work where necessary. | 6-months |
