# **FIRE SAFETY INSPECTION REPORT**

## **ORGANIC JEANS LTD.**

**PLOT NO. A/1 & 2, BLOCK-B, BSCIC INDUSTRIAL  
AREA, FOUZDERHAT, SAGARIKA ROAD**

May 19, 2014

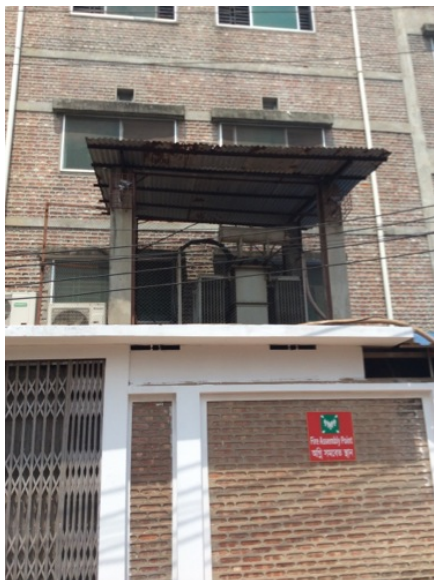
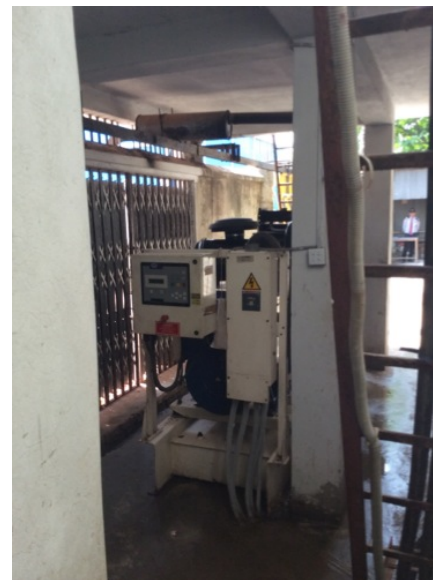
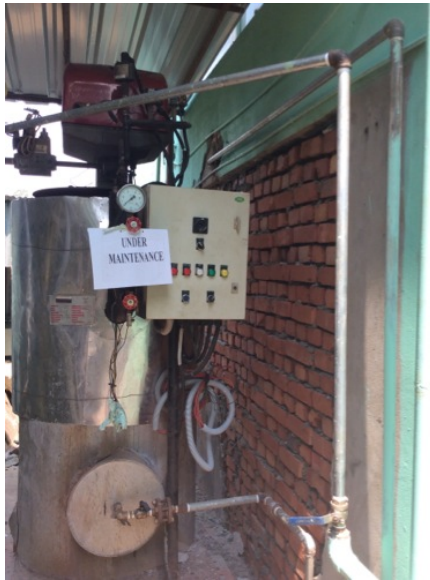
| No. | Category | Finding | Recommendation | Remediation Timeframe |
|---|---|---|---|---|
| F-1 | Fire Rated Construction | The boiler, generator and transformer room was not separated by fire-rated construction (openings, non-rated doors, penetrations). | Separate the boiler, generator and transformer room by a minimum 2-hr fire-rated construction. Seal and/or protected all openings to maintain the required fire separations | Within 3 months |

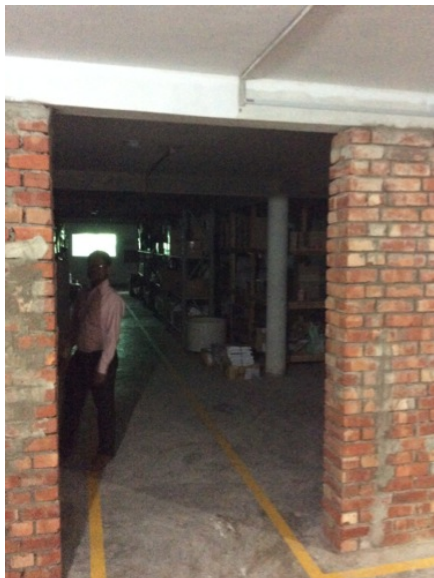
| F-2 | Fire Rated Construction | Areas used for combustible storage are not separated by fire-rated construction The ground floor storage at present is open to all egress routes. | Provide dedicated storage rooms separated by minimum 1-hr fire-rated construction. | Within 3 months |

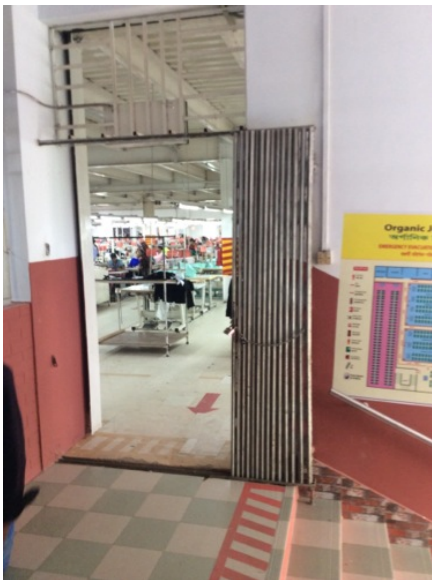
| F-3 | Fire Rated Construction | The exit stairs are not separated from work areas, other spaces on each floor by fire-rated construction. | Provide minimum 1.5-hr fire rated doors and seal all unprotected openings to separate the exit stairs from work areas and other building spaces on all floor levels. Ensure that the fire doors are self-closing and positive latching and that they are provided with fire exit (panic) hardware where serving production floors. | Within 3 months |

| | | | If fire doors are required to be held open for functional reasons, provide automatic-closing devices tied to the fire alarm system. | |

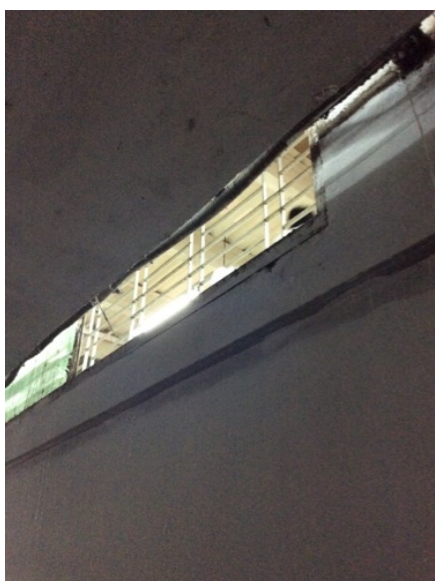
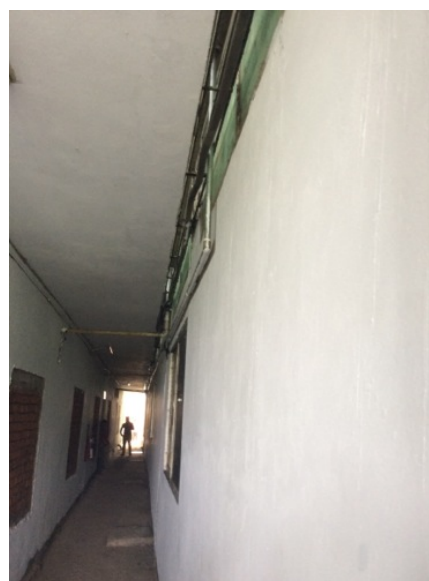
| F-4 | Fire Rated Construction | The exit discharge path serving the rear building exit is less than 10 ft wide and is not separated from the building interior. | Seal all penetrations and openings to the interior of the building along the discharge path, up to a height of 10 ft., to provide a minimum 1-hr fire separation. | Within 6 months |

Alternatively, provide a second remote discharge path to the public way (only include this if feasible).

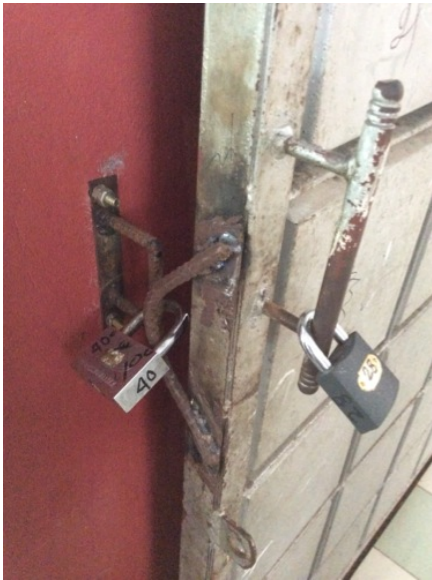
| F-5 | Egress | Egress doors / gates with locking features are provided at building exits, exit stairs, along egress routes and main exit discharge. All gates/doors were open and unlocked during the inspection. | Remove locking features from all egress doors / gates.<br><br>If locks are required for security reasons, utilize special door locking features complying with NFPA 101. | Immediate |

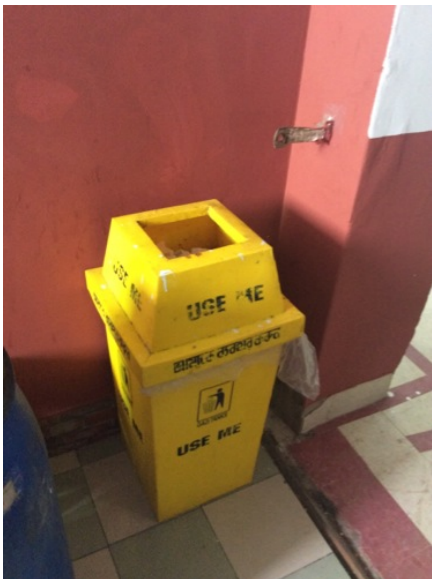
| F-6 | Egress | Storage such as trash cans was located in exiting stairwells. | Remove all storage from exit stairs and egress paths. | Immediate |

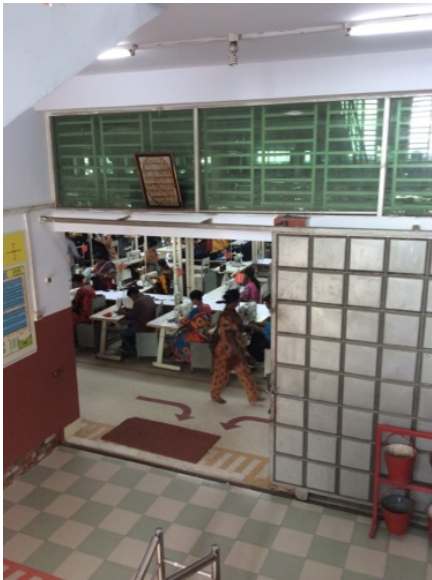
| F-7 | Egress | Collapsible gates / sliding doors are provided at building exits, exit stairs, along egress routes and main exit discharge. | <p>Replace all gates / sliding doors along the means of egress with side-hinged, swinging egress doors.</p> <p>If locks are required for security reasons, utilize special door locking features complying with NFPA 101.</p> | Within 1 month |

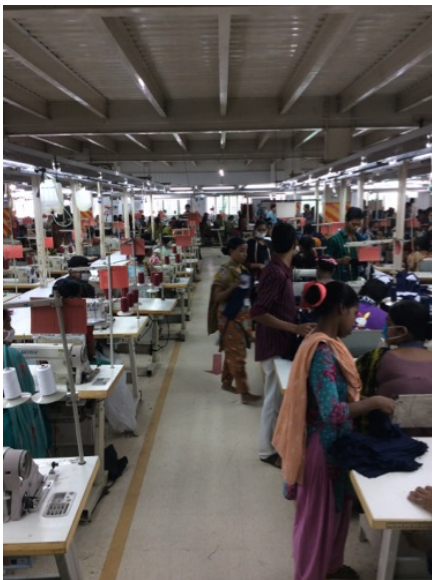
| F-8 | Egress | The width of egress aisles is less than 36-in on the second floor of the factory building. | Provide minimum aisle widths of 36-in. | Within 3 months |

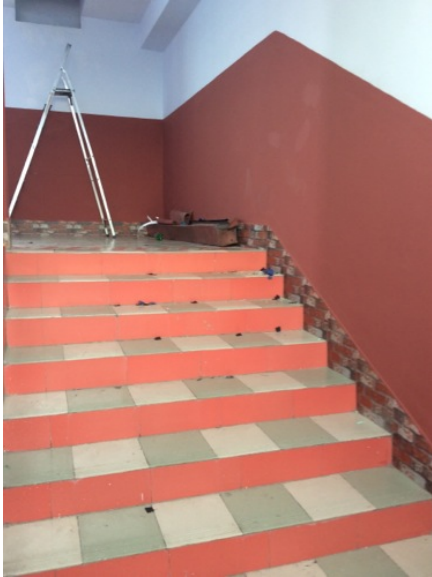
| F-9 | Egress | Handrails are not provided in the exit stair from the roof space to the dining area on the third floor, North East facing stair. | Provide handrails on at least one side of exit stair. | Within 3 months |

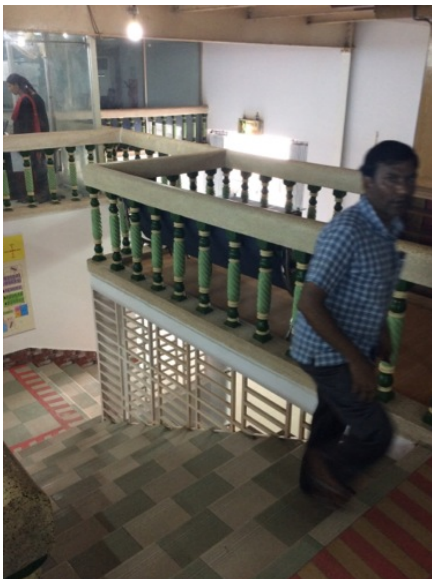
| F-10 | Egress | The two north facing mezzanine exit stairs discharge inside the building, with an approx 25ft travel distance to the main building exit and in close proximity to open ground floor storage. | Provide 2-hr fire-rated exit passageway leading directly outside (vestibules to separate any storage areas). | Within 6 months |

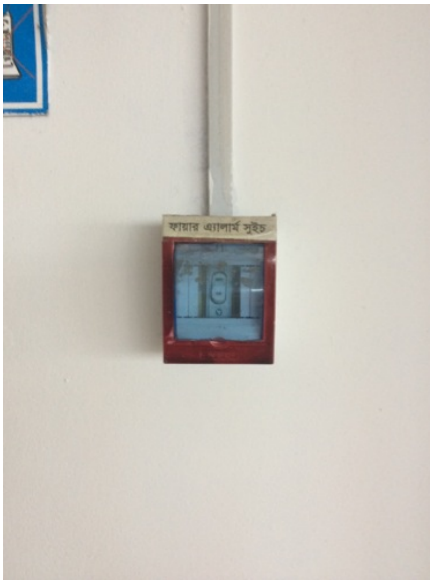
| F-11 | Fire Protection | The fire alarm system is antiquated, not a listed system, and does not provide alarm and notification features consistent with acceptable standards. | Replace the fire alarm system with a new, listed addressable fire alarm system in accordance with NFPA 72. | Design within 4 months, install within 9 months |

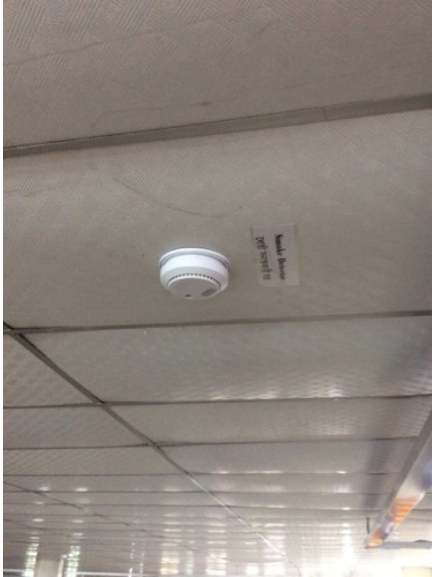
| F-13 | Fire Protection | The building is equipped with single-station smoke alarms. Smoke alarm activation sounds only a local alarm and does not provide automatic fire alarm notification of occupants. | Remove single-station smoke alarms. Provide automatic smoke detection throughout the building in accordance with NFPA 72. | Within 6 months |

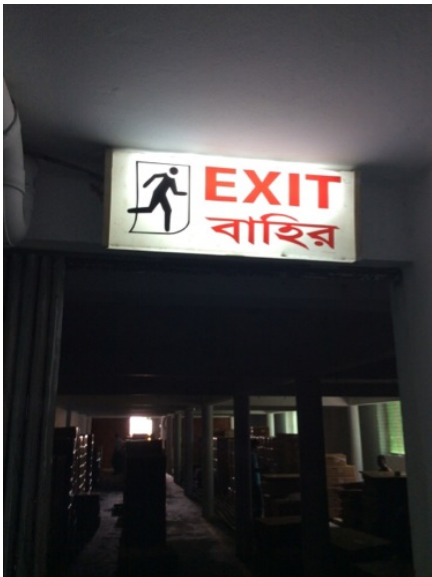
| F-14 | Egress Lighting | Exit signage unclear on the ground floor. At present signage guides occupants to storage area as an egress route. The signage was installed to allow occupants to escape the storage space using the exit. | Relocate to the inside of floor area | Immediate |

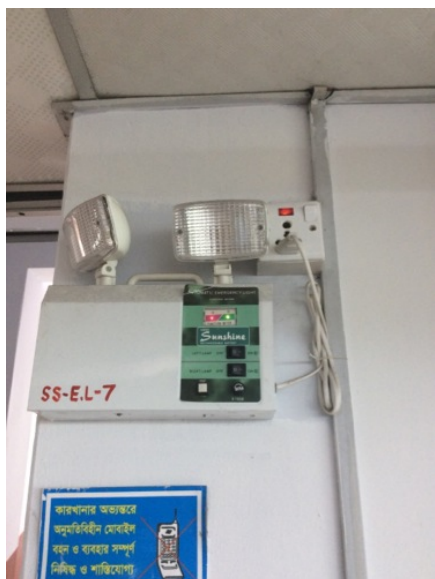
| F-15 | Egress Lighting | Manual on-off switches is provided for emergency lighting units. | Remove manual on/off switches from emergency lighting units to prevent them from being switched off. | Within 1 month |

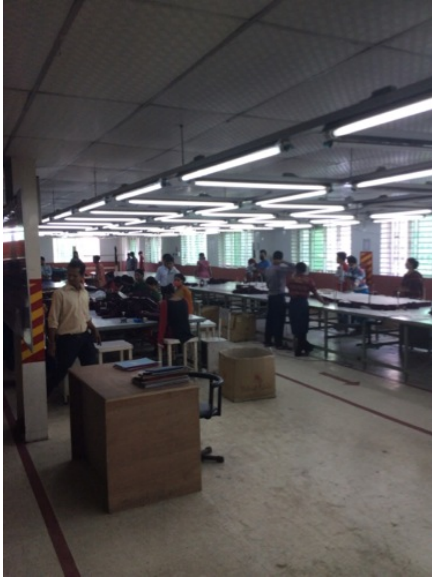
| F-17 | Egress Lighting | Based on the number and location of emergency lights observed, adequate illumination levels are not anticipated along egress routes on the third floor dining space area. | Test the emergency lighting system on each floor and provide additional emergency fixtures to provide adequate illumination along the means of egress. Provide a minimum illumination of 10 lux at the floor level within exit stairs and exit discharge paths and minimum 2.5 lux along exit access aisles. | Within 3 months |
