# Honeywell Garment Ltd. (9725)

Plot#1010,1011, Ambag, Mouza Baghia, Konabari, Gazipur, Bangladesh

25.MARCH.2014

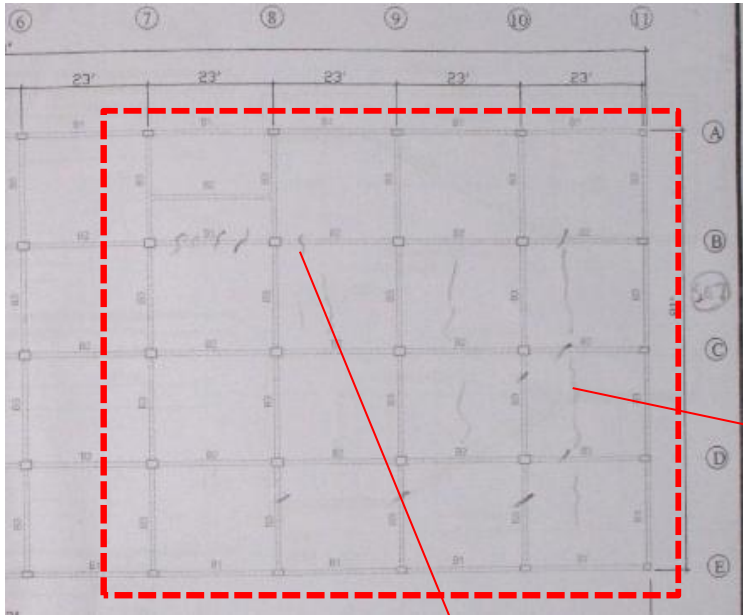
Cracks in slabs and beams, this needs further investigation and local slab and beam capacity checks.

It is appeared cracking in slab and beam on 3<sup>rd</sup> to 4<sup>th</sup> floor in this area without heavy load during survey.

- A Detailed Engineering Assessment of the factory is to be carried out and a suitable method of repairs developed.
- Simply plastering over is not allowed.

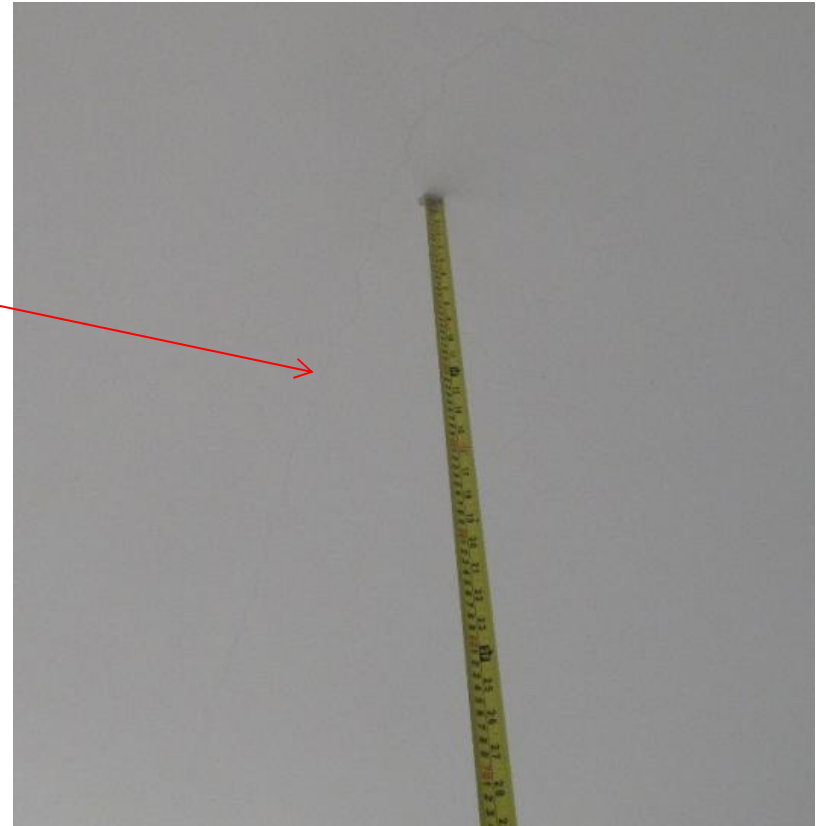
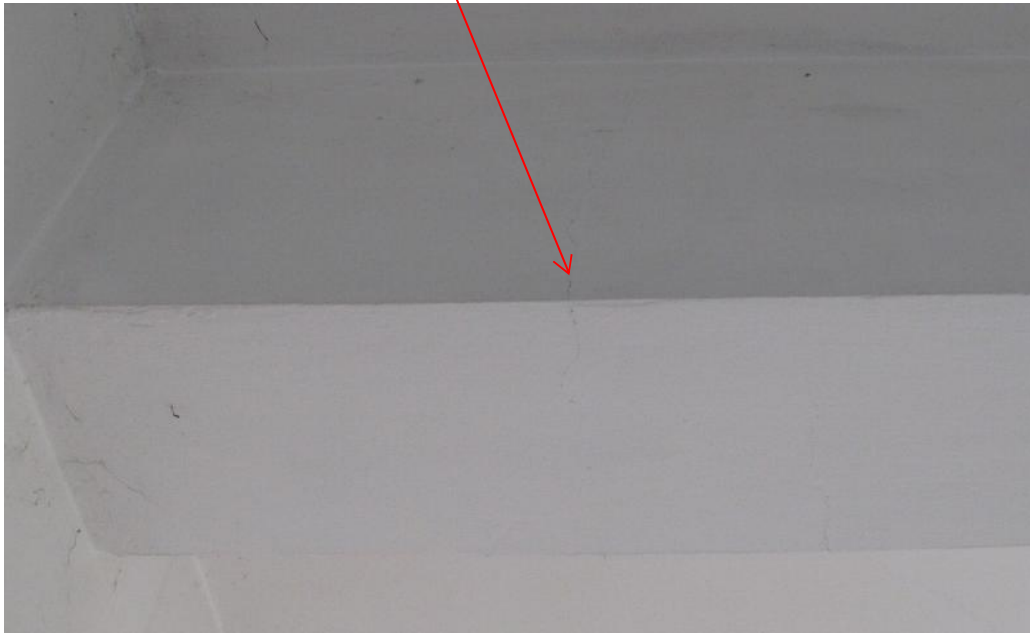
Priority 2 Concern

Appeared cracking in slab and beam, investigate further, carry out beam and slab capacity checks. Suitably repair if structurally adequate.

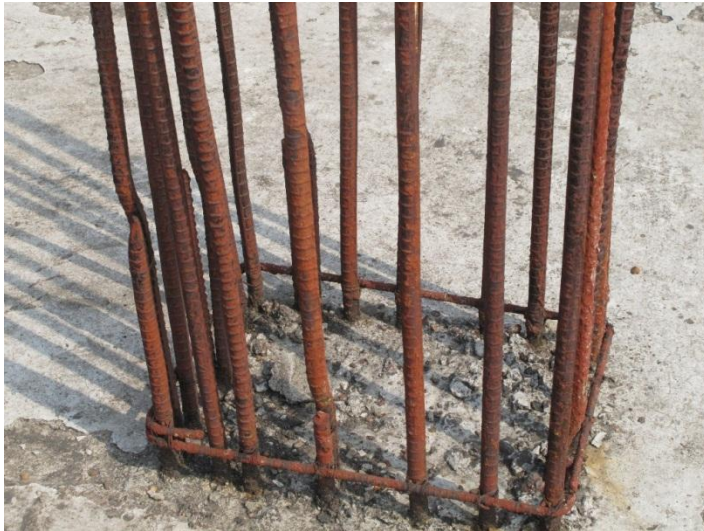
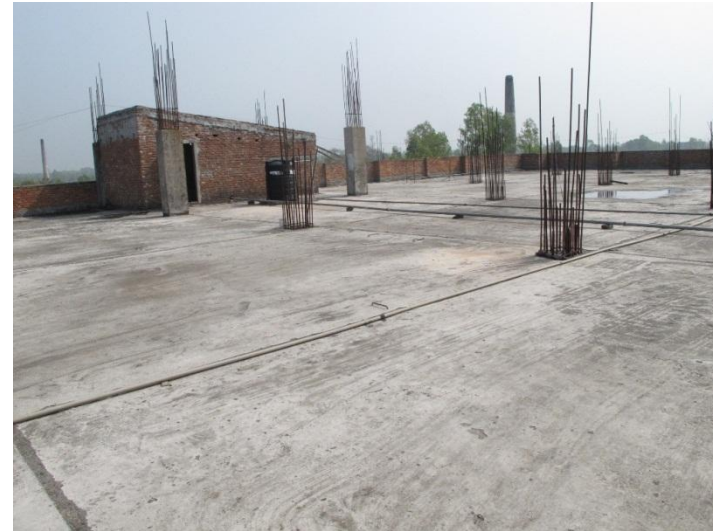
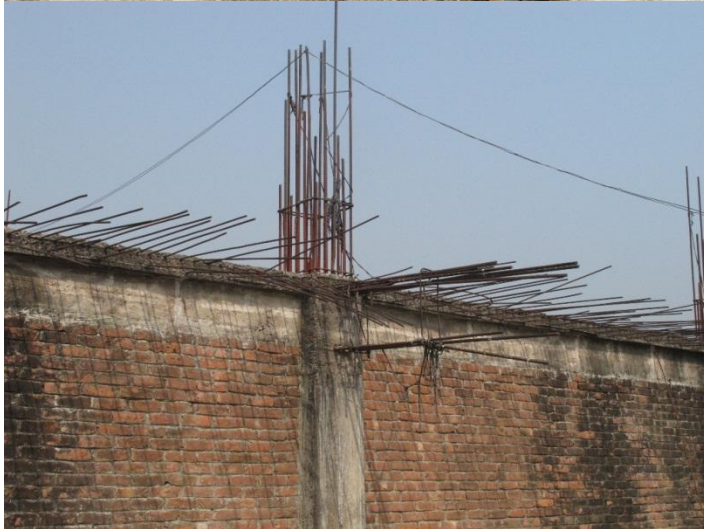
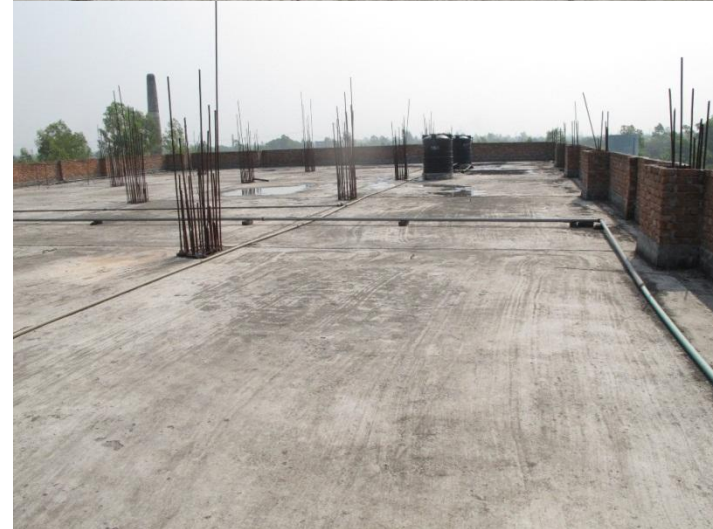
## Priority 2 Concern

An appropriate layer of waterproofing needs to be applied including anti-rust paint for the exposed reinforcement.

- Waterproofing material to be applied including rust-proof paint for the exposed reinforcement

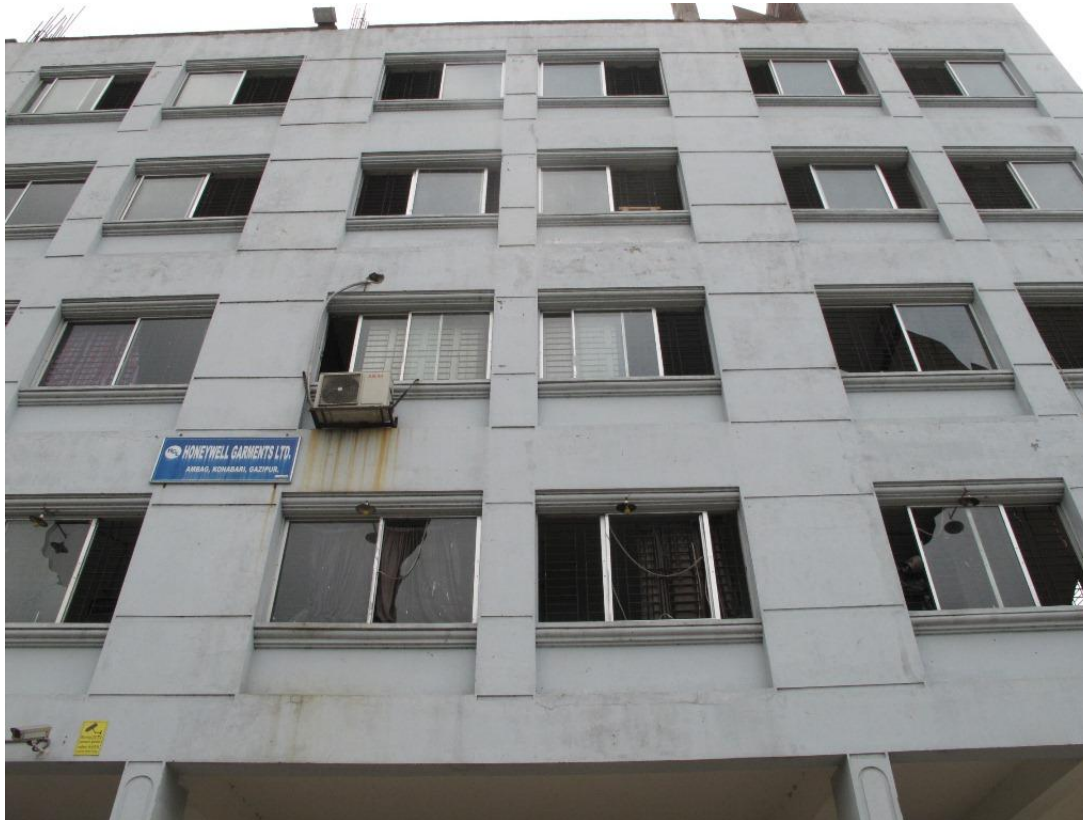
Concerns on the stability system's ability to withstand for normal lateral seismic loading. Façade brickwork has little capacity - lack of moment capacity in the connections between columns and beams.

A Detailed Engineering Assessment is required to determine if the existing lateral stability system is able resist normal and earthquake lateral loads.

- A Detailed Engineering Assessment is to be carried out considering in particular overall stability and foundation suitability.

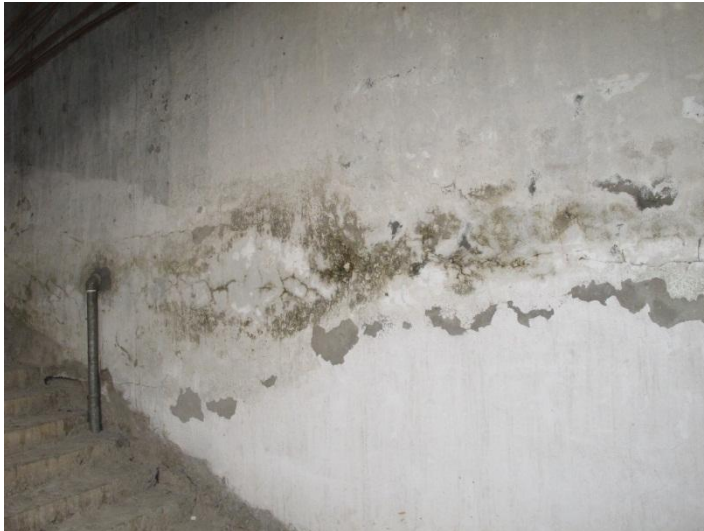
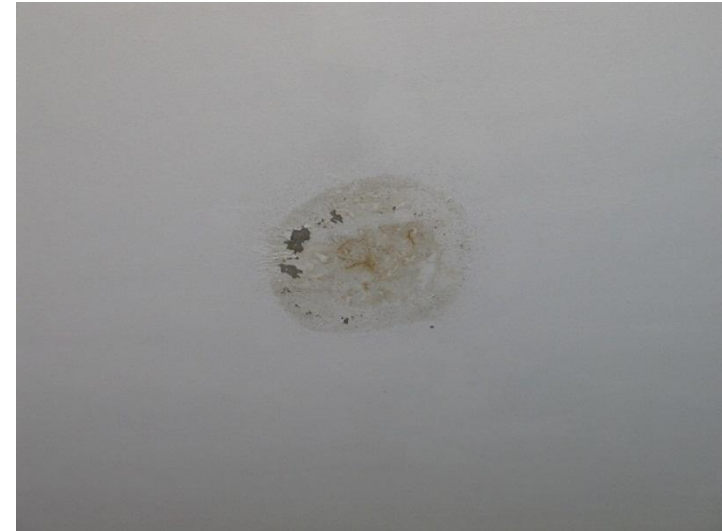
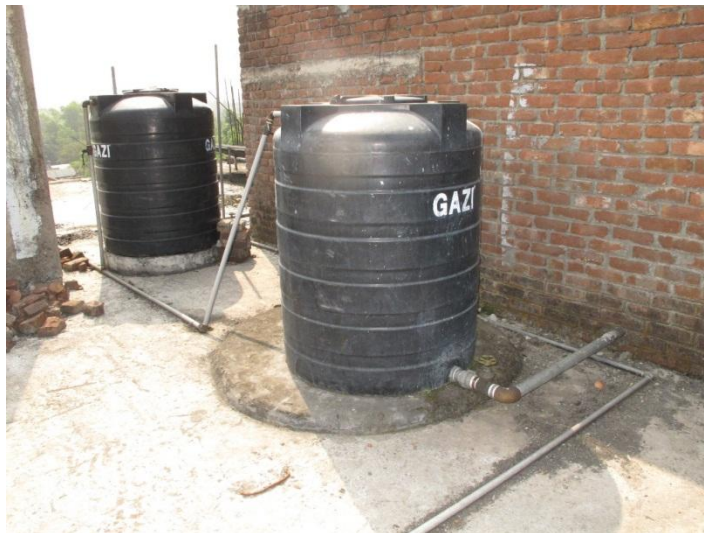
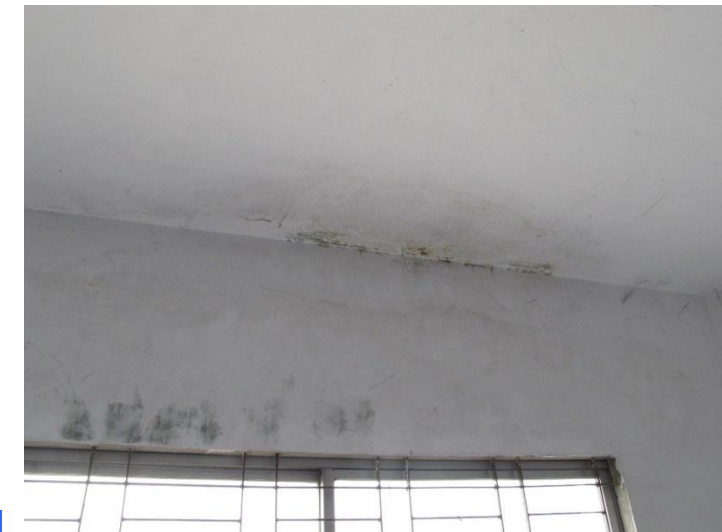
## Priority 2 Concern

It appears that water has been allowed to enter the structure from roof level, adjacent to the roof top water tank and possibly other areas. This will cause deterioration to structural elements if left unattended.

- The factory engineer is to inspect the water damaged structure including the exterior and proposed a suitable repair. An effective roof drainage system and waterproofing system is to be installed.

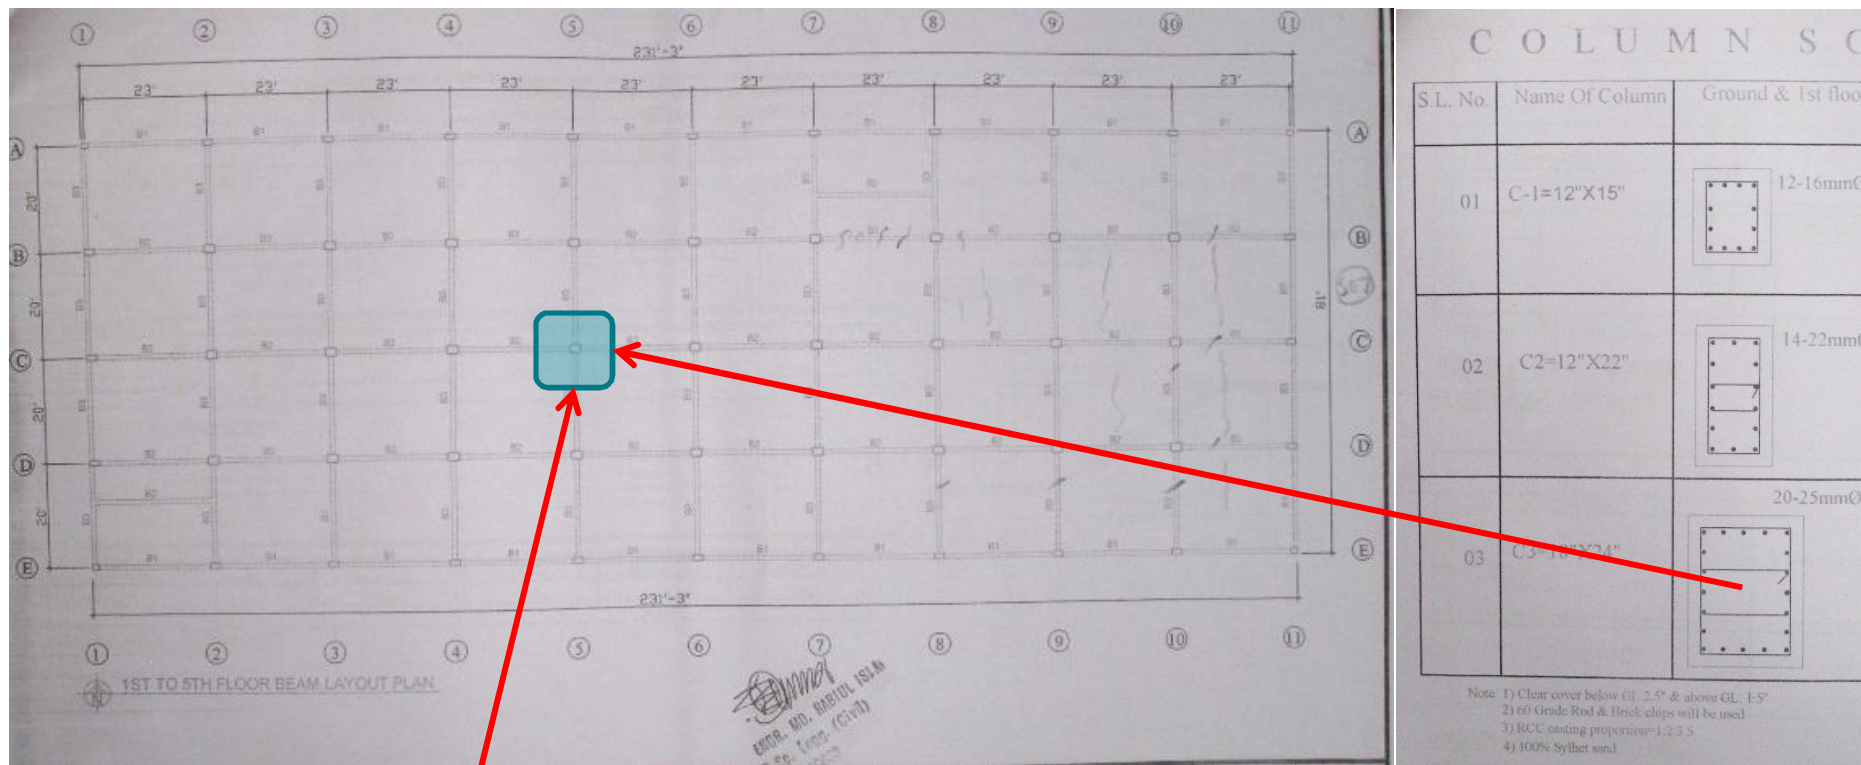
**Load rundown** at the key steel column, it is found that the column stress is within the range of FOS greater than 1.86 which is **GREEN** rating.
