FIRE SAFETY INSPECTION REPORT

**TAMMAM DESIGN LTD.
ZIRABO, ASHULIA, SAVAR, DHAKA**

ACCORD
on Fire and Building Safety in Bangladesh

April 22, 2014

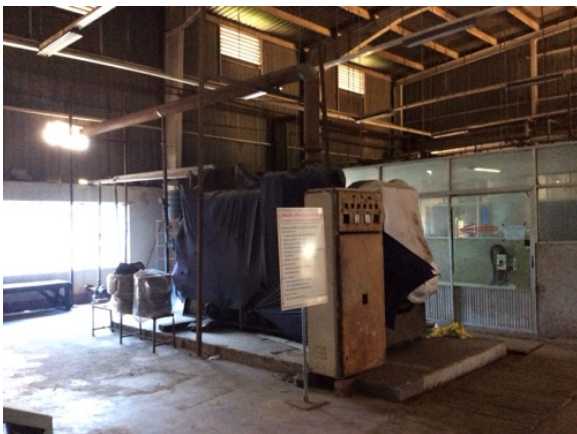
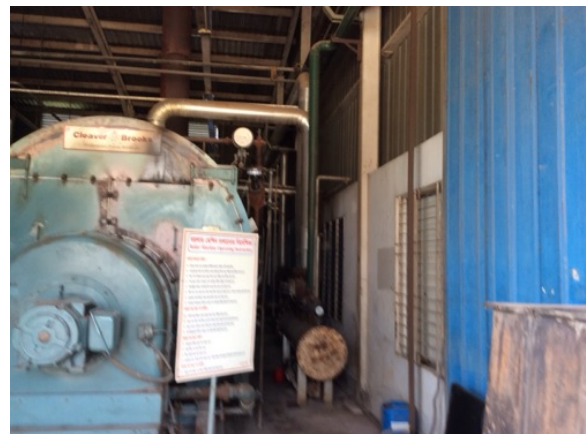
F-1	Fire Rated Construction	The boiler and generator room is not separated from the working areas of Beq Fabrics (adjacent building) by means of fire-rated construction (openings, non-rated doors, penetrations).	Separate the boiler and generator room from the adjacent working areas by a minimum 2-hr fire-rated construction. Seal and/or protected all openings to maintain the required fire separations.	Within 3 months
-----	-------------------------	---	---	-----------------

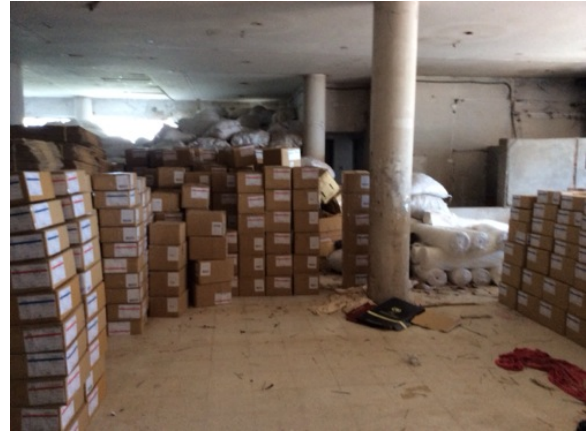
F-2	Fire Rated Construction	Dedicated storage areas on the 7th and 1st floor were not separated from the working area by means of fire rated construction (non-rated door and unprotected openings)	Provide dedicated storage rooms separated by minimum 1-hr fire-rated construction.	Within 3 months
-----	-------------------------	---	--	-----------------

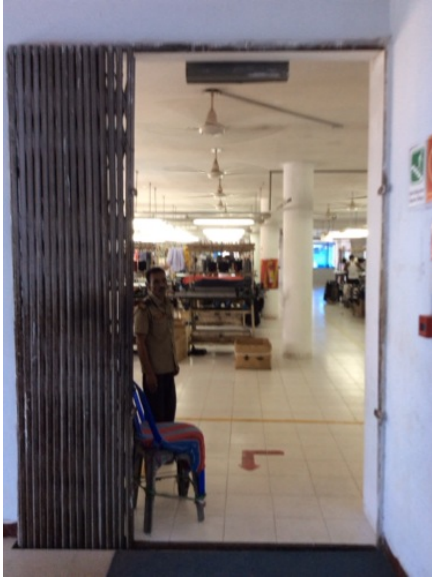
F-3	Fire Rated Construction	The exit stairs are not separated from work areas on each floor by fire-rated construction.	Provide minimum 1.5-hr fire rated doors and seal all unprotected openings to separate the exit stairs from work areas and other building spaces on all floor levels. Ensure that the fire doors are self-closing and positive latching and that they are provided with fire exit (panic) hardware where serving production floors.	Within 3 months
			If fire doors are required to be held open for functional reasons, provide automatic-closing devices tied to the fire alarm system.

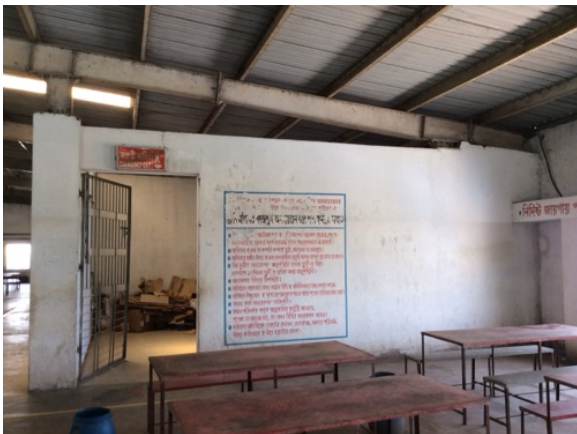
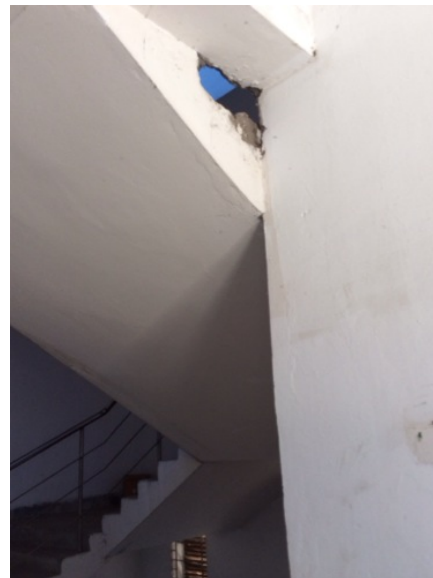
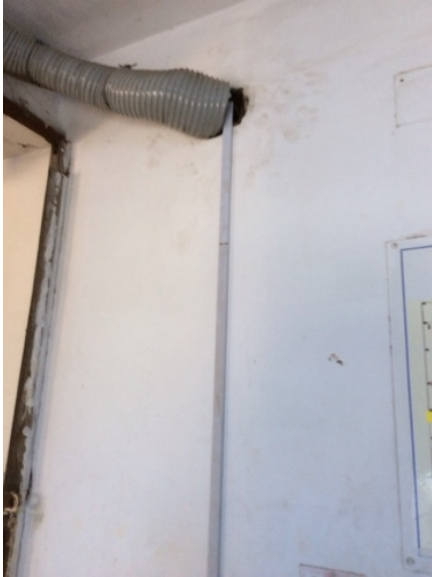
F-4	Fire Rated Construction	Unsealed penetrations and openings were observed in multiple locations such as the Western stair enclosure (7th floor), Northern stair enclosure (7th floor) etc.	Seal all penetrations and openings in exit stair enclosure walls to maintain the fire separation.	Within 3 months
-----	-------------------------	---	---	-----------------

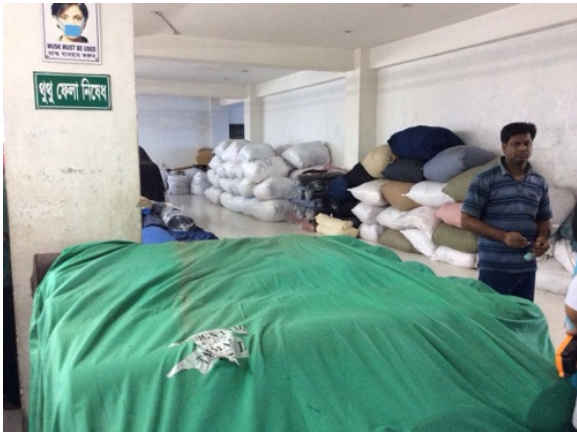
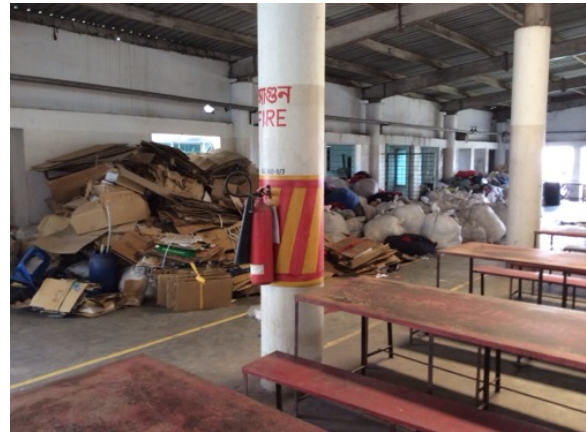
F-5	Fire Rated Construction	The exit discharge path of the Southern exit stair to the assembly point has a width less than 10 ft. and unprotected openings at a height of less than 10 ft.	Exterior building wall adjacent to passageway shall be rated 1-hr up to 10 ft. above grade.	Within 3 months
F-6	Fire Rated Construction	Transient storage areas on the 7th and 2nd floors were not separated from the adjacent working areas by means of fire rated construction.	<p>Provide dedicated storage rooms separated by minimum 1-hr fire-rated construction.</p> <p>Provide defined storage areas and limit the storage arrangement as follows:</p> <ul style="list-style-type: none"> - Maximum height of 2.4m and maximum area of 23m² - If sprinkler protected: maximum height of 3.66m and maximum area of 93m² <p>Separate areas of unenclosed combustible storage by a minimum clear distance of 3m.</p>	Within 3 months

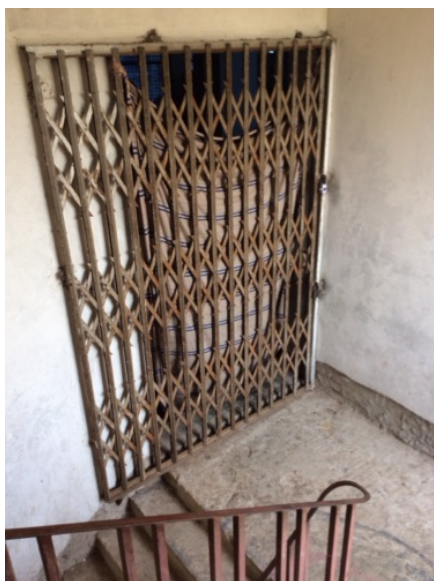
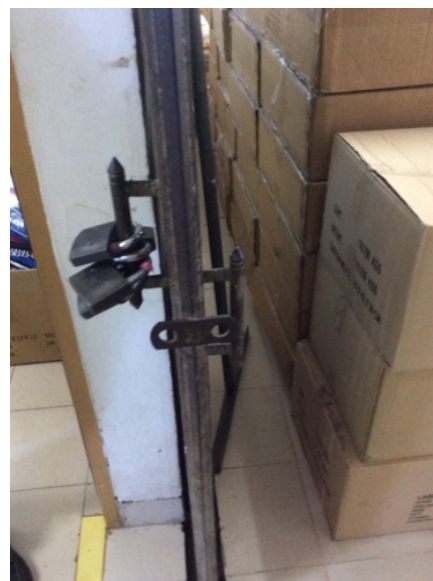
F-7	Egress	Locking features were found in numerous locations through out the building. Apart from the exit gates for the Southern stair enclosure (on the 7th and 1st floor) all gates/doors were found to be open and unlocked during the inspection.	Remove locking features from all egress doors / gates. If locks are required for security reasons, utilize special door locking features complying with NFPA 101.	Immediate
-----	--------	---	--	-----------

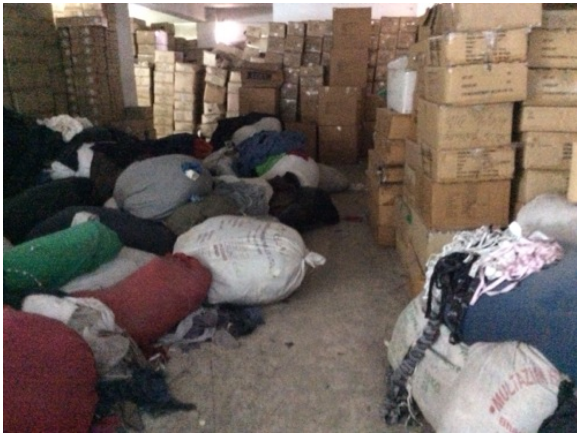
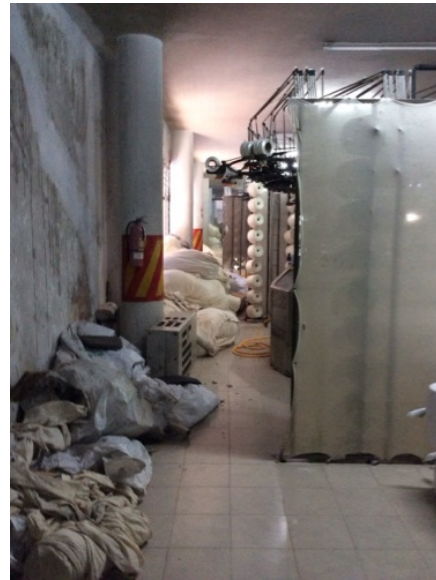
F-8	Egress	Storage in the path of egress was found on the 7th floor.	Keep egress paths and stairs clear of storage.	Immediate
-----	--------	---	--	-----------

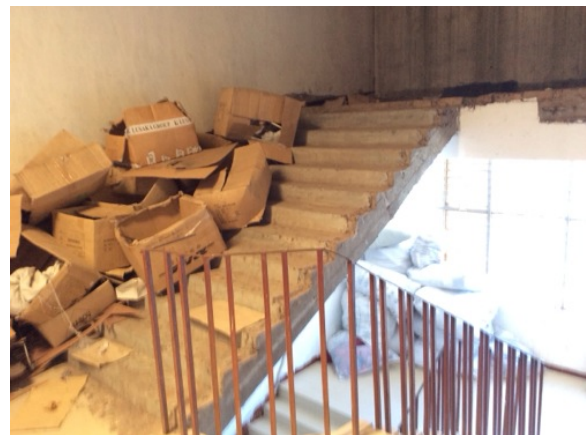
F-9	Egress	General storage was located in all the three stair enclosures.	Remove all storage from exit stairs and egress paths.	Immediate
-----	--------	--	---	-----------

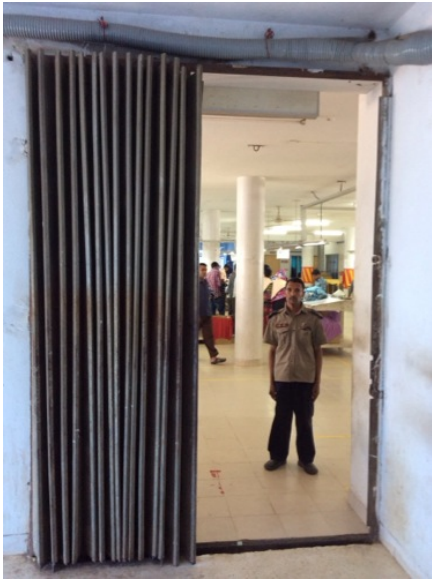
F-10	Egress	Collapsible gates and sliding doors are provided at all building exits, exit stairs, and exit discharges.	Replace all gates / sliding doors along the means of egress with side-hinged, swinging egress doors.	Within 1 month
			If locks are required for security reasons, utilize special door locking features complying with NFPA 101.

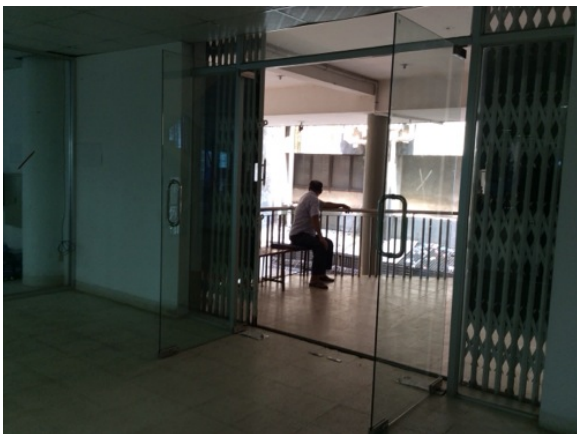
F-12	Egress	<p>Exit capacity is not adequate for the occupant load.</p> <p>The Dining area on the 7th floor is used by 500 workers at a time. The Southern stair exit was found to be locked and the specific egress path goes through a Fabrics store. The discharge capacity of the other stairs (Northern and Western stairs) are found to be inadequate to meet the egress requirement of the floor.</p>	<p>Unlock the Southern stair exit and provide a means of egress that does not require passage through the hazardous area.</p>	<p>Within 3 months</p>
F-13	Egress	<p>The main egress door serving the Office area on the 1st floor does not swing in the direction of egress travel.</p>	<p>Modify the egress door to swing in the direction of egress travel.</p>	<p>Within 3 months</p>

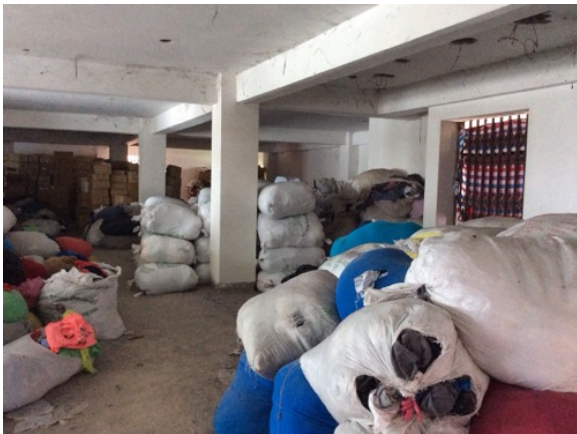
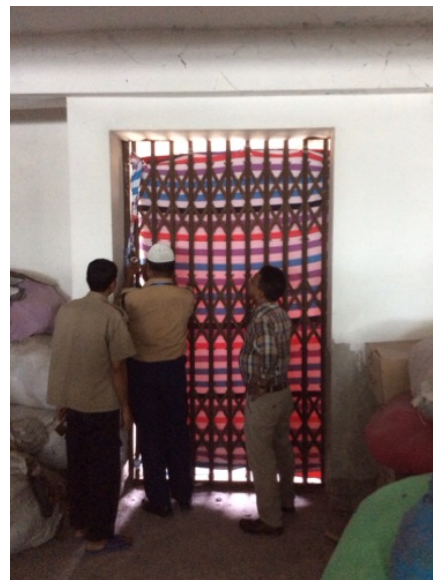
F-14	Egress	<p>The exits are not remotely located from each other such that a single fire event could compromise both exits.</p> <p>The Southern exit stair was found to be locked on the 1st and 7th floors. On these floors the Northern and Western, being the only functional stairs on the floors, were found to be non-remote.</p>	<p>Modify exit arrangement and insure that the Southern stair is usable on the mentioned floors.</p> <p>Provide sprinkler protection in accordance with NFPA 13.</p>	<p>Within 3 months</p>
F-15	Egress	<p>The egress path to the southern exit stair (7th floor) has to go through an area of increased hazard (combustible storage).</p>	<p>Provide 1-hr fire rated passageway that provides safe access to the Exit stair.</p>	<p>Within 3 months</p>

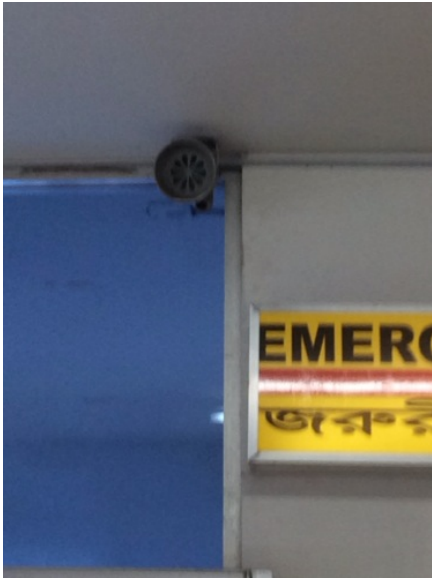
F-16	Fire Protection	The fire alarm system is antiquated, not a listed system, and does not provide alarm and notification features consistent with acceptable standards.	Replace the fire alarm system with a new, listed addressable fire alarm system in accordance with NFPA 72.	Design within 4 months, install within 9 months
------	-----------------	--	--	---
